**NANSEN ROAD ENGINEERING & CONSTRUCTION**  
**PRELIMINARY STUDY**

July 1988

July 14, 1988  
File: 186-001-40

**RE: Preliminary Engineering & Construction Study for the Mt. Nansen Road from  
Carmacks to Approximately Km. 55**

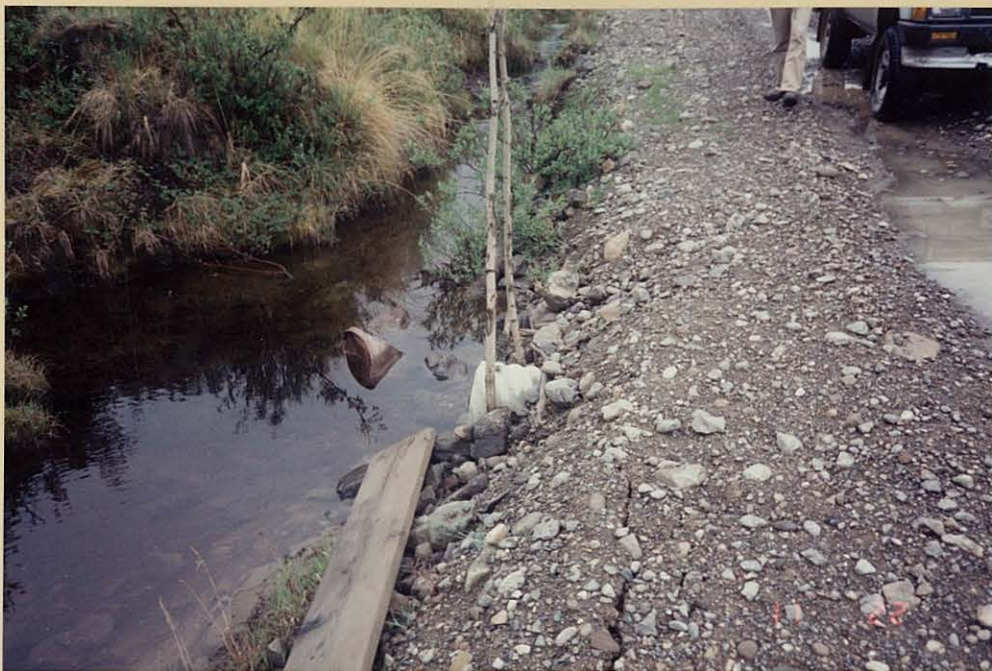
1. Km. 16.3. Drainage work site

- Km. 16.3: This has an existing 400 mm Ø culvert which requires lowering approximately 0.2 m. There are some signs of incipient grade failure, thus, it may require 20-30 m<sup>3</sup> imported fill for repairs.

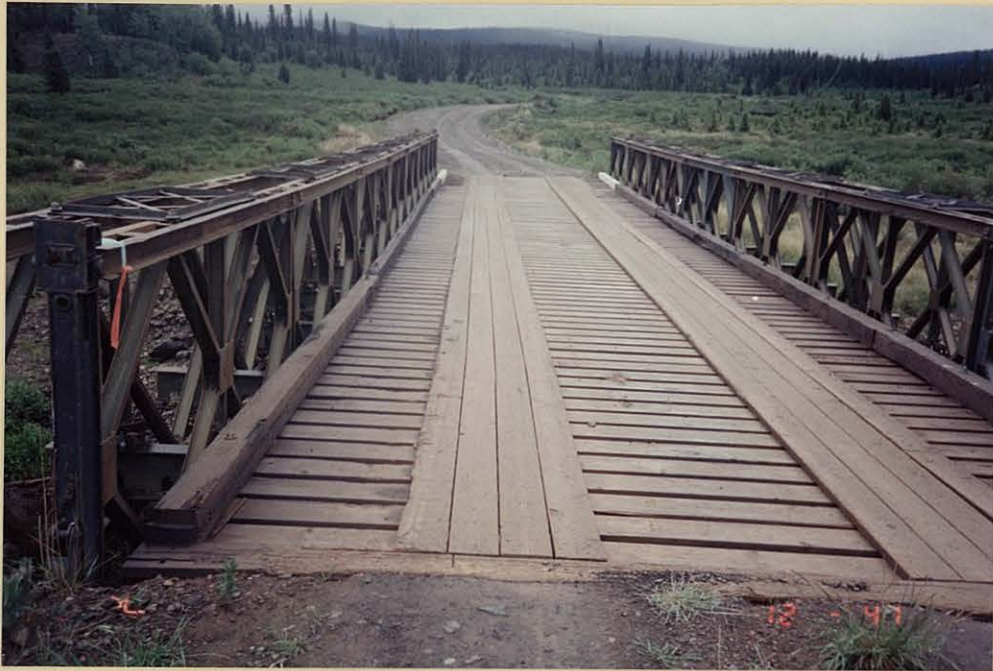
5. Km. 30. Rowlinson Creek, 70-ft.  
Bailey bridge D.S.

- The bridge is of "double single" (D.S.) configuration with light construction in that there are only two transoms per 10 ft. bay of bridge (Class 40).
- Span is 70 ft. from end bay post to post.
- Deck has transverse timber (2") on stringers with in line decking (2") forming a double trackway.
- Transom clamp(s) missing.
- West landing bay transom is being stressed and has sustained damage through live load end reaction.
- Inadequate grillage or bearing plates under all end posts.
- Improper bearings too close to slope line of each bank.

Long term recommendations include an upgrading of the bridge's class or configuration. We suggest that the bridge be converted to a double single reinforced configuration (D.S.R. in tables). This entails the application of chord reinforcement (top and bottom) of all trusses with the exception of trusses contained in each landing bay (the first bay of bridge at each end of the bridge). The D.S.R. configuration also requires the application of 4 transoms per 10 ft. bay; therefore, two more transoms per bay will be required.

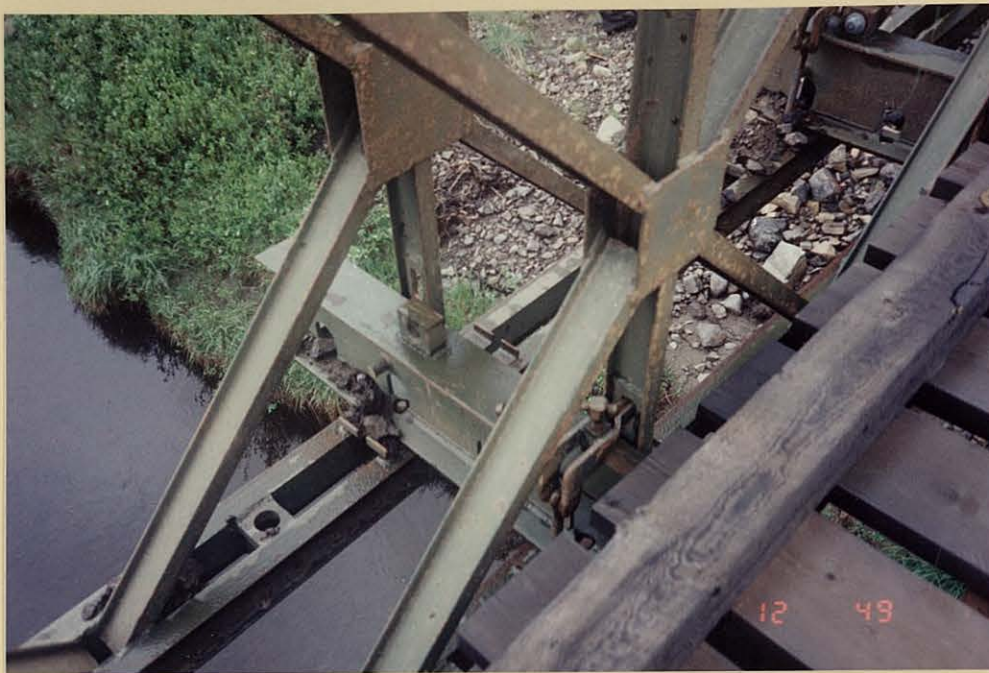
7. Km. 30. Rowlinson Creek Bridge - missing transom clamp

- Replacement of missing transom clamp(s)
- Tightening of all bracing components in sequence. i.e. rakers, bracing frames, transom clamps and sway braces
- Replacement of missing sway braces - every bay of bridge requires these. The sway braces are critical to the health of this structure. When carrying out the sway bracing operation, each bay should receive incremental tightening throughout all bays of the bridge in the same period of time.

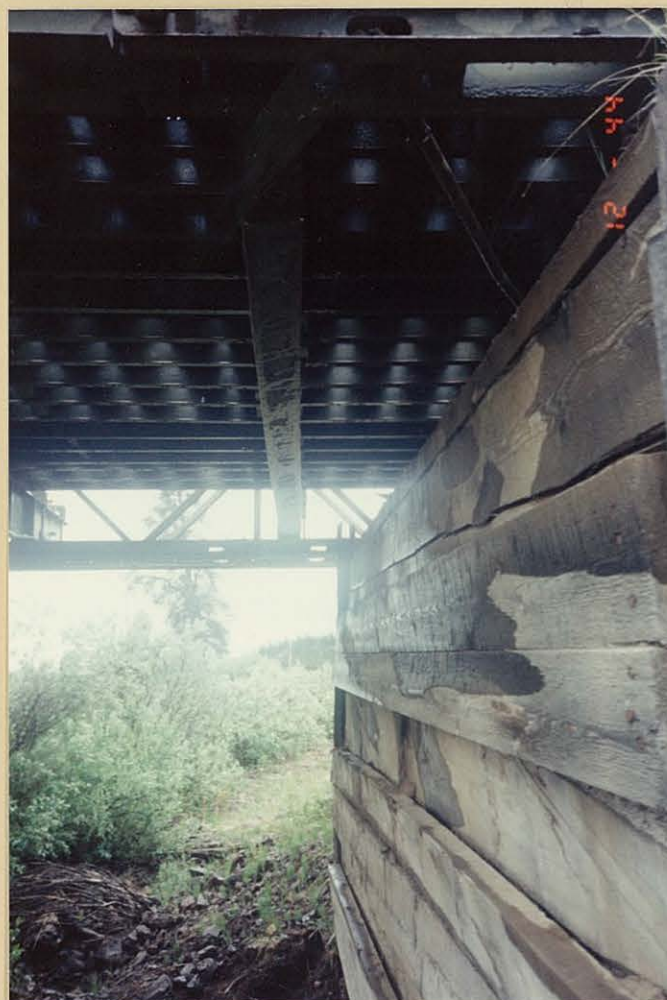
8. Km. 30. Rowlinson Creek Bailey bridge

It is difficult to say whether our design live load (worst case) has ever been applied to the structure, however, we do know that the landing bay transom on the west end has been bent and is torqueing about its X axis. It is thought that the damage is the result of a combination of shear and live load end reaction.

Note: Stressed transom forward of crib.

Due to the poor bearing situation at each end of the bridge, it is recommended that rock filled cribs be constructed. This will serve three functions; namely, to stabilize the bank under and forward of the bank seats, and to provide adequate surface under the end post bearings for improved load transfer to the soil. The third function served will be discussed in the following.

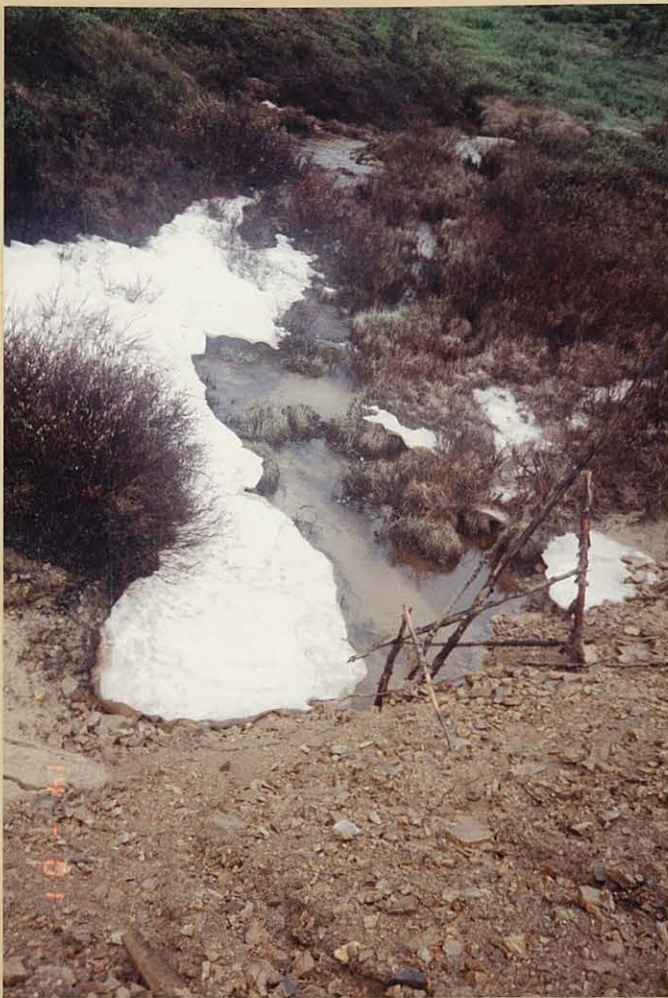
12. Km. 44.8. Drainage  
work site

- Km. 44.4: Requires the installation of 4-600 mm Ø CMP, possibly supplemented with 30-40 m<sup>3</sup> imported fill. Imported fill is close by.
- Km. 44.8: Constitutes a major creek crossing with a deep fill containing a 36" Ø CMP. There is 24" Ø CMP overflow culvert with its overt barely covered by the road crown. Examination indicates the likelihood of past problems with this crossing. It is recommended that a 1000 mm Ø CMP be installed beside the existing 36" Ø CMP and that the 36" Ø structure be extended 2.5 m on both the inlet and outlet ends. The road carriageway is just over 4 m in width at the narrowest point in the fill and the shoulders show sign of incipient failure. As well, the fill material has steeper than a 1-1/2:1 fill. Accordingly, it is recommended that the road be widened at this point and the side slopes formed to a more stable angle of repose. Rip rap or armour should be placed around culvert ends and slope toes with special attention to CMP inlets and the upstream toe of the fill. It is suggested that heavy rip rap (shot rock) placed initially in a bed about the toe of the slope (at the appropriate off set to accommodate the proposed angle of repose) would enhance the efforts to widen the carriageway and flatten the side slopes. Proper fill estimates would require a detailed survey; however, a cursory estimate indicates a minimum requirement of 150-200 m<sup>3</sup> of fill which may be acquired adjacent to the site. This does not include the heavy rip rap which will have to be imported from elsewhere. (See Km. 41.2, possible quarry source - borrow pit list.)

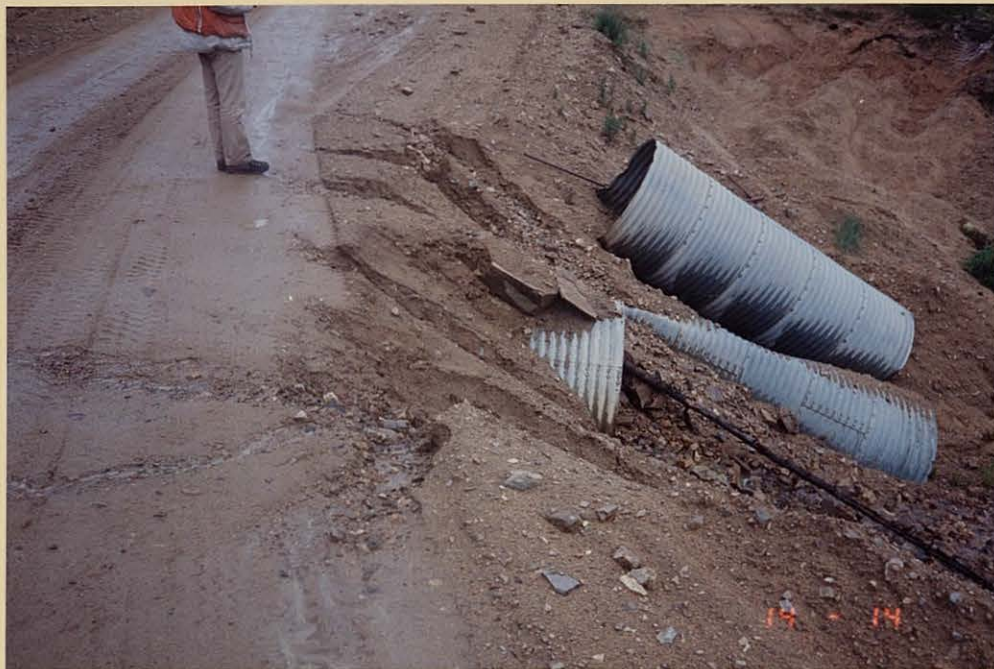
14. Km. 46.7. Drainage work site

- Km. 46.4: Requires replacement of a 16" Ø CMP with a 600 mm Ø CMP. Ditching is also required at this location.
- Km. 46.7: Has a 40" CMP in place. The structure is within unstable fill. Recommendations include removal of the culvert, excavation of the existing grade, replacement with course pit run (approximately 300 m<sup>3</sup> volume), replacement of the 40" CMP at the appropriate grade and rip rap the inlet and outlet ends. Ditching in this location is also required.

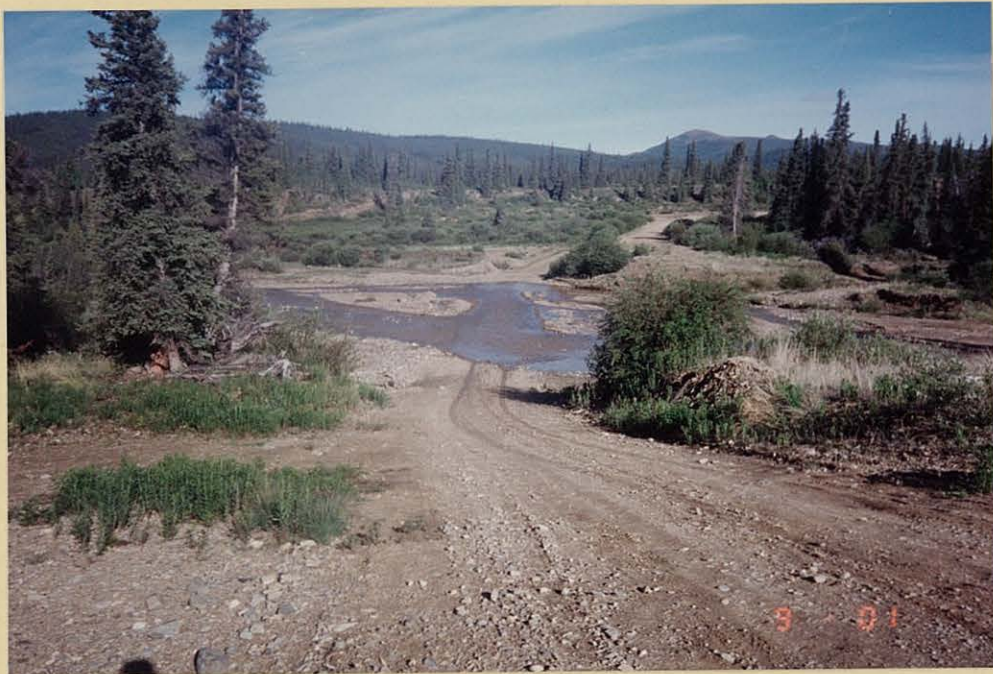
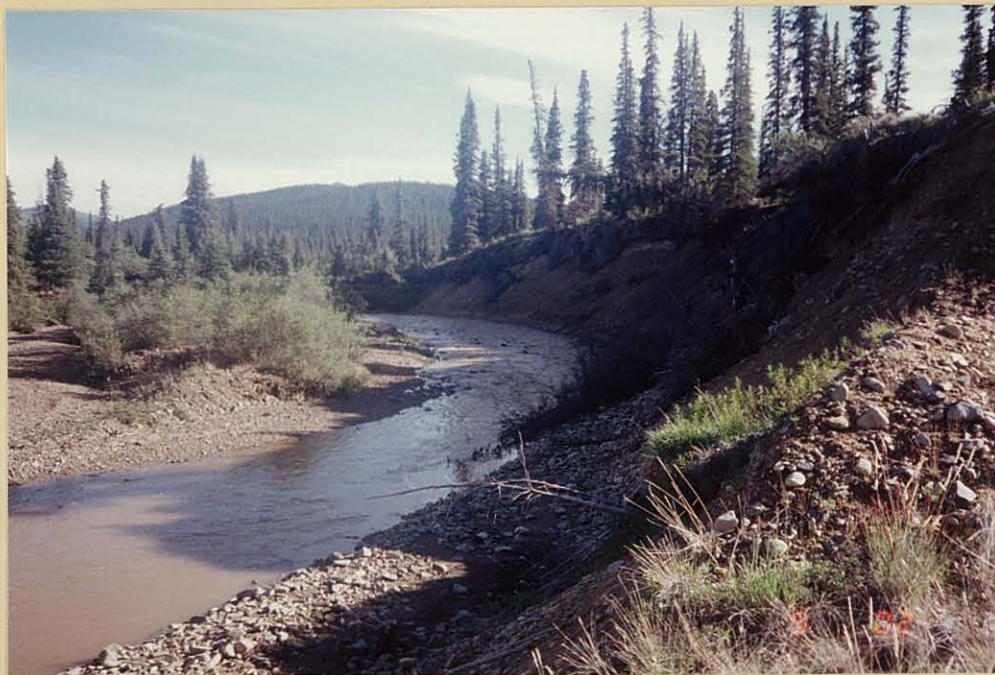
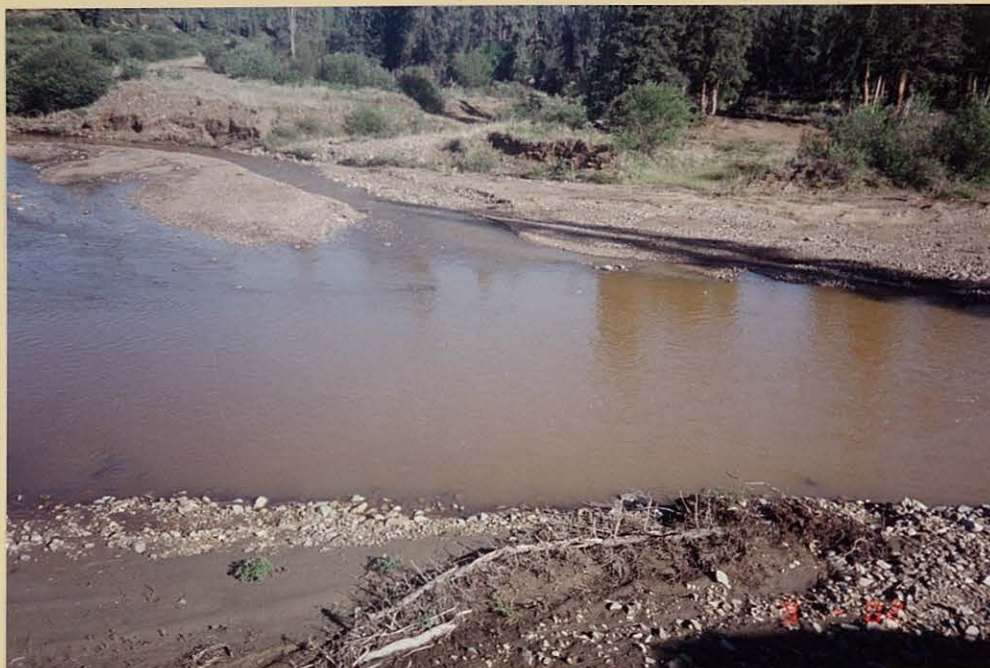
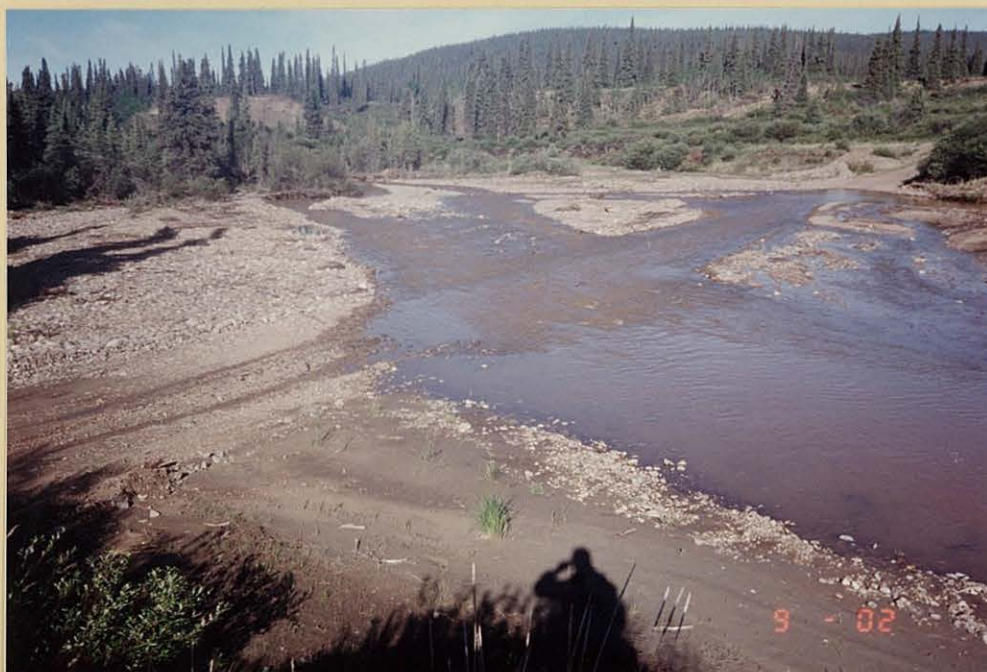
As described previously, Victoria Creek is crossed by means of a ford. Although the writer is not aware of spring conditions, the ford appears stable and able to handle the traffic presently using the road.

17. Km. 53.1. West aspect from east bank of ford  
at Victoria Creek

18. Km. 53.1. Looking upstream from east bank  
of Victoria Creek

19. Km. 53.1. Looking east to west immediately north of ford centreline. Note previous approach development on far bank (west) in left background. Victoria Creek

20. Km. 53.1. South southwest aspect from east bank looking downstream. Ford crossing photo centre. Victoria Creek

It is not within the scope of this report to examine or make recommendations for a crossing structure as this area will require a detailed survey and analysis. It can be said that any structure in this location will require considerable rip rap or armour around the structure and on the east bank for some distance upstream. This crossing point is on a curve and also a transition point from a narrow channel on the upstream side to a widened and braided area downstream.
