### **PROJECT MEMORANDUM**

<b>To:</b>	<b>Faro Mine Closure Planning Office</b>	<b>Fax No.:</b>	<b>Via e-mail</b>
<b>Attention:</b>	<b>John Brodie</b>	<b>CC:</b>	<b>Rock Drain Working Group</b>
<b>From:</b>	<b>Selina Tribe, Gerry Ferris</b>	<b>Date:</b>	<b>July 7, 2006</b>
<b>Subject:</b>	<b>Natural Hazard Terrain Assessment – NFRC and South Slope RCDC</b>		
<b>No. of Pages (including this page):</b>	<b>14 + Figures &amp; Appendices</b>	<b>Project No:</b>	<b>0257-031-01</b>

This memorandum provides a summary of the natural hazard terrain assessment performed for the North Fork Rose Creek (NFRC) basin and the natural slopes above the Rose Creek Diversion Canal (RCDC). In this study, only those natural hazards visible on airphotos within these two specific areas are addressed. There was no site reconnaissance carried out in conjunction with this phase of the assessment. This assessment of past performance (via historical airphotos) is thought to give an indication of the future performance within these two areas. This study does not provide a landslide hazard map for the basin (TBR 1996) nor address the various potential man made hazards within these basins (such as those from the c

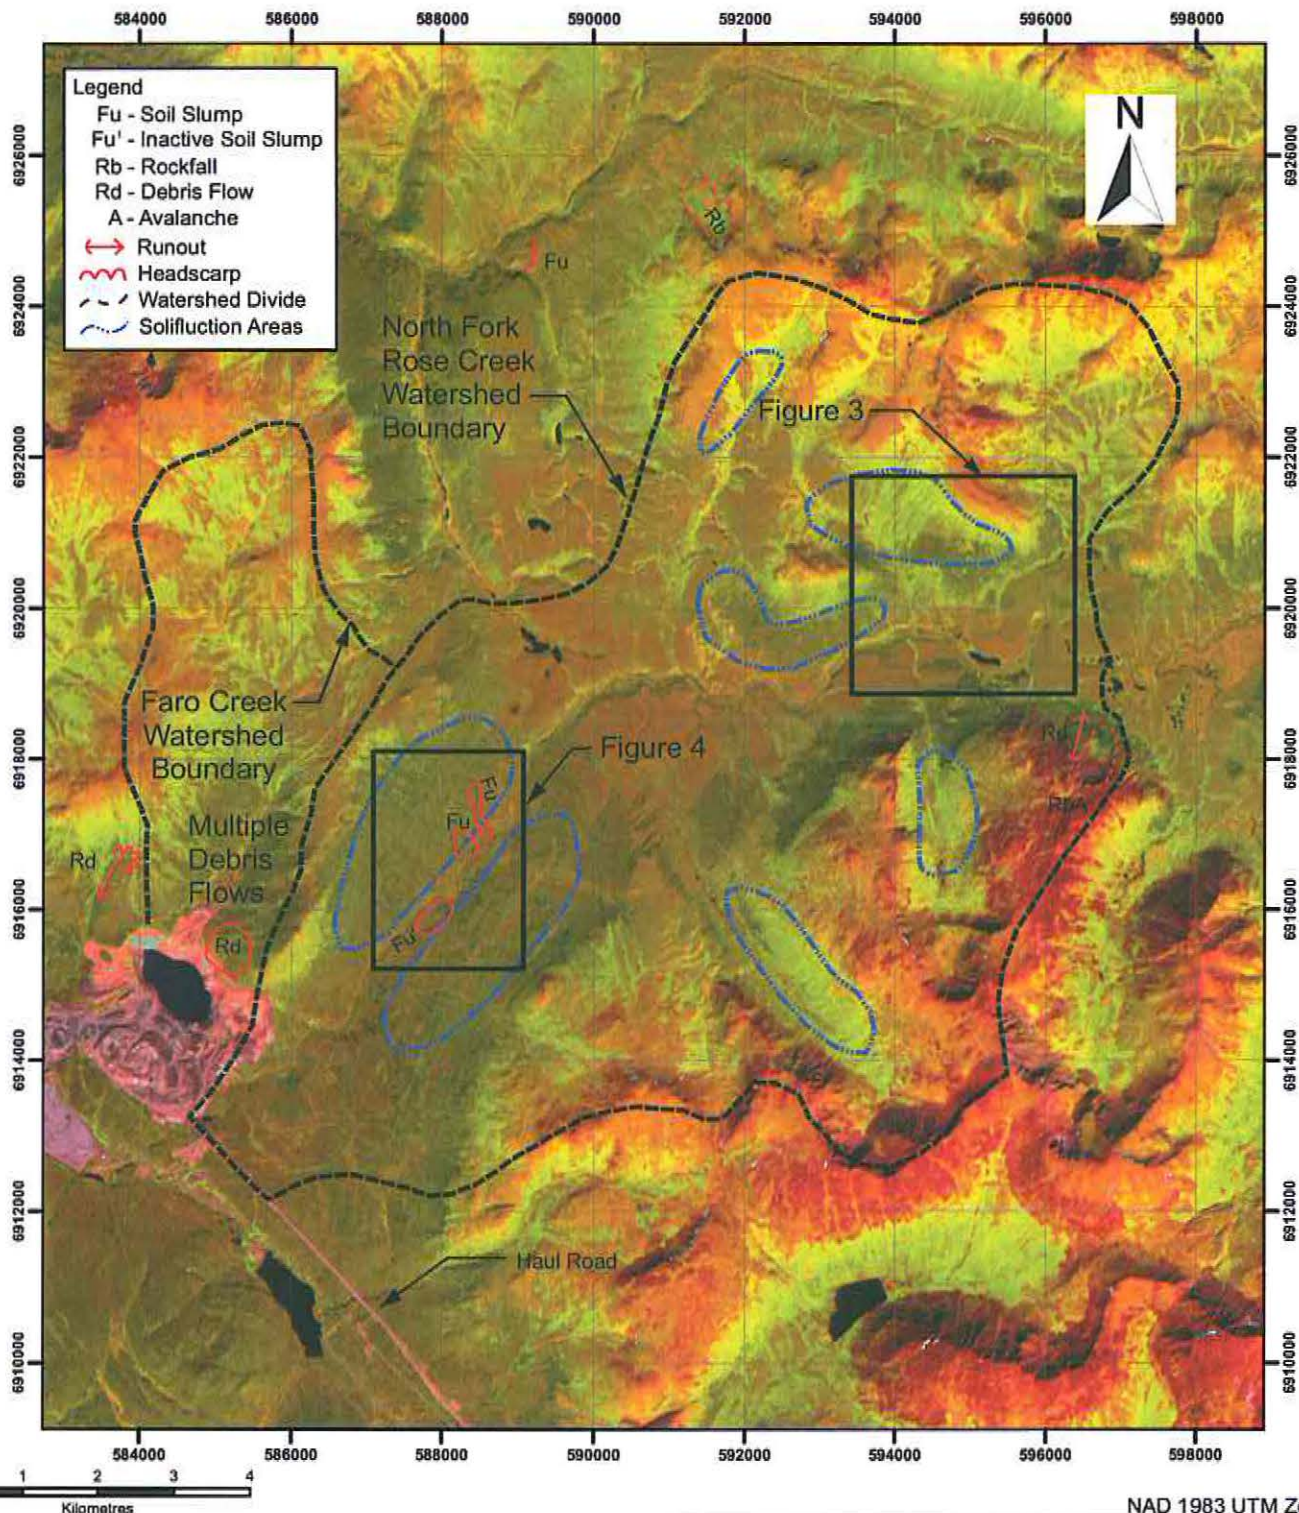
FIG No.  
**1**

The North Fork Rose Creek Valley has moderate to high relief, comprising the mountains of the Anvil Range and an upland plateau (Figure 1). The upland plateau has been deeply incised by glacial erosion, rivers and streams. Numerous glacial cirques interrupt the rolling plateau surface to form biscuit-board topography<sup>1</sup>. Most of the higher elevations are dominated by bedrock with a patchy veneer of till. Weathered, frost-shattered rock is expected to exist at the bedrock surface. An overview of the North Rose Creek valley is shown on Figure 2, which was taken from the top of the waste rock dump looking toward Mt. Mye.

The locations of the active and inactive geomorphic processes in NFRC basin are shown by polygons and symbols on an overview map (Figure 1). Terrain symbols used are given in Table 3.

A group of at least four (4) debris flows (Rd) were observed on the 1971 photos which appear immediately adjacent to road cuts on steep slopes just east of the open pit. They are mapped on air photo A22406 #60 and the area is indicated on Figure 1 above the Faro Pit. Recent air photos (2003) do not show instability in that area. Also, no instability was noted in the air photos dating from 1949 (A12203 #395 and 396). It is likely that these debris flows were a direct result of the exploration roads that were cut in the mountain side. A few additional debris flows were identified elsewhere in the basin on steep valley slopes.

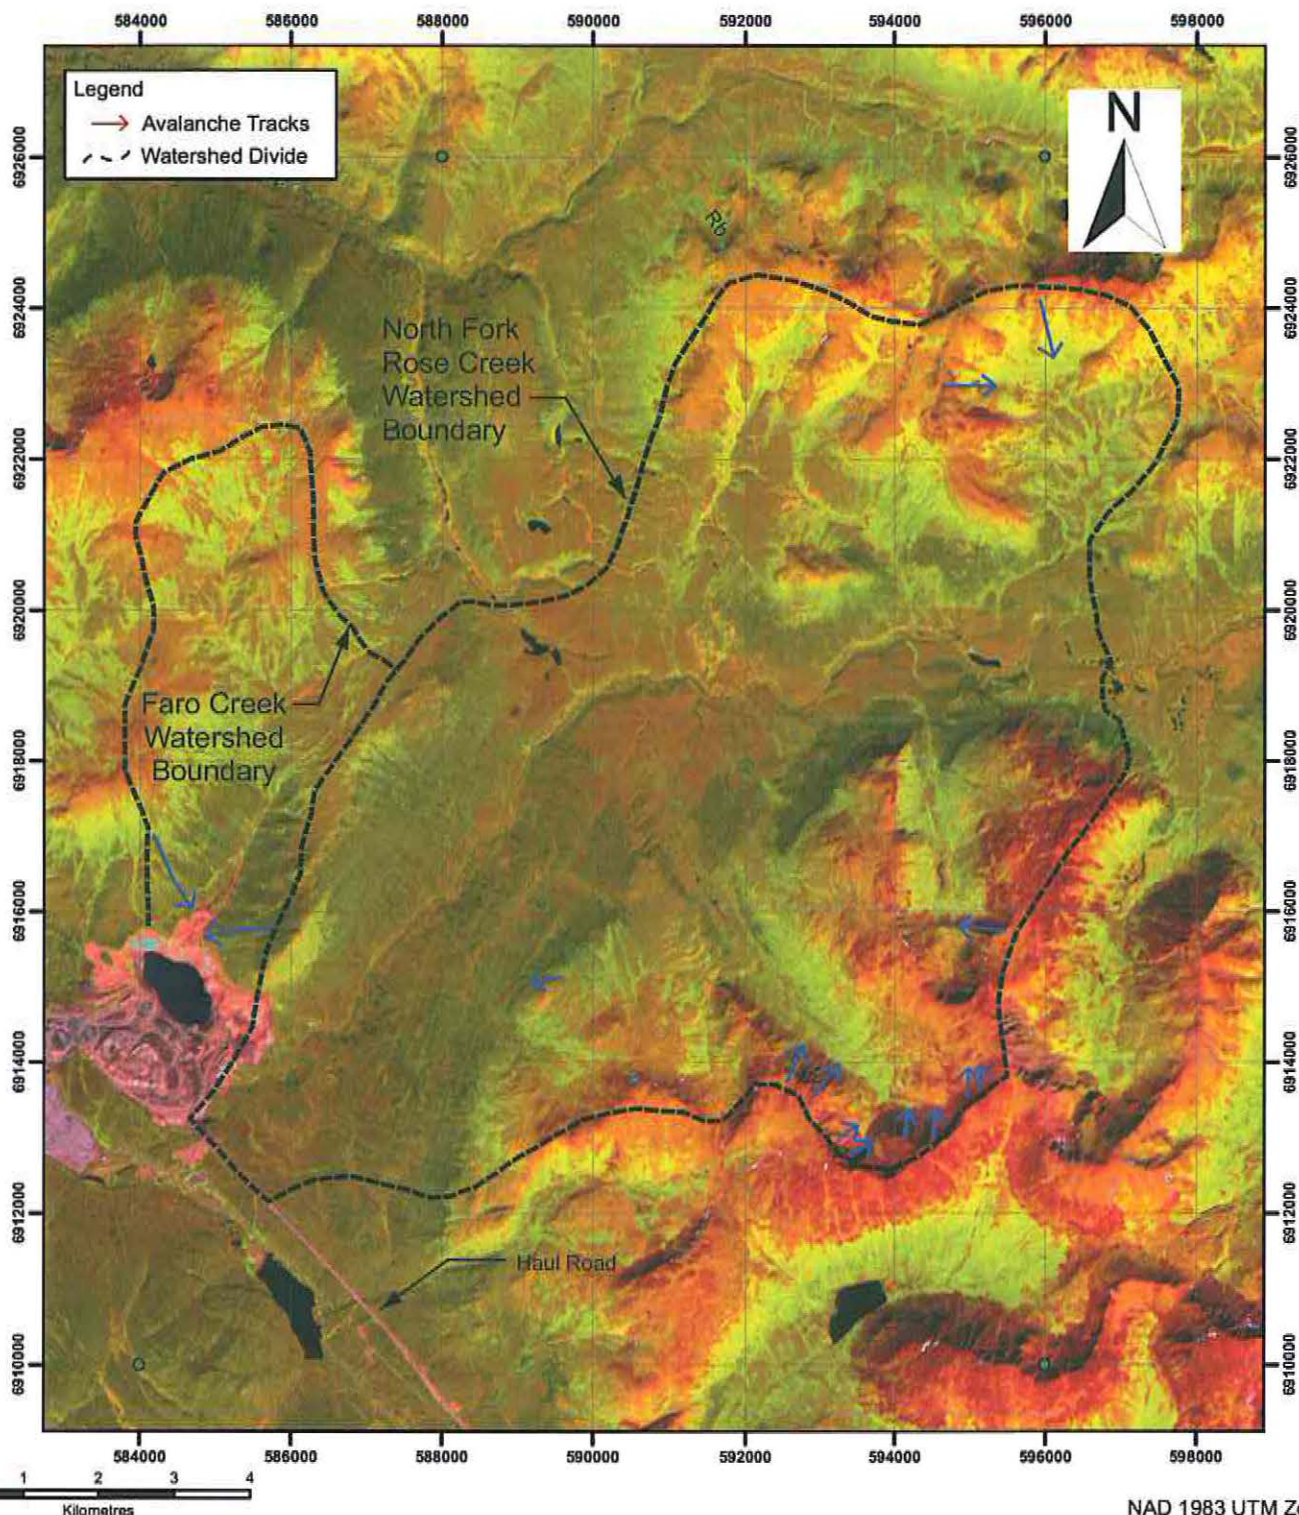
PROJECT No. <b>0257-031-01</b>	FIG No. <b>5</b>	REV. <b>0</b>
-----------------------------------	---------------------	------------------

Snow avalanche tracks occur throughout the study area, especially in regions of steep relief and snow accumulation zones. Many avalanche tracks do not reach the valley floor. The location of the avalanche tracks are noted on Figure 5.

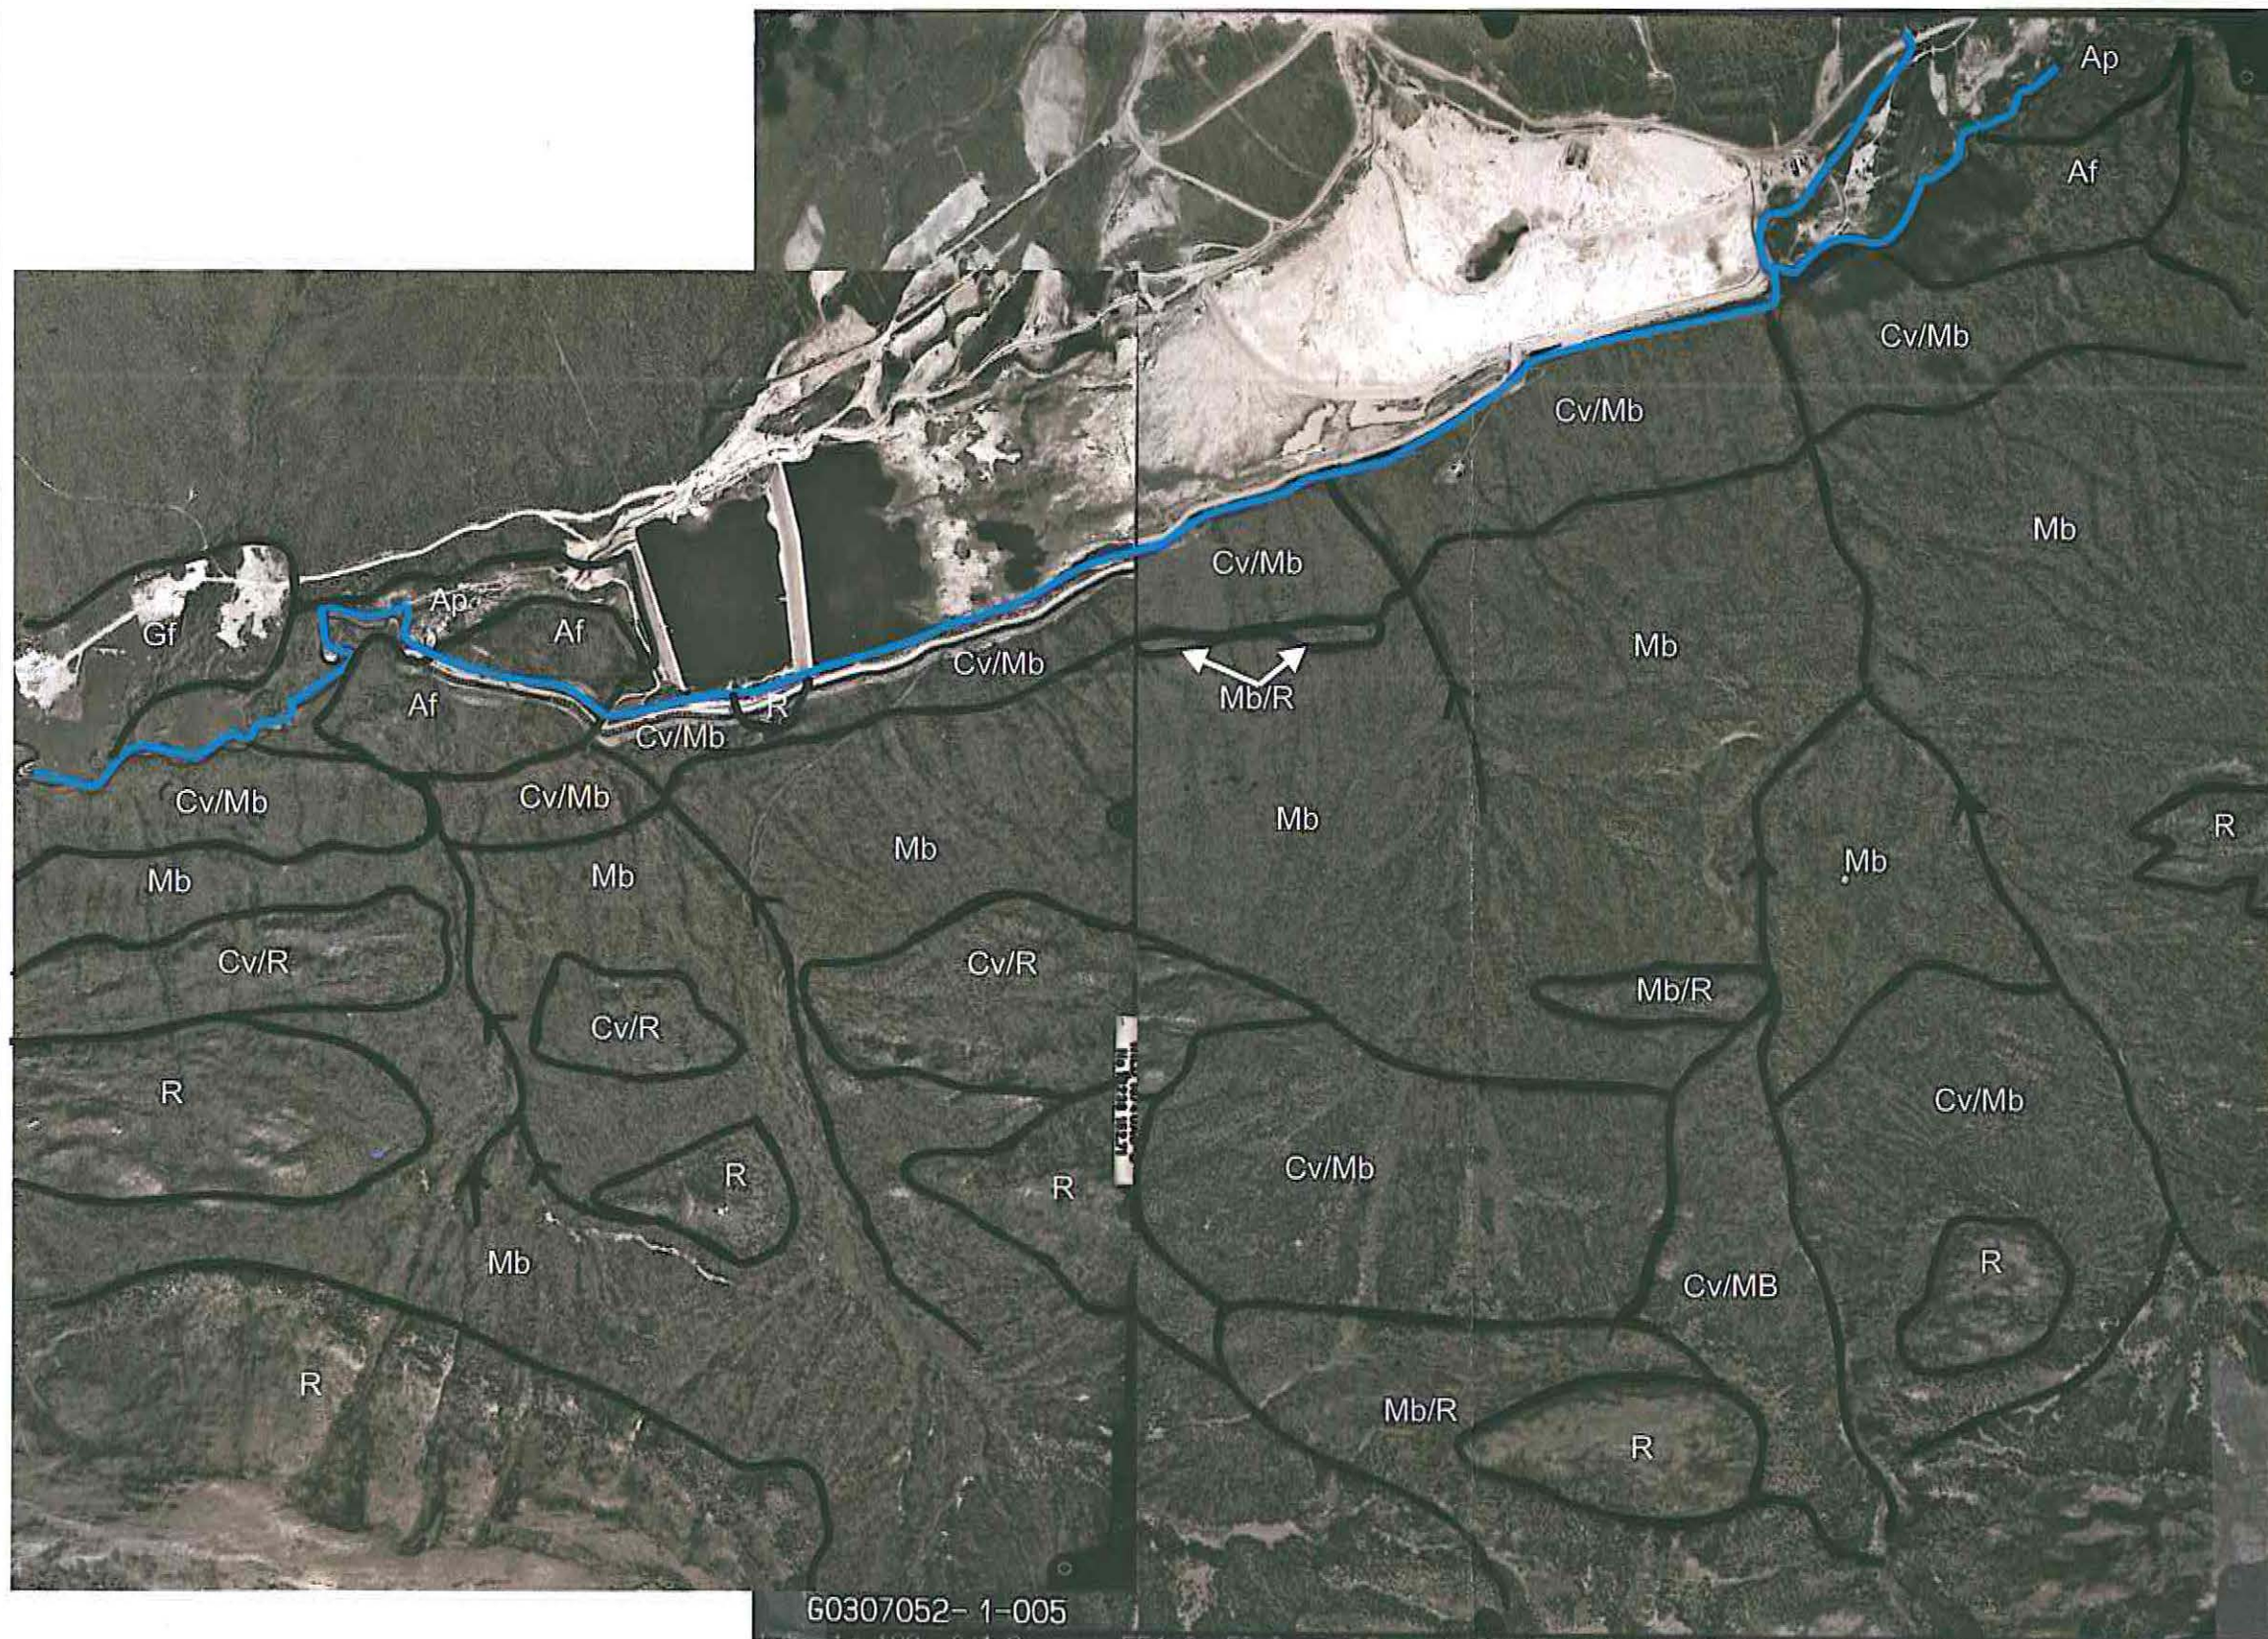
PROJECT	NATURAL HAZARD TERRAIN ASSESSMENT NFRS AND SOUTH SLOPE RCDC		
TITLE	TERRAIN ANALYSIS UPSLOPE OF RCDC		
PROJECT No.	FIGURE No.	REV.	
0257-031-01	7	0

Thick alluvial deposits are observed on the valley floor of Rose Creek downstream of the current dam locations (Figure 7 and Appendix A). These deposits are composed of interbedded sands and silts, with the possibility of some gravels and clay.

The locations of the alluvial fans along the valley wall are shown by polygons and symbols on an overview map (Figures 7 and 8). Terrain symbols used are given in Table 4

At least four (4) alluvial fans (Af) were observed on the 2003 air photos which appear immediately downstream of the Cross Valley Dam. The weir section of the RCDC appears to have been constructed on two coalescing fans that originate on the south valley wall. They are mapped on air photo G0307052-1-003 (Figure 8) and indicated on the surficial geology map (Appendix A). A review of the historical air photos (1979 and 2003) indicates that the alluvial fans have not increased in size and thickness during this period. A borehole (BGC05-021) drilled during a 2005 site investigation (BGC 2005) confirms the presence of fine-grained interbedded sediments with organic materials along distinct horizons. A few additional alluvial fans were identified elsewhere along the valley wall (Figure 7) in the vicinity of the RCDC, however, these fans were small and poorly developed.
