**NVWID OUTFALL SECTION CULVERT
AS BUILT REPORT**

FARO MINE, YT

FINAL REPORT

PROJECT NO.: 0257-026-03

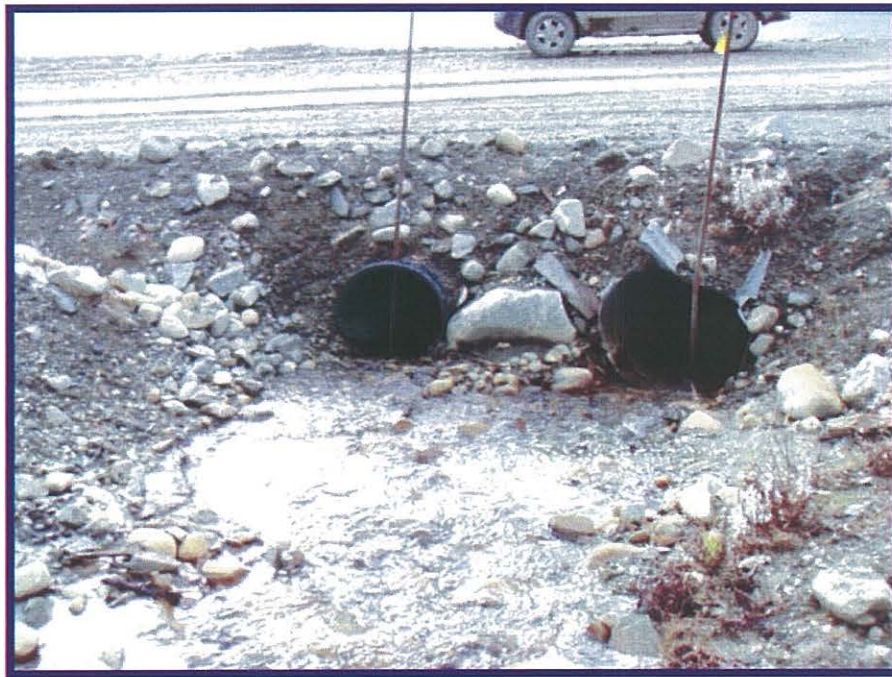
Photo 1: View of inlet of old culverts prior to construction activities.
(Photo taken September 29, 2002)

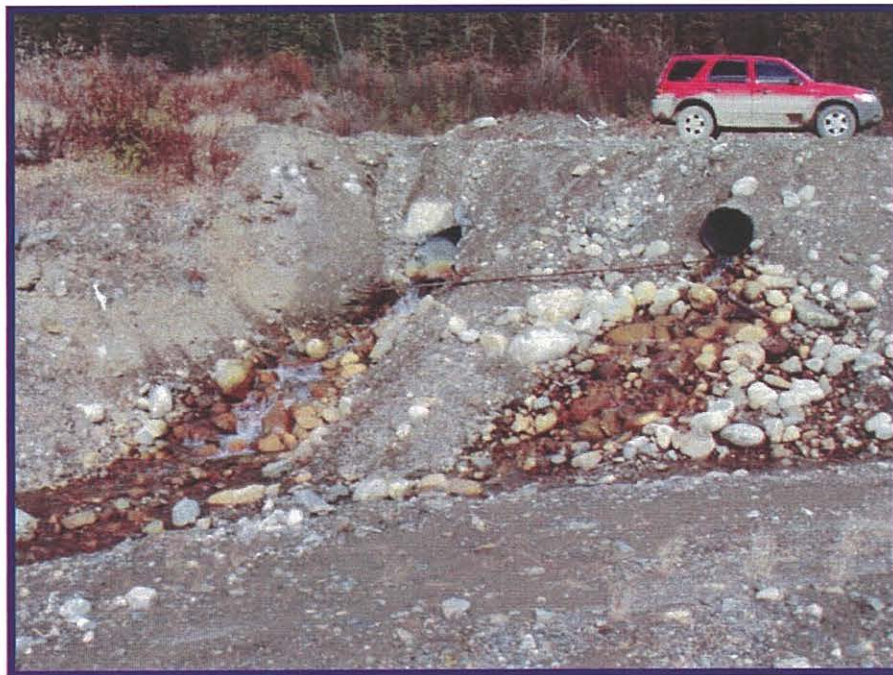
Photo 2: View of outlet of old culverts prior to construction activities.
(Photo taken September 29, 2002).

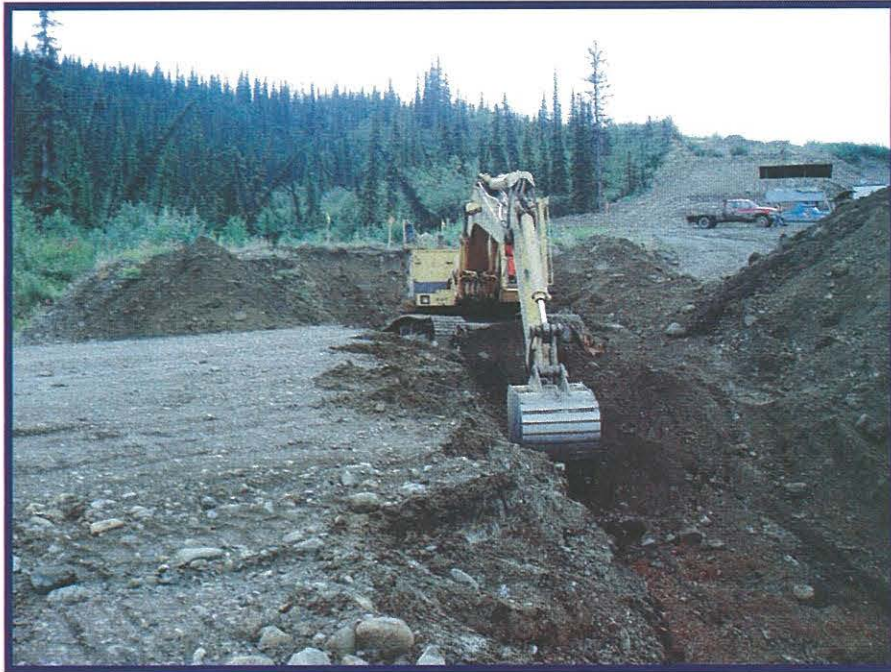
Photo 3: Starting the excavation for the culvert installation.

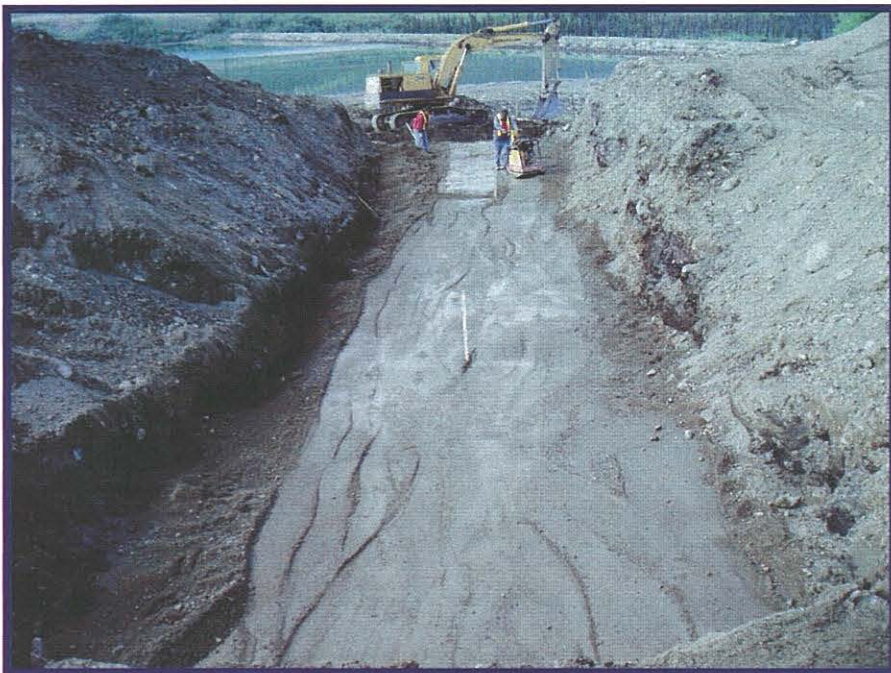
Photo 4: Compacting the sand and gravel base prior to culvert placement.

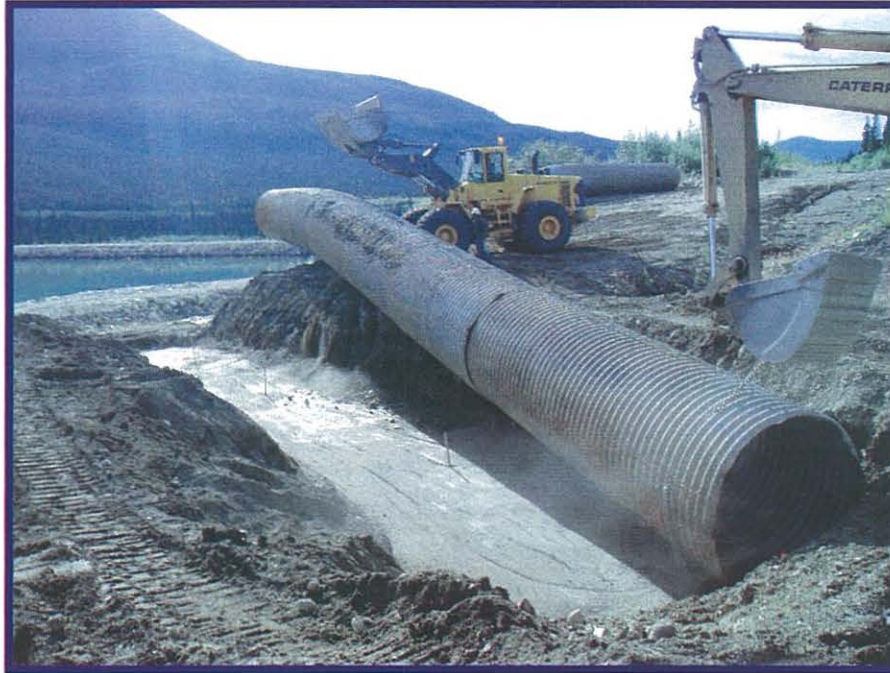
Photo 5: Placing the culvert in the trench.

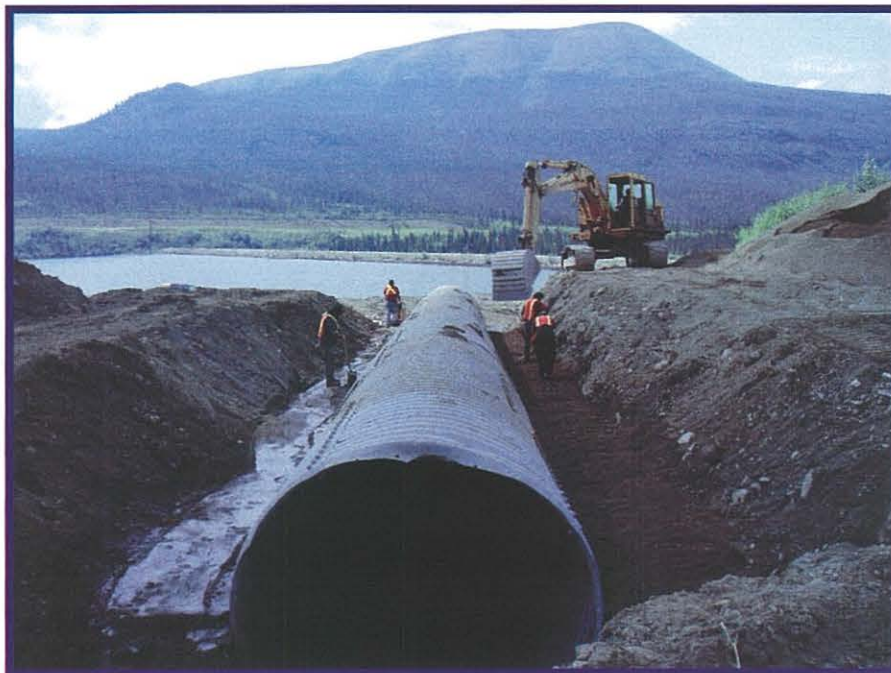
Photo 6: Placing and compacting sand and gravel along the sides of the culvert.

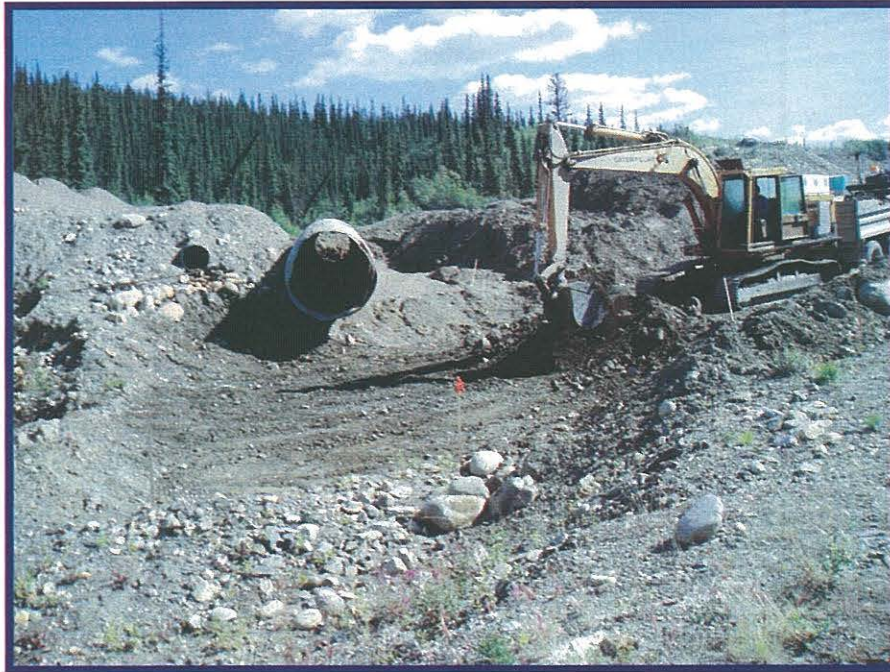
Photo 7: Excavating the plunge pool.

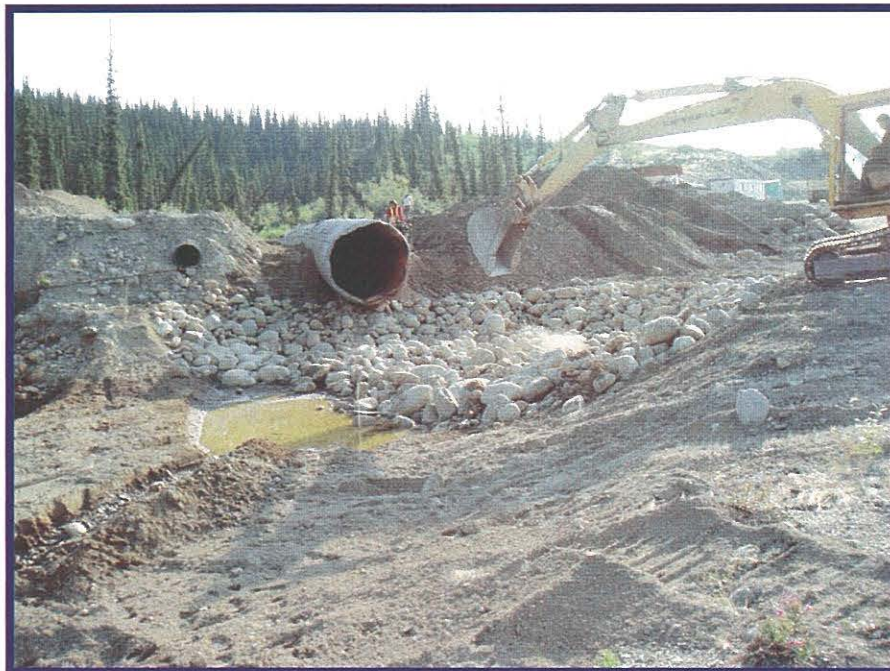
Photo 8: Placing rip-rap over sand and gravel base in plunge pool.

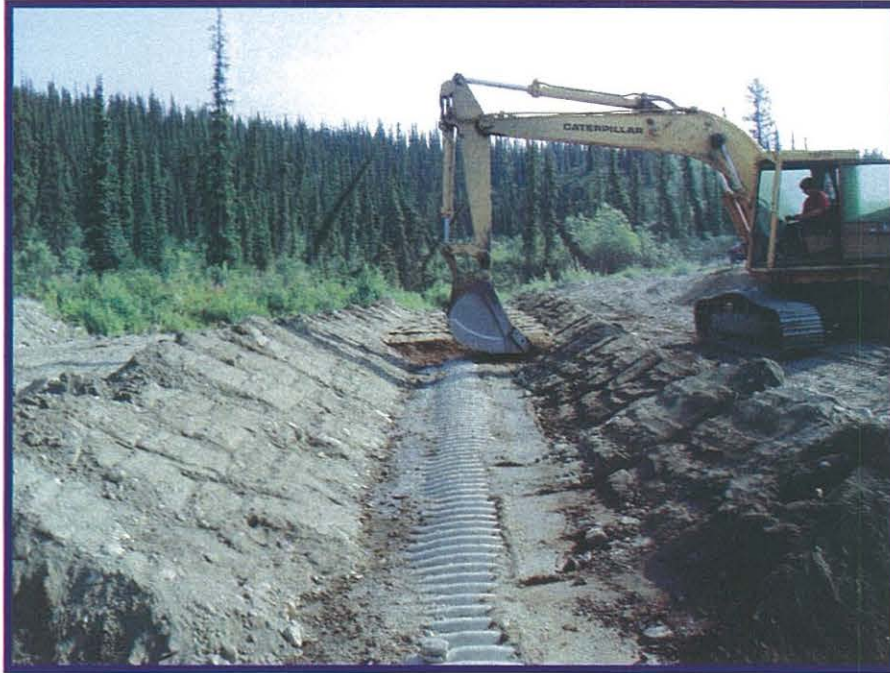
Photo 9: Placing sand and gravel over top of culvert.

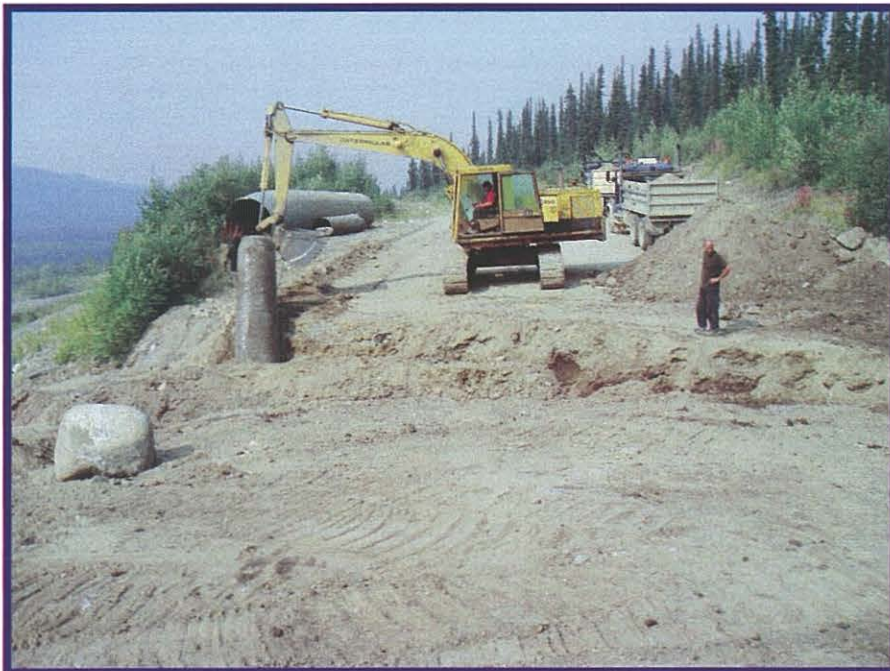
Photo 10: Removing the two old culverts.

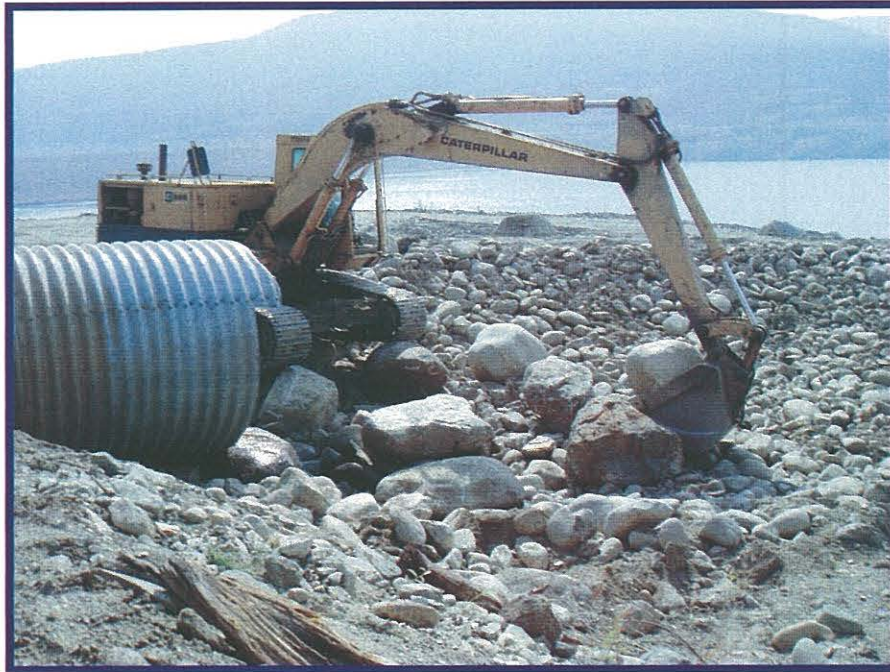
Photo 11: Placing large boulders in the plunge pool.

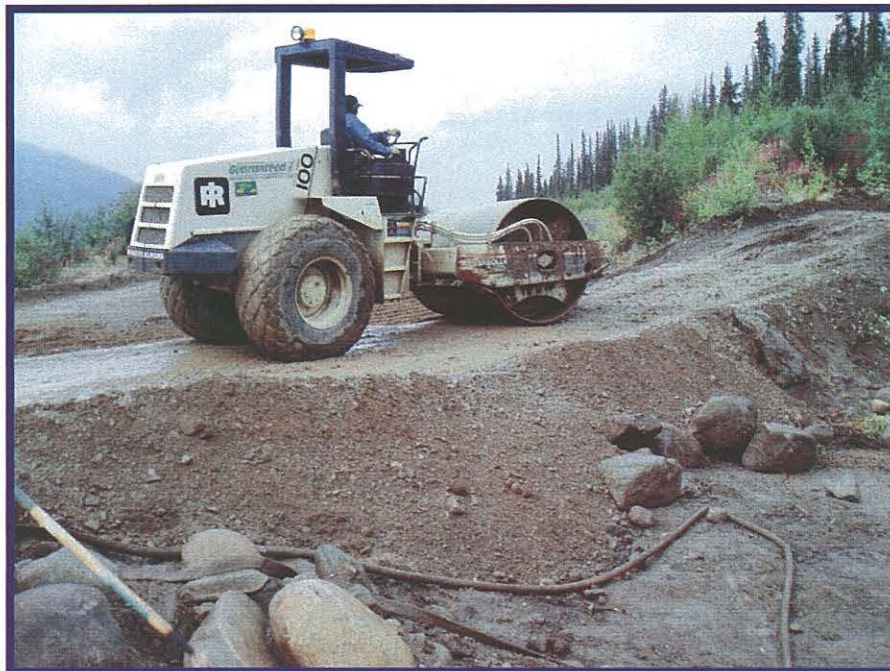
Photo 12: Compacting berm above inlet end of the culvert.

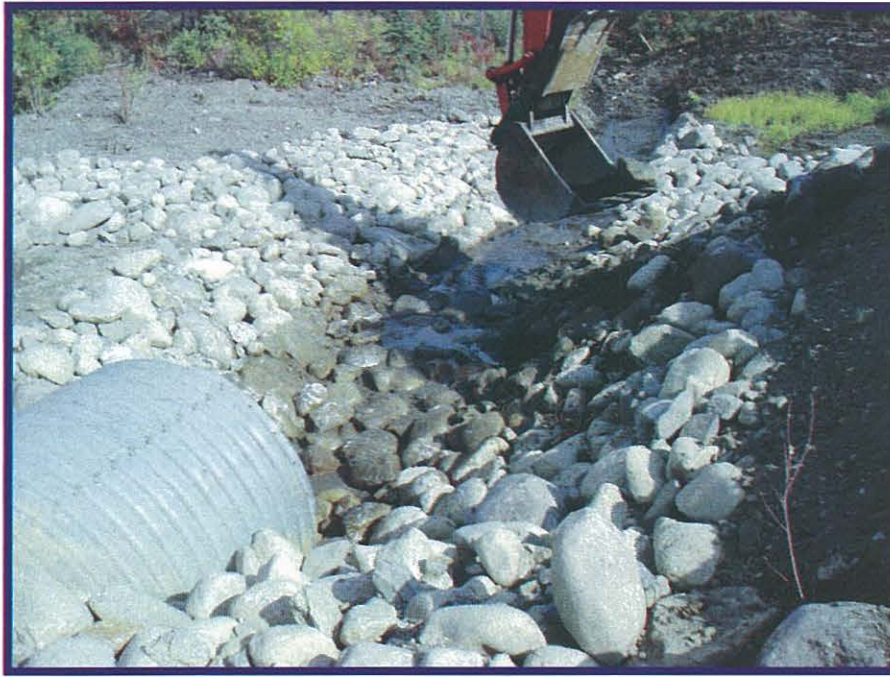
Photo 13: Placing rip-rap around inlet end.
