**Dept. of Energy Mines & Resources,
Gov't of Yukon**

**Preliminary Site Evaluation and Prioritisation
of Safety and Environmental Issues of the
Keno Hill Property, Yukon**

PR313945.001
FL313945.201
Rev. 0, July 2003

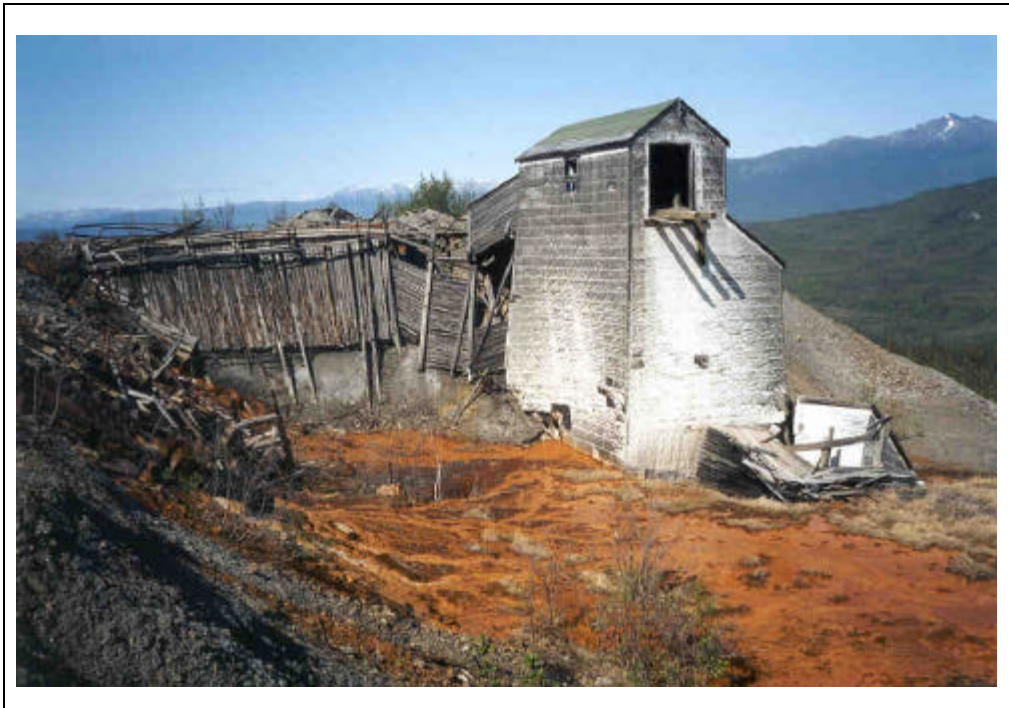
Metal loading of the aquatic system (in particular Galkeno 300). The Galkeno 300 adit is currently discharging water containing approximately 123 ppm Zn to the environment at a rate of 40-50 L/sec. The flow in 1996 was negligible. The pressure at the Galkeno 900 bulkhead should be checked to determine if excess water pressure is causing the Galkeno 300 flows. Short term action plans are to quantify the effect of this flow on Christal Creek and immediately commission an engineering study to treat the water. Primary water treatment option studies (including costs) for the Keno Hill site should be completed by Dec 2003 and appropriate treatment methodology should be in place for the 2004 freshet. The lime treatment systems at Silver King and Bellkeno should be maintained in working condition should treatment be required at short notice. In the longer term, an effective water treatment method for all the sites at Keno Hill is required. Lime treatment appears to be acceptable in the short term, however it is expensive and requires intensive management. Studies on natural attenuation and other passive systems should be continued.

Galkeno 300 mine water flowing down hill

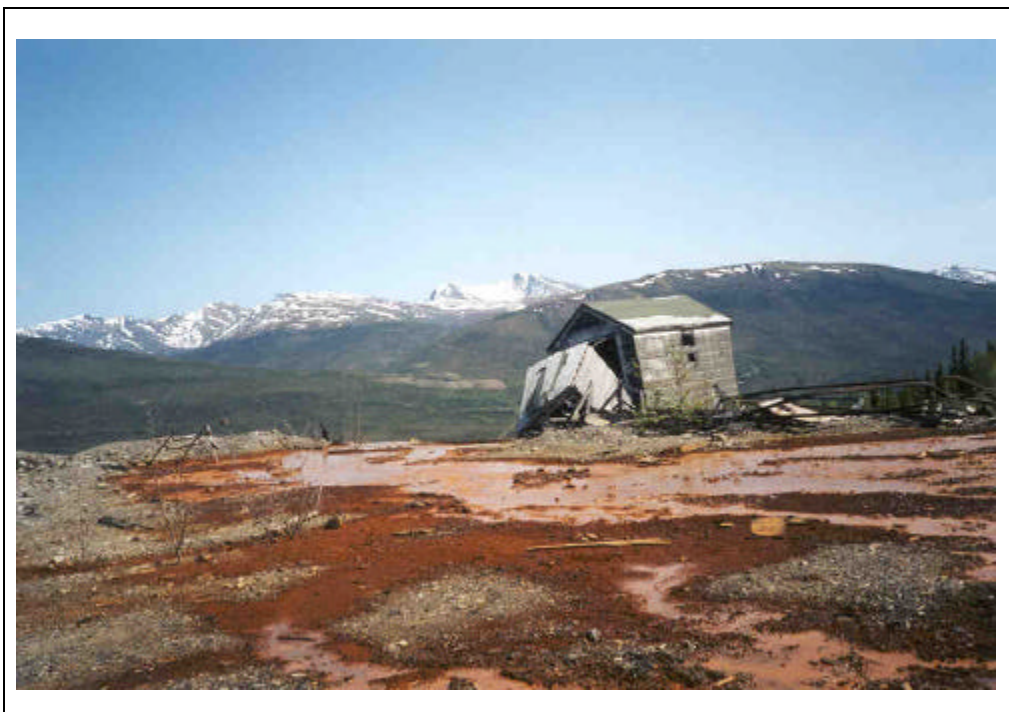
Galkeno 300 water crossing Calumet road

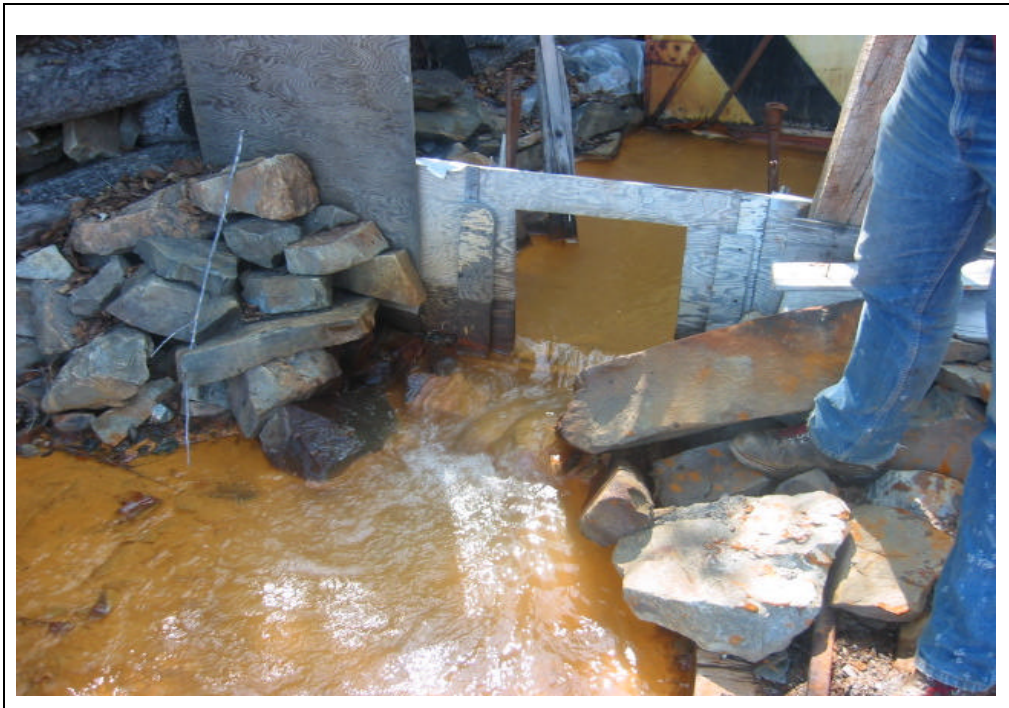
Galkeno 300 weir

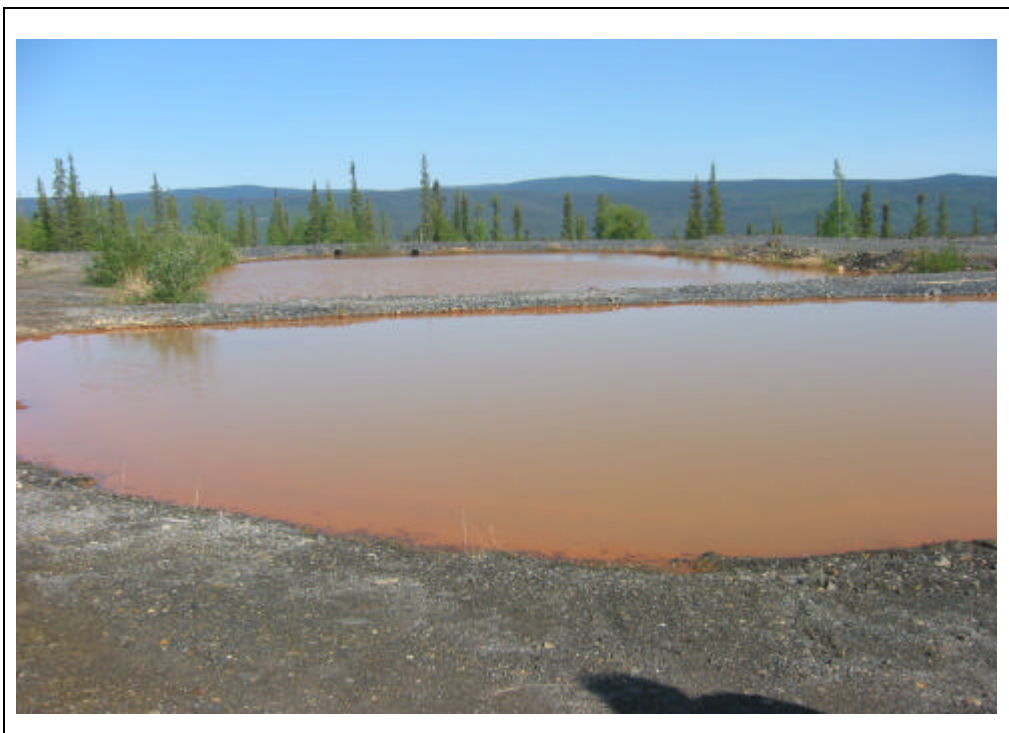
Silver King Water Treatment Ponds

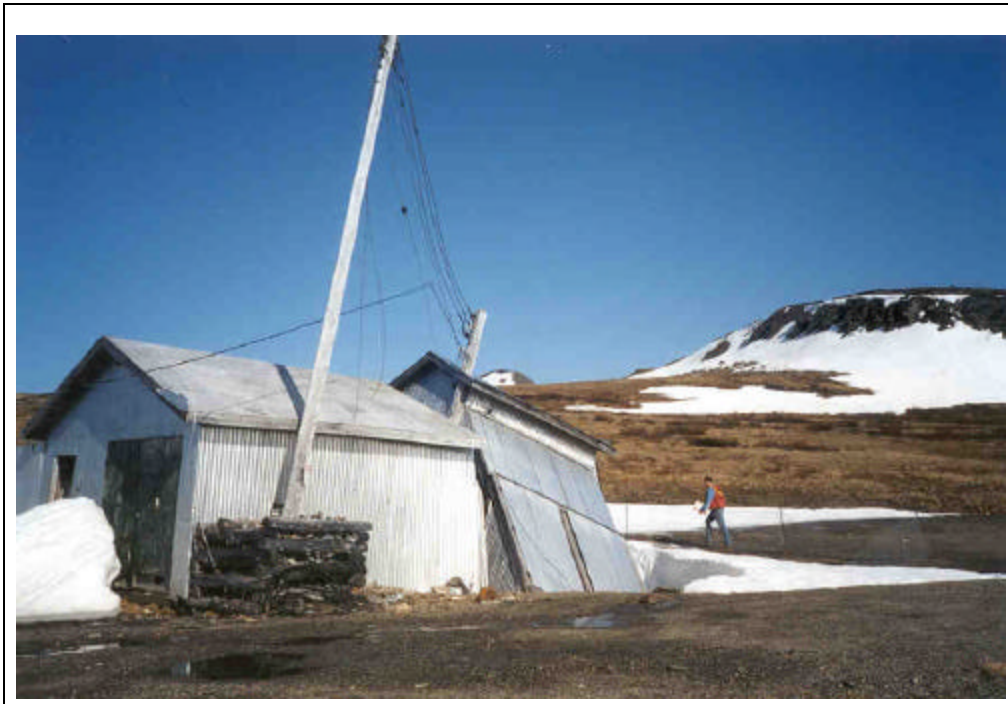
Hatch/Rescan visited a few of the dangerous sites on June 11, 2003 and photographs are presented in Appendix B. The Shamrock J skip house is particularly hazardous to the public due to its location adjacent to the popular Signpost Road.

Shamrock J Skip

Public safety is an immediate concern and as a priority all open stopes should be locked, danger signs should be posted at all dangerous sites and fences with gates erected to restrict public where possible. In the longer term, a demolition and clean up plan should be prepared including proper closure of all mine openings and removal of unsafe buildings and equipment.

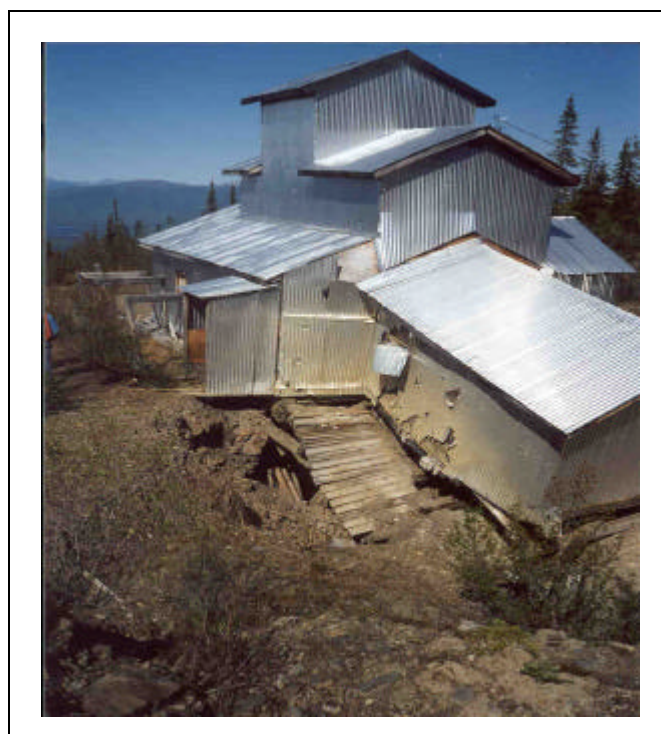
Ruby Skip

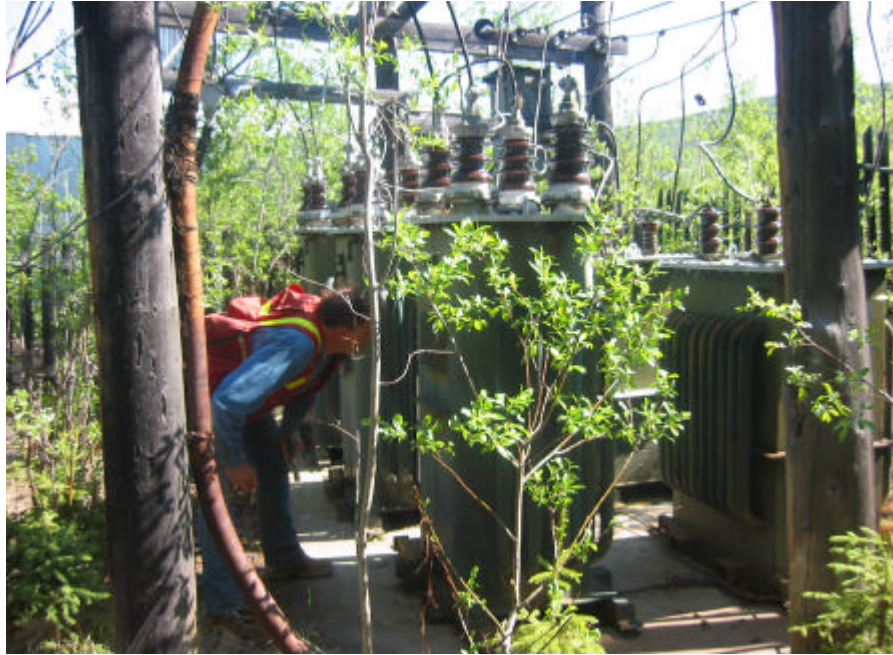
The Keno Hill site contains many obvious unused transformers and likely has quantities of capacitors and lighting ballasts that may contain PCBs. The Canadian Environmental Protection Act requires that PCB material be stored in an approved site or removed and treated. The fact that a PCB storage area exists indicates that previous owners were aware of the issues and may have already tested unused equipment for PCBs. However, this documentation was not seen. A detailed assessment and inventory of PCBs at Keno Hill will be necessary to determine if PCB storage is an issue. Should PCBs be found at site the material will have to be removed or stored in an approved facility for future destruction.

Husky Site Transformers

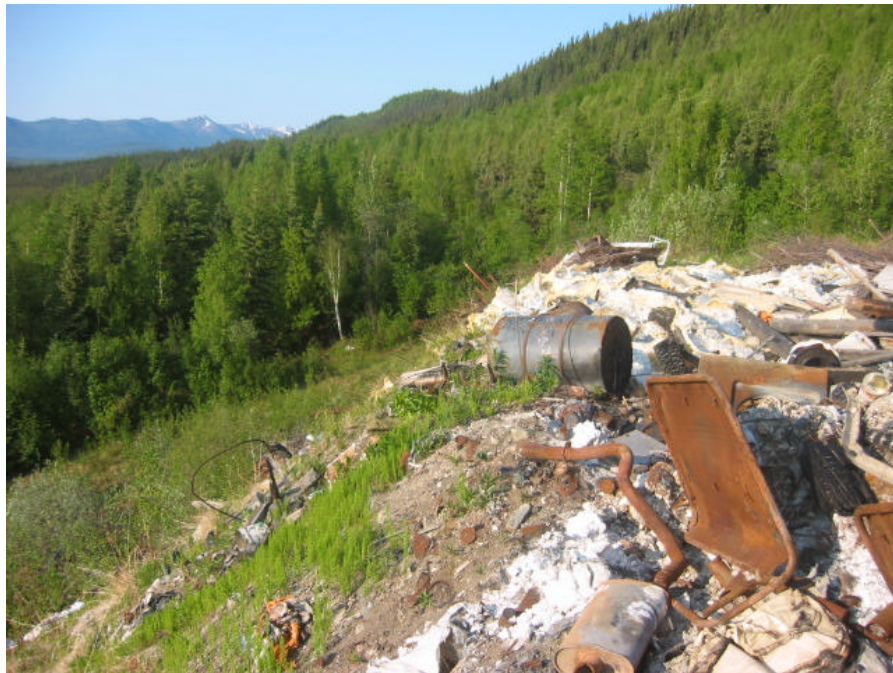
The Keno Hill property has many storage buildings containing potentially hazardous items such as chemicals, oils and lubricants. There are reportedly no explosives or cyanide on site. There are above ground and below ground fuel and oil storage tanks with evidence of spills. The PWGSC, 2000 report contains references to eight solid waste dump areas on the site containing old drums, electrical equipment, batteries, waste oil, scrap metal, rubber tires and wood debris. The major dump north of Elsa is still being used for municipal waste. The PWGSC, 2000 report presents anecdotal evidence that this dump may have been used for hazardous materials.

Elsa Garbage Dump

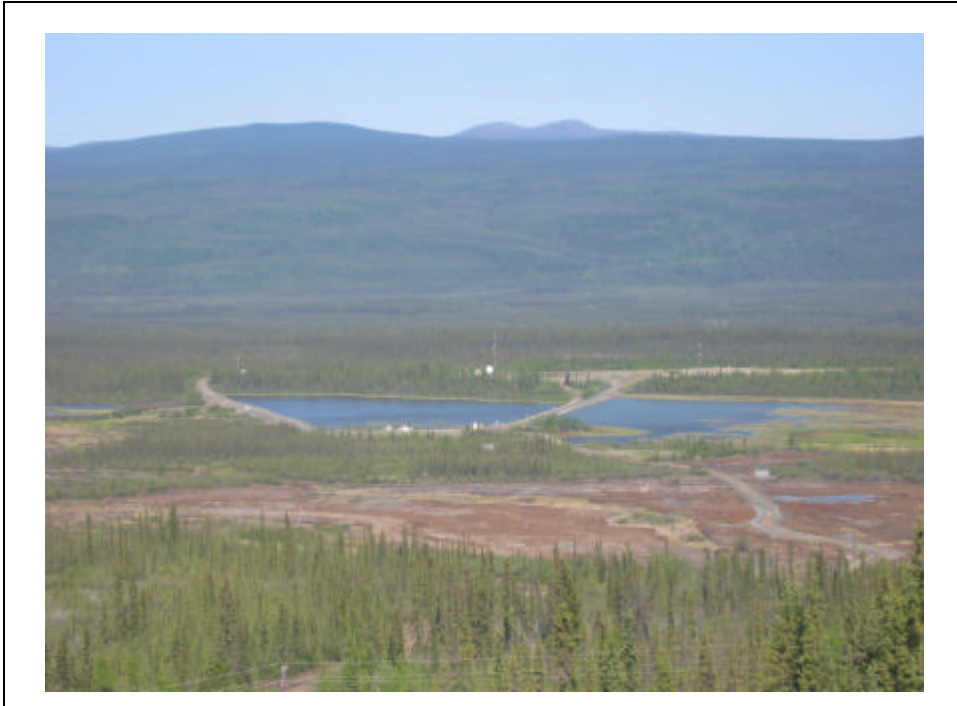
The Elsa tailings dams were built on permafrost using inadequate construction methods and have breached at least twice resulting in release of sediment to Flat Creek. The dams were classified as “marginally stable” by UKHM’s own geotechnical consultants in 1996 (Yukon Water Board, 1997: Exhibit 1.6).

Elsa Tailings Dam viewed from Calumet

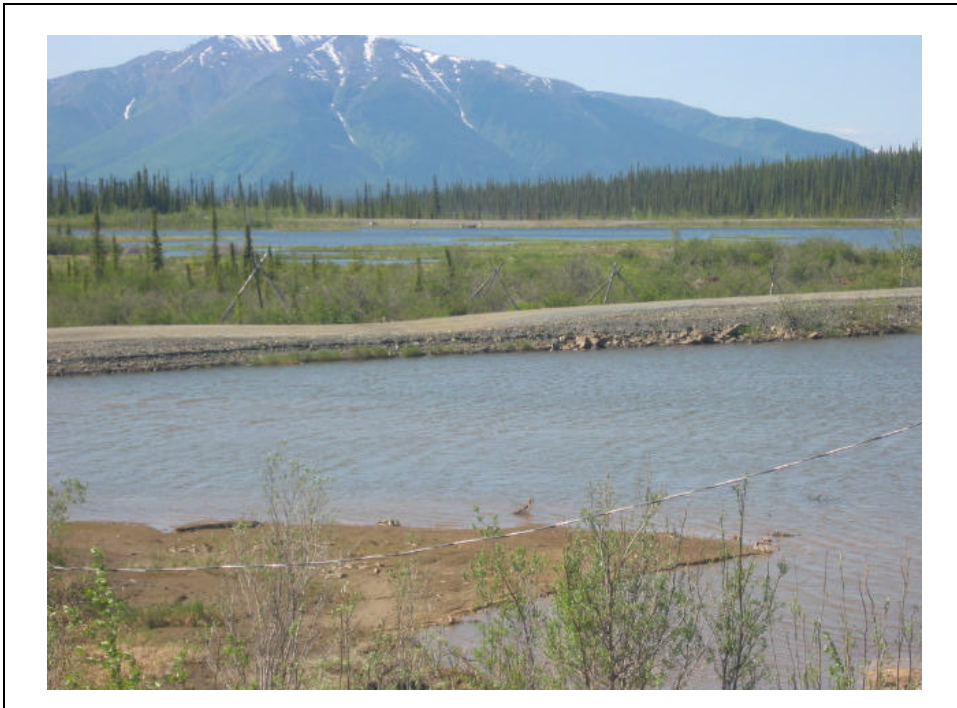
Therefore, the stability of the tailings dams remain uncertain. There is currently no long-term plan to stop dam subsidence. Future dam failure and release of tailings and supernatant into Flat Creek and the South McQuesten River are possible, although the length of time that may pass before failure occurs has not been estimated.

Elsa Tailings Dam subsidence

Failure of Tailings Dam	Monitor the subsidence of the dam and complete repairs as necessary. Obtain geotechnical advice as to the stability of the dam.	If the site is to be maintained under care and maintenance, the dam will likely require repairs as specified in the Water License QZ96-001. If the site is to be abandoned then the dam should be closed and rehabilitated.
Ice Plugs in Adits	Monitor the presence of ice and flow of water in all adits. Relieve water pressure when necessary.	Closure of the adits with proper drainage should eliminate the ice plug issue
Failure of Porcupine Diversion Ditch	Monitor the condition of the diversion ditch.	As per the tailings dam, the diversion ditch should be repaired as specified in the Water License QZ96-001 or rehabilitated.
Maintain integrity of Elsa Mill building	Install vertical support of cracked roof beam to prevent collapse of building and hazardous recovery of asbestos	Identify hazardous structures and demolish unsafe buildings.

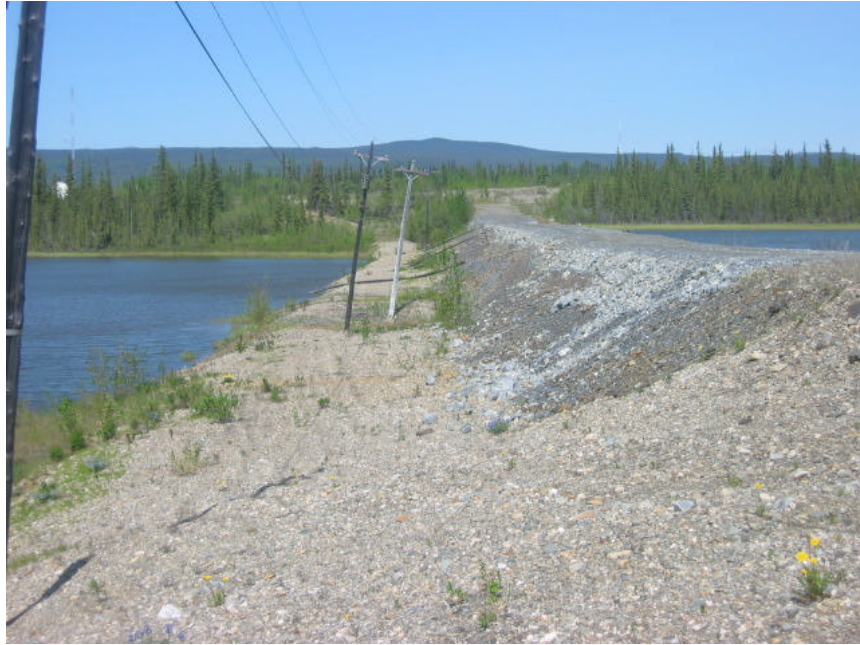
Elsa Tailings Dam #1 lift and toe berm

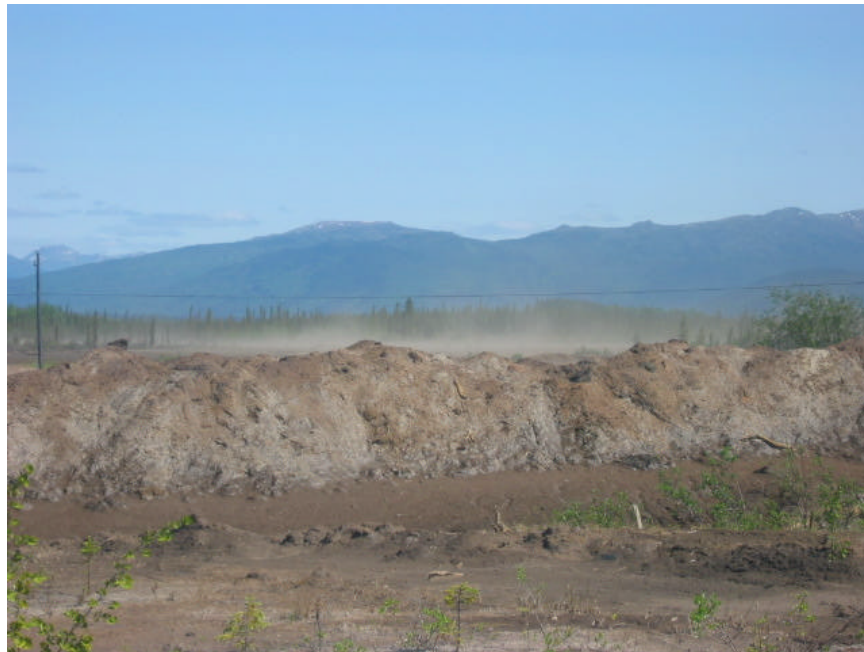
The Elsa tailings impoundment is an old facility that is partly covered by grasses and water. However, the upper reaches are un-vegetated and are susceptible to wind generated dust. Although local dust concentrations appear to be high, it is unlikely that that this dust will be hazardous to residents of Keno City, approximately 5 km away. The future closure plan for the tailings impoundment should address revegetation to eliminate the dust problem.

Elsa tailings dust observed over internal tailings ditch in foreground
