## MT. NANSEN MINE

**REPORT  
ON  
1989 SITE INSPECTION  
OF  
MT. NANSEN MINE AREA**

Prepared for:  
**NORTHERN AFFAIRS PROGRAM**  
Whitehorse, Y.T.

Prepared by:  
**GEO-ENGINEERING (M.S.T.) LTD.**  
Calgary, Alberta

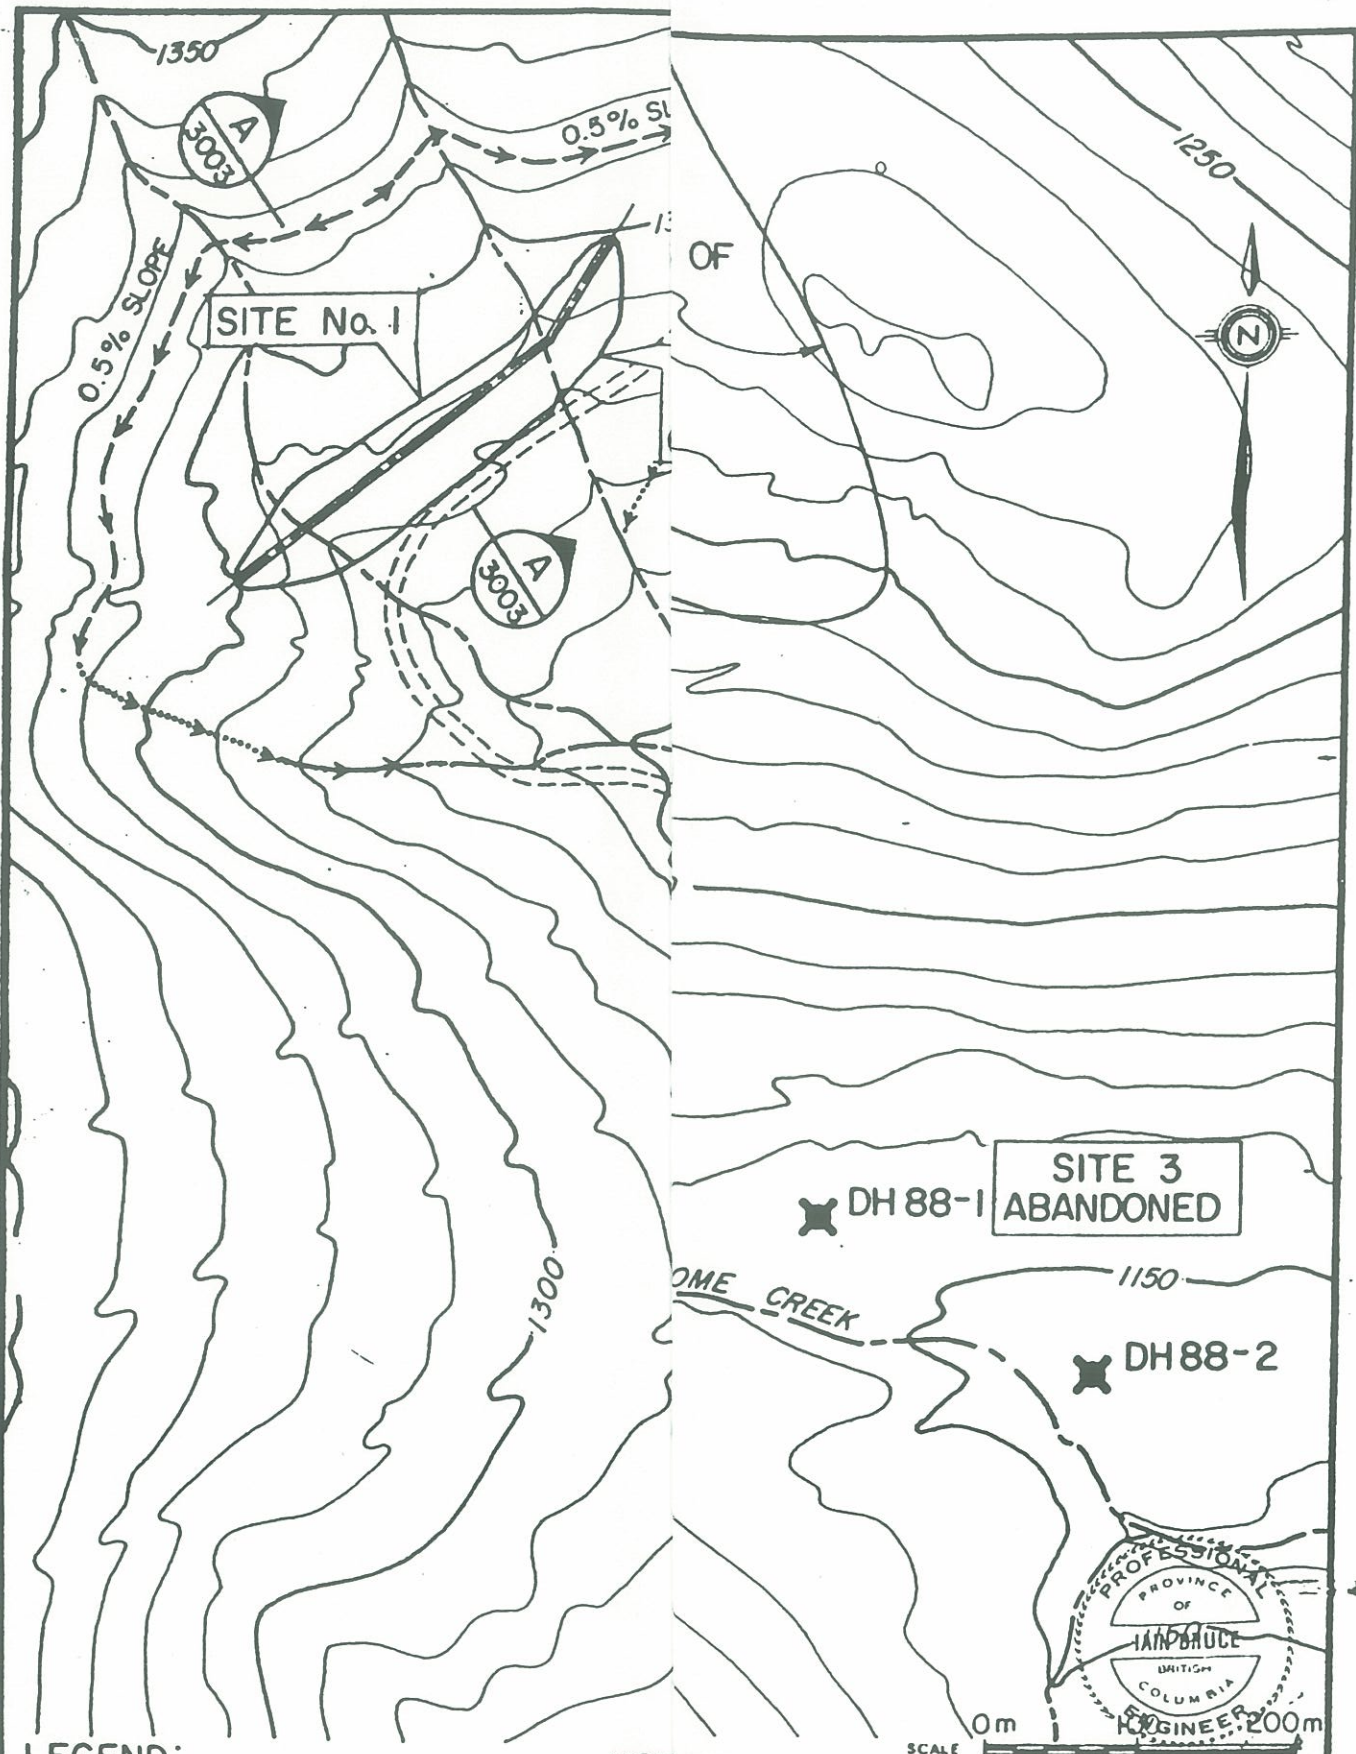
1. S
  2. C
- LOCATION OF BOREHOLES AND DAM OUTLINES**

The designated area is approximately 150 m x 250 m in size and has been previously cleared. There are two minor intermittent drainage courses directing surface runoff into the proposed pond area (Figure 1).

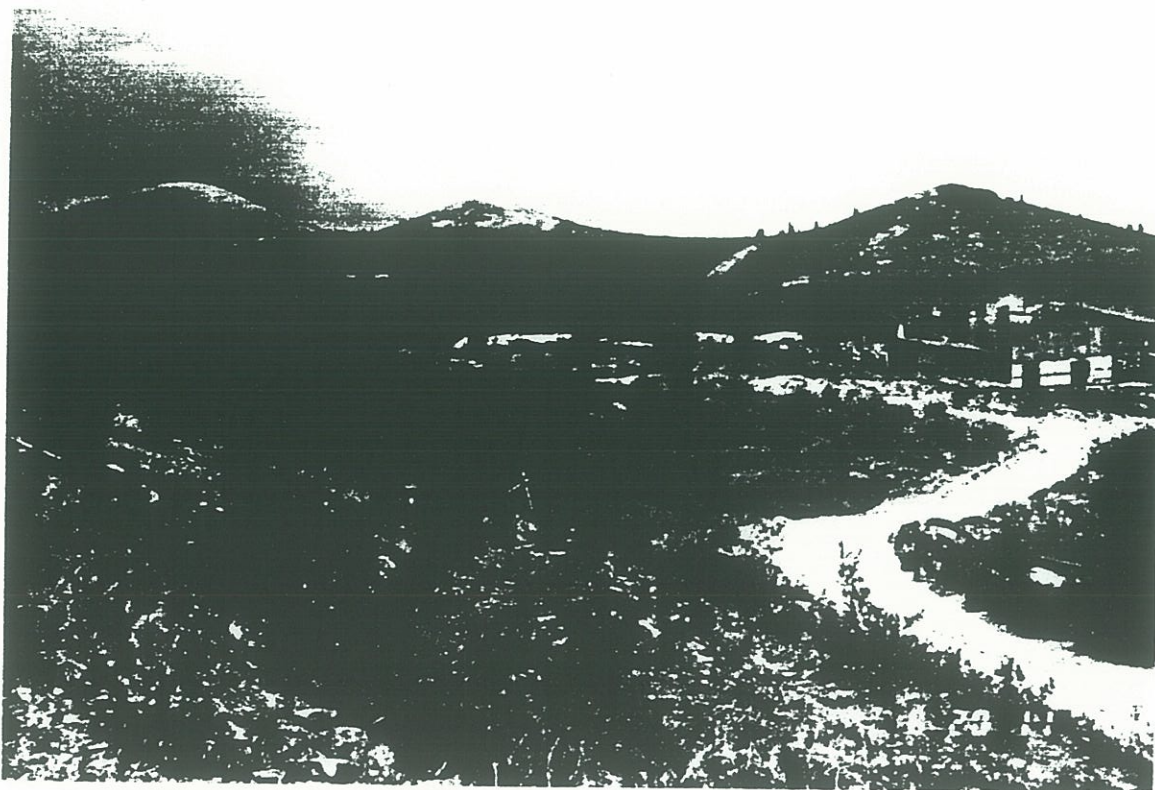
The bedrock, exposed on the ridges surrounding the site (Photo 2) and in exploration trenches, consists of igneous rocks of the Mt. Nansen Group which have intruded into the Pelly Formation metamorphic rocks. The metamorphic rocks have been mapped as undifferentiated schists, gneisses, quartzites, and marbles (Archer, Cathro, 1986). As mentioned above, the bedrock is deeply-weathered and badly fractured.

Photo 2: View of Site 1 tailings pond area, currently partly occupied by old facilities.

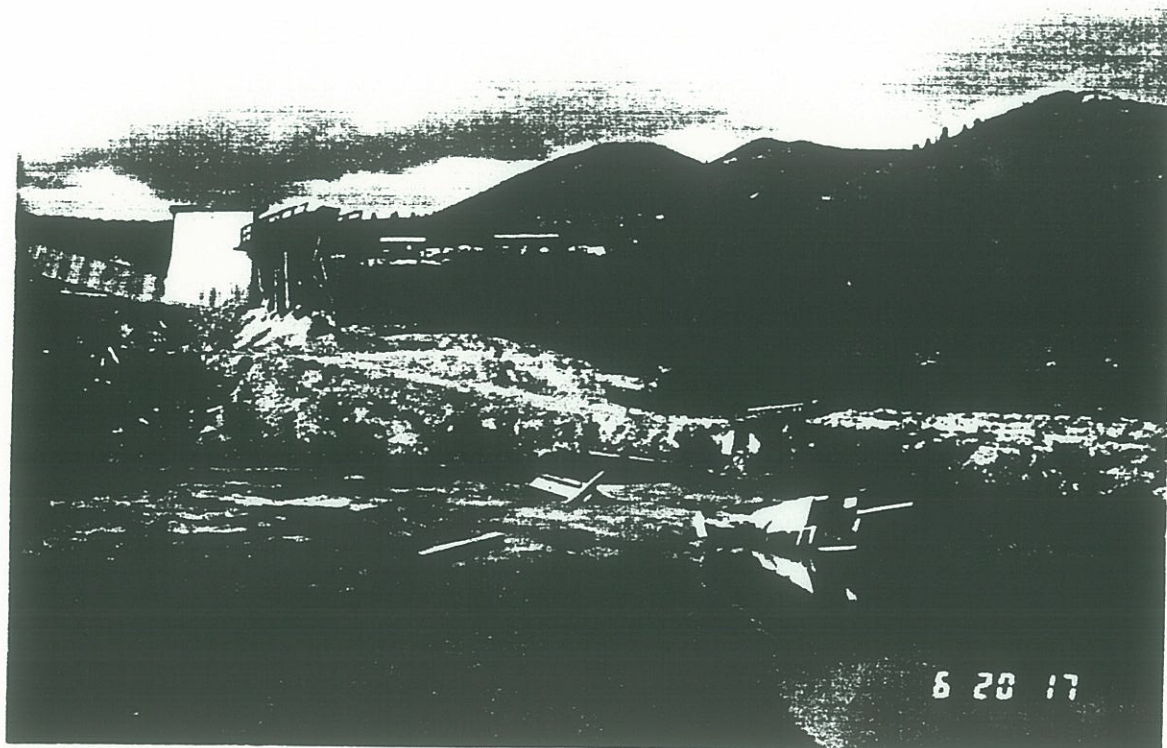
The valley bottom is covered with organic deposits covering ice-rich materials. The old ponds are deteriorating (Photo Nos. 3 and 4). Their embankments exhibit widely-opened cracks and their slopes, locally as steep as 1.5(H):1(V), are sloughing.

Photo 3: Existing tailings pond, immediately adjacent to the mill.

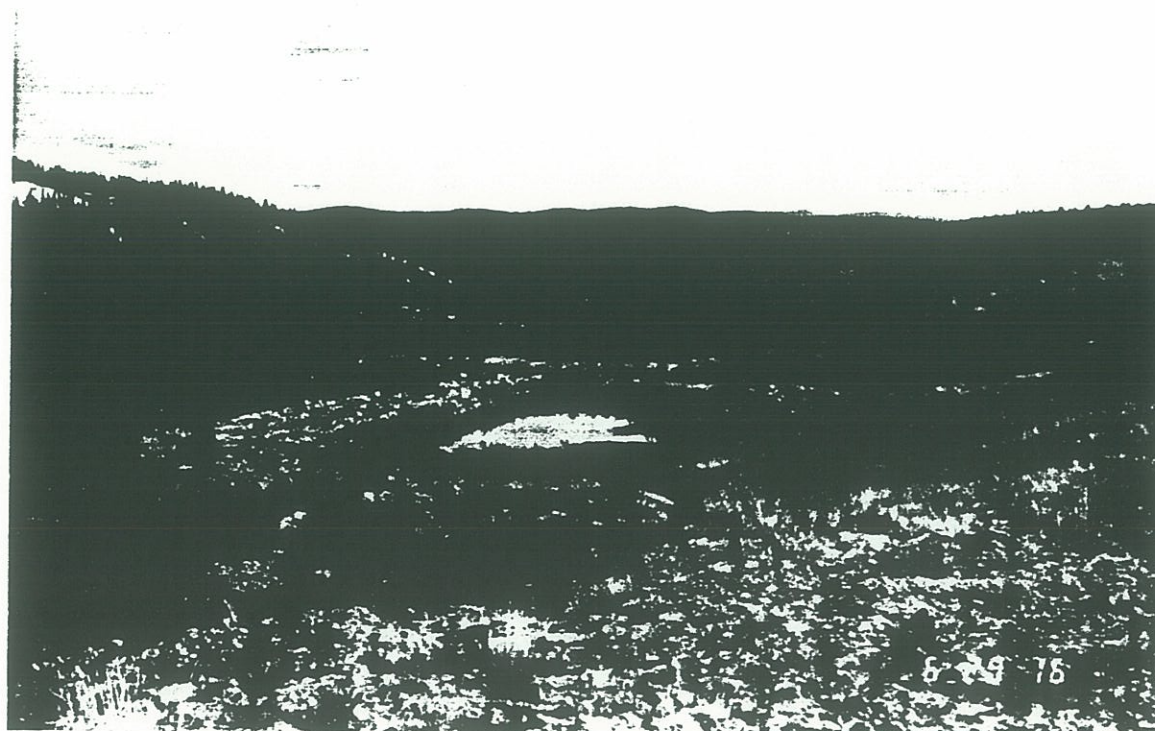
Photo 4: Second tailings pond, looking towards Site 2 area.
