CURRAGH RESOURCES CORPORATION

ANVIL PIT

REPORT ON
GEOTECHNICAL REVIEW
OF THE EAST WALL
OF THE ANVIL PIT

PROJECT 85-804A

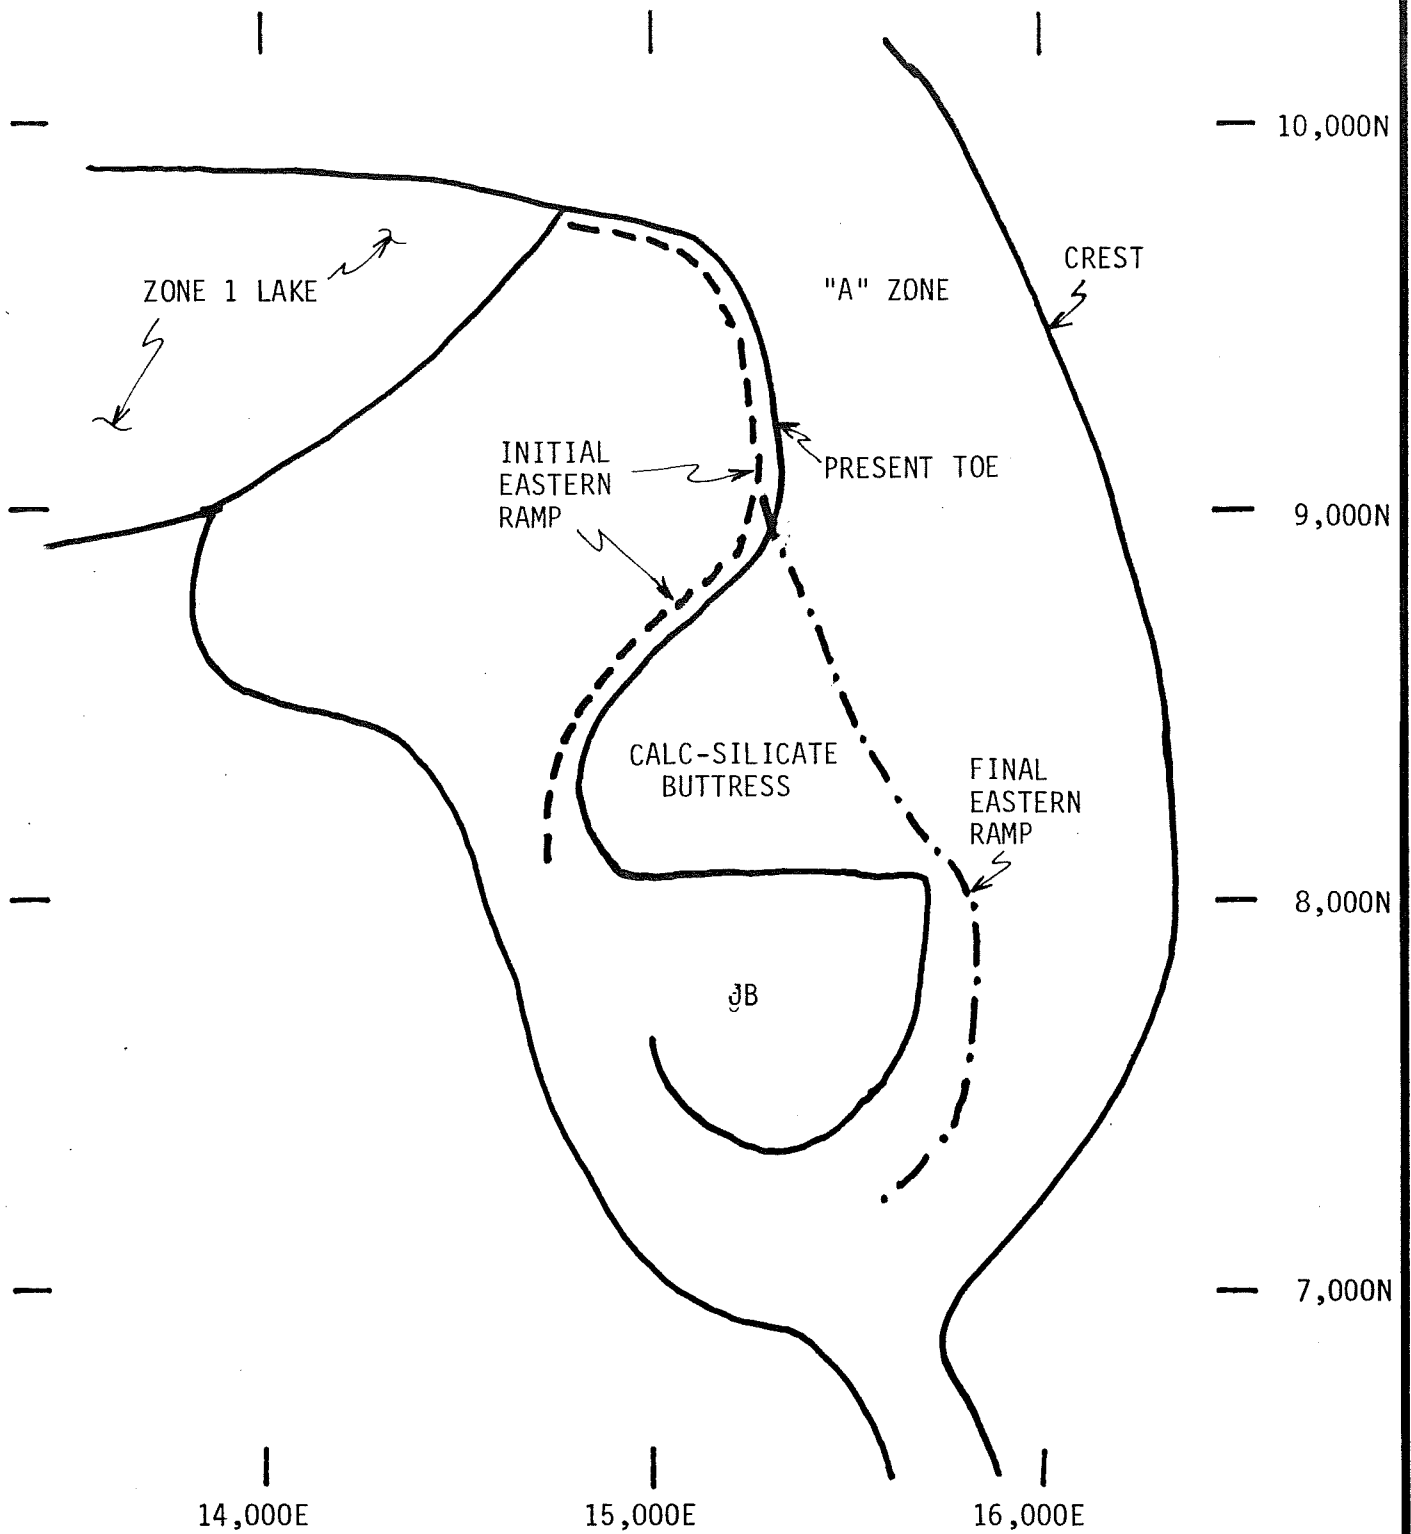
FIG. 1

For purposes of discussion, the existing east wall can be subdivided into three main areas, as follows (see Fig. 1):

- i) the "A" Zone area north of the calc-silicate buttress (i.e. north of about 9000N)
- ii) the calc-silicate buttress area (i.e. between about 9000N and 8000N)
- iii) the JB area (i.e. south of about 8000N)

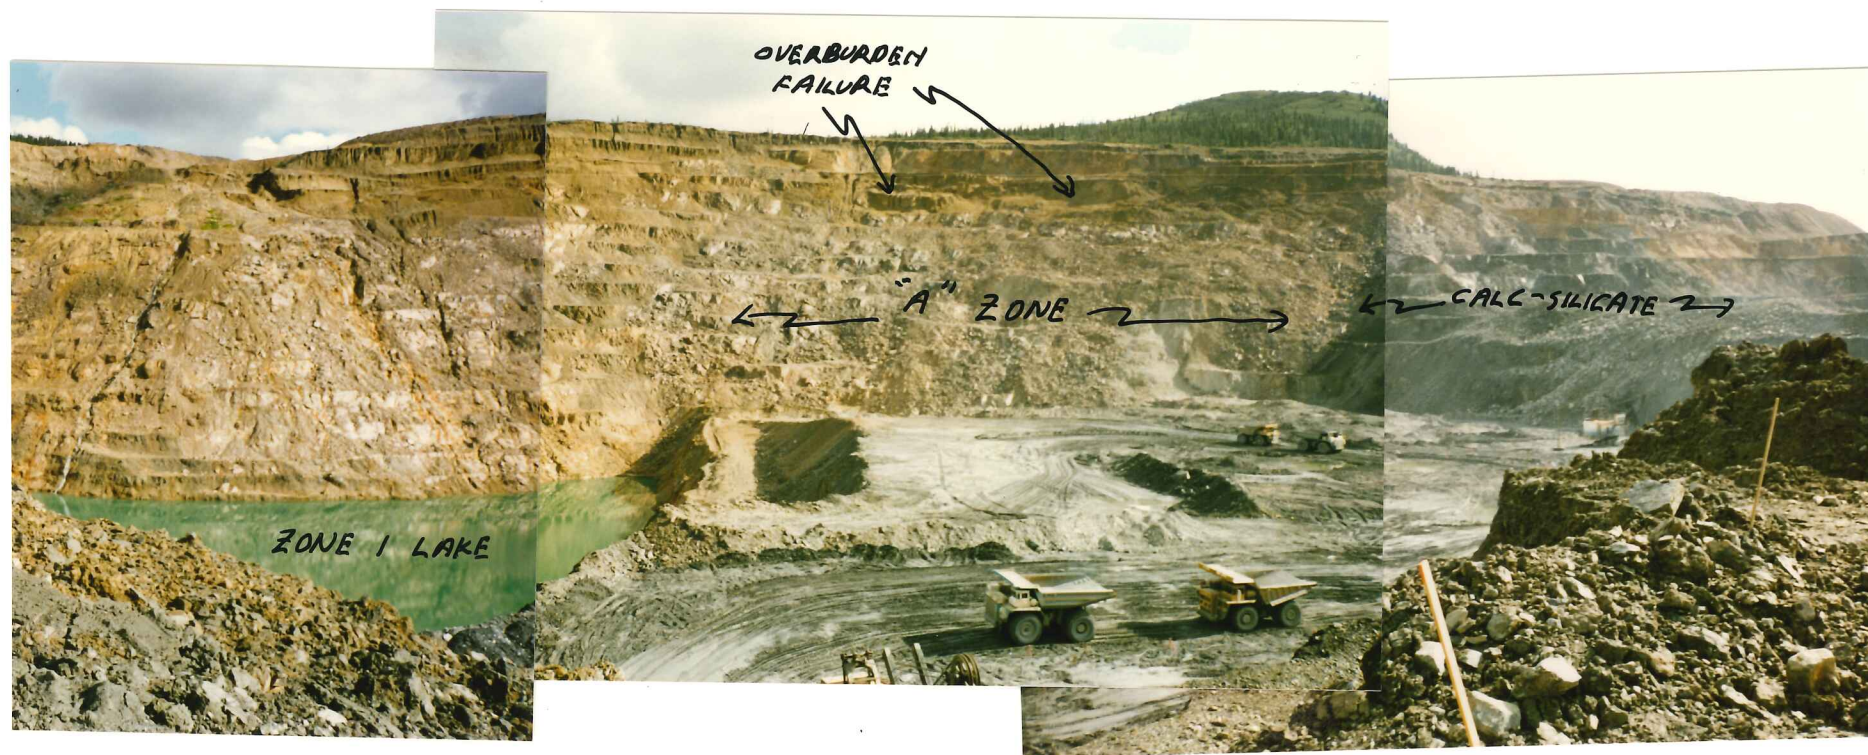
The existing slope in the "A" Zone area (see Photo 1) is up to about 500 ft (150m) high and is excavated primarily in muscovite schist, which has a foliation dip of about 35° to 50° directly out of the slope. Due to breakback and sloughing of most benches which has occurred over the life of the mine, the wall resembles a rubble or scree slope at an overall slope angle of about 33° to 35°. It is apparent from the loose debris and active ravelling that some movement is occurring. However, rates of movement would appear to be very slow.

Near the crest of this portion of the wall there is an active slope failure which occurs largely in overburden. This failure, which is estimated to be about one to two benches high and up to about 800 to 1000 ft (240 to 300m) wide, appears to be situated in an infilled depression in the bedrock surface. The overburden/ bedrock contact has not been well defined but appears to be relatively steep in some areas (i.e. dipping up to 65° west). It is noteworthy that, while only overburden was observed to be moving in the northern portion of this

The portion of the east wall that is "buttressed" by the calc-silicate (i.e. between about 8000N and 9000N) is considerably lower than the "A" Zone wall, being only about 300 ft (90m) high (see Photos 1 and 2). In general, the upper portion of the wall is excavated largely in schist, while the lower portion of the wall is in calc-silicate. At least one major dyke traverses obliquely down the wall from north to south. Although the existing overall slope angle appears to be approximately the same as in the "A" Zone, the condition of this portion of the wall is somewhat better than that of the "A" Zone. While numerous bench

PHOTO 1. Northern portion of East Wall. Note "A" Zone and calc-silicate portions of wall. Also note overburden failure on "A" Zone wall.

Besides those prism locations already discussed for the JB area, it is suggested that two other areas of the east wall should be monitored at this time. In the "A" Zone portion of the wall, prisms could be used to monitor the overburden failure. Specifically, it is suggested that two sets of prisms should be used

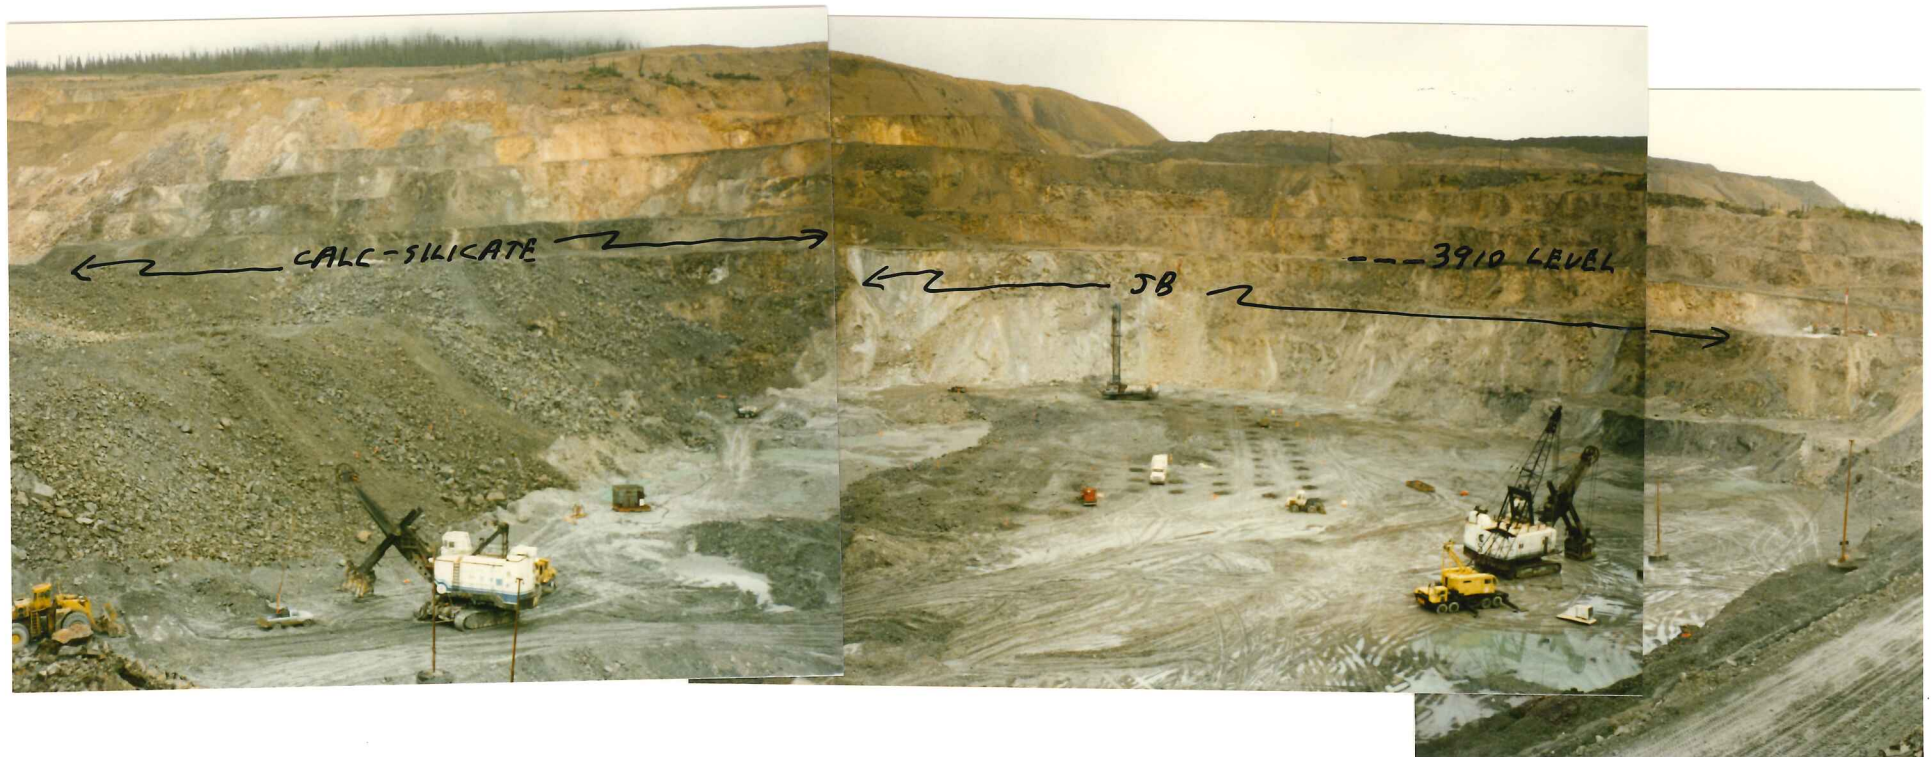
The JB area (see Photo 2), which is south of about 8000N, was being actively mined at the time of the site visit. This portion of the east wall, which is excavated primarily in schist, is up to about 240 ft (73m, or six benches) high with a berm up to 200 ft (60m) wide on the 3910 level. Below the 3910 level, to the present pit bottom at the 3790 level, much of the wall has been excavated with no safety berms. In this area, it would appear that overblasting and over-digging have taken place, with the result that there is considerable cracking

and breakback occurring at least 20 ft (6m) behind the crest on the 3910 level. The 120 ft (36m) high slope face was observed to be heavily fractured and was ravelling almost continuously. The overall slope angle varied between about 40° and 50°.

The most active area of instability is in the northern end of the JB area, where what appears to be primarily a structurally controlled failure is occurring (see Photo 2). In this area, it would appear that continuous structures sub-parallel to the Big Indian Fault zone are possibly combining with foliation joints and at least one major structure that strikes approximately normal to the slope to form a plane and/or wedge shaped failure. The broken nature of the in-place rock, combined with the apparent overblasting, has resulted in continuing breakback and ravelling of the slope in this area.

PHOTO 2. Southern portion of East Wall. Note calc-silicate and JB portions of wall. Also note 120 ft (36m) high slope below 3910 level and failure next to calc-silicate buttress.

As discussed above, the east wall of the JB area appears to have been overblasted and overdug. The resulting slope below the 3910 level, which is up to 120 ft (36m) high with no safety berms, is heavily fractured. Breakback of the crest of this slope will likely continue (particularly during wet weather and during spring runoff) until a stable overall slope angle is reached. Judging from the orientation of some structural discontinuities in the slope, breakback of the crest at the 3910 level may continue until a slope of about 40° is achieved. However, the highly fractured nature of much of the rock, and the likely presence of a number of faults or shears, may allow the slope to break back to a slightly flatter angle. As rockfalls and ravelling can be expected to continue on this slope, it is important that an adequate catchment berm be left on the 3790 level at the base of the 120 ft (36m) high unbenched slope.

To evaluate the potential for further breakback and failure of the east wall of the JB area, it is recommended that monitoring of the wall be conducted. While mining is being carried out in this area, regular visual inspections of the slope, particularly on the 3910 level, should be made to assess the amount of movement taking place and the amount of breakback which may occur. The amount of movement can be determined by a number of means, the simplest being the visual inspection of a straight line of survey stakes or the direct measurement (using a tape measure) of the distance between two pins placed on either side of a crack. More sophisticated techniques, such as the use of survey prisms, can also be used.
