REPORT
ON
REQUIREMENTS FOR DEVELOPMENT OF
A REHABILITATION PLAN
CLINTON CREEK MINE
CASSIAR ASBESTOS CORPORATION
(1977)

Prepared for:
Yukon Territory Water Board

Prepared by:
R.M. Hardy & Associates Ltd.
Calgary, Alberta

December 30, 1977

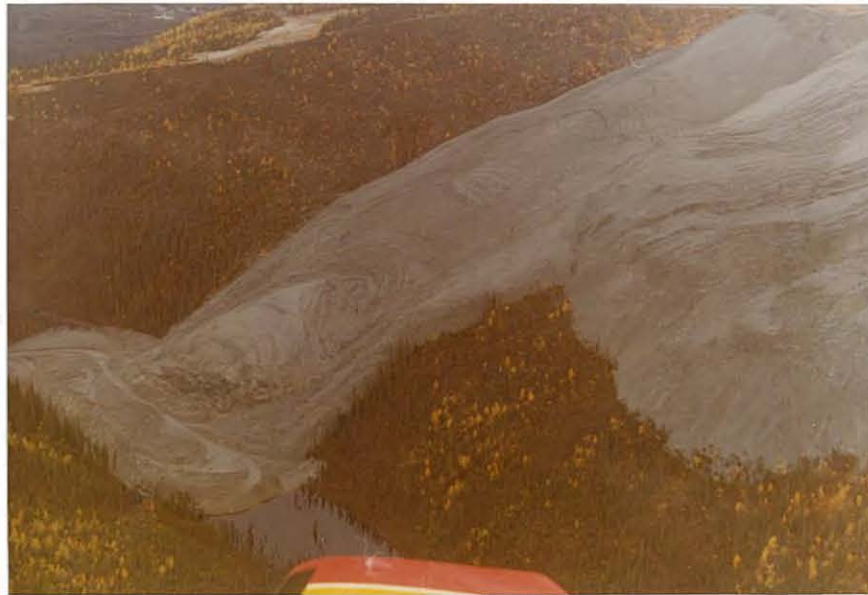
Photograph 1 shows the failed portion of the tailings pile. The failure occurred in 1974. It is clear from the cracks on the pile that movement is still occurring in this area. There also seems to be a substantial amount of spreading at the bottom. We are unable to assess to what extent the spreading was carried out with mechanical equipment at the time that the channel was bulldozed through. Photograph 2 shows a view of the channel that was evidently bulldozed in 1974. The very fresh face of the right bank indicates it is moving and experiencing continual erosion. It is obvious the channel has squeezed shut to a large degree since it was bulldozed open. Photograph 1 also shows a lobate form north of the failed area which was reported to have been moving at a rate of 3 inches (76 mm) per day in January 1976. Observations of movement had been taken only over a relatively short period.

indicates that the direction of movement of the southern portion of this slope is towards the mass that failed in 1974. A substantial amount of bulging at the bottom indicates the failed mass is supporting the south side of this slope. In our opinion it is quite possible that a failure similar to that experienced in 1974 could occur at this location. The movement appears to be a combination of flow within the tailings mass as well as a failure of the foundation soils.

- #1 Failed portion of tailings embankment. Failure occurred in 1974. Cracks throughout the failed mass indicate current movement.

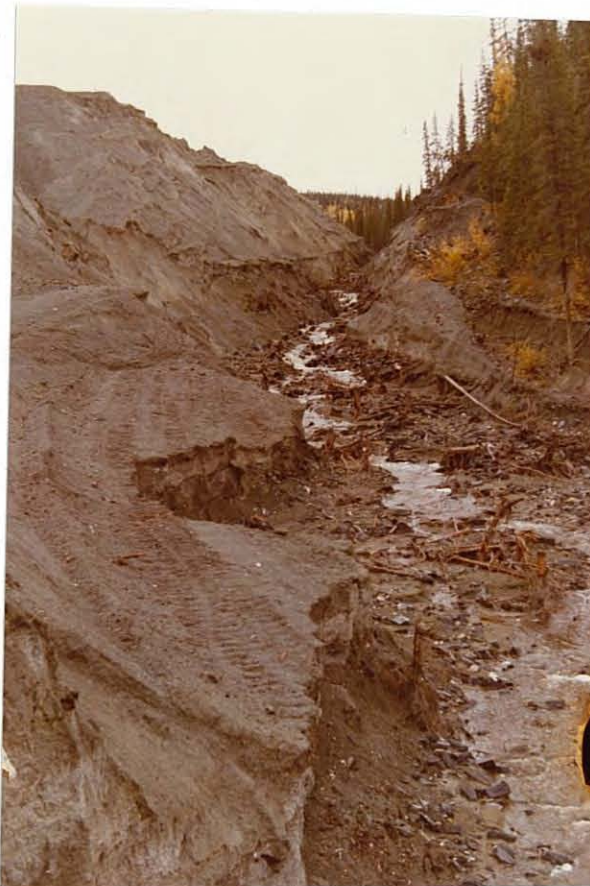
- #2 Wolverine Creek Channel looking upstream. Eroded banks are fresh. Note recent slumping.

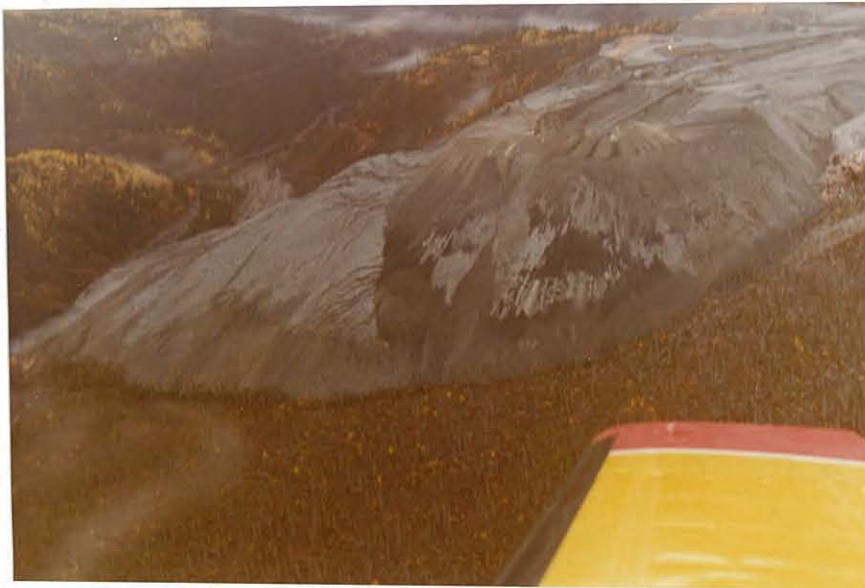
Photograph 3 shows the area where tailings were being dumped at the time of our field inspection. The angle of repose of the frontal part of the tailings pile is judged to be at about 38° to 39° as previously reported by Golder Brawner and Associates. The natural slope of the ground in this area is flatter than the slope to the south and that towards the bottom of the valley. Localized failures will very likely be experienced at this location but it is unlikely that they would encroach on Wolverine Creek.

#3 Current tailings disposal at northwest end of embankment. Angle of repose is about 38° .

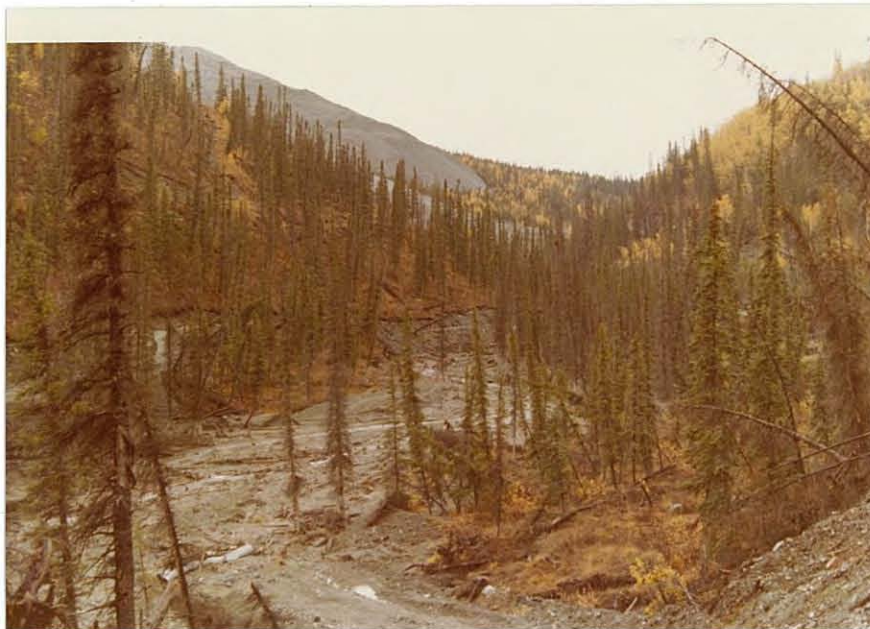
Photograph 4 shows the area downstream and the material deposited in the stream bed when the water broke through after the failure in 1974.

#4 Floodplain of Wolverine Creek downstream from tailings pile. Tailings were deposited after the embankment failure in 1974.

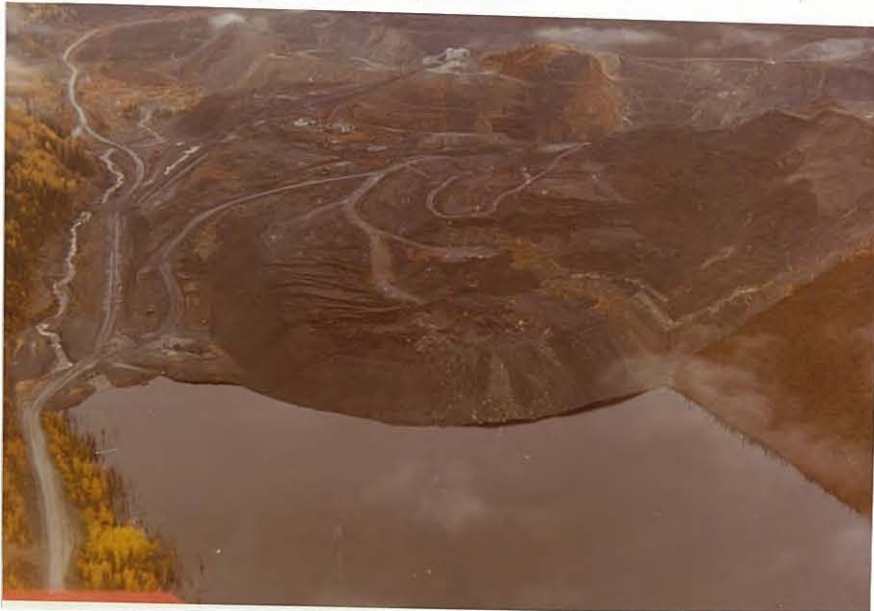
Photograph 5 shows the west end of the dam and the stream channel on the north side. The cracks throughout the dump are evident in this photo as well as in the aerial photo. It is clear it would not be practical to stabilize this mobile mass. Photograph 6 shows a closer view of the cracks within the mass and one of the graben features.

#5 West end of dam forming Hudgeon Lake.

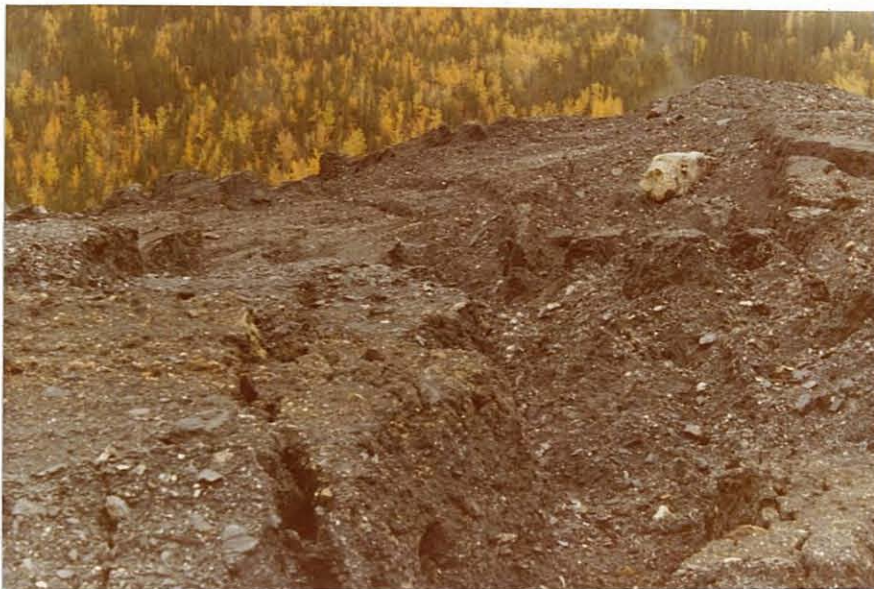
#6 Closeup view of surface cracks in waste embankment.

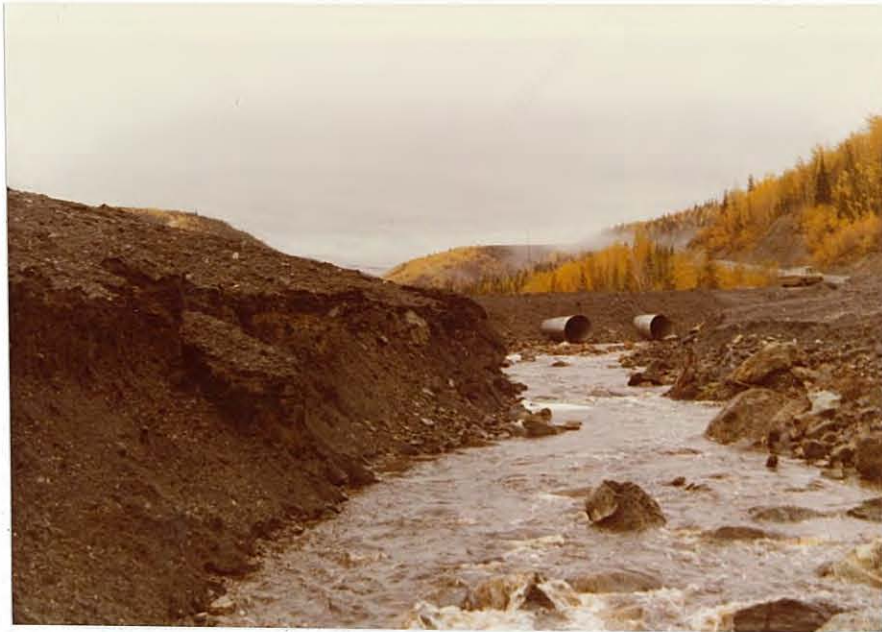
The north-eastward movement towards Clinton Creek at the toe of this slope, as reported in January 1977, was comparatively minor. It can be seen from photograph 7 that there is continual erosion and fresh slumping at the toe.

#7 Eroding bank at toe of waste-embankment along Clinton Creek.

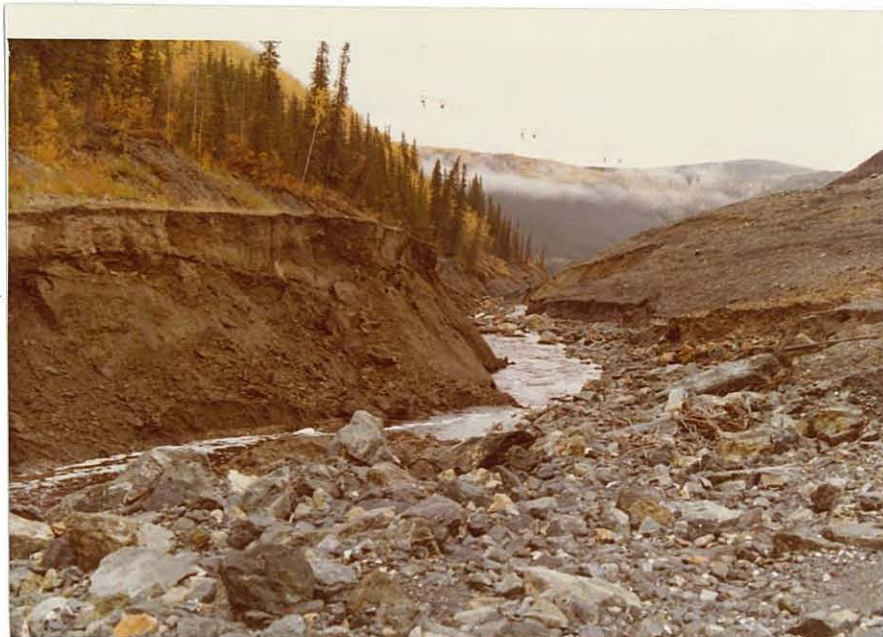
Bottom heave has also been reported from the previous observations at the site. Photograph 8 shows the left banks of natural soil downstream from the culverts. We understand that the maximum flow for 1977 occurred in May and was equal to approximately 1000 cfs ($28 \text{ m}^3/\text{sec}$). A large amount of fines was eroded from the toe of the slope as shown in photographs 9 and 10, leaving a

#8 Eroding bank of natural slope immediately downstream from culverts.

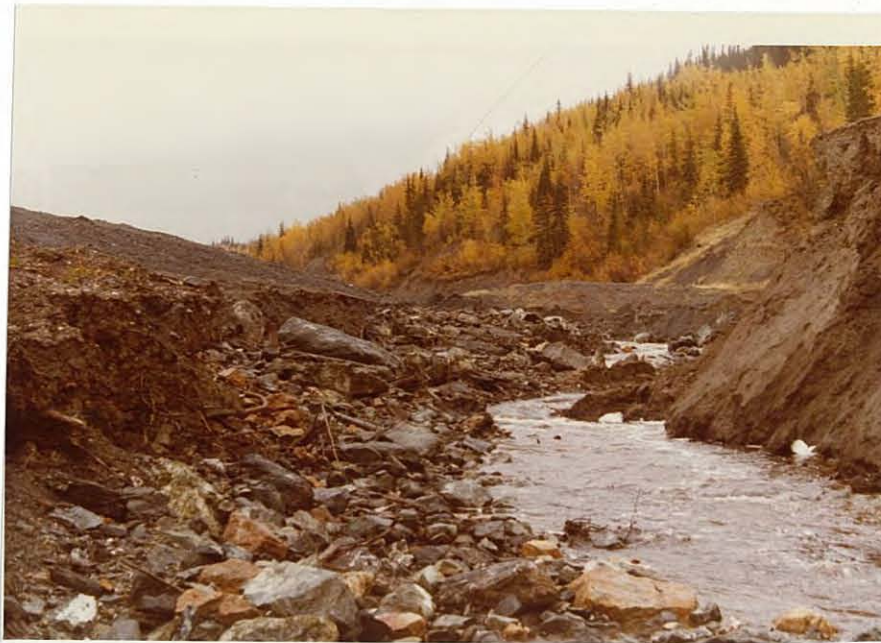
#9 Clinton Creek looking upstream. Fines have been eroded from the toe of slope.

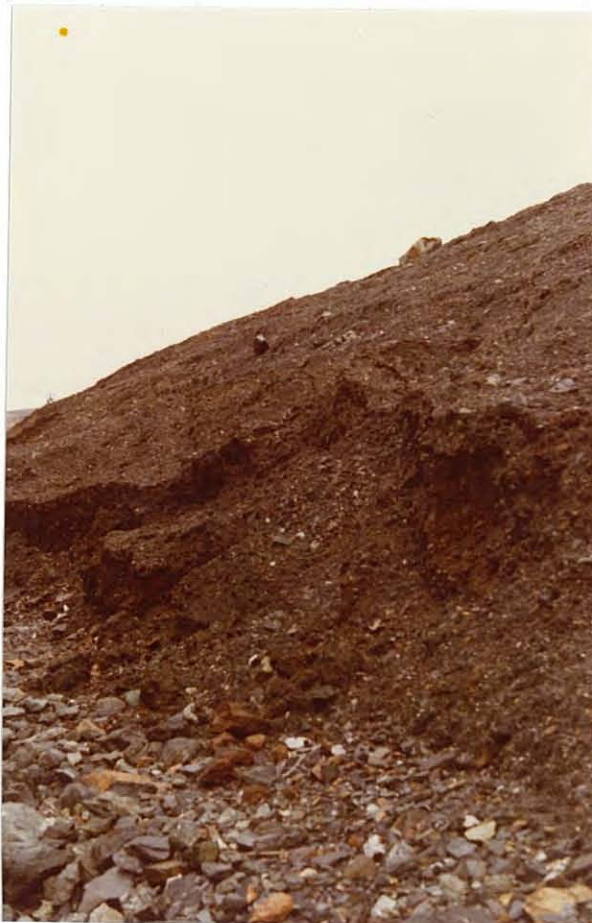
#10 Erosion from toe of slope during period of peak flow.

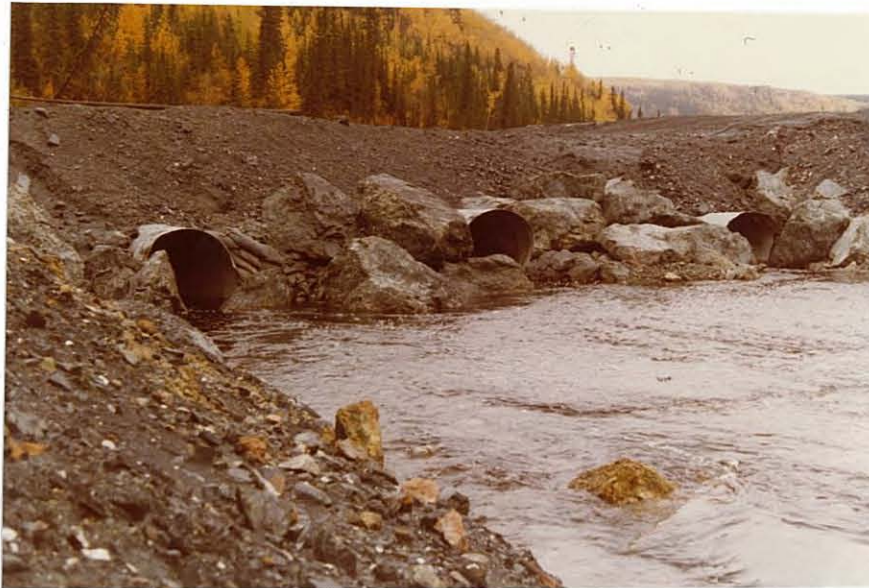
#11 Inlet of culverts draining Hudgeon Lake.

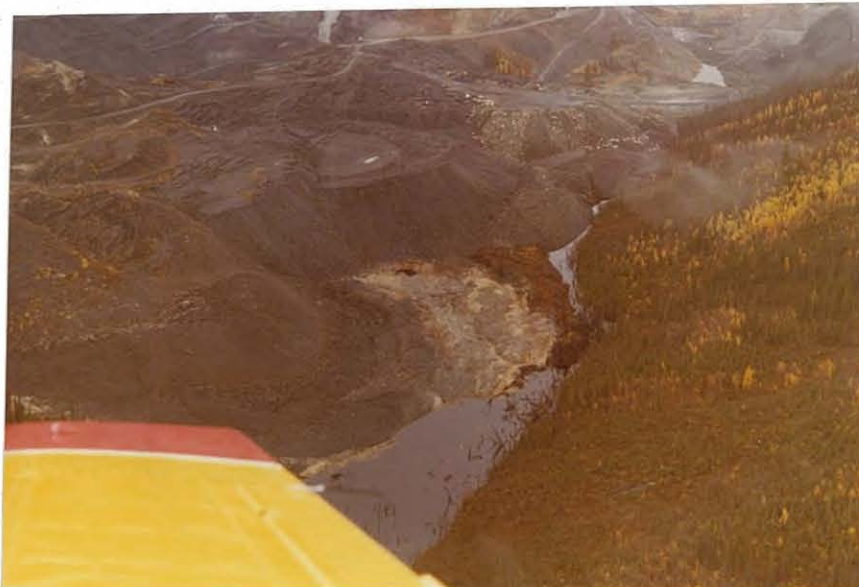
The spoil piles in this area are also experiencing movement as illustrated in Photograph 12. A small reservoir has developed as a result of the blocking of Porcupine Creek but the water appears to be percolating through the spoil. It is reported that the majority of the rock at the bottom of the slope is large diameter serpentine boulders and this would account for the flow of water through the mass. Since the coarse material at the bottom of the valley is relatively permeable and since the flow appears to be quite small, it is unlikely that a much greater reservoir will develop. The argillite and Serpentine boulders do not appear to be contributing sediment to the small outflow. We do not consider this area to present a potential hazard with respect to pollution of the stream. Rehabilitation requirements in this area would be predominantly concerned with meeting the stability requirements for surface reclamation.

#12 Waste embankment on Porcupine Creek.
