REPORT
TO
CASSIAR ASBESTOS CORPORATION LTD.
ON
GEOTECHNICAL ASPECTS OF MINE CLOSURE
CLINTON CREEK MINE YUKON TERRITORY

April 1978

V77016

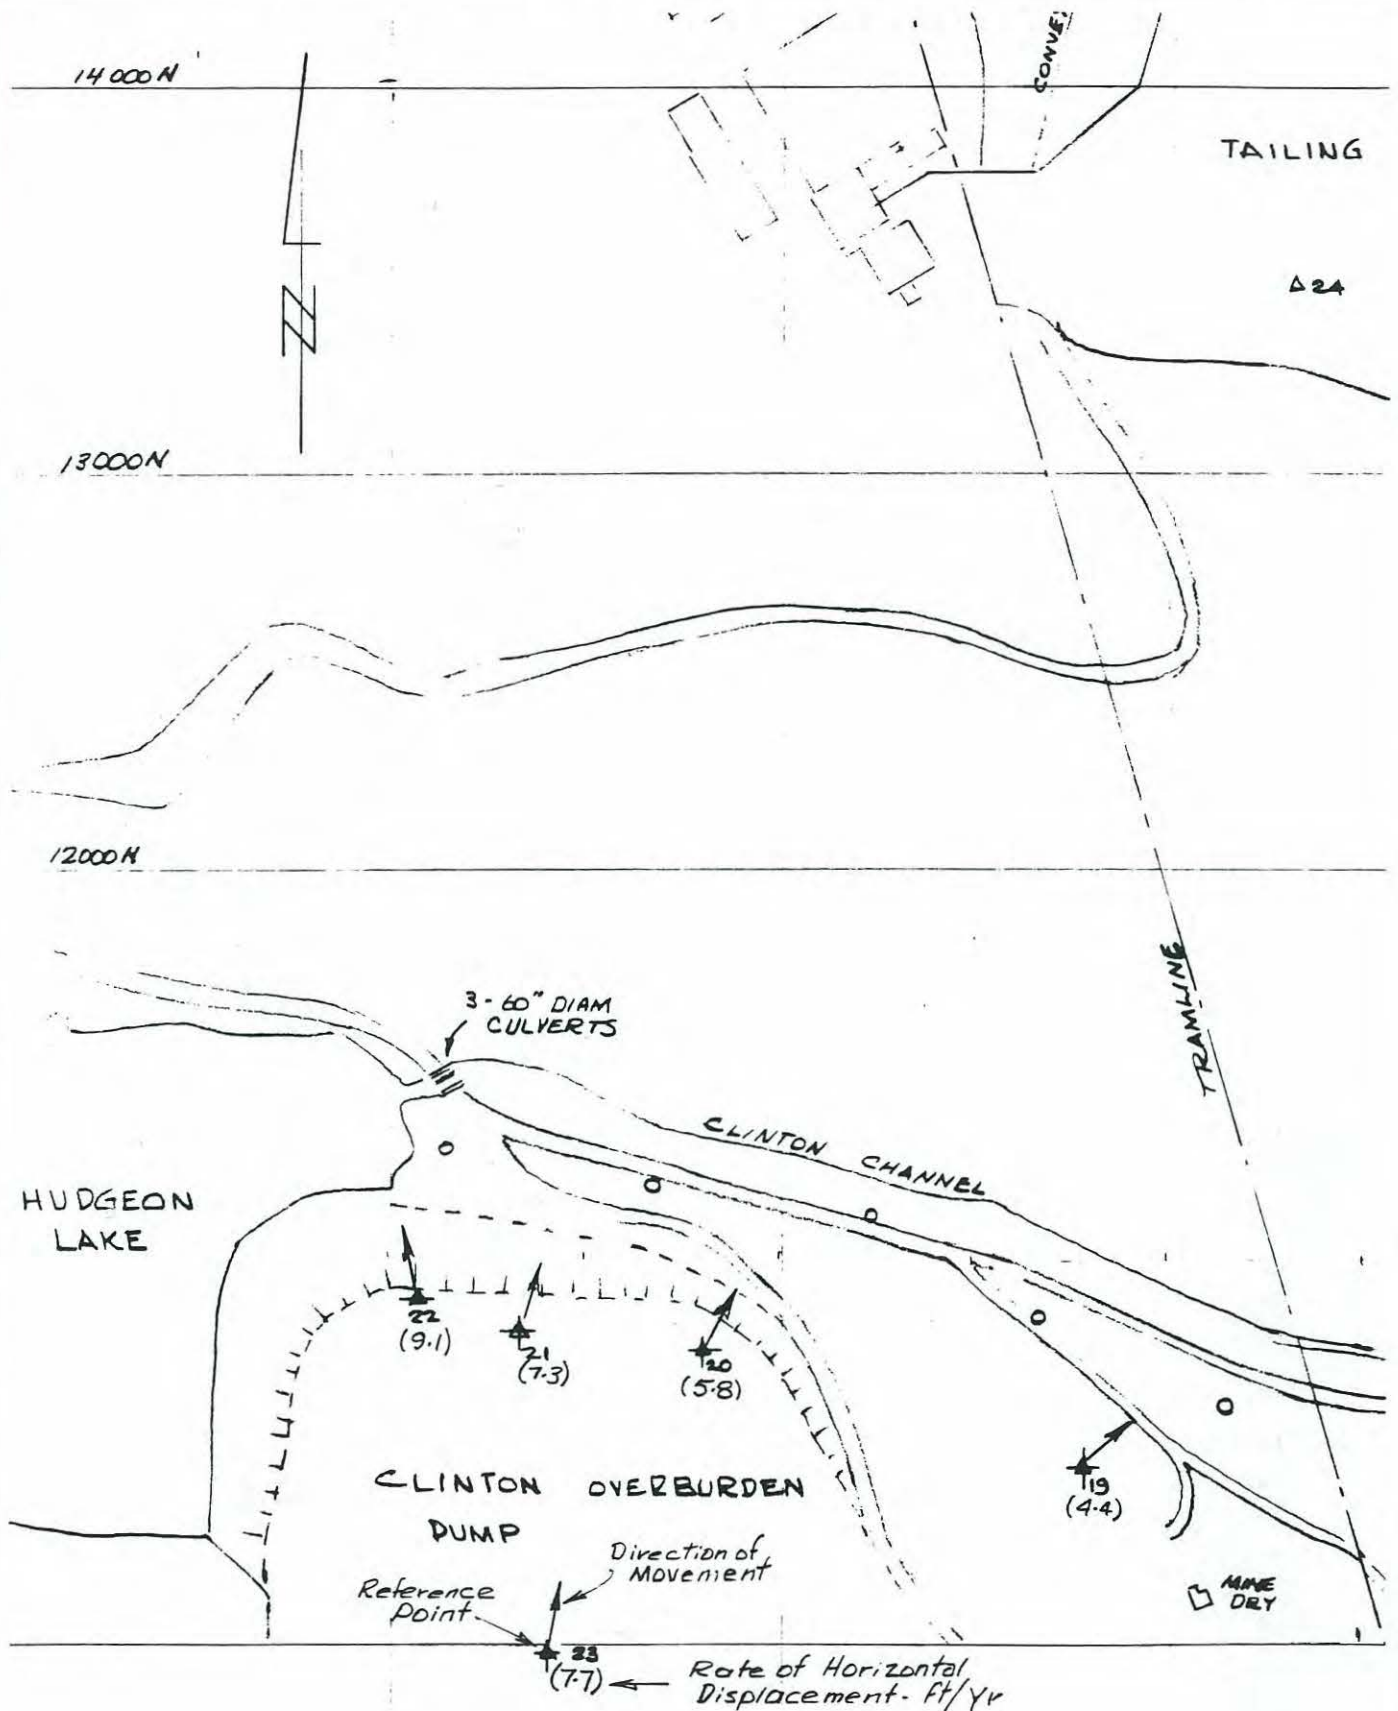
Figure 1

Observations on reference points located on the surface of the Clinton waste dump show that surface movements continue to occur. The horizontal movement vectors are aligned radially outward toward the perimeter of the dump. Plots of the horizontal displacement versus time for the reference points on the surface of the dump do not show any significant trend of decreasing rate of movement with increasing time.

The data so far gathered indicate that movements are primarily the result of horizontal spreading as opposed to rotational shear failure.

Prior to April 1978, horizontal movements on the surface of the waste dump were being monitored at five locations, as shown on Figure 1. As at March 1978, the observations at reference points, Nos. 19 and 23, cover a period of approximately 475 days. The period of observation on the remaining waste dump reference points is somewhat shorter. The data show that each of the reference points is moving at a virtually uniform rate, which varies between 0.025 ft. per day to 0.012 ft. per day (9 ft. - 4.4 ft. per year). The movement records show that the waste dump is continuing to creep and to crowd the segment of the channel located along the junction between the northern limit of the dump and the toe of the north valley wall. Creep movements of the dump in the direction toward Hudgeon Lake are also continuing, as evidenced by a pressure ridge that formed on the ice surface of Hudgeon Lake during the winter of 1977-78. This pressure ridge is located a short distance out from the face of the dump and parallel to the shoreline where the face of the dump plunges into Hudgeon Lake.

As a result of the continuing creep movements, the northern limit of the waste dump encroaches on the segment of the creek channel that borders the northern limit of the dump. However, the channel is maintained by stream erosion of both waste dump material and in situ bedrock on the northern slope of the valley.

In our opinion, the continuation of movements in the waste dump should be accepted, and provision should be made to maintain the level of

the outlet from Hudgeon Lake and to guard against excessive downcutting of the channel. We recommend that a series of rock groynes be constructed transverse to the channel, and extending approximately 200 ft. south of the channel (see Figure 2). As the creep movements at the toe of the dump continue, the rock will be shifted gradually into the channel. A 200 ft. long groyne would accommodate movements at the present rate for a period of 20 to 30 years. We expect that the creep movements will have ceased by that time.

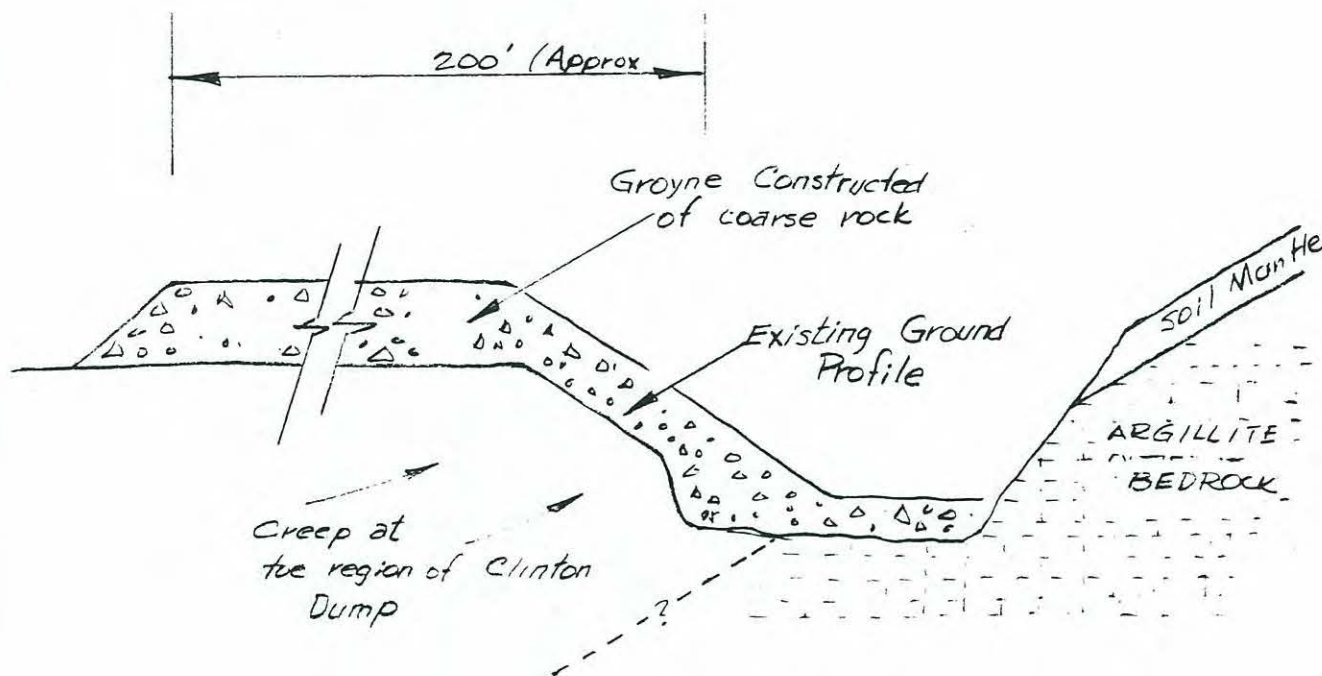
SCHEMATIC CROSS SECTION
SHOWING ROCK GROYPE
TO CONTROL DOWNCUTTING OF CHANNEL

As noted in Section 3.1, the overburden dump continues to creep toward the creek channel. The creek maintains its grade and channel cross-section by erosion of both in situ bedrock along the toe of the hillside on the north valley wall, and overburden materials that encroach on the channel as a result of the creep movements.

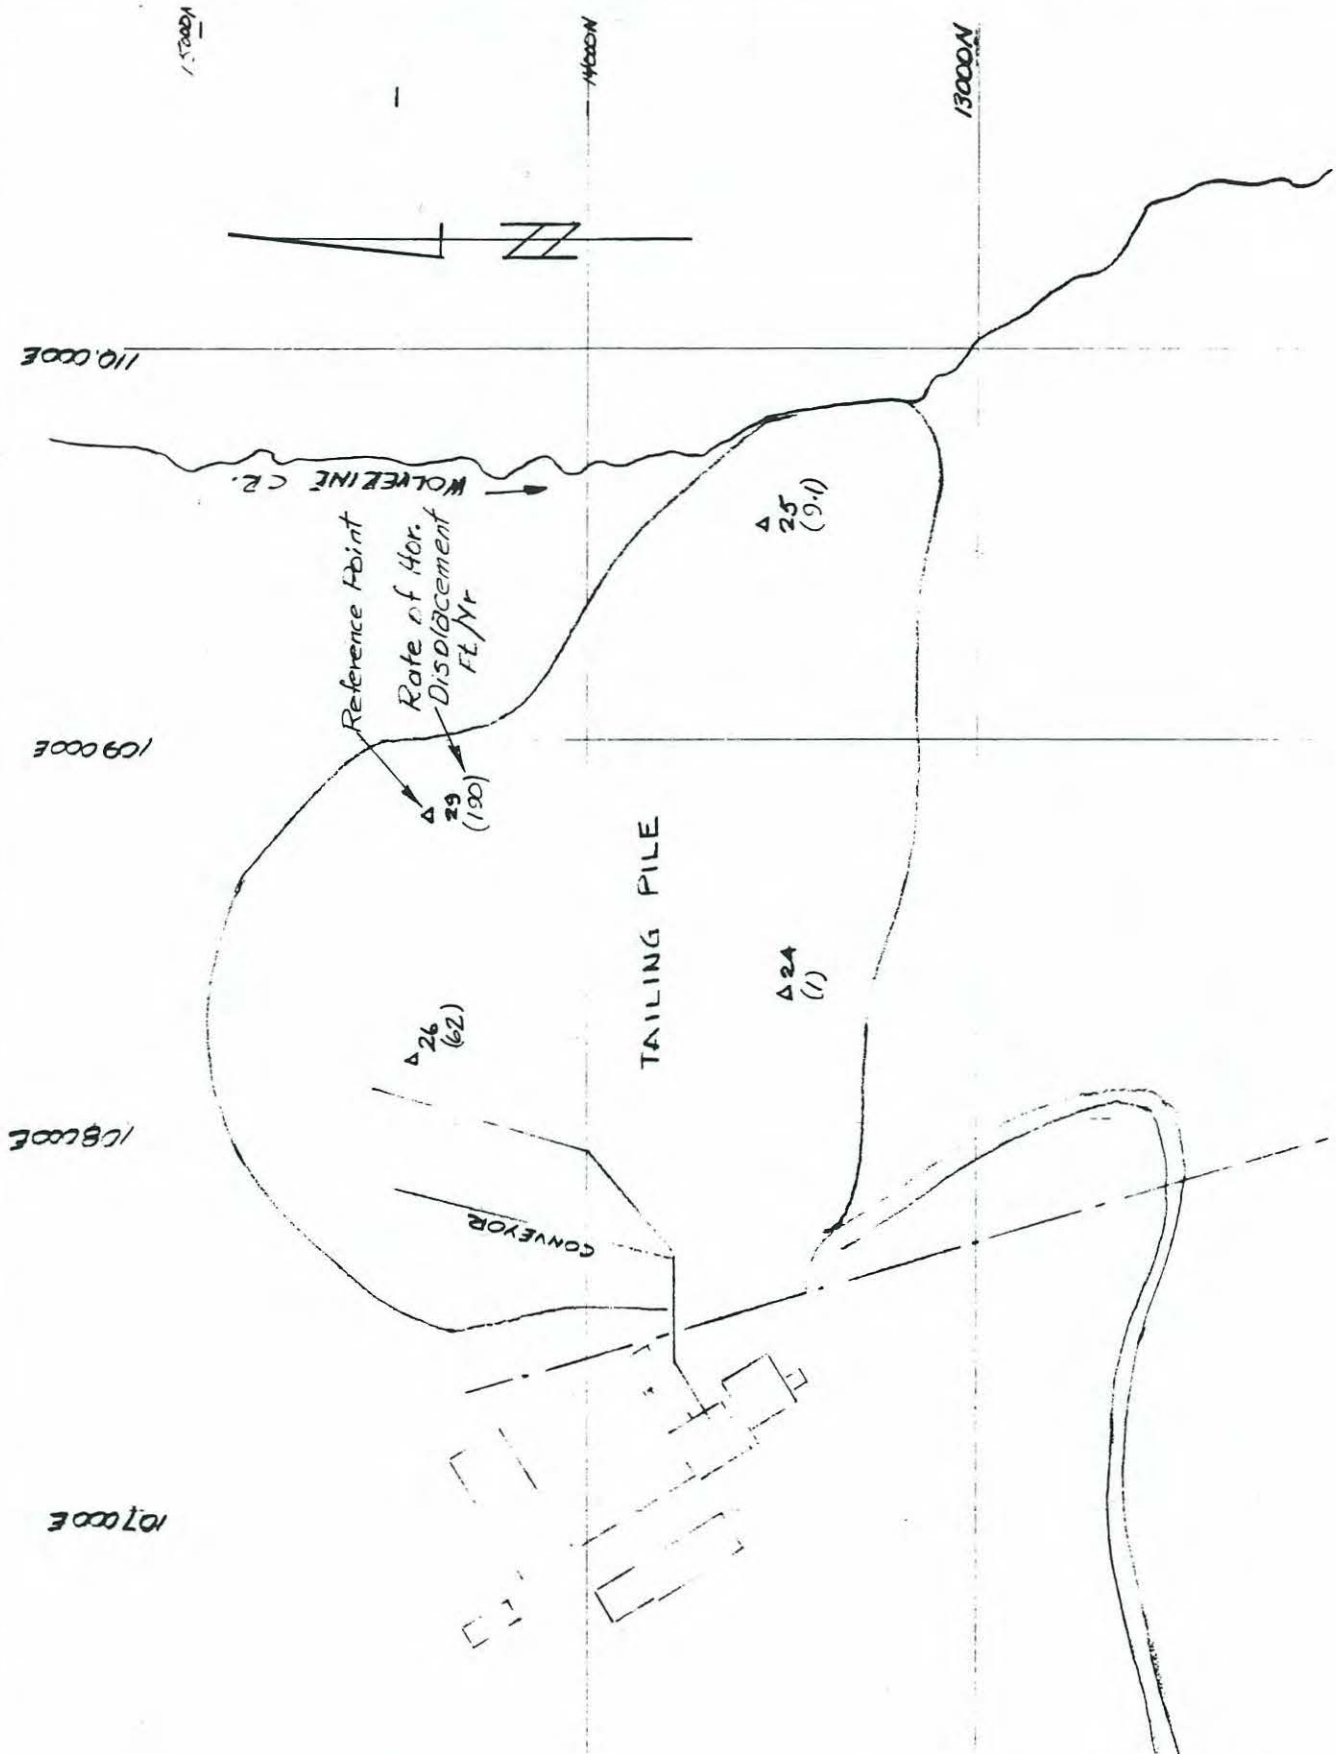
HORIZONTAL SURFACE MOVEMENTS TAILING PILE

Reference points have been established on the surface of the tailing pile to monitor the rates of movement at various locations. Prior to April 1978, 4 reference points had been installed, 2 on the 1974 failure lobe, and 2 on the northern segment of the waste pile. The approximate locations of the reference points on the tailing pile are shown on Figure 3. Additional reference points have recently been installed on the surface of the pile.

Reference point No. 25 located at the toe of the 1974 failure lobe indicates that the movements within this region of the tailing pile are continuing at a rate of approximately 1/4 inch per day. There is no indication that this rate of movement is diminishing significantly with time. Reference point No. 24, located at or near the upper limit of the 1974 failure lobe, indicates that movements within this region of the tailing pile have virtually ceased.

Monitor No. 29, located within the toe region of the actively moving northern segment of the waste pile, is moving at a steady rate of about 0.5 ft. per day. *up from = 5 in/day* Field observations indicate that the toe segment to the east of monitor No. 29 is creeping downslope at a rate slightly greater than 0.5 ft. per day. The toe of the tailing pile, when inspected on March 8, 1978, was estimated to be approximately 300 ft. from Wolverine *< 2 yrs. to creek* Creek. During field inspections on April 4 and 5, 1975, it was noted that a segment of material from the toe region of the tailing pile in this area had moved downslope since the inspection of March 8. The nature of these movements suggests that the downslope creep movements will continue, and that the northern segment of the tails will eventually reach Wolverine Creek.

Examinations in the field show conclusively that the downslope creep movements of the tailing pile are accompanied by displacements of significant amounts of in situ foundation materials on which the pile has been deposited. The dominant material which has been displaced by the downslope movements of the tailing pile is weathered argillite bedrock. The field observations also show that the displaced material which is bulldozed ahead of the tailing pile as it moves downslope varies in thickness from a few feet up to thicknesses of the order of 15 to 20 ft. At one soil exposure within the toe region of the tailing pile, the displaced materials consisted of weathered inorganic soils with a total accumulated thickness of between 35 and 40 ft.

Ore that enters the mill is heated to approximately 20 degrees C during the milling process. Thus, the tails exiting the mill also have a temperature of approximately 20 degrees C, suggesting that a considerable amount of latent heat may be contained within the tailing pile. Examination of aerial photographs taken prior to construction of the tailing pile, together with onsite examinations of the character of the ground surface within the area immediately surrounding the perimeter of the pile, indicate that the hillside is underlain by permafrost. This was corroborated by a field inspection on April 4 and 5, 1978, during which a bulldozer was used to penetrate the frozen weathered material downslope of the toe of the tailing pile. The in situ frozen material was observed to contain a high percentage of water in the form of ice crystals and ice lenses. Several ice lenses observed during the inspection were greater than 1 inch thick. On the basis of these observations it is considered possible that the creep movements within the tailing pile may be associated with thawing of permafrost with an accompanying build-up in pore water pressures within the weathered inorganic soils beneath the pile itself.
