Golder Associates
CONSULTING GEOTECHNICAL ENGINEERS

REPORT TO
CASSIAR ASBESTOS CORPORATION LTD.
RE
MINE WASTE DUMP AND TAILING PILE
CLINTON CREEK OPERATIONS
CLINTON CREEK YUKON TERRITORY

July 1978

V77016

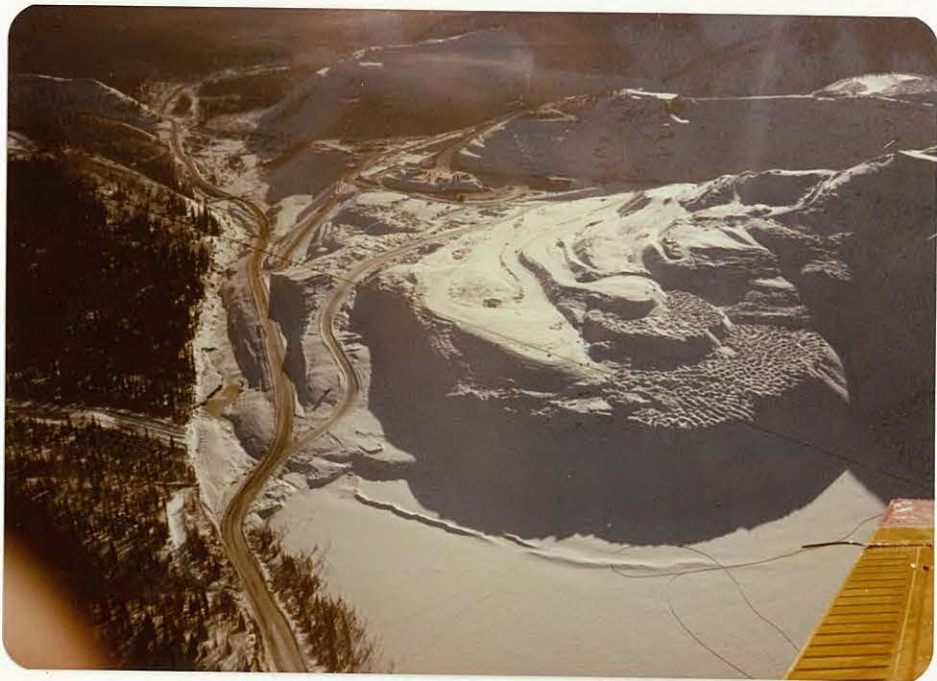
PHOTO 1

were responsible for development of a pressure ridge on the ice surface of Hudgeon Lake during the winter of 1977-78 (see Photo 1 of Appendix A), and they are also responsible for development of the cracks on the surface of the dump as illustrated on Photos 2 and 3. The mechanism of crack development, the orientation of the cracks, and the implied stress conditions within the dump are discussed in Appendix E.

View of Clinton Dump looking downstream, and showing pressure ridge on ice surface as a result of creep movements during the winter of 1977-78. Date of Photo, March 9th, 1978.

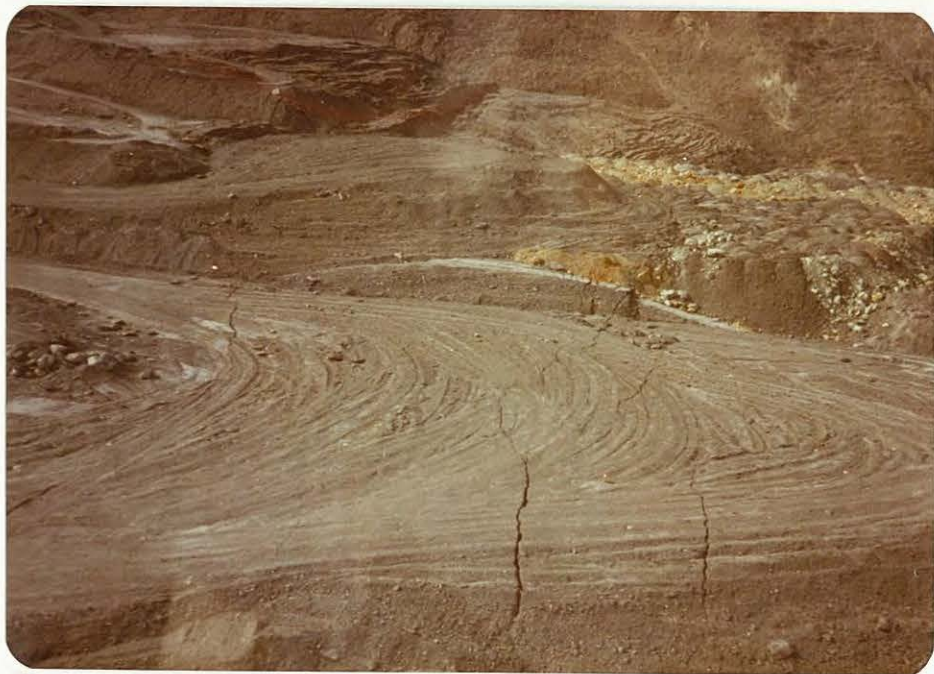
PHOTO 2

Tension cracks on surface of Clinton Dump as a result of horizontal movements due to shear of the dump on its base.

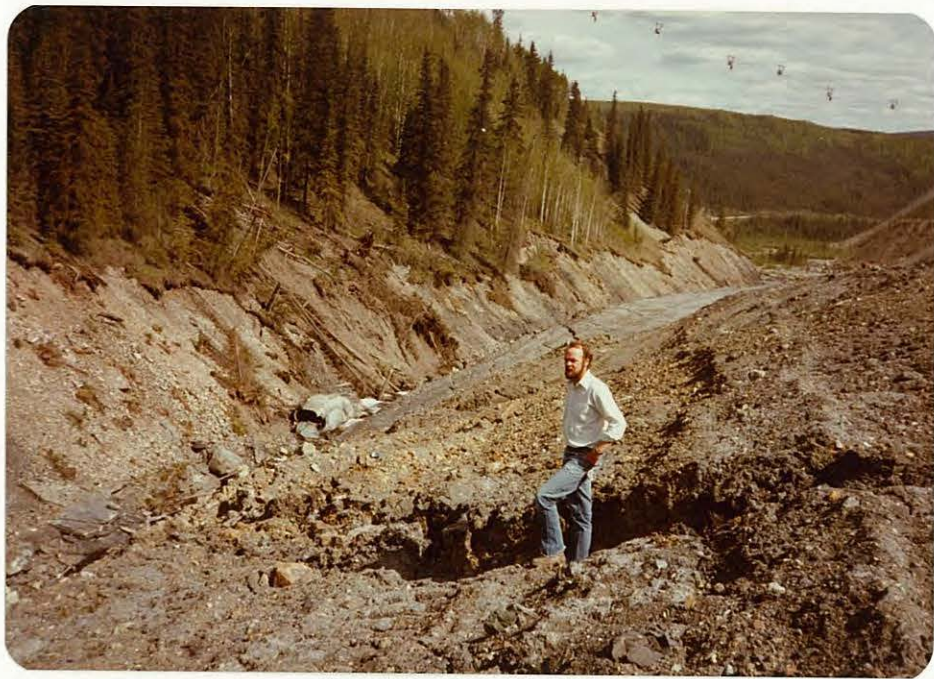
PHOTO 3

Tension crack aligned approximately perpendicular to Clinton Channel.

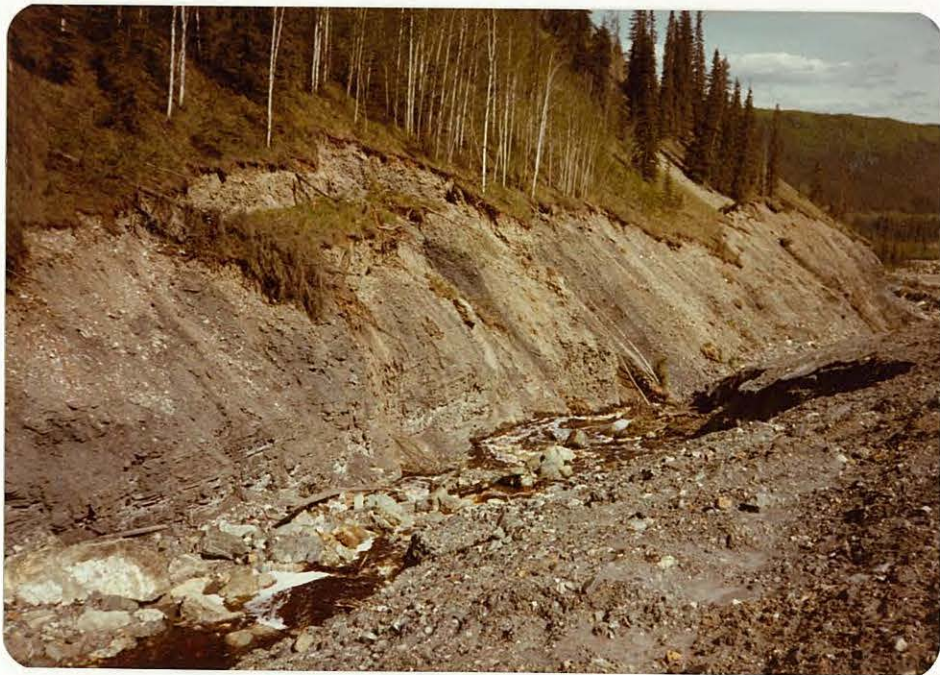
PHOTO 4

Showing bedrock exposed on left side of Clinton Channel at a point midway between cross channel reference lines B-B and C-C (see Figure 2 for location).

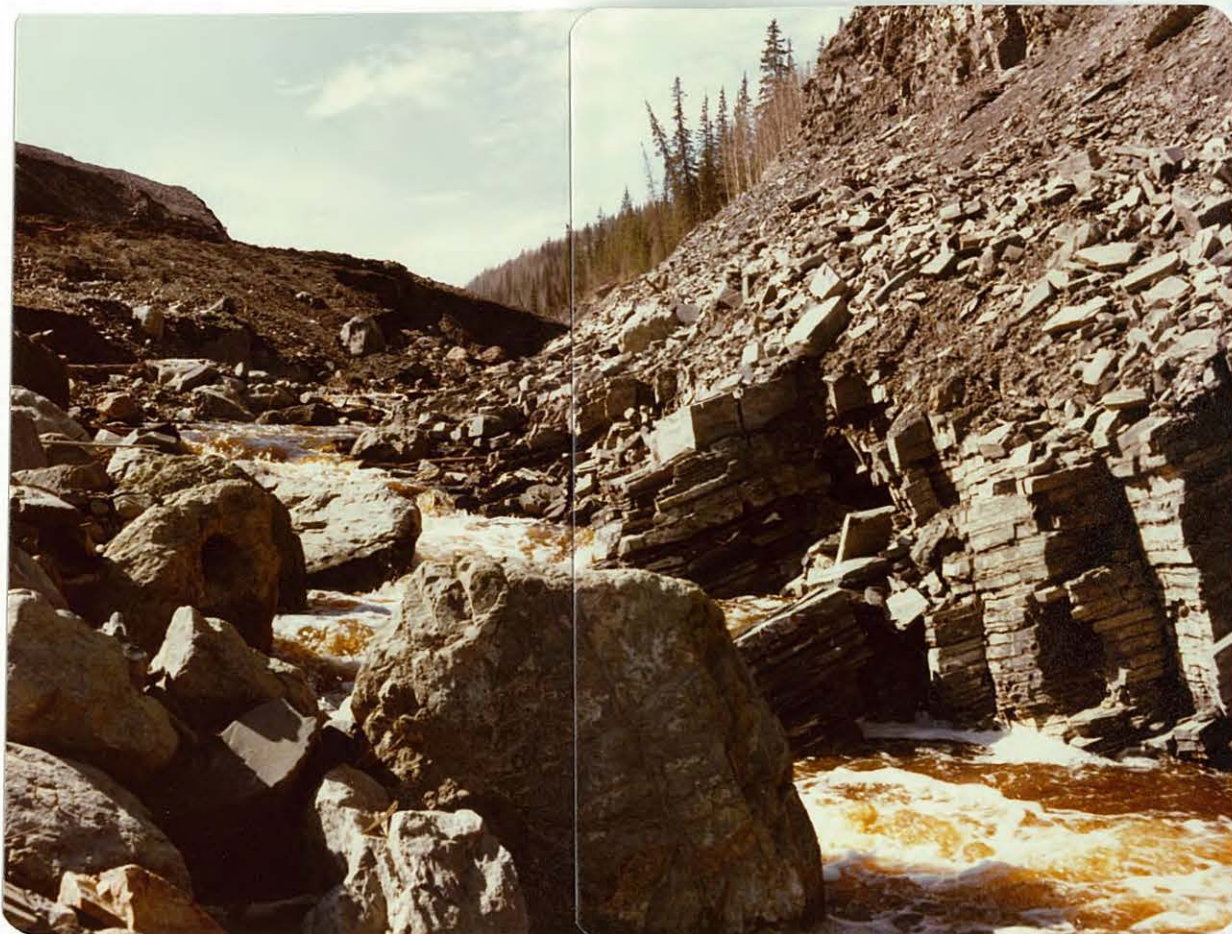
PHOTO 5

Subsequent to the advance of the dump across the valley floor and impoundment of the stream flows, Clinton Creek channel has become incised in both waste dump material and in situ bedrock along the contact between the northern limit of the dump and the hillside that formed the north valley wall of Clinton Creek. The waste dump material contains scattered fragments of hard, durable rock which have accumulated within the channel bottom, and provide resistance to erosion of the bottom of the channel during normal flow conditions (e.g. Photo 5, Appendix A).

View of Clinton Channel looking upstream showing exposed bedrock on north side. Bedding dips at approximately 20 degrees toward the channel, and well developed cross joints are aligned perpendicular to the bedding joints. Large rocks on left side of photo are remnants from the waste dump.

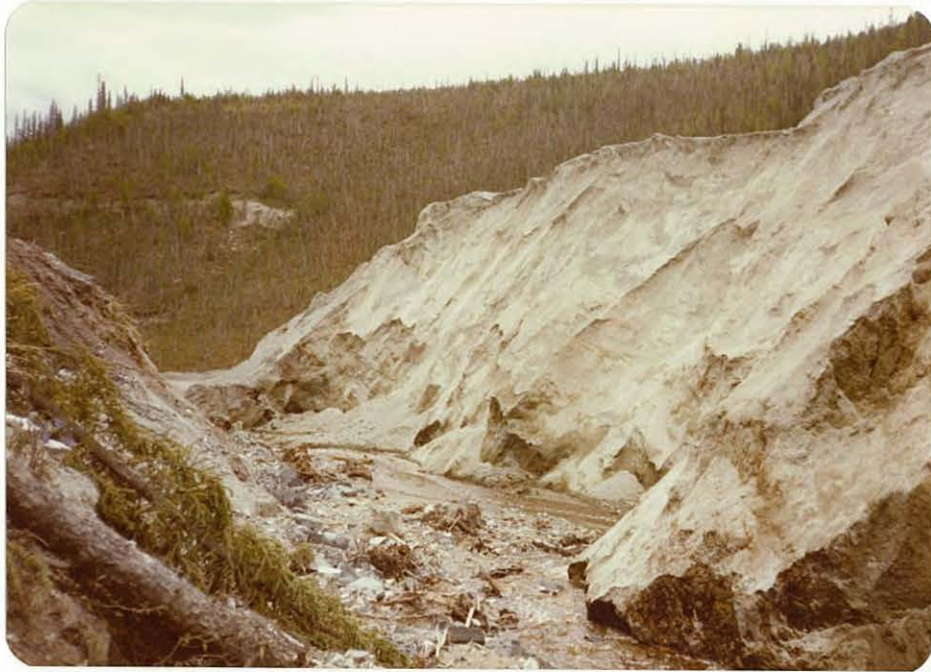
PHOTO 8

View of Wolverine Creek channel at toe of 1974 failure lobe showing the effects of stream erosion on the tailings.

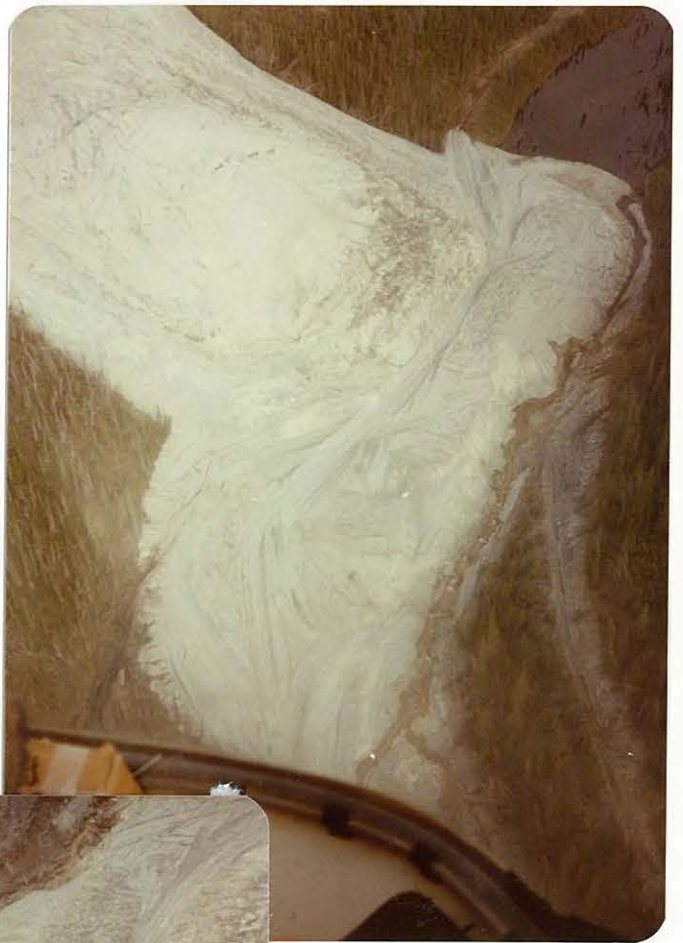
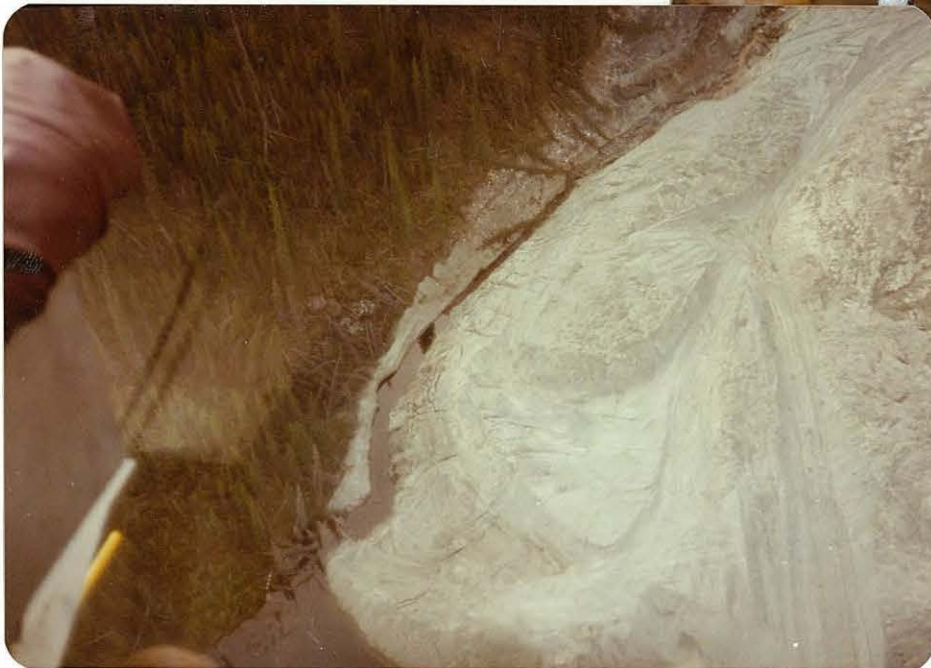
PHOTOS 9 & 10

Aerial views of the 1974 failure lobe. Note the crack pattern at the toe of the failure.

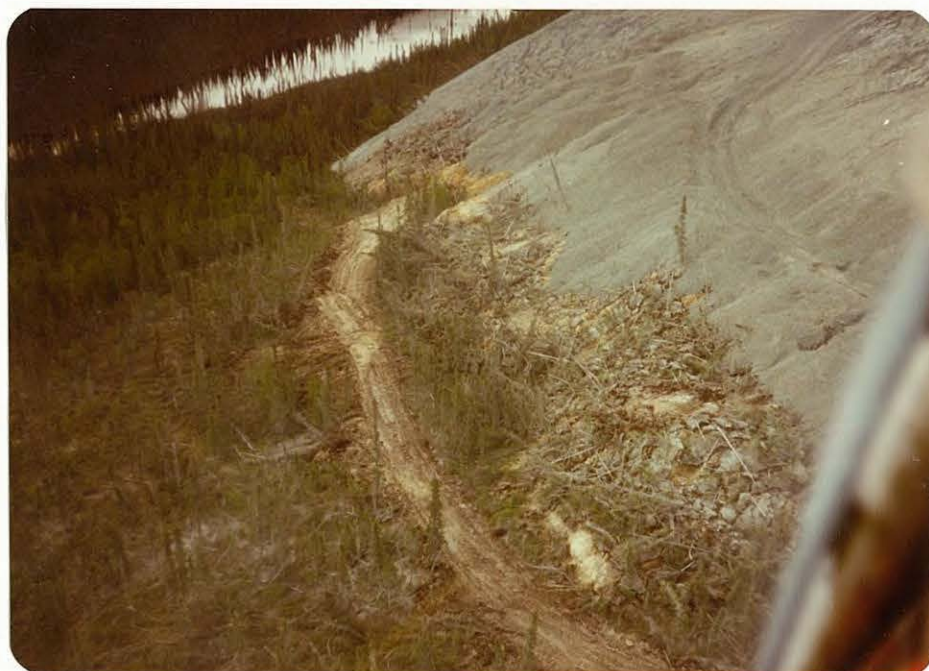
PHOTO 11

Toe of north lobe of tailing pile showing
foundation soils bulldozed ahead of the
pile.

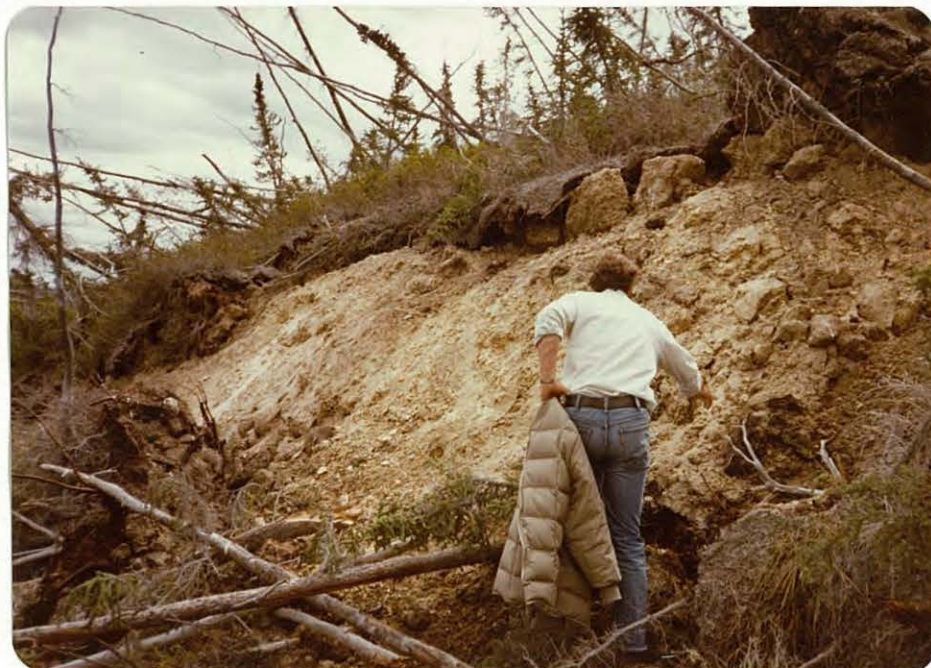
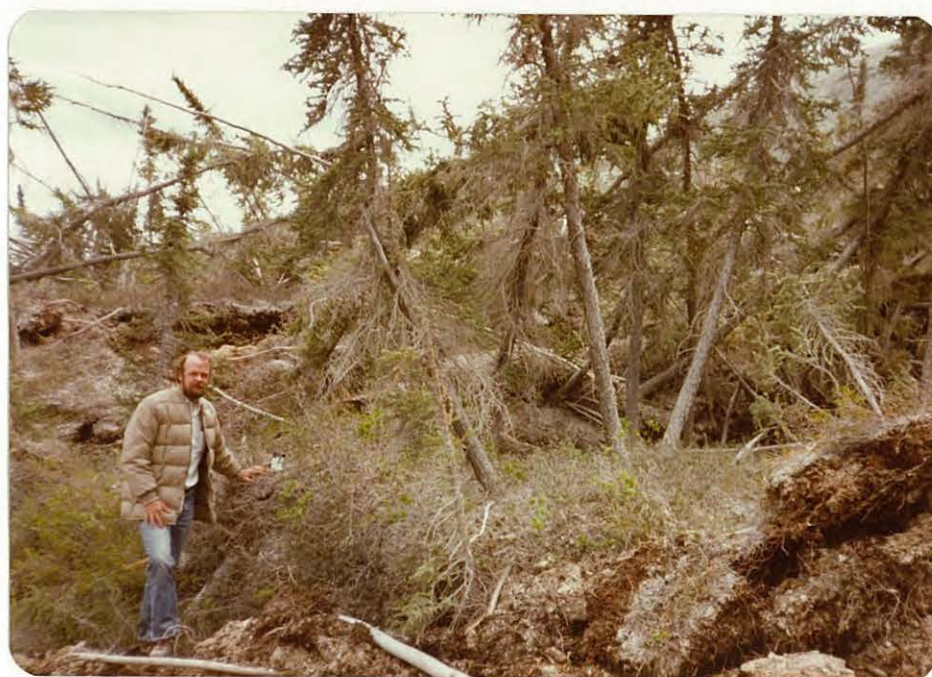
PHOTOS 12 & 13

Views of slabs of foundation soils pushed ahead of the tailing pile. These soil exposures are approximately 60 ft. in front of the toe of the tailing pile.

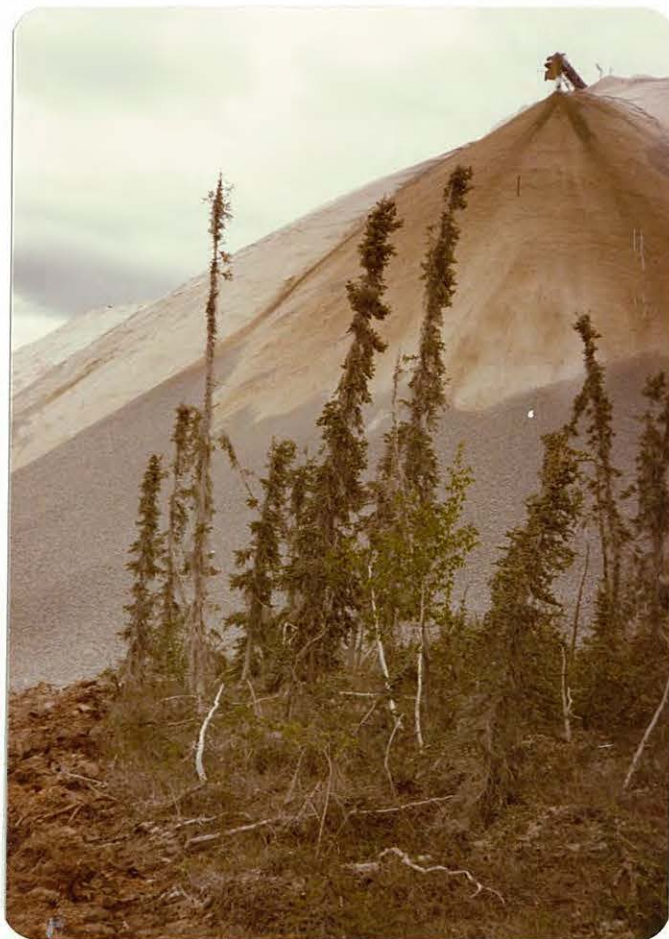
PHOTO 14

Northwest corner of tailing pile. Note the segregation of particle sizes as the tails travel down the face of the pile.
