REPORT TO
CASSIAR ASBESTOS CORPORATION LIMITED
ON
STABILIZATION MEASURES
FOR MINE CLOSURE

CLINTON MINE

YUKON TERRITORY

Originally submitted in draft: May 1976

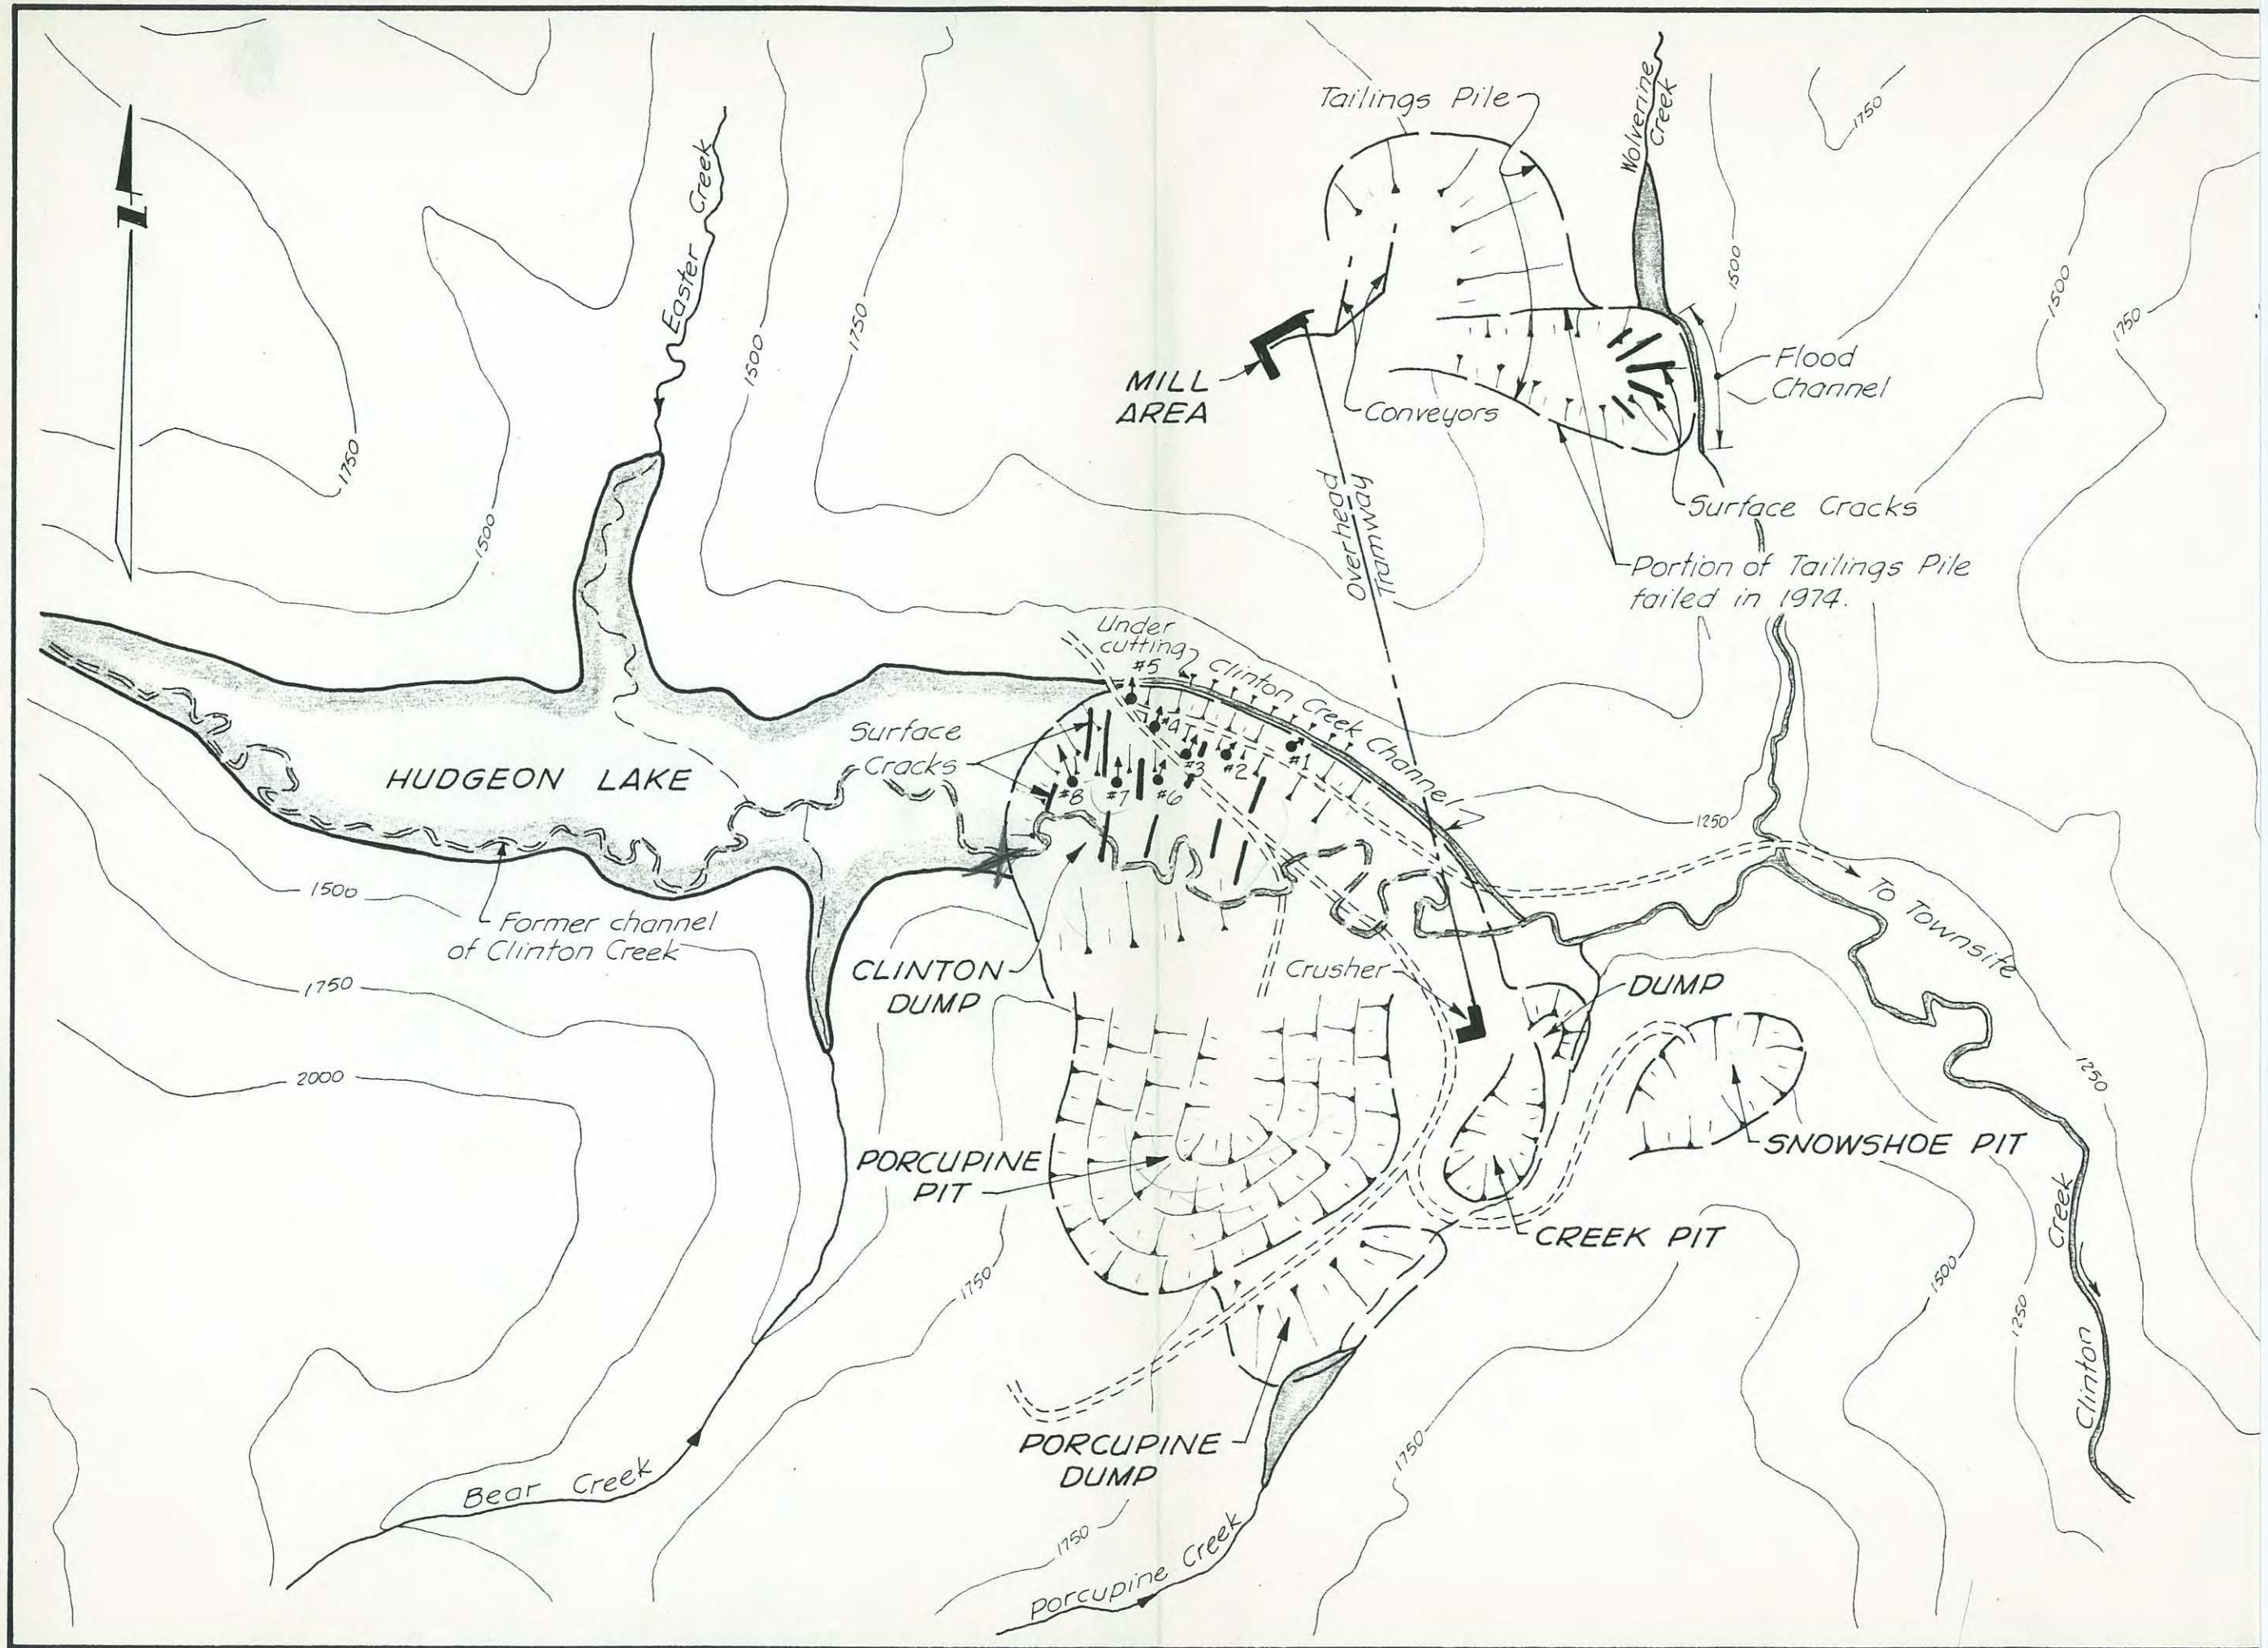
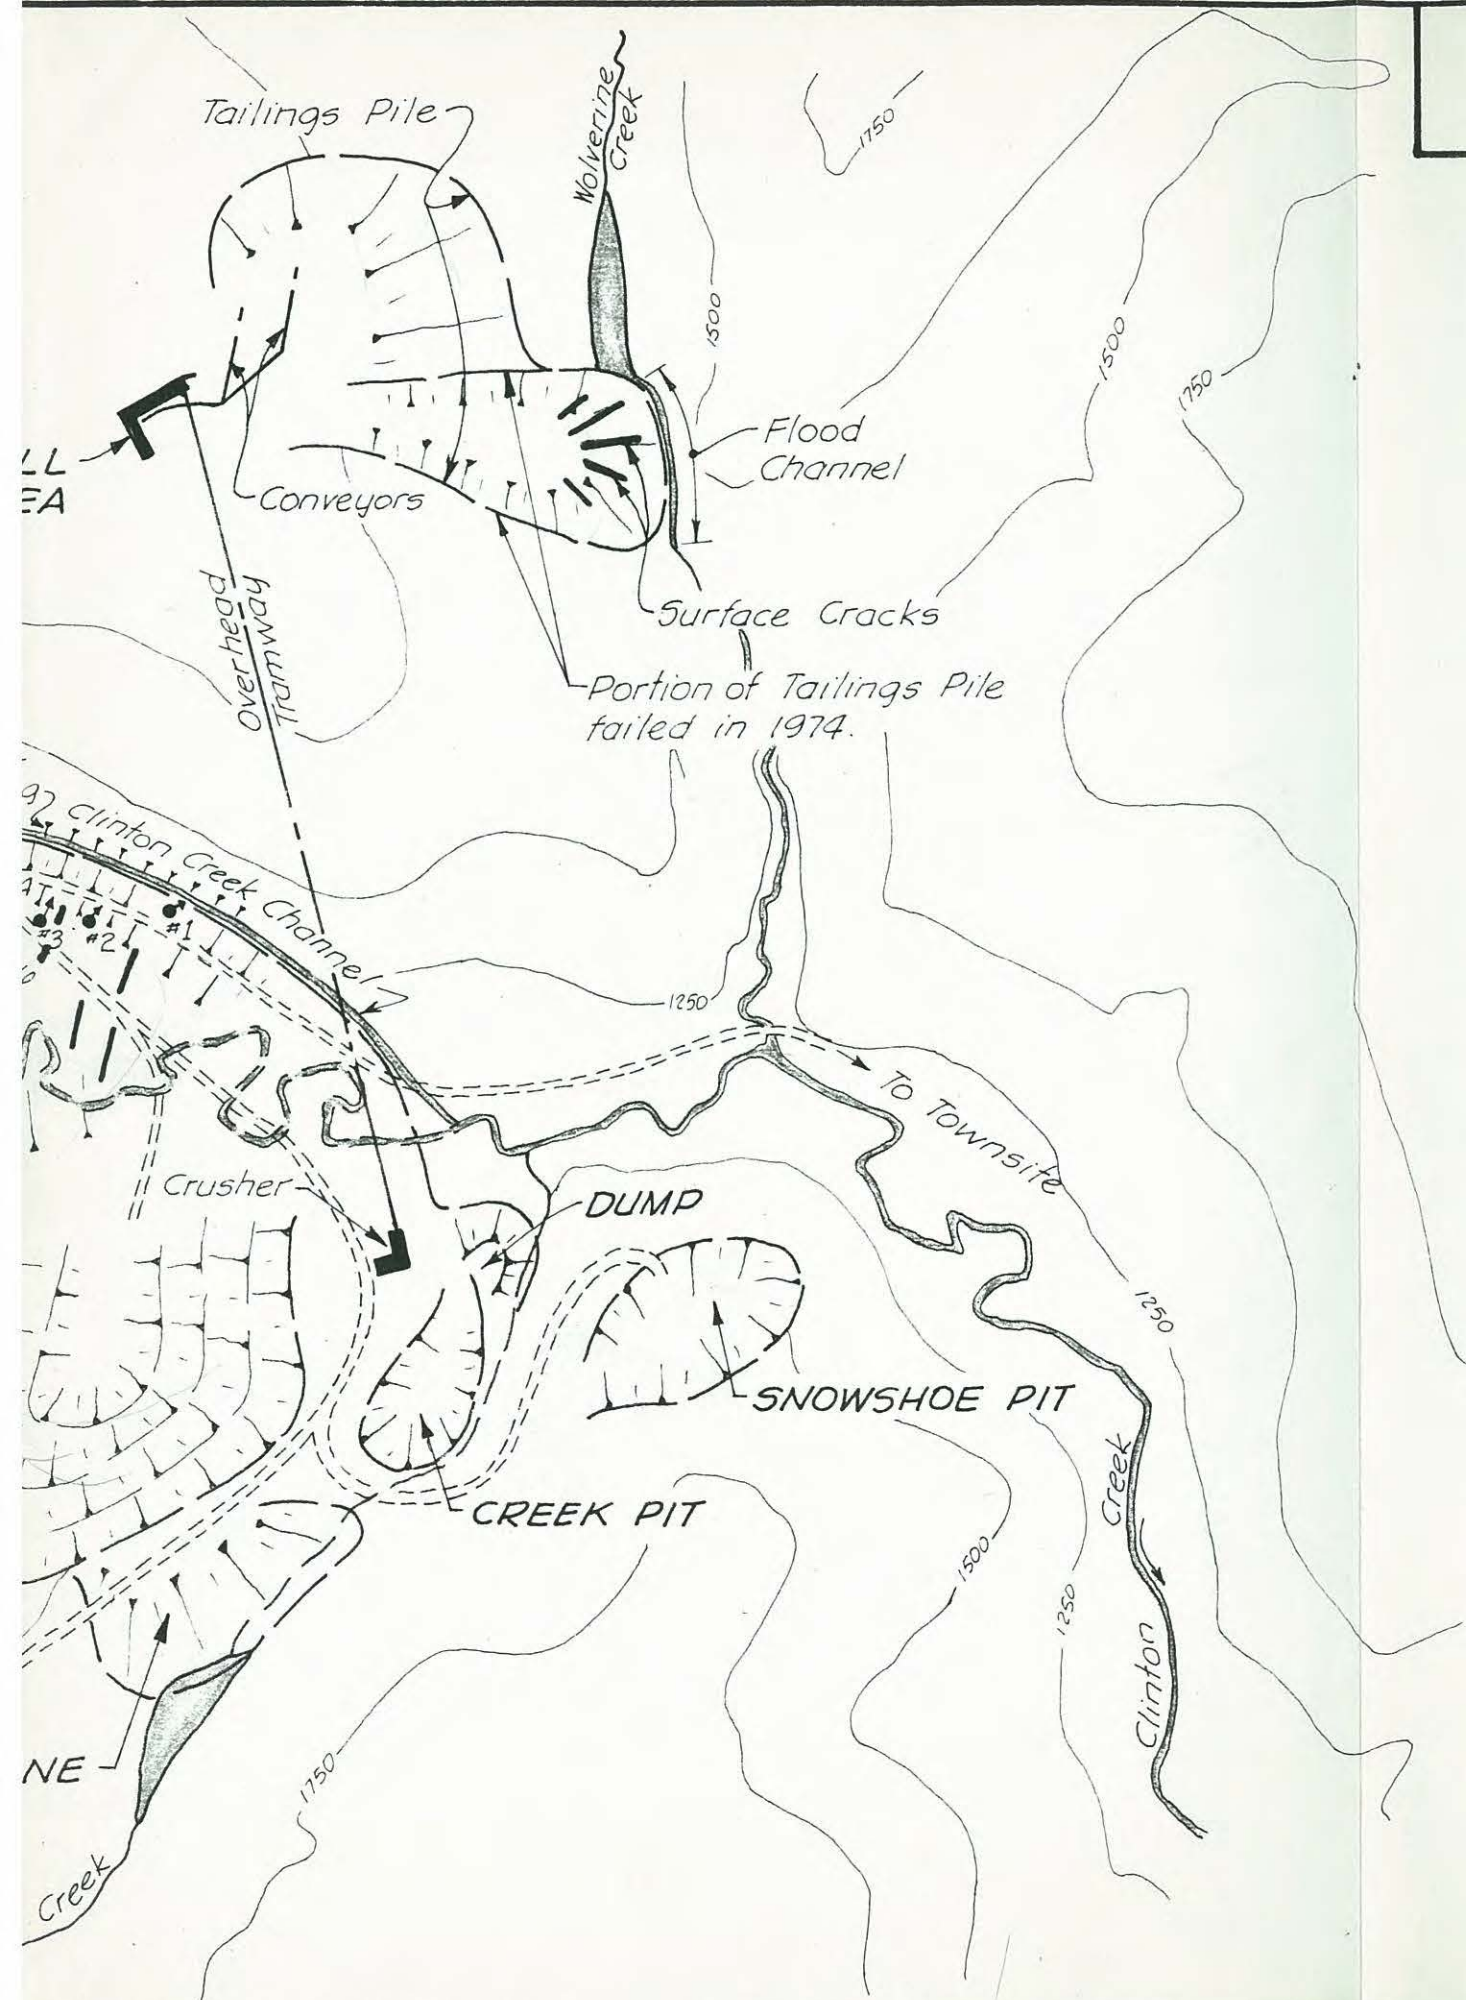
FIGURE 1

The surface of the toe of the slide is marked by 2 to 3 ft. deep cracks which are orientated radially, as shown on Figure 1. These cracks extend to the extreme toe. Surface cracking and slumping is evident in the upper region of the tailings pile.

CLINTON MINE, PLAN OF MINESITE AND MILLSITE AREAS

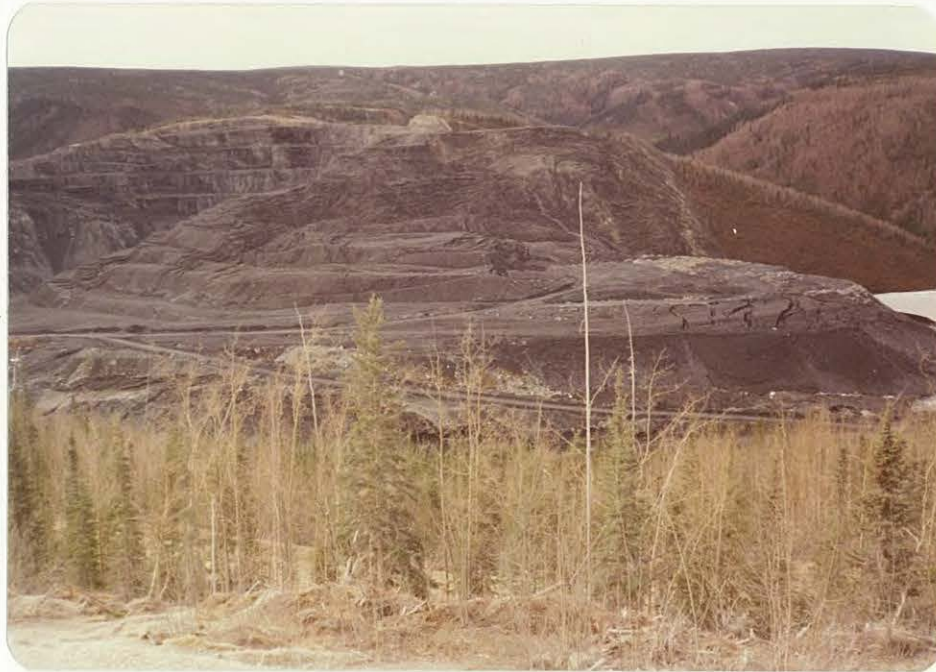
is at about El. 1340 on the north side of the valley. A view of the dump is shown in Photograph 1.

The original channel of Clinton Creek was blocked as a result of waste material gradually creeping downslope. During the initial stages of dumping, material was dumped at or near the top of the slope, and it crept downslope with relatively little bulldozing. We understand that, as creep was taking place, there were no sudden or deep-seated movements of material. After the channel was blocked, a lake was formed upstream of the toe of the dump, (Hudgeon Lake). This lake can be seen on the right of Photograph 1.

1. Clinton Waste Dump - looking across valley from North Side. Note cracks in lower part of dump in across-valley direction.

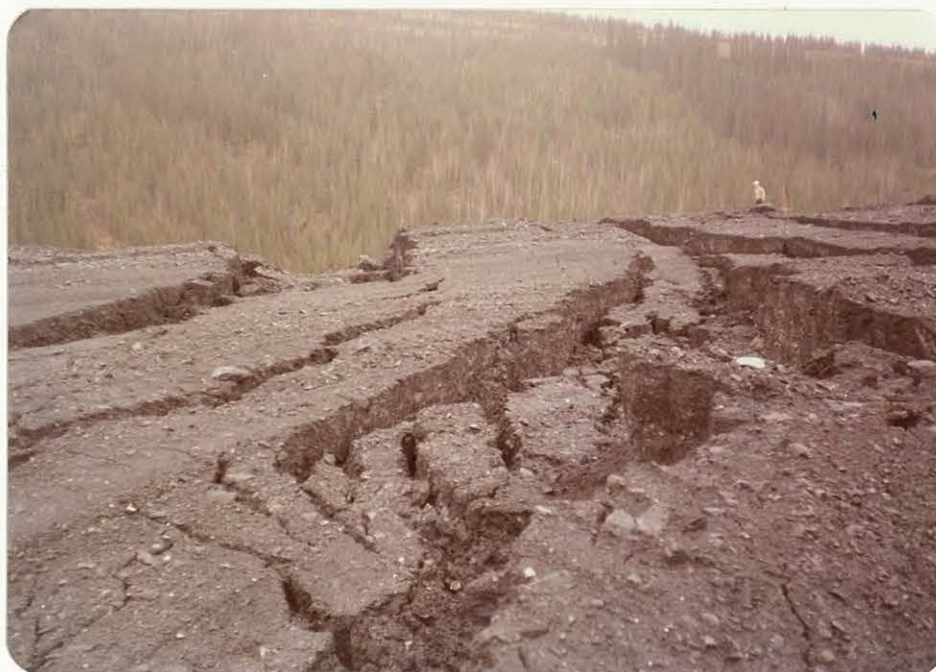
Cracks having widths of up to 3 ft. and depths up to 10 ft. were observed in the surface of the Clinton Dump, (see photographs 2 and 3). The cracks in the upper part of the dump are orientated roughly east-west, i.e. parallel to the contours of both the dump surface and original ground surface. These cracks appear to be scarps caused by vertical shear as the dump material has gradually crept downslope. In the lower part of the dump, most of the cracks are aligned approximately north-south, i.e., in the across-valley direction, and there is evidence of graben development (downward movement of a block of material, relative to the blocks either side). Some of the north-south cracks extend almost to the creek, i.e., across the main access road from the townsite. In some areas near the crest of local slopes in the lower part of dump, cracks have developed parallel to the crests of the local slopes.

2. View looking North showing cracks in Clinton Waste Dump. Dump monitor No. 7 on right.

2. Further monitoring locations should be established on the toe region of Clinton Dump, at least 200 ft. back from the crests of local slopes. Readings on existing monitors, which are at the crests of local slopes, may include the effect of localized surface movements on these slopes. The existing program of displacement measurements should be expanded to include the new monitors, as well as the existing ones.

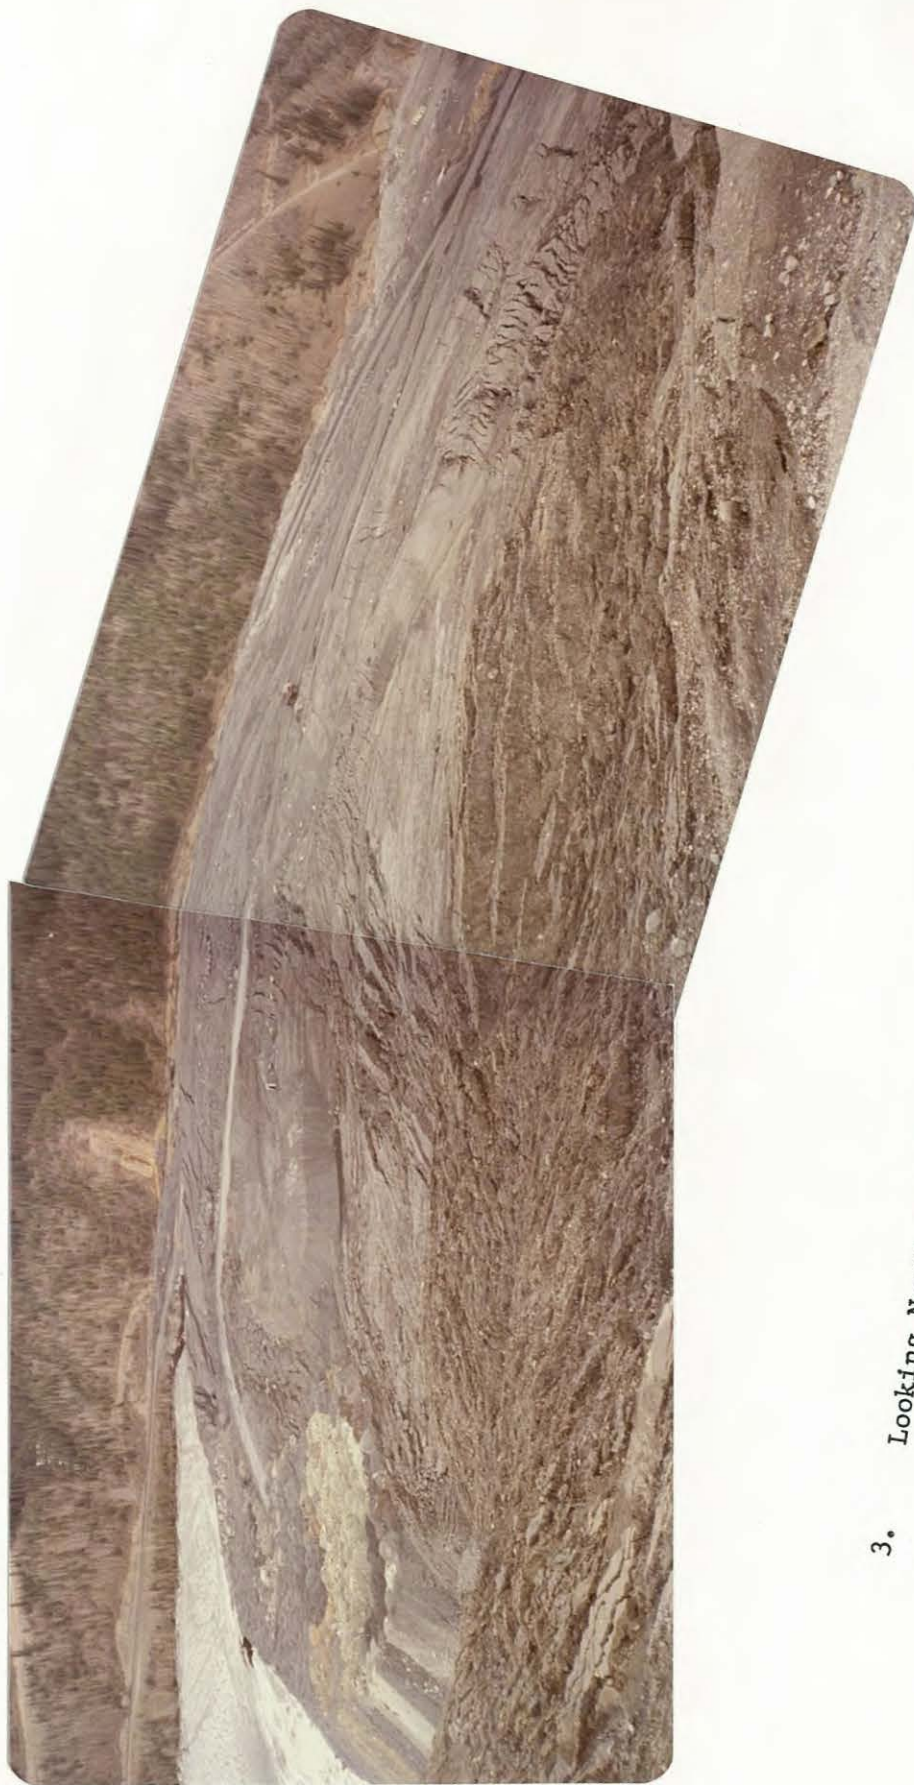
3. Looking North over Clinton Waste Dump, from upper crest.

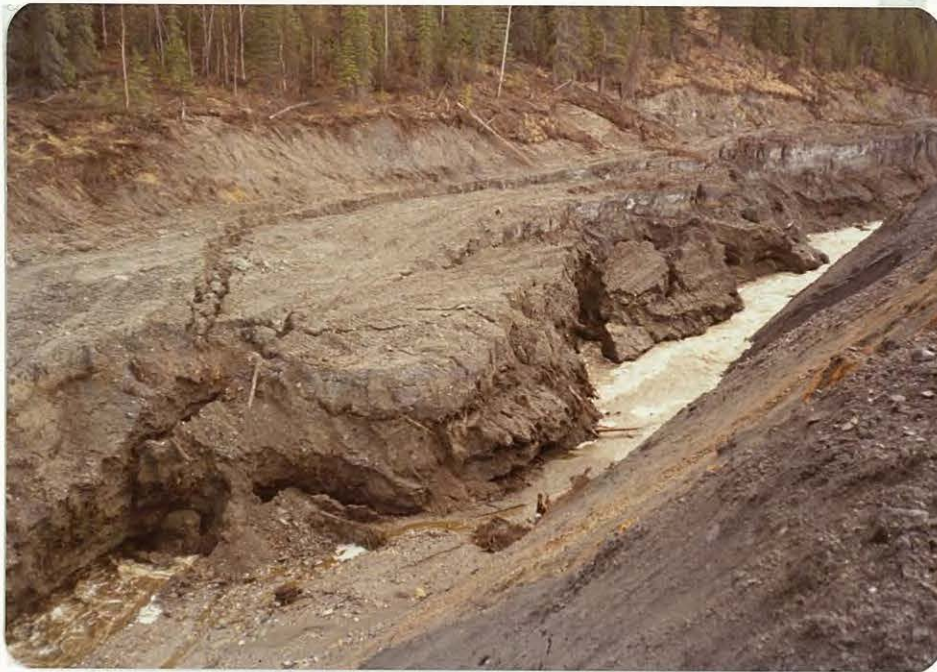
The channel had undercut its north bank in several areas. For example, opposite dump monitor 3, the channel was completely hidden at the time of inspection, as flows were undercutting a 200 cu.yd. block of waste material on the north bank (photograph 4). Bedrock (argillite) is exposed on the north bank opposite monitors 1 and 2. This had been eroded to a depth of about 5 ft. below the original bedrock surface.

4. Clinton Creek discharge, May 5, 1976, looking downstream at a location opposite dump monitor No. 3. Note undercutting of in situ material on left bank.

4. When it has been confirmed from monitor readings that dump movement towards Clinton Creek channel has virtually ceased, a construction program should be carried out on the channel where it passes the dump, to prevent large-scale channel creek erosion. The program should consist of principally:

- (a) flattening certain local slopes in the dump material, adjacent to the channel of Clinton Creek,
- (b) constructing energy dissipators in the channel.

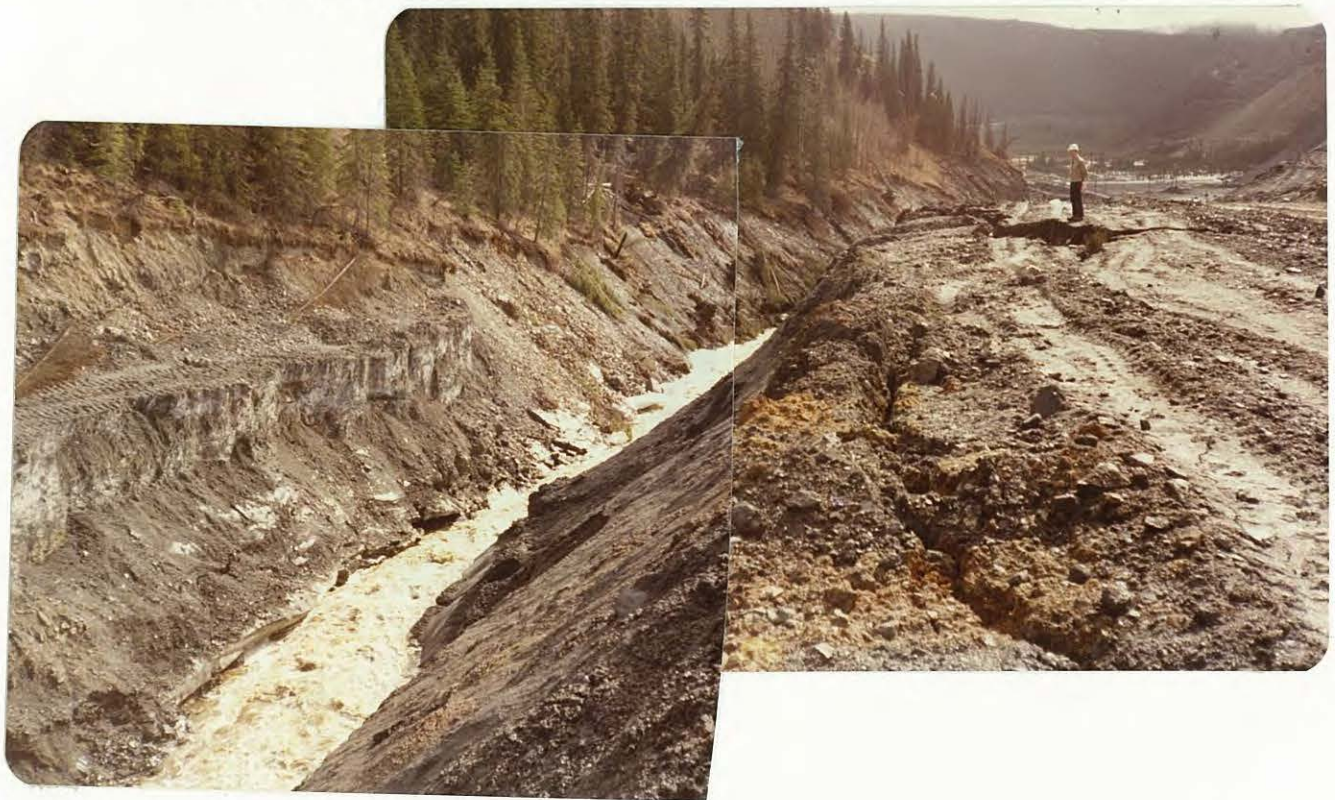
Along the south side of the channel, the local slope (within dump material) is at its maximum height and inclination between dump monitors 1

and 2. Vertical shear cracking at the top of the slope indicated that this part of the slope was about to slump into the channel (photograph 5).

5. Clinton Creek discharge looking downstream, between dump monitors Nos. 1 and 2. Note cracking at top of oversteepened right bank.

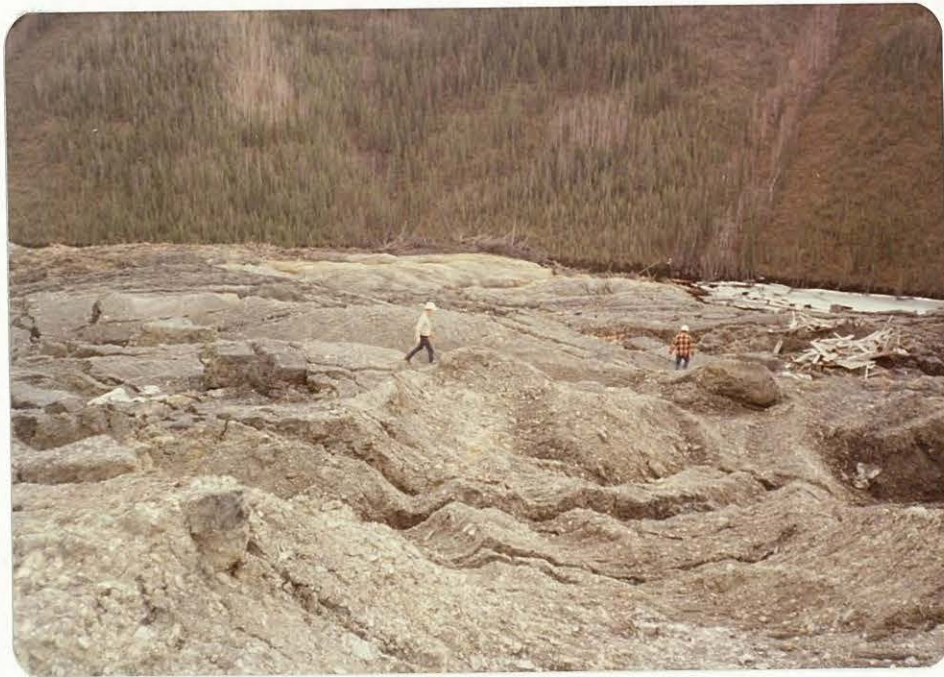
Porcupine Dump has a much smaller volume than Clinton Dump, and the pond that has been formed upstream of the toe of the dump is much smaller and shallower than Hudgeon Lake. The surface of the dump is very hummocky, and has an estimated average slope of 3 horizontal to 1 vertical, (see photograph 6). There are many cracks in the dump surface, mostly parallel to the overall surface contours, and there are some cracks indicating graben-like features. The majority of the waste material in this dump is argillite rock fragments.

The cracking and hummocky features on the surface of the dump indicate that creep movements have occurred, and may still be occurring. No measurements have been made of movement on the surface of this dump, but the writers were shown a pile of broken lumber, which was once at the crest and has now moved to a point 200 ft. down the slope from the crest and about 60 ft. vertically below the crest.

6. Porcupine Creek dump, looking East from crest. Note extremely broken surface in foreground, indicating large vertical and horizontal movement, and graben-like development. Note also debris and trees pushed up against the valley wall at the base of the dump.

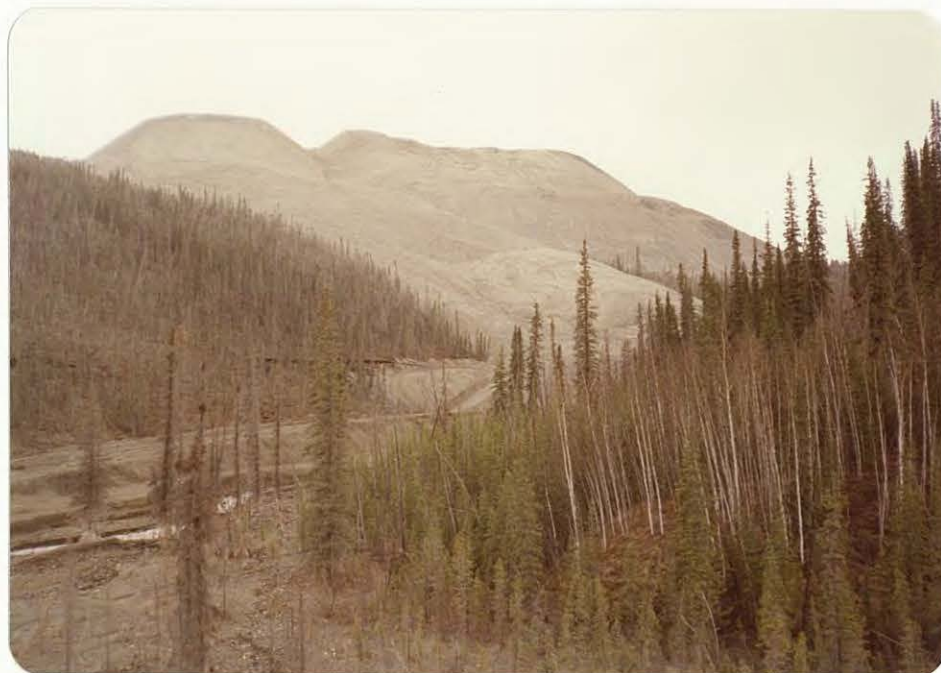
In the spring of 1974, a large section of the tailings pile moved downslope, and blocked Wolverine Creek (photograph 7). The crest of the pile is approximately 700 ft. above the toe of the slide. A small pond formed upstream of the toe of the slide. Considerable tailings erosion occurred when the pond level rose sufficiently for water to spill over the toe of the slide. Flood waters in Wolverine and Clinton Creek channels downstream of the slide rose to several feet above the banks of the creeks, and white mineral fibre can still be seen clinging to the bottom 2 ft. or so of the trees in the valley bottoms. After the slide occurred, a channel for flood flows in Wolverine Creek was bulldozed across the toe region of the slide.

7. Tailings Pile, looking upstream from East side of Wolverine Creek. Portion of pile which moved downslope in 1974 is in foreground.

To check on possible creep movements within the slide, surface markers (monitors) should be installed in the toe region, and reference points established on stable ground on the east side of Wolverine Creek. The monitors on the tailings pile should be located at least 200 ft. back from the crests of locally steeper slopes within the toe region. Periodic measurements should be made of the distance between the reference points and the monitors.

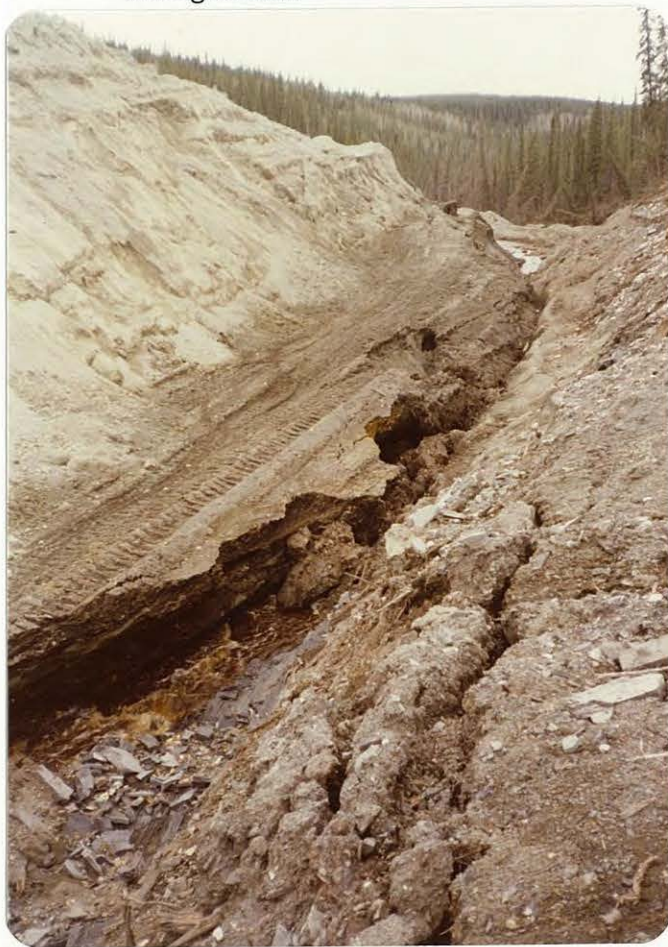
The creek has now cut below the level of the bulldozed flood channel and is flowing on bedrock (argillite) that outcrops at the toe of the slope on the east side of Wolverine Creek (see photograph 8). The erosion below the flood channel has also exposed organic soil mixed in with the tailings. This would suggest that the seat of movement within the toe region of the 1974 slide was in unfrozen soil close to the original ground surface. Inspection of the topographic contours of the area (made prior to tailings disposal) indicates that the portion of the tailings pile that failed was located above a shallow draw in the hillside. The presence of the draw could have contributed to the slide, in that the surface soil in the draw could have been locally

8. Base of tailings pile, looking upstream. Wolverine Creek has cut below the level of the 1974 flood channel. It now appears to be flowing on bedrock (argillite) that is visible in foreground.

7. Large-scale erosion of tailings by Wolverine Creek, such as occurred in 1974, is not expected to recur. To prevent small-scale erosion as the creek downcuts the tailings on a continuing basis, the channel could

be lined with rockfill. Alternatively a culvert could be installed in the tailings to carry flood flows.

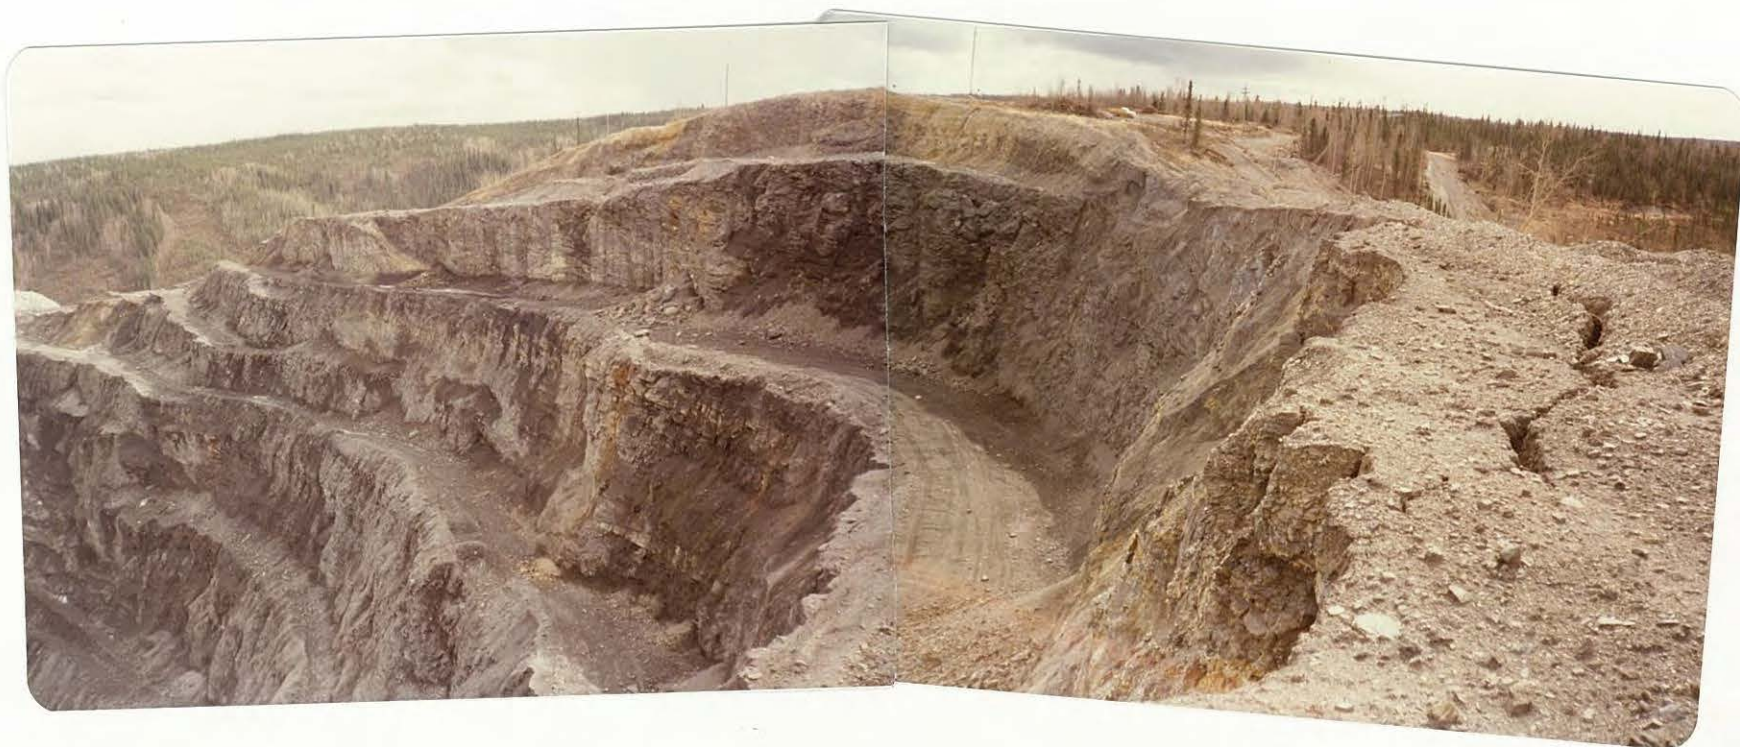
Ravelling and numerous small wedge failures have occurred on the inter-bench slopes of the west wall, as evidenced by accumulations of broken rock debris on the benches. Cracks were observed at a maximum distance of 10 ft. behind the crest of the west wall, as shown in photographs 9 and 10. At the time of inspection, the pit walls above El. 1380 were final, and the El. 1380 bench on the west wall had been left approximately 150 ft. wide. The mining company propose to cut this back eventually to 58 ft. width.

9. West wall of Porcupine Pit. Note cracking at rim of pit, and numerous cases of ravelling on the inter-bench slopes.

Instability of the pit walls to date has been confined to the inter-bench slopes of the west wall. Material from surface ravelling is accumulating on the benches. This material should be removed as practicable in order to restore the bench catchment.

Surface markers should be set up on the west wall of the pit to monitor small scale movements, and to provide adequate advance warning of potential deep-seated slides. The locations of the markers should be selected so that surface movements can be differentiated from deep-seated movements. The distance between the markers and fixed reference points established on the east side of the pit should be measured on a regular basis, to monitor movements on the west wall of the pit.

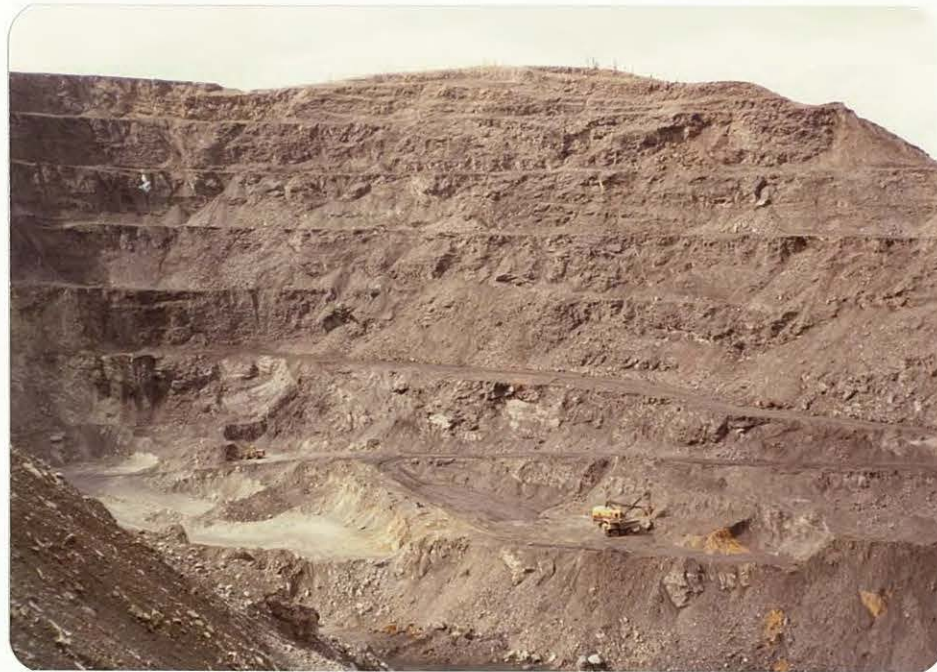
10. West wall of Porcupine Pit. Pit wall above El. 1380 bench (i.e. the bench above that on which loader is working) is final. Further excavation is planned below El. 1380, leaving a 58-ft. wide bench at El. 1380.
