REPORT
TO
DEPARTMENT OF INDIAN AFFAIRS AND
NORTHERN DEVELOPMENT
ON
WASTE DISPOSAL OPERATIONS
CLINTON CREEK MINES LTD.

CLINTON CREEK YUKON TERRITORY

August 1974

V74172

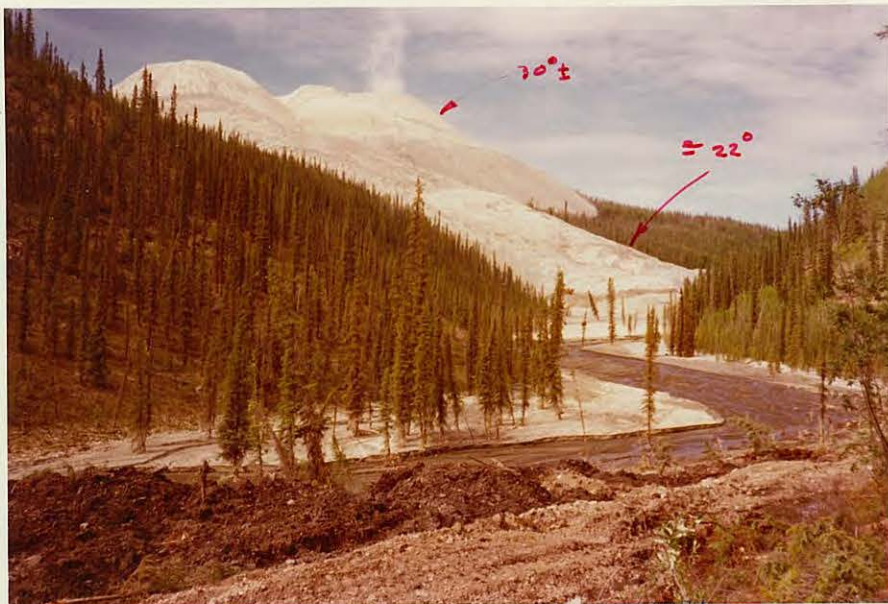
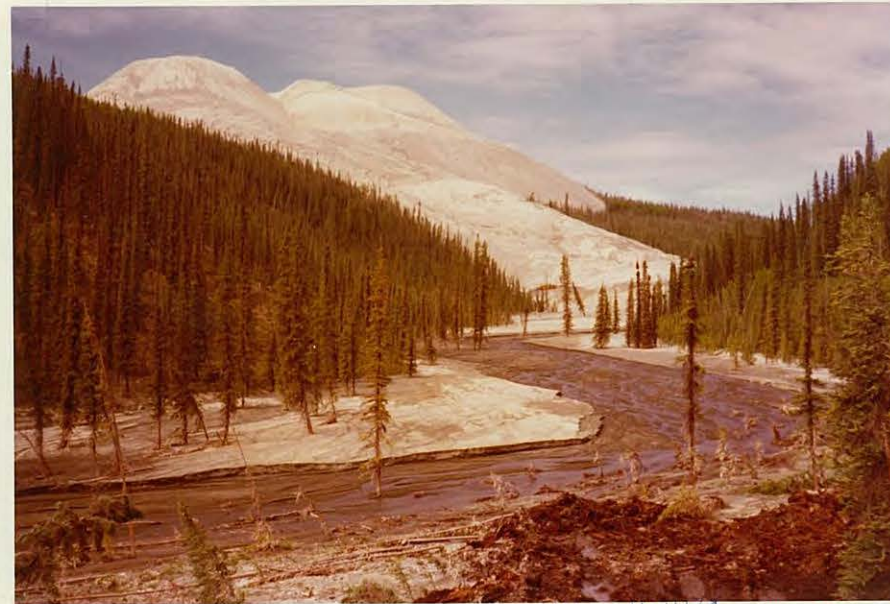
- 1-8 & 1-7 View of the Clinton Creek tailings pile looking upstream, and showing the toe regions of a massive slide. This slide blocked Wolverine Creek, and formed a small lake on the upstream side. During the spring runoff period of 1974, the pond on the upstream side of the slide overtopped the slide debris. When this occurred, the tailings were downcut very rapidly, resulting in flash flooding in Wolverine Creek downstream. The present flow in the Creek is the result of seepage through the tailings and/or the in-situ foundations soils. At the time of the inspection on July 29, no surface flows were passing from the pond to the downstream side of the slide. The bed of Wolverine Creek as shown in these photographs is comprised of transported tailings. Note the tailings deposited on the far side of the Creek, among the standing black spruce.

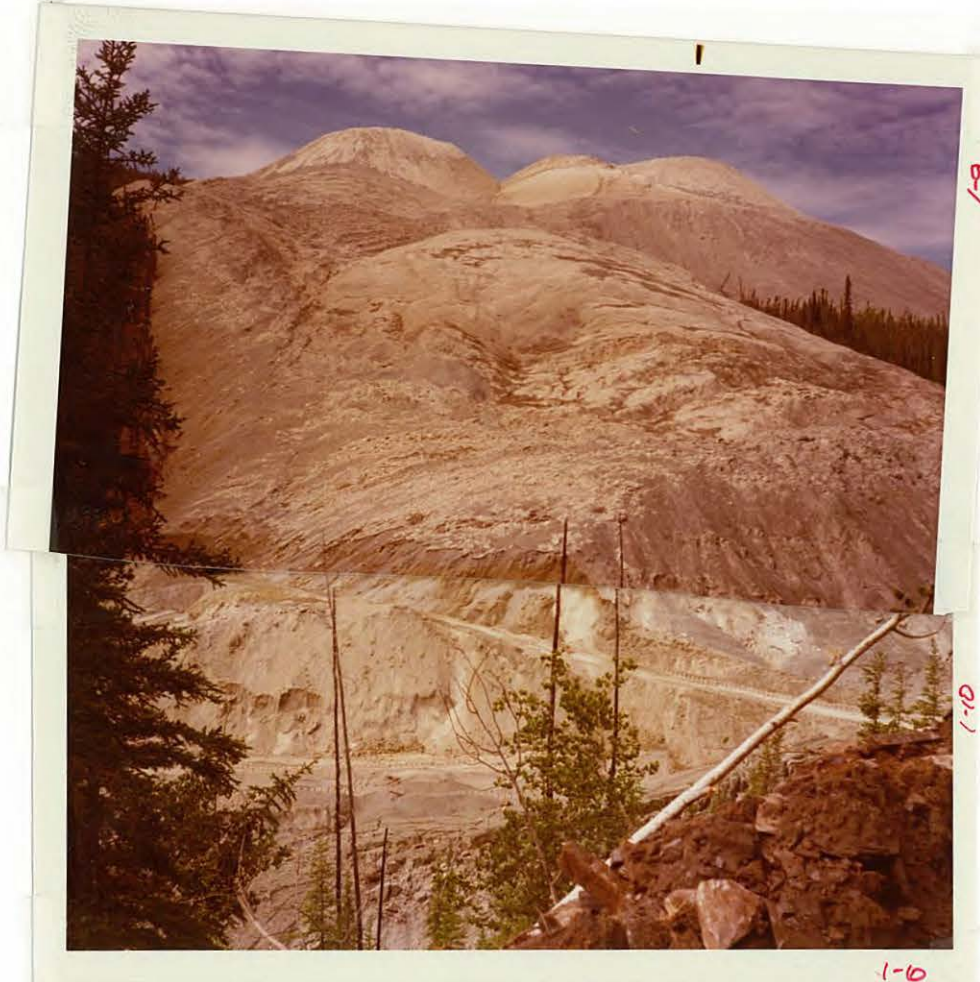
1-10 & 1-9

Another view of the Clinton Creek tailings pile looking from the toe toward the crest of the pile. At the time of the inspection on July 29th, Clinton Creek was actively bulldozing a trench at the toe of the slide in an attempt to open the drainage channel from the pond on the upstream side of the toe. Note the Cat work at the toe region of the slide. The photographs show that the slide movements extend uphill almost to the crest of the tailings pile. Note the arcuate slide scarps on the surface of the pile extending uphill to the base of the truncated cone against the skyline. Note also the quasi-ridge below and to the left of the truncated cone. The movements appear to have been initiated within the central portions of the slide, probably beneath the toe. These movements appear to have resulted in loss of lateral support, and retrogressive slide movements in the uphill direction. The central portion of the slide appears to have moved toward Wolverine Creek, but appear not to have involved to the extreme southern limit of the tailings pile, thereby resulting in the formation of a ridge along the southern limit of the active slide movements.

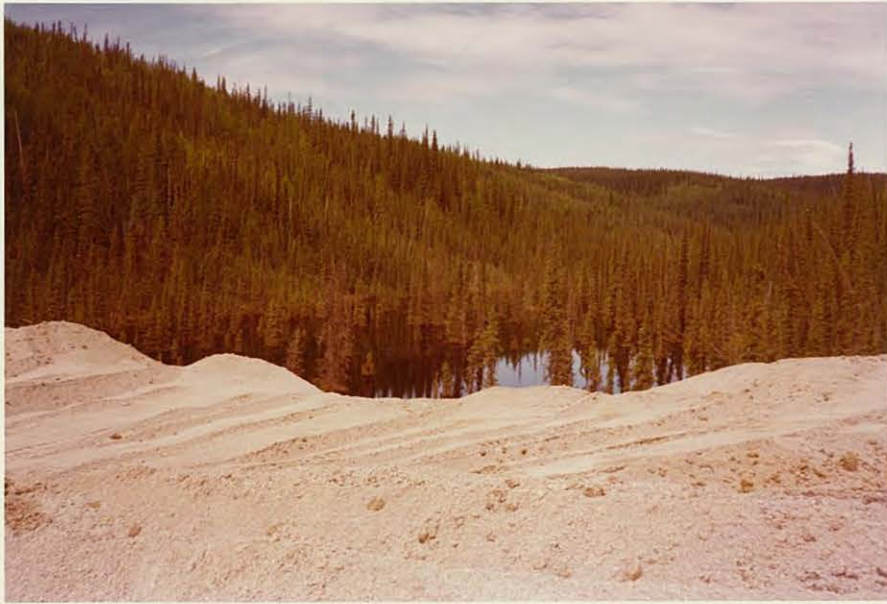
1-11 Showing the pond that has been developed as a result of damming of Wolverine Creek by the toe of the tailings pile.

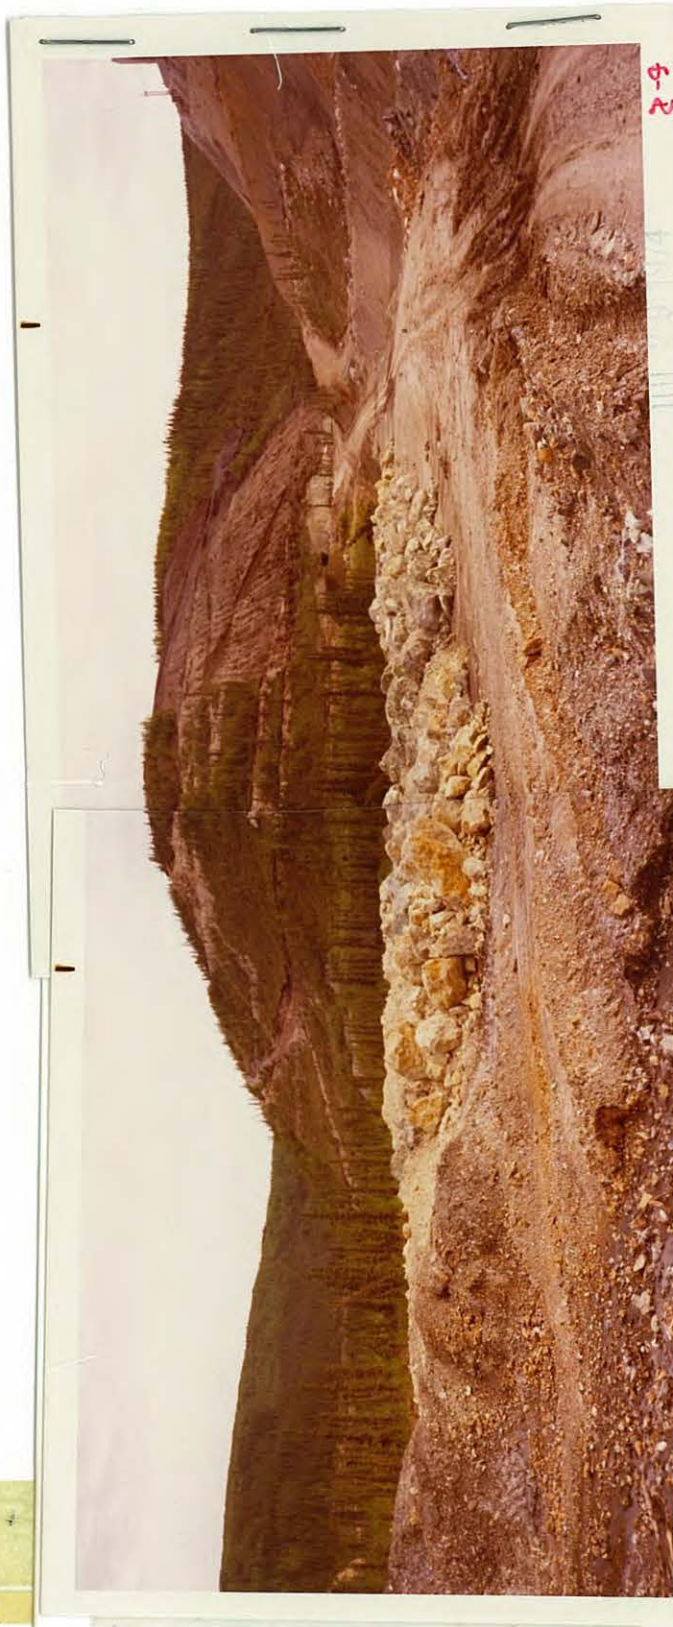
2-6-9 incl.

Clinton Creek appears to the right of centre of photograph 2-7. The proposed extension of the overburden waste pile is bounded on the east by the powerline, and will extend southward approximately to the face of the Snowshoe pit.

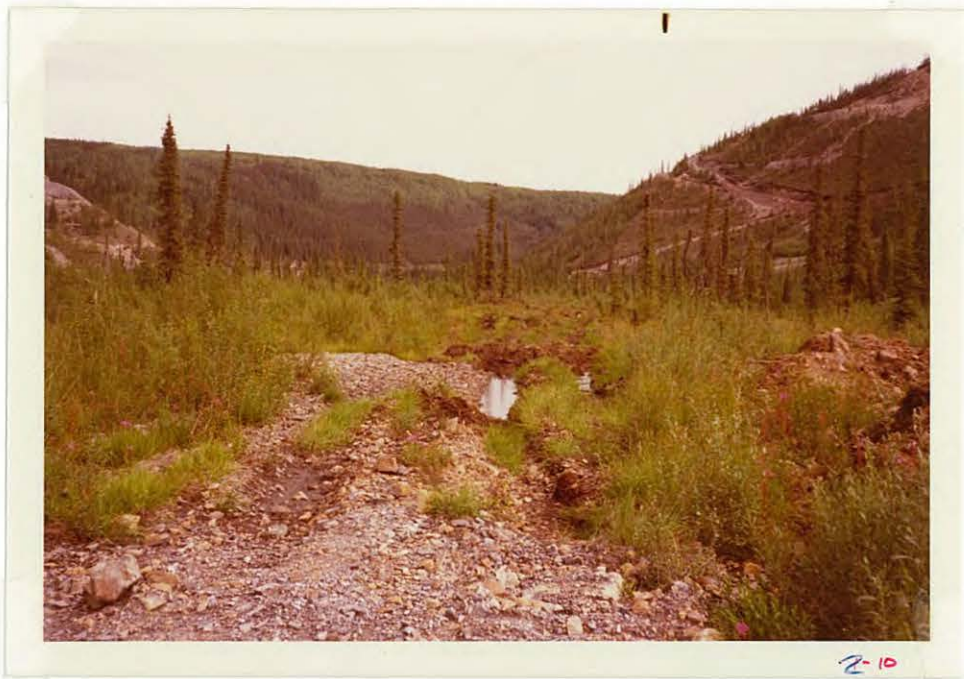
2-10

A cursory examination of the foundation area of the proposed waste pile on July 29 indicates that the surface of the area is mantled with typical northern black organic soils. These soils may or may not have sufficient shear strength to maintain stability for this proposed waste pile development. For example, organic soils appeared to be involved in the shear displacements that have occurred at the toe of

Photograph showing the general foundation conditions within the area proposed for the extension of the overburden waste pile. Note the ground disturbance by bulldozer in the centre portion of the photograph. The surface soils consist of the typical black organic muck.

If investigations show that the organic soil mantled within the foundation area of the proposed waste pile do not have sufficient strength to assure stability of the proposed waste pile extension, we suggest that the organic soils be stripped from the area, or alternatively that the foundation area within the proposed extension of the pile be allowed to freeze, and then be covered with a 10 ft. thick layer of waste rock before the subsequent spring thaw. If the organic surface soils are frozen, they will unquestionably have sufficient shear strength. The 10 ft. layer of waste rock should preclude the possibility of thawing and loss of strength during the subsequent summer.

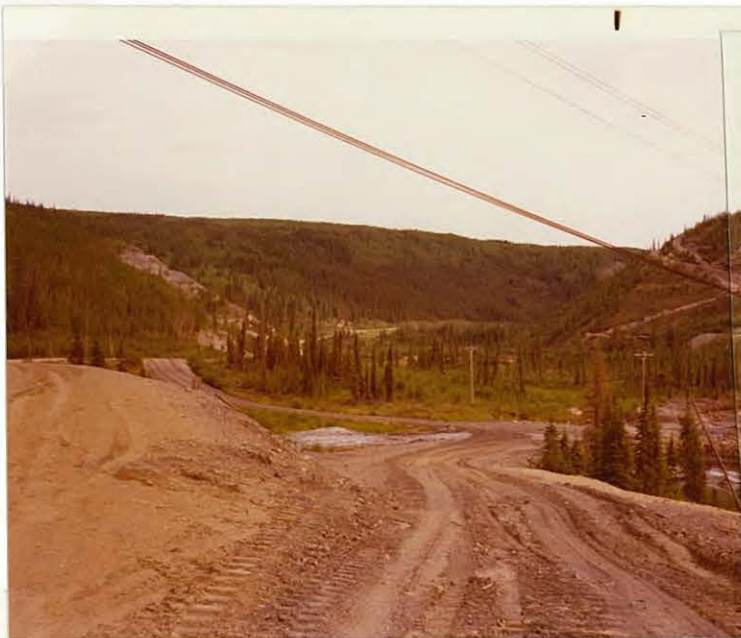
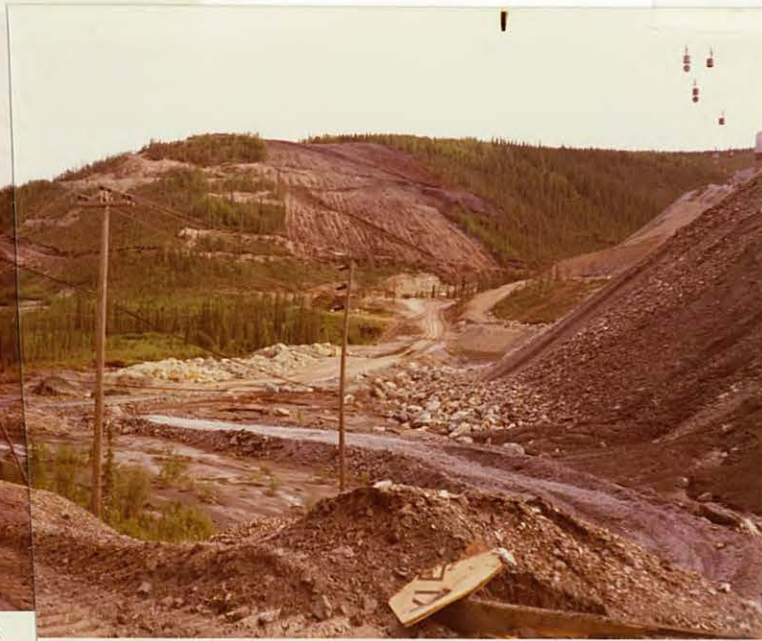
- 2-11-12 Another view of the general area shown in photograph 2-6 to 2-9 the proposed extension of the overburden dump. The tramway or cars appear at the extreme upper right of photograph 2-12. Clinton Creek proposed to extend the overburden waste pile outward from the level terminus of the tramway approximately.

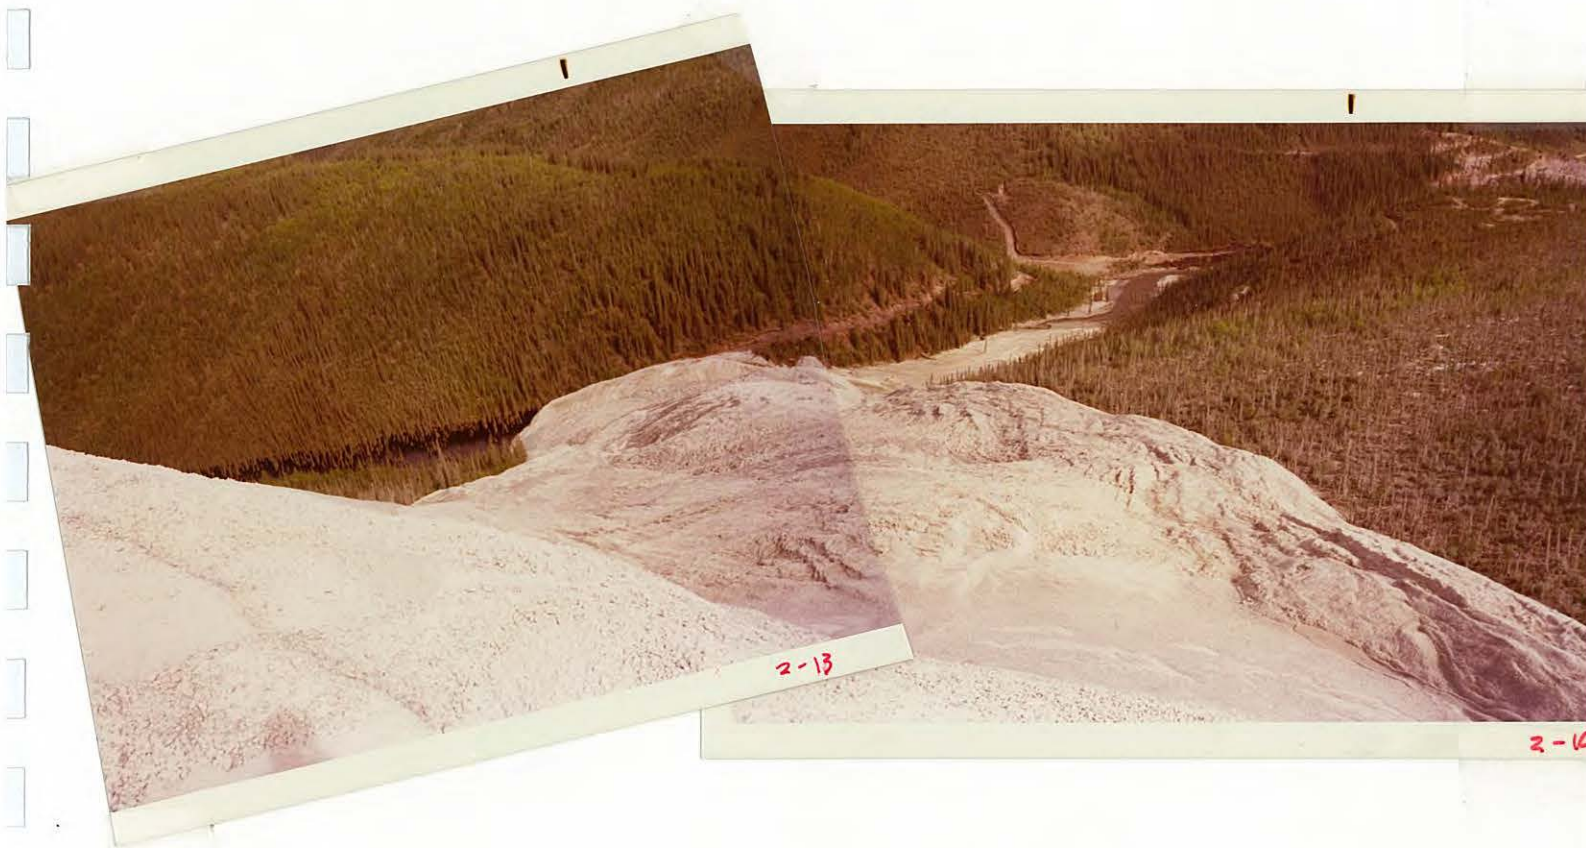
The slide at the tailings pile appears to have occurred at a location where solifluction had resulted in the accumulation of organic soils within the lower regions of a micro draw on the west side of Wolverine Creek. Apparently, as the toe of the tailings pile advanced onto this area, the in situ surface soils were incapable of sustaining the imposed shearing stresses. Displacement of organic surface soils was also evident at at least one other location at the toe of the tailings pile.

2-13 & 14 View of the tailings pile failure looking downslope from the crest of the tailings pile. Note where the toe of the slide has blocked Wolverine Creek, resulting in ponding on the upstream side of the toe of the slide. Note on the downstream side of the toe, the tailings that have been deposited in Wolverine Creek at the time that the toe of the slide was overtopped. Note the crack pattern on the surface of the slide which suggests flowage of the toe regions, and the formation of the ridge along the right hand side of the zone of active movement.

- i The channel could be lined with suitably sized rock, to resist erosion by the surface flows.
- ii The channel could be equipped with an overflow structure at the downstream end. The purpose of the overflow structure would be to maintain velocities sufficiently slow that erosion of the tailings would not occur, and to dissipate energy at the downstream end of the channel.
- iii Installation of a culvert may also be a suitable alternative at this location. The culvert would be installed with a headwall at its upstream end, and the upstream invert of the culvert above the invert of the open channel. The culvert would be designed to carry flood flows only during normal flow periods, water would pass from the upstream to the downstream side of the tailings via seepage through the

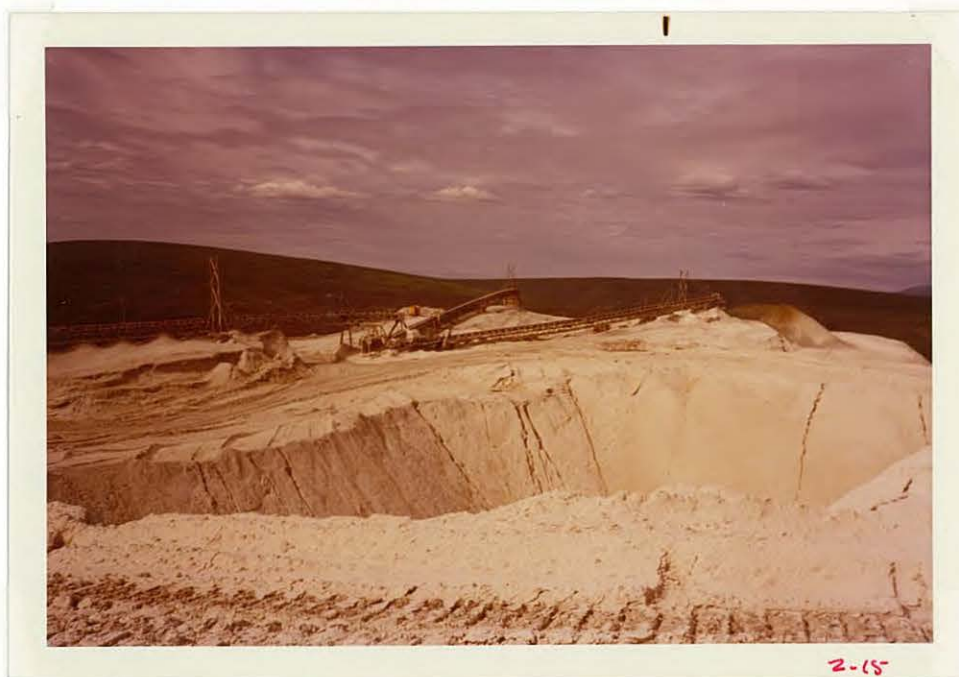
2-15 Showing the belt conveyor and disposal operations at the crest of the tailings pile. The tailings are deposited from the end of the conveyors, and the materials are then bulldozed over the crest of the tailings pile. The short conveyor in the foreground is to be moved to a position running away from the camera.

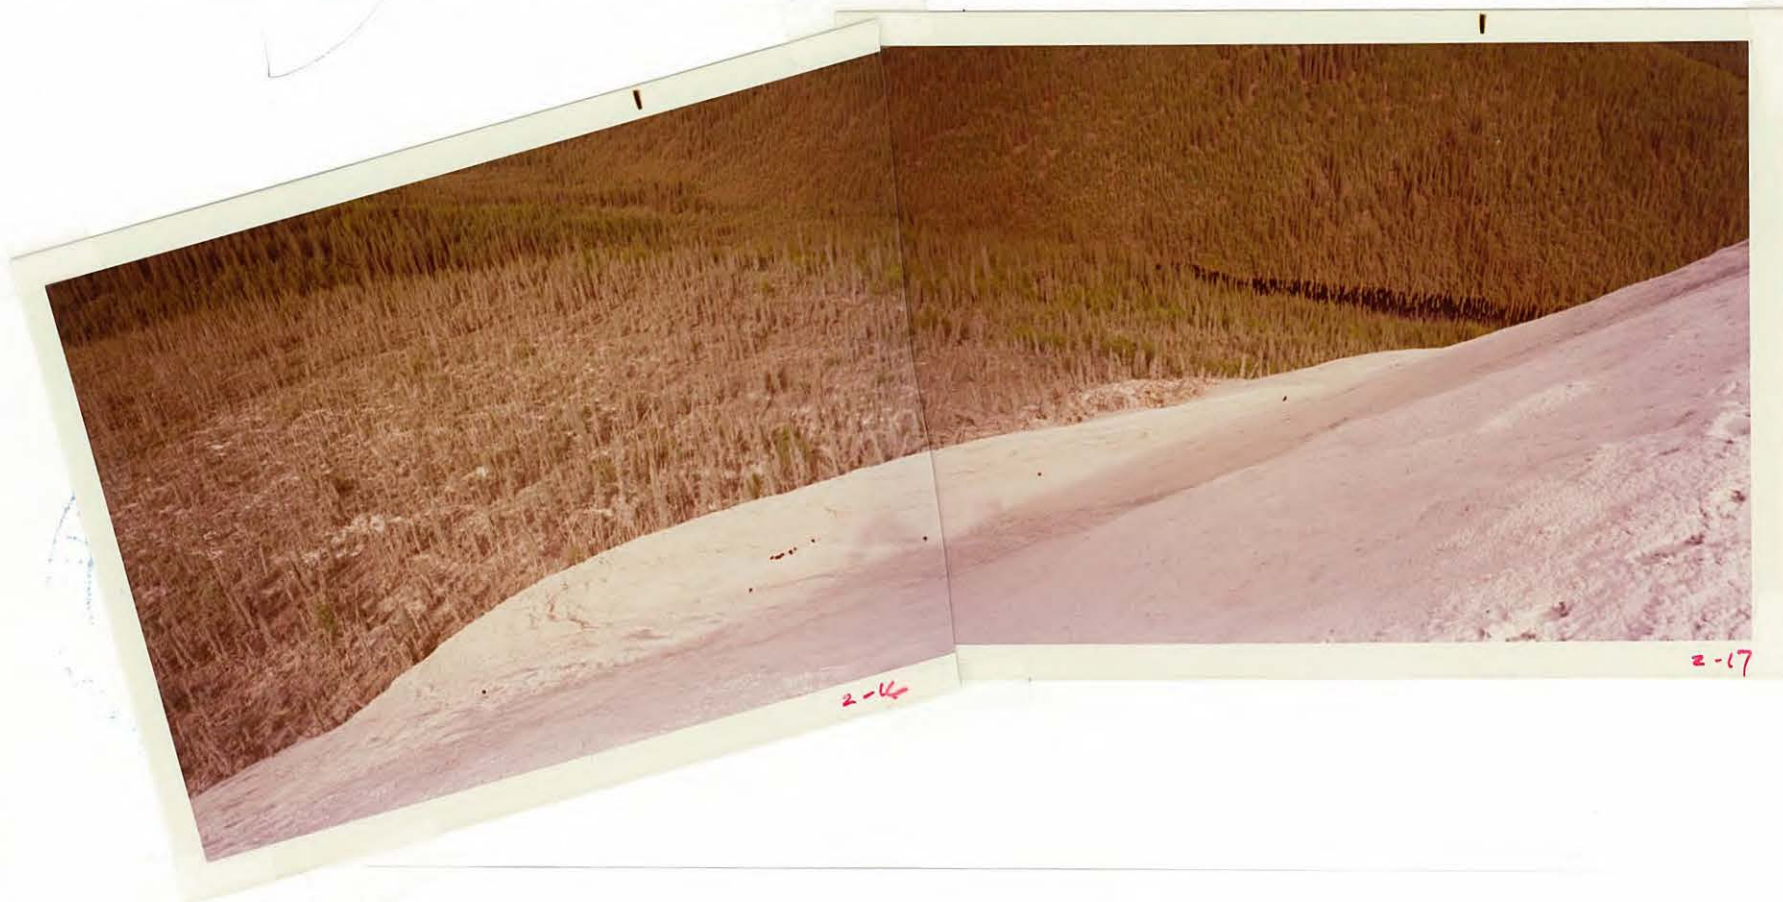
2-16 & 17 A view looking down the northeastern slope of the tailings pile. Note the pond that has resulted by blockage of the Wolverine Creek drainage. Note in the left central portion of photo 2-17 disturbance of the natural ground surface. The shearing stresses imposed at the toe of the tailings pile have resulted in shearing displacement, and bulldozing of the active soil layer at the toe of the pile. The active soil layer has been bulldozed ahead of the toe of the tailings, resulting in disturbance and toppling of the natural forest cover.
