## Anvil Range Mining Complex: Results from Trial Covers at Rose Creek Tailings Impoundment

2005/06 Task 22b

**DELOITTE & TOUCHE INC.**

**FARO MINE CLOSURE PLANNING OFFICE**

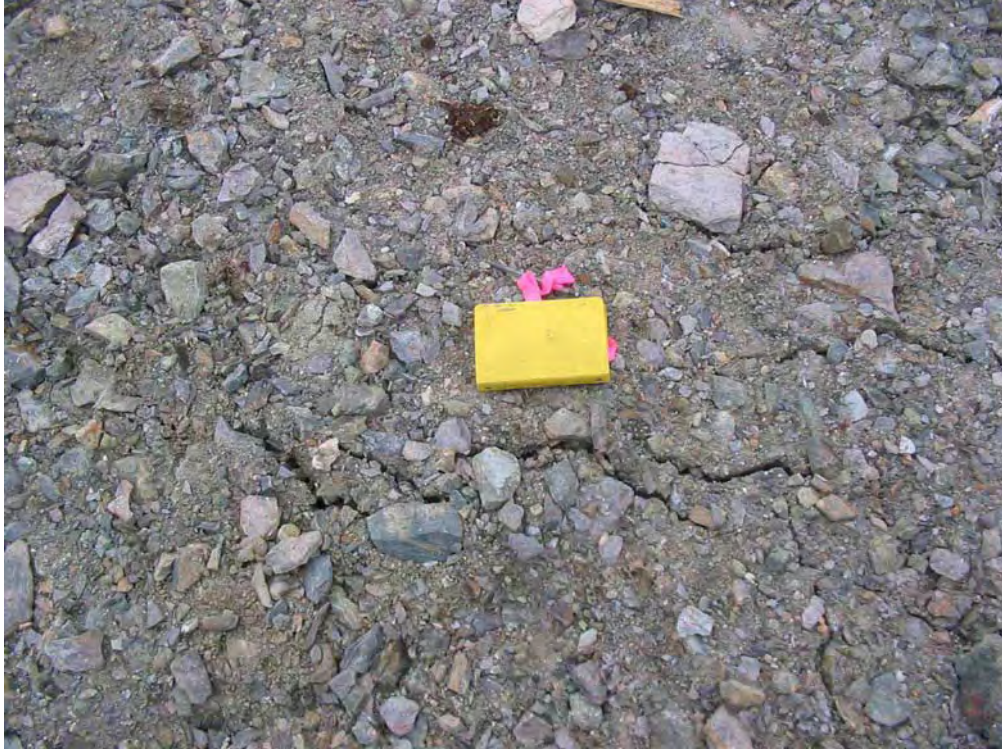
Figure 1. East test cover: Small cracks along eastern edge.

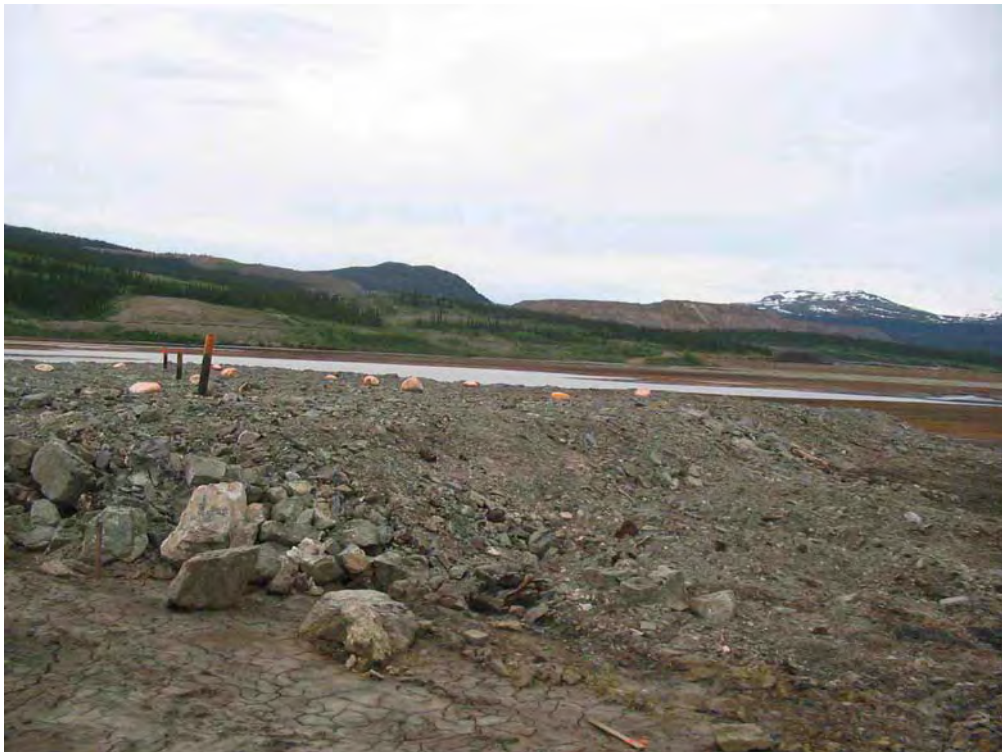
Figure 2. East test cover: Southwest steel column leaning to the southeast.

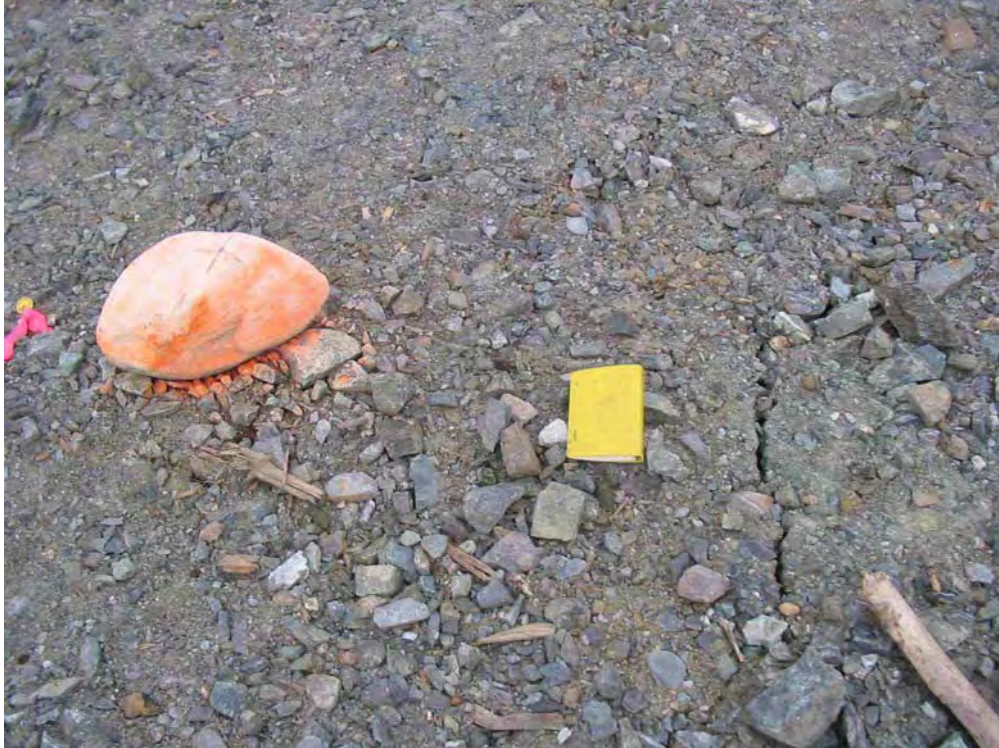
Figure 15. West test cover: Minor cracking near center of cover.

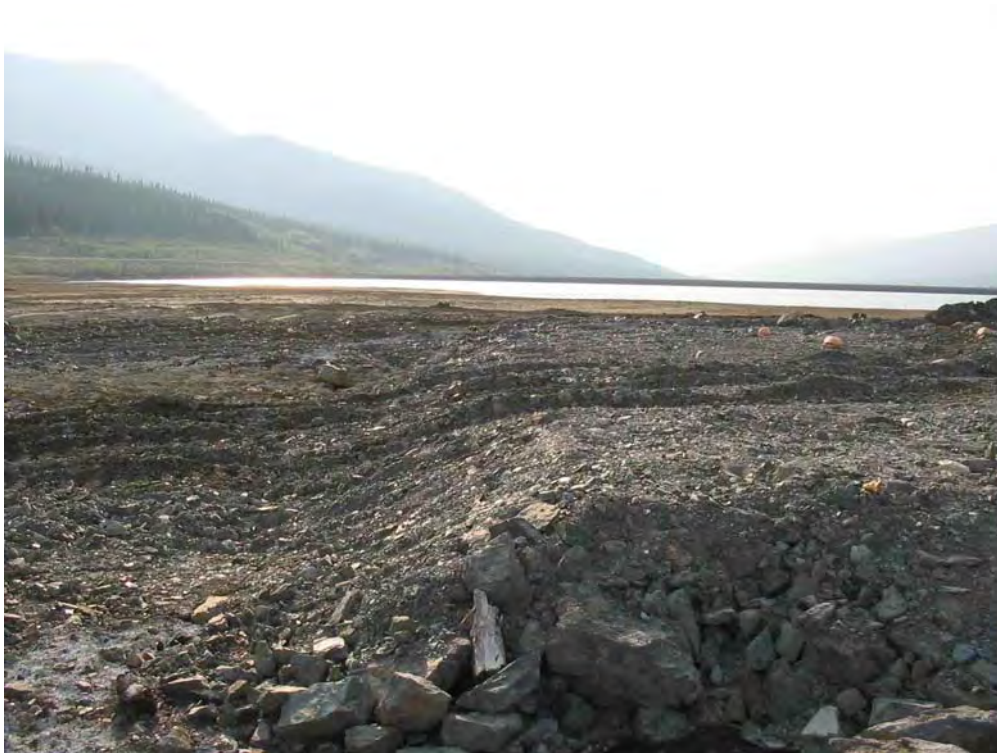
Figure 23. West test cover: Southern edge, showing damage from equipment.

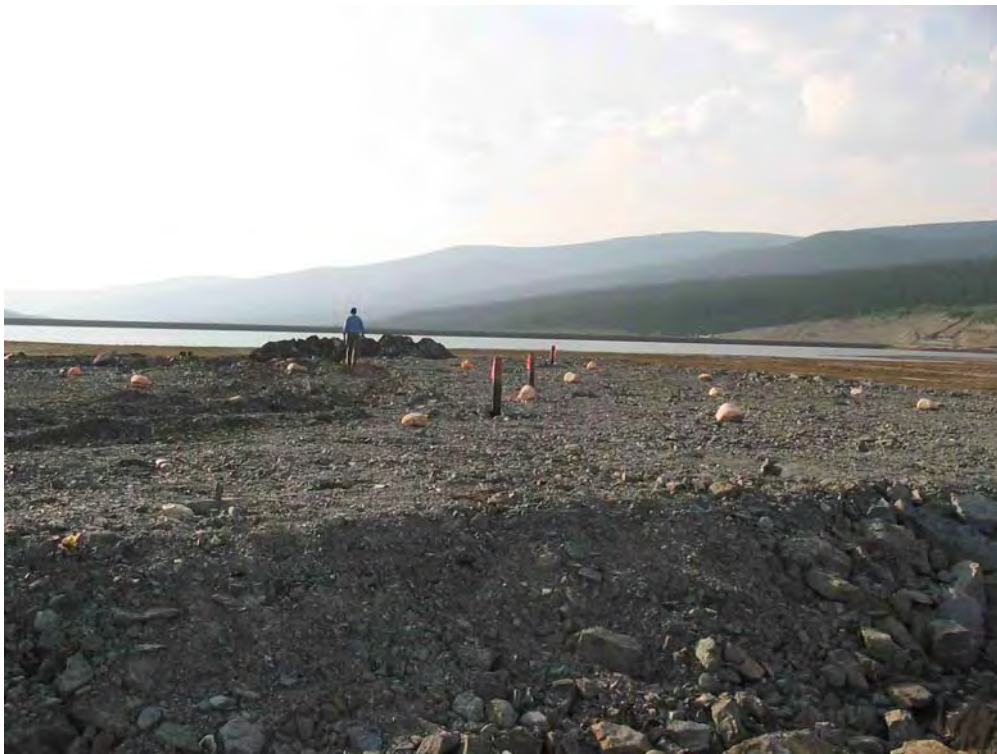
Figure 24. West test cover: Comparison of damaged SW and pristine NE portions of test cover.

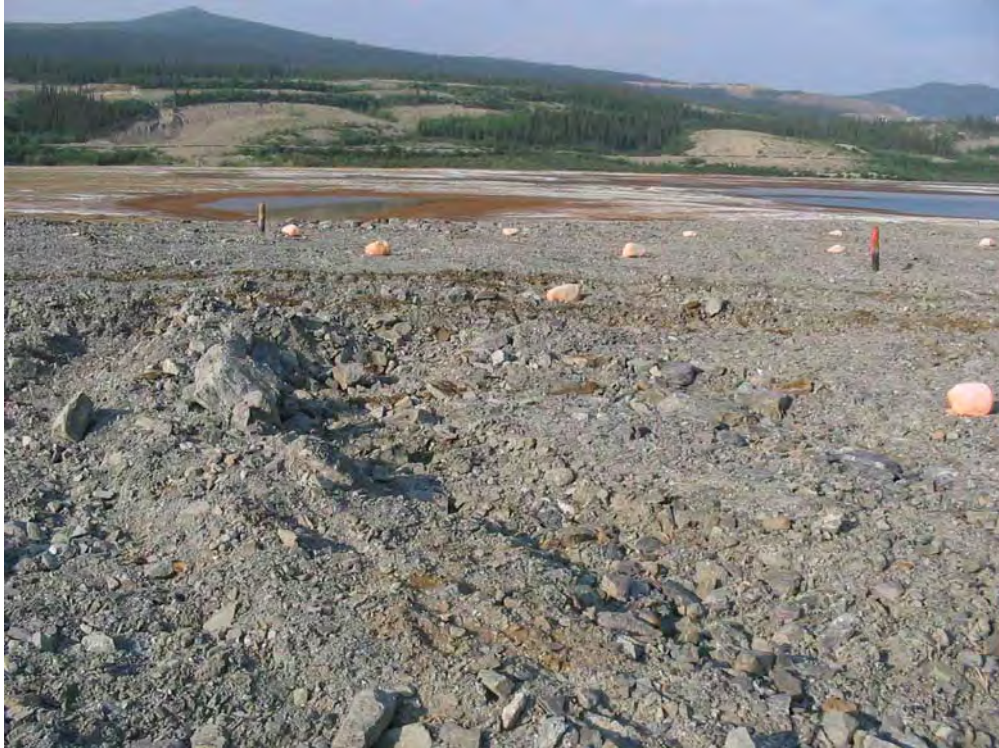
Figure 27. West test cover: Looking NE from SW corner, showing surface damage from equipment.

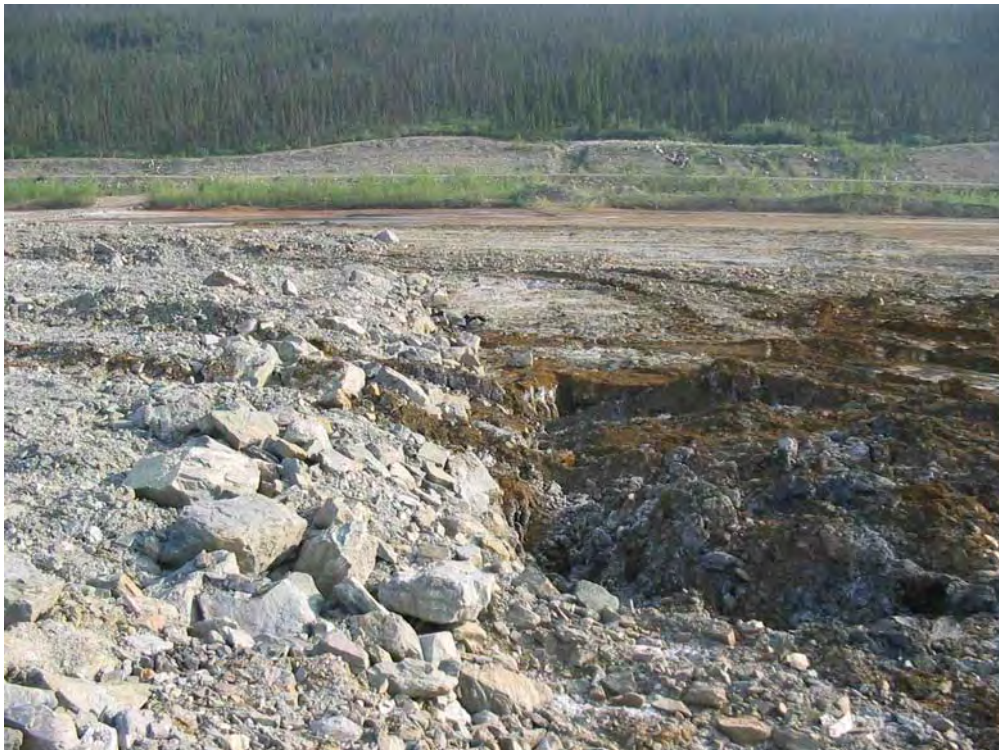
Figure 30. West test cover: Western edge, showing damage from equipment.

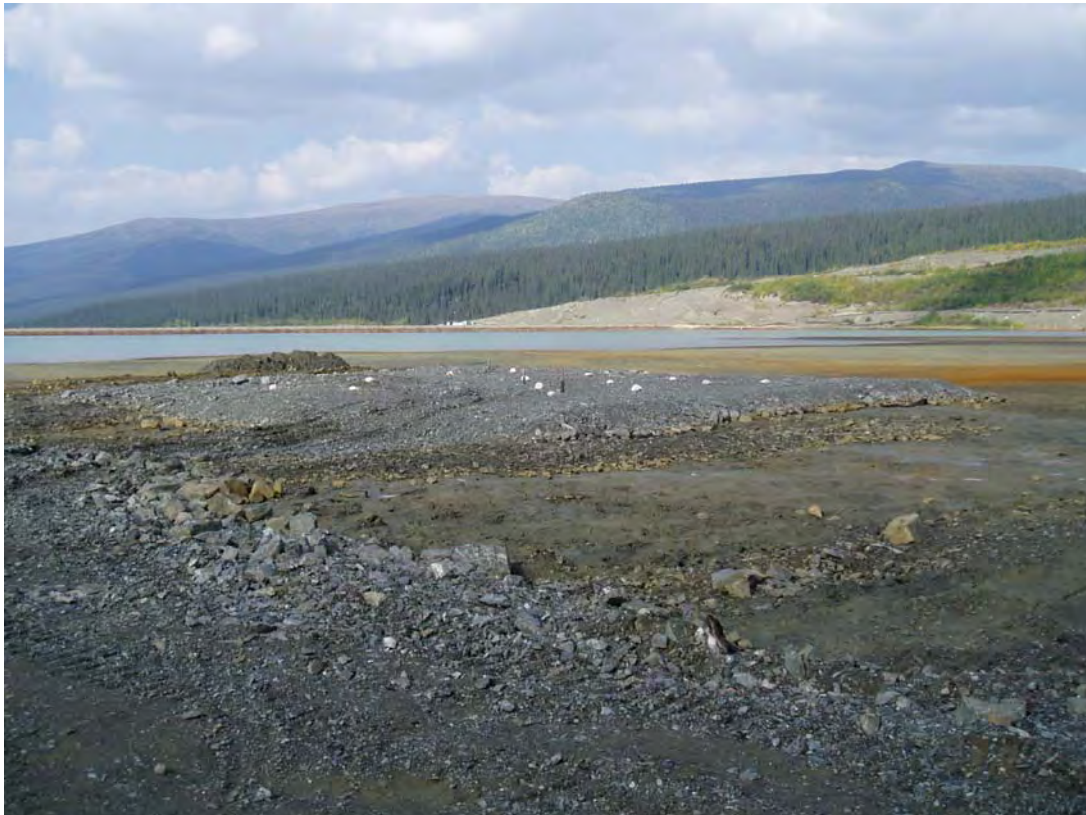
Photo 2: North-east view across the West Pad (including geotextile) surface. Note the dozer tracks leading onto the pad as a result of the excavator retrieval on June 17, 2004.

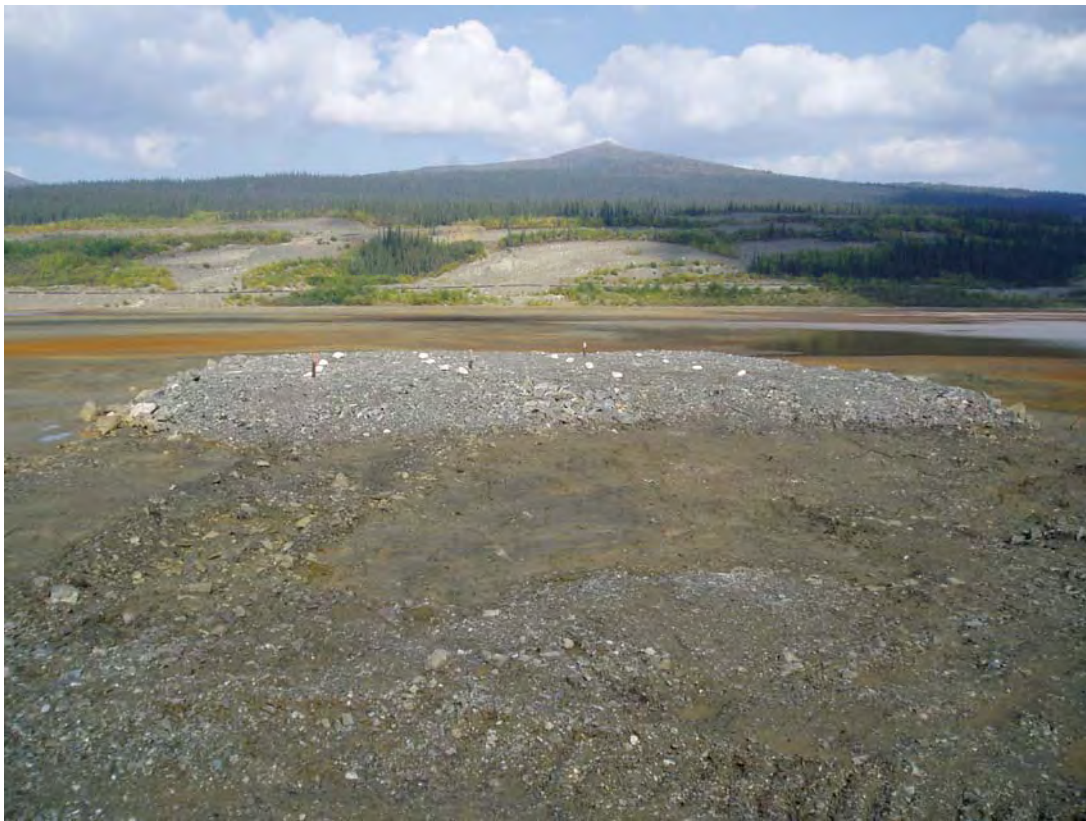
Photo 3: Looking north towards the East Pad. Note the standing water in the background.

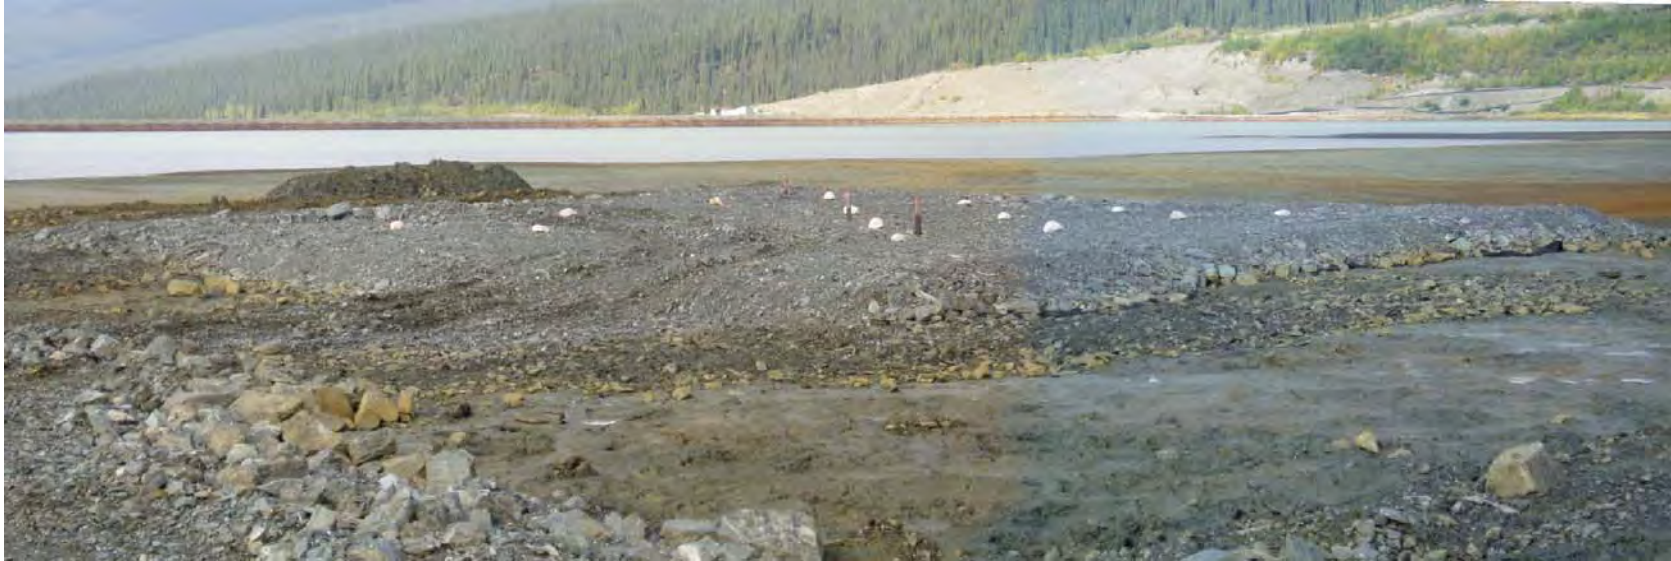
Photo 4: Panoramic view of the West Pad (including geotextile) from the south-west. Note the permanent pond in the background and the damage caused by the dozer in the foreground.

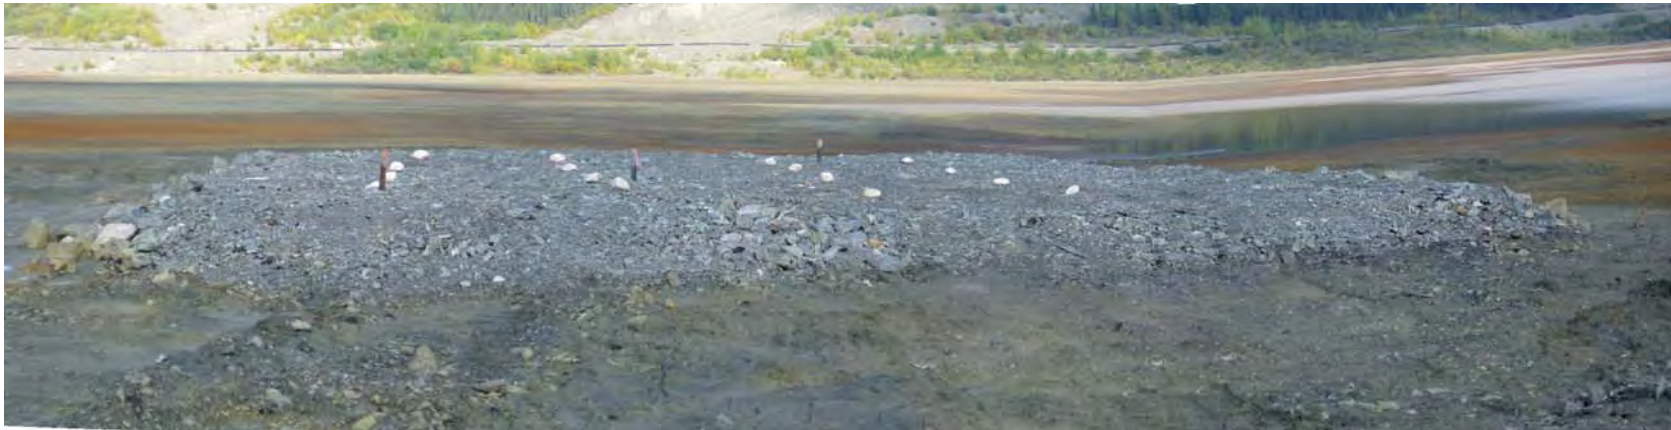
Photo 5: Panoramic of the East Pad from the south. Note the presence of standing water behind the pad. This water is not dammed up against the pad.

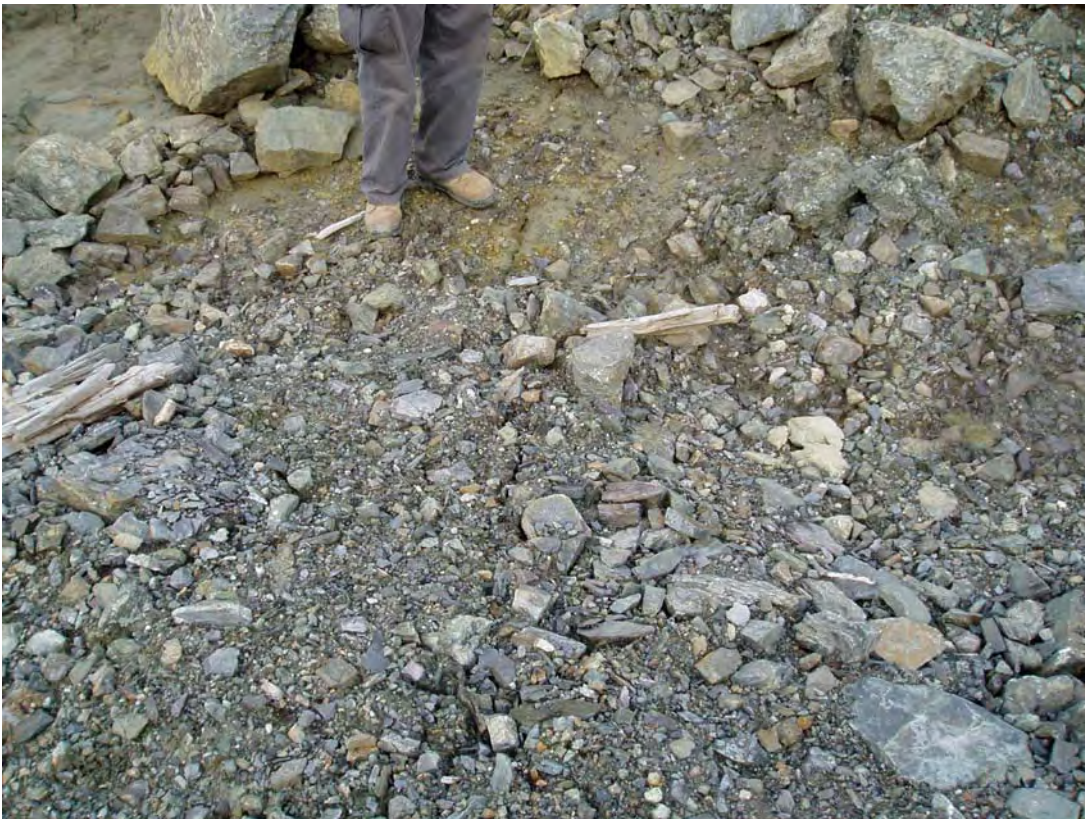
Photo 7: Close-up view of a crack on the corner of the East Pad. Note the crack continues from the tailings and on through the pad.

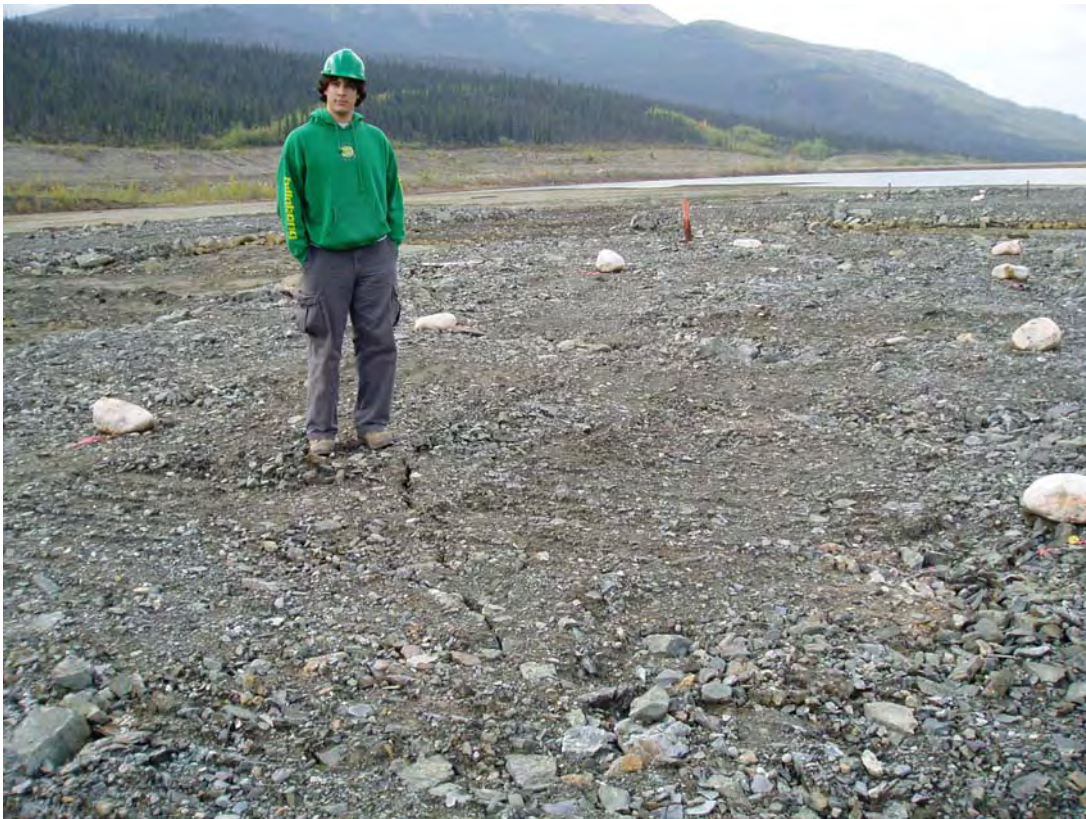
With the exception of the damage sustained to the West Pad as a result of the excavator extraction incident, the only noticeable feature during the 2004 inspections was surface cracking. A schematic of the extent of the cracks as observed during the August 29, 2004 site inspection is presented in Figure 6. Appendix D contains photos of these features taken during the inspection. The surface cracks are randomly spaced across the pad surface, and vary in width from a few millimetres to more than 2 cm and are approximately 10 cm deep (as probed from the surface). Surface cracks were first observed during the June 7, 2004 site inspection, and although a schematic similar to Figure 6 was not developed at the time, the inspector's field notes and photos (Appendix C) suggest that cracking was less severe and slightly more common on the West Pad than on the East Pad. This trend was reversed during the August 2004 inspection, with significantly more cracks observed on the East Pad.

Photo 8: Close-up view of a crack on the surface of the East Pad. The crack is curved and measures approximately 5 m long, 10 to 20 mm wide and 10 to 100 mm deep.

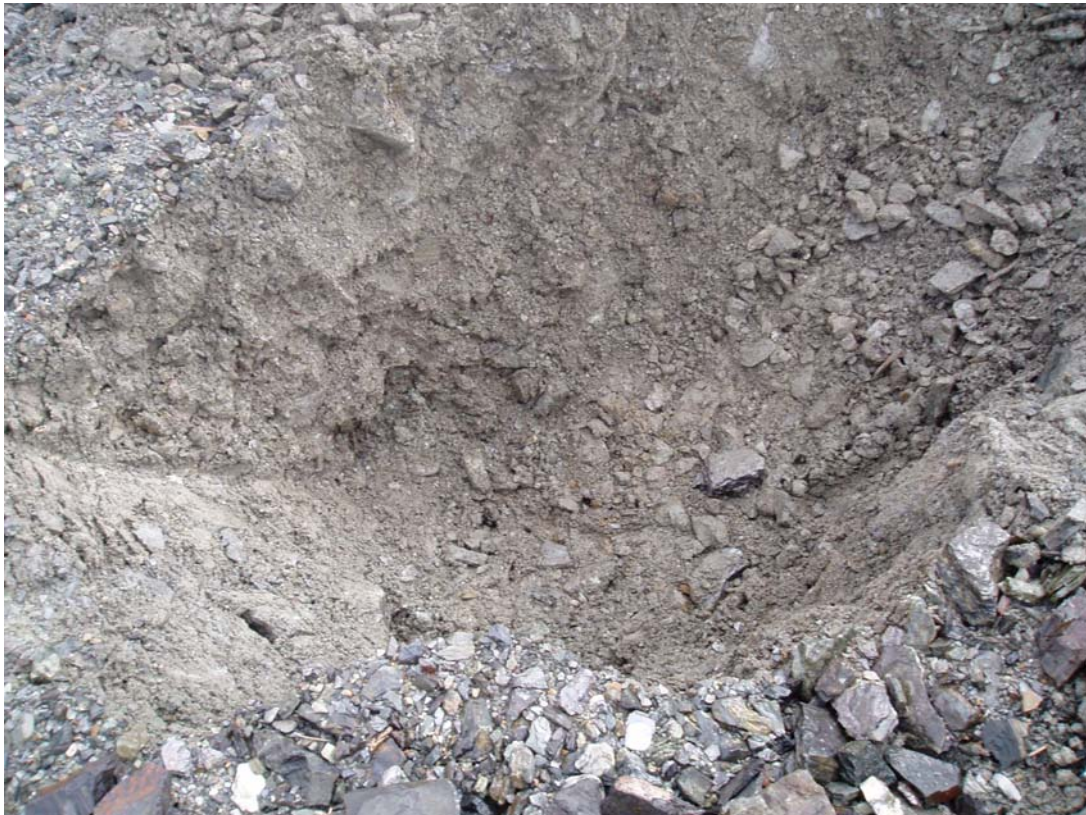
Photo 14: TP-TTC-05-06 The tailings has not migrated through the geotextile.
