Anvil Range Mining Complex: Results from Trial Covers at Rose Creek Tailings Impoundment

2006/07 Task 17b

DELOITTE & TOUCHE INC.

FARO MINE CLOSURE PLANNING OFFICE

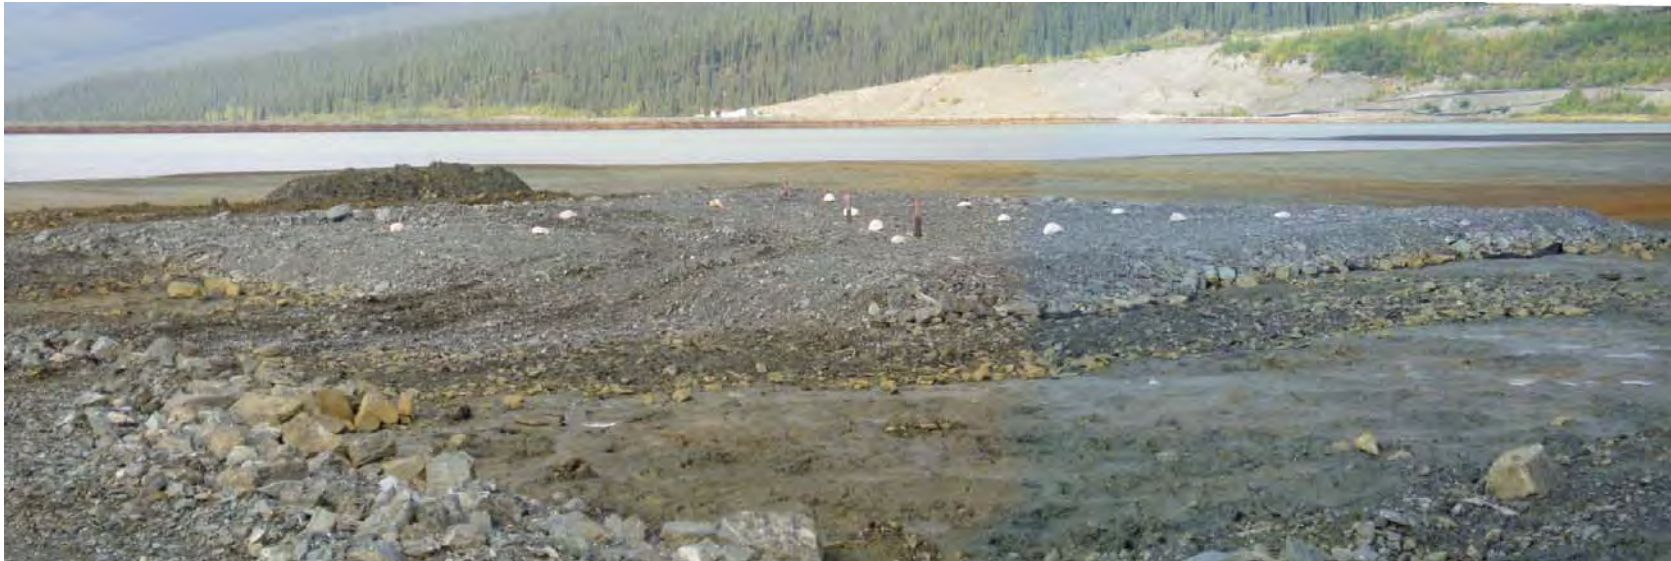
Photo 4: Panoramic view of the West Pad (including geotextile) from the south-west. Note the permanent pond in the background and the damage caused by the dozer in the foreground.

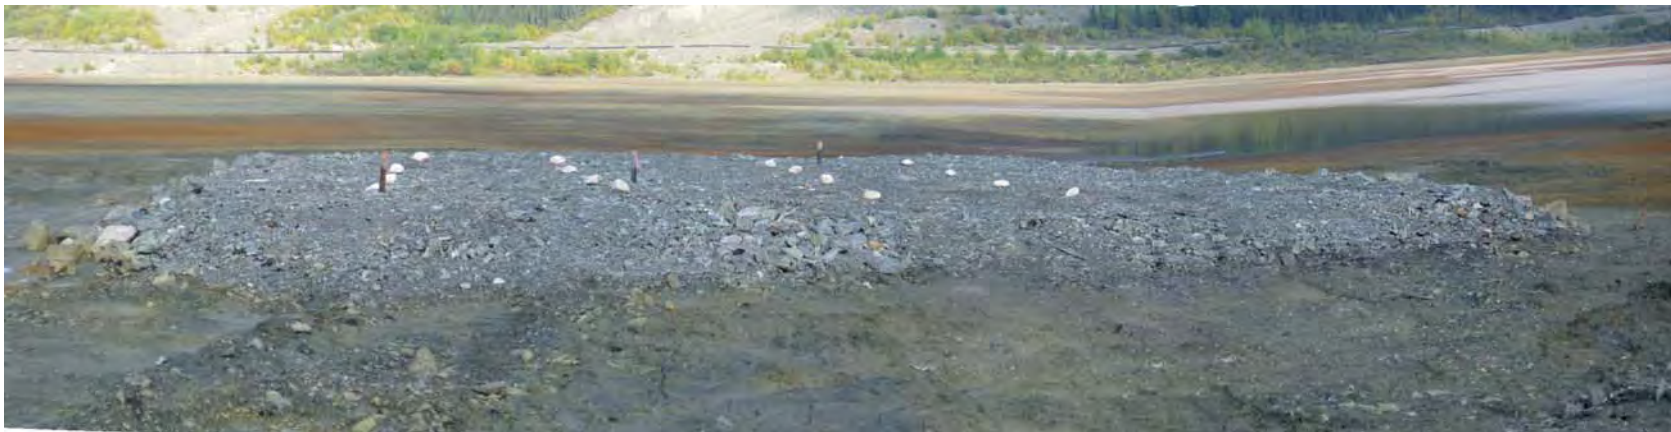
Photo 5: Panoramic of the East Pad from the south. Note the presence of standing water behind the pad. This water is not dammed up against the pad.

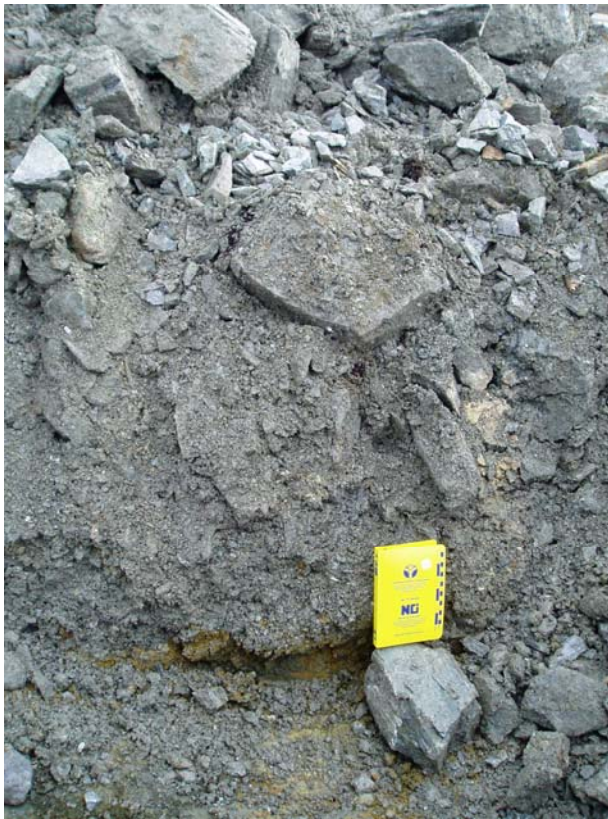
Photo 1: TP-TTC-04-01 Profile of test pit showing the undulated interface between tailings and cover material where mixing has occurred.
