Anvil Range Mining Complex Results from Trial covers at Rose Creek Tailings Impoundment: 2007 Data Summary

2007 Task 18b - FINAL

Deloitte and Touche Inc.

May 2008

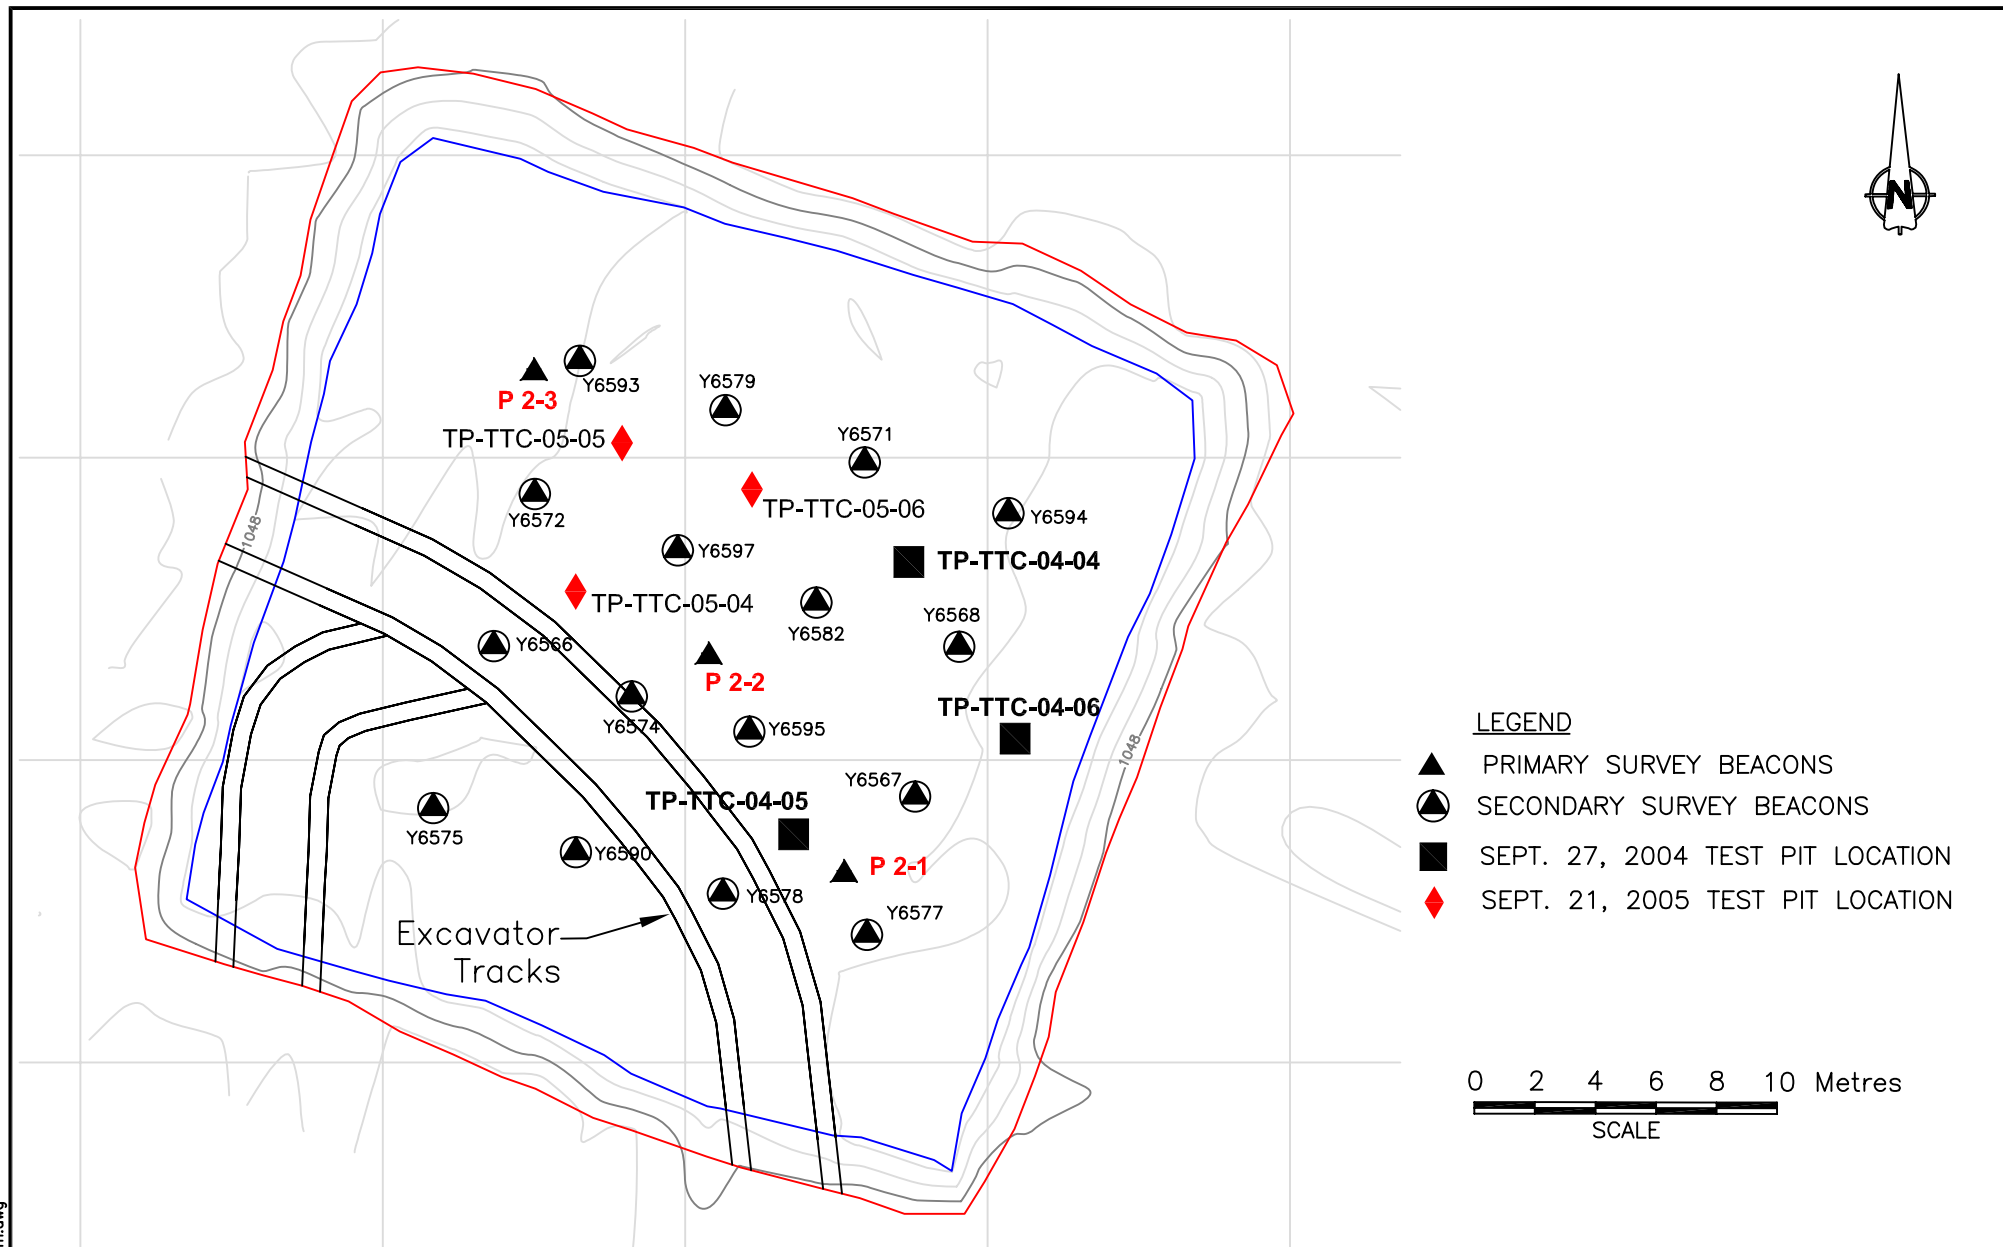
Schematic Presentation of Damage to West Pad on June 17, 2004

On June 17, 2004, ARMC was excavating a test pit approximately 10 m west of the West Pad using the ARMC CAT 235 tracked excavator. The excavator got stuck during this excavation and the ARMC D9 Dozer had to be used on the West Pad to facilitate recovery of the excavator. Upon recovery, the excavator crawled across the trial cover, resulting in disturbance to the south-east corner of the trial cover, as well as to secondary survey beacons 6566, 6574 and, possibly, 6578. The damage on the trial cover is presented schematically on Figure 5.

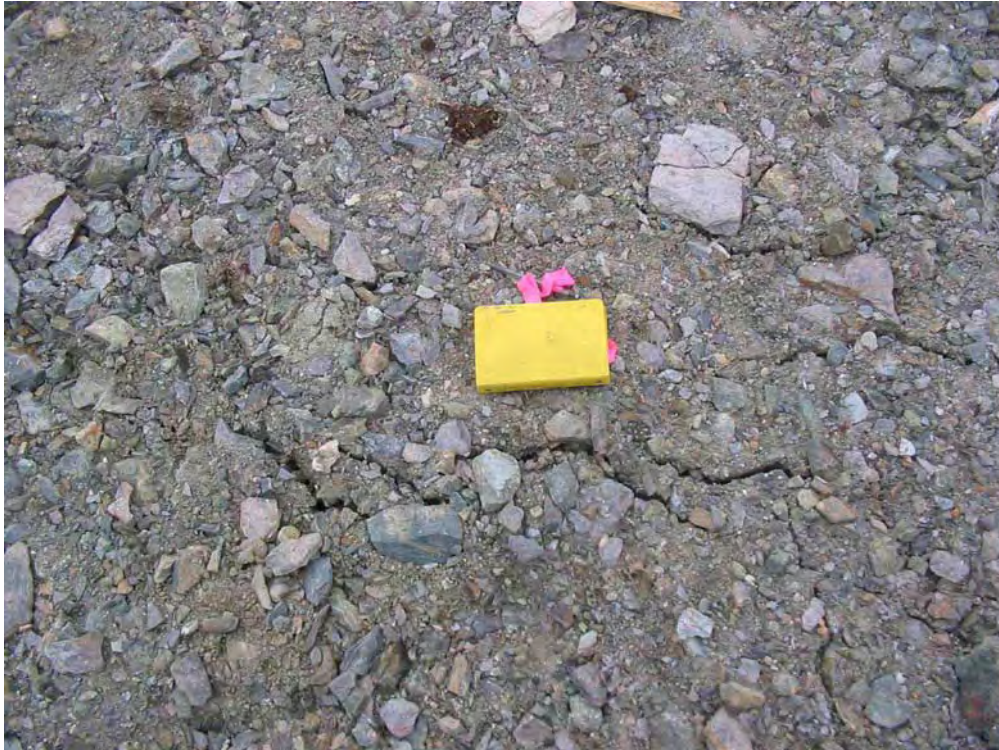
Figure 1. East test cover: Small cracks along eastern edge.

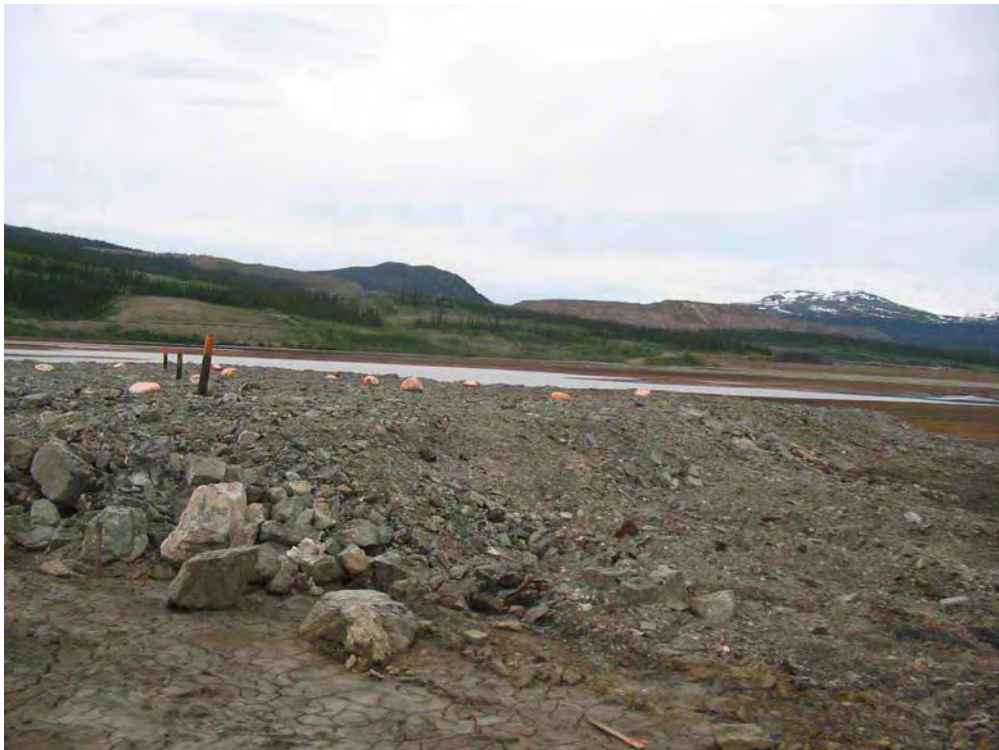
Figure 2. East test cover: Southwest steel column leaning to the southeast.

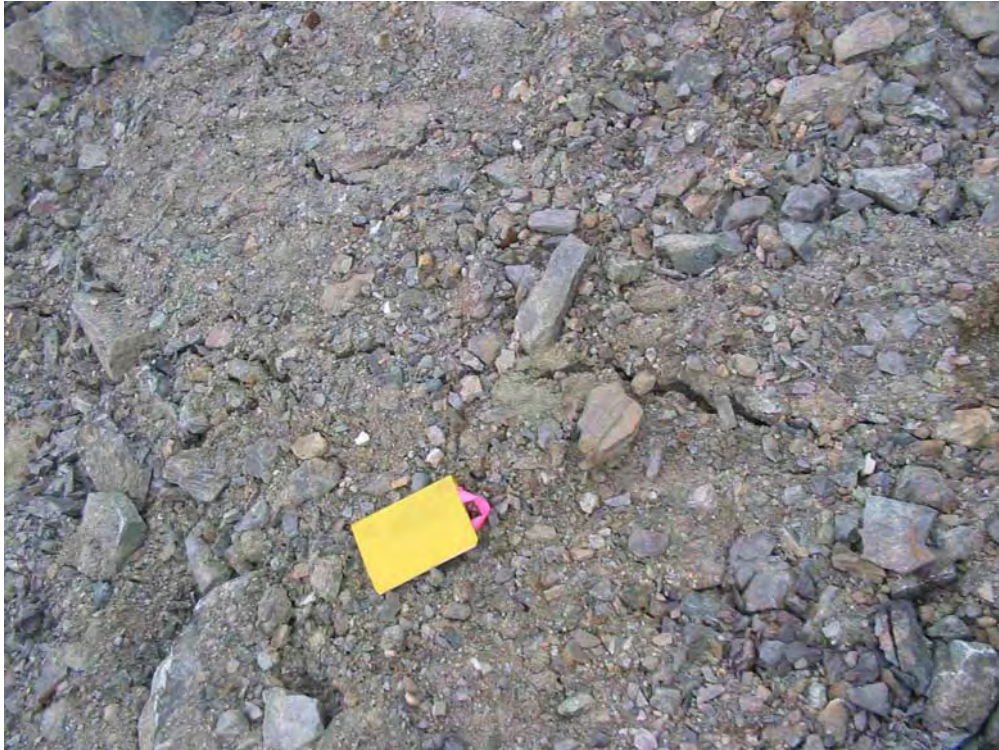
Figure 7. East test cover: Eastern edge, showing minor cracking.

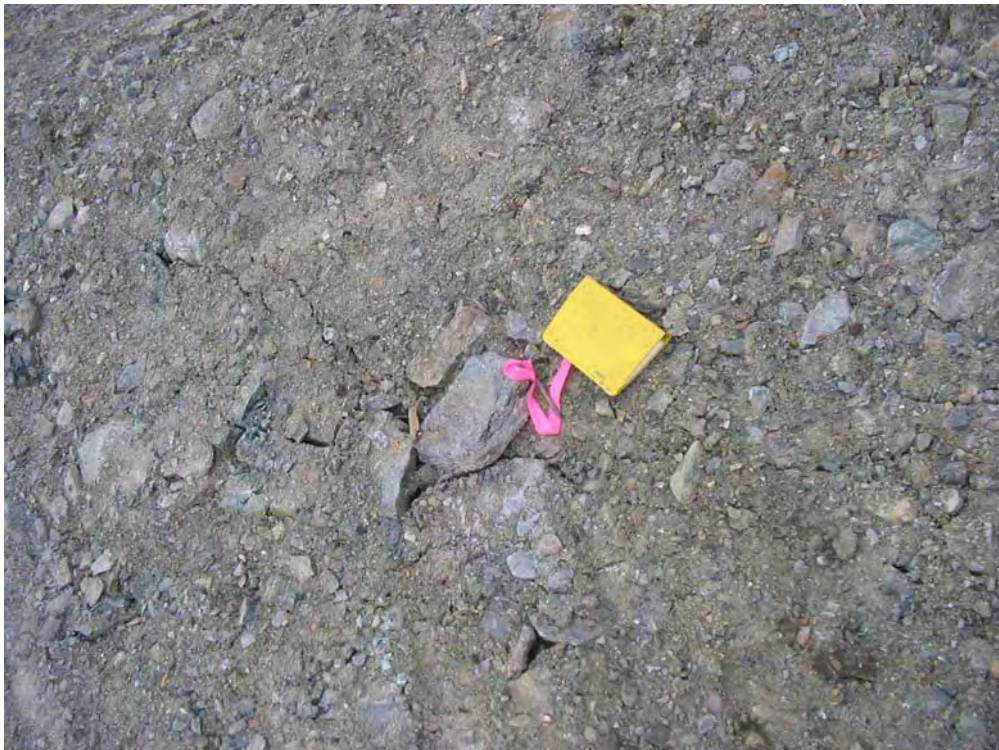
Figure 14. West test cover: Minor cracking along eastern edge.

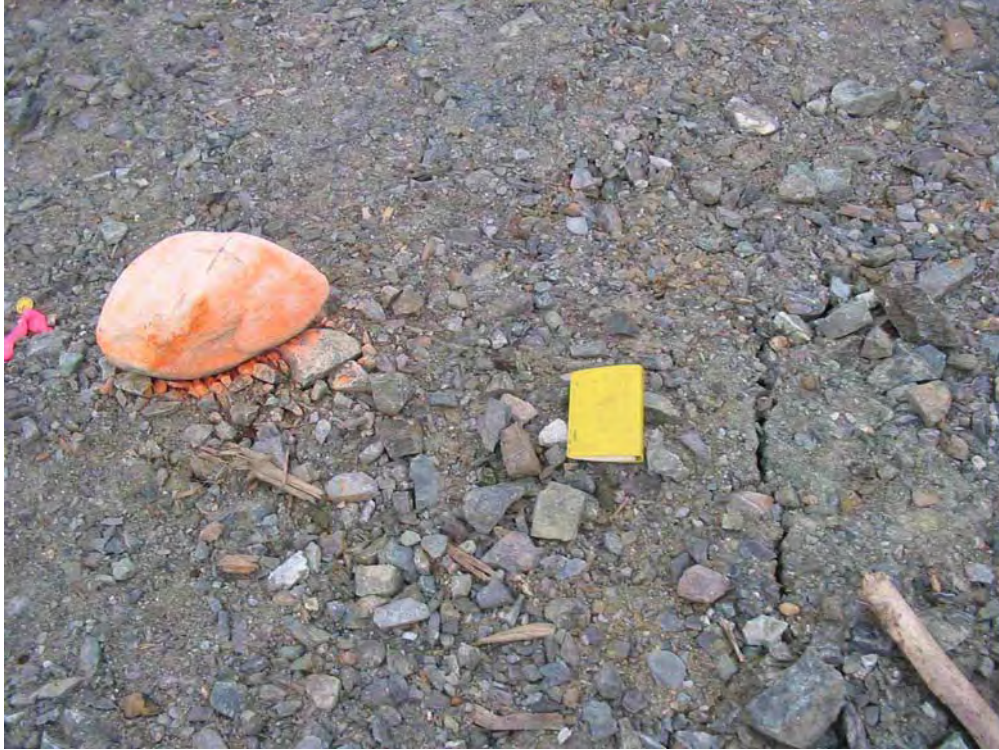
Figure 15. West test cover: Minor cracking near center of cover.

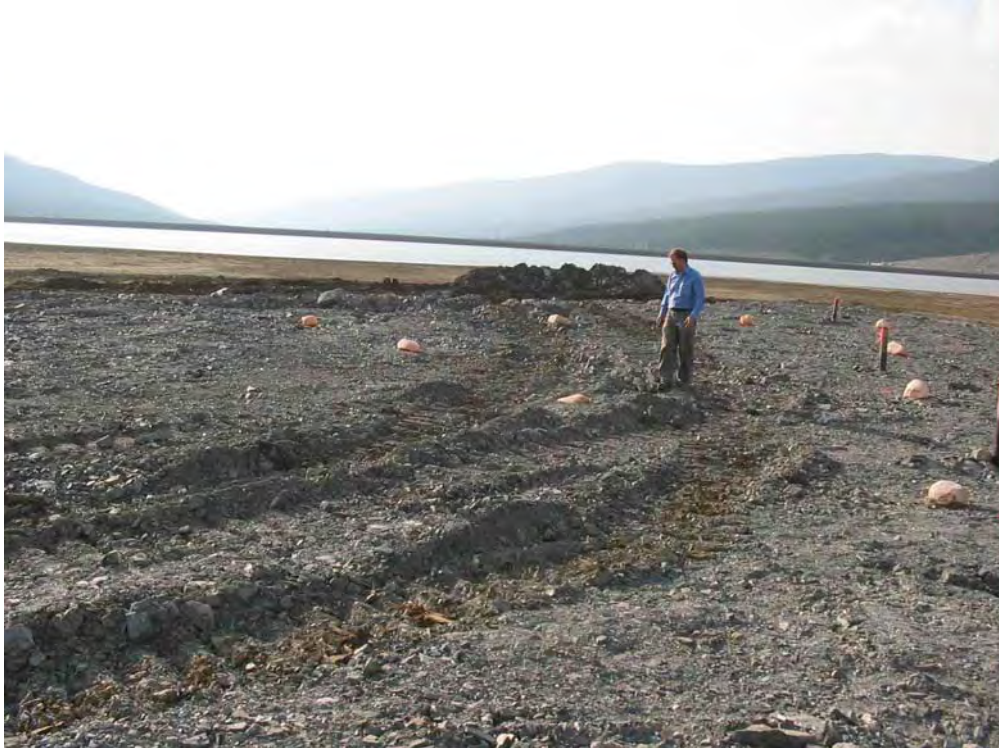
Figure 21. West test cover: Damage to surface of cover by equipment. Note disturbed marker stone in center.

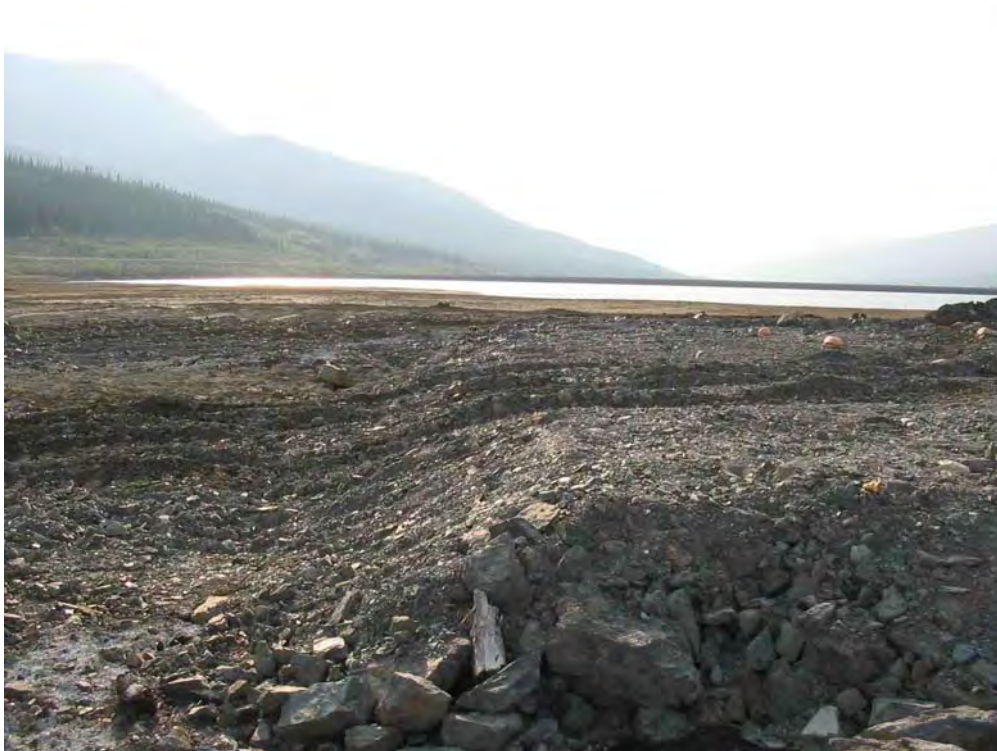
Figure 23. West test cover: Southern edge, showing damage from equipment.

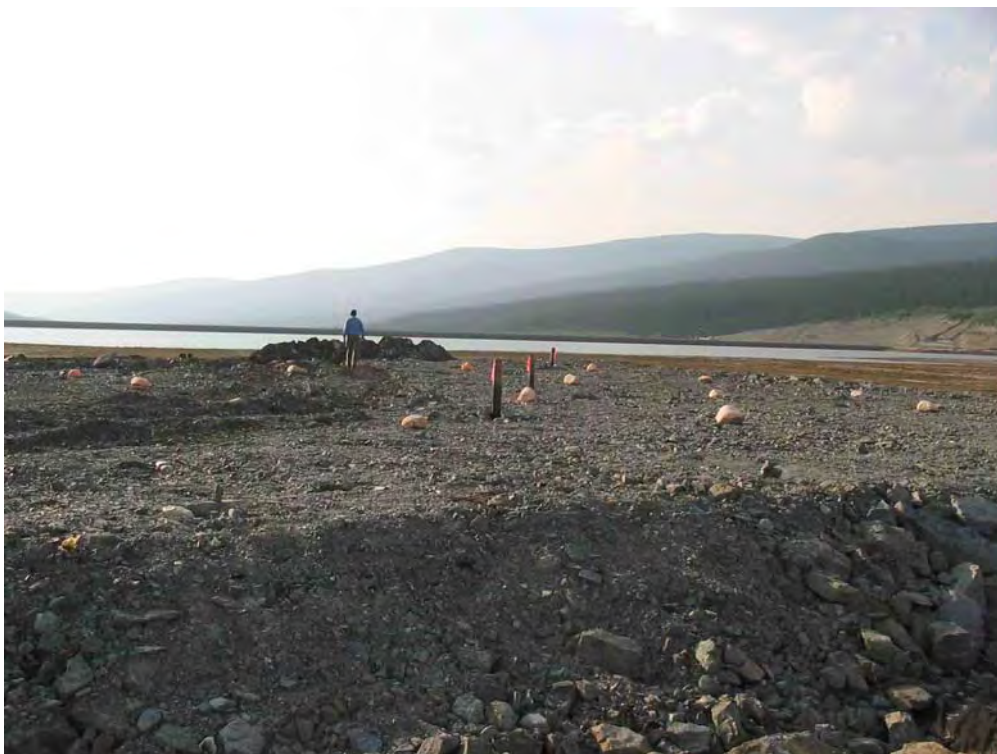
Figure 24. West test cover: Comparison of damaged SW and pristine NE portions of test cover.

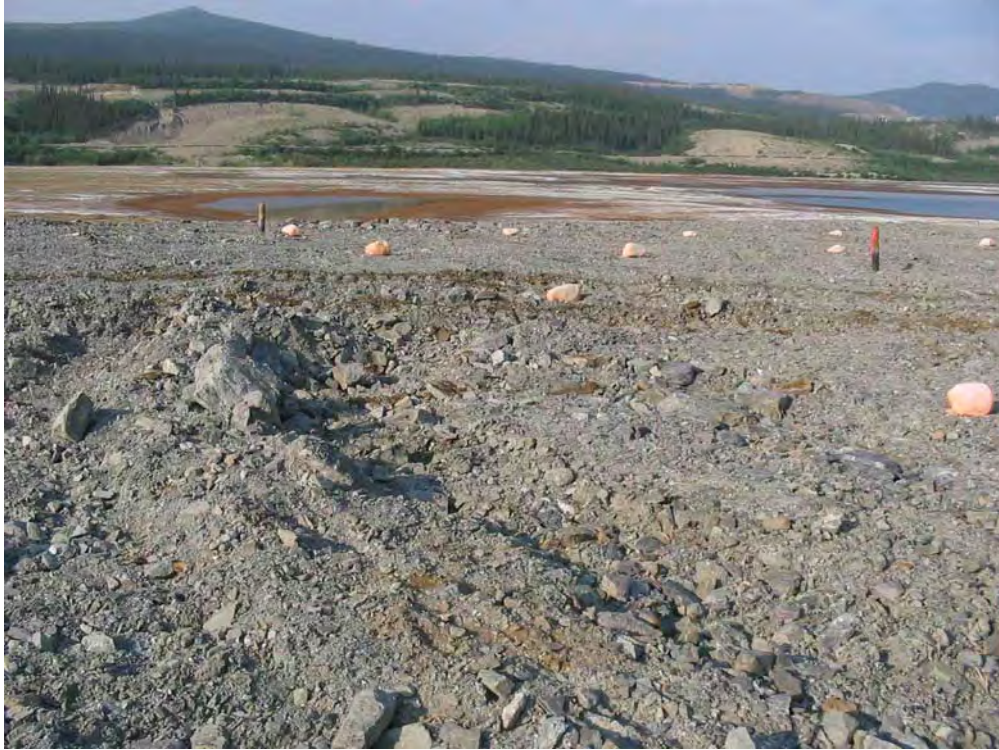
Figure 27. West test cover: Looking NE from SW corner, showing surface damage from equipment.

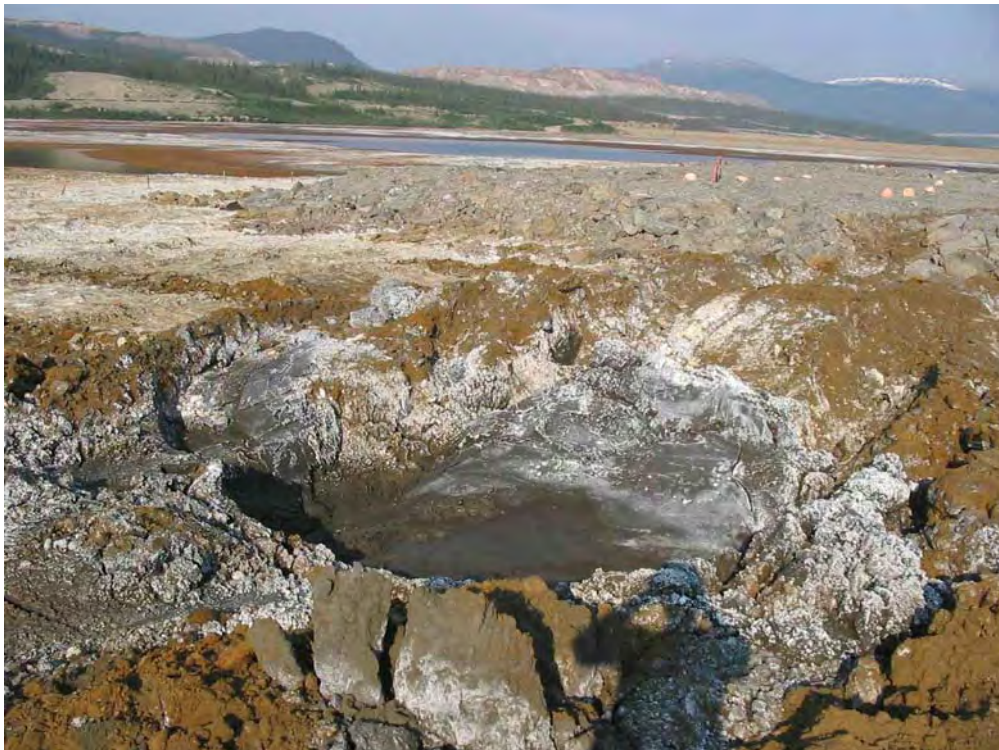
Figure 28. Location where excavator was stuck, adjacent to west test cover.

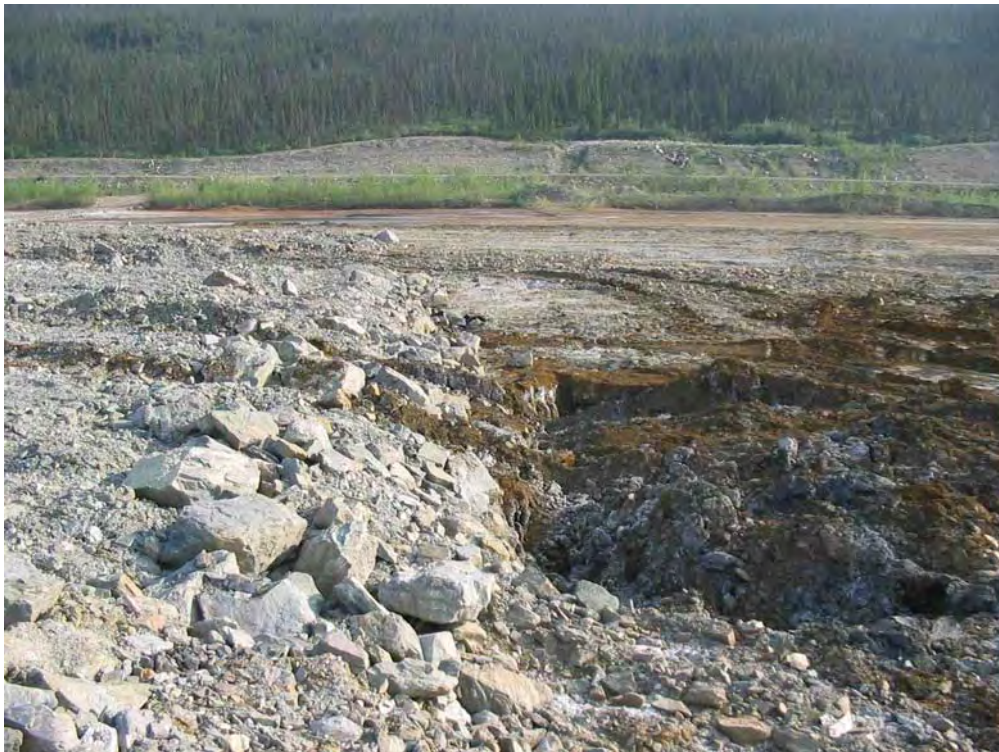
Figure 30. West test cover: Western edge, showing damage from equipment.

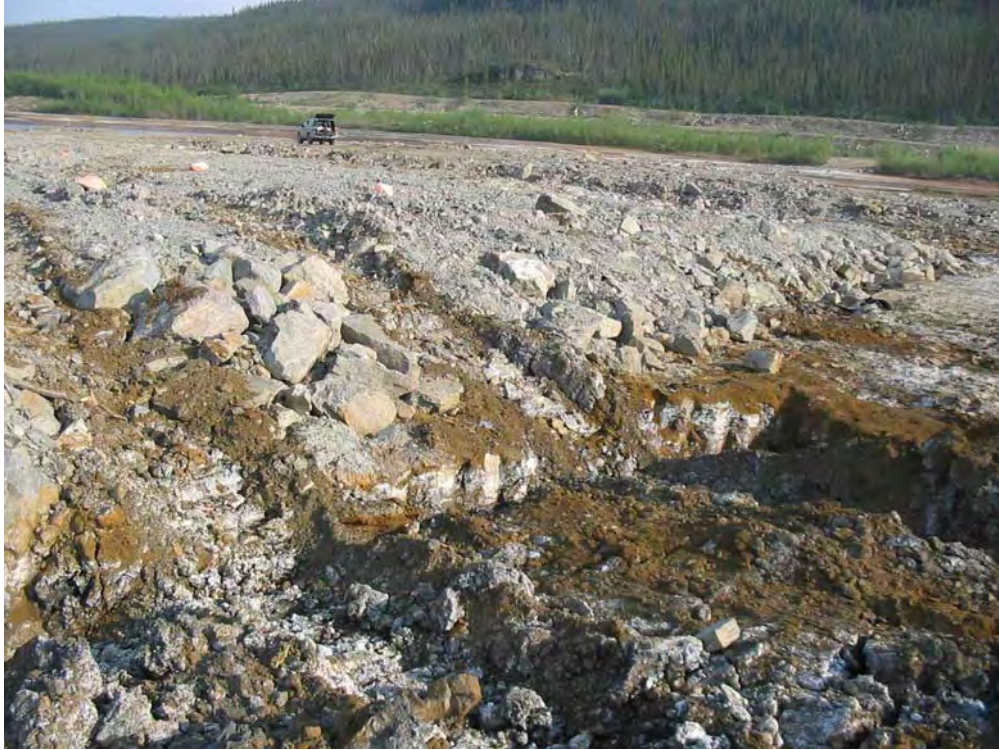
Figure 31. Western edge of west test cover showing equipment tracks in tailings and damage done to edge of cover by equipment.

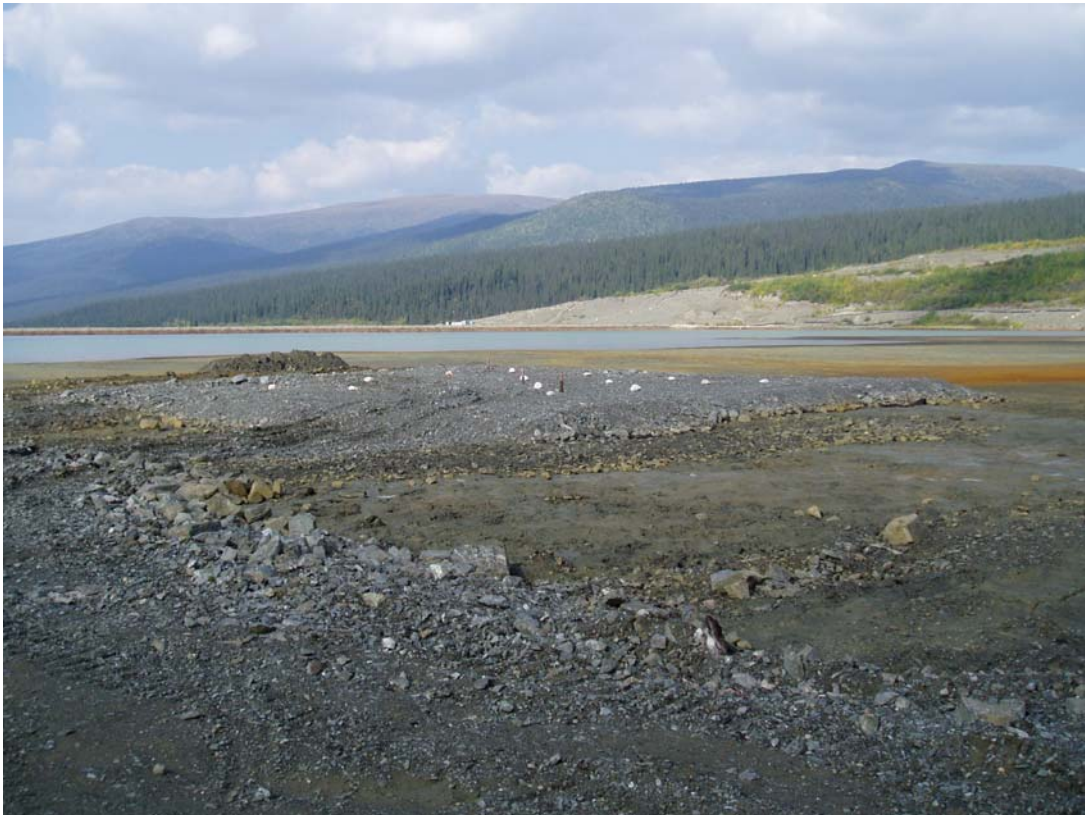
Photo 2: North-east view across the West Pad (including geotextile) surface. Note the dozer tracks leading onto the pad as a result of the excavator retrieval on June 17, 2004.

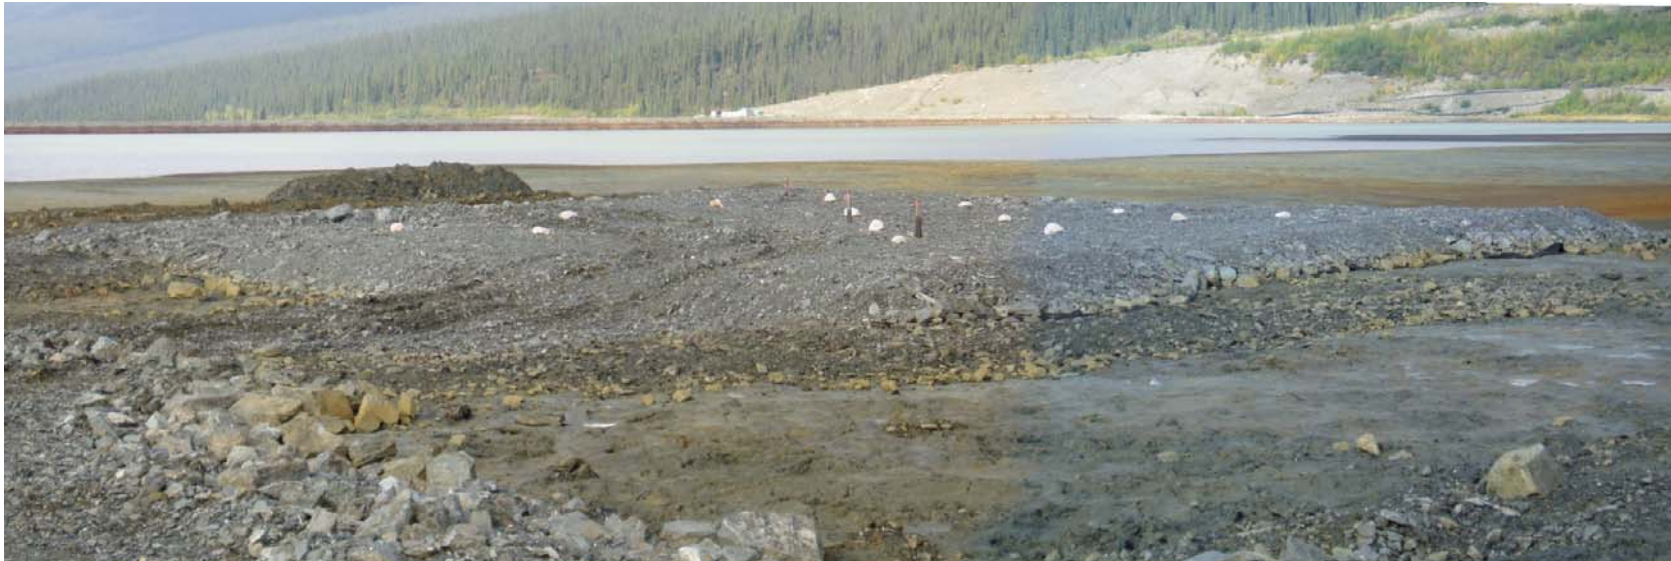
Photo 4: Panoramic view of the West Pad (including geotextile) from the south-west. Note the permanent pond in the background and the damage caused by the dozer in the foreground.

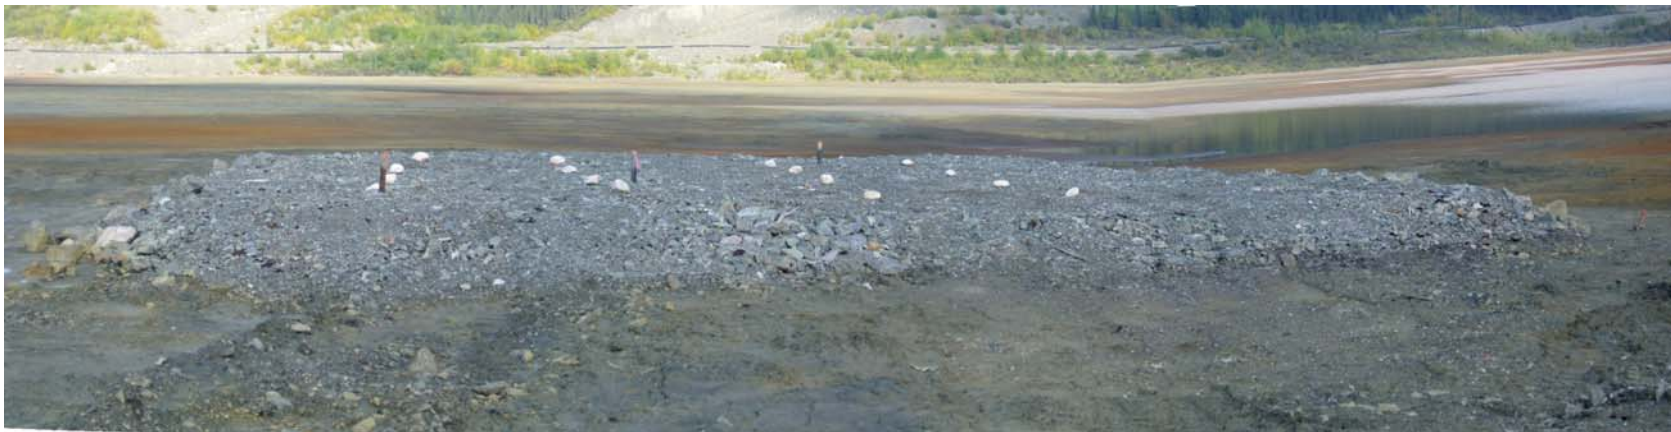
Photo 5: Panoramic of the East Pad from the south. Note the presence of standing water behind the pad. This water is not dammed up against the pad.

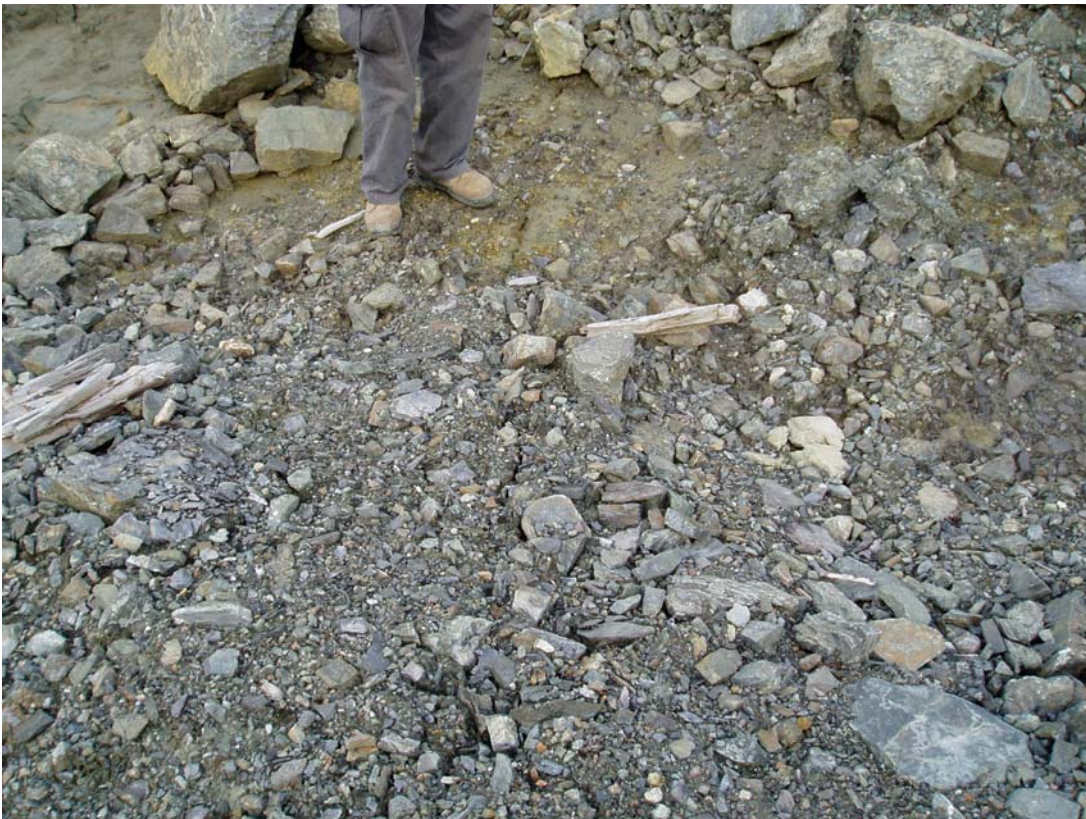
Photo 7: Close-up view of a crack on the corner of the East Pad. Note the crack continues from the tailings and on through the pad.

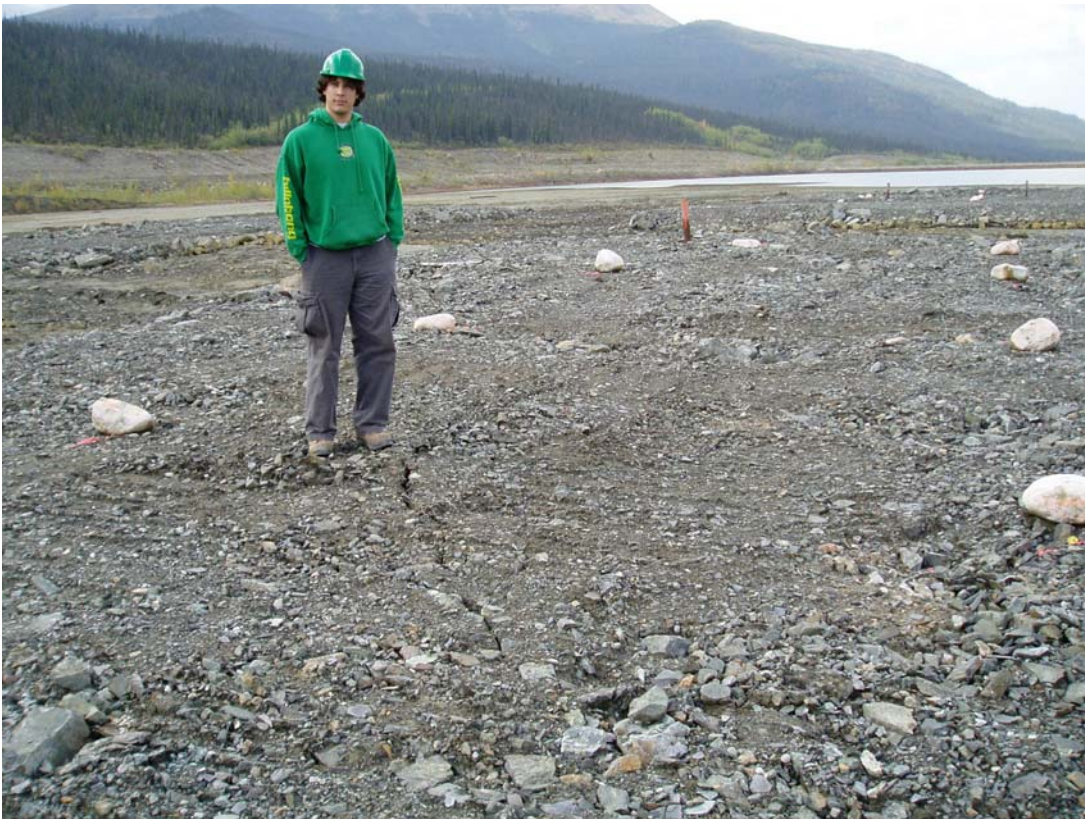
Photo 8: Close-up view of a crack on the surface of the East Pad. The crack is curved and measures approximately 5 m long, 10 to 20 mm wide and 10 to 100 mm deep.

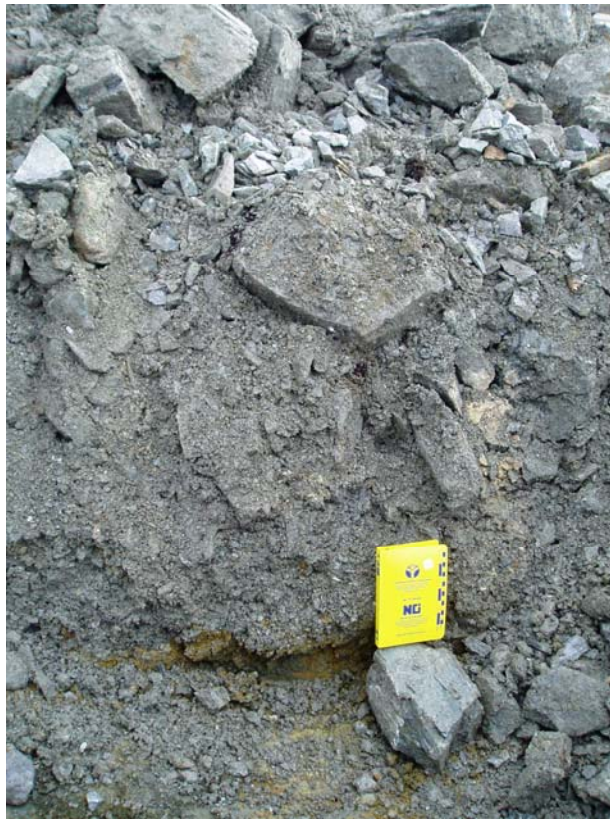
Photo 1: TP-TTC-04-01 Profile of test pit showing the undulated interface between tailings and cover material where mixing has occurred.

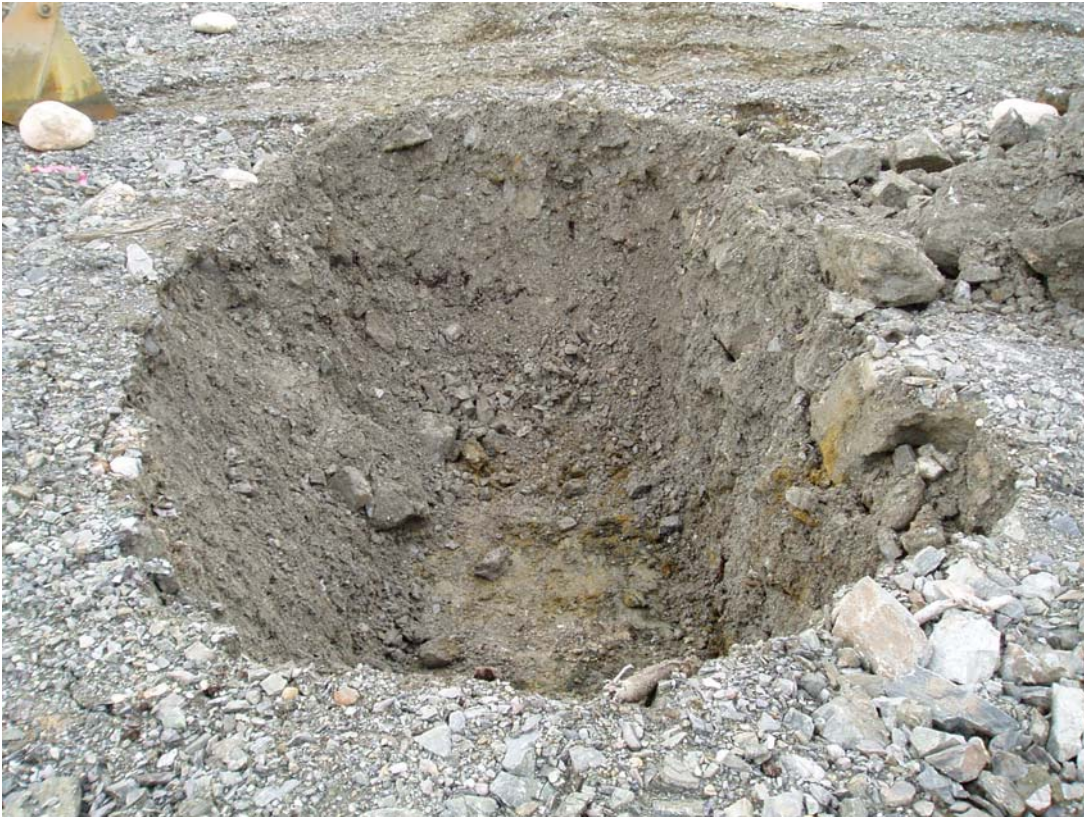
Photo 8: TP-TTC-04-02 Note the slope angle of the test pit walls. The material is very wet and the walls continuously caved in.

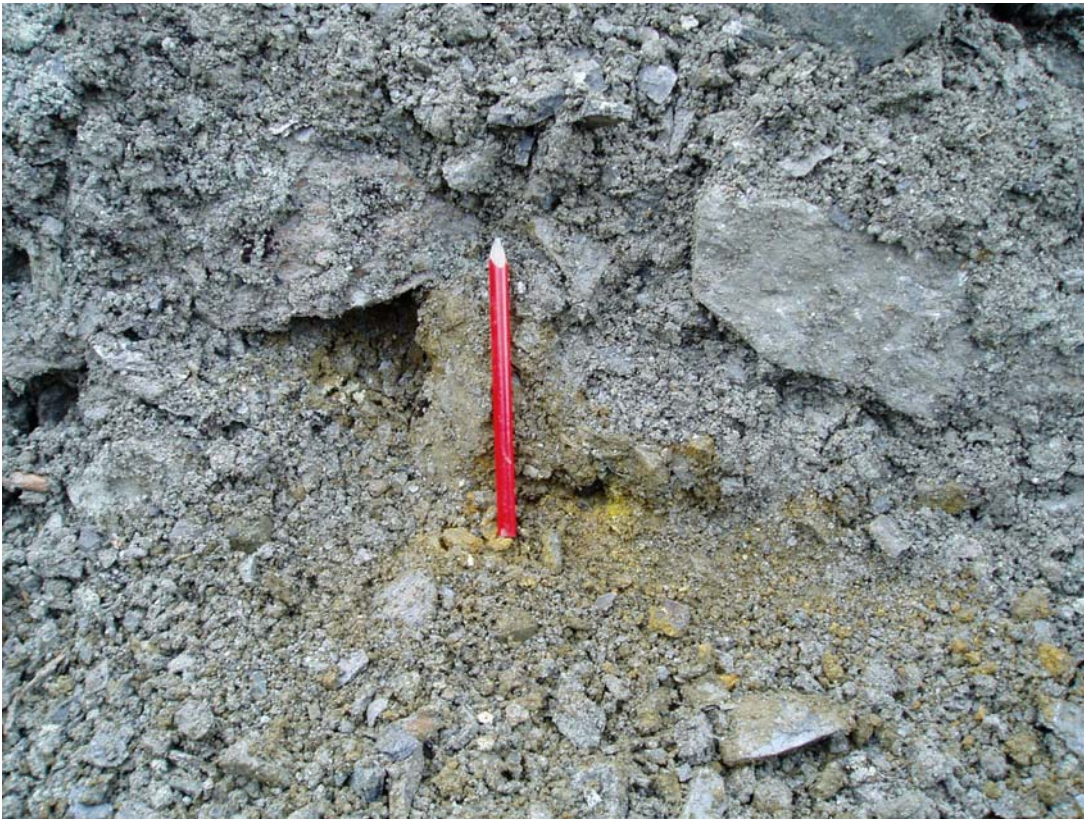
Photo 9: TP-TTC-04-03 Mixed zone of cover material and tailings of approximately 20 cm. The mixing appears to be dominated by larger boulders.

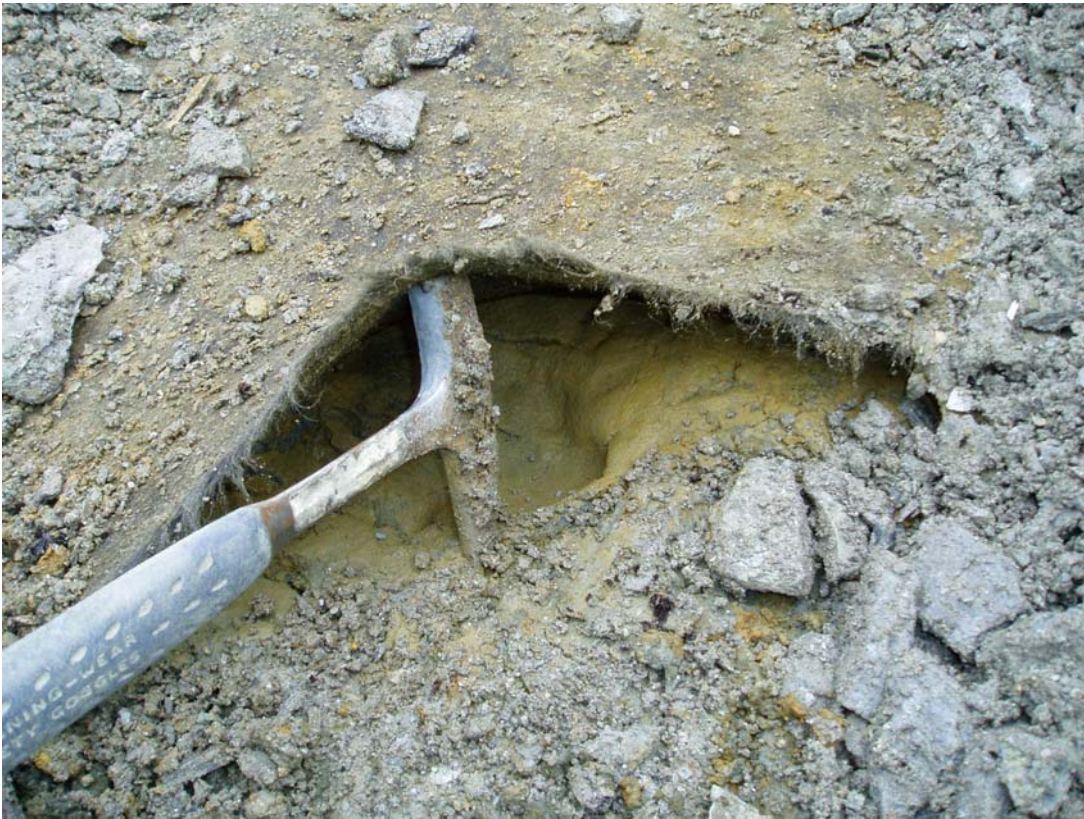
Photo 11: TP-TTC-04-04 Minor undulating surface at contact between cover material and tailings.

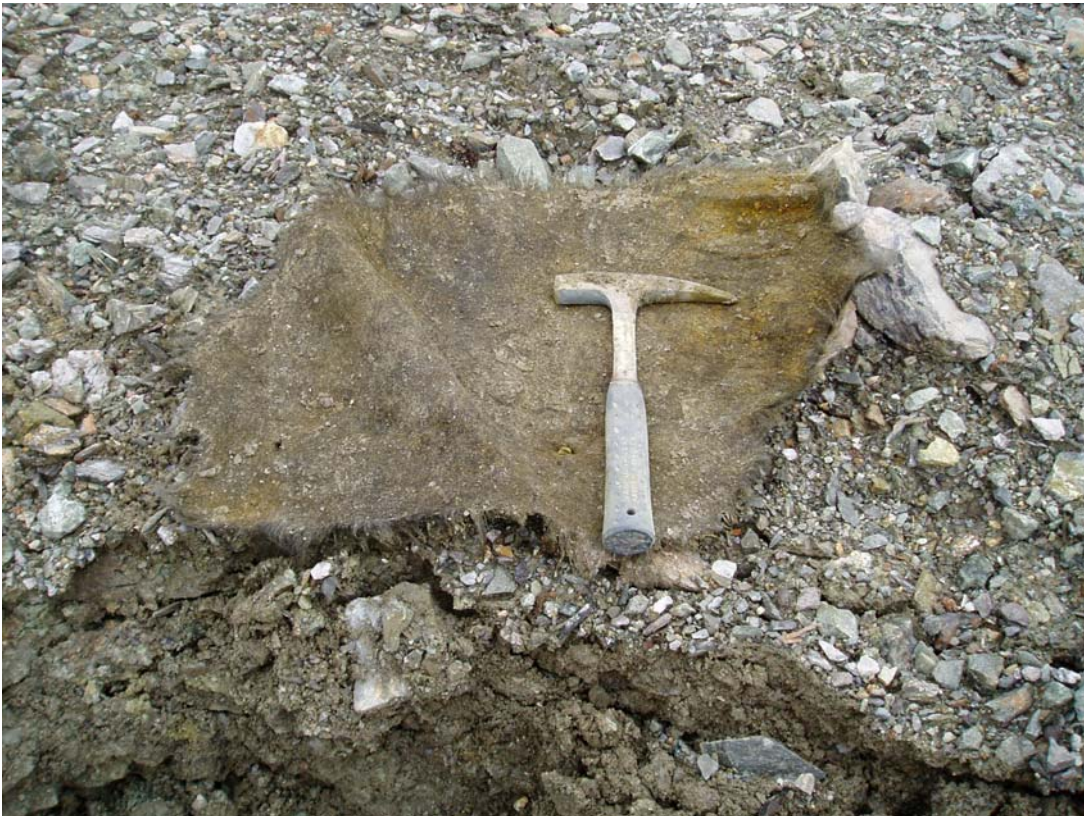
Photo 12: TP-TTC-04-04 The tailings has not migrated through the geotextile. Although both the tailings and the cover material were very wet, the geotextile was relatively dry.

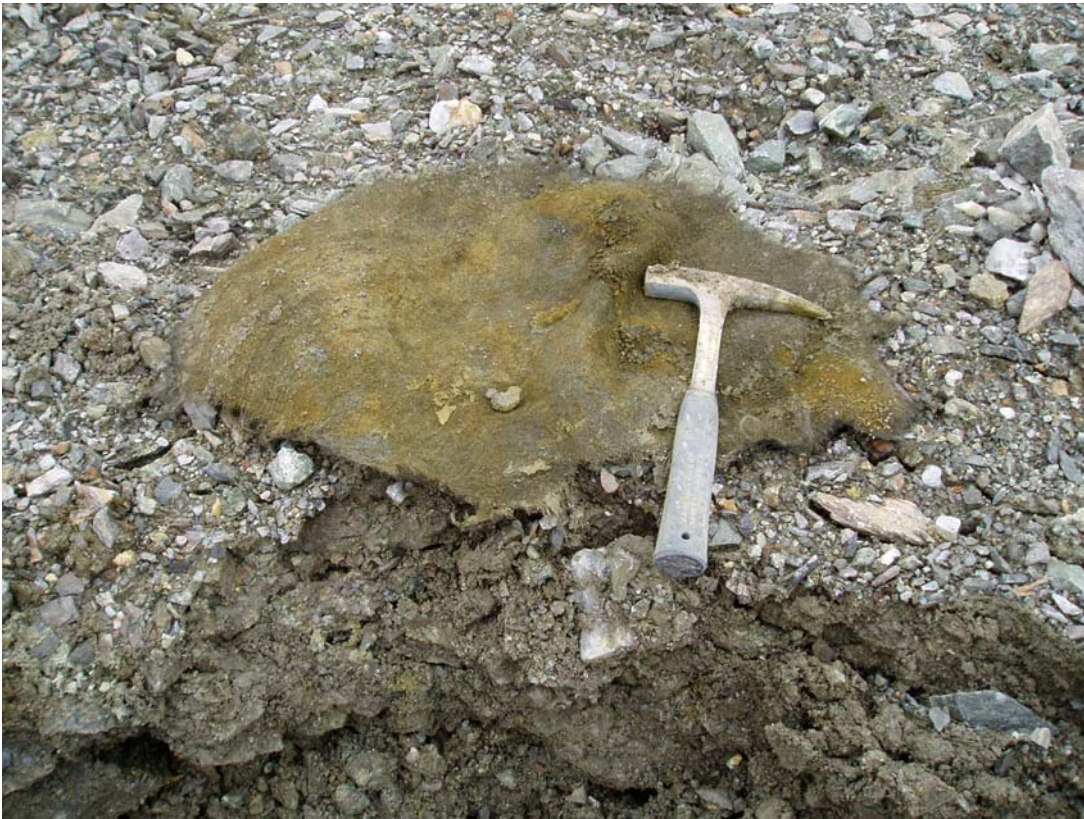
Photo 13: TP-TTC-04-04 The bottom of the geotextile is stained with tailings. It is possible that tailings is clogging the geotextile and subsequently slowing down the consolidation time.

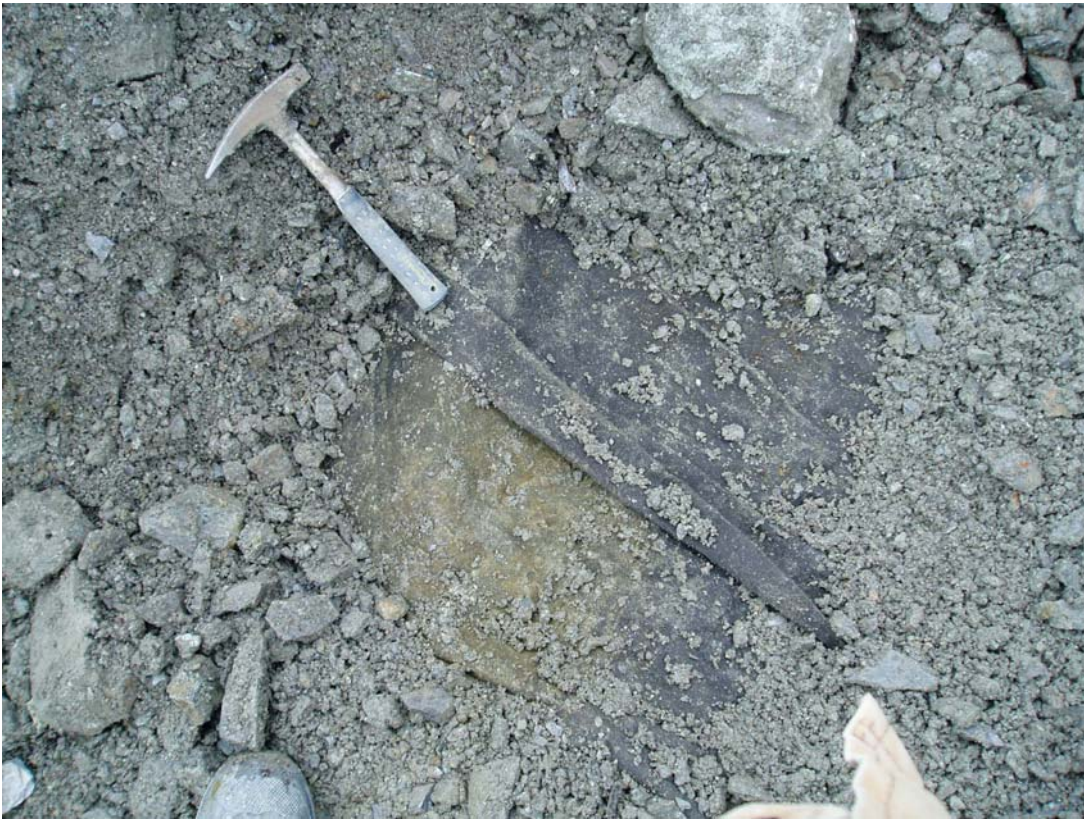
Photo 15: TP-TTC-04-05 Overlap section of the textile showing no signs of moving apart as a result of differential settlement. Also, no tailings are oozing through the seam opening.
