Anvil Range Mining Complex Results from Trial covers at Rose Creek Tailings Impoundment: 2007 Data Summary

2007 Task 18b - FINAL

Deloitte and Touche Inc.

May 2008

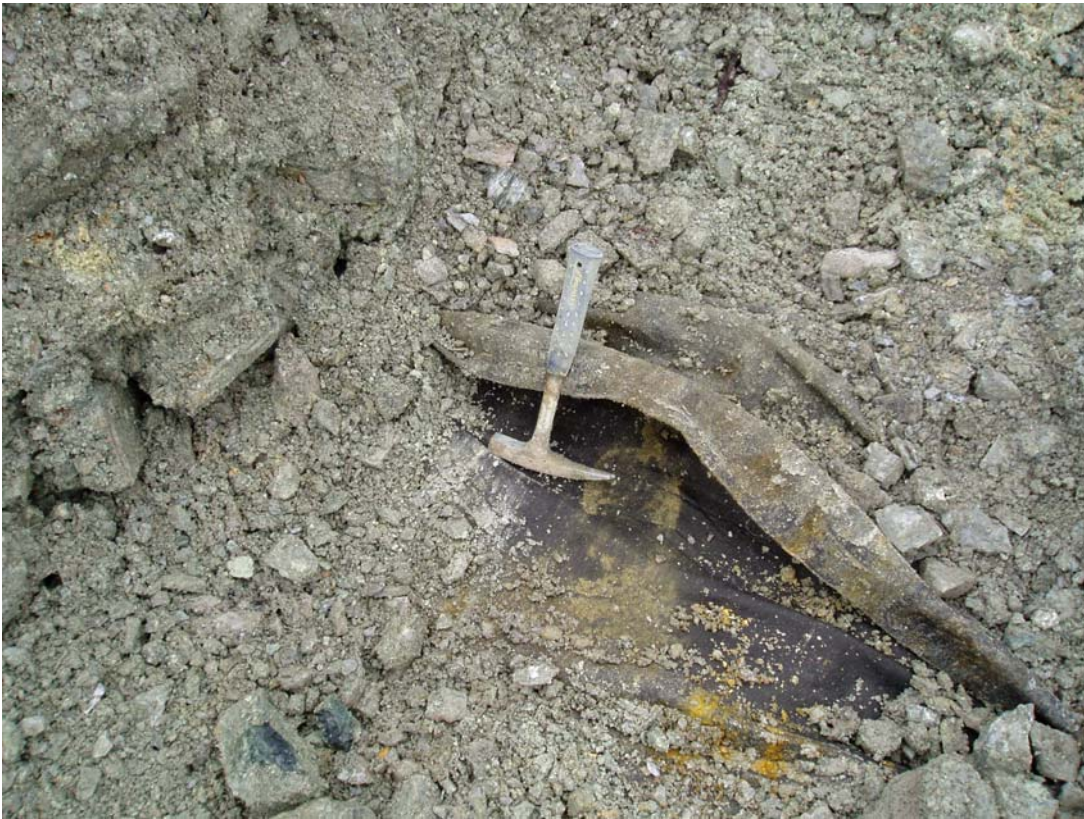
Photo 17: TP-TTC-04-06 Geotextile overlap showing no signs of tailings moving through the geotextile. The folds in the geotextile is as a result of rutting during construction caused by the trucks passing over the geotextile

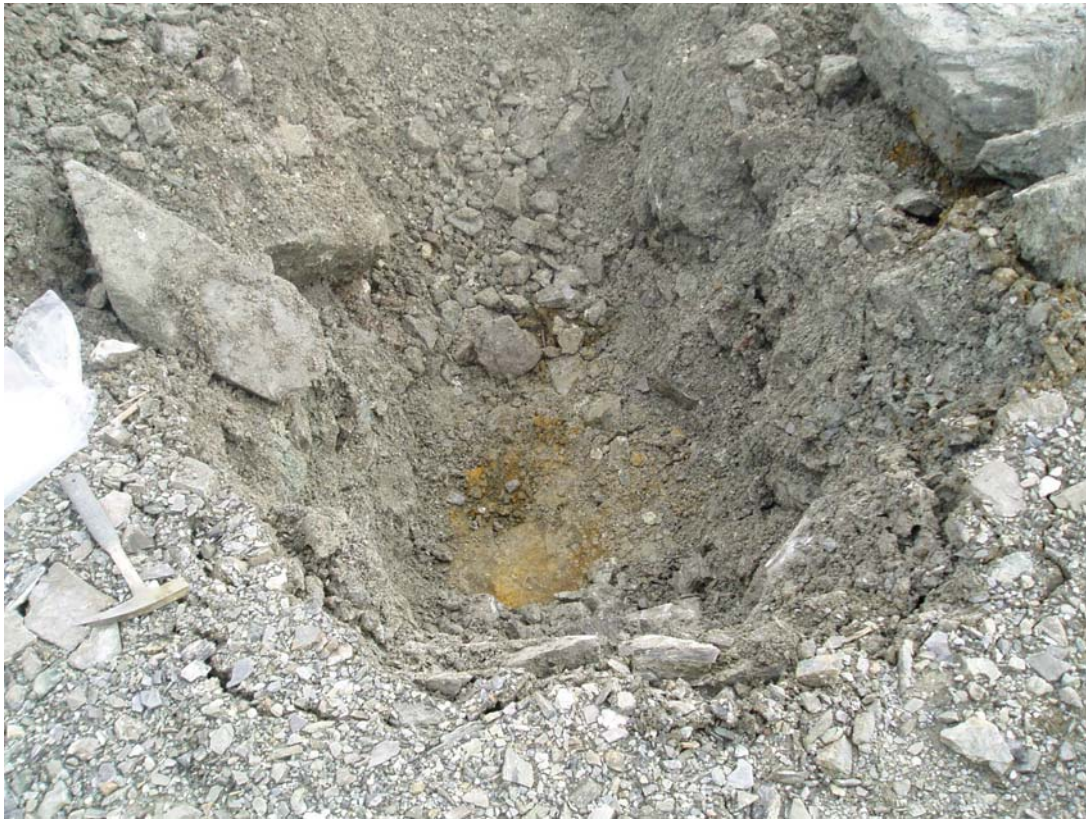
Photo 11: TP-TTC-05-04 The tailings has not migrated through the geotextile.

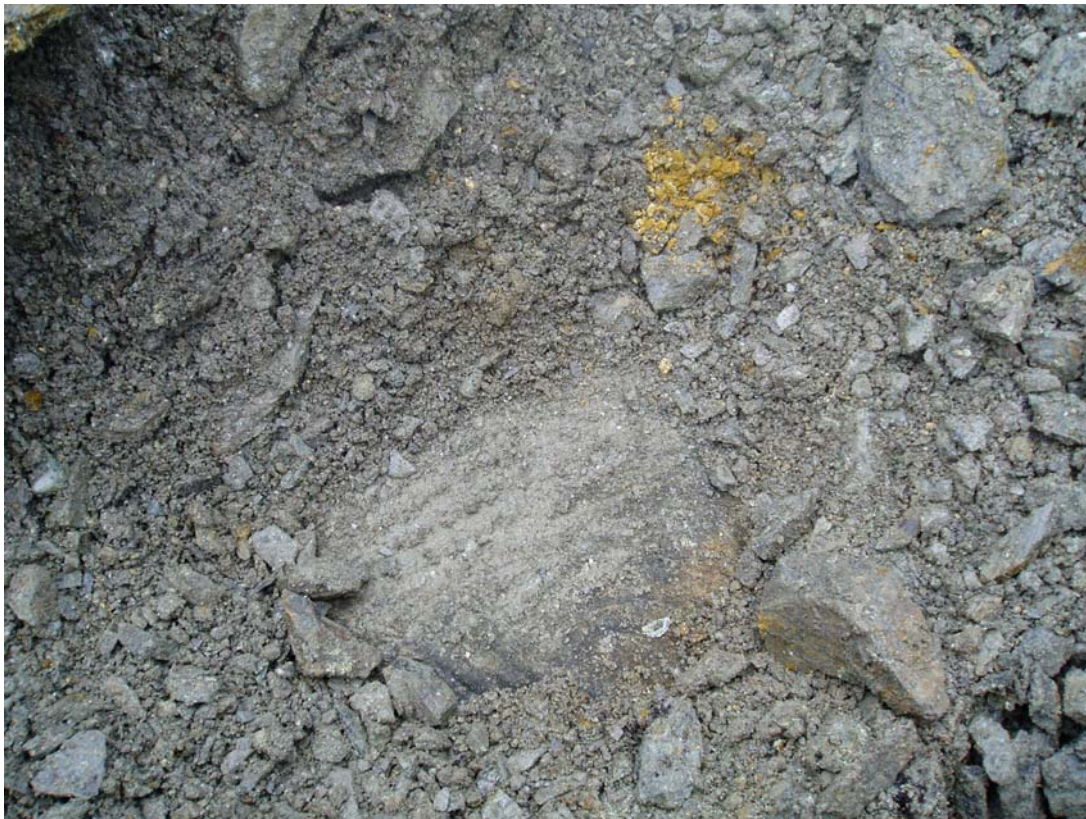
Photo 12: TP-TTC-05-05 The tailings has not migrated through the geotextile.

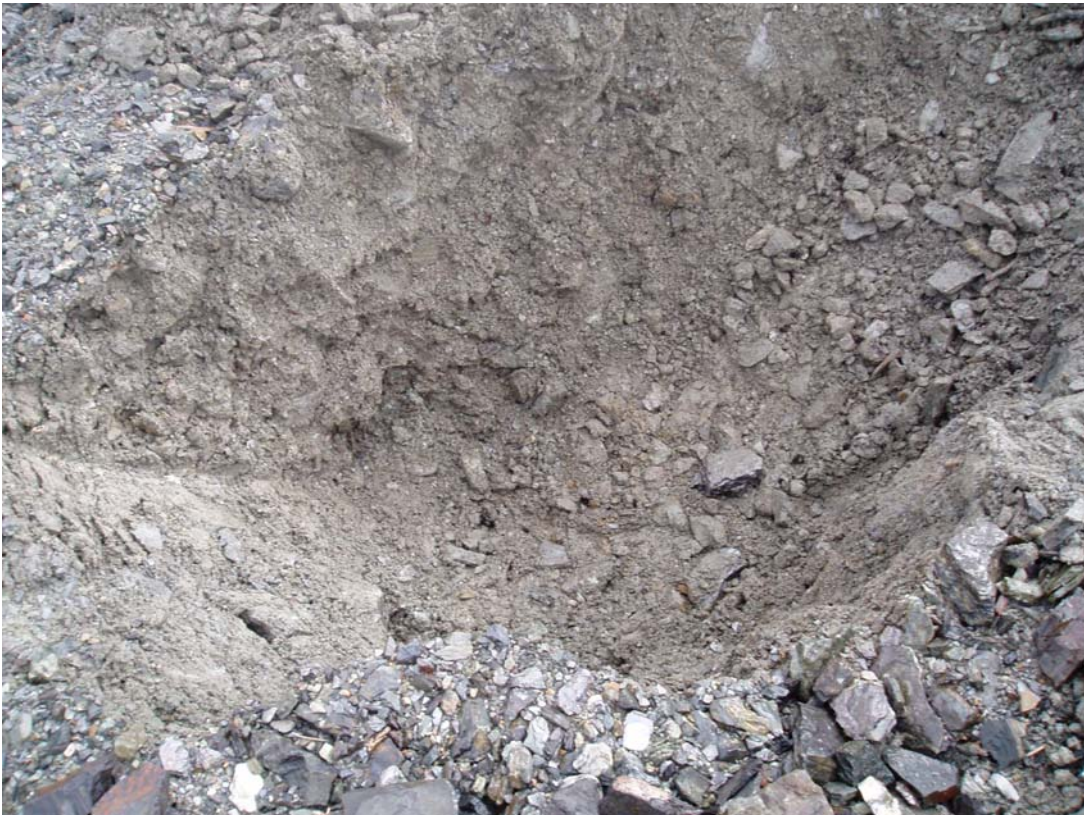
Photo 14: TP-TTC-05-06 The tailings has not migrated through the geotextile.
