C.A.M.C.
ROSE CREEK DAM INVESTIGATION
OPERATIONS REPORT

B. Berzins
H.E. McRae
1985-11-15

ATTACHMENT A - LOCATION PLAN & SECTIONS

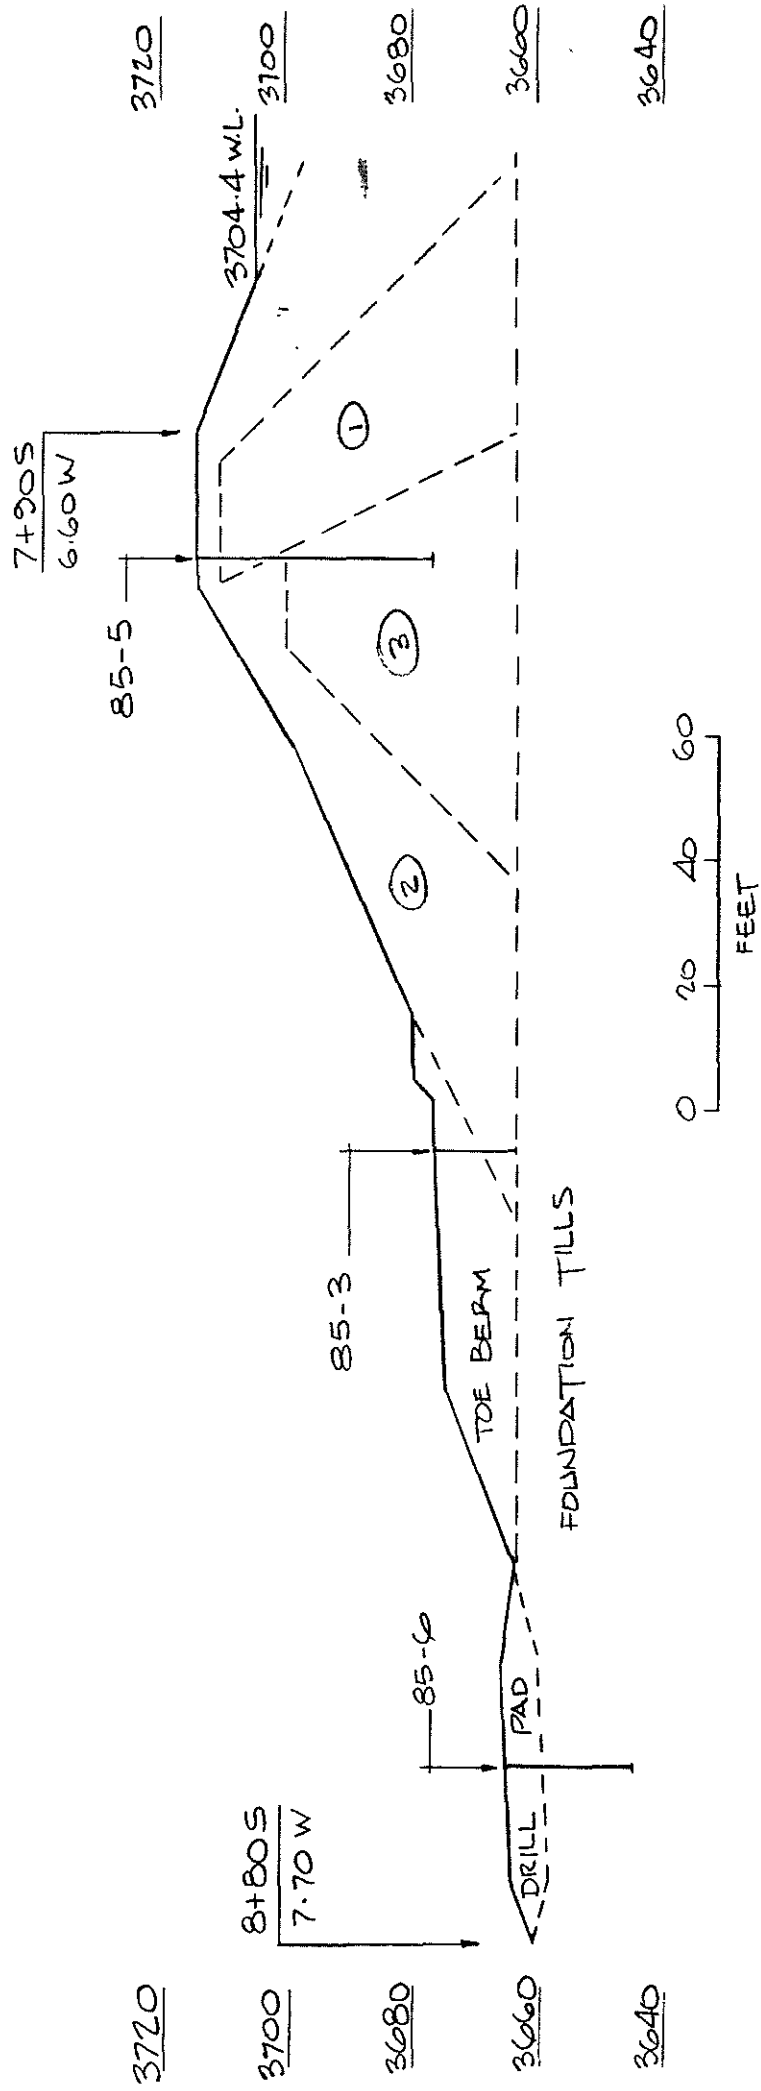
SECTION A - A'

On September 12, the rig was moved to the crest of the dam and commenced drilling Borehole 85-4 on Section A-A¹. This hole was drilled with an HW casing advancer and Revert drilling medium to a depth of 31.8 feet, where the casing refused on a boulder. Sampling was commenced below the crest rockfill and was carried out at 5 foot intervals in Zones 1 and 3 material. Upon completion on September 13, a standpipe piezometer was installed to full depth and the installation was completed by a steel protective cap.

The results of recent explorations have indicated that there are two separate piezometric surfaces, one within the embankment fill, the other in the overburden foundation. Piezometers installed within the Zone 3 fill have indicated high piezometric heads. It is noted that Zone 3 fill is composed of a silty till comparable in gradation to Zone 1. Thus, the central zone of the dam (Zones 1 and 3), together with the silty nature of portions of the downstream Zone 2 fill, indicate that the dam is a near-homogeneous fill embankment.

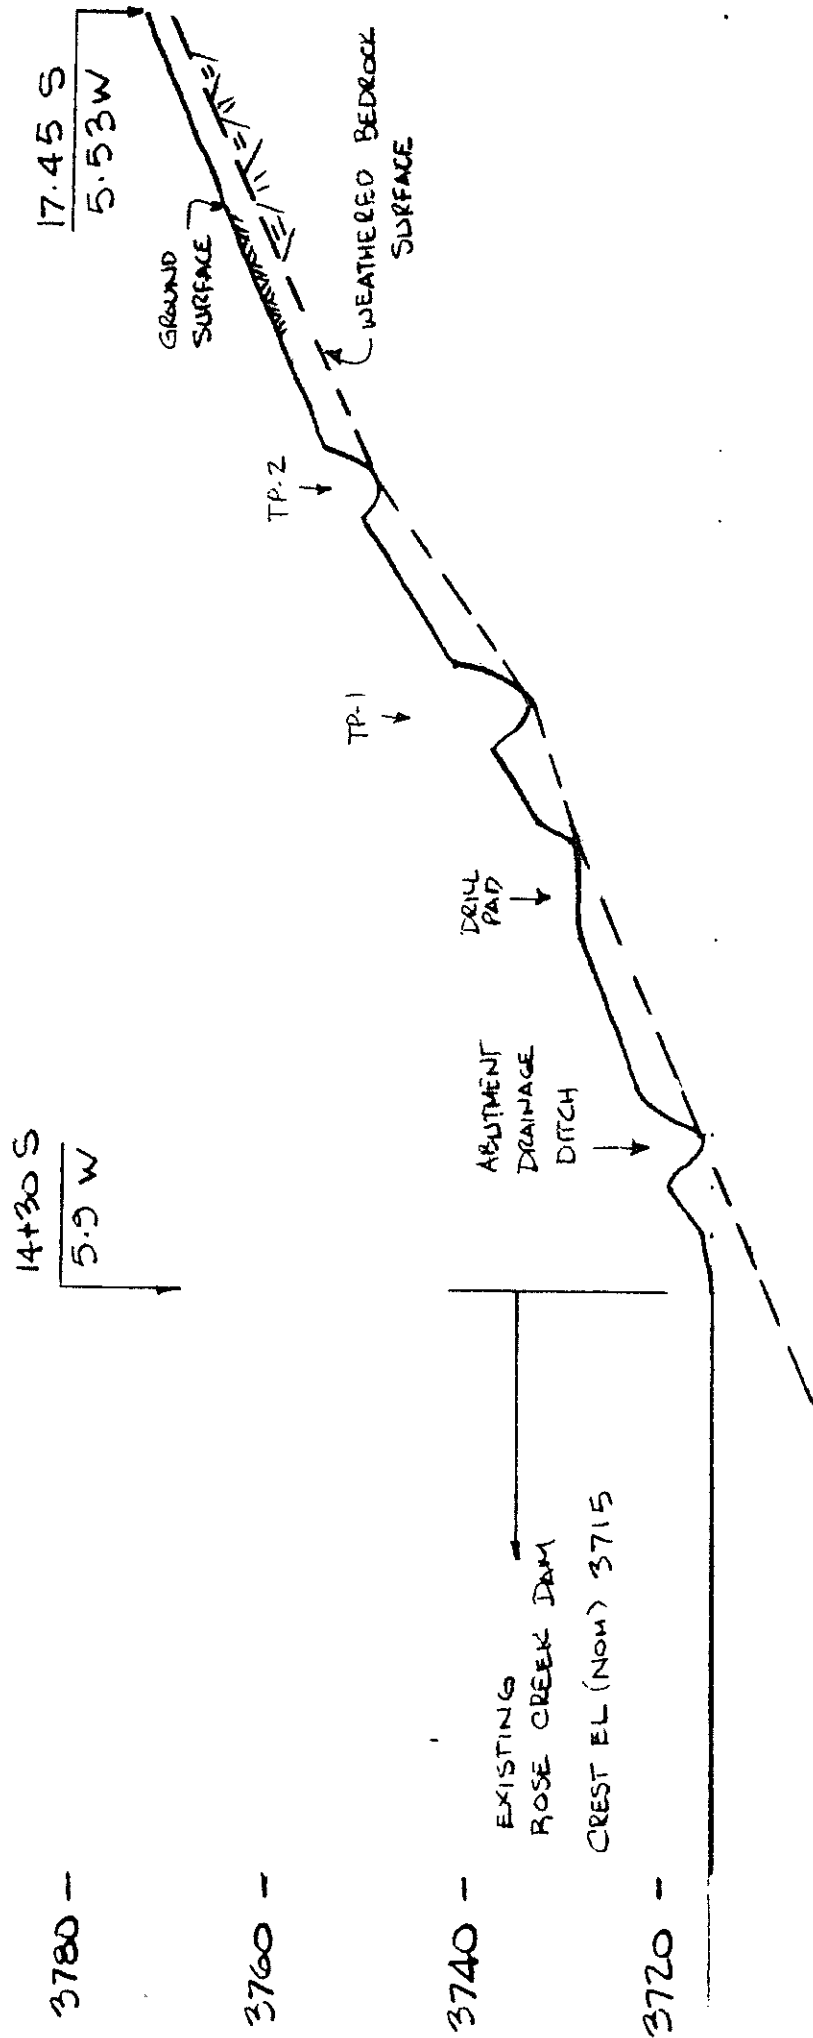
SECTION B-B'

In light of the problems encountered in 85-2, it was decided to move on to Section B-B¹ and drill only to the water table with solid shaft auger at a location on the toe berm similar to 85-2. This was accomplished in the afternoon of September 11, and Borehole 85-3 was advanced to a total depth of 13.1 feet. Upon completion, a standpipe piezometer was installed to a depth of 12 feet. Due to poor trafficability downstream of the dam on Section B-B¹, a borehole at the west end of that section was deferred until a rockfill pad could be constructed for drill access.

Borehole 85-5 on Section B-B¹ was collared on September 13 and drilled to refusal on a boulder at a depth of 37.5 feet on September 15. Slow progress in the hole, due mainly to the presence of boulders in Zone 3 and an inappropriate casing bit design, led to a decision to install both a standpipe piezometer and a thermistor string in the single borehole. Thermistor String No. 621 was taped to the standpipe with wooden stand-offs and the piezometer installed to full depth in the hole. The hole was backfilled, sealed, and completed with a steel protective cap.

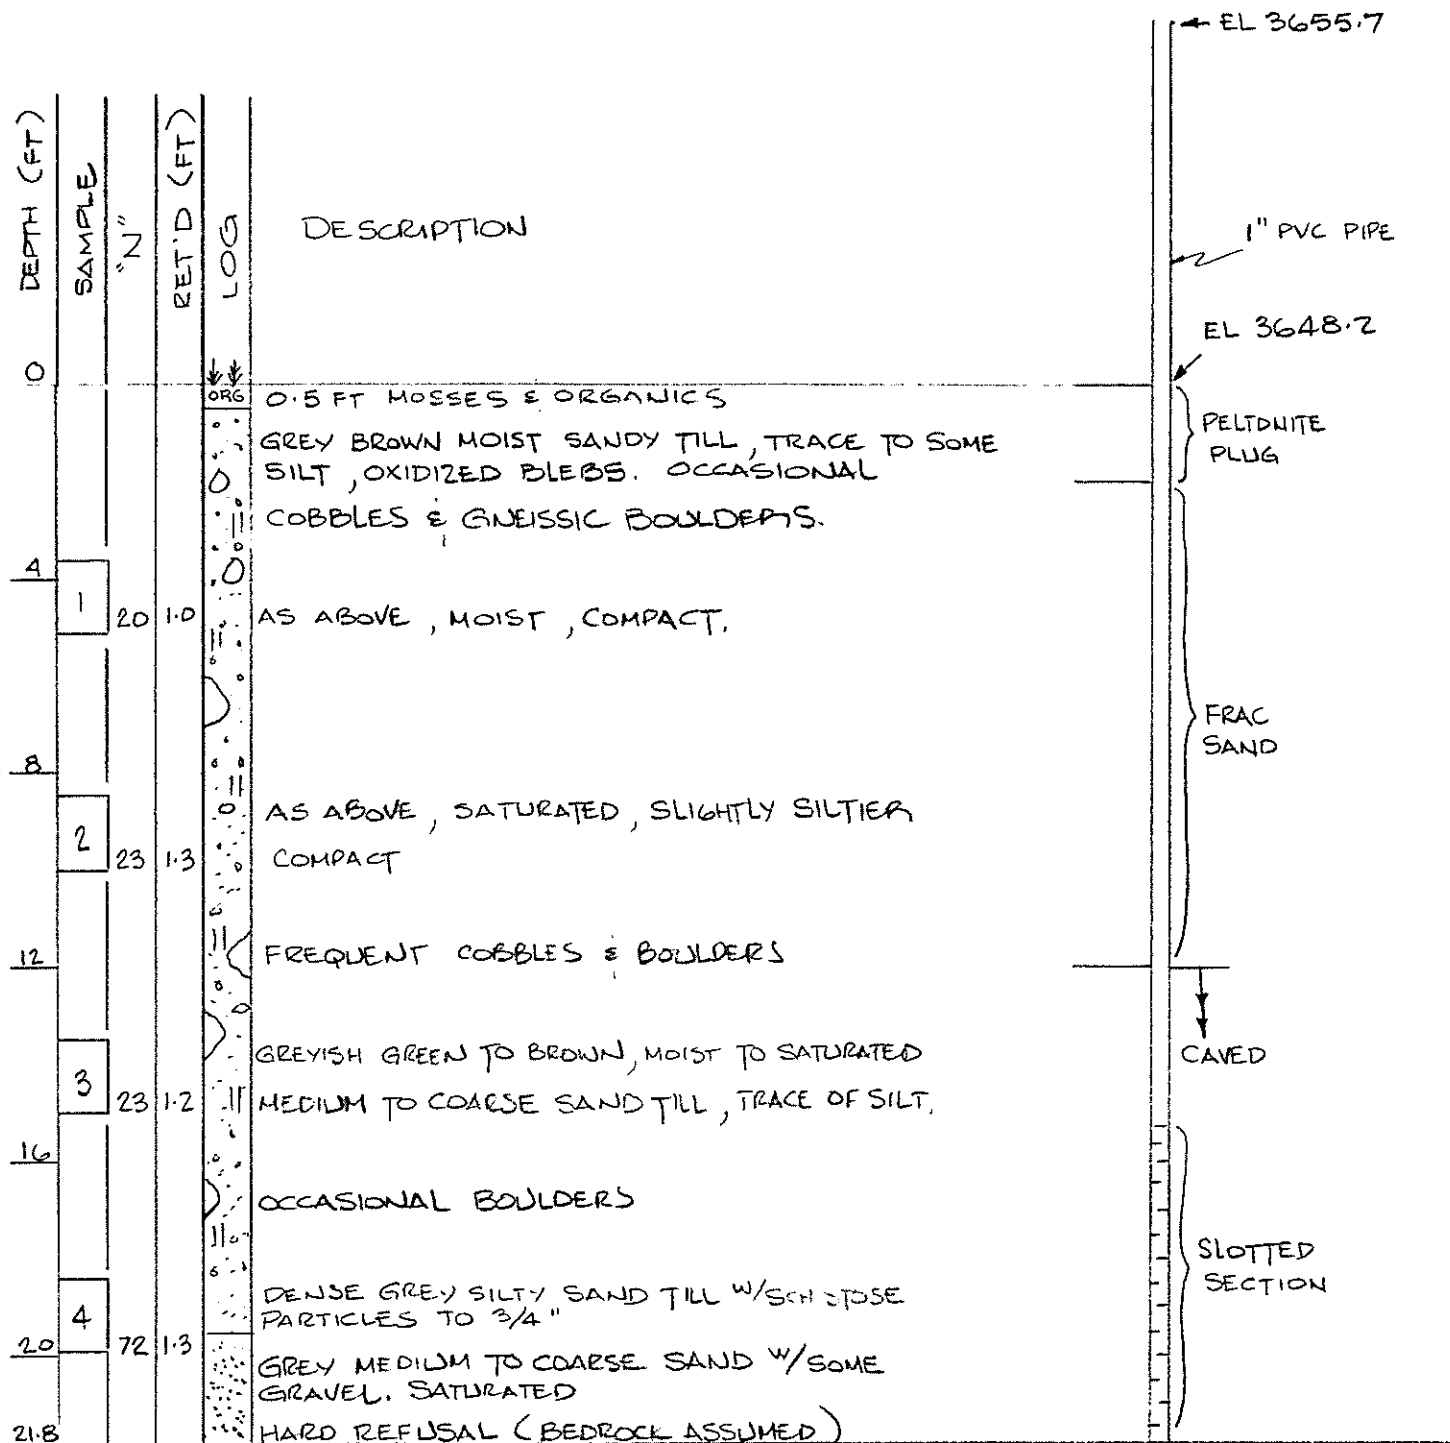
BH - 85-1 (HOLLOW STEM AUGER)

Borehole 85-1, located on the foundation materials downstream of the maximum height section (see attached location plan and sections), was drilled with hollow-stem auger to hard refusal on assumed bedrock at a depth of 21.8 feet. For details of materials encountered and samples obtained, see attached graphic log. Upon completion, a standpipe piezometer was installed to the full depth of the hole, but appreciable artesian flow in the hole made auger removal and peltonite placement very difficult, and only a partial seal was achieved around the piezometer tubing. The piezometer pipe was extended to a height of 7.5 feet above ground surface, and a trickle flow was noted over the top of the pipe at this height.

- NOTES :
- ① DRILLED WITH HOLLOW STEM AUGER, SPLIT SPOON SAMPLED
 - ② HOLE MADE WATER UPON COMPLETION WITH 3.5 FT AUGER STICKUP
 - ③ HOLE HAS TRICKLE FLOW OVER TOP OF PVC AND SOME WEEPING AROUND THE PELTONITE PLUG. DIFFICULT TO SEAL.

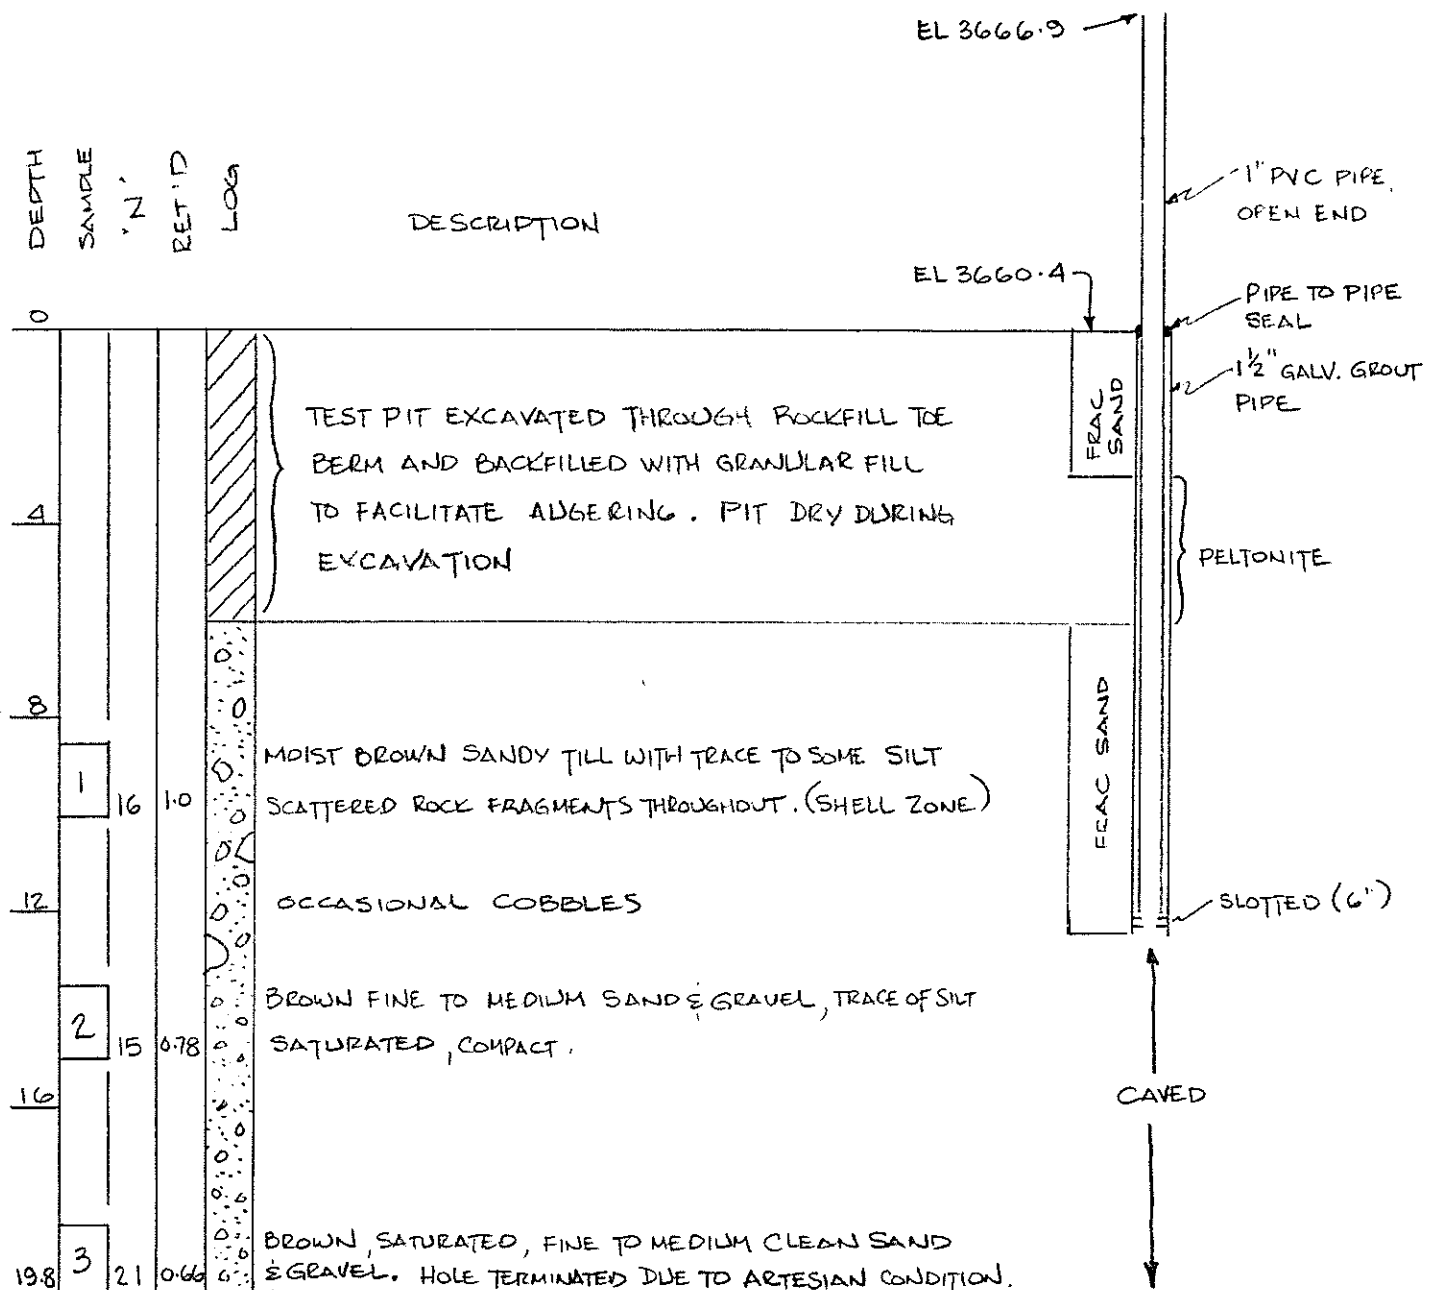
BH - 85-2 (HOLLOW STEM AUGER)

NOTES: ① HOLE FLOWED (± 1 gpm) UPON COMPLETION OF SAMPLE #3.

② ATTEMPTED TO SEAL WITH BENTONITE SLURRY, BUT WATER FLOW BAILED BENTONITE FROM HOLE

③ PLACED GALVANIZED PIPE IN AUGERS PRIOR TO WITHDRAWAL, AND NOTED FLOW FROM SAME

④ BACKFILLED HOLE & PLACED PELTONITE SEAL, THEN INSERTED PVC PIPE IN GALVANIZED PIPE AND SEALED AS STANDPIPE

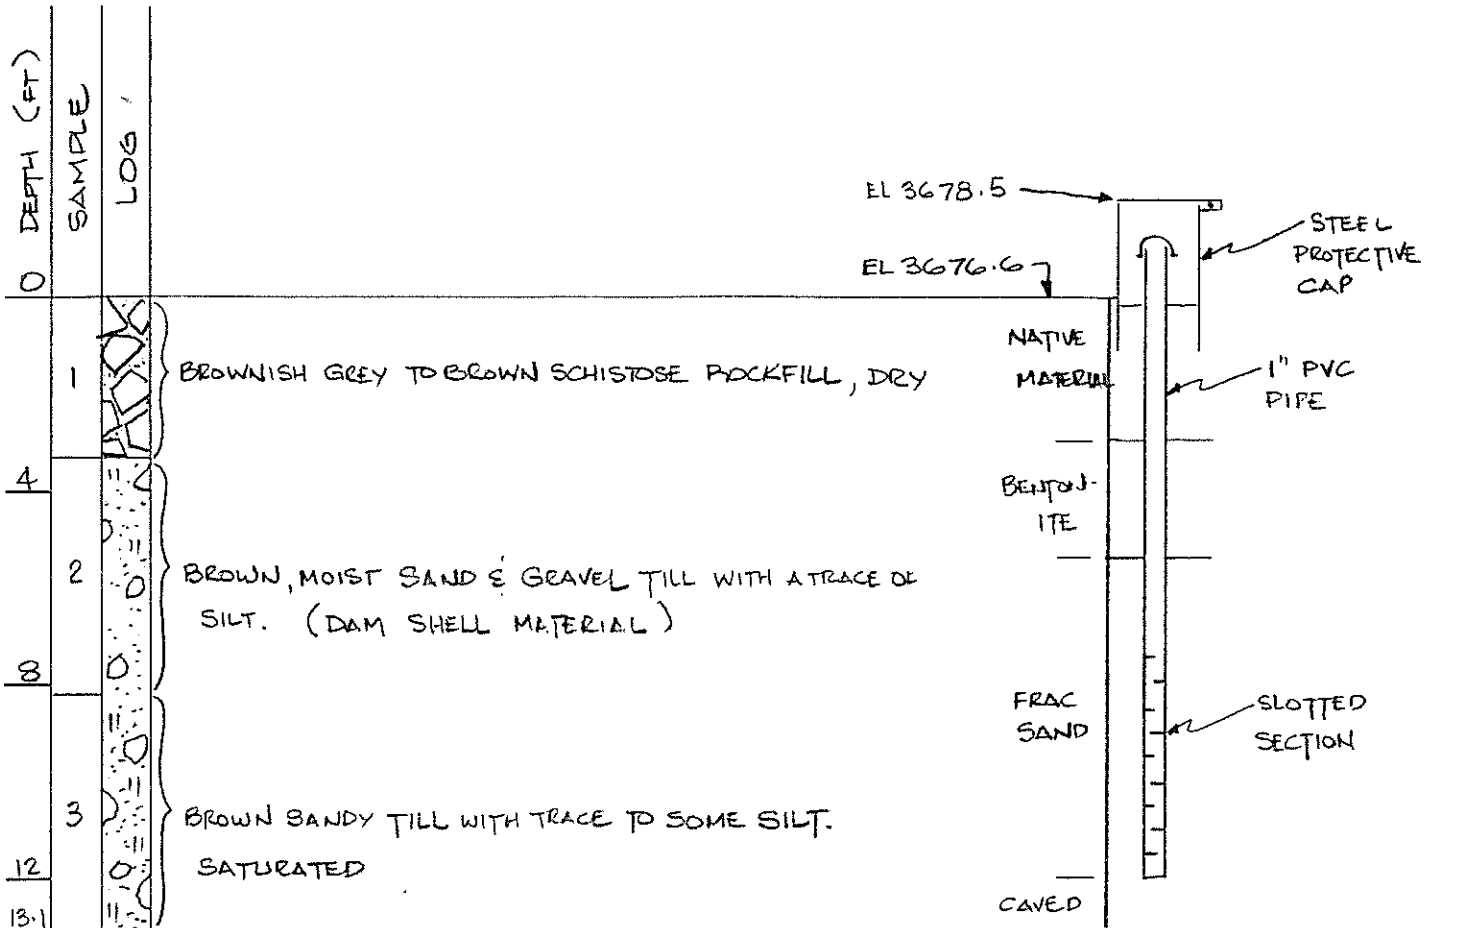
BH-85-3 (6" FLIGHT AUGER)

NOTES: ① HOLE DRILLED WITH SOLID AUGER TO WATER TABLE AND TERMINATED BEFORE PENETRATING TOO DEEPLY INTO PRESSURIZED FOUNDATION MATERIALS.

② 3 SAMPLES TAKEN FROM AUGER FLIGHT, ONE AT END OF EACH STROKE. THOUGHT TO BE REPRESENTATIVE OF THE ZONES INDICATED.

③ SLOTTED PIPE PIEZOMETER INSTALLED AFTER REMOVAL OF AUGER STEM. ALL READINGS REFERENCED TO TOP LIP OF STEEL PROTECTIVE CAP.

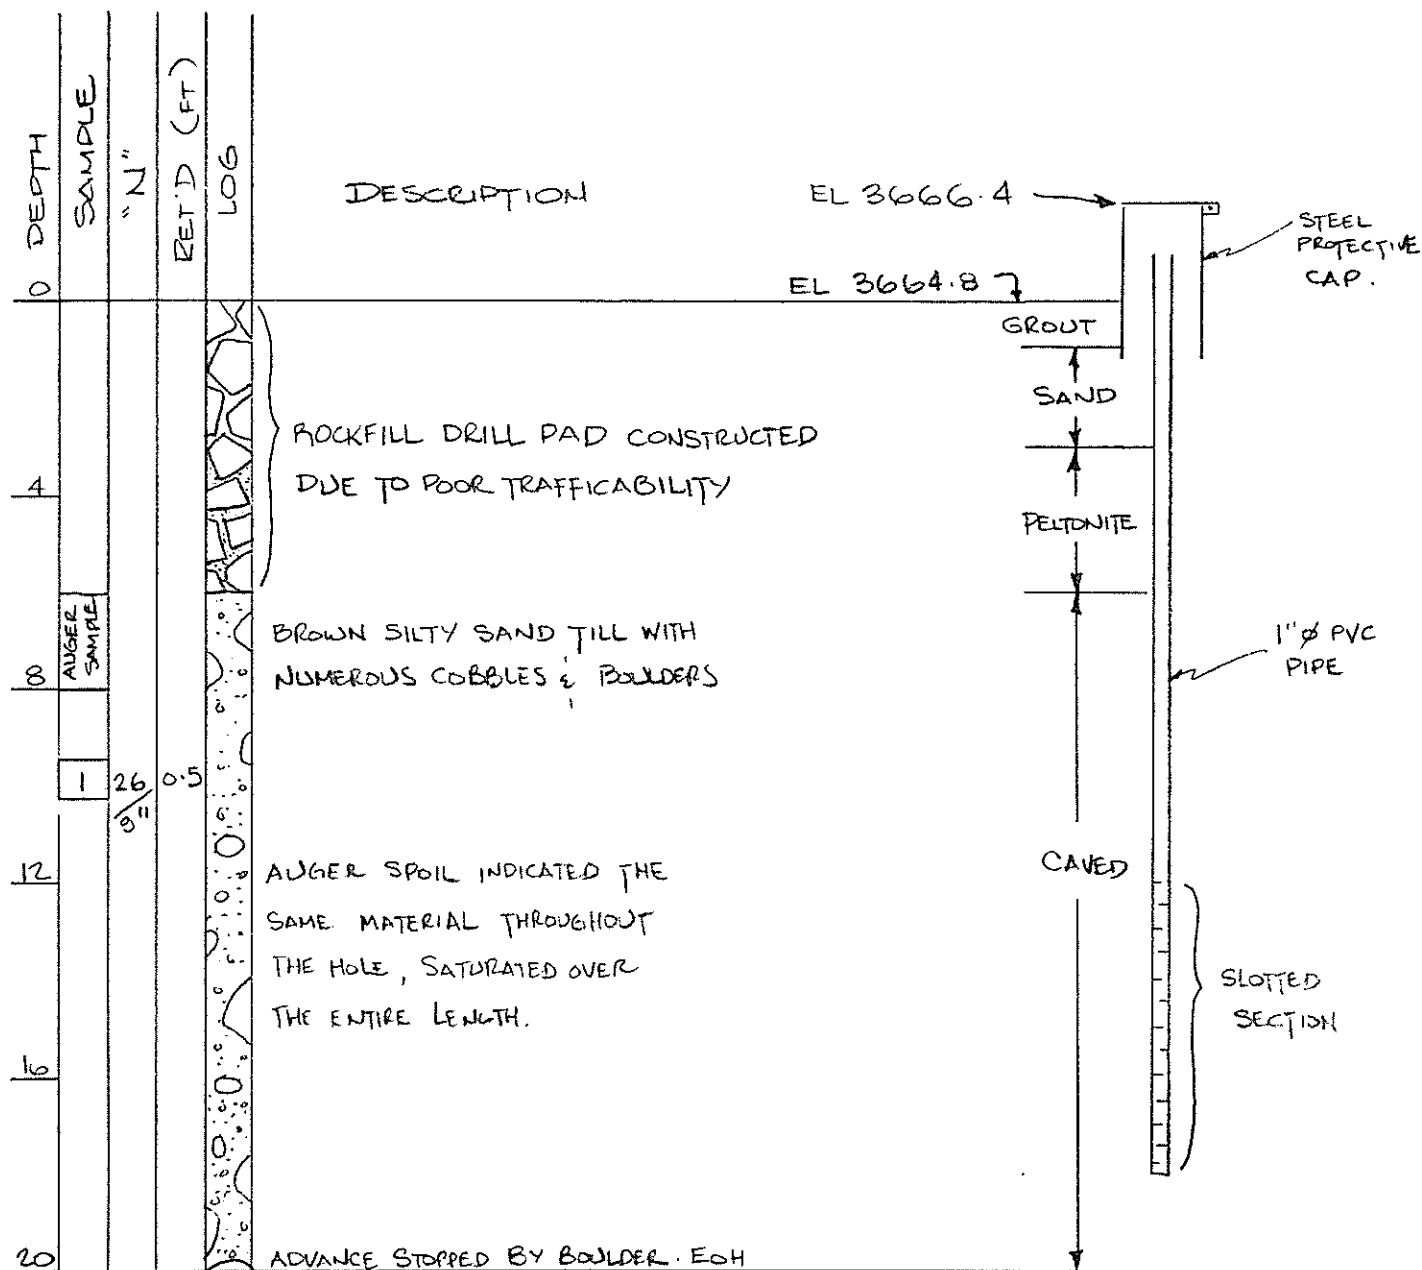
BH- 85-6

On the afternoon of September 15, the rig was moved to a rockfill drill pad at the west end of Section B-B¹, and Borehole 85-6 was collared. Numerous attempts were made to advance the hole with the HW casing advancer, but boulders prevented penetration below 10 feet. The rig was relocated slightly, and open hole was advanced with continuous flight auger to a depth of 20 feet where the bit refused on a boulder. Although the hole caved upon auger removal, a standpipe piezometer was installed by jetting to a depth of 18 feet. The hole was sealed with peltonite and a protective steel cap installed.

NOTES- ① SEVERAL ATTEMPTS WERE MADE TO ADVANCE THE HOLE WITH HW CASING ADVANCER, BUT NUMEROUS BOULDERS HINDERED PENETRATION, HOLE RELOCATED SEVERAL TIMES, AND FINALLY ADVANCED TO REFUSAL WITH 6" FLIGHT AUGER

② PIEZOMETER INSTALLED IN CAVED HOLE BY JETTING WITH REVERT.
