ROSE CREEK DIVERSION CANAL DIKE UPGRADE AS BUILT REPORT

FARO MINE, YT

FINAL REPORT

PROJECT NO.: 0257-026-03 DATE: JUNE 29, 2005 DISTRIBUTION LIST: DELOITTE & TOUCHE INC. 2 COPIES ANVIL RANGE 2 COPIES BGC – CALGARY 2 COPIES BGC – VANCOUVER 1 COPY

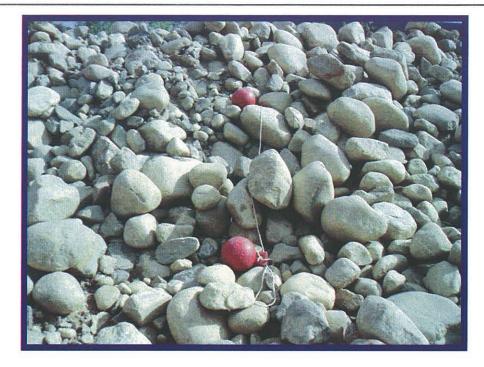
Photo 1 shows the Split Net balls on the riprap stockpile.

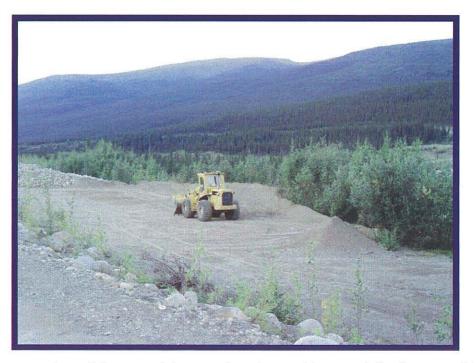
Photo 2 shows a view of the remaining sand and gravel borrow following completion of the RCDC crest raise.

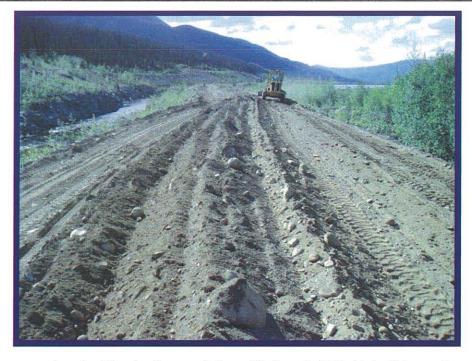
Photo 3 shows a view looking to the west from Station 0+750. Note this section is currently having the winter placed fill removed. This material is being windrowed into the central section. This material is being reused (with large cobbles removed) in the dike raising.

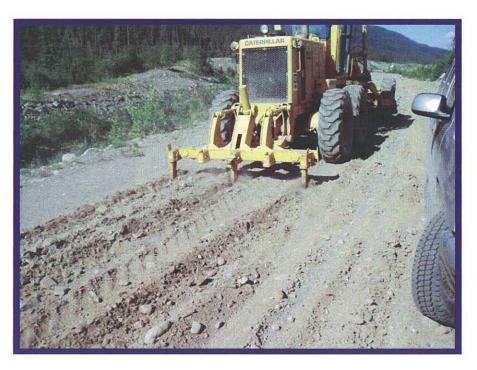
Photo 4 shows a view of the 160G grader as it starts to scarify the surface of the Canal Dike.

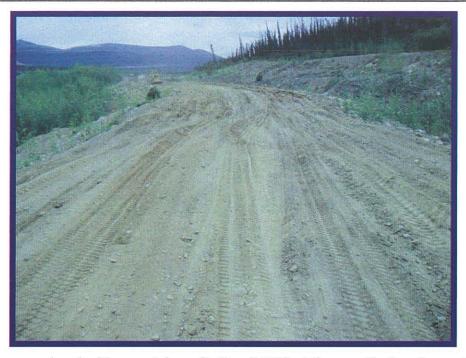
Photo 5 shows a view looking east from Station 0+500 at the scarified surface of the original Canal Dike. This is the original surface of the dike, following removal of the winter placed fill.

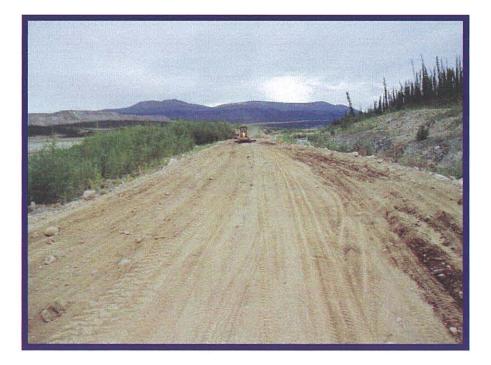
Photo 6 shows a view taken from Station 0+550 looking towards the east. The scarified surface of the road is now being back-bladed to create a smooth upper surface prior to compaction.

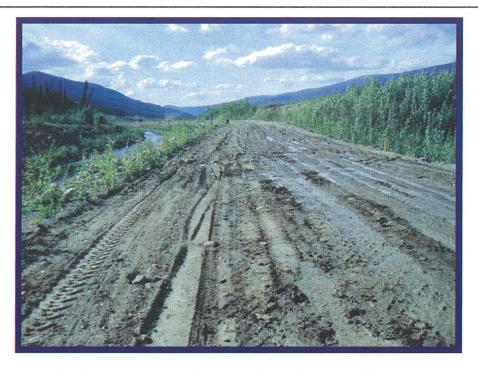
Photo 7 shows a view looking towards the west from Station 0+950. Note on the right hand side of this photo that water has been placed and compaction started and on the left hand side no water has yet been placed.

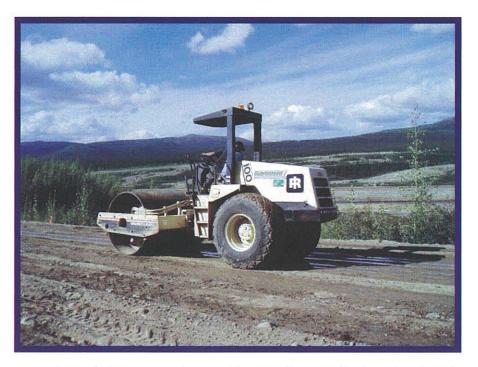
Photo 8 shows a view of the compacter working on the scarified and watered surface near 0+925.

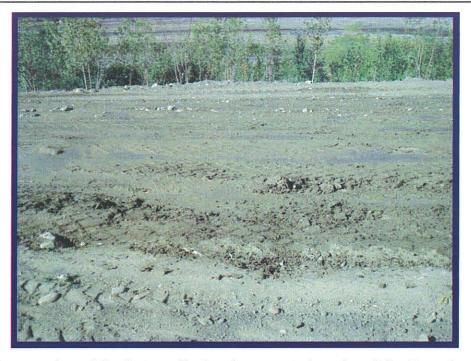
Photo 9 shows a view of the first scarified and compacted section of the Rose Creek Diversion Canal Dike, looking to the north from station 1+000. Note the application of water.

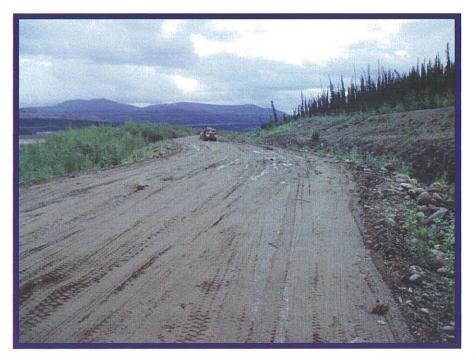
Photo 10 shows the surface of the scarified and re-compacted surface. This photo is taken looking to the east from Station 0+525.

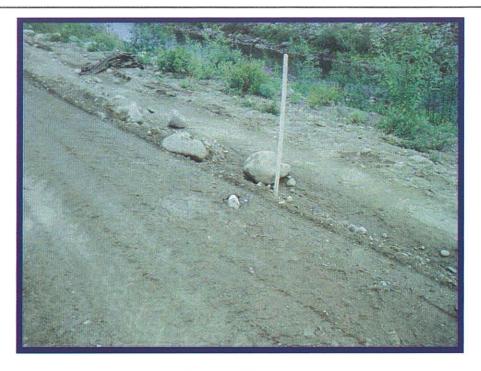
Photo 11 shows the grade stake at station 0+800.

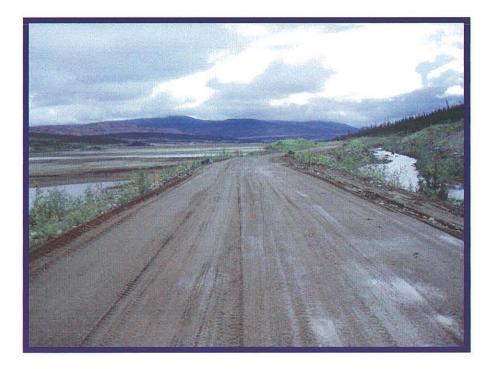
Photo 12 shows a view looking to the east from station 0+150. This shows the second lift of general fill (sand and gravel) currently being compacted.

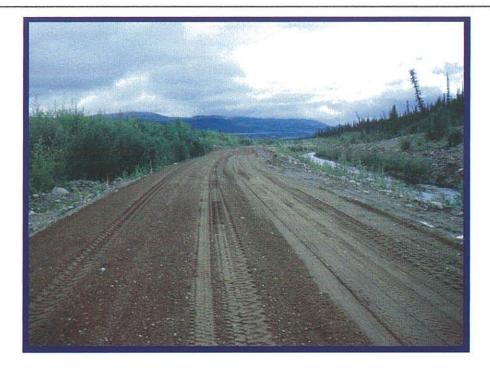
Photo 13 view looking to the east from station 0+650. In this section the third lift of gravel has been placed and bladed level in preparation for compaction.

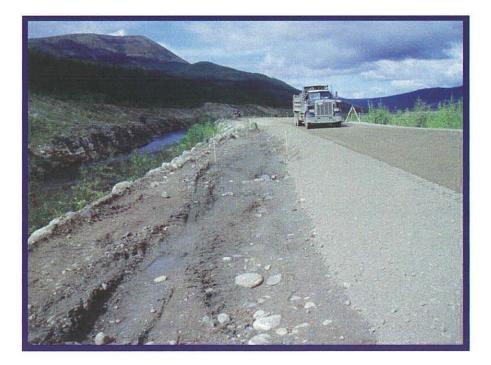
Photo 14 shows a view looking to the east from station 0+725. Note the wide space between the stakes, this area needs to be filled with granular fill prior to riprap placement.

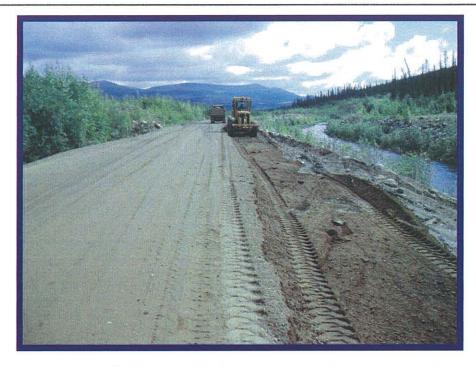
Photo 15 shows a view looking to the west from station 0+725. This shows the area from the previous photo and the start of fill placement in this area.

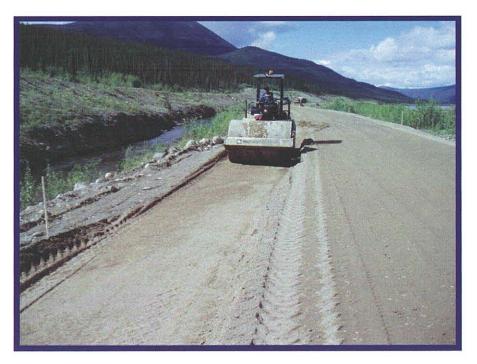
Photo 16 shows a view looking east from station 0+850. This photo shows the grade staking for riprap placement and the soil that has been in filled in this area.

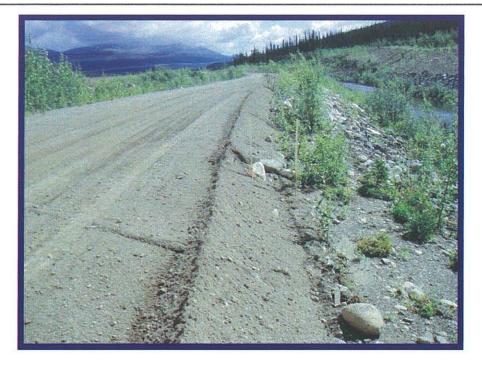
Photo 17 shows grade stakes for riprap placement.

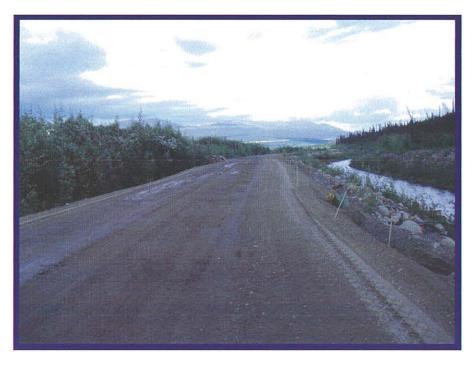
Photo 18 shows a view at station 0+700. Note the instrument location which has some fill directly adjacent to it. Some fill needs to removed around this instrument and riprap placed in this area.

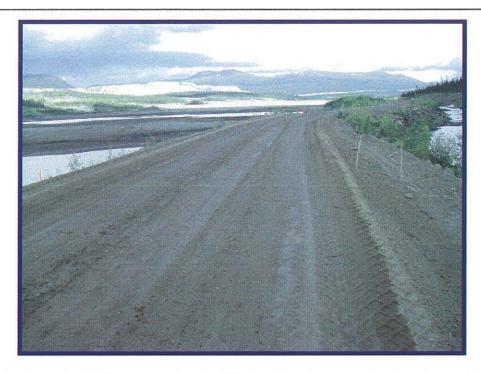
Photo 19 shows a view taken at station 0+175 showing the completed surface of the general fill and the grade stakes for riprap placement.

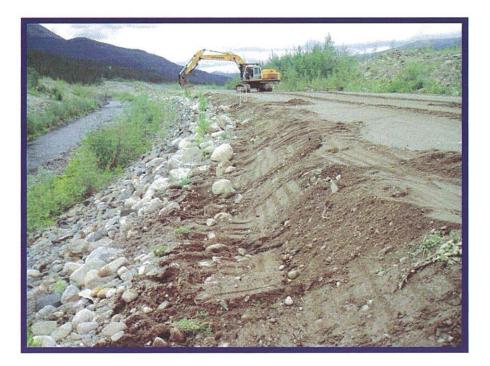
Photo 20 shows a view at station 0+825 of the prepared surface for riprap placement.

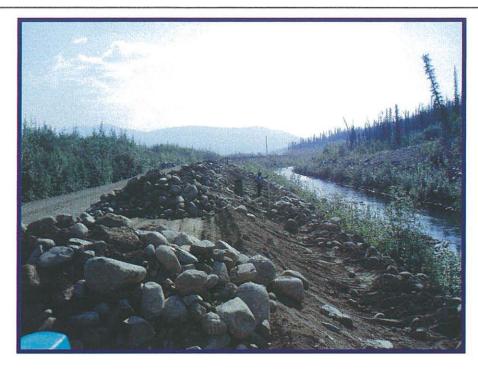
Photo 21 surveying the prepared surface at the RCDC riprap upgrade prior to placement. Note the stockpiles of riprap ready for placement.

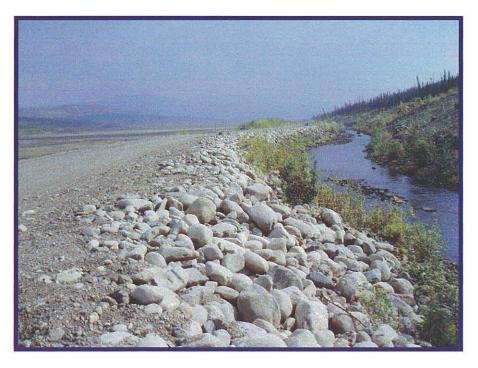
Photo 22 shows a view of the completed riprap surface, at Station 0+150 looking east.
