# TECHNICAL MEMO

<b>TO:</b>	Josée Perron, YTG Assessment and Abandoned Mines	<b>DATE:</b>	January 13, 2012
<b>C:</b>		<b>MEMO NO.:</b>	001
<b>FROM:</b>	Richard Trimble, Kisa Elmer	<b>EBA FILE:</b>	W23101530
<b>SUBJECT:</b>	Summary of Geotechnical Services at Mount Nansen Abandoned Mine Site

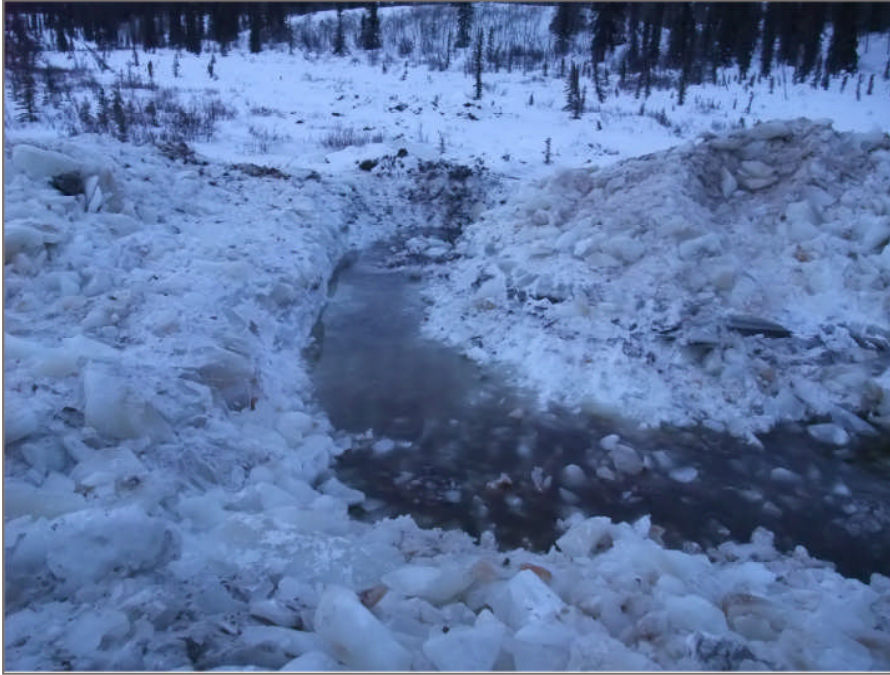
**Photo 1:** At Dome Creek (10-Jan-2012)

At the time of excavation there was no evidence that riprap or liner in the spillway had been damaged. Photographs 1 through to 8 documenting the condition of the diversion channel post excavation are included in Appendix A – Photographs.

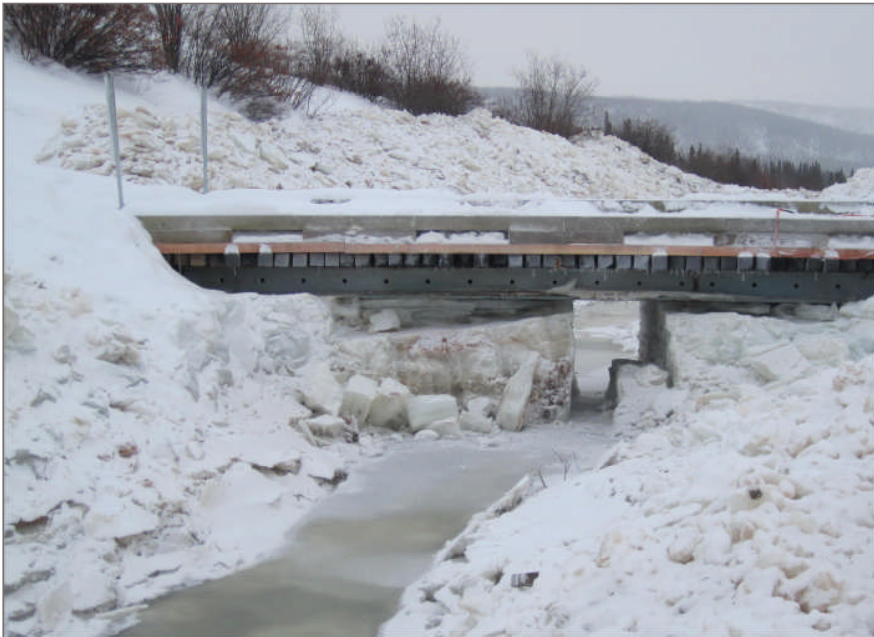
EBA field personnel were onsite observing the excavation of Dome Creek Diversion Channel. Excavation began January 7, 2012 and was completed January 10, 2012. The Denison steamer crew began removing ice from the west bridge beam and cutting a channel about 1 m wide from the base of the bridge to the

bottom of the diversion channel on January 8, 2012 and finished January 9, 2012. The channel provides temporary drainage under the bridge.

**Photo 5:** Ice Removal Under the Bridge (09-Jan-2012)

- In order to reduce the risk of blockages and protect the bridge abutments from the erosive forces of ice jamming during freshet, YTG should remove the remaining ice beneath the access bridge;
- Excavate the ice in the diversion channel once the ice accumulates in the ditch to half or two-thirds the height of the diversion ditch berm and before ice accumulates to the base of the access bridge;
- Continue to monitor and record daily pump rates from the seepage collections pond and verify with EDI Environmental Dynamics that the flow is accurate; and,
- Monitor thermistors and piezometers once per week until after spring freshet.

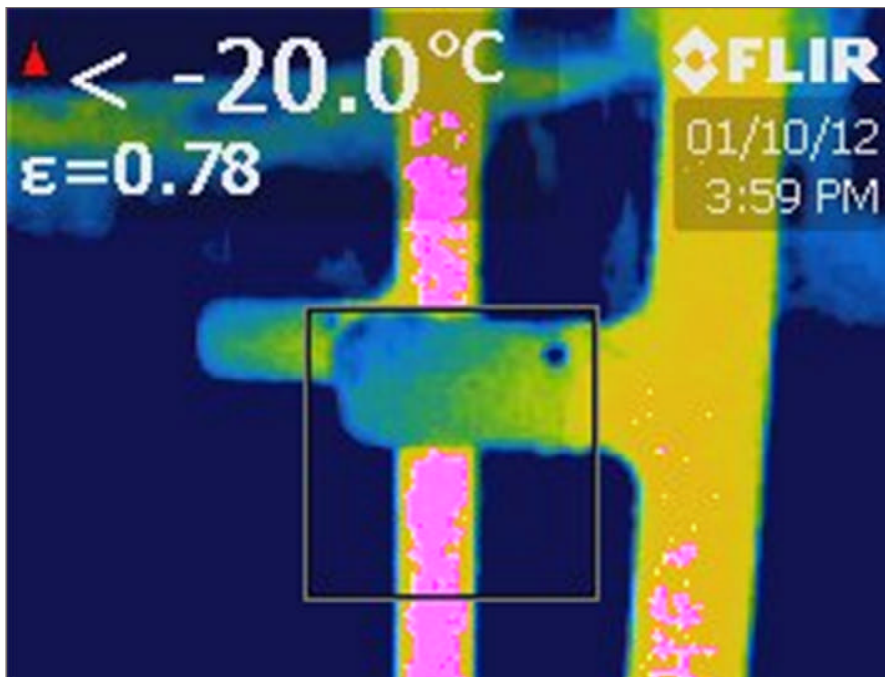
EBA used an FLIR IR Camera to measure the thermal gradient of the thermosyphons installed under the seepage collection dam. Photograph 9 show a temperature gradient between the thermosyphons and surrounding environment. Therefore, the thermosyphons are still performing as designed.

**Photo 9:** IR photo of North Abutment Thermosyphon radiators (10-Jan-2012)

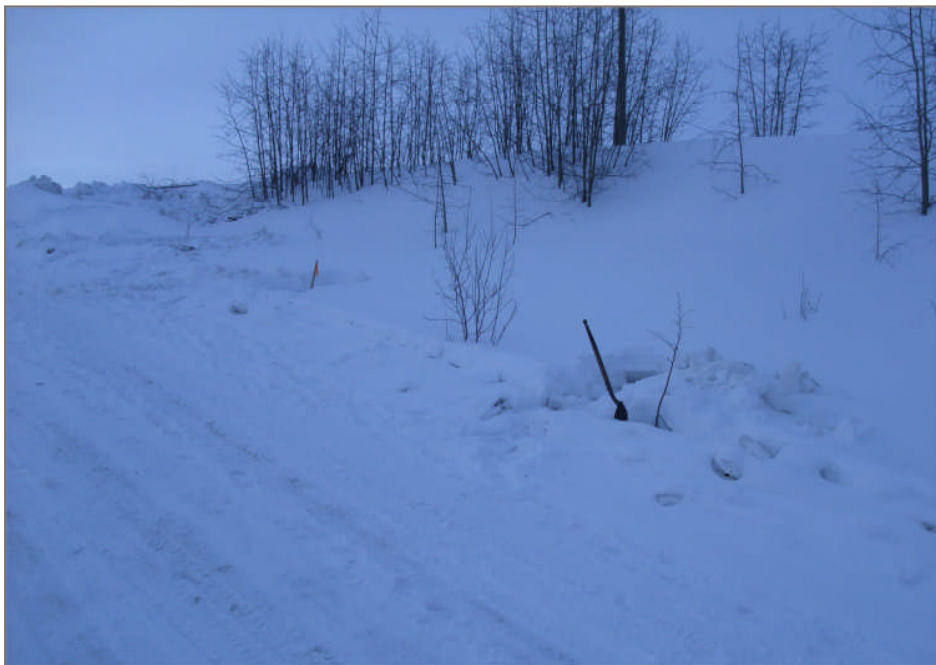
EBA inspected four testpits excavated through snow down to original ground and found no evidence of “piping” or seepage along the sand side slopes above the seepage pond. The locations and conditions of these testpits are shown in photographs 10 and 11.

**Photo 10:** Location of exploratory pits to look for water seepage along slope between diversion ditch and seepage collection pond (10-Jan-2012)

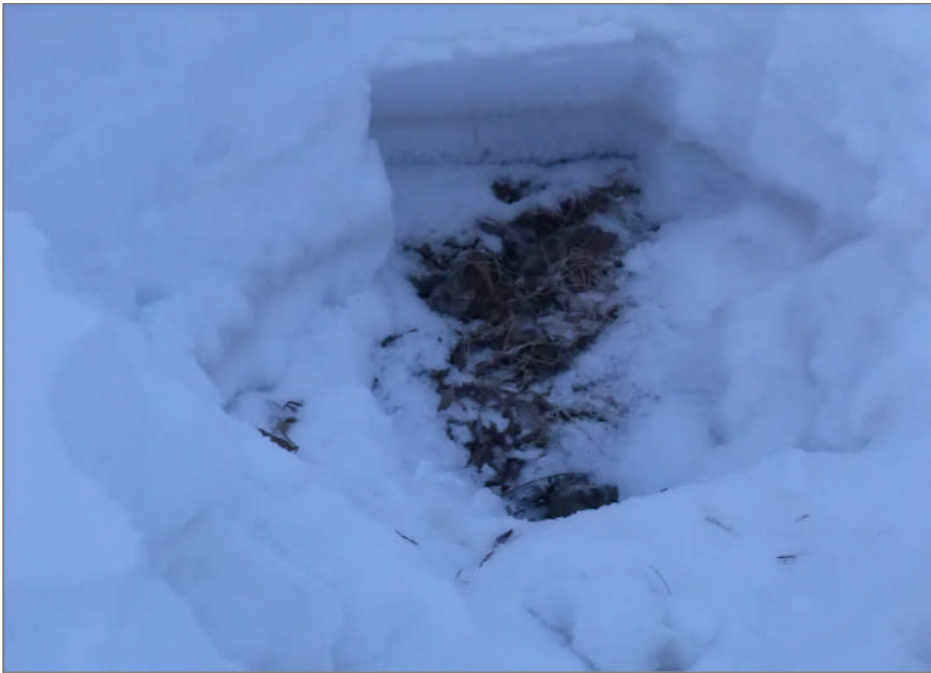
**Photo 11:** No evidence of water seepage along the slope (10-Jan-2012)
