CLINTON CREEK ASBESTOS MINE

WASTE DUMP AREA

REVIEW OF REHABILITATION MEASURES

CG-10075
June 1984
5/28

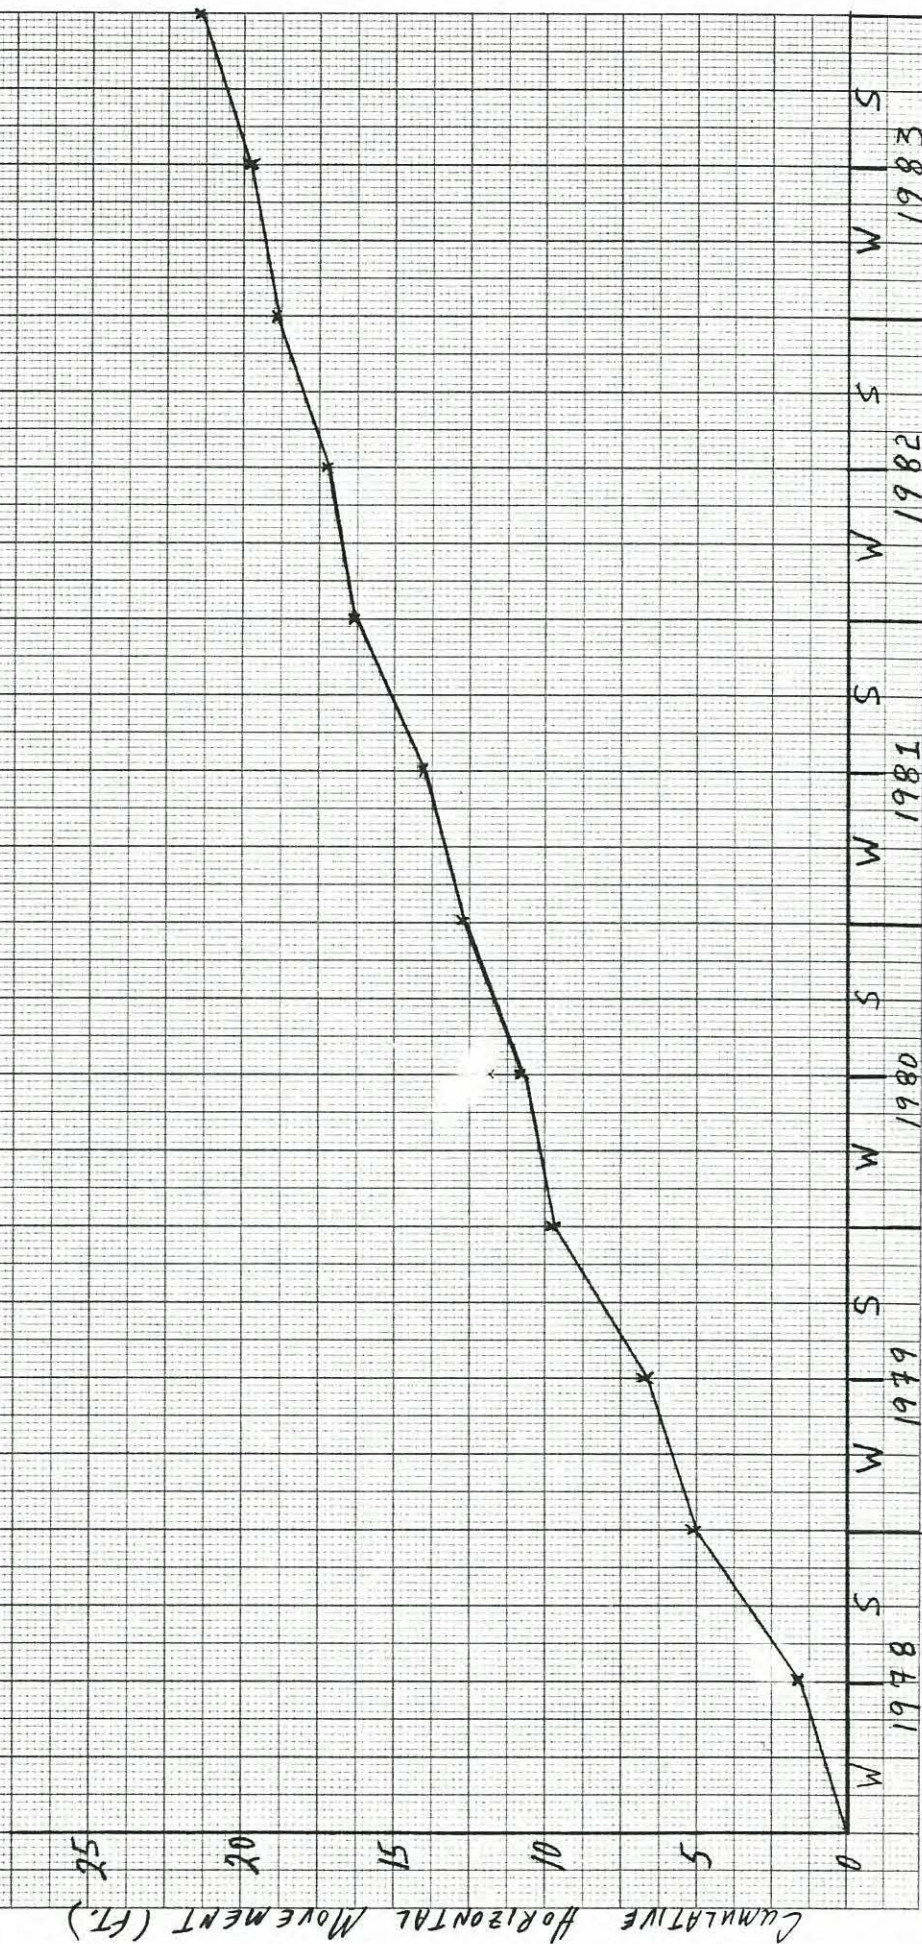
FIGURE 1 CLINTON CREEK WASTE DUMP
AVERAGE HORIZONTAL MOVEMENTS
TOE OF MAIN DUMP SEGMENT

Figure 1 shows a plot of movements at the toe of the main dump segment. Horizontal movements are currently in the order of 0.75 m per year (2.5 ft/yr). These movements have been relatively constant over the past three years. Average vertical movements are less than 0.3 m per year (1 ft/yr) at the toe of the dump.

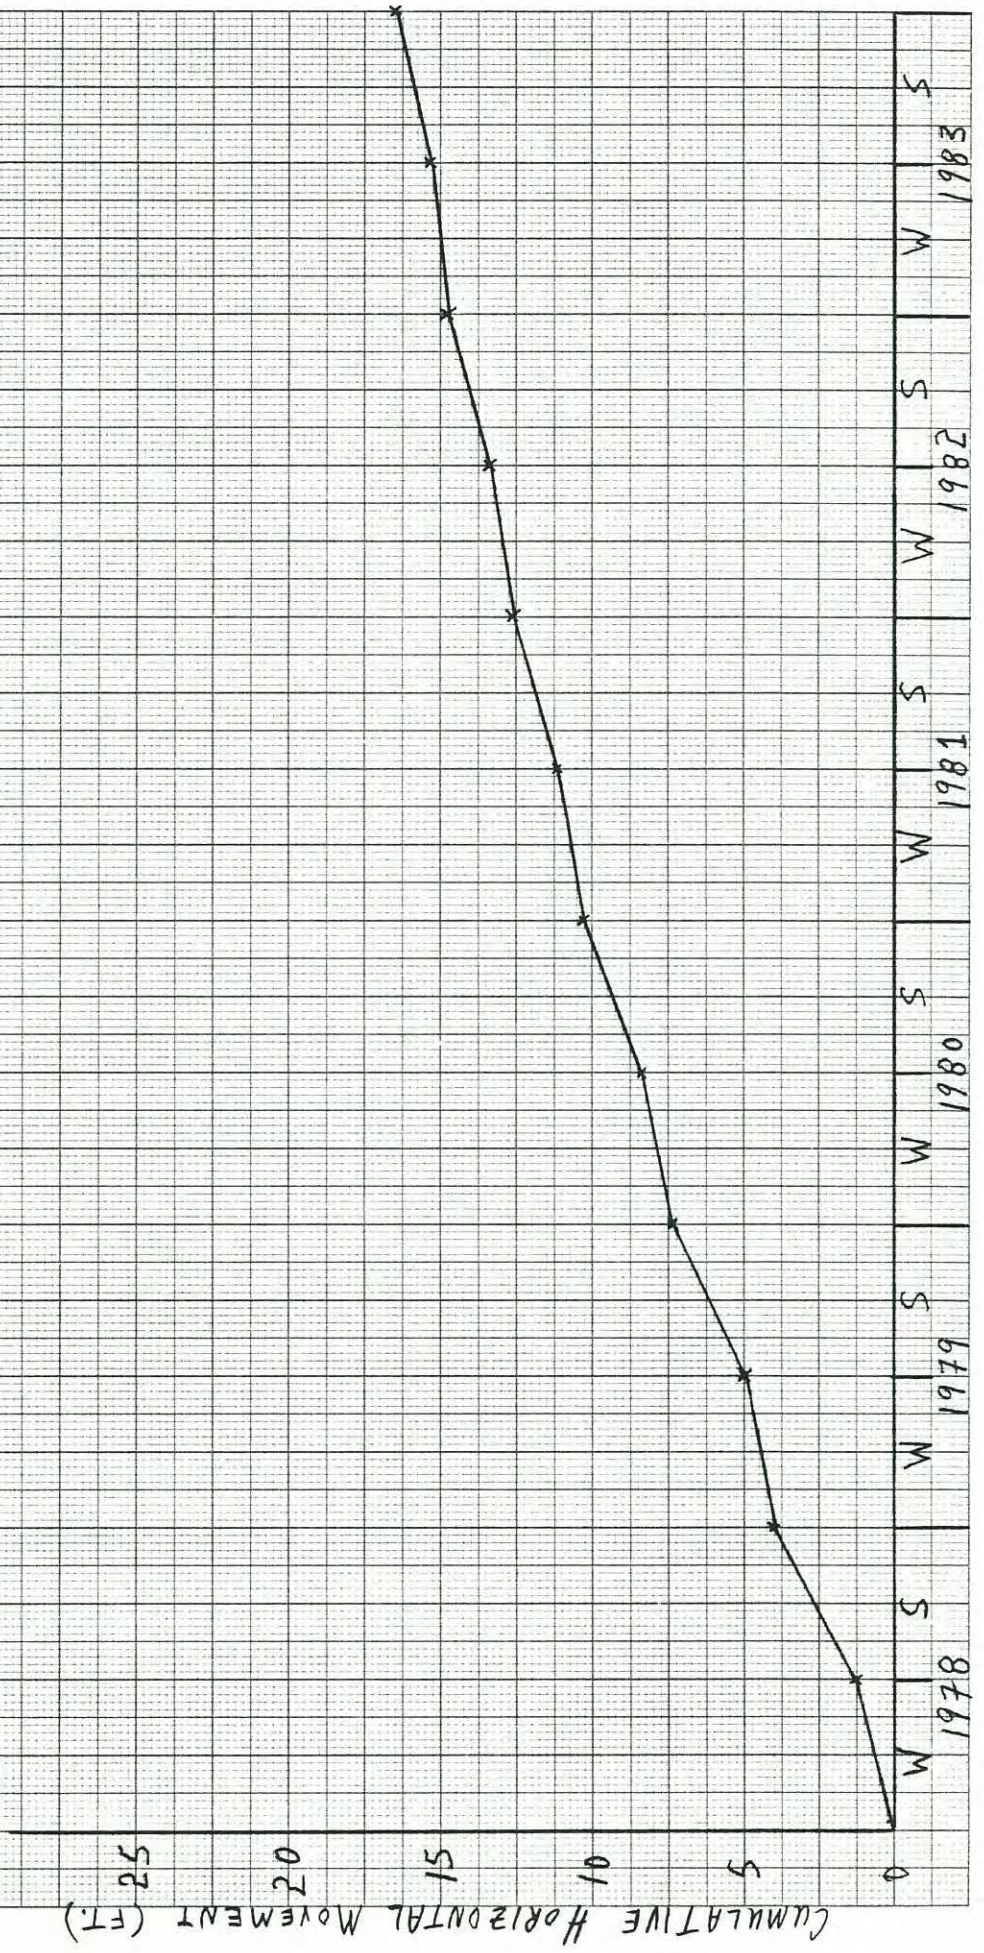
FIGURE 2 CLINTON CREEK WASTE DUMP

Creek closure measurements are plotted on Figure 2. Closure movement is currently in the order of 0.6 m per year (2 ft/yr). Again, movements have been relatively constant over the past couple of years.

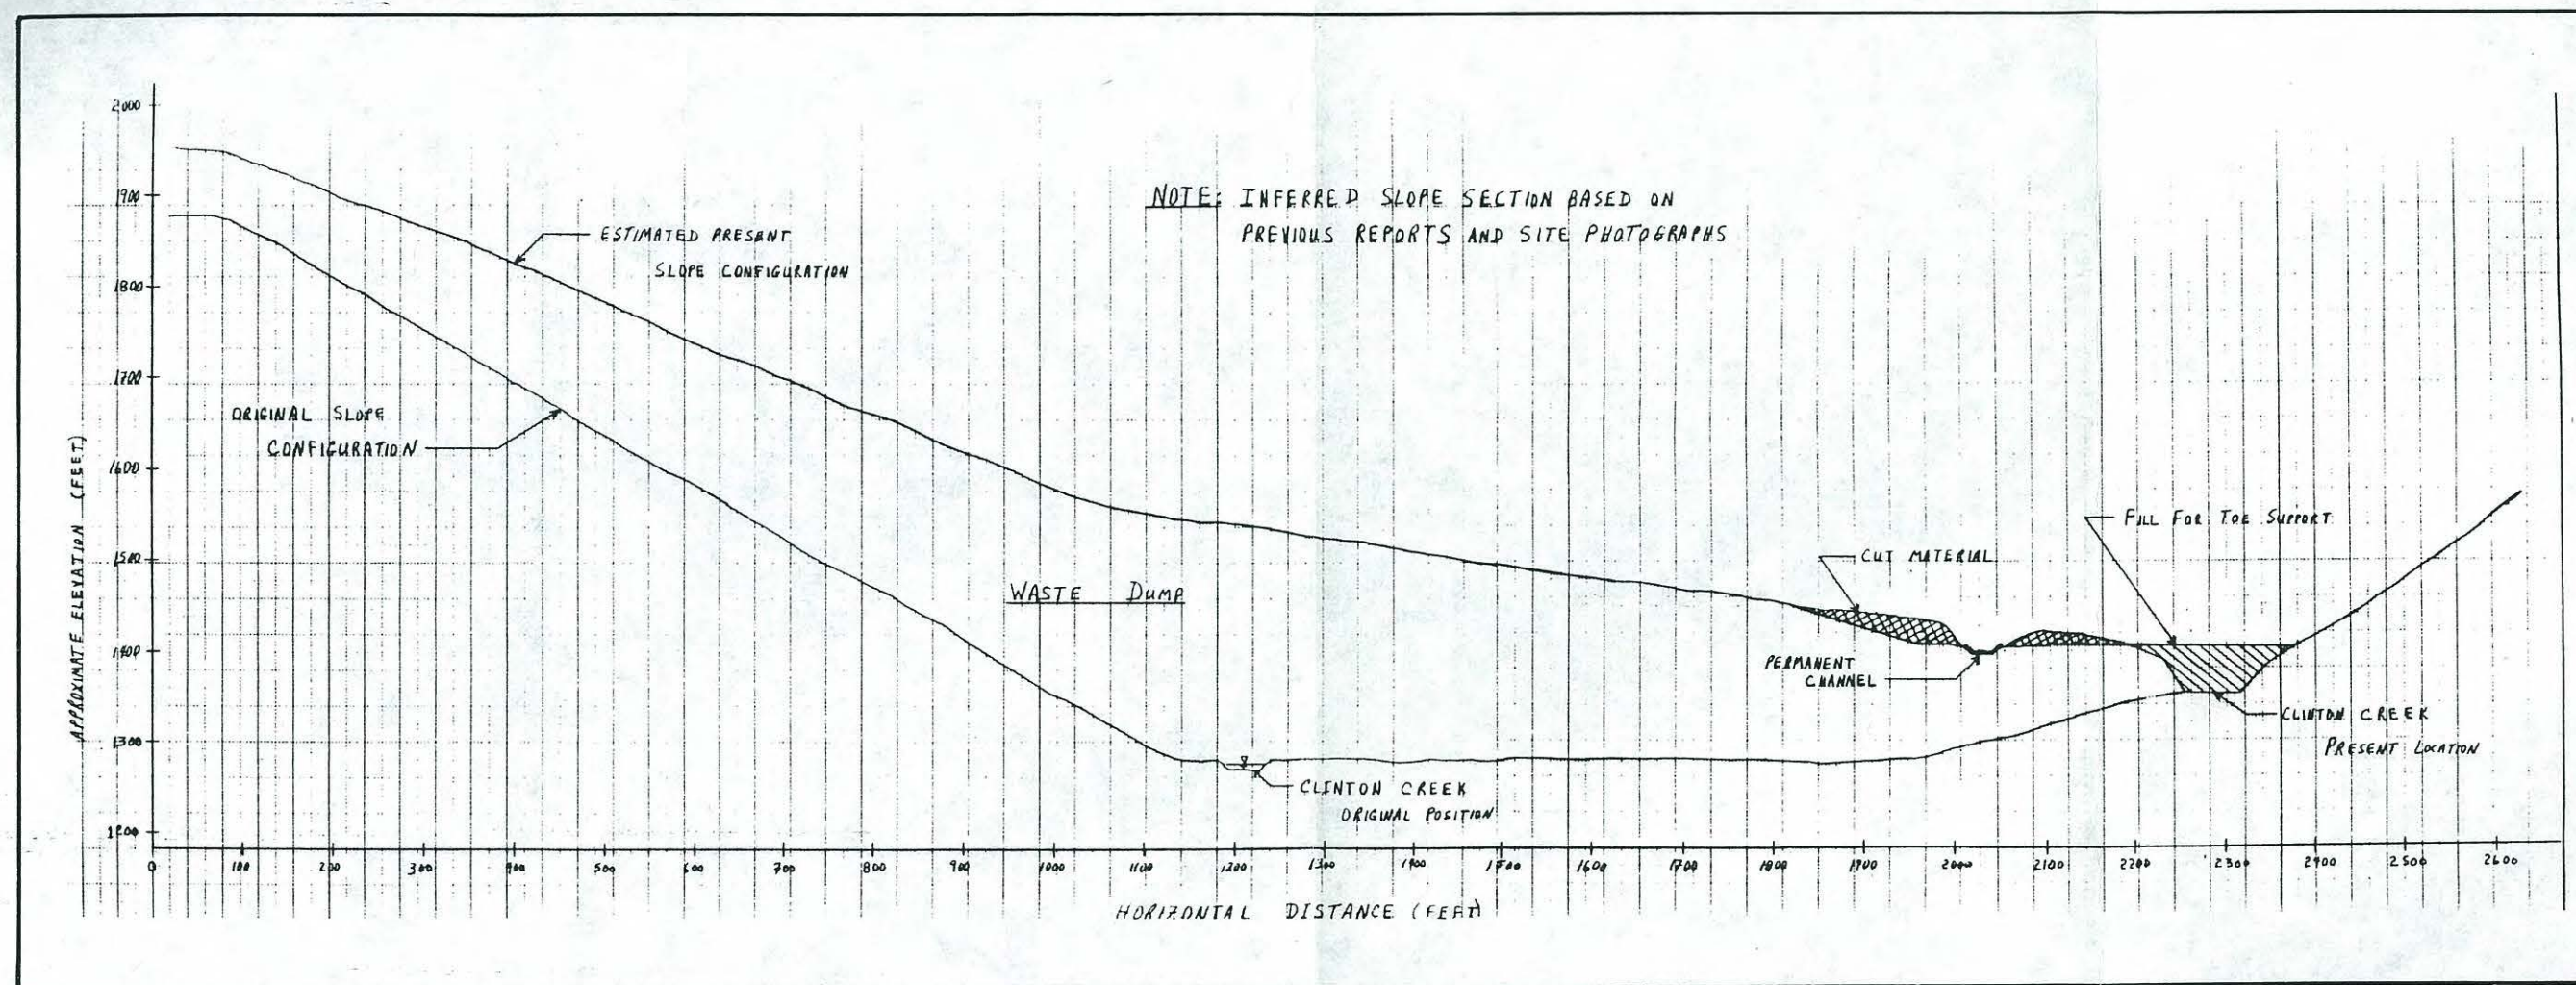
PLATE A1

The moving toe of the slide debris forced the Clinton Creek channel northward across the valley and up onto the north slope (see Plates A1 and A2, Appendix "A"). The channel moved a distance of approximately 300 m (1000 ft). The failed waste dump dammed the valley impounding a body of water known as Hudgeon Lake. The deepest point of this lake is in the order of 26 m (85 ft).

Plate A1 shows the original valley and slope configuration, the inferred waste dump surface profile and the proposed cut and fill areas. The estimated fill volume for stabilization is in the order of 150,000 m³.

A detailed slope stability analysis would be required to determine the amount of fill required to achieve stabilization. As a rough estimate, it is believed that raising the creek channel elevation by about 15 m (50 ft) would be adequate. This estimate is based on the inferred slope cross-section shown on Plate A1. The slope section presented has been based on available photographs and reports discussing the site conditions. A proper survey of the present dump profile would be necessary prior to detailed analysis.

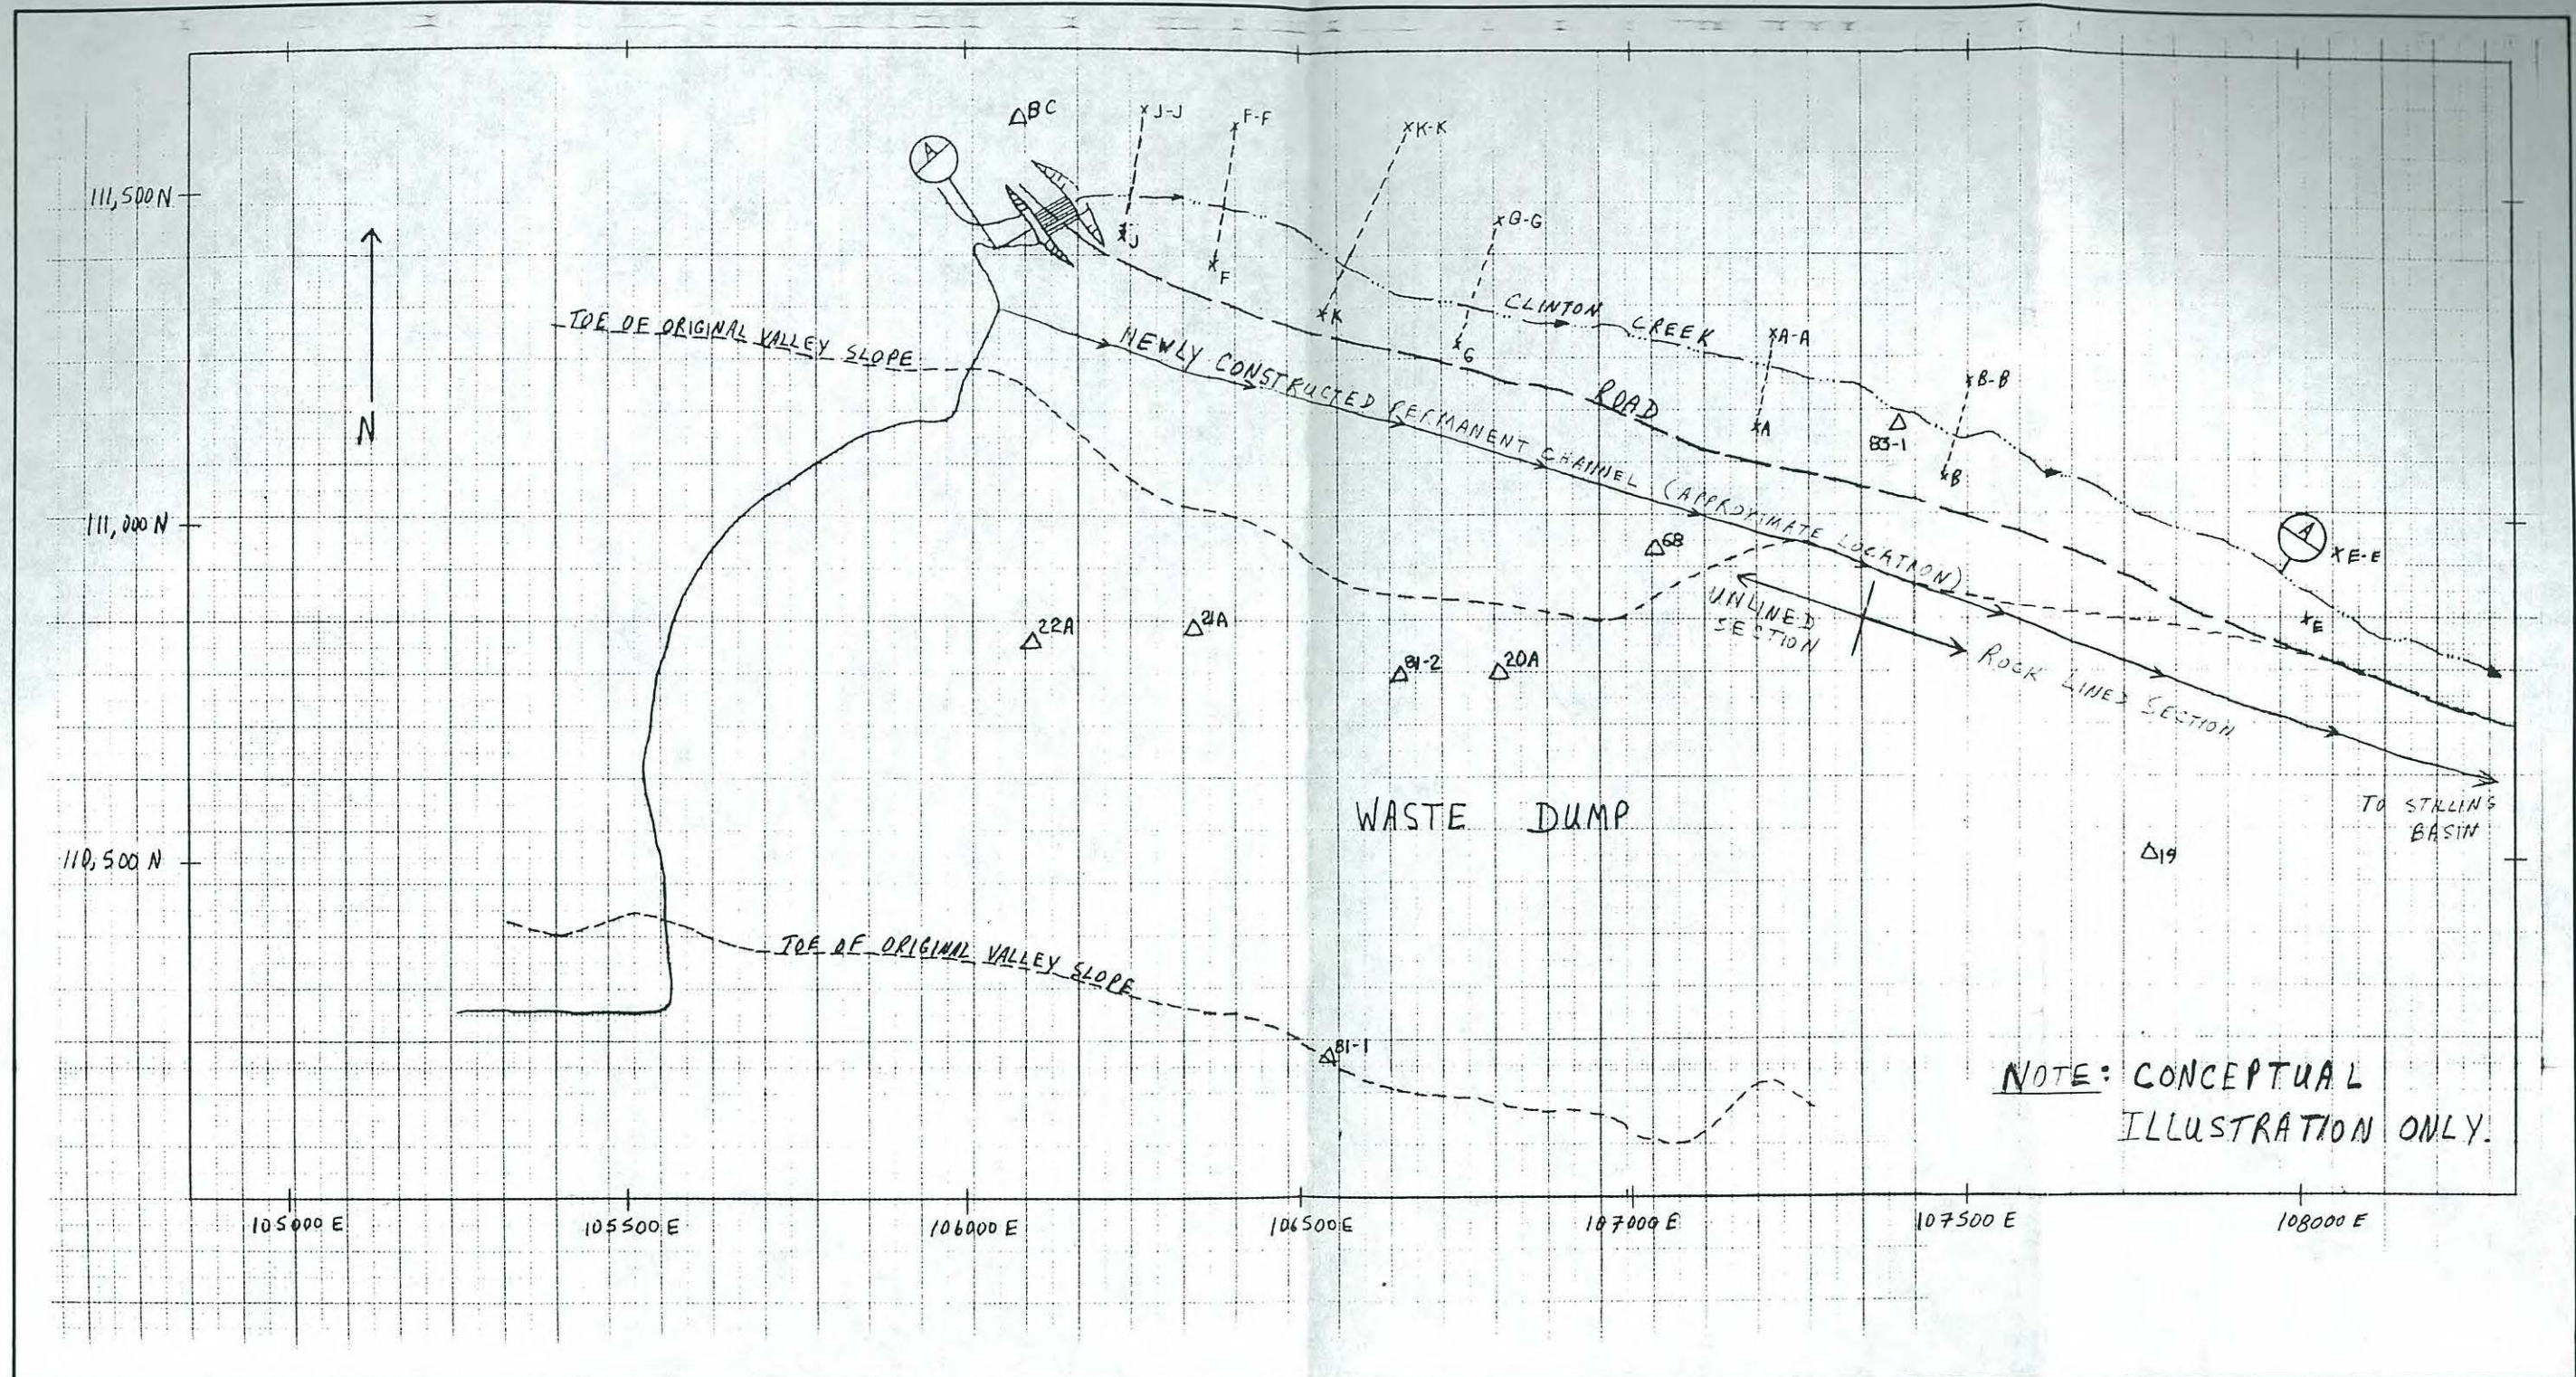
PLATE A2

Measurement of movements of the waste dump toe and creek closure measurements have been taken since 1977. A total of seven slope monitoring points and six creek closure sections have been monitored. The locations of these stations are shown on Plate A2, Appendix "A".
