WOLVERINE CREEK TAILINGS PILES  
CLINTON CREEK ASBESTOS MINE

REVIEW OF REHABILITATION MEASURES

CG-10075

June 1984

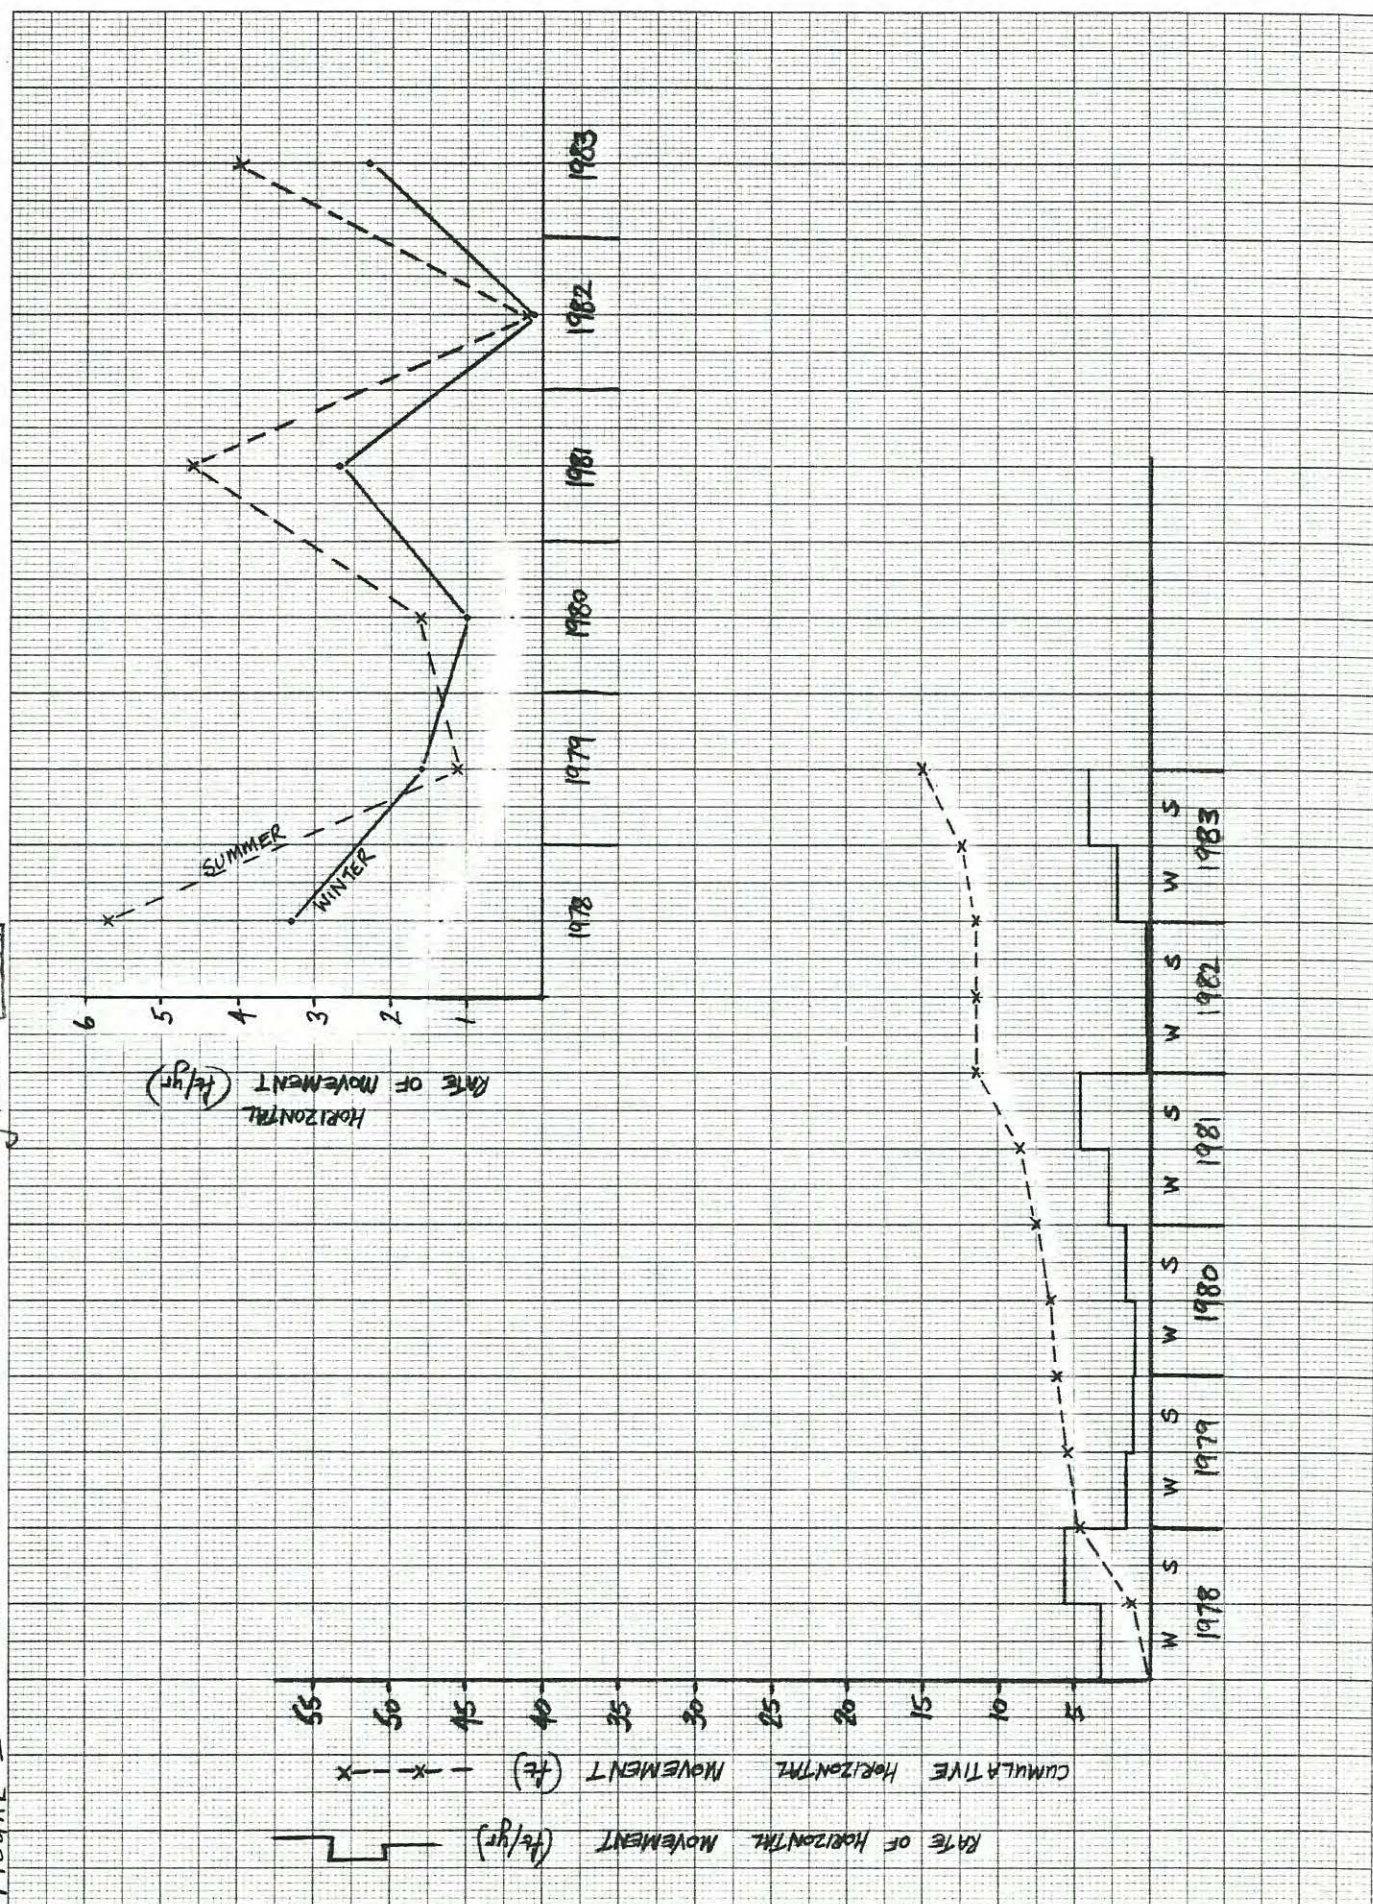
FIGURE 1

Figure 1 shows the results from Survey Point 26-A, on the upper slope. The rate of horizontal movement fluctuates considerably from year to year and is relatively small (0.3 to 1.5 m per year).

Upper Slope; NORTH LOBE - Sunny Point

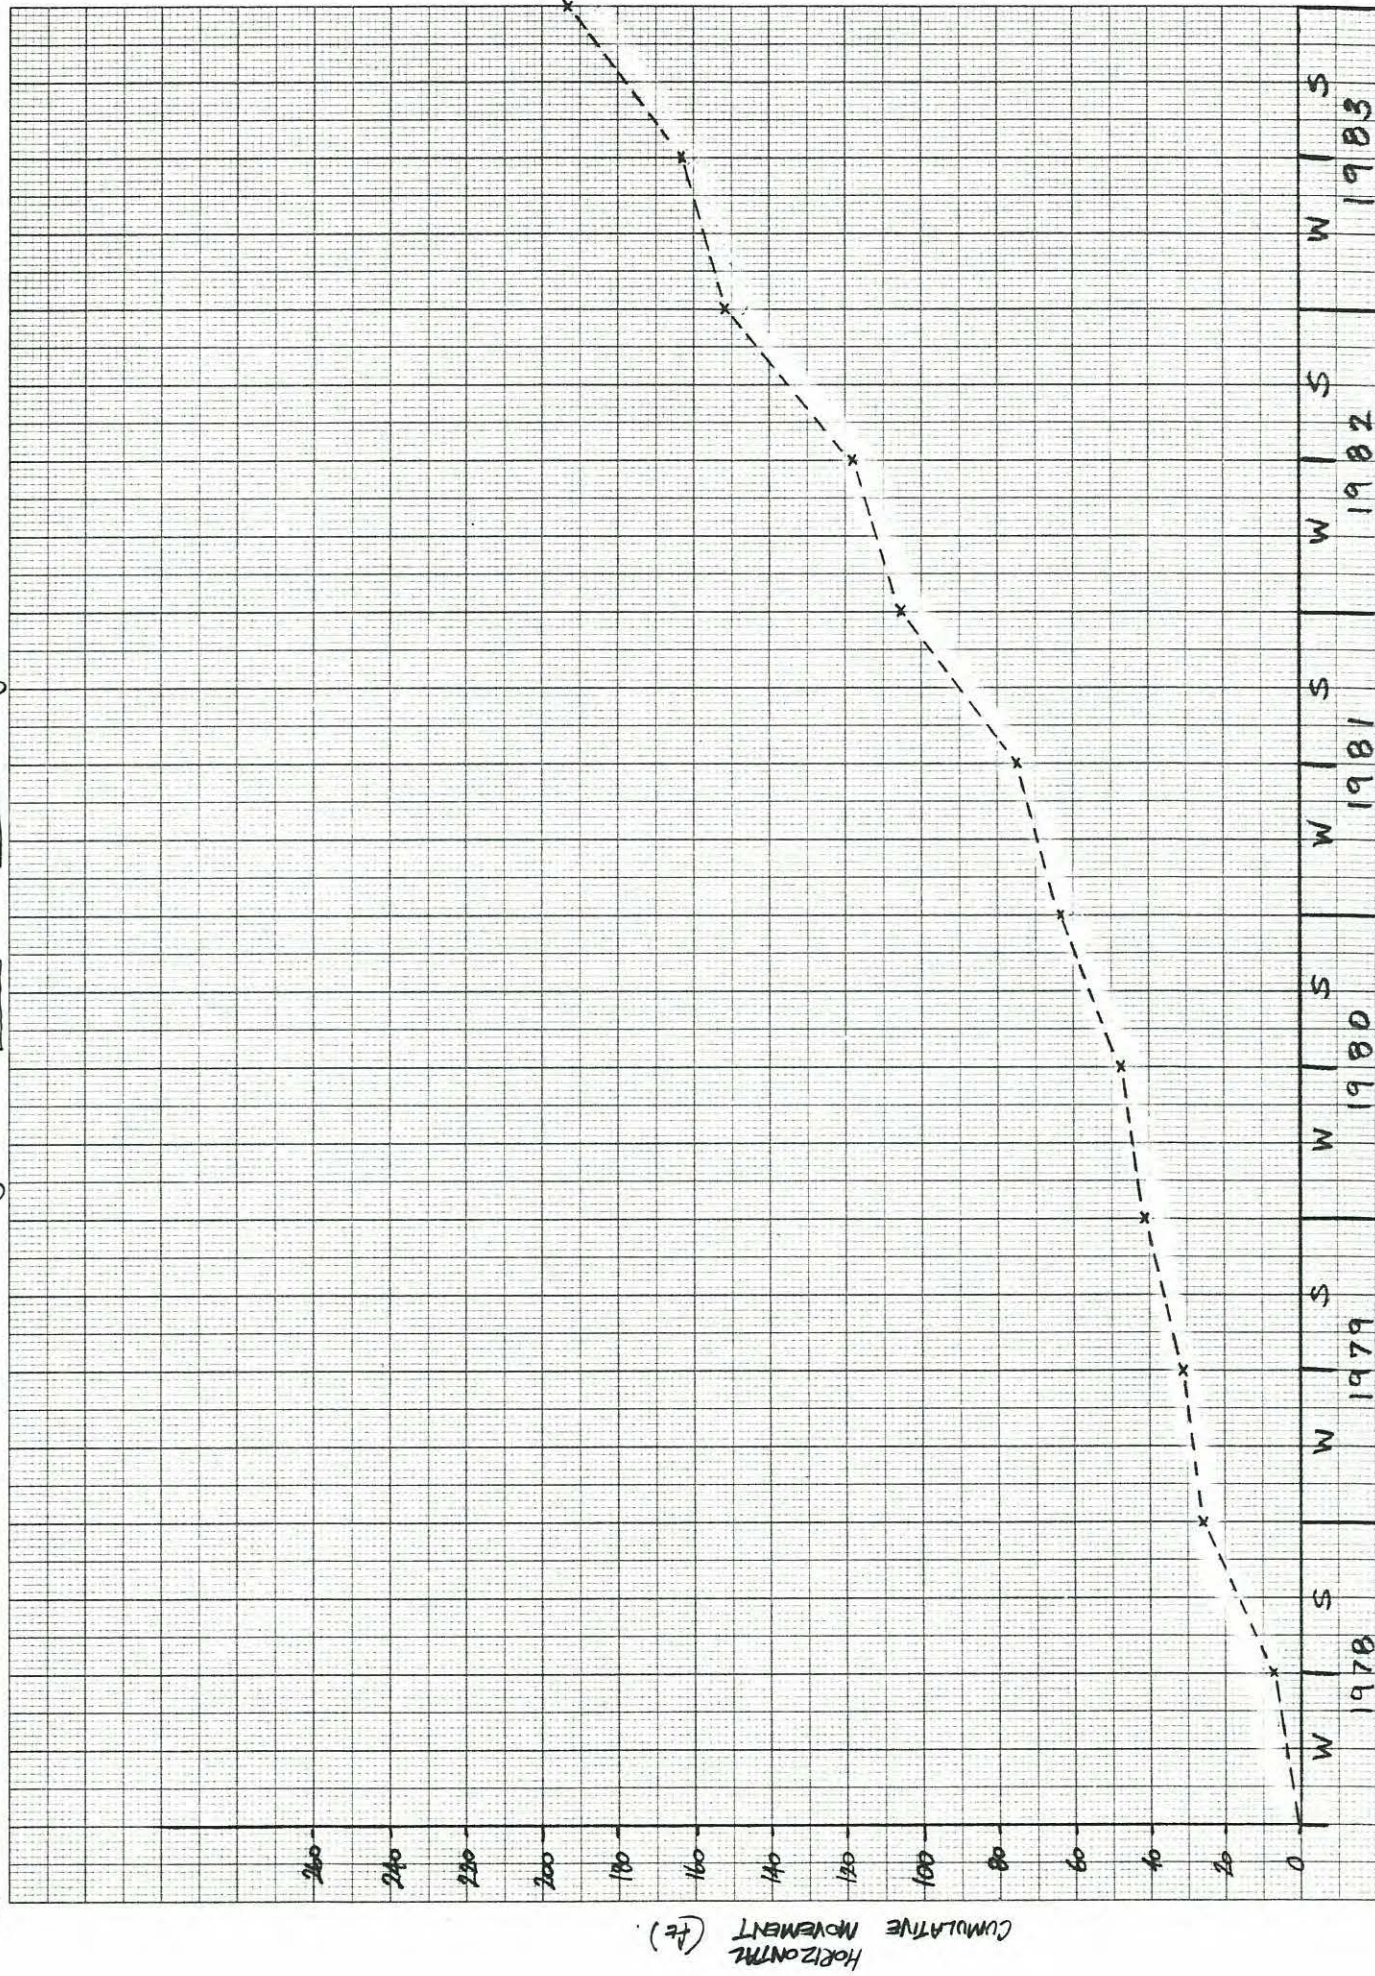
Average horizontal movements at mid slope (Survey Points 500-1 and 650-1) over the monitoring period are plotted on Figure 2. A general increase in the average yearly rate of movement can be noted with the present average rate in the order of 10 m per year (33 ft/year).

FIGURE 2 Mid Slope North LOBE - Survey Points [500-1] and [650-1] averaged.

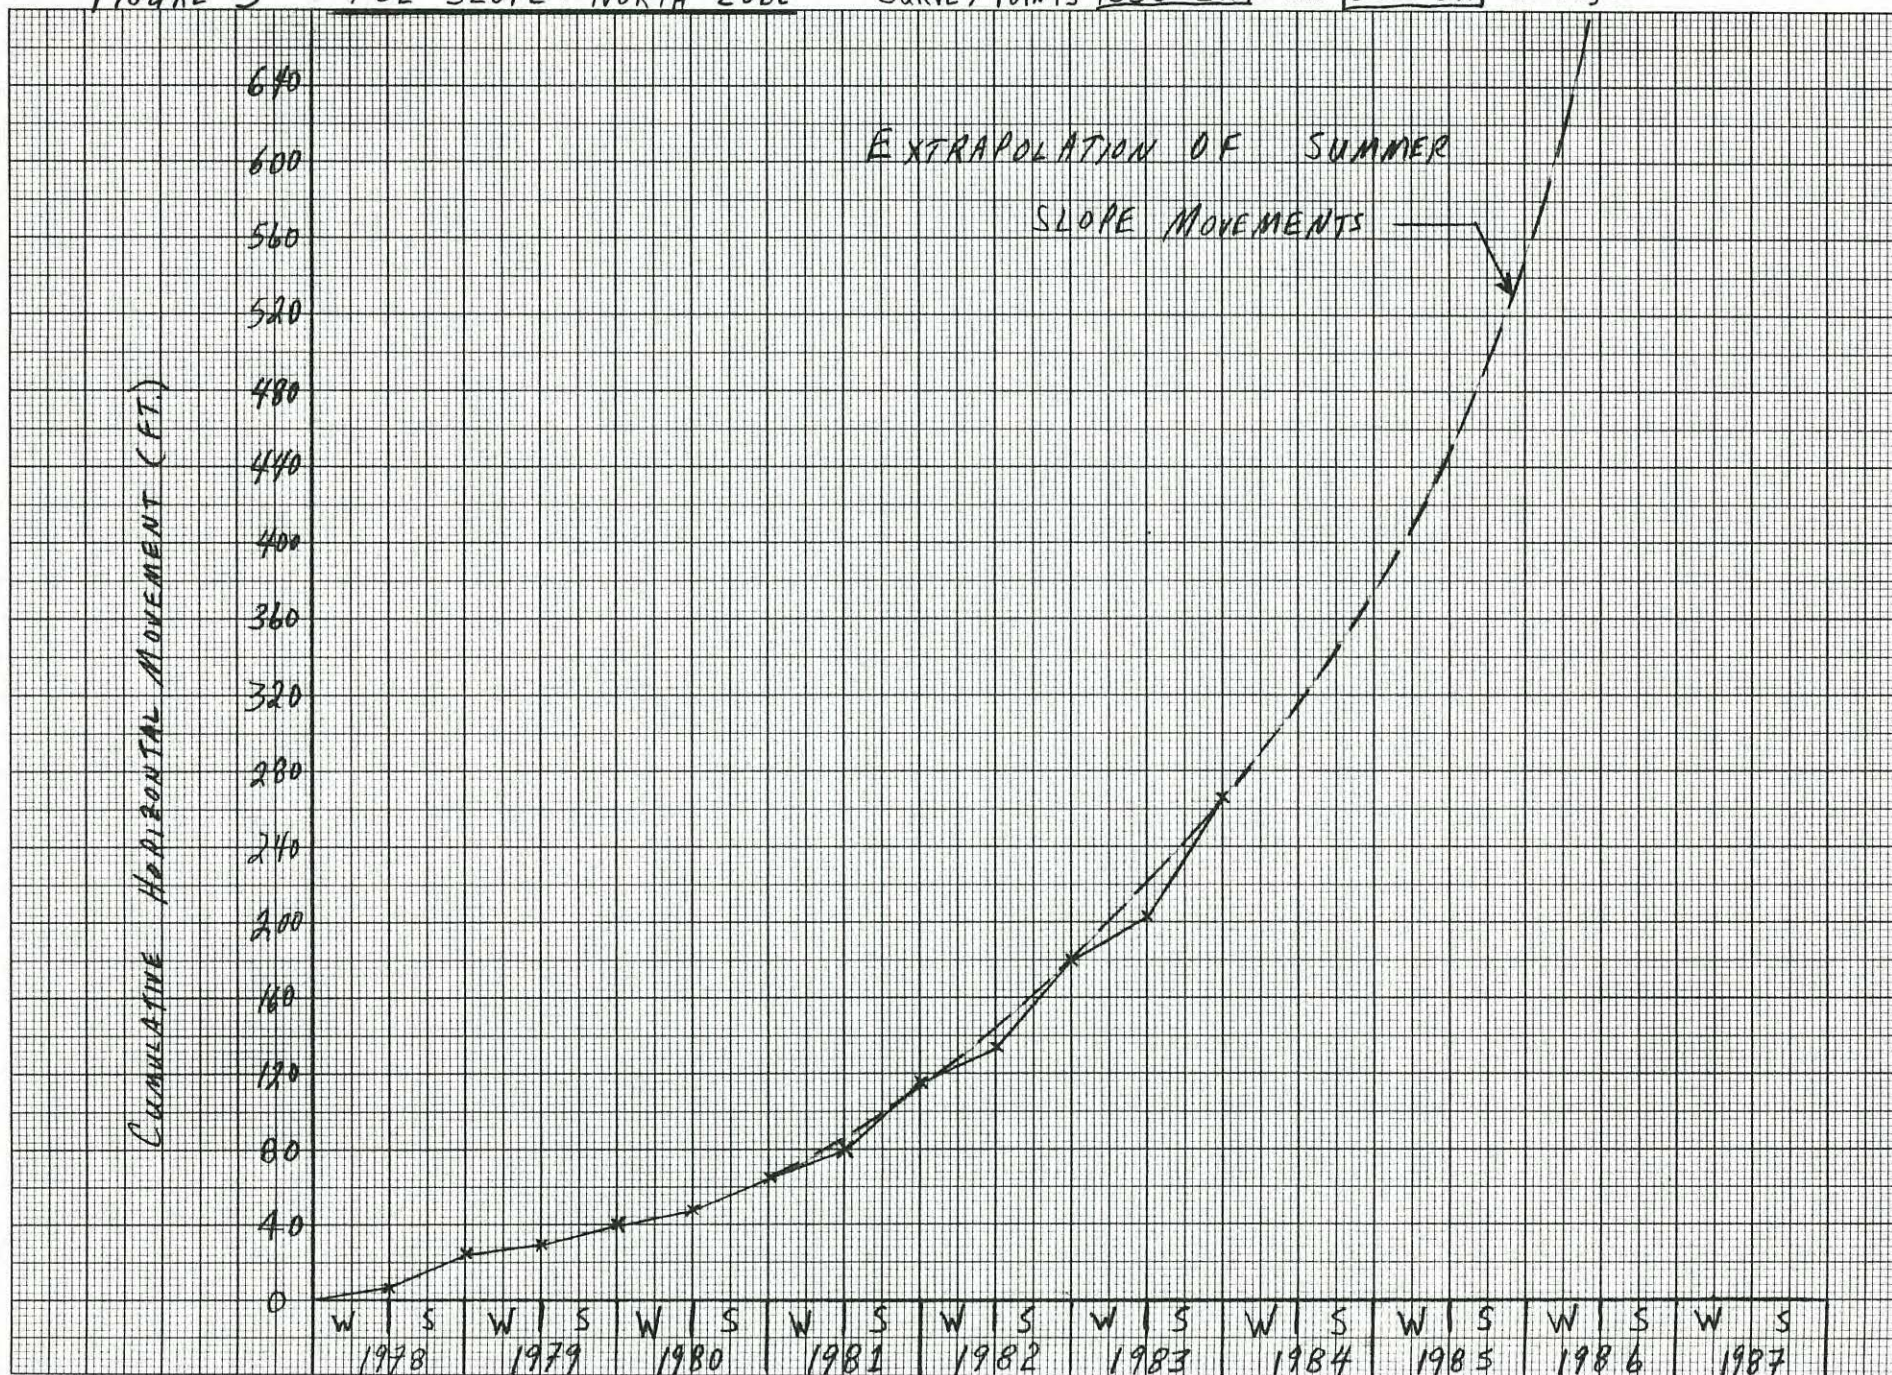
Cumulative horizontal movements at the toe of the north lobe are shown on Figure 3. Movements have accelerated over the past few years and are presently in the order of 30 m per year (100 ft/year). Based on the previous trends, the cumulative horizontal movement curve (Figure 3) has been extrapolated to predict future movements. If the present trends continue, it is predicted that a major failure of the north lobe would occur within the next couple of years (1986).

The movement rates recorded suggest that the tailings lobe is moving in a "caterpillar-like" manner. As a lower segment fails, toe support for the section above it is removed and the failure gradually progresses up the slope with the amount of horizontal movement decreasing in the upslope direction.

FIGURE 3 TOE SLOPE - NORTH LOBE SURVEY POINTS 350-2A and 350-3A averaged

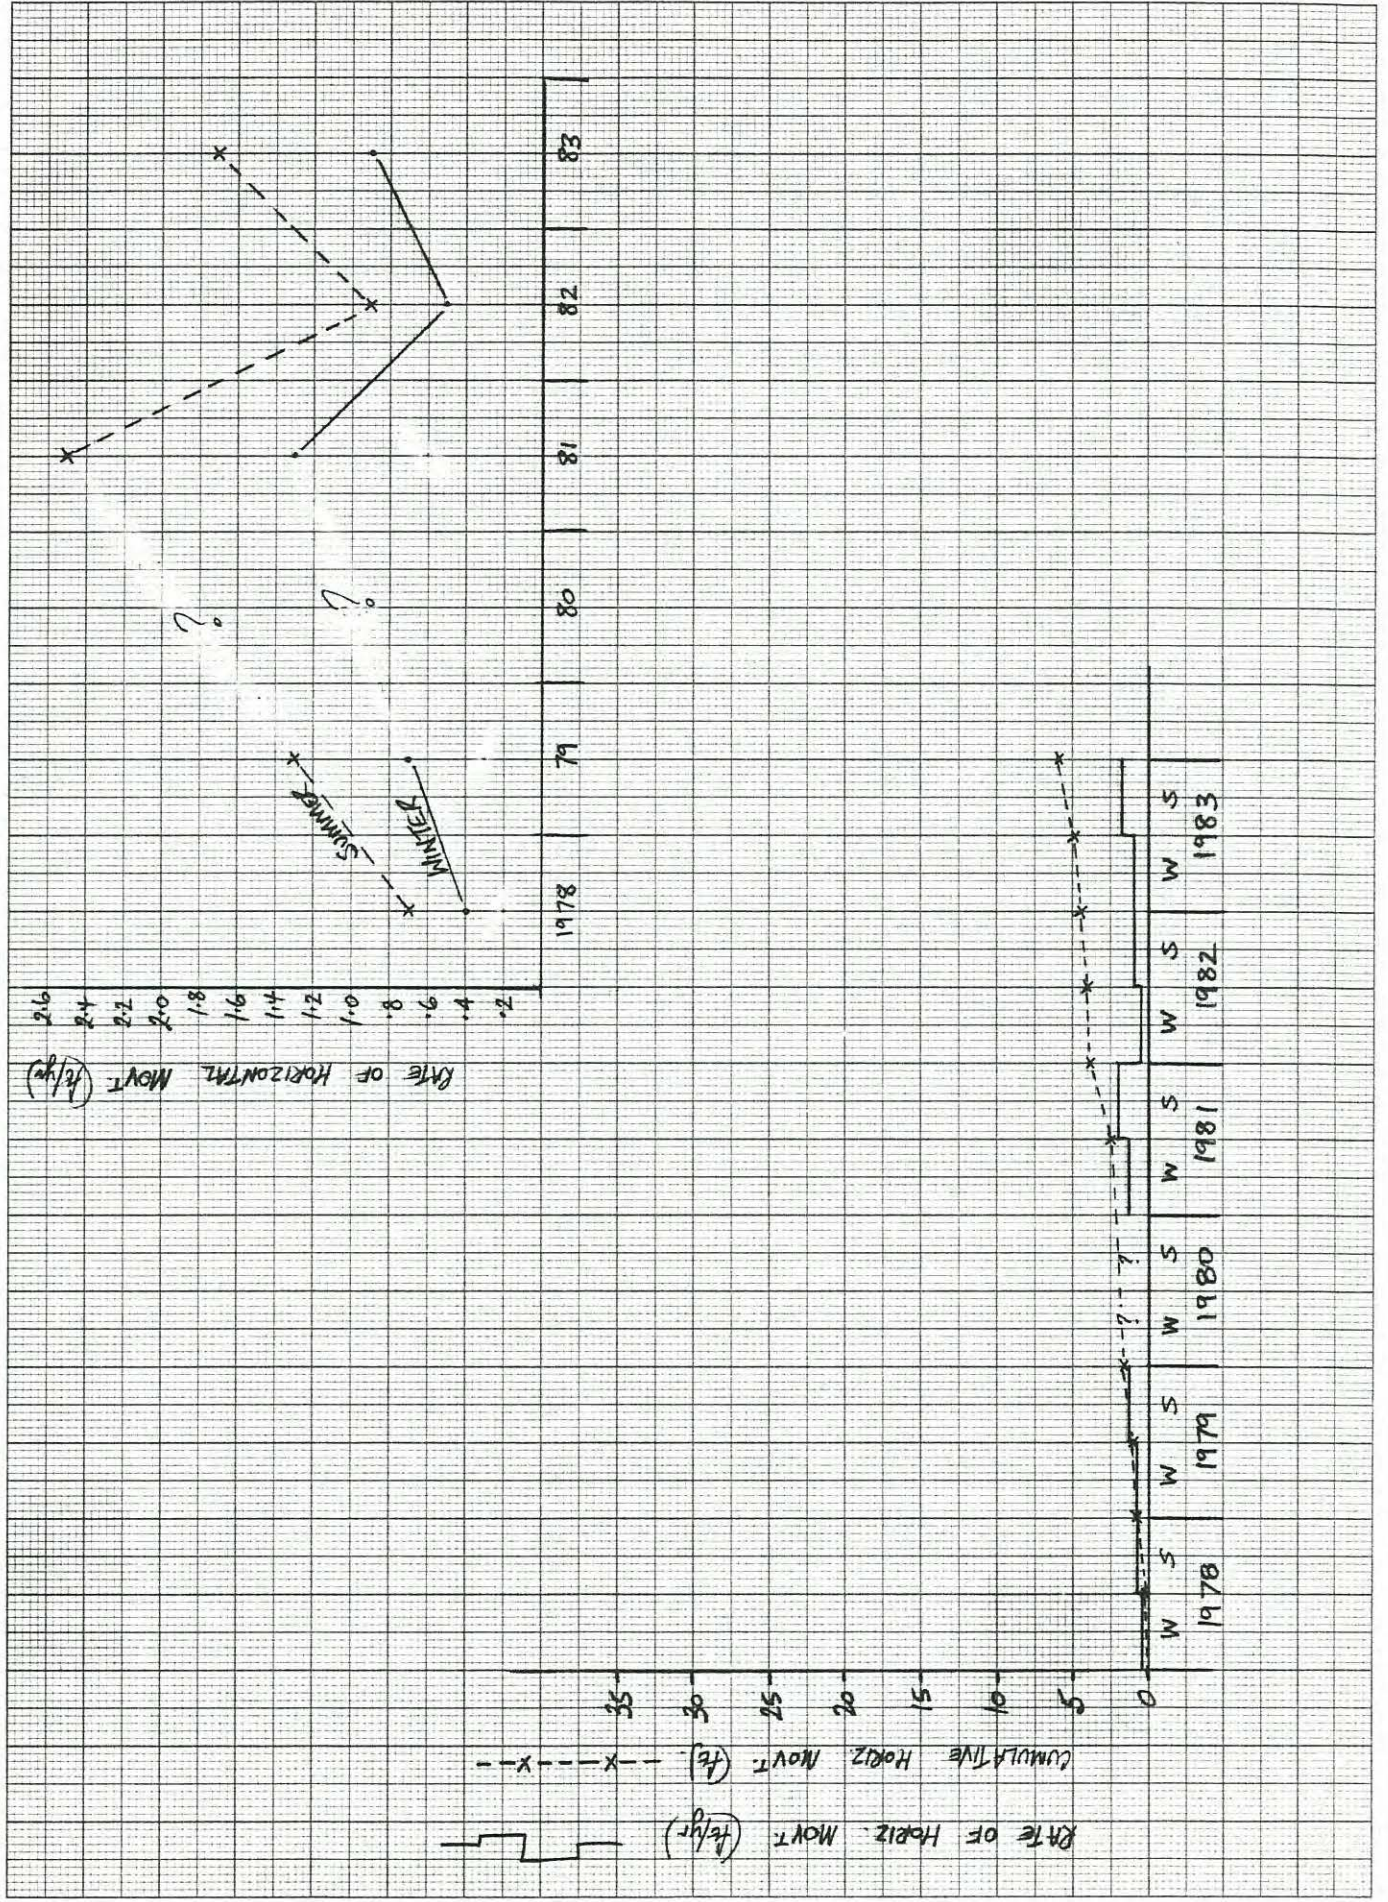
Figures 4 through 6 show cumulative horizontal movements recorded on the upper, middle and lower slope of the south lobe. Rates of movements have been more or less constant over the past few years. It is believed that these downslope movements will continue unless more toe support than presently in existence is provided.

FIGURE 4 Upper Slope of SOUTH LOBE - Survey Point [24]

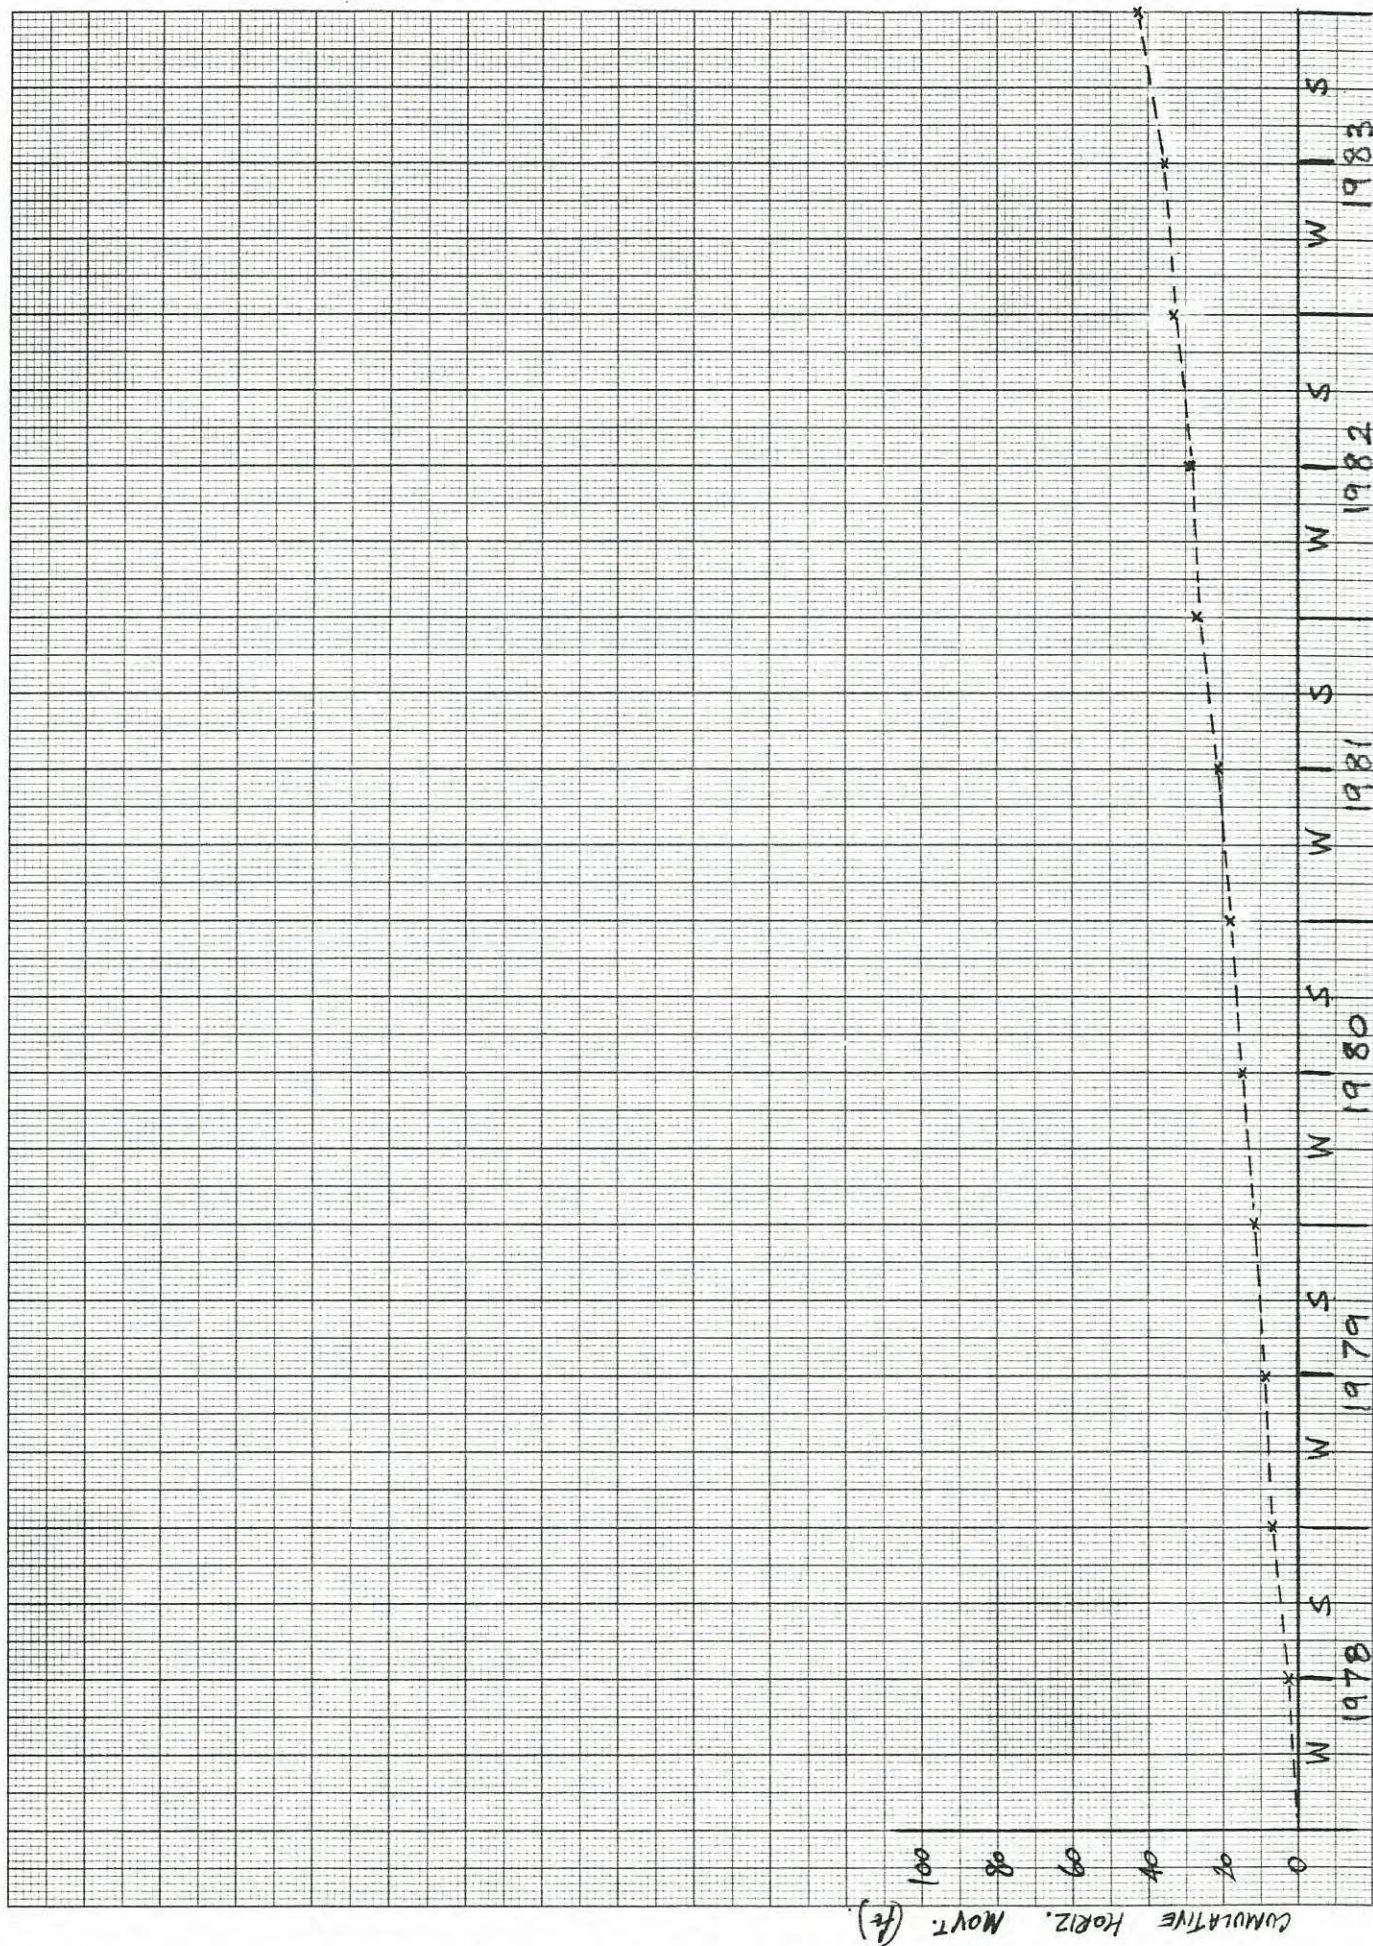
FIGURE 6 Toe Slope - SOUTH LOBE - Survey Points 24-D, 25-B and 25-C

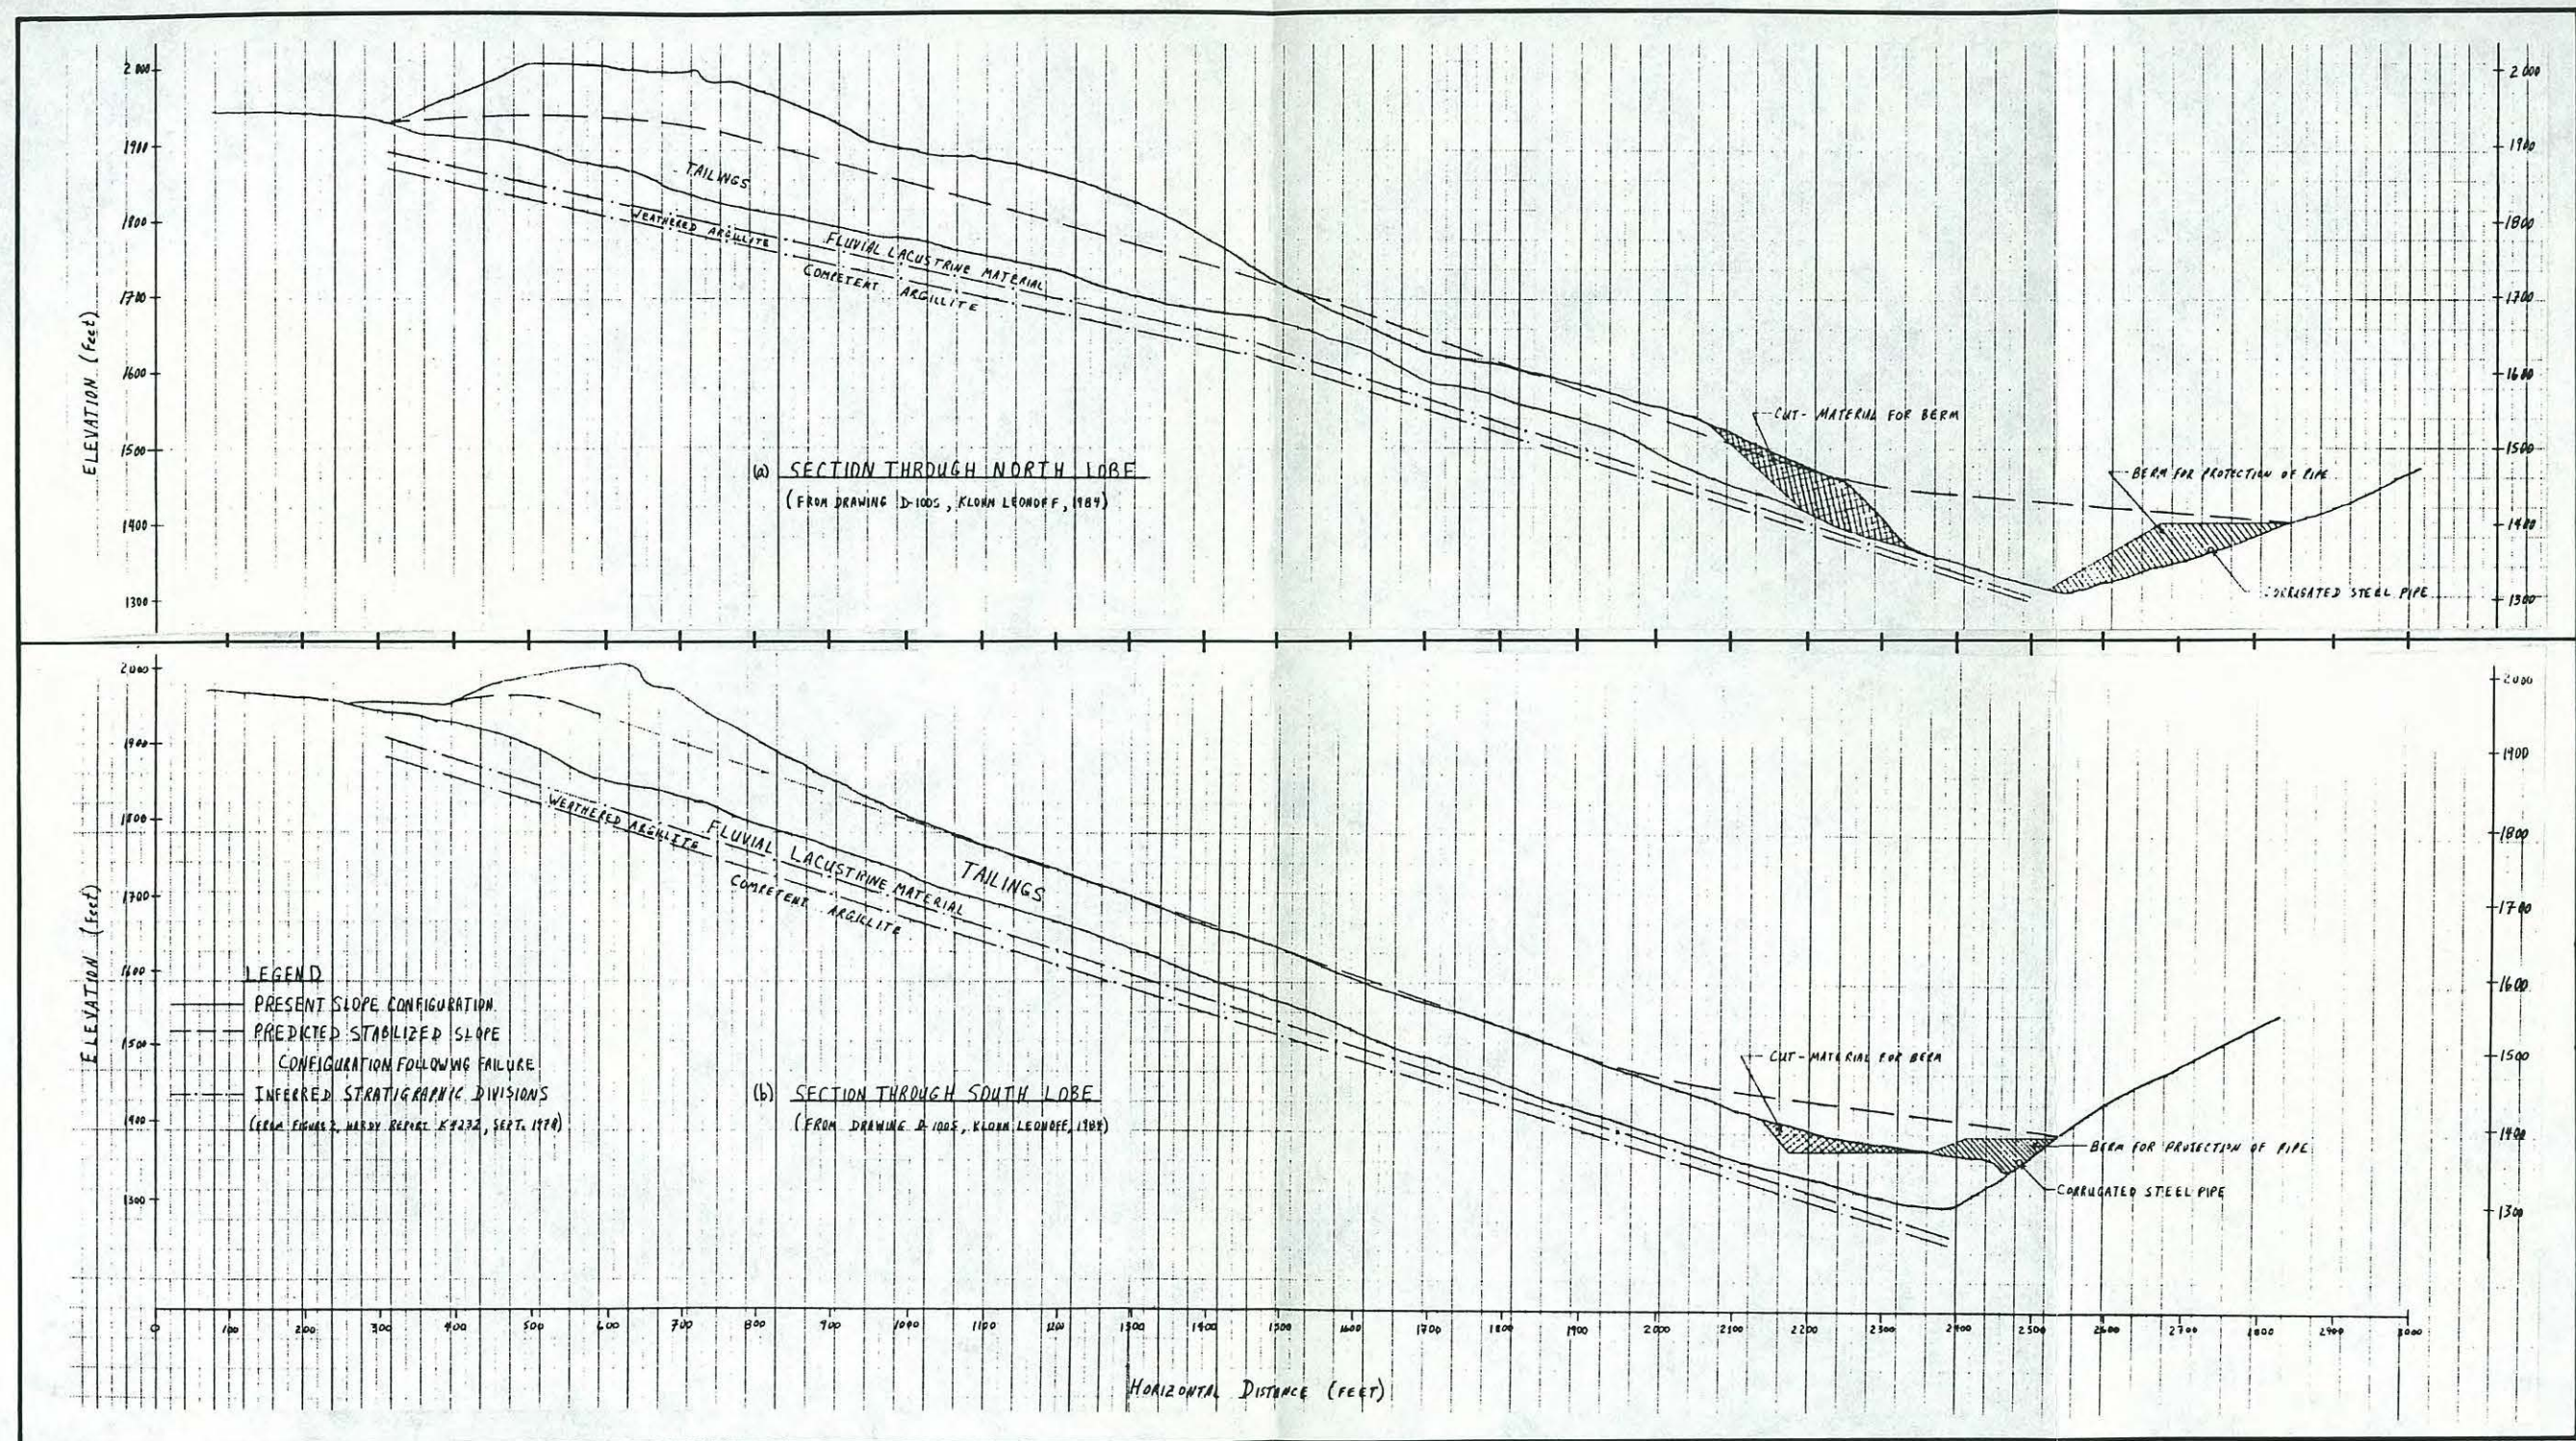
FIGURE 7

**CASSIAR ASBESTOS MINE - WOLVERINE CREEK  
 CONCEPTUAL ILLUSTRATION OF  
 CORRUGATED PIPE ALTERNATIVE**

Material for construction of the berms could be taken from the toe area of the tailings piles. This would accelerate movement of the tailing piles. Failure of the north lobe would still be anticipated. Figure 7 shows a prediction of the final location of the tailings piles following stabilization of movement.

Only very shallow trenches would be required for the installations and the cost involved is expected to be in the order of \$50,000. It would be necessary to place a "berm" over the pipes so that material moving downslope would not destroy the pipes (see Figure 7). The berms could be constructed of tailings or native material. It would be necessary to conduct a detailed study to determine the amount of material cover required to ensure the safety of the pipe. A conceptual illustration of the proposed scheme is shown on Figure 7. The construction costs for the berms is estimated to be in the order of \$300,000, based on a fill volume of about 280,000  $\text{yd}^3$ .

Material volumes required for construction of the berms have been estimated based on the cross sections shown on Figure 7. Actual fill volumes may vary considerably. For example, the section of pipe over the length between the two tailings piles may not require as much fill for adequate protection. Similarly, fill requirements near the outer limits of the two tailings piles may be reduced. On the other hand, the berms illustrated on Figure 7 may not provide adequate protection for the pipe and additional fill may be required.

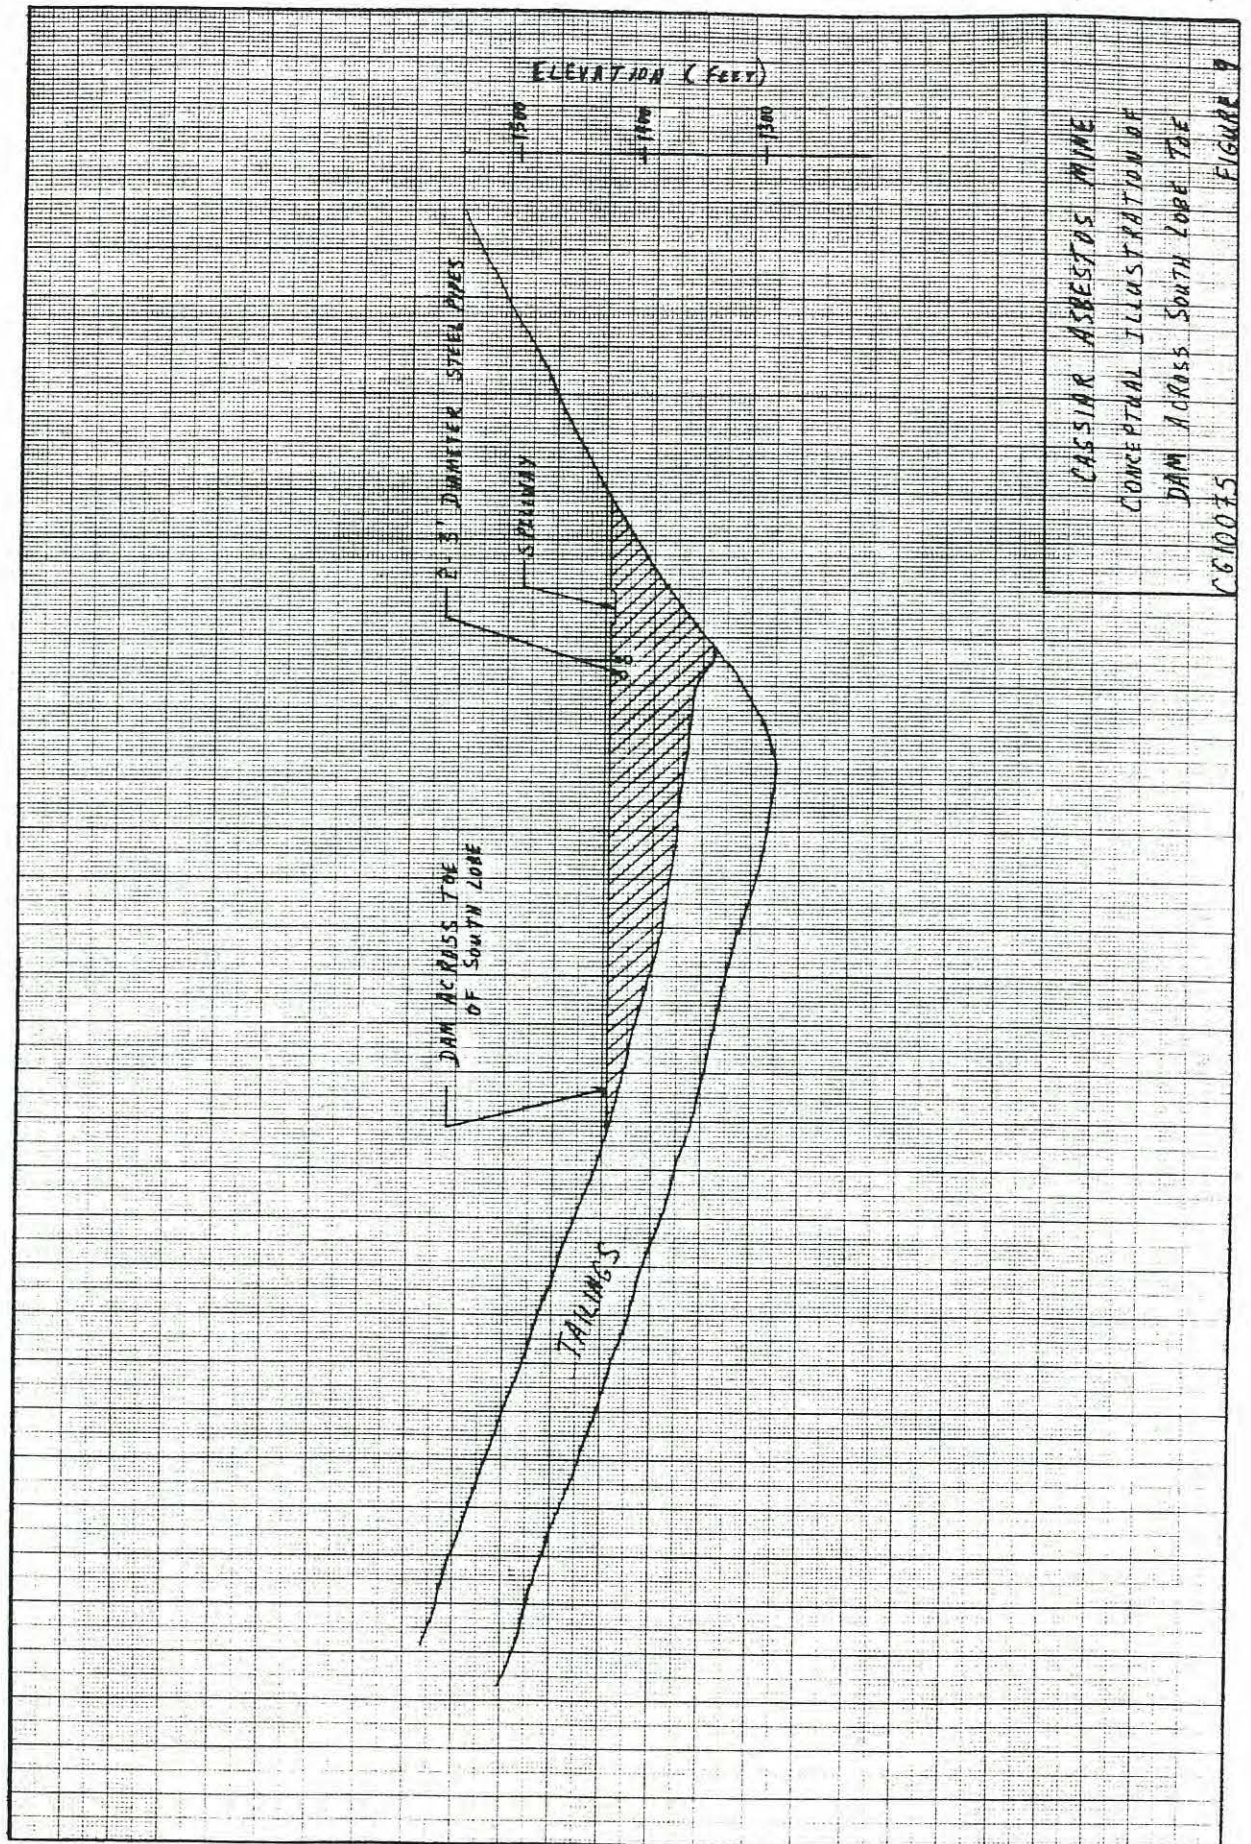
FIGURE 8

TYPICAL DAM CROSS SECTION

armoured channel (Figure 8). Alternatively, a "flow through" segment can be designed to convey the creek flow into the armoured channel. The dam could be constructed from tailings material.

Preliminary studies indicate that a crest elevation of about 1425 feet (434.3 m) would be required. The corrugated steel pipes would require a diameter of 900 mm and could be placed at staggered elevations of about 1410 feet (429.8 m) and 1413 feet (430.7 m) as shown on Figure 9. The pipes should be equipped with valves to allow all the flow to be channeled through the spillway if required.

No detailed design has been undertaken at this time, but it would be prudent to provide relatively shallow upstream and downstream slopes on the dam, in the order of 4:1 (horizontal to vertical). These slopes could accommodate an increase in dam height (if necessary) and to withstand cyclic loading conditions associated with possible earthquakes.
