**Miles Canyon Bridge  
Level II Inspection Report  
Whitehorse, Yukon**

*Prepared by*  
**Dan Tingley Ph.D., P. Eng. (Yukon)**

**Final Report  
23 November 2015**

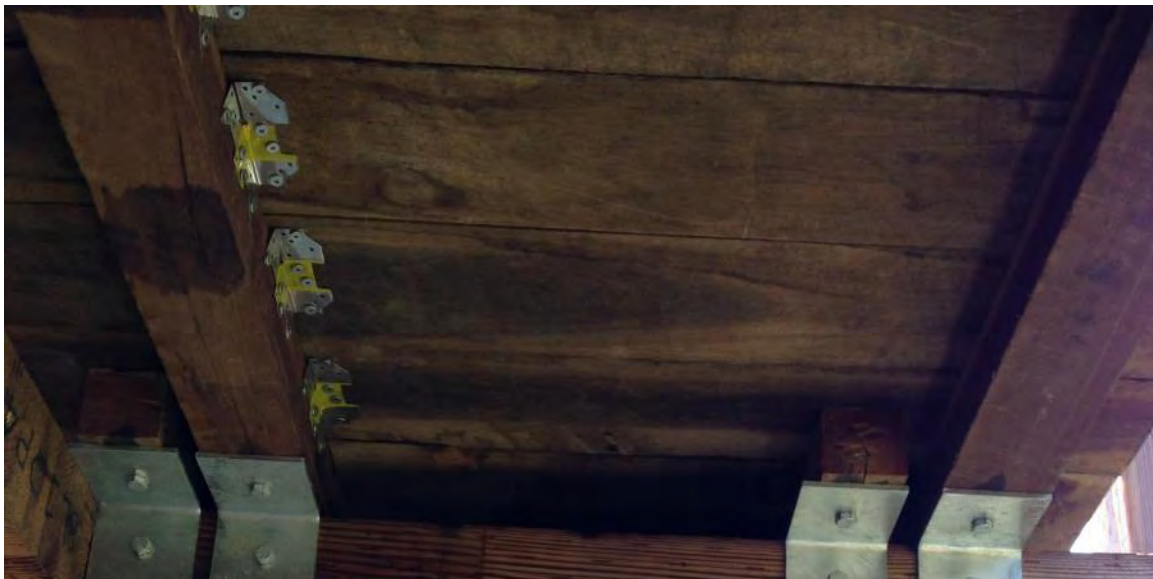
**Figure 3-2: An example of a pedestrian walkway deck secured with angle clips and screws below the deck. This system avoids the use of vertical fasteners that penetrate the top surface of the deck or stringers.**

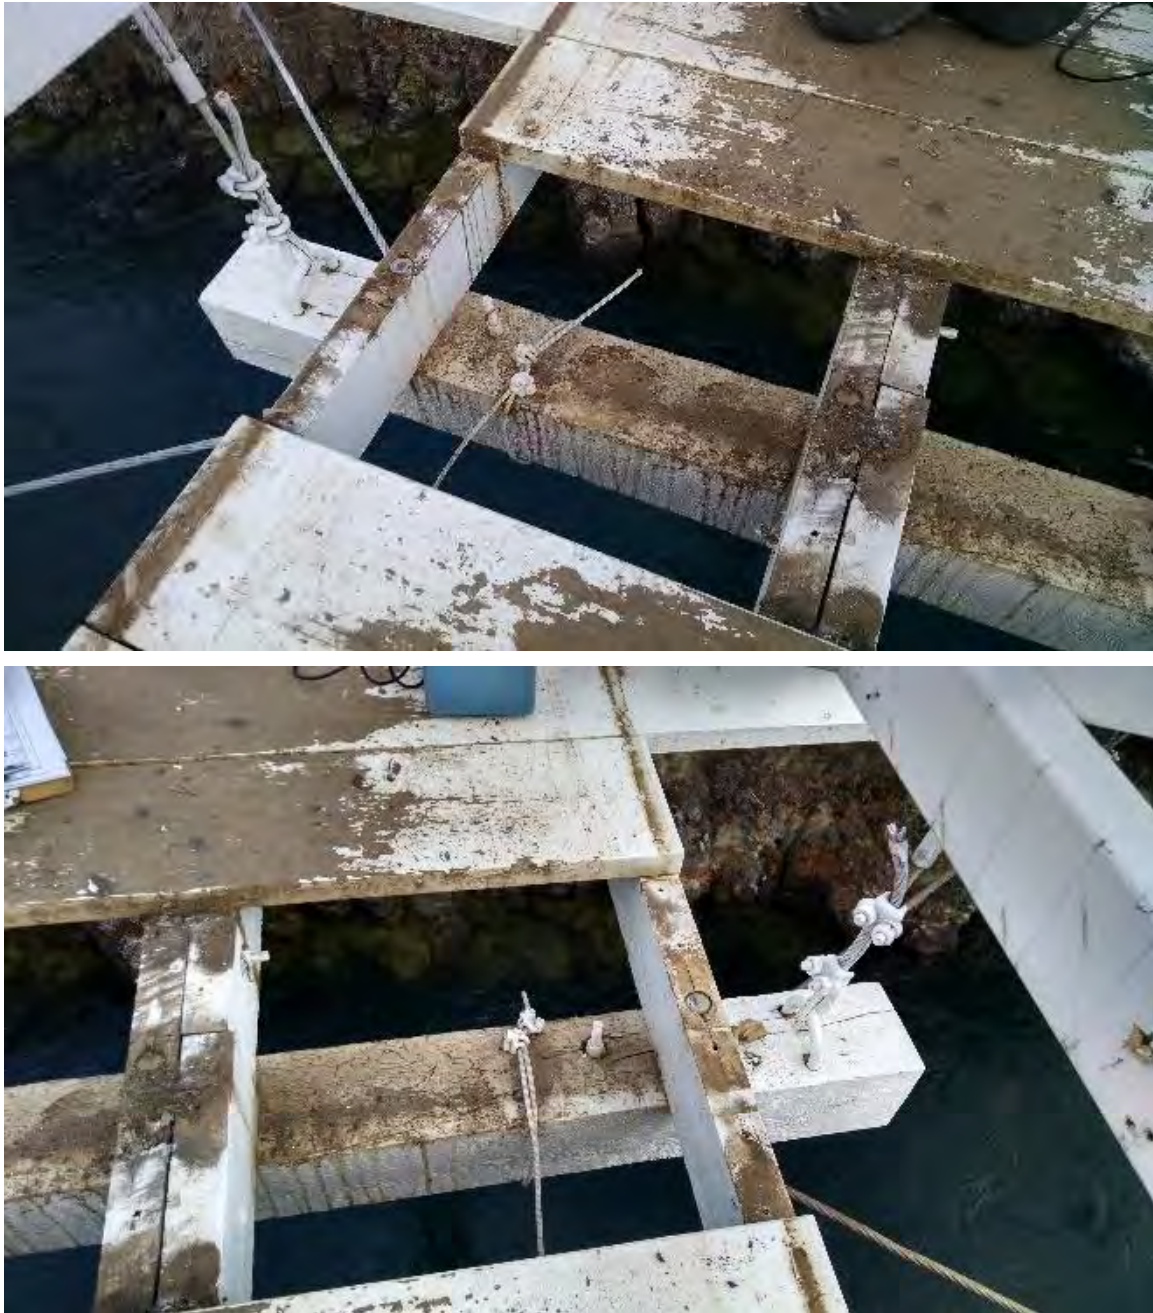
**Figure 3-4: Deck planks were removed over Crossbeam 11, allowing visual inspection and non-destructive testing of the stringers in the ends of Spans 11 and 12. Further visible evidence of decay was seen when the top surfaces were exposed, especially near the vertical bolt in Stringer 2; this was confirmed by high SWT results in the same area.**

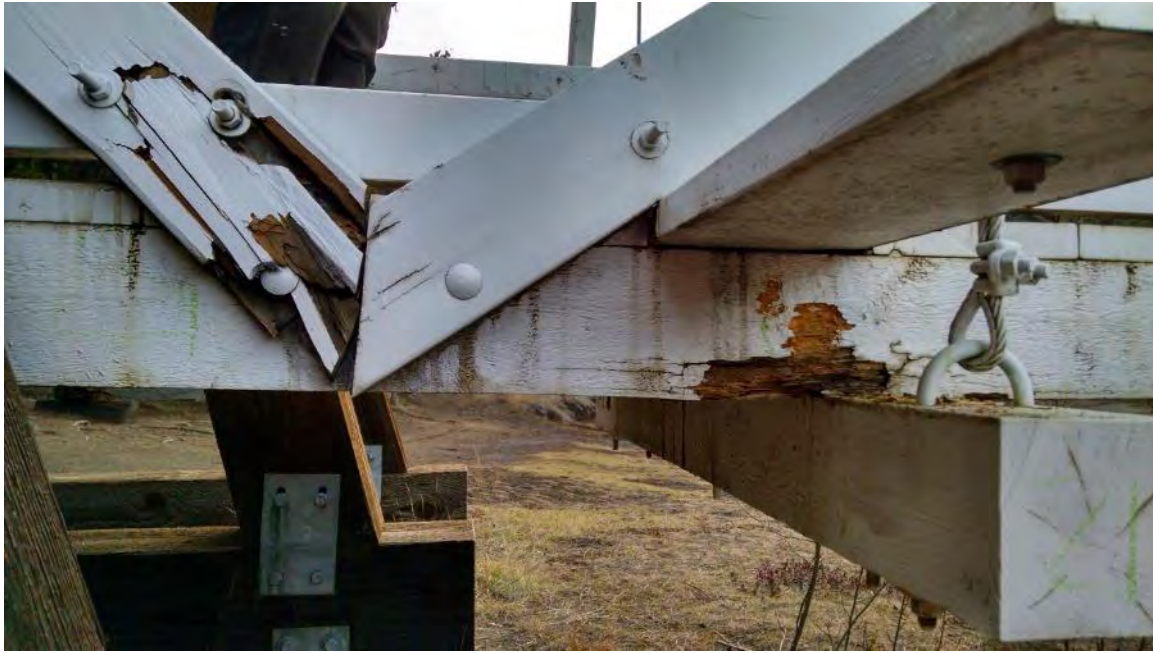
Stringer 1 in Span 22 was found to have significant decay in and partial failure near the support at Crossbeam 21. This area also shows excessive deflection under load, which has led to the failure of the railing cross brace connections in Span 22.

**Figure 3-5: Stringer 1 has failed over Crossbeam 21. This has caused excessive deflection in Span 22, and the railing cross braces have failed there.**

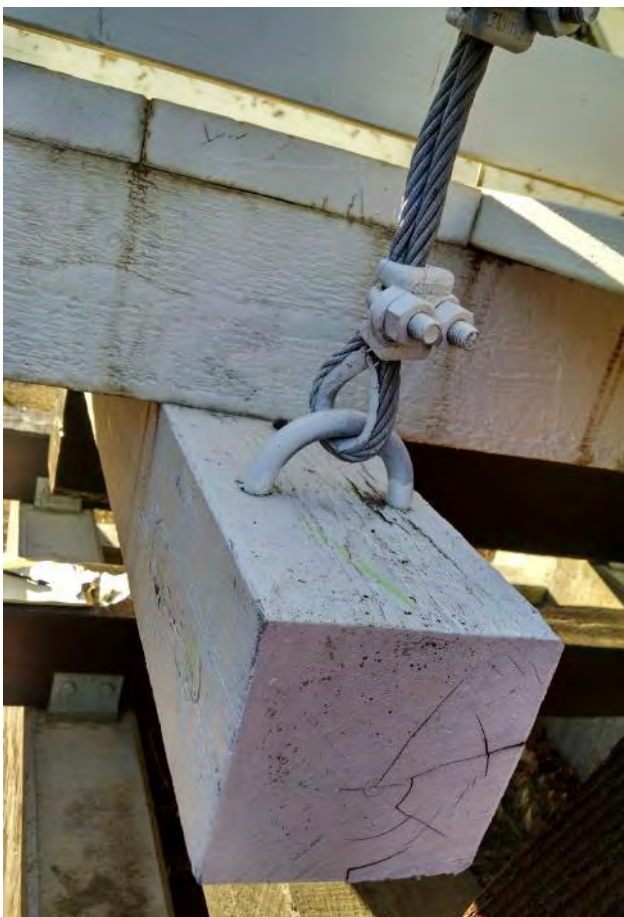
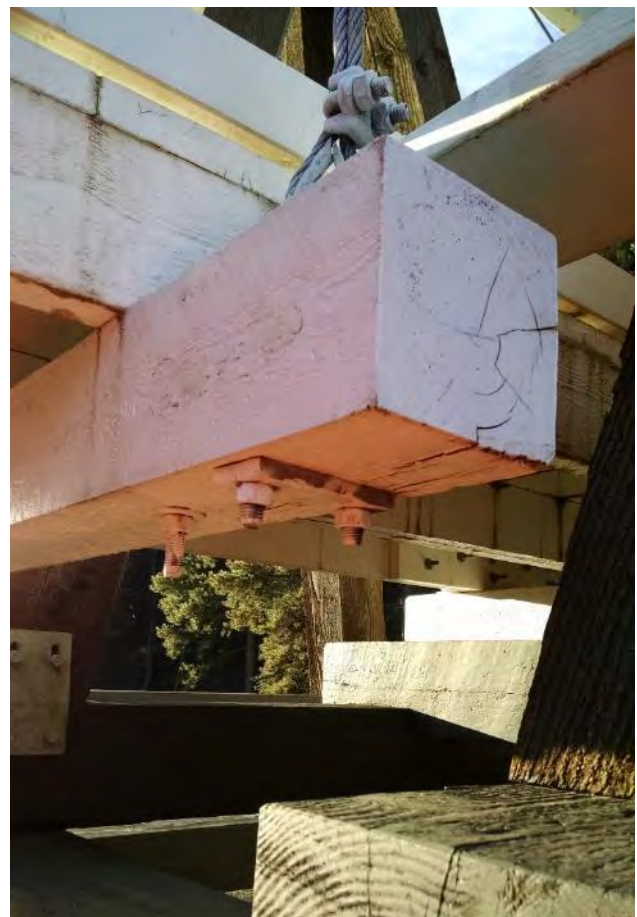
These connections are primary load-bearing connections in the main structure. Failure of one of these connections would effectively double the span of the stringers above and significantly increase the loads on the adjacent crossbeams. If the adjacent crossbeams or stringers in the area are also weakened by decay, the increased stresses could cause them to fail as well. This situation creates the potential for a rapid progressive failure of a large portion of the primary structure.

**Figure 3-6: Typical connection between the crossbeam and the suspender cable (at Crossbeam 1, Side 1). There are external signs of decay around the connection, including discoloration; peeling paint; and soft, punky wood. SWT results confirmed the severity of the decay. This beam had red zone readings (1-2000 microseconds per foot) within the first 16 inches, and yellow zone readings throughout.**

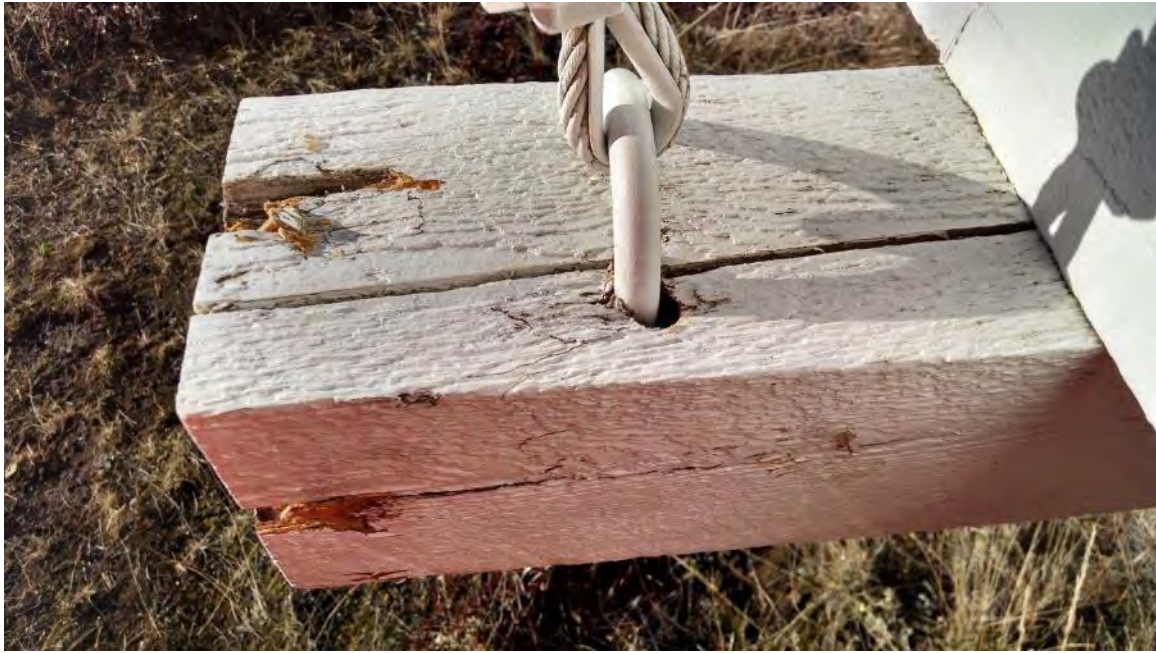
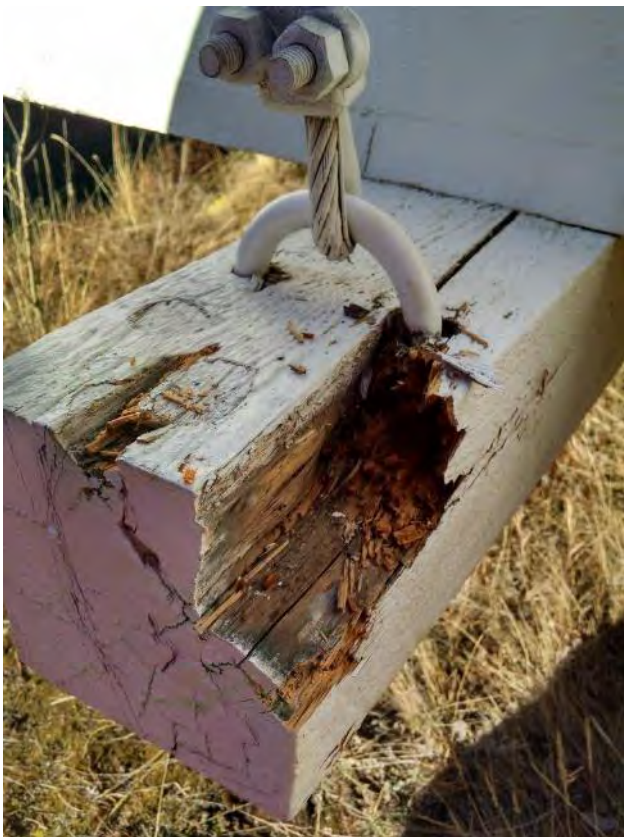
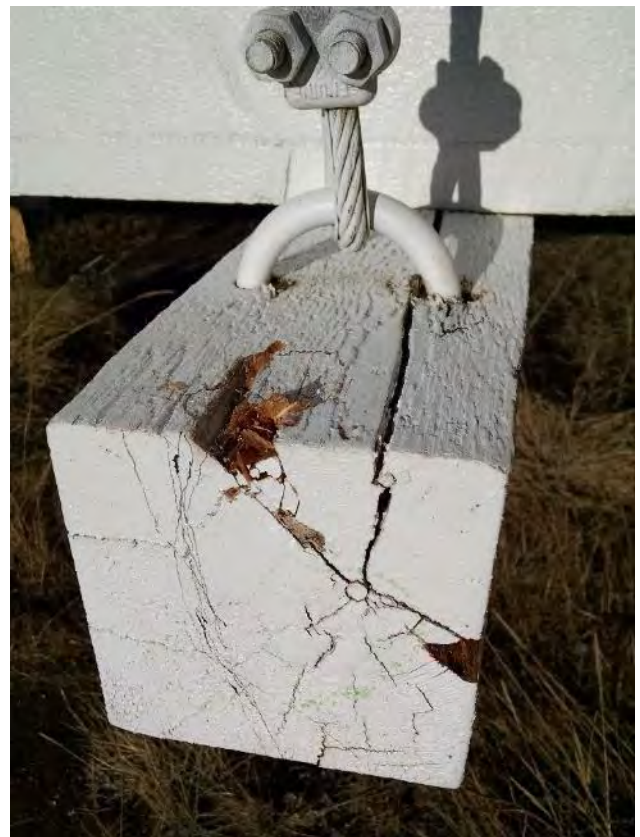
**Figure 3-7: Crossbeam 20 was found to be severely decayed at End 2, and a portion broke off during SWT testing. This is a result of the combination of shrinkage cracks in the timber and severe decay around the vertical fastener.**

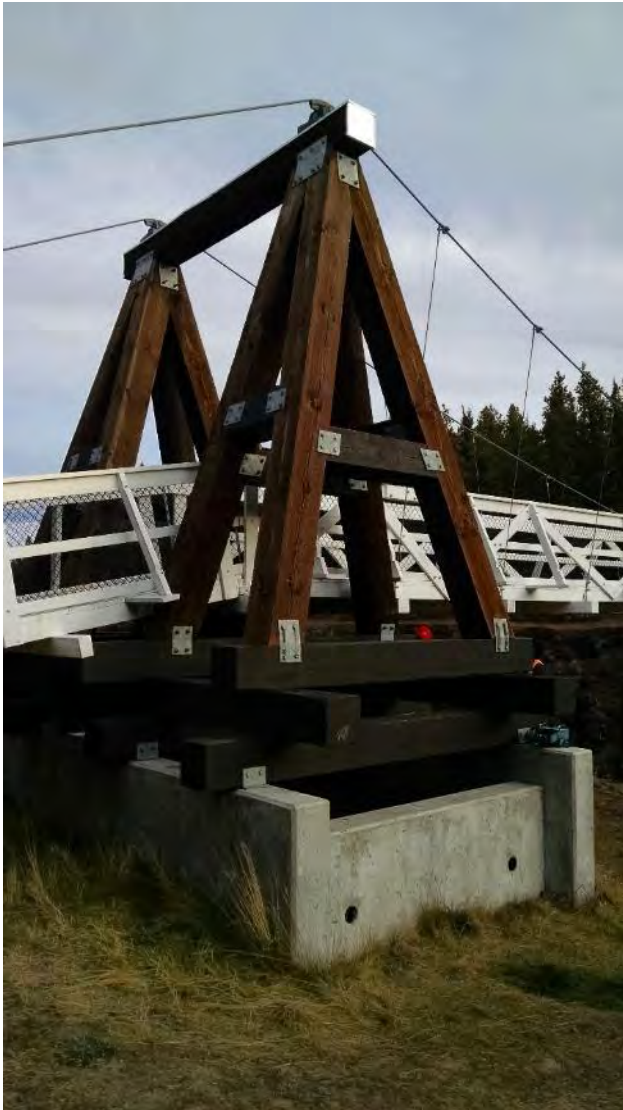
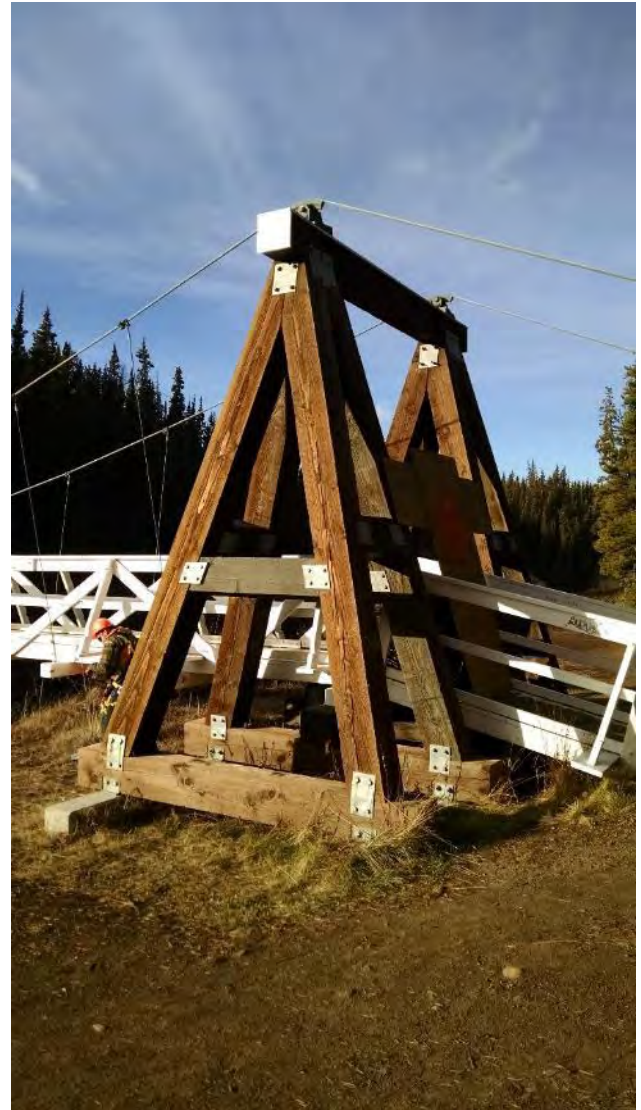
**Figure 3-8: Towers at Abutment 1 (left) and Abutment 2. The towers are in good condition overall, with moderate decay in some of the elements, especially the elements which were made from salvaged timber when the towers were rebuilt in approximately 2009.**

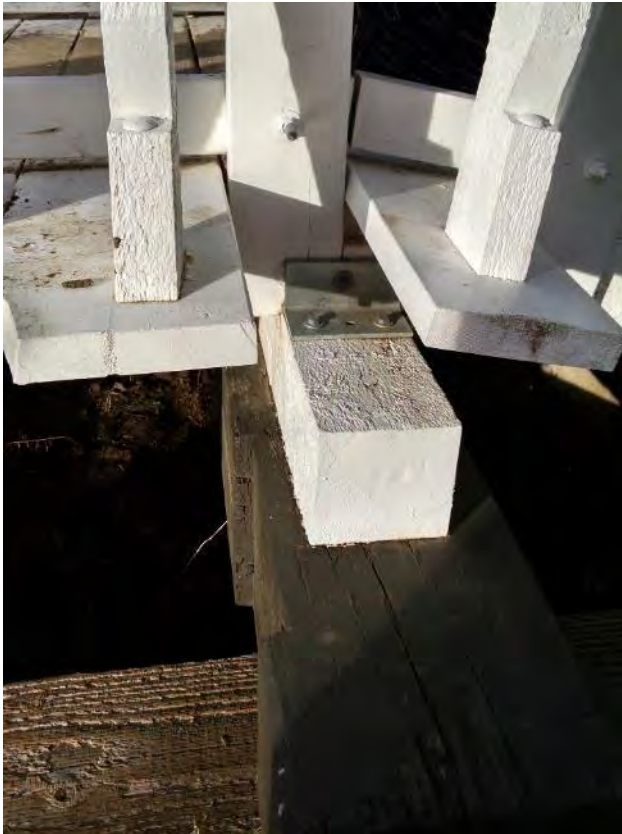
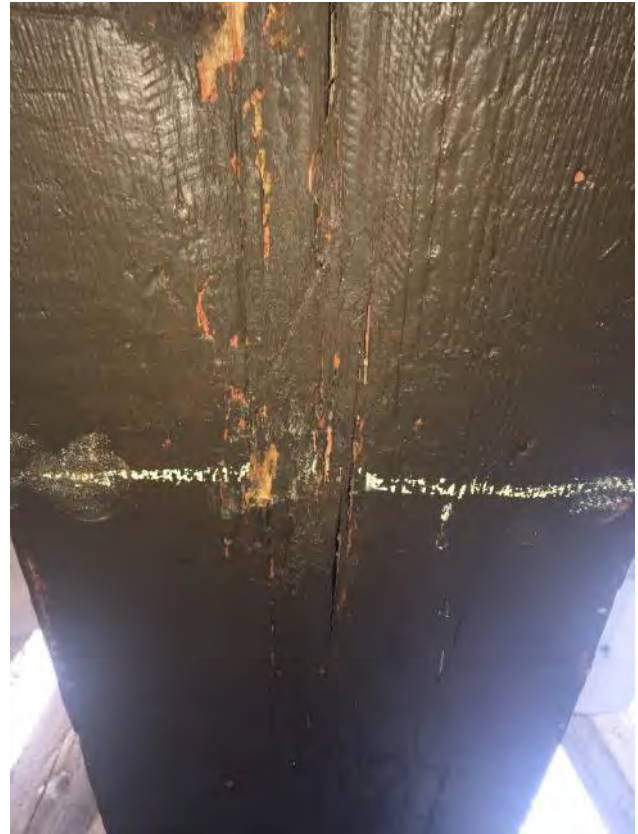
**Figure 3-10: The subcap has signs visible of decay in both abutments, including soft, punky wood along the centerline on the bottom face. This is likely a result of the vertical spikes securing the crossbeam on top (the end of one can be seen about 6 inches from the end of the white crossbeam in the left photo). These fasteners penetrate through the preservative treated layer of timber and create a path for moisture to enter the core of the member, causing accelerated decay.**

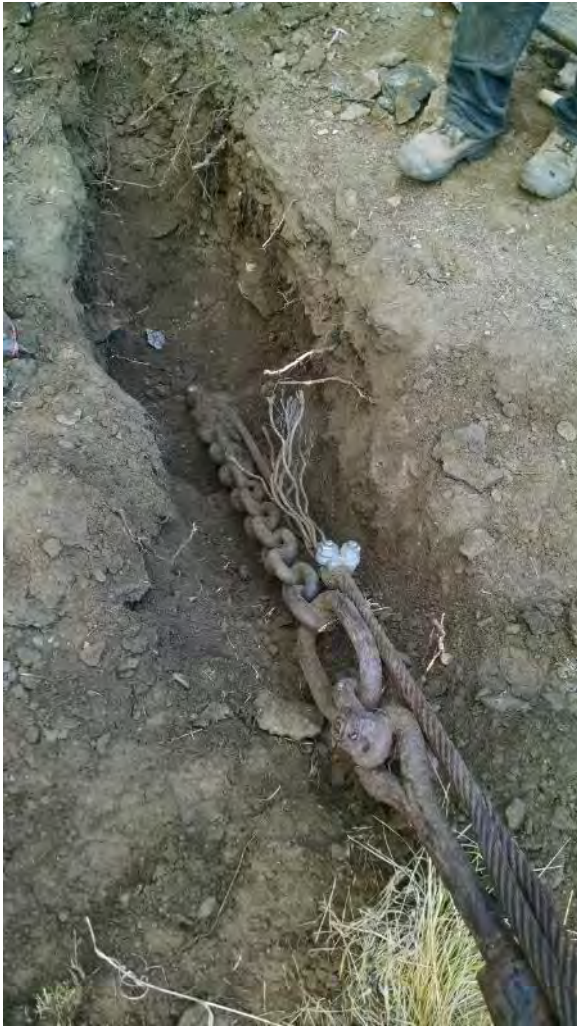
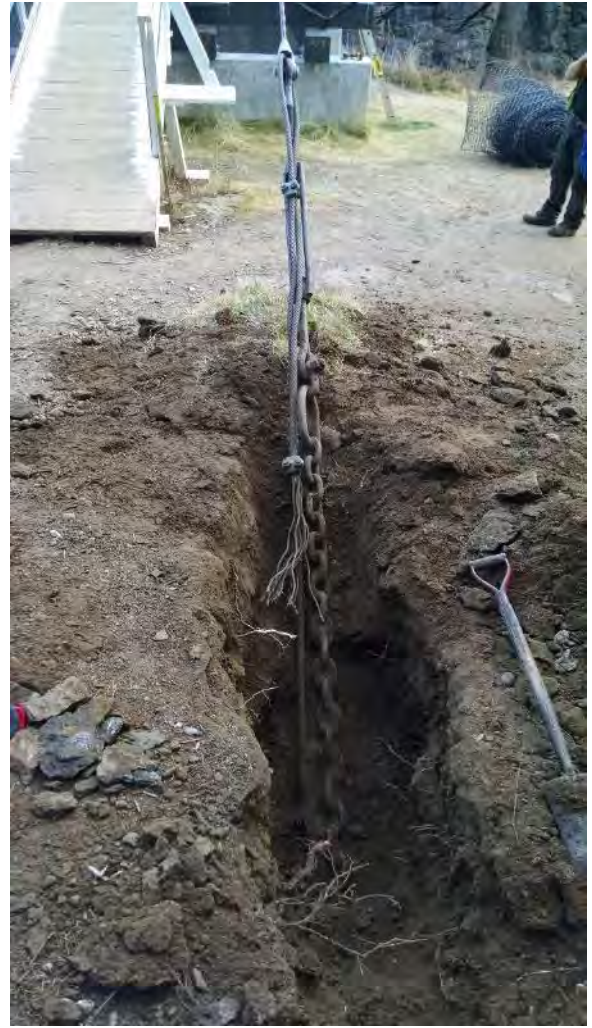
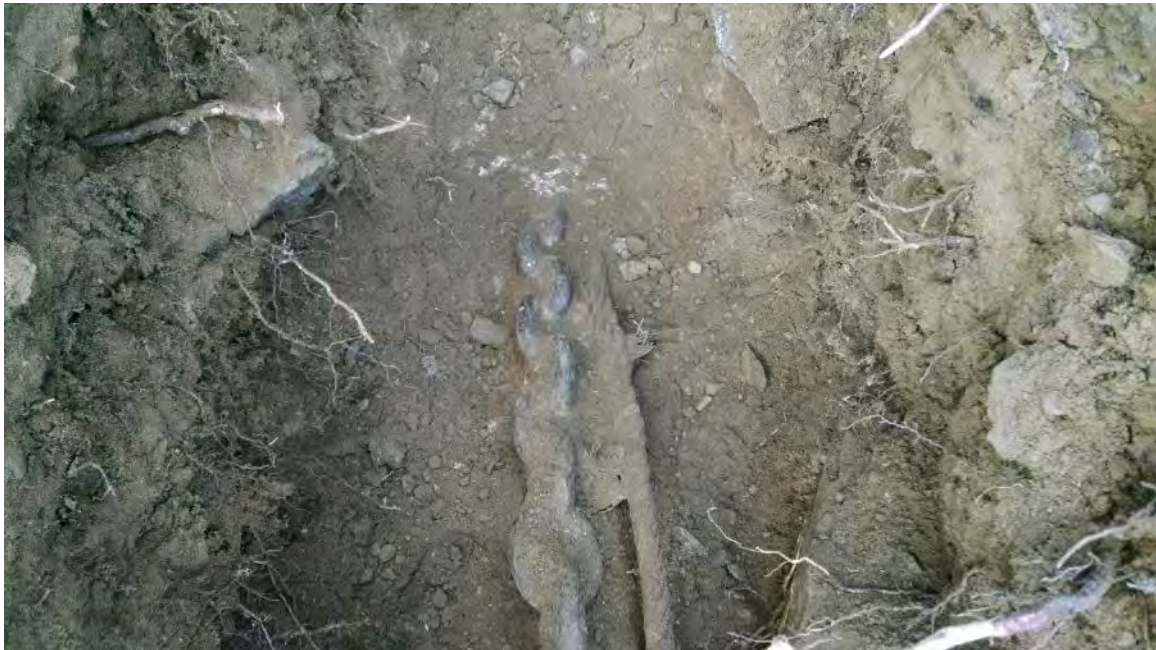
**Figure 3-11: Cable anchor at Cable 2, End 1. The chain and cable sling are embedded in concrete, approximately 3 feet below ground. The steel components show surface rust, but no signs of section loss. It is unknown how far the cable extends into the concrete, or how large the concrete block is.**

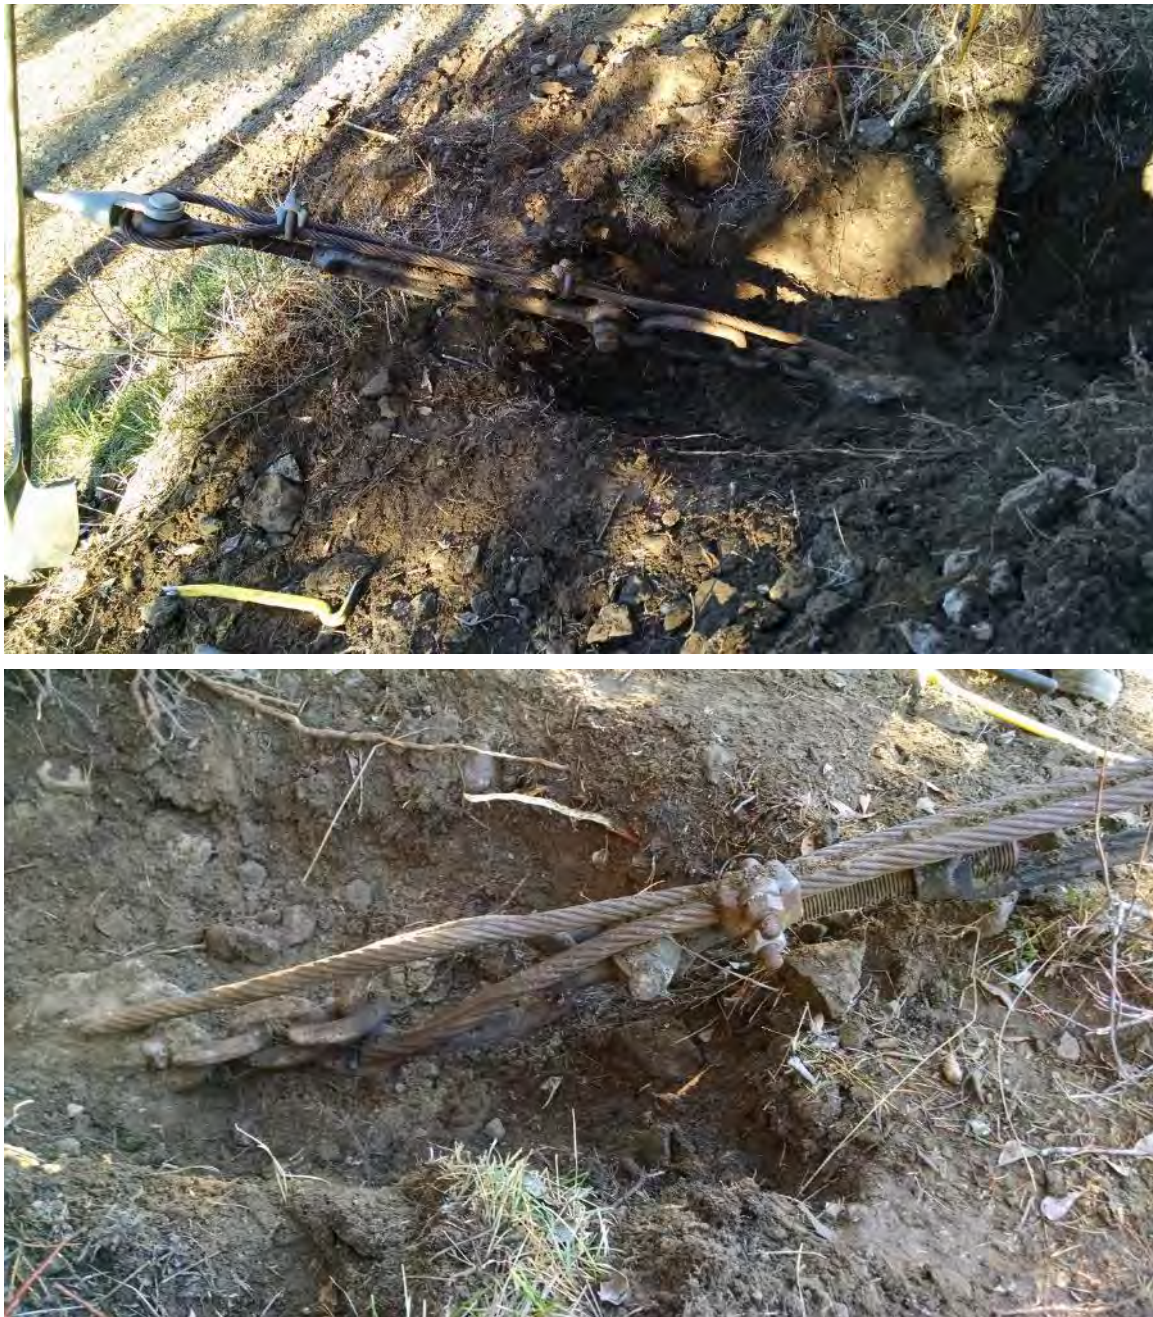
**Figure 3-12: Cable anchor at Cable 2, End 2. At approximately 2 feet below ground, this anchor is not as deep as the anchor at End 1; however, it is in similar condition, with minimal surface rust, and no signs of section loss.**

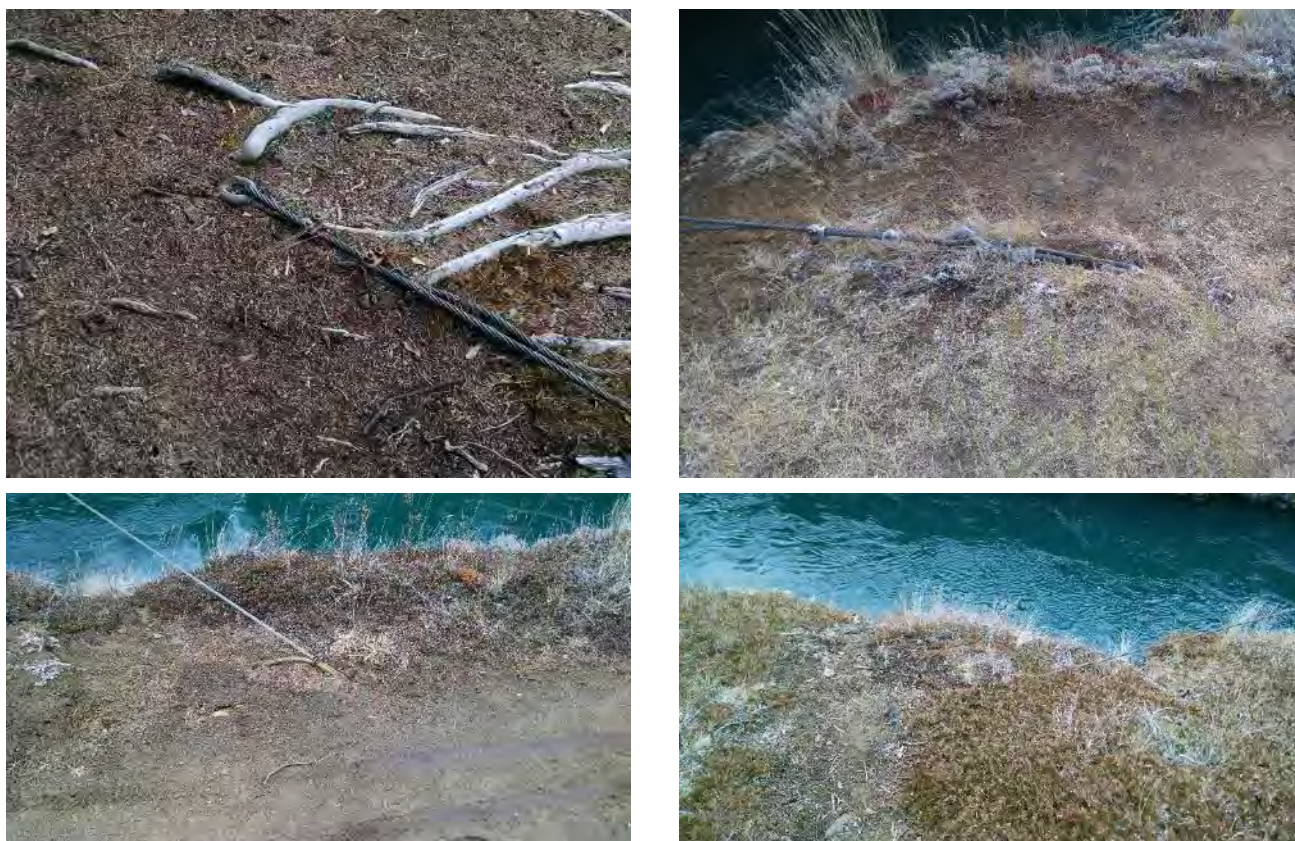
**Figure 3-13: Lateral stabilizing cable anchors (clockwise from top left) Side 1 End 1; Side 2 End 1; Side 2 End 2; Side 1 End 2. The cables and their connections to the rock appear to be in fair condition.**

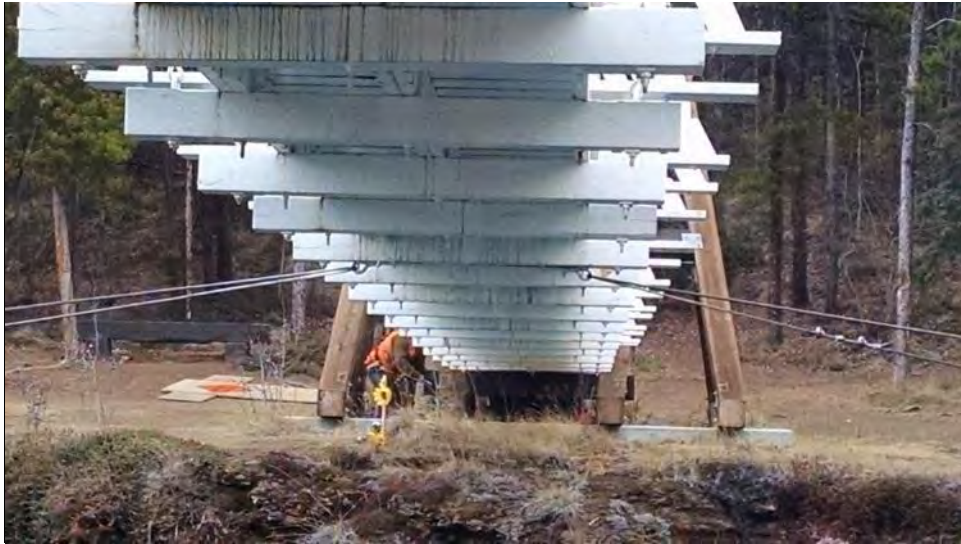
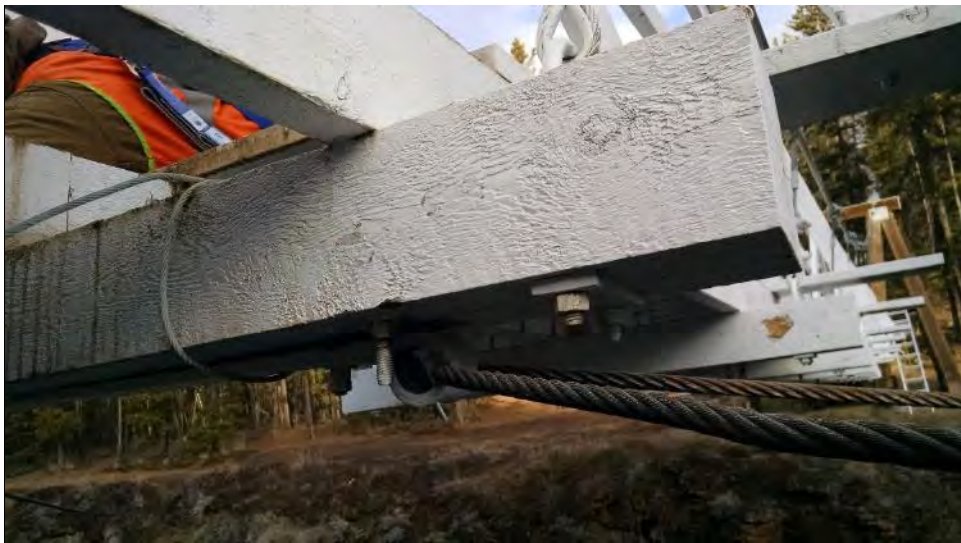
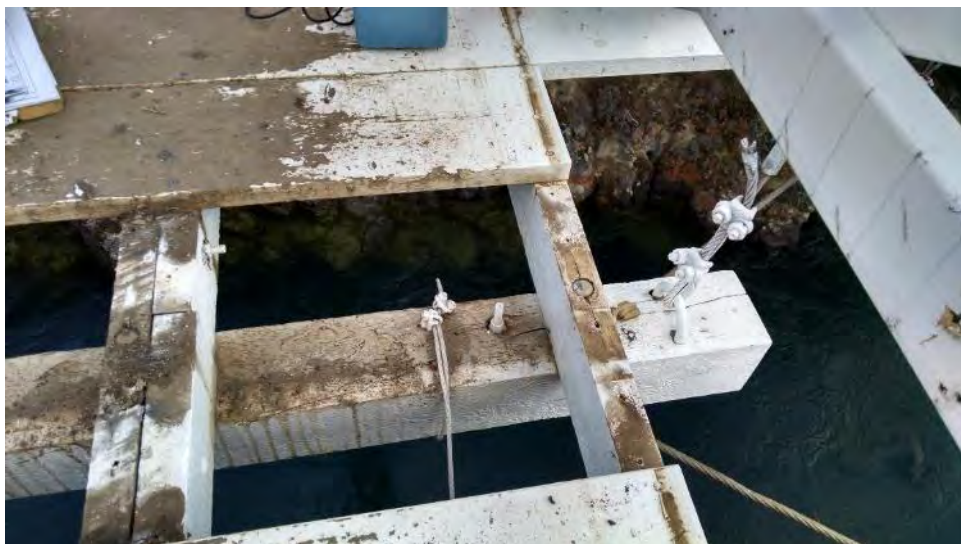
**Figure 3-15: Lateral cable connection to Crossbeam 11 at mid-span. The vertical through-bolt which connects to the steel strap is sinking into the beam, and the timber shows signs of decay.**

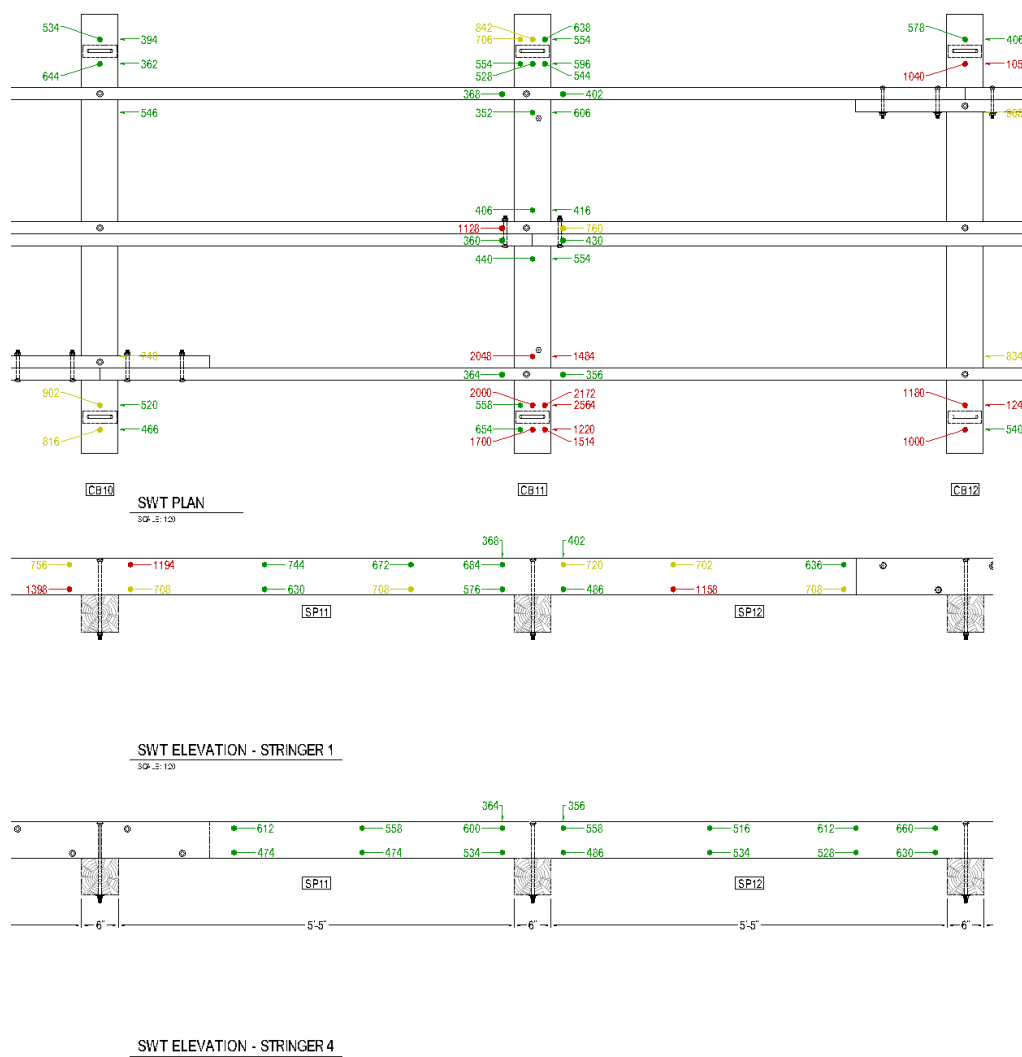
**Figure 3-16: The drawing above shows the SWT results for Crossbeams 10 through 12 and stringers in Spans 11 and 12. Values in green show areas where the timber is in sound condition; values in yellow indicate that the area is weakened decay and capable of carrying and unknown live load; values in red indicate that the area is no longer capable of carrying even its own dead weight. Note the concentration of red-zones around the vertical U-bolt connections in Beams 11 and 12. Deck planks were removed above Crossbeam 11 allowing for additional test of this beam and of Stringers 2 and 3. See Appendix B and the provided drawings for complete results.**

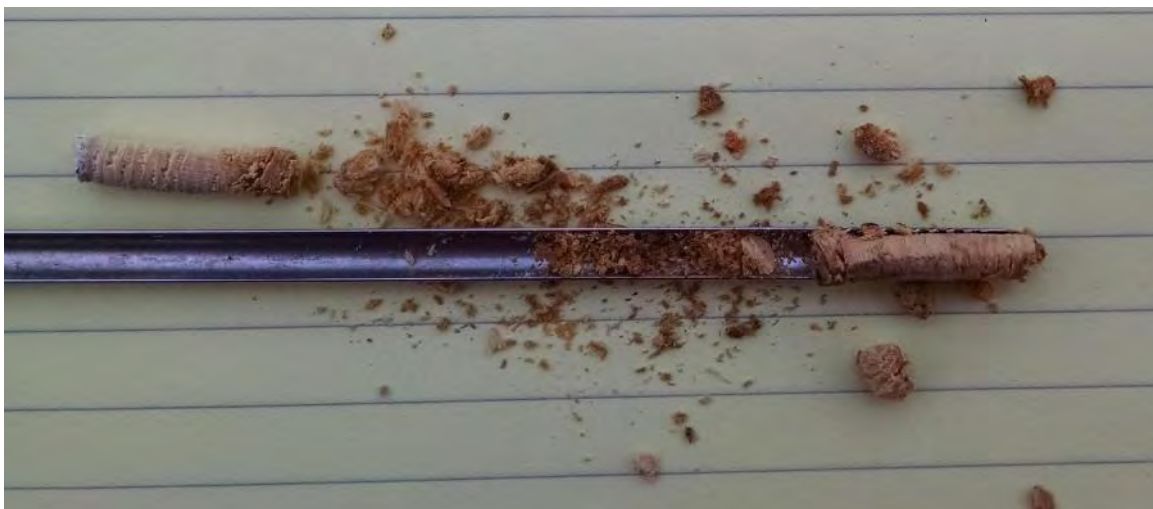
**Figure 3-19: Crossbeam 2, 68 inches from End 1. Horizontal core, Side 1 at left.**  
The middle section of this sample was crumbled into fine powder, indicating severe decay and cavitation at this location. Specific gravity calculations cannot be made on the crumbled section, but results show very high moisture content. The sample was taken approximately 2 inches from the suspender cable U-bolt connection.
