SOIL TEMPERATURE AND STABILITY EVALUATION  
FIFTH AVENUE REPLACEMENT SEWER SYSTEM  
DAWSON CITY, YUKON

0201-10471

SEPTEMBER, 1991

EBA Engineering Consultants Ltd.  
14535 - 118 Avenue  
Edmonton, Alberta  
T5L 2M7

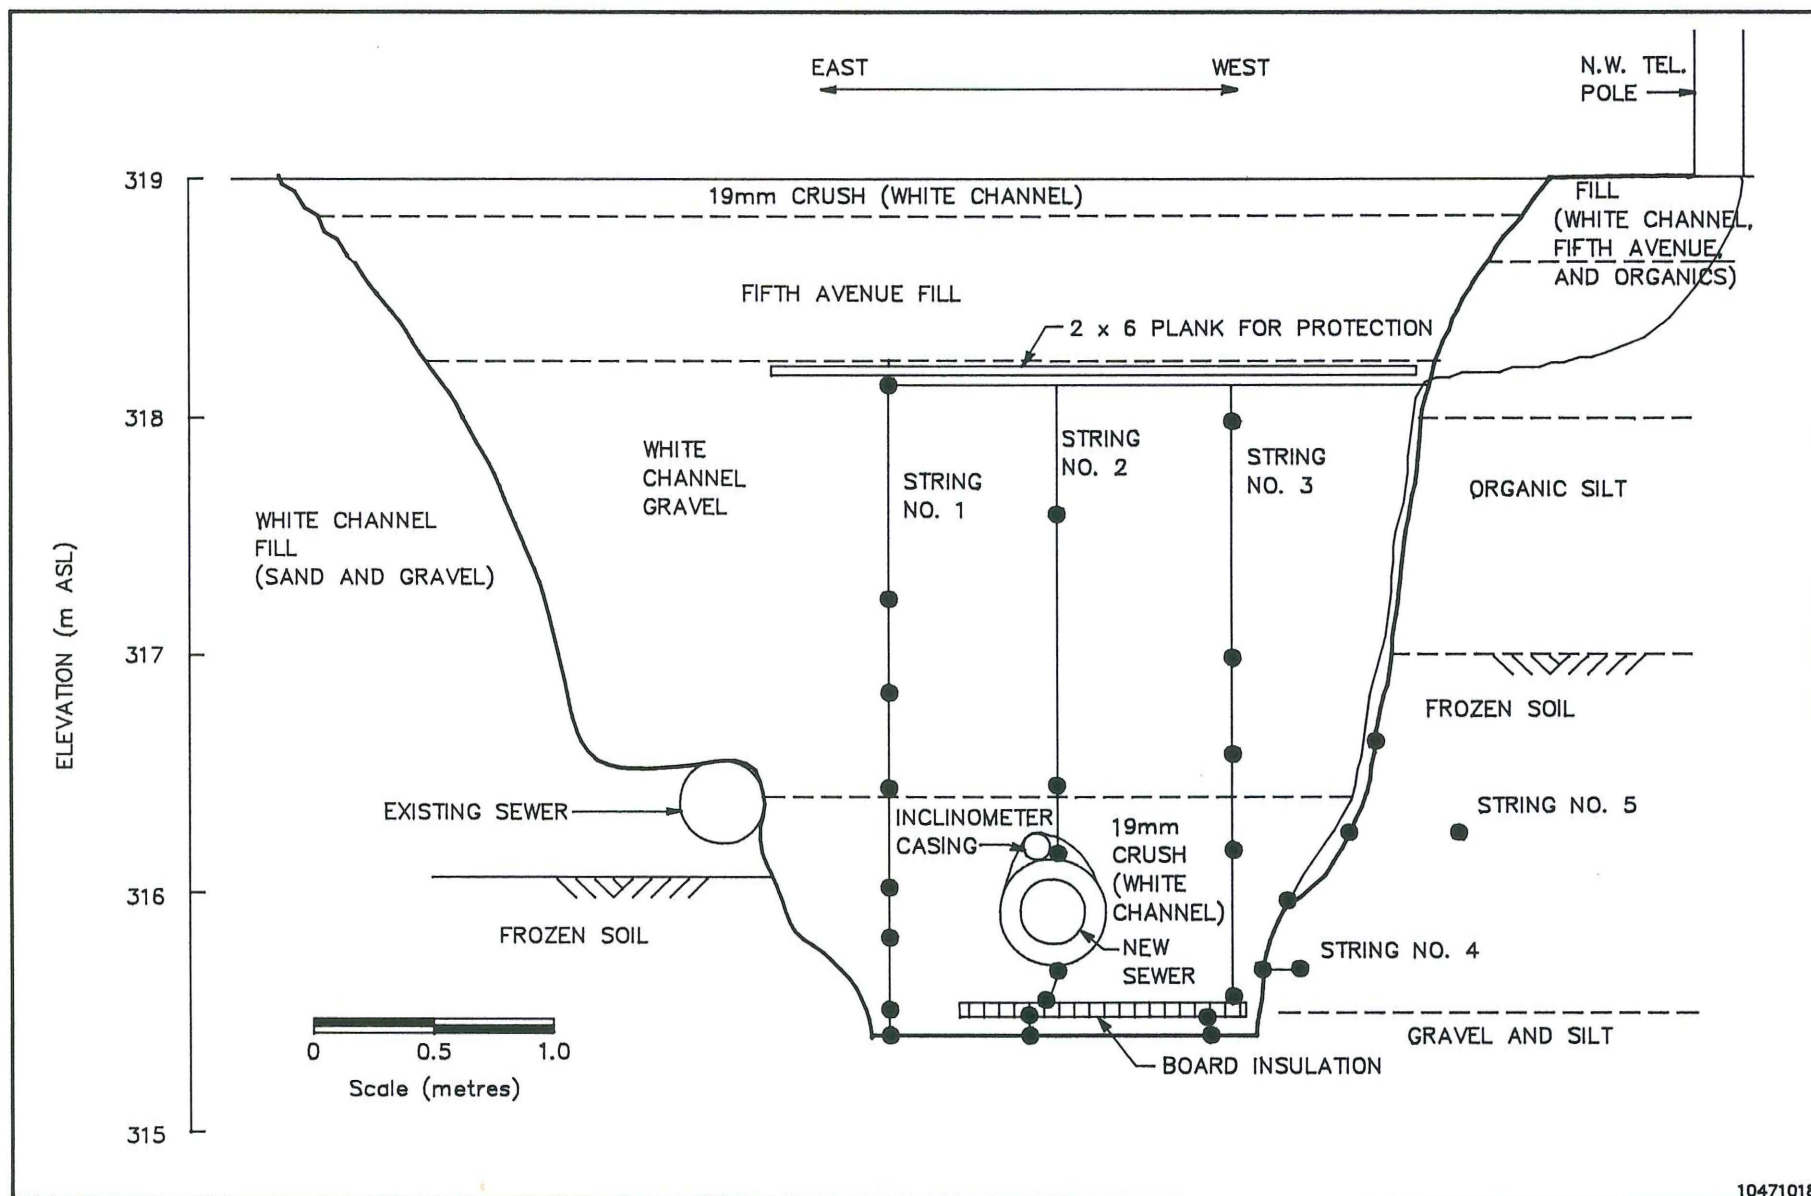
FIGURE 4 THERMISTOR SUITE #1  
BLOCK HF – LOT 15, FIFTH AVENUE  
INSTALLED CONFIGURATION  
CROSS-SECTION FACING SOUTH

Conditions encountered in the trench at the locations of the instrumentation are illustrated on Figures 4 and 5. At thermistor Suite 1 the active layer was approximately 2 m thick on the west side of the trench, whereas on the east side of the trench, the presence of the old sewer system allowed thaw to penetrate to a total depth of about 3 m, approximately 100 mm below the base of the pipe.

casing was installed. Approximately 150 mm of the trench was excavated into this material at the location of thermistor Suite 1.

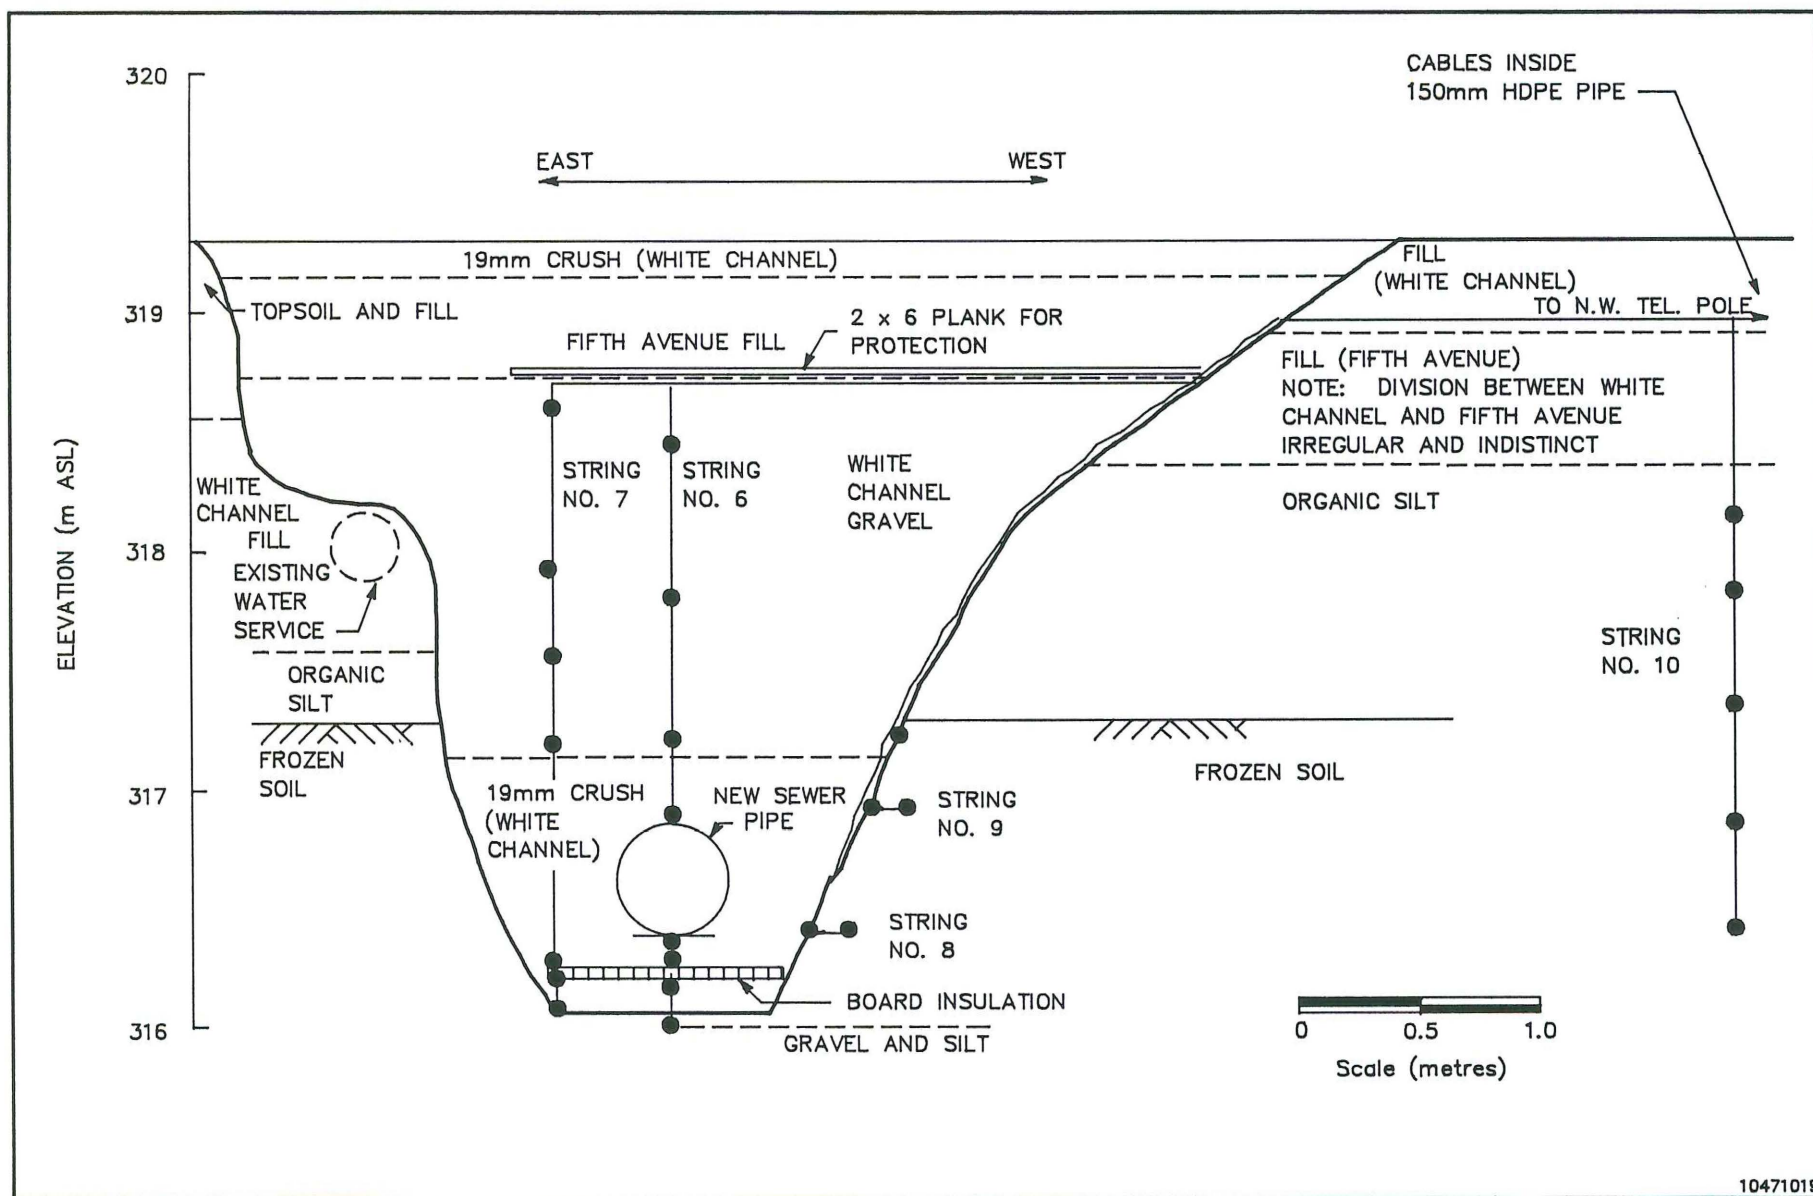
**FIGURE 5 THERMISTOR SUITE #2  
FIFTH AVENUE AT ROBERT SERVICE SCHOOL  
INSTALLED CONFIGURATION  
CROSS-SECTION FACING SOUTH**

Very similar conditions were observed at the Suite 2 location. The silty gravel layer was encountered approximately 50 mm below the base of the trench. Frozen soil was encountered at a depth of 2 m in the trench but appeared to be deeper when a hole was augered 4 m from the trench centreline in the centre of the street.

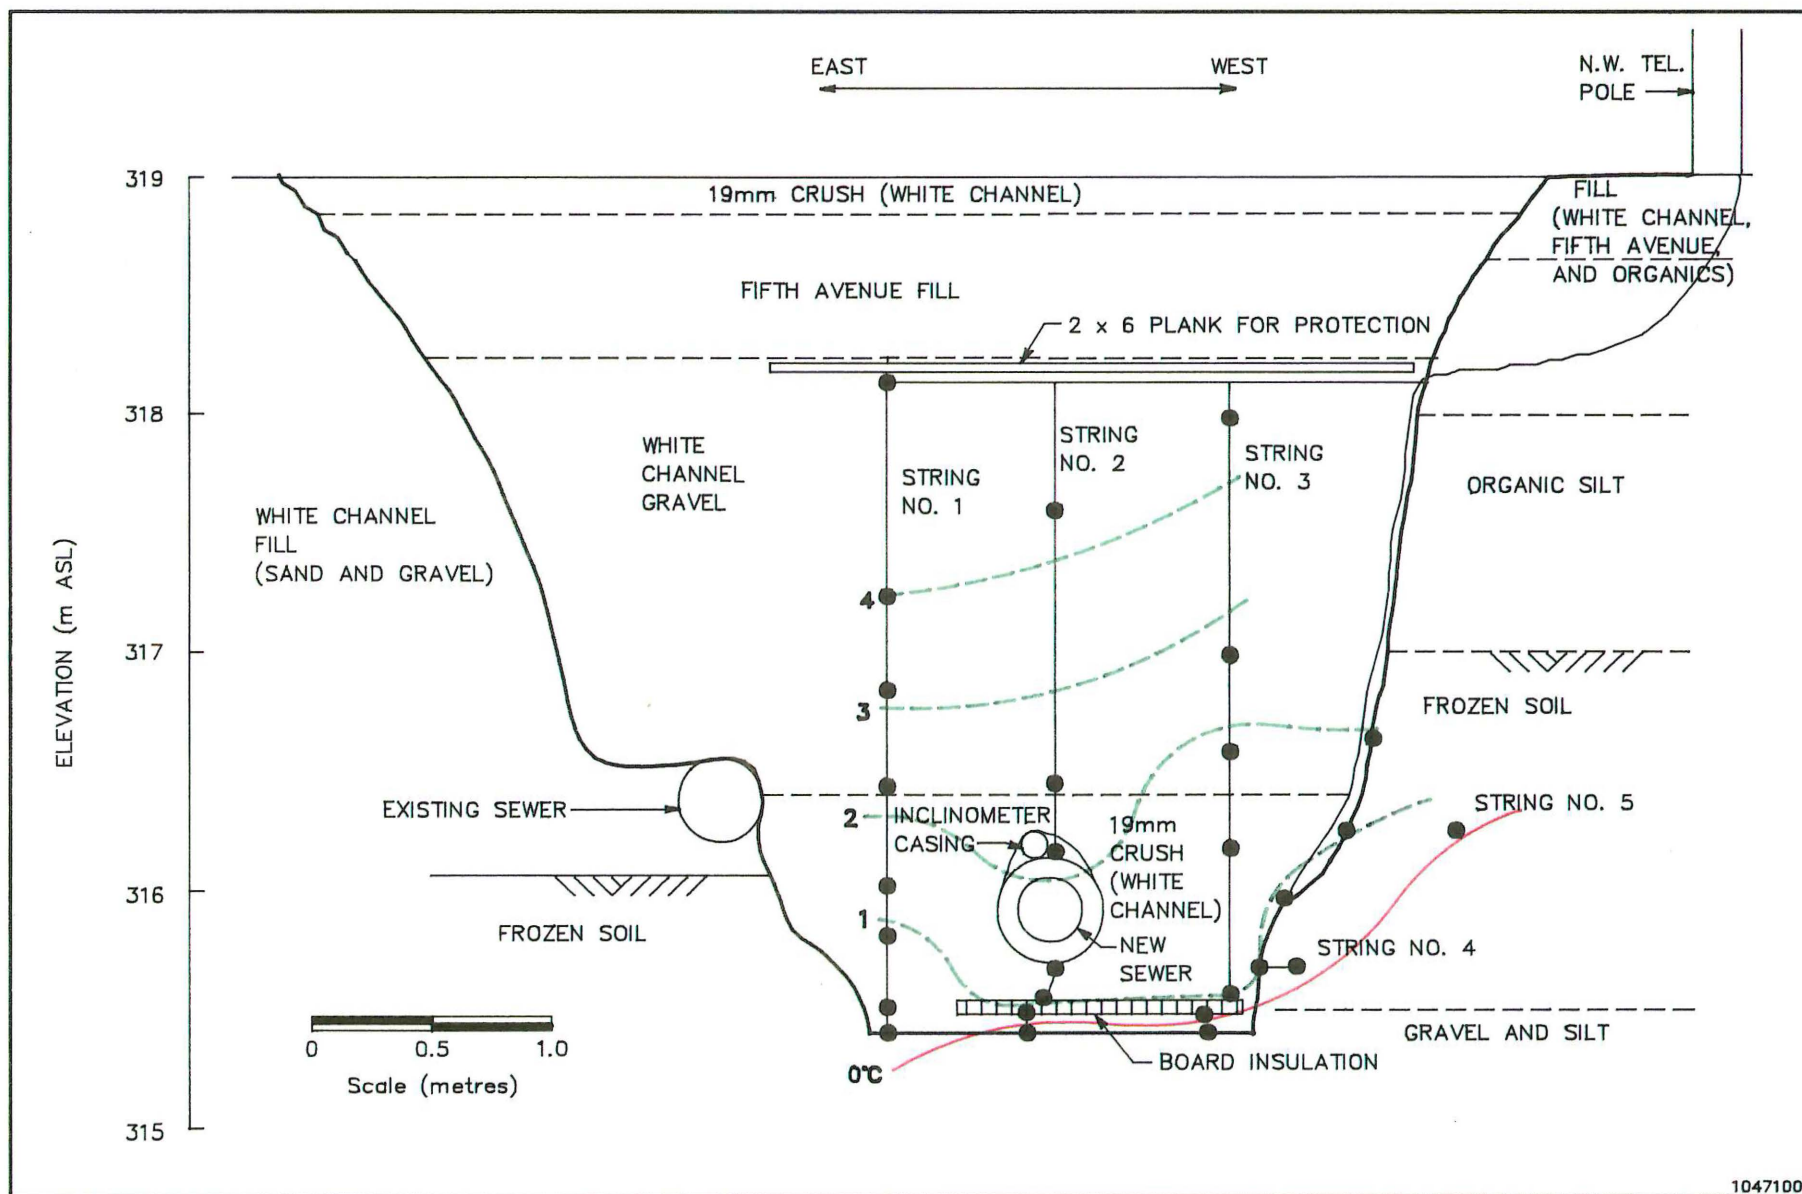
**FIGURE 9 THERMISTOR SUITE #1  
TEMPERATURE ISOTHERMS  
SEPTEMBER 14, 1987 (PEAK THAW)**

The contour plots show that during peak thaw in September of 1987 (Figures 9 and 16), the maximum thaw depth is maintained within the rigid board insulation at the Suite 2 location and fairly well maintained within the trench backfill at the trench bottom (except near the east wall) at the Suite 1 location. The slightly poorer performance at the Suite 1 location may be partly due to both the wider trench dimension and the lack of insulation extension across the full width of the trench floor. Both trench locations are shown to have frozen back entirely by the time of peak freeze in March of 1988 (Figures 11 and 18).

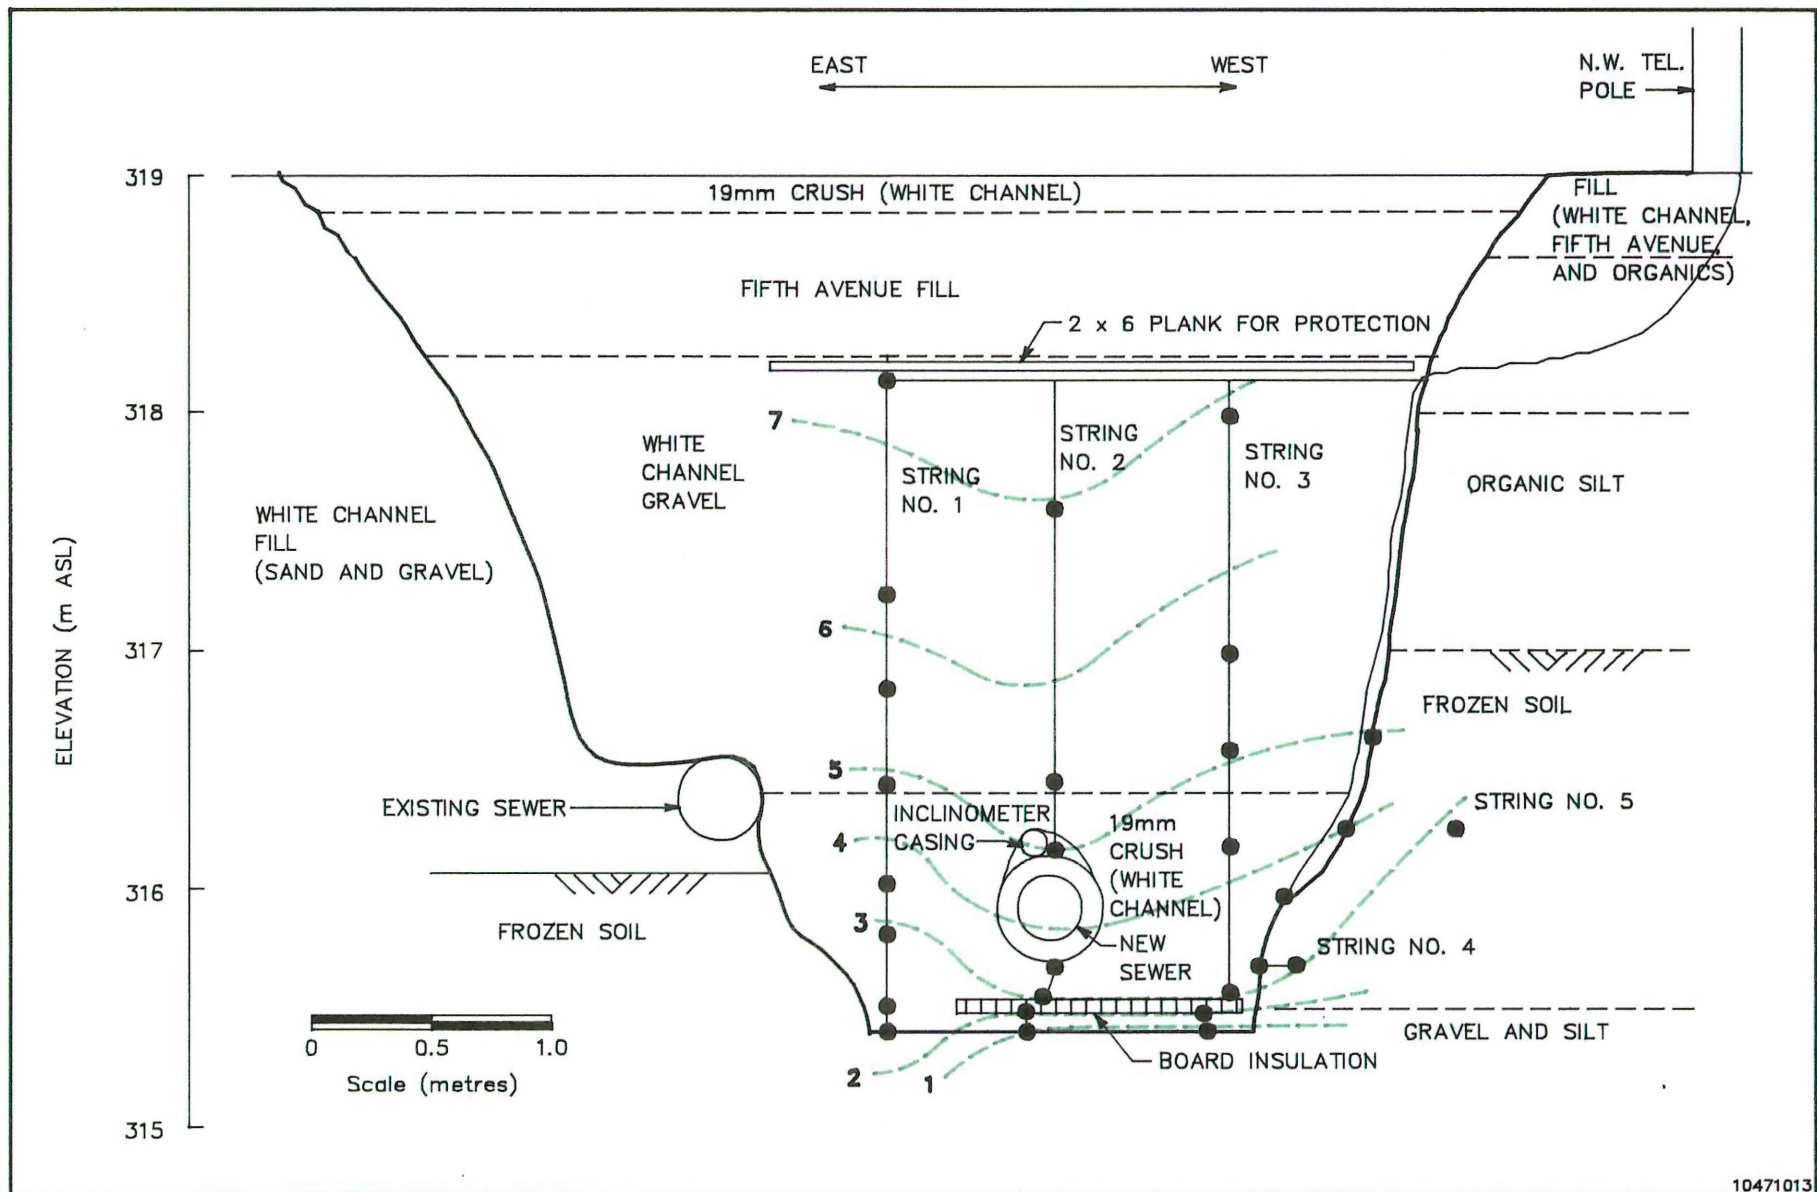
FIGURE 13 THERMISTOR SUITE #1  
TEMPERATURE ISOTHERMS  
SEPTEMBER 12, 1988 (PEAK THAW)

Greater thaw depths and backfill warming were experienced at both suite locations during the second summer (1988), as shown by the temperature contours presented in Figures 13 and 20. Thaw had penetrated into the underlying native soil by the time of peak thaw in September. It is uncertain as to the reason for this condition. It may be a result of slight differences in corresponding freezing and thawing indices for the years of 1987 and 1988. The mean monthly air temperature information collected at the Dawson City airport indicates slightly colder winter temperatures and marginally cooler summer temperatures over the year preceding the 1987 maximum thaw depth in comparison to 1988. Another possible cause might be the change in the pavement surface characteristics following application of a bituminous surfaced treatment (BST) in 1987, although a test section study conducted by EBA (1987b) suggested the BST application would have minimal effect.

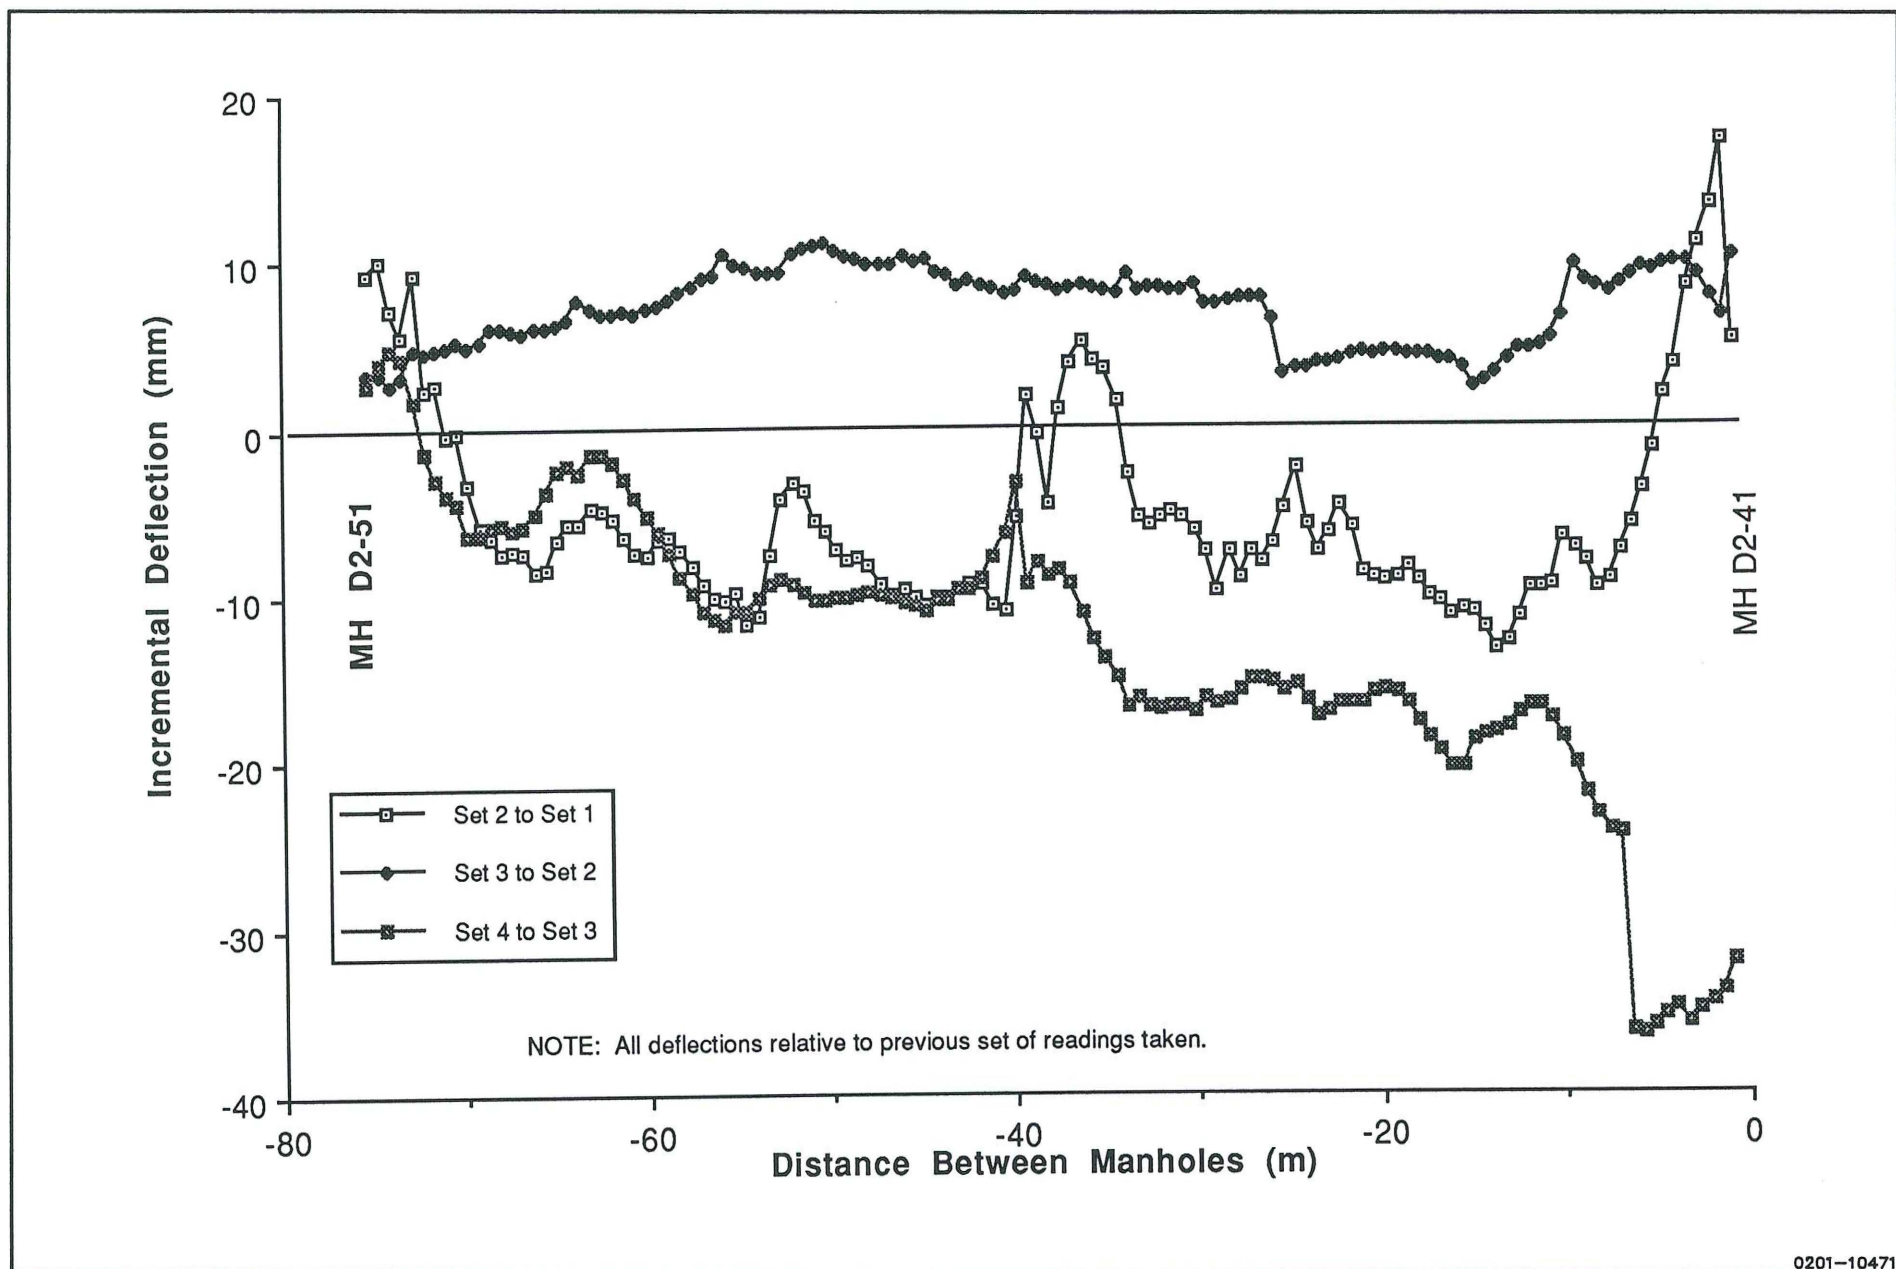
FIGURE 22 5TH AVENUE SANITARY SEWER  
INCREMENTAL DEFLECTIONS

These dates were selected to allow computation of the incremental pipe movements attributed to the respective intervening periods of thaw settlement and frost heave below the pipe. The incremental pipe deflections between manholes MH D2-51 and MH D2-41 are presented in Figure 22.

The incremental deflection profiles indicate that the pipe settled about 10 mm over most of its length during the first post-installation thaw season (when thaw was contained above the trench floor). During the following freeze-back season, the settlement was more or less recovered by heave approaching 10 mm over most of the pipe length. These observations are consistent with expected behaviour in closed system freezing and thawing, where movements result from the volumetric phase change associated with conversion of water to ice. It should be noted that the plotted deflections have been computed relative to a zero reading at manhole MH D2-51 and assume the manhole itself is not subject to seasonal movement. If there has been manhole movement (unknown), the magnitude would be additive to the plotted deflections in determining absolute pipe deflections.

The 1988 thaw season again reproduced about the same settlement over the northern half of the instrumented pipe segment, but showed additional settlement over the southern half. This seems to be consistent with the greater thaw depth (into the underlying native soils) experienced during 1988. Since the trench floor was mostly founded within the top of a silty gravel deposit, the different settlement response between the northern and southern halves of the pipe segment might reflect a difference in the inherent thaw stability of the gravel deposit along these intervals. It is noted that the presence of three large 1.5 m thick ice wedges were indicated on the trench wall logs (EBA, 1987) at distance positions of -28 m, -22 m and -12 m between manholes. As seen by the coordinates on the distance axis in Figure 22, these positions are located through the interval where greater thaw settlements were observed.

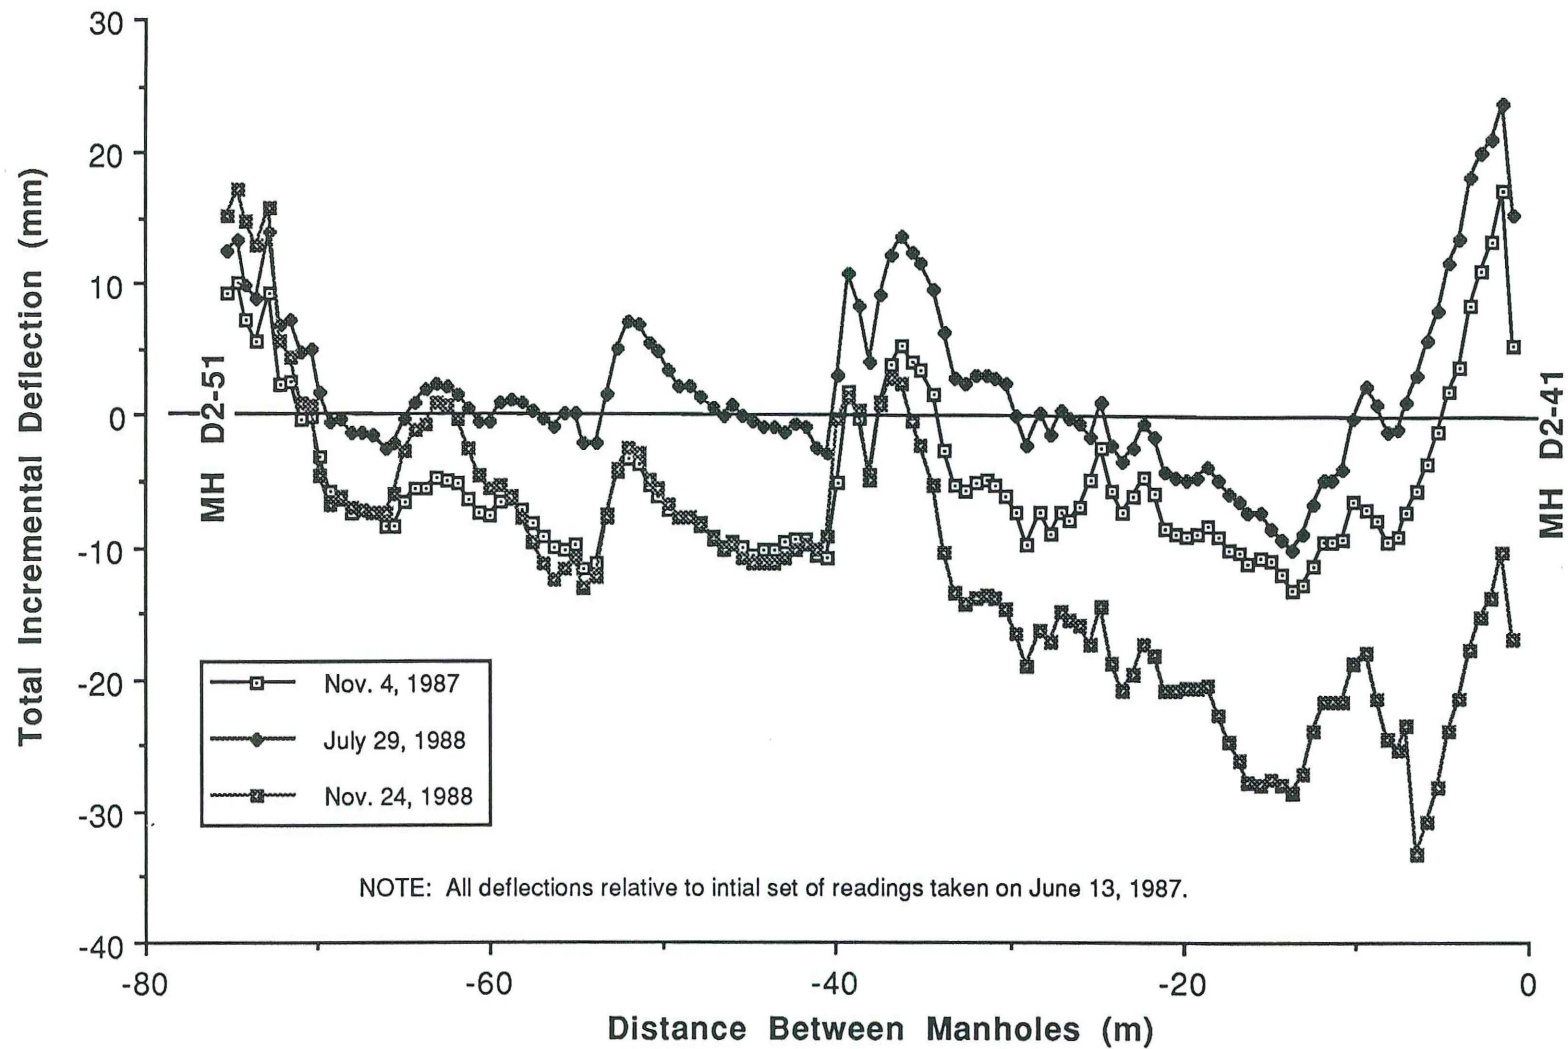
FIGURE 23 5TH AVENUE SANITARY SEWER  
DEFLECTION BETWEEN MANHOLES

Figure 23 presents the cumulative pipe deflections relative to the initial reading on June 13, 1987. These profiles show the vertical position of the

new sewer line has mostly remained with  $\pm 25$  mm of its installed position, assuming negligible manhole movement.
