April 20, 2023

ISSUED FOR USE
FILE: 704-ENG.WARC04345-01
Via Email: matt.ball@yukon.ca

Subject: Updated Geohazard Study (Rev 1)
5th Avenue and Rogers Street – Whitehorse, Yukon

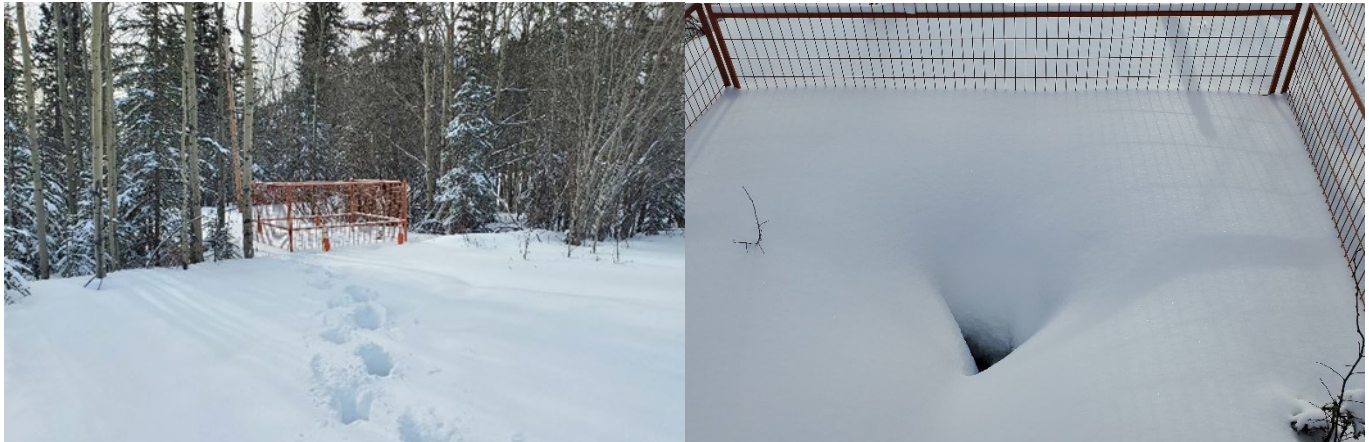
YG has advised that a potential sinkhole is present at the site. Tetra Tech completed a site visit on March 2, 2023 to observe the potential sinkhole and review its origin. The hole is located in a stand of trees, approximately in the centre of the parcel. The hole was mostly obscured by snow at the time of the site visit and was surrounded by fencing, as shown in the photos below.

Sinkholes form when subsurface voids collapse to create an open depression at the ground surface. Naturally occurring sinkholes are common in karst terrain areas that are underlain by soluble, carbonate rocks (e.g., limestone); voids form as the rocks are dissolved by groundwater and eventually collapse to form sinkholes. This type of process is not believed to be occurring at the subject site, since the bedrock beneath the site is understood to be granitic and not susceptible to karst processes. In urban environments and previously developed sites, such as the subject site, the most likely cause of sinkhole formation is the collapse of voids related to uncontrolled fill (e.g., loose fill with construction debris and large voids) or possibly abandoned underground utilities (e.g., old sewer lines).

Photo 1 (left): Potential sinkhole area in stand of trees near centre of the parcel, surrounded by fencing.
Photo 2 (right): Potential sinkhole mostly obscured by snow during the site visit on March 2, 2023.

The sinkhole should be checked in snow-free conditions to confirm its depth, which is likely no deeper than the maximum depth of ground disturbance from previous site developments.

New development at the subject site should include a geotechnical site investigation to determine the depth of potentially unstable soil, and site preparation procedures should be implemented to eliminate the risk of uncontrolled soil subsidence. Site preparation procedures generally consist of excavation to remove uncontrolled fill, old foundations, abandoned underground utilities, and other potentially deleterious materials. These should be replaced with fill that is placed in lifts and compacted to suit site development requirements.

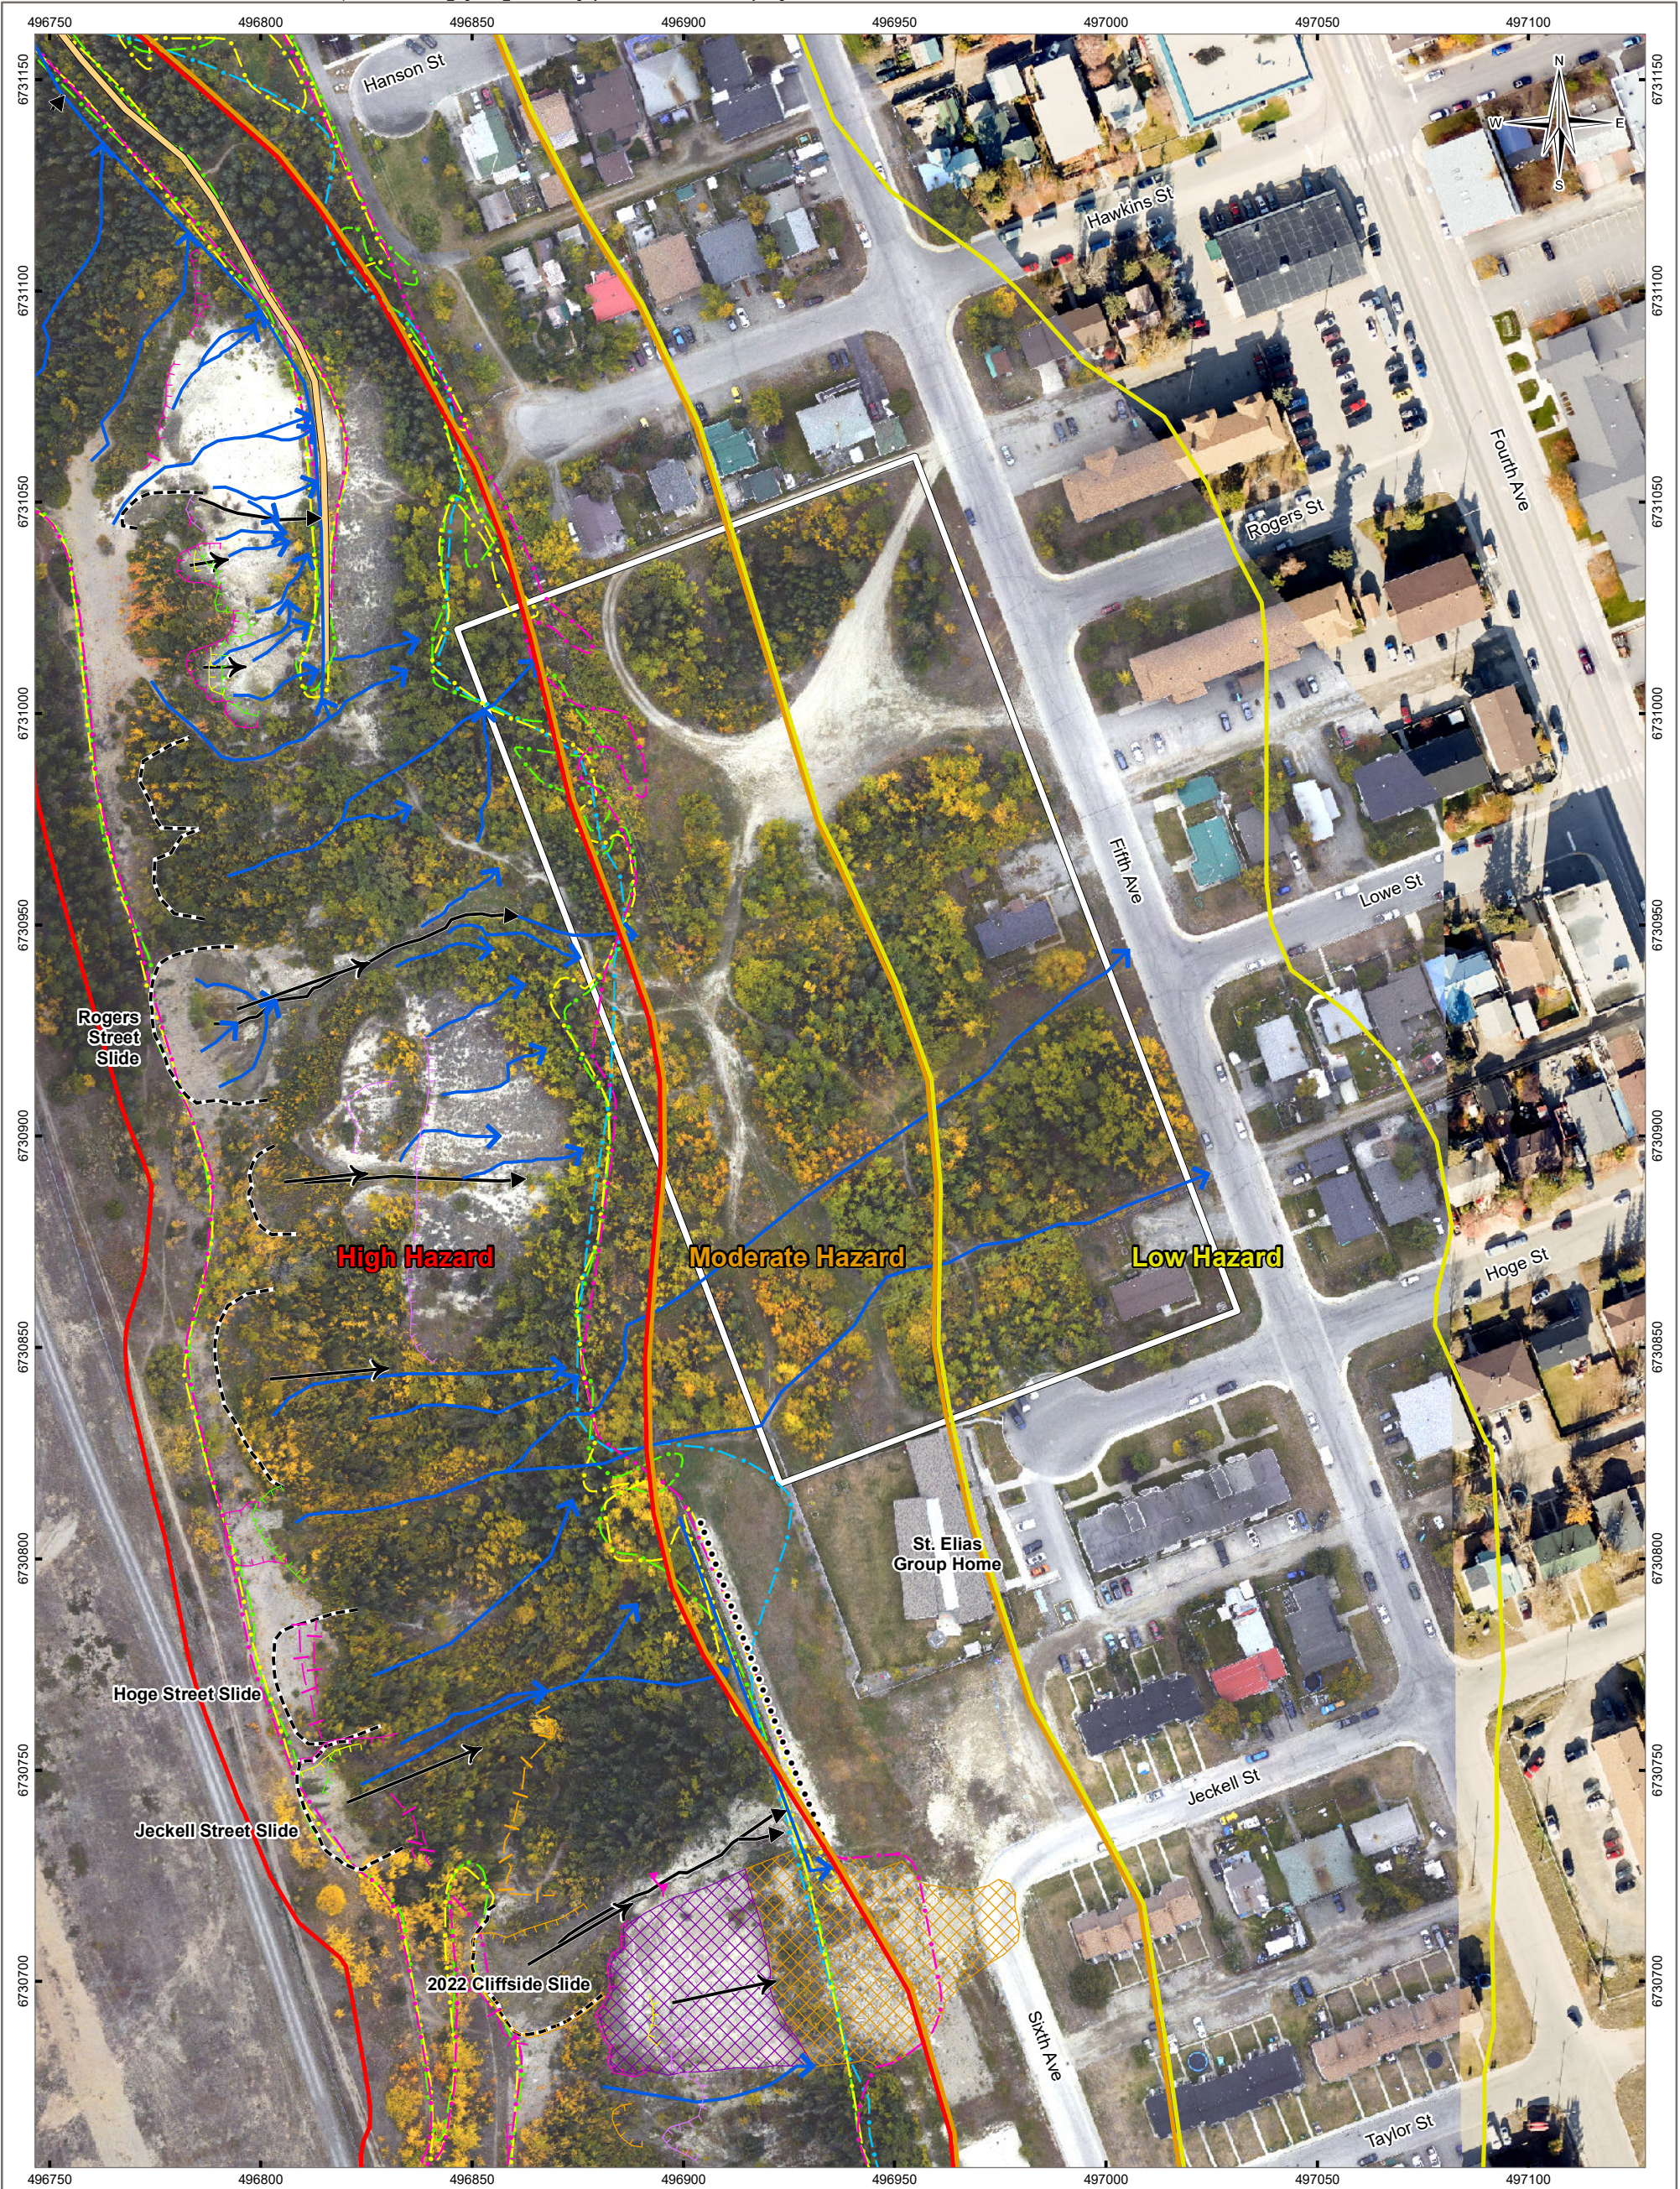
Figure 1

As with Tetra Tech's 2012 study, this historical air photo and LiDAR interpretation study coupled with elevation change detection analysis have determined that no changes are warranted to the 2002 Landslide Hazard zones at the 5th and Rogers parcel. The Escarpment slopes continue to show expected active thaw-flow slides and erosion and mass movement are ongoing at a manageable and predictable rate that reflects the landslide hazard zone and land use guidelines developed by EBA in 2002.

The parcel at 5th and Rogers is located mostly within the Low Hazard Zone (50% of parcel area) and Moderate Hazard Zone (46% of parcel area), with the exception of the northwestern corner that is at the boundary of the High Hazard Zone (4% of parcel area).

2022 Imagery
Slope Instability Feature Interpretation
and Landslide Hazard Designation

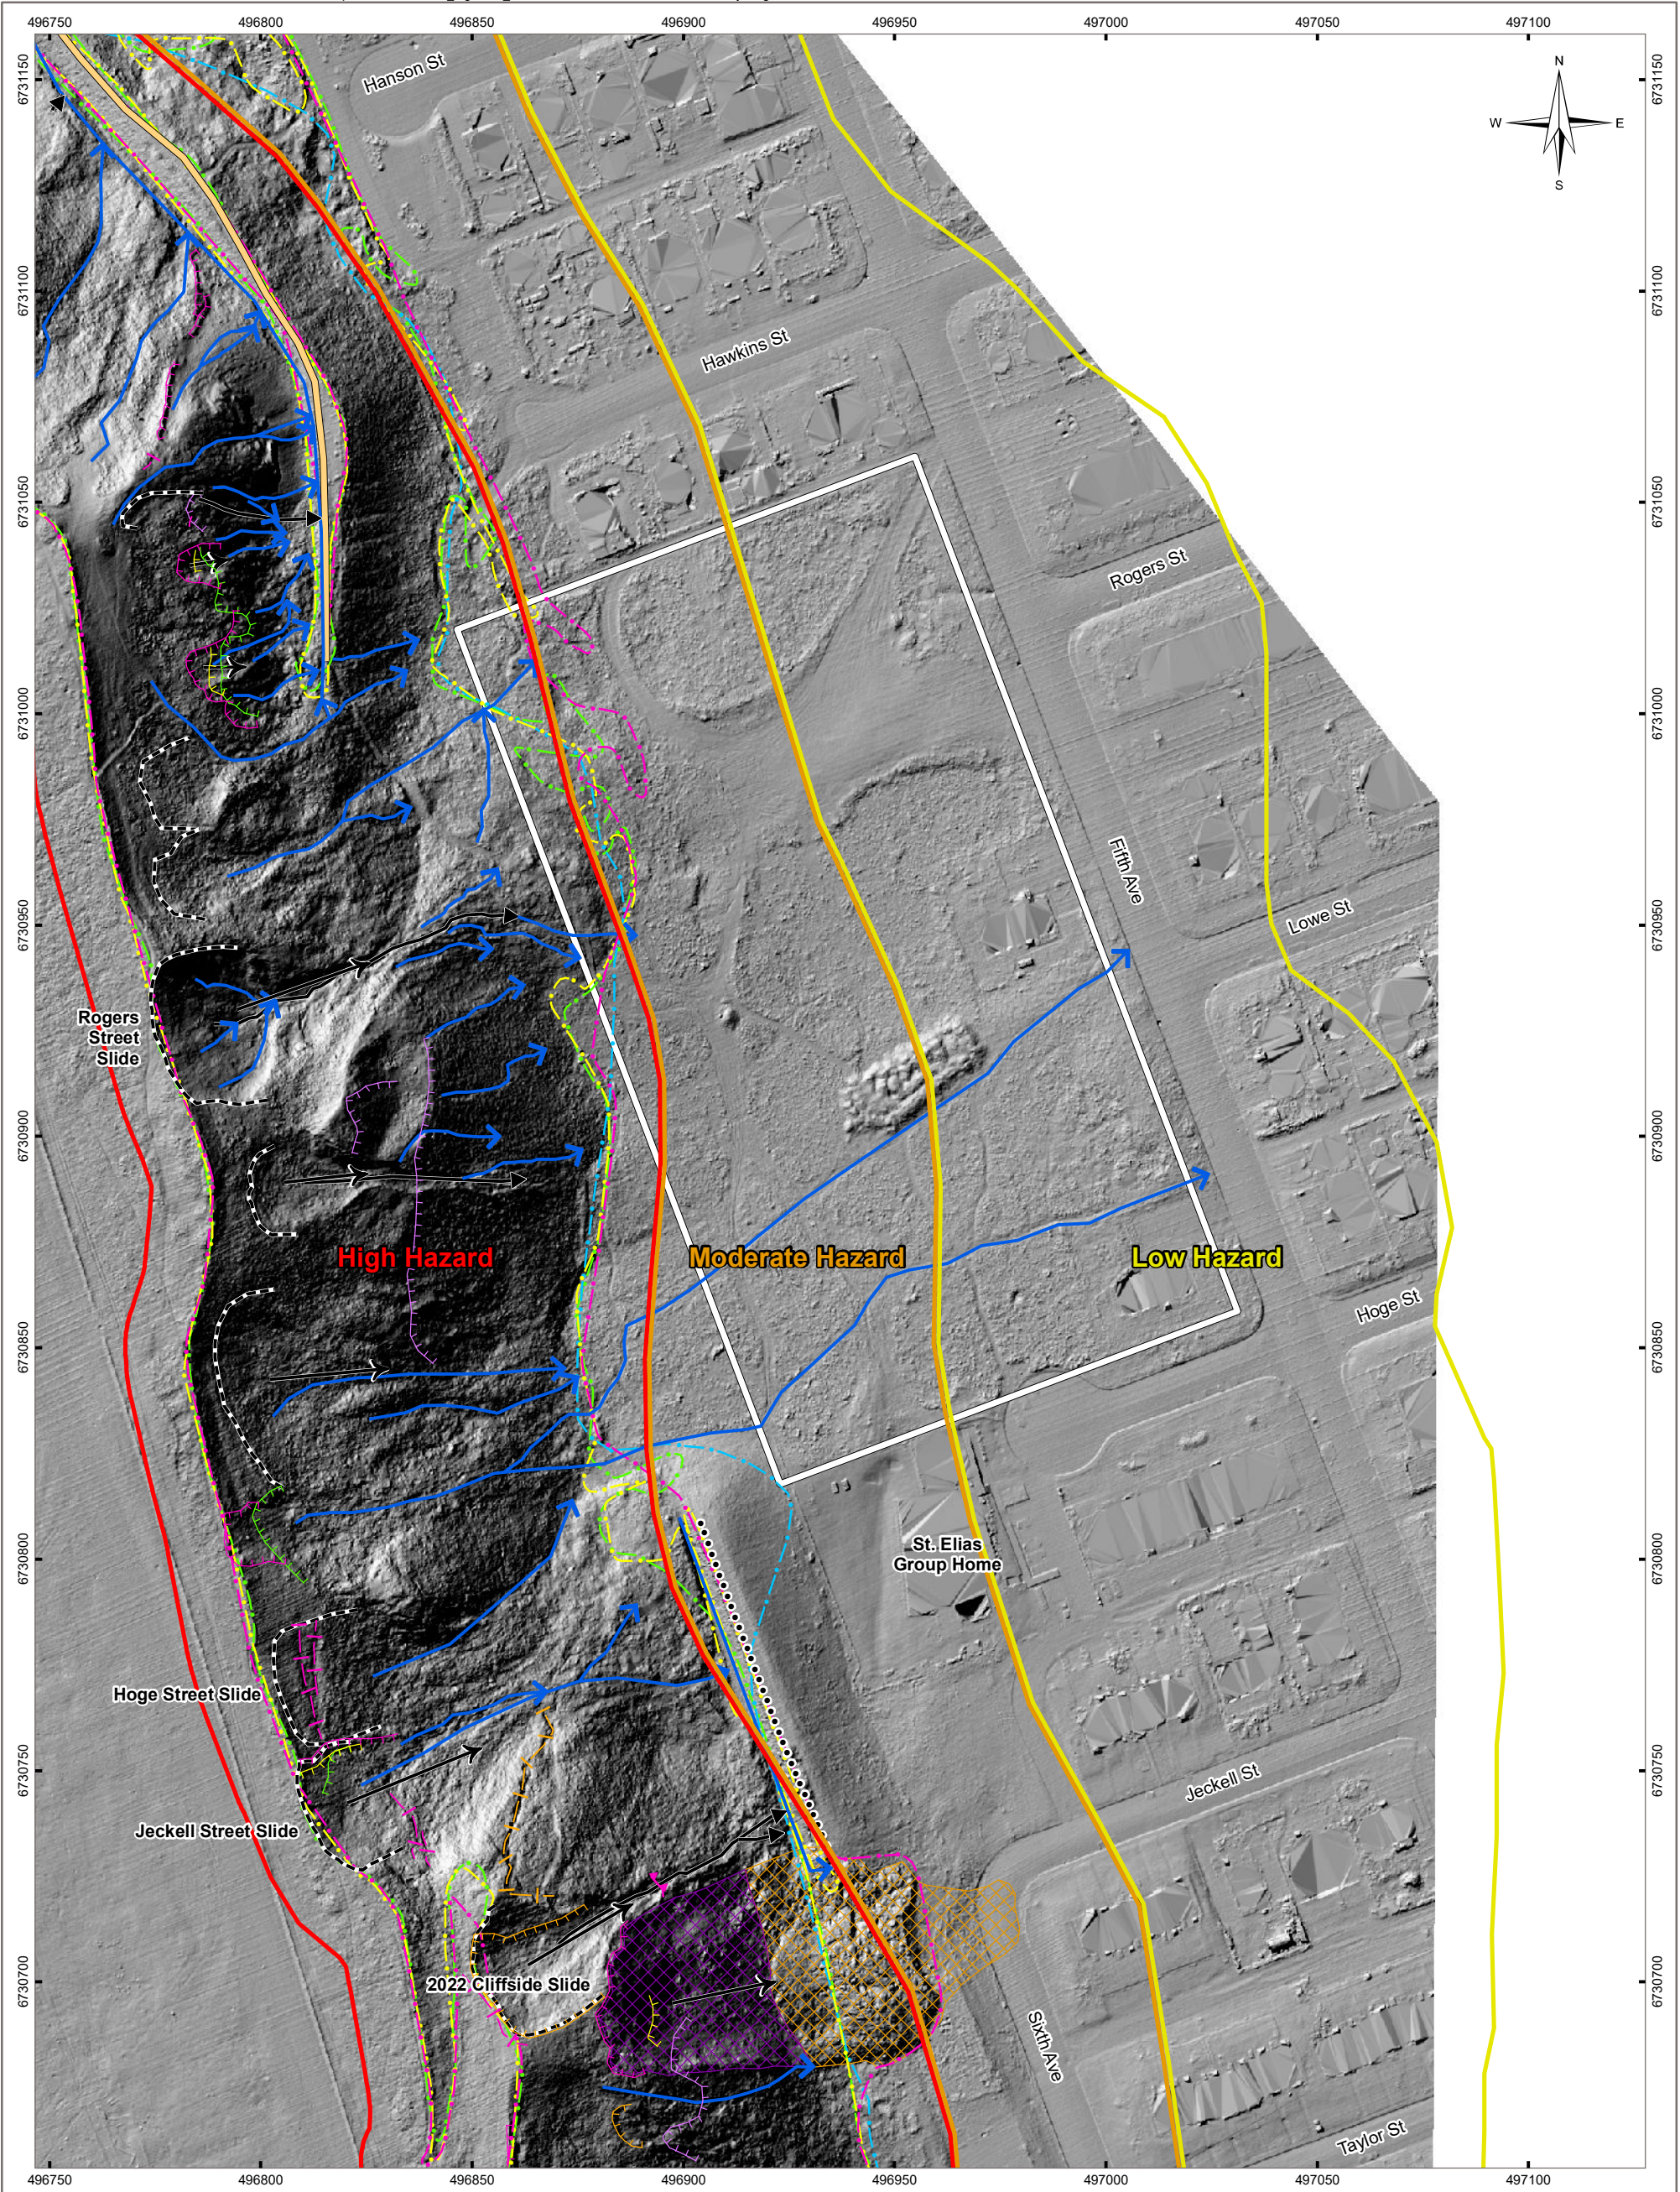
2022 Bare Earth Shaded Relief Digital Elevation Model
Slope Instability Feature Interpretation
and Landslide Hazard Designation

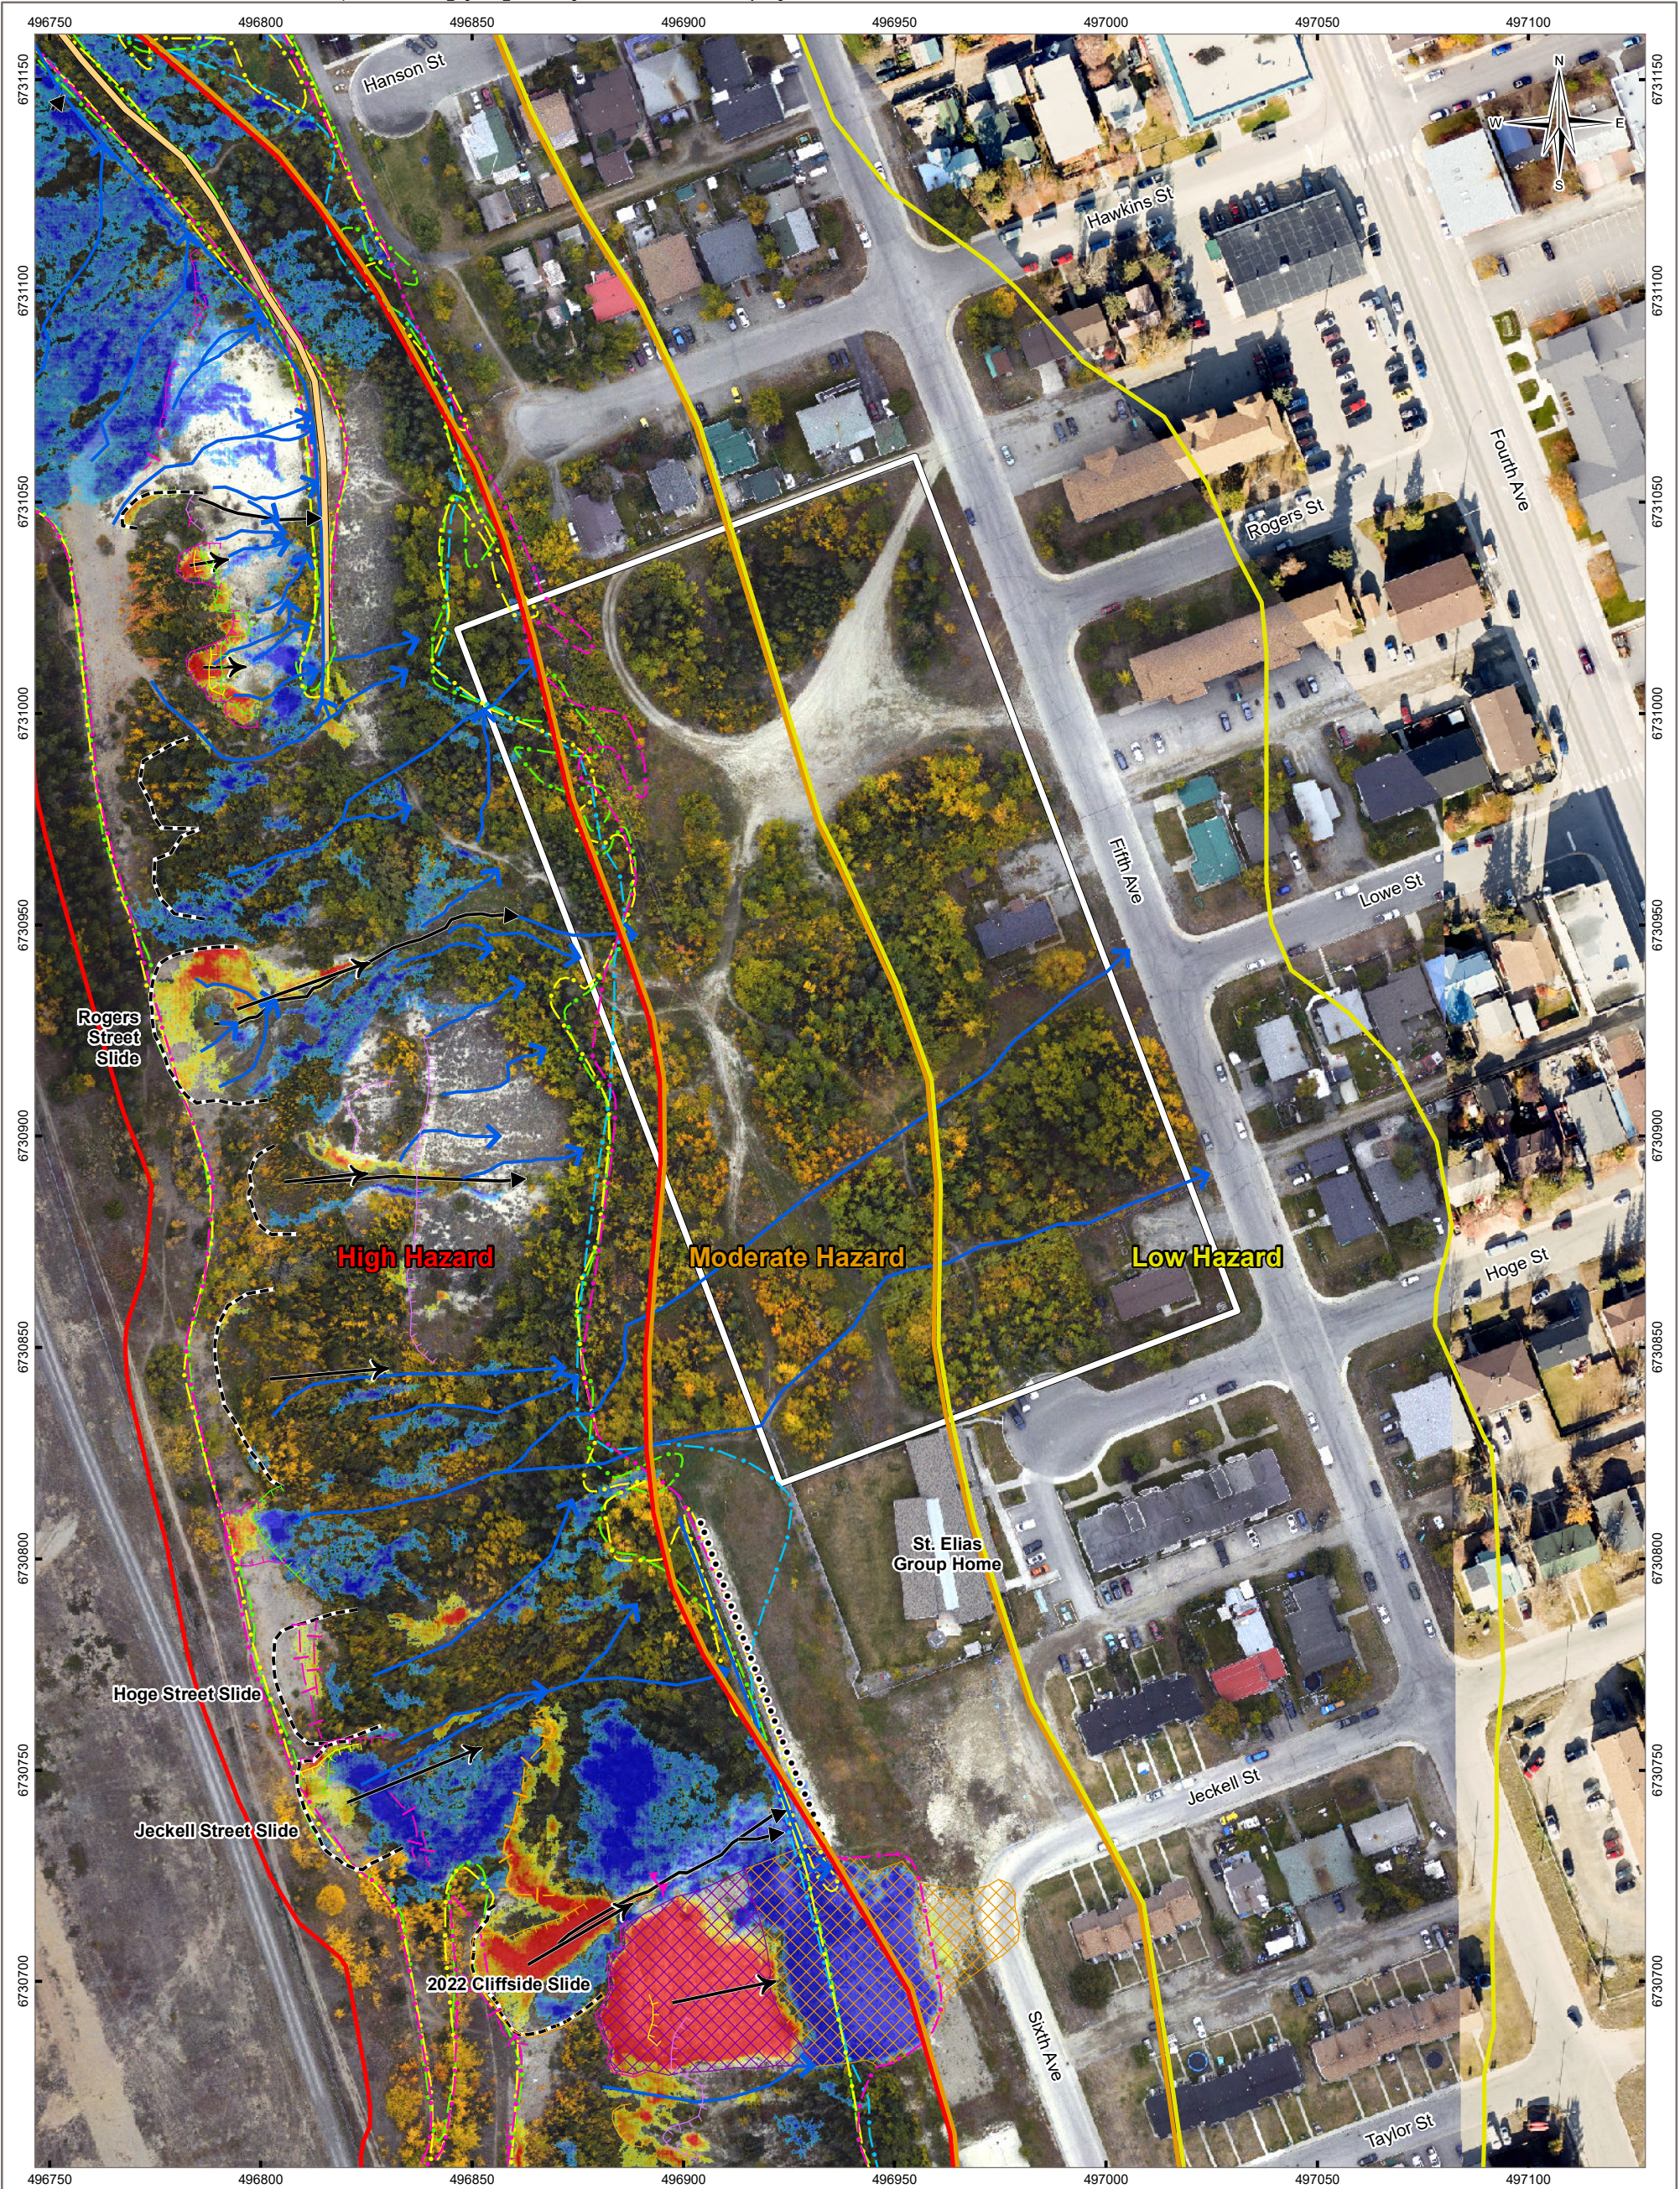
Figure 4

This analysis also determined that the Escarpment toe at this location has transitioned eastwards by up to approximately 50 m since 2019. Although the area is still vegetated, given the nature of the process and texture of the material, the fan is accumulating material by continual seepage from upslope backscarp faces. Significant flow of sediment-laden water is visible flowing down the slope and into the west side of the subject site during the spring. Significant precipitation events may have the potential to increase the volume of material and possibly cause damage to property.

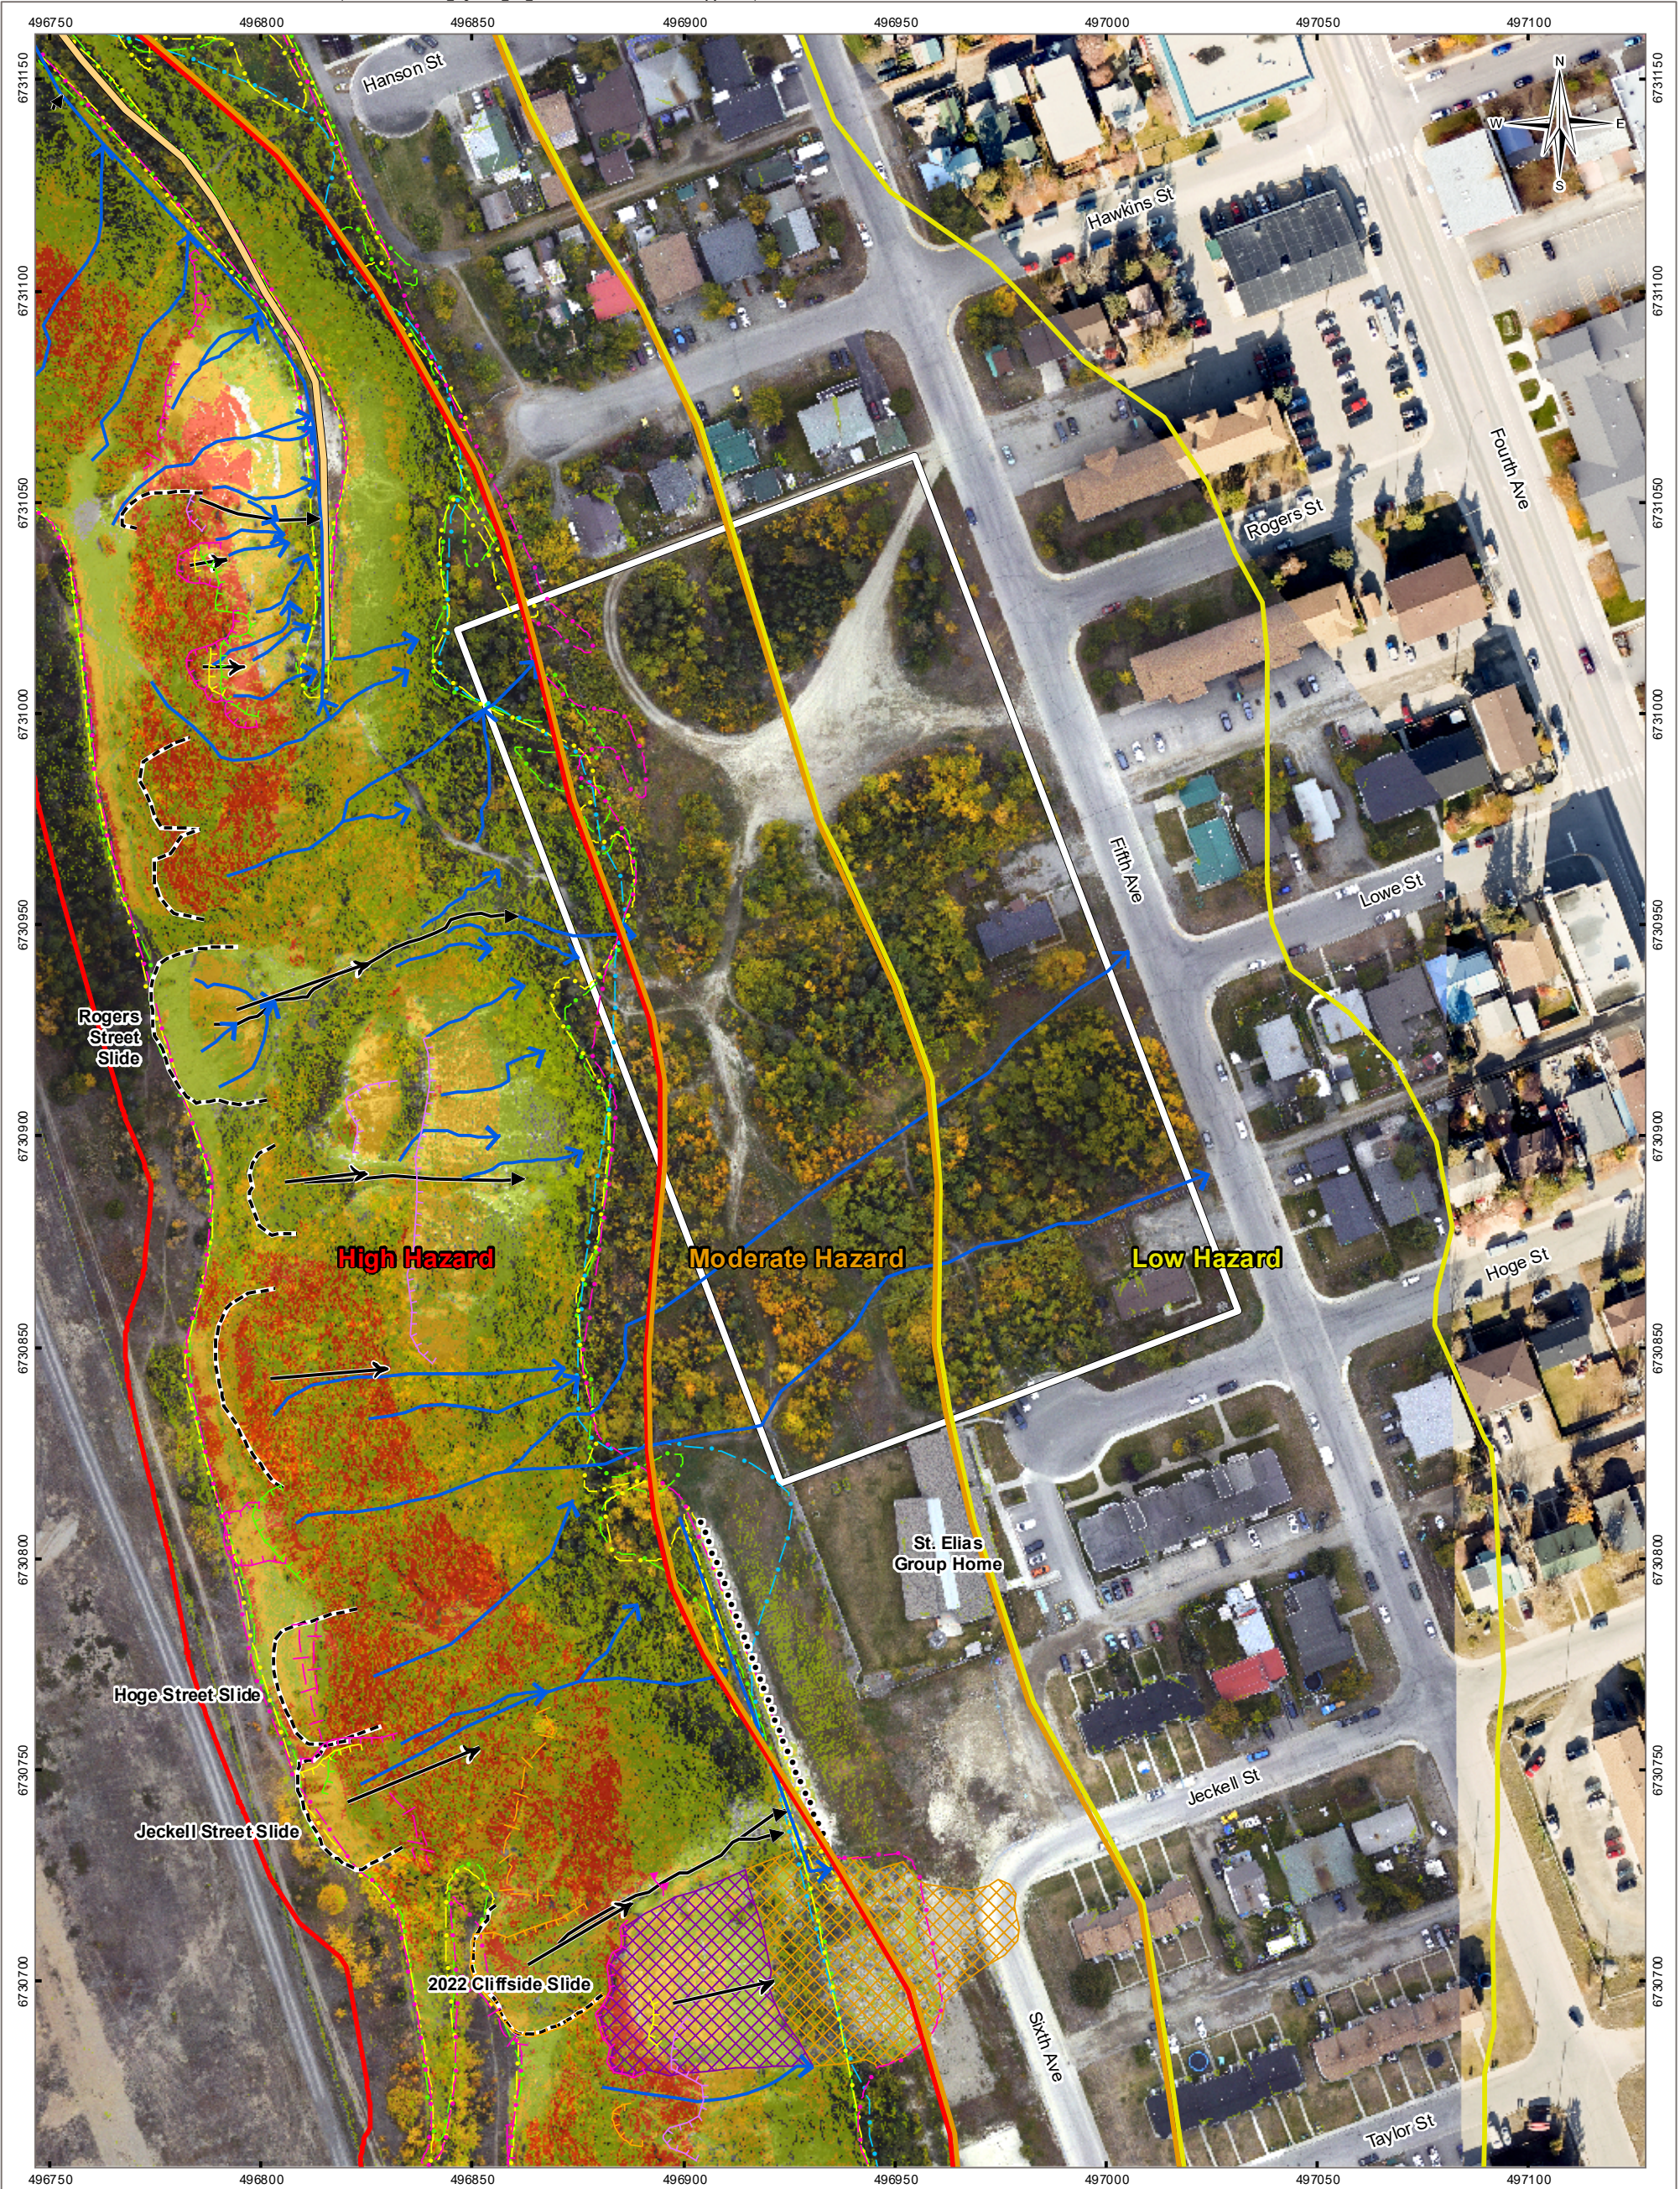
Figure 5

In general, most of the Escarpment slope above the 5th and Rogers parcel is within the low and moderate slope susceptibility hazard model indices using both FR and GLM outputs. The slopes at the northern (north of Rogers Street) and southern (south of Lowe Street) extents of the parcel area show high susceptibility, corresponding to terrain conditions and slope instability feature mapping described in section 3.1. High susceptibility hazard was modeled at the sand/silt interface, approximately three quarters of the way up the Escarpment, extending downwards to approximately the middle of the Escarpment, and is generally focused within historic headscarps.

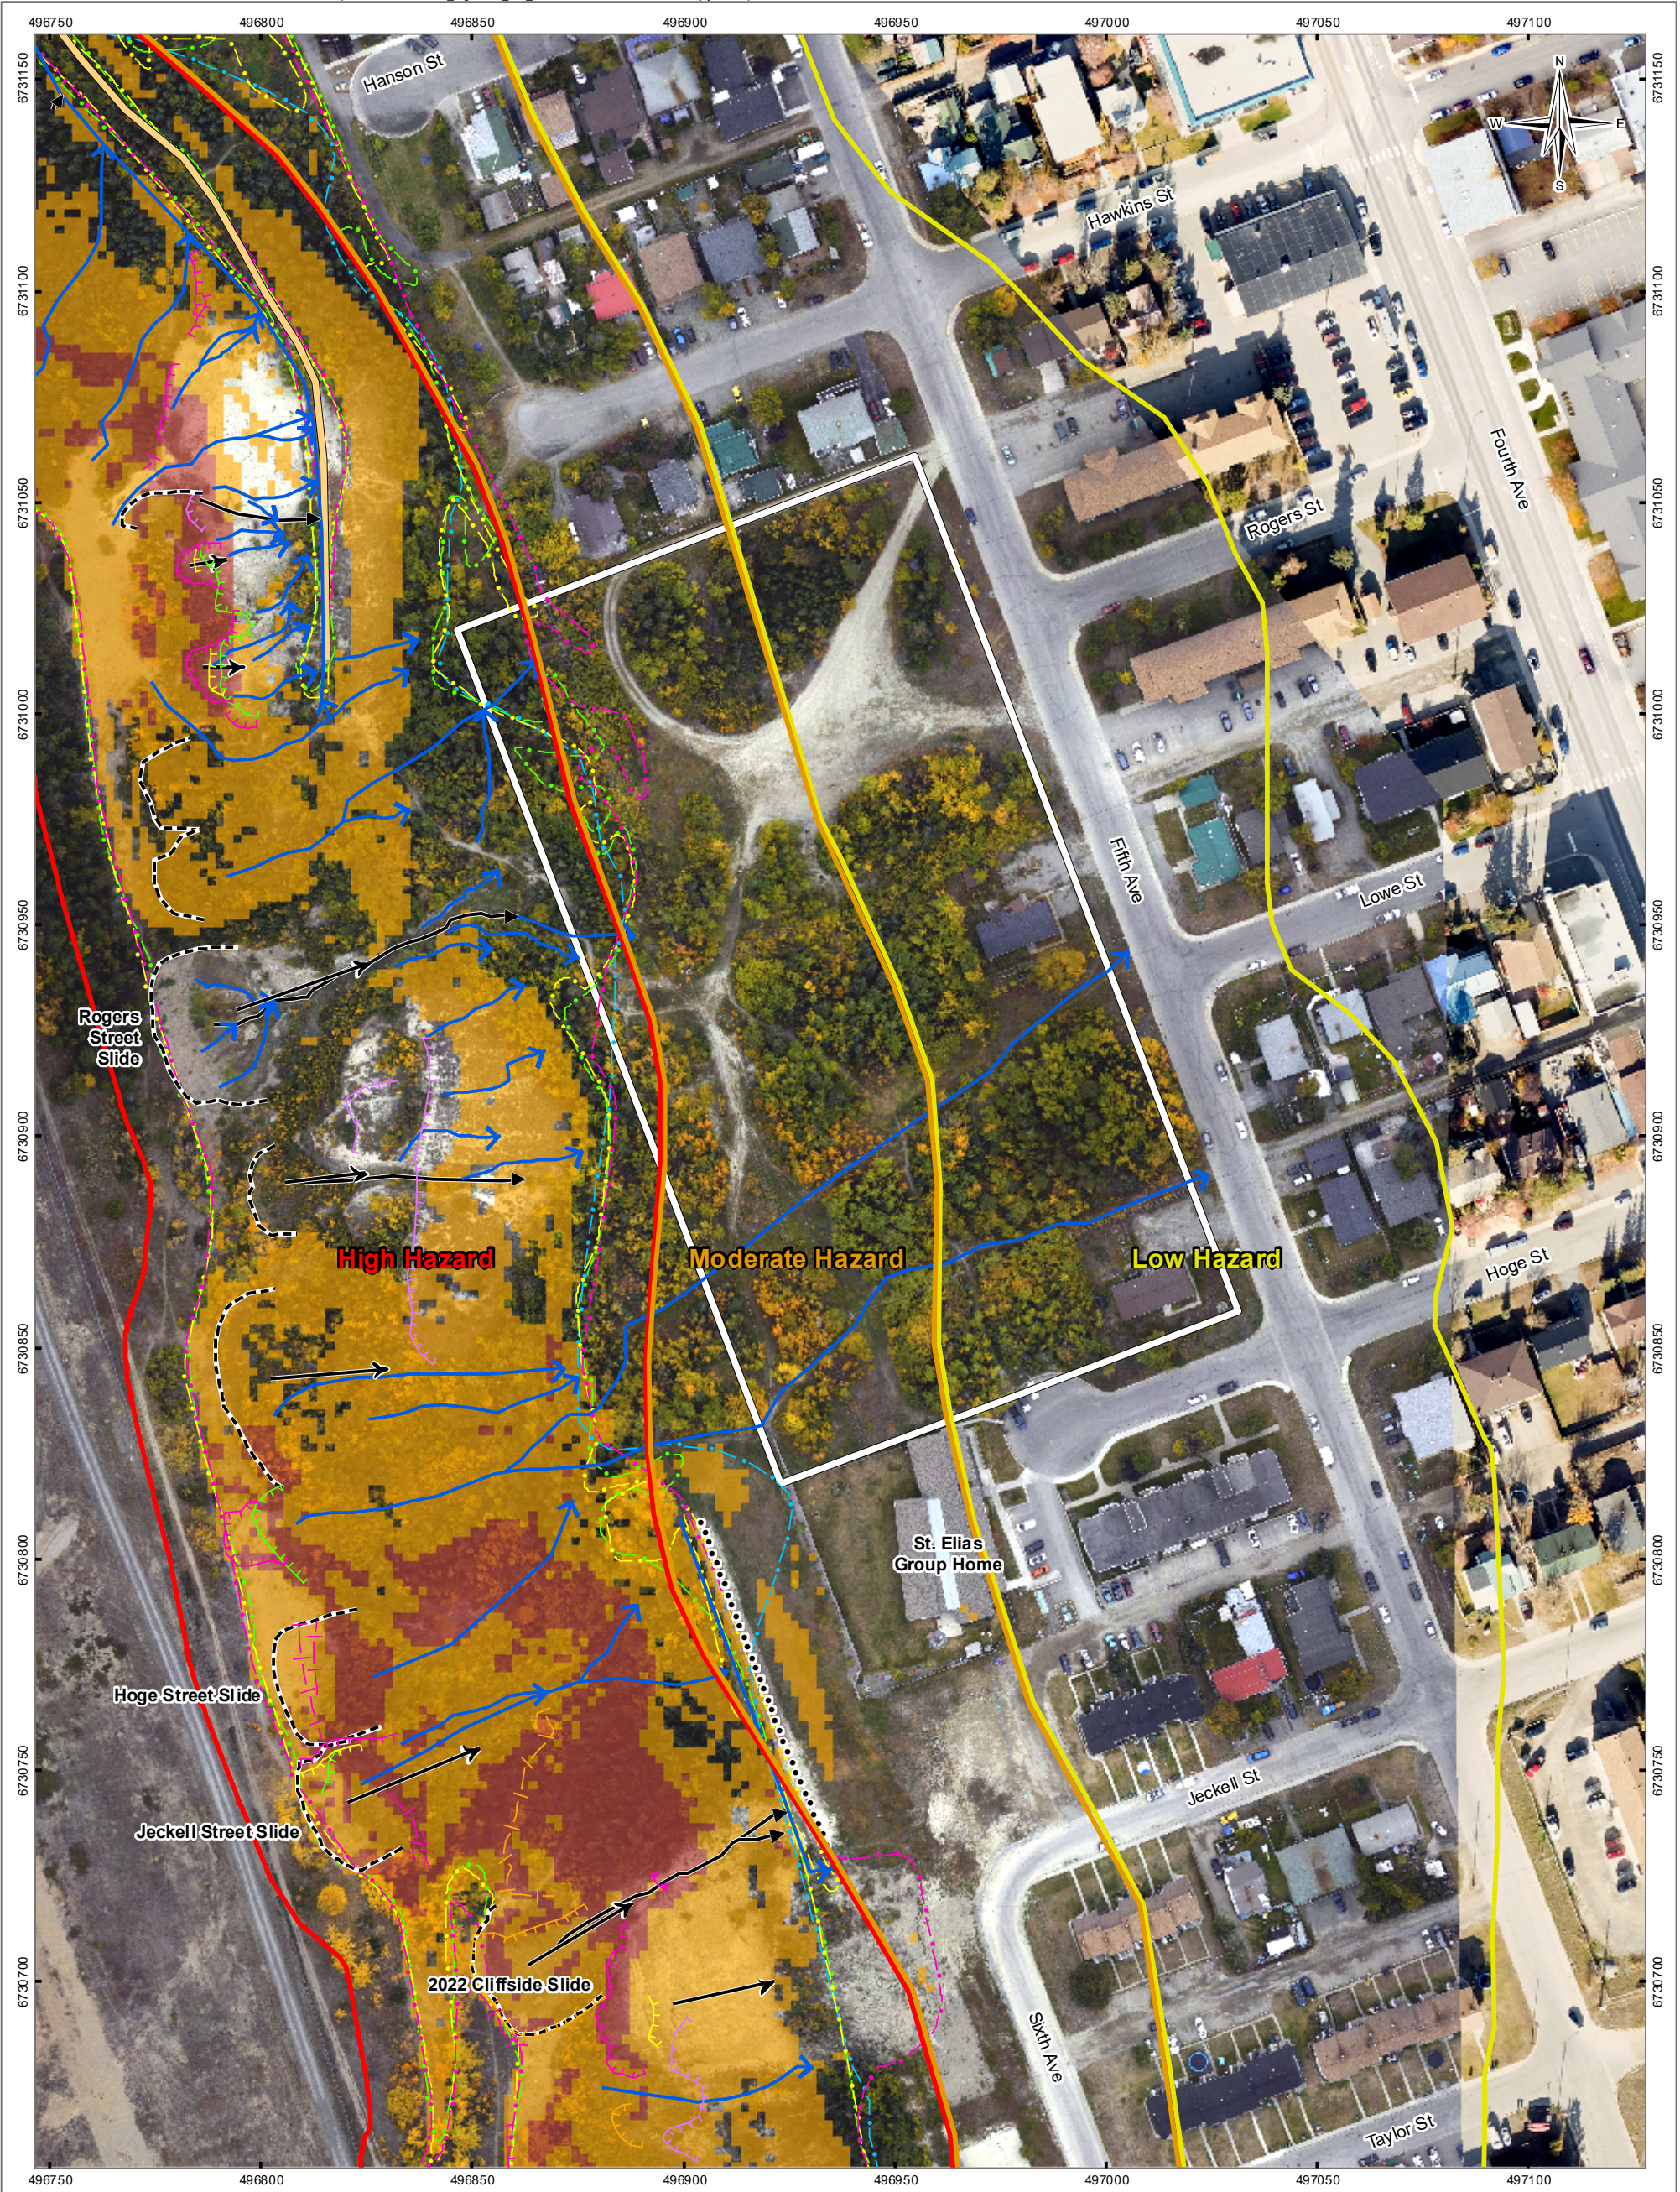
The resulting model was then used to predict the probability of slope failure under specific conditions. The output from the GLM model for the parcel is presented in Figure 6.
