ENHANCED “NATURAL” INCREMENTAL REMEDIATION APPROACH FOR A FINE-GRAINED BORROW PIT IN THE NORTH

Jim Cassie¹, P.Eng. and Geoff Claypool, P.Eng.
BGC Engineering Inc., Calgary, AB

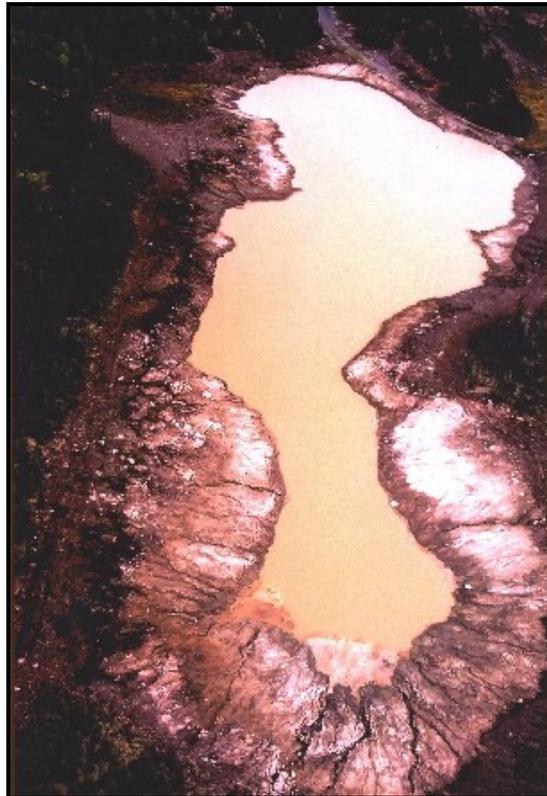
In addition to pit water high in TSS and turbidity, several areas around the borrow pit exhibited indications of permafrost degradation. Observations of tension cracks, settlement troughs, collapsing vegetation covers and slumping of pit walls indicated that permafrost degradation has occurred. Several significant erosional gullies at the south and west sides had formed, providing sediment load to the pond. Figure 2 provides an aerial view of the borrow pit before any remediation works were initiated.

Figure 2: Aerial view looking north of borrow pit before remediation (Summer 2001).

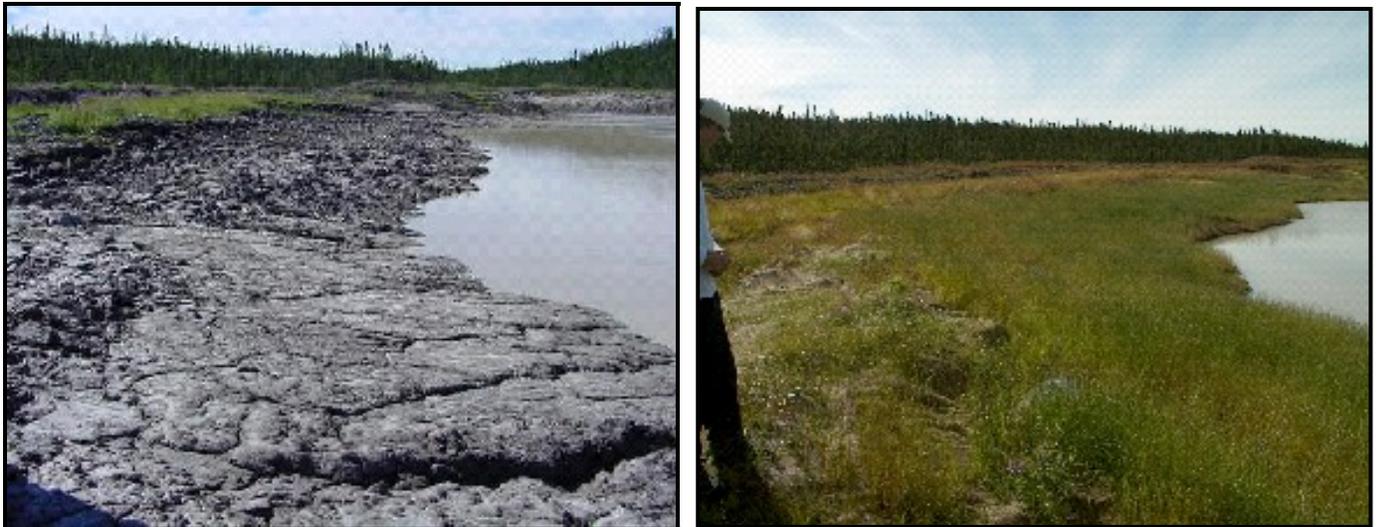
- Re-vegetation around the pit appears to be developing well. The majority of the previously disturbed ground surface is now re-vegetated, as shown on Figure 3.

Figure 3: Comparison of vegetation along borrow pit shoreline prior to vegetation enhancement (August 2002, left) and after vegetation enhancement (August 2003, right).

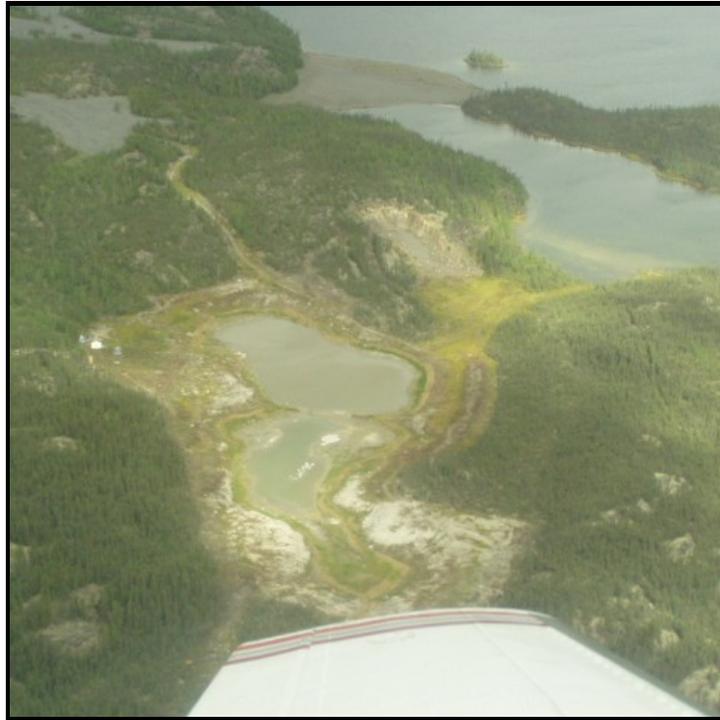
In summary, the previous rehabilitation work, coupled with dry conditions this year, have progressed the remediation condition of the borrow pit. Figure 4 provides an aerial view of the borrow pit showing the progress of the re-vegetation efforts. The dry weather, however, has also led to decreased seed germination rates for the seed spread in 2004. The advancing thaw front has caused additional thaw settlement at the northeast corner of the pit.

Figure 4 Oblique aerial photo of the borrow pit, looking north (August 23, 2004).
