# **BREACHING OF THE FRESH WATER SUPPLY DAM AND RECLAMATION OF THE FORMER RESERVOIR, FARO MINE, FARO, YUKON**

**Gerry Ferris**

**Cam Scott**

**Dana Haggar**

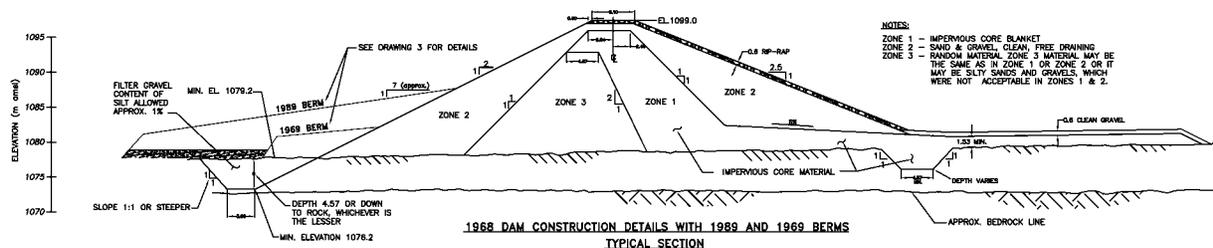
Figure 2 Cross Section of the Fresh Water Supply Dam

Seepage was noted at the downstream toe of the FWSD immediately following first filling of the reservoir, during the 1969 freshet. The near-surface groundwater table and anticipated increase of pore pressure from the construction of the dam lead designers to expect seepage to occur at the downstream toe of the dam. Shortly after construction was completed, the appearance of seepage and accompanying sand boils lead to the design and construction of a downstream toe drain/berm in 1969. The location of the berm is shown in plan on Figure 2. The designers noted that the total amount of seepage observed at the toe was less than expected.

Following a stability assessment in 1988, another toe berm which included drainage measures, was placed for enhancement of the downstream slope stability. The berm addition contains a preferentially pervious lower section (0.5 m thickness) that provides discharge capacity for artesian seepage. The 1989 toe berm was 55 m long, approximately 7 m high at the original toe of the dam, and slopes downstream at 7.5H:1V to a seepage collection trench at the toe.

Significant longitudinal cracking has been encountered on the upstream side of the dam crest for nearly 20 years. Investigations indicated that the cracking was attributable to frost action on the upstream face and crest of the dam. The investigation traced the cracks to a depth of almost 2 m.

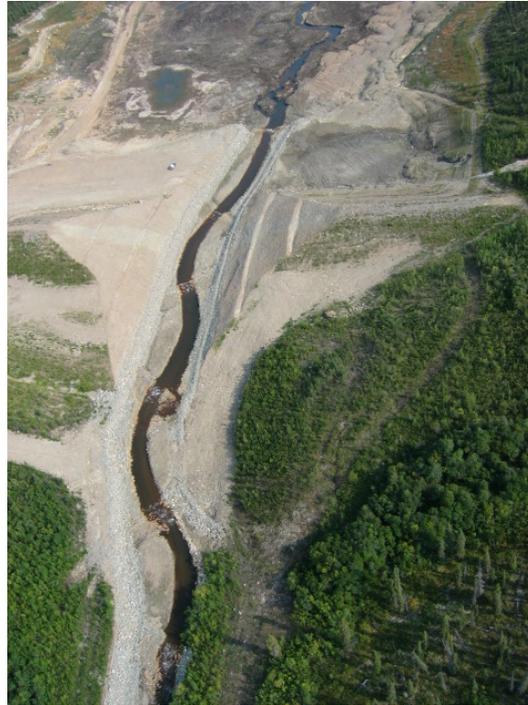
*Figure 5 View of the completed breach, Summer of 2004.*

In general, the channel section through the breach worked as designed. The majority of the creek flow was concentrated in the channel section, even during the highest flow period of 2004. During the high flow period, erosion of some of the soil placed on top of the riffles and inlet structure occurred, as shown in Figure 5. Additionally, some erosion occurred along the edges of the channel; this level of erosion was expected and was allowed as part of the adaptive management scheme for this project.
