2008 Reconnaissance-level landform grading field investigation at the Faro Minesite

SRK Project #: 1CY001.015 Task 004 // BGC Project Number: 0533-002

Final report May 26, 2009

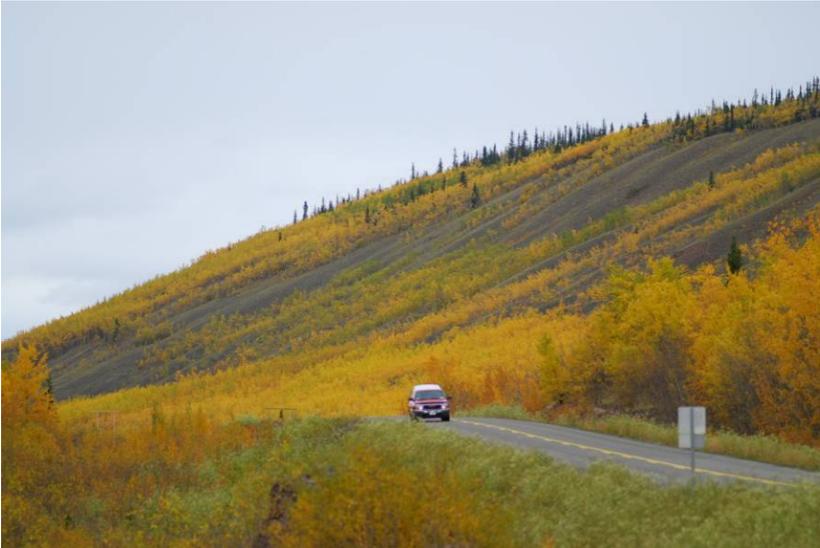
Location	Observation	Photo	Landform design implication
<p>First stop, slopes 110km north of Whitehorse</p> <p>GPS 701 61.620N 135.87W Elevation 2200ft (670m) NTS 105E12</p> <p>Near Klusha Creek, Conglomerate Mountain Yukon Highway 2; Klondike Highway 110km north of Whitehorse 150km SW of Faro Minesite ~5km south of South of Twin Lakes campground</p>	<p>Corrugated slopes on a large scale Slopes are steep and roughly linear top to bottom Subtle ridge and swale topography Large mounds on the slopes Some solifluction like rock strips near heads of slopes Aspen vegetation in the swales Some bedrock cored Approx 2 to 4m high ridges, perhaps 20m spacing Concave toe (probably) hidden by trees From topo maps, slopes are 27 to 33 degrees at midslope. West facing</p>

<p>These slopes provide useful analogues to for dozer-sized downslope furrows for Faro waste rock dumps. They provide insight into geometry, soils, vegetation communities and tailored planting, convex toe slopes, and mounds on the slopes. Useful natural analogue for large downslope corrugated slopes.</p>

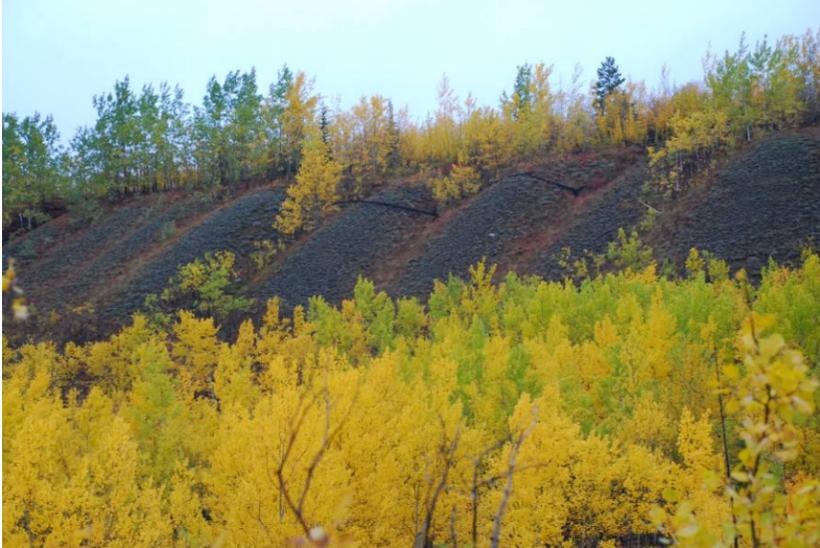
Location	Observation	Photo	Landform design implication
<p>Gullies above Faro townsite GPS 709, 587,072, 6,899,917 Close to gully 562</p>	<p>Show slope analogue, bare upper slopes, good place to bring people out to. Likely very thin soil covers.</p>

<p>This slope provides a useful analogue to for dozer-sized downslope furrows for Faro waste rock dumps. It provides insight into geometry, soils, vegetation communities and tailored planting, convex toe slopes, and mounds on the slopes. Useful natural analogue for large downslope corrugated slopes.</p>
<p>Gullies below Faro townsite (Gully behind townhouse over Pelly River)</p>	<p>28 degree valley wall, trembling aspen forest, glaciofluvial vegetated circular scarp</p>

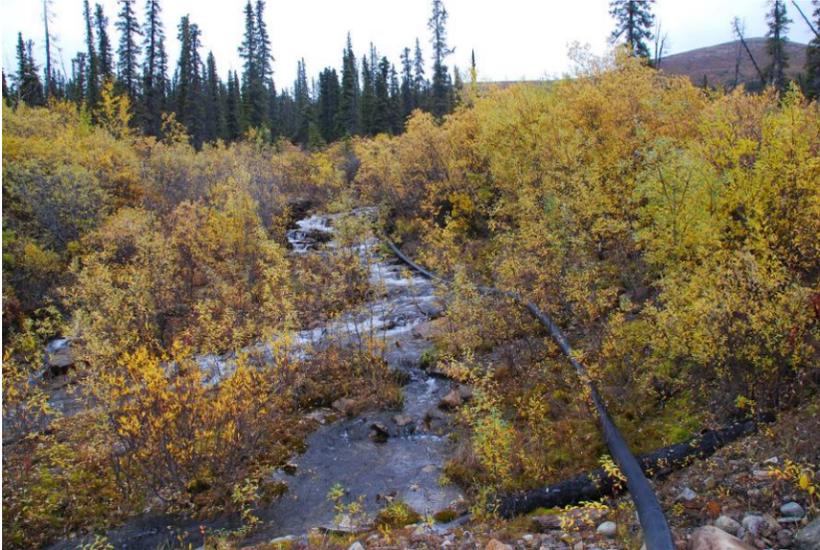
Location	Observation	Photo	Landform design implication
<p>Creeks near the mine 62°18'19.09"N 133°17'51.26"W</p>	<p>Creek near 563 Creek, flowing over rocks. Borrow pit, rounded cobbles in silty sand matrix, 5 to 10mm organic layers, willows – sparse but nice 500usgpm In undisturbed areas, moss hummocks, blue berry, two organic layers. Almost all creeks are naturally armoured with boulders or are underlain by bedrock.</p>

<p>Almost all creeks are naturally armoured with boulders or are underlain by bedrock. Plan to armour all channels. Give consideration to building floodplain and tree islands as in these natural creeks.</p>
<p>Natural area at base of two dump swales just southwest of Faro pit GPS 706</p>	<p>There are some areas of natural veg in the mine area – try to preserve these as seed sources</p>

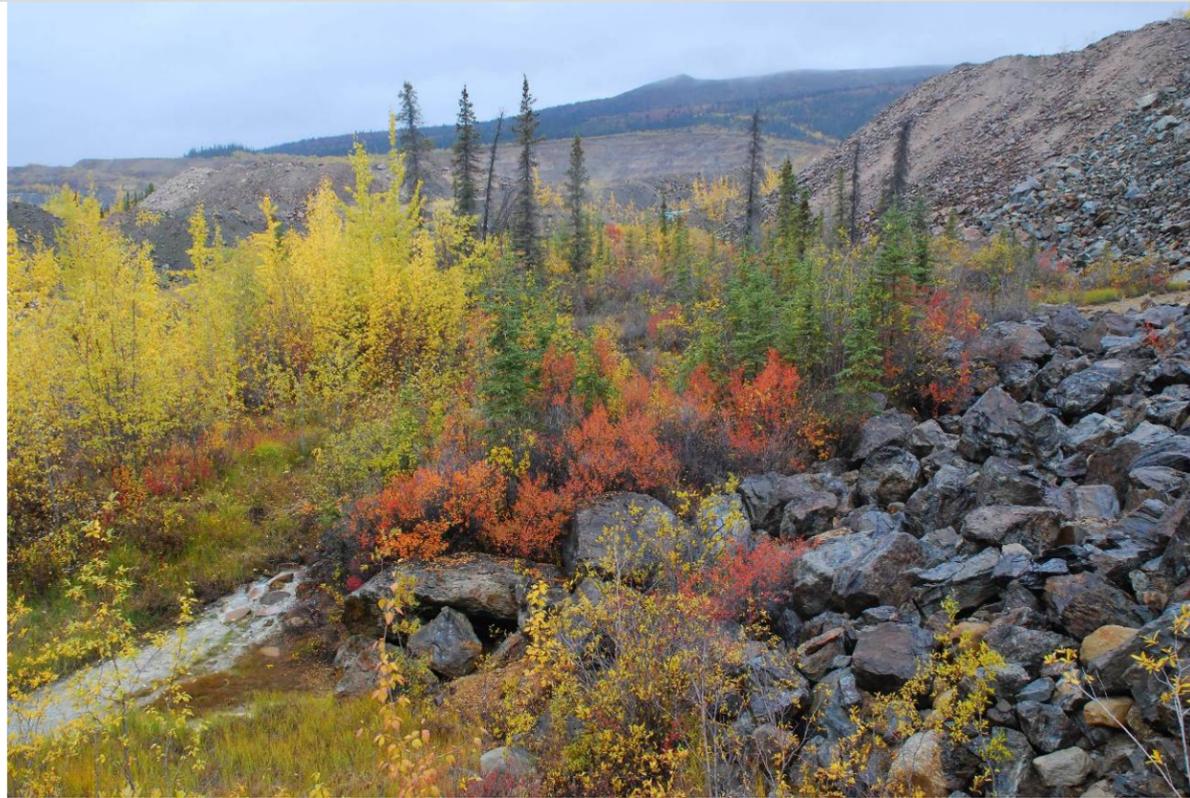
Plate C-1. Natural area and seep at base of angle of repose waste rock dump at Faro Mine. Note segregation and erosion of finer grained angle-of-repose waste rock slope in background and apron of coarse waste rock at base of slope that provides good sediment catchment in the foreground. Landform designs should seek to protect natural areas within the disturbed footprints as mature “islands” that offer seed sources and some habitat.

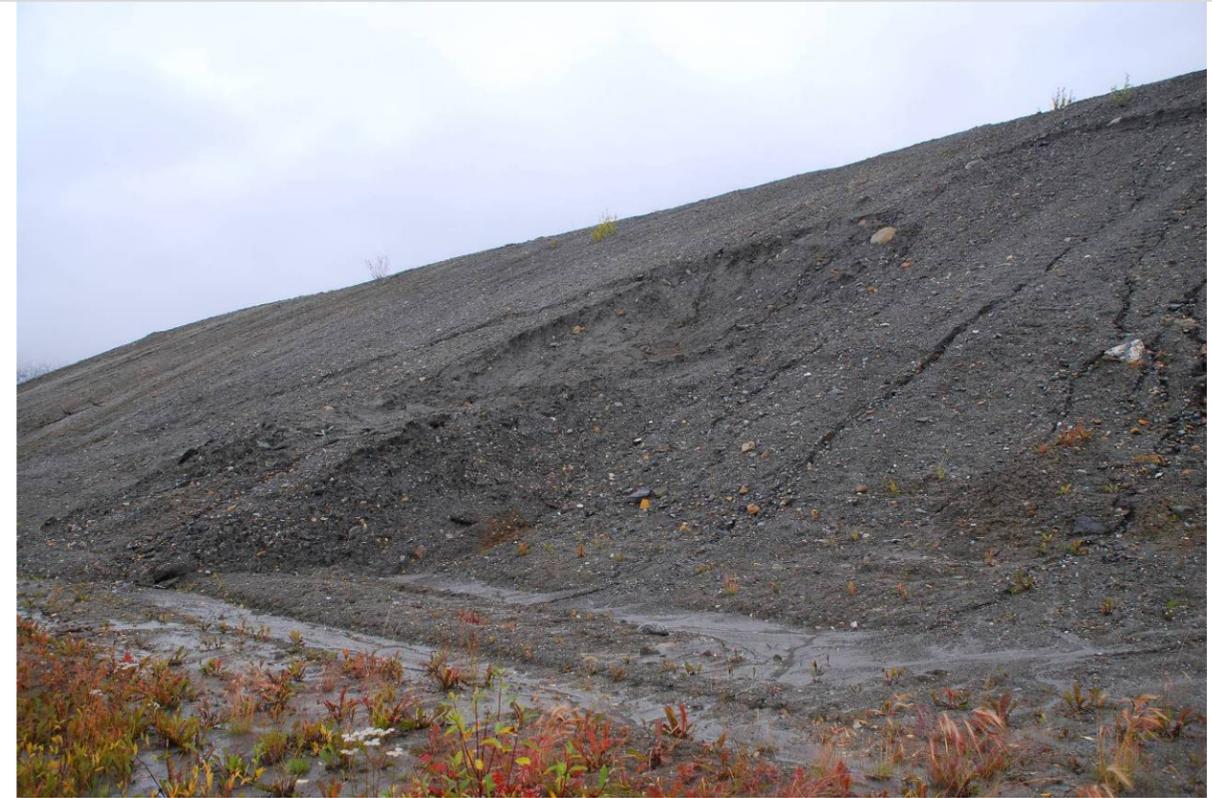
Initiation of small slump in resloped dump	There is the headscarp of a slump in the lowest bench of the resloped capped Vangorda dump. The cause of this slump needs to be investigated and the slope needs to be repaired. The slump may be due to foundation conditions, water table conditions, and something related to the waste rock or till cover.	Understand the cause of the slump to see if it is due to local conditions (more likely) or whether the slope is generally too steep (less likely)
	Gully depth in low k cover should not exceed cover thickness	Seems obvious, but has major implications and forms perhaps one of the most major design criteria.	Need to design critical covers not to gully and be prepared to fix gullies as they develop.
	Set up for seepage collection drain buried, allows surface water to shed to natural environment (Sketch p 84 notebook). Diverse forest here at 1130masl (ELEVATION CONTROLS?), pine, alder, willow, black spruce, quite a lot of pine	Real problems with overcompaction or other digenesis of placed till. Needs to be formally ploughed and planted right away Designs may be elevation sensitive (different designs for high areas vs low areas of site)

Plate C-2. A small slump in on the resloped till capped Vangorda waste rock dump. Note scarp of larger slump in upper right hand corner of the photograph. Note also the near lack of vegetation on this resloped dump even after many years of recolonization and the formation of small rills and accumulation of erosional debris in small fans at base of slope. The geotechnical stability of all slopes is an important design element.

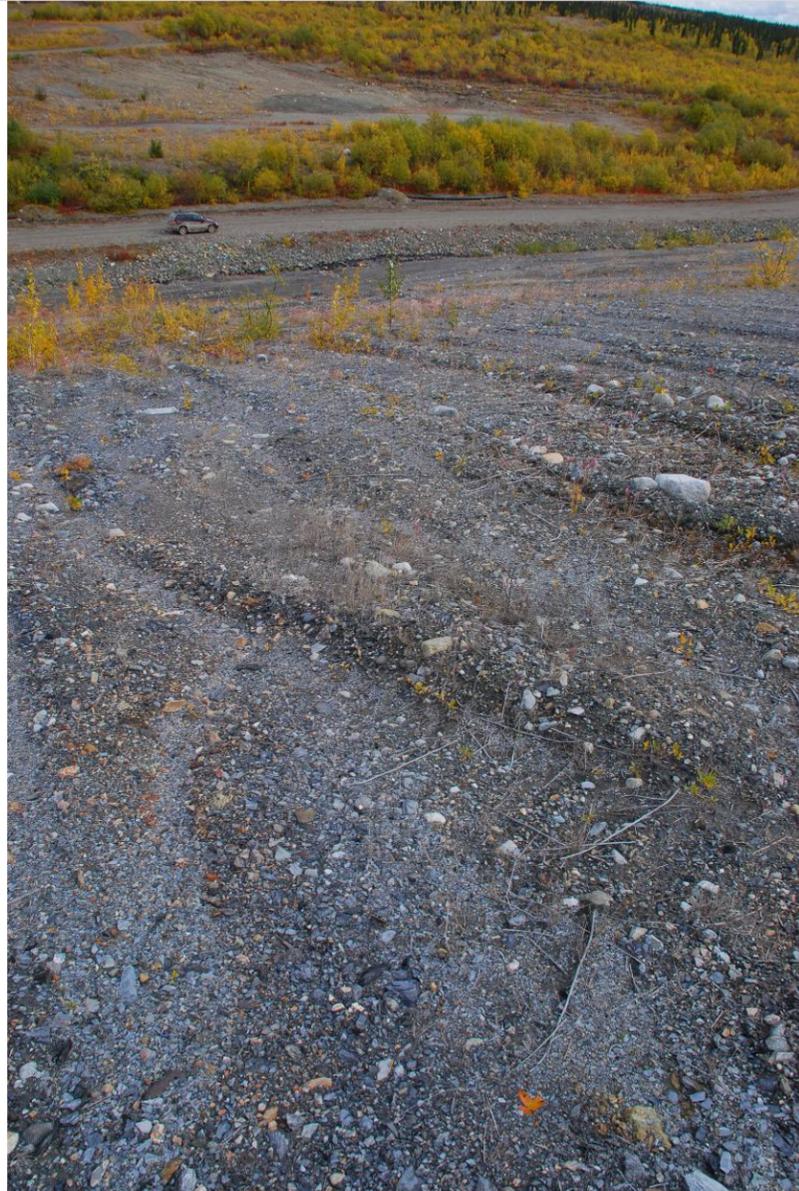
Plate C-3. Rilling on north dump of resloped overburden dump. Erosion rates are much faster where slopes exceed a threshold of about 20 degrees (3H:1V).

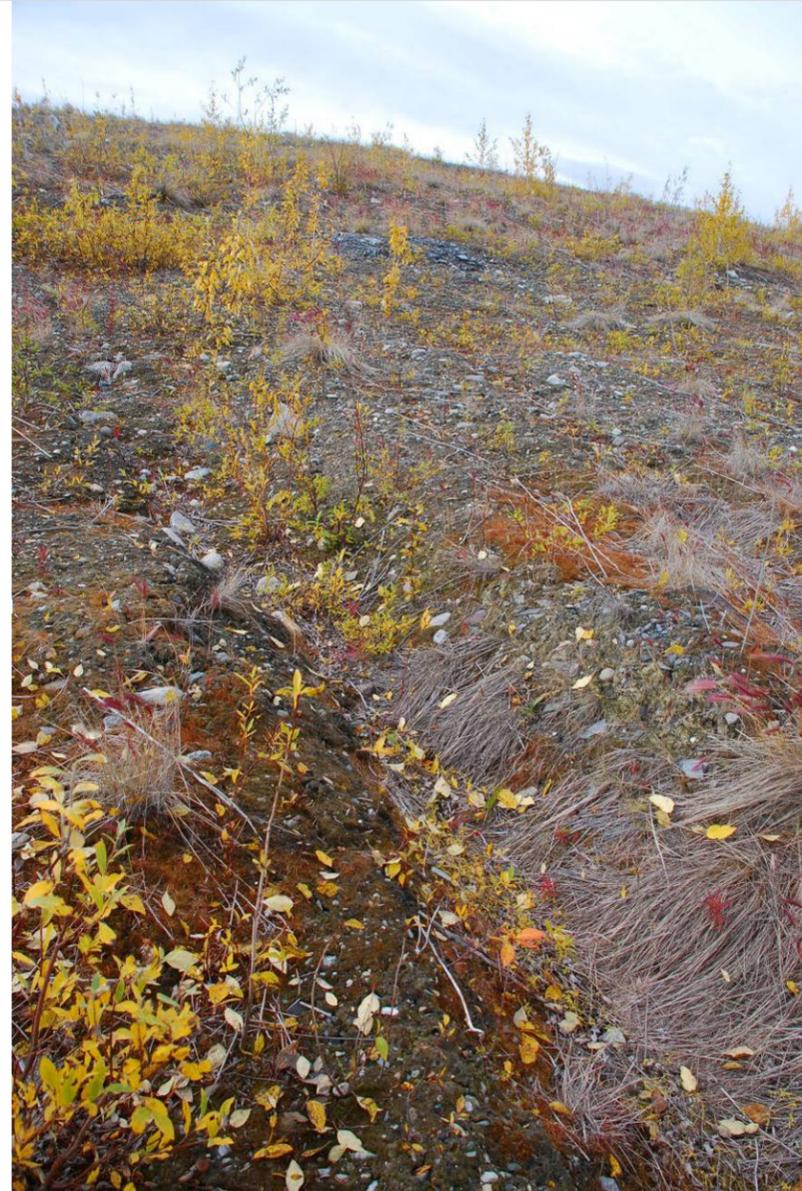
Plate C-4. A small gully, partially stabilized on the north slope of the overburden dump. This is some of the densest vegetation growth on the dumps, yet is still sparse.

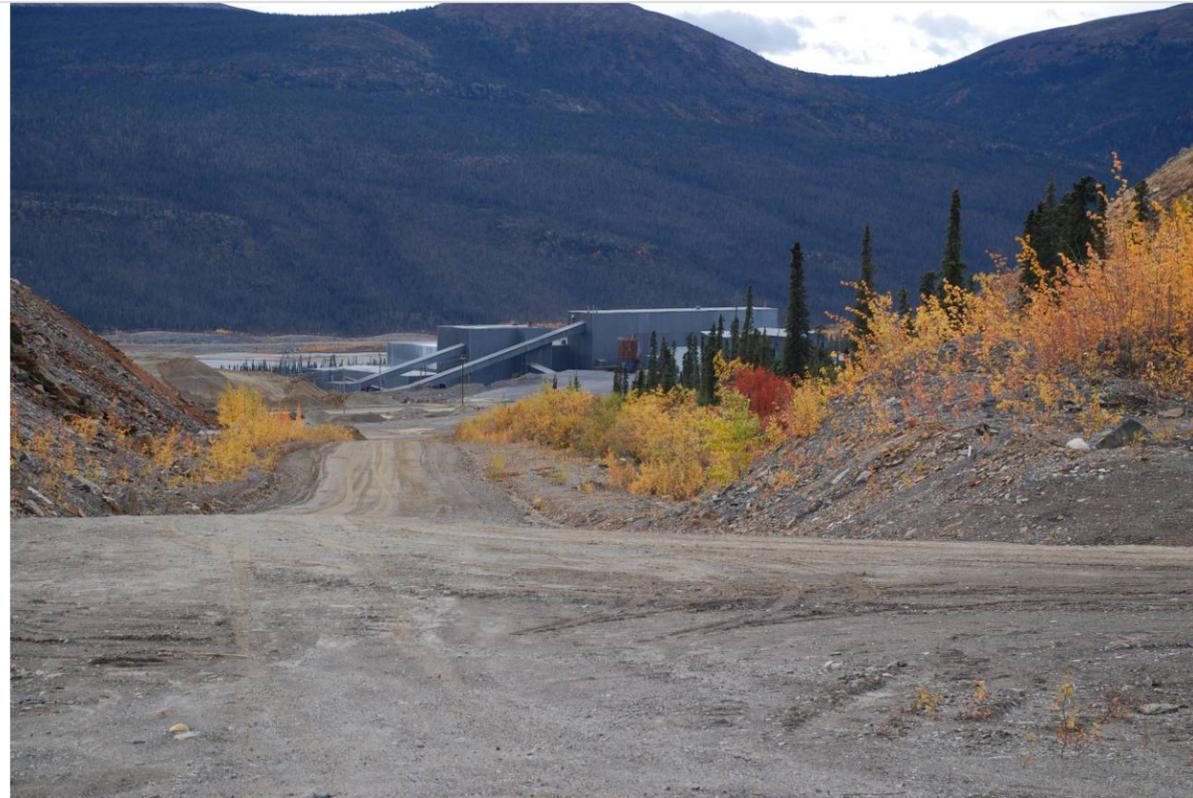
Plate C-5. Roads can be converted into channels to drain the dump areas

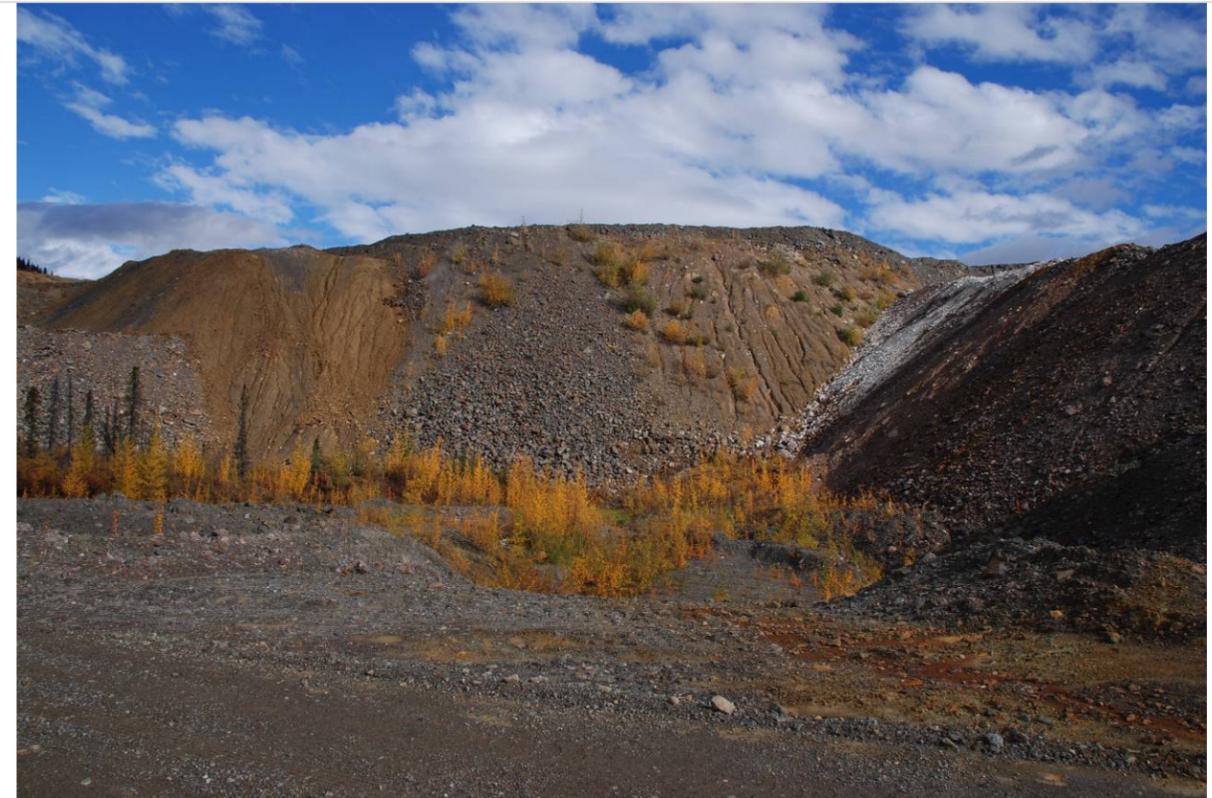
Plate C-6. The grain size of the rock at repose plays an important role in erosion.

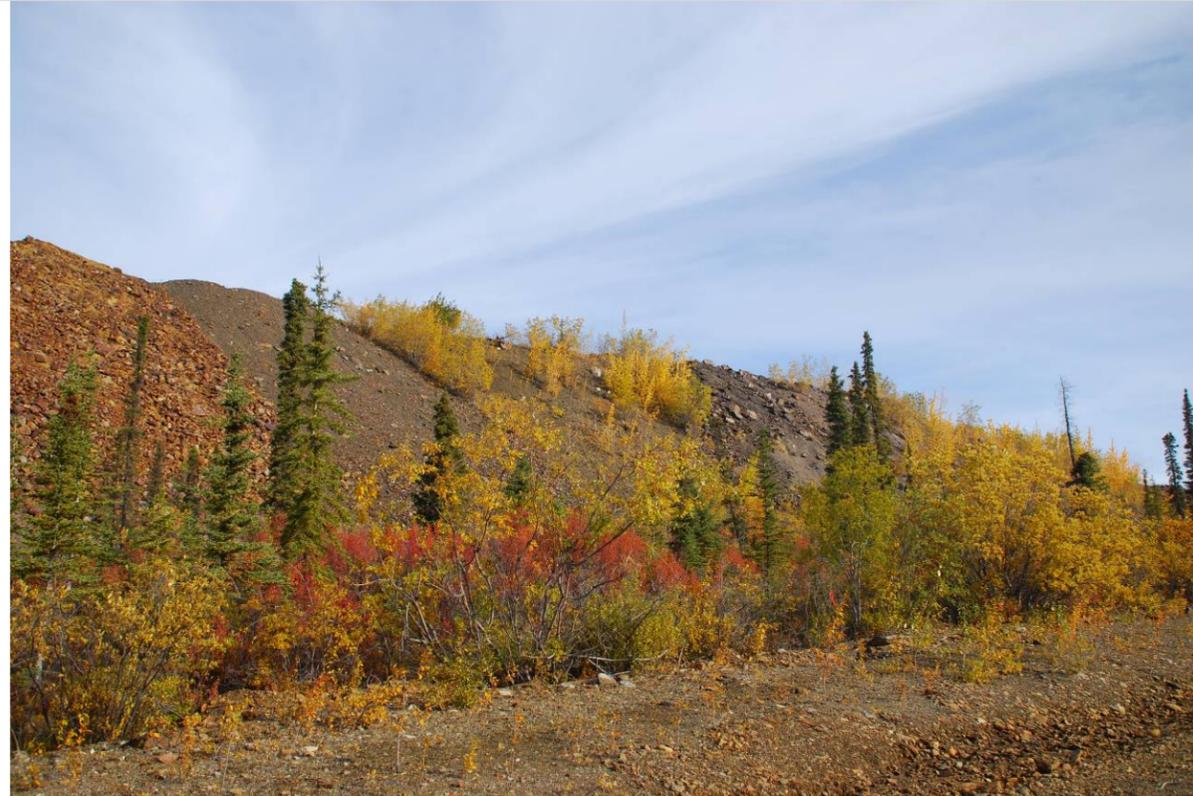
Plate C-7. Vegetation preferentially growing in the wet are at the toe of a small dump slope

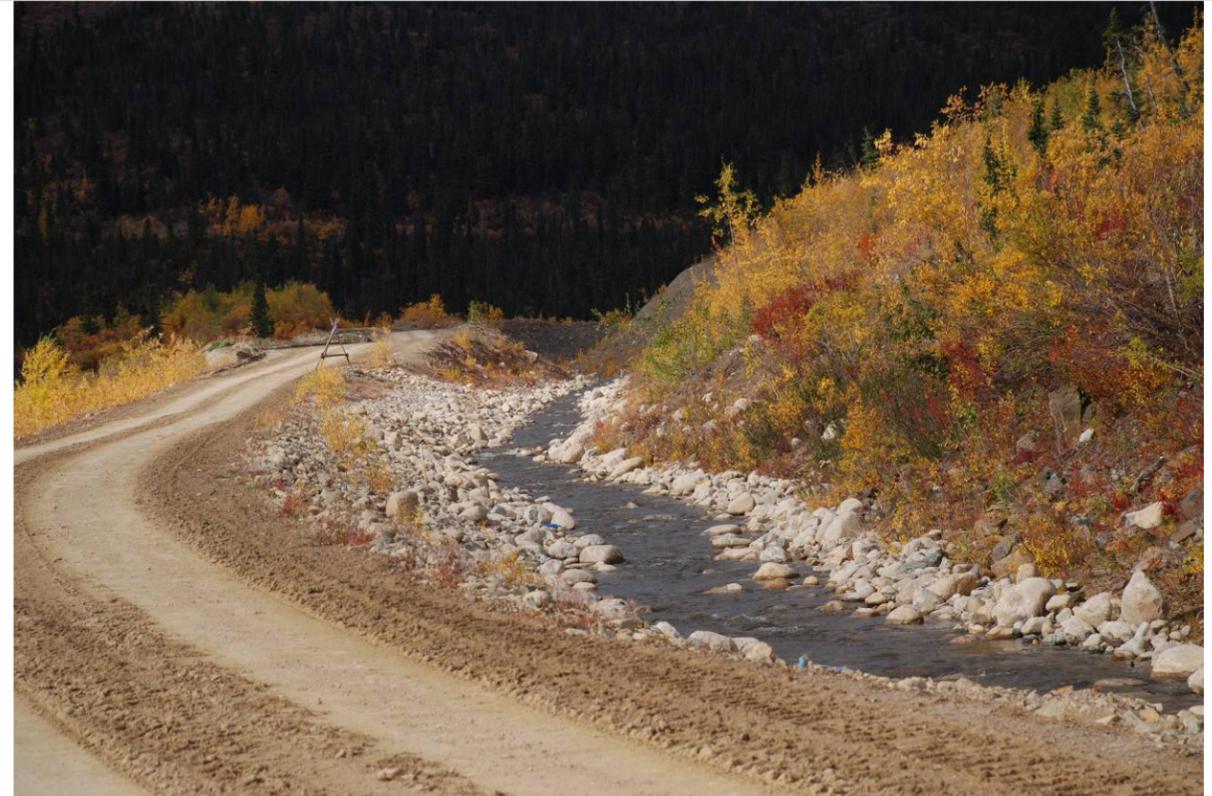
Plate C-8. Good performance of a diverted creek above the pit.

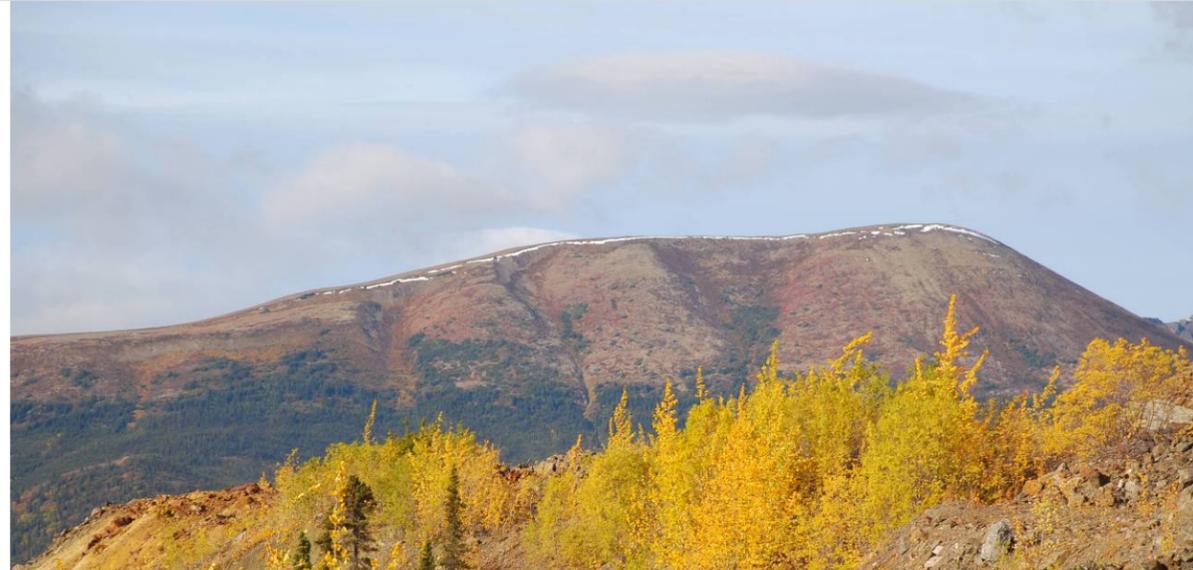
Plate C-9. Natural downslope drainage on rocky ground in the region.

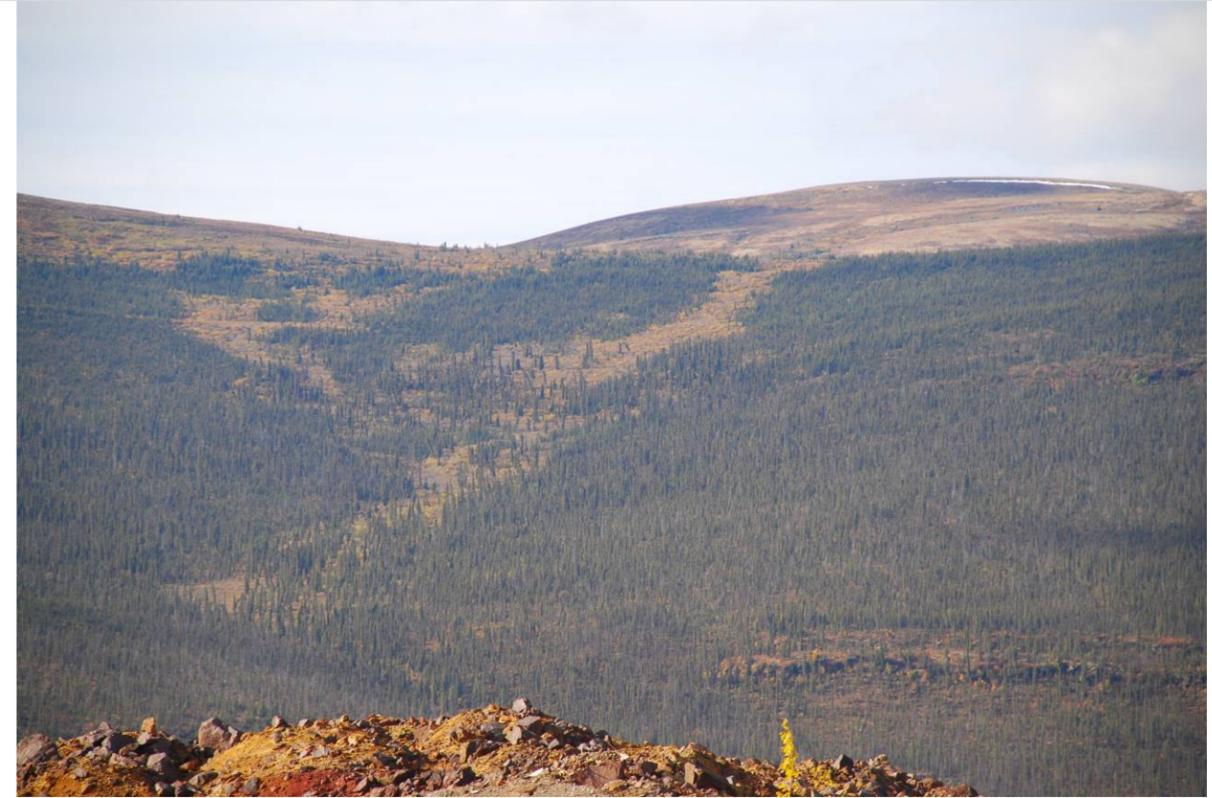
Plate C-10. Natural swale south of the mine.

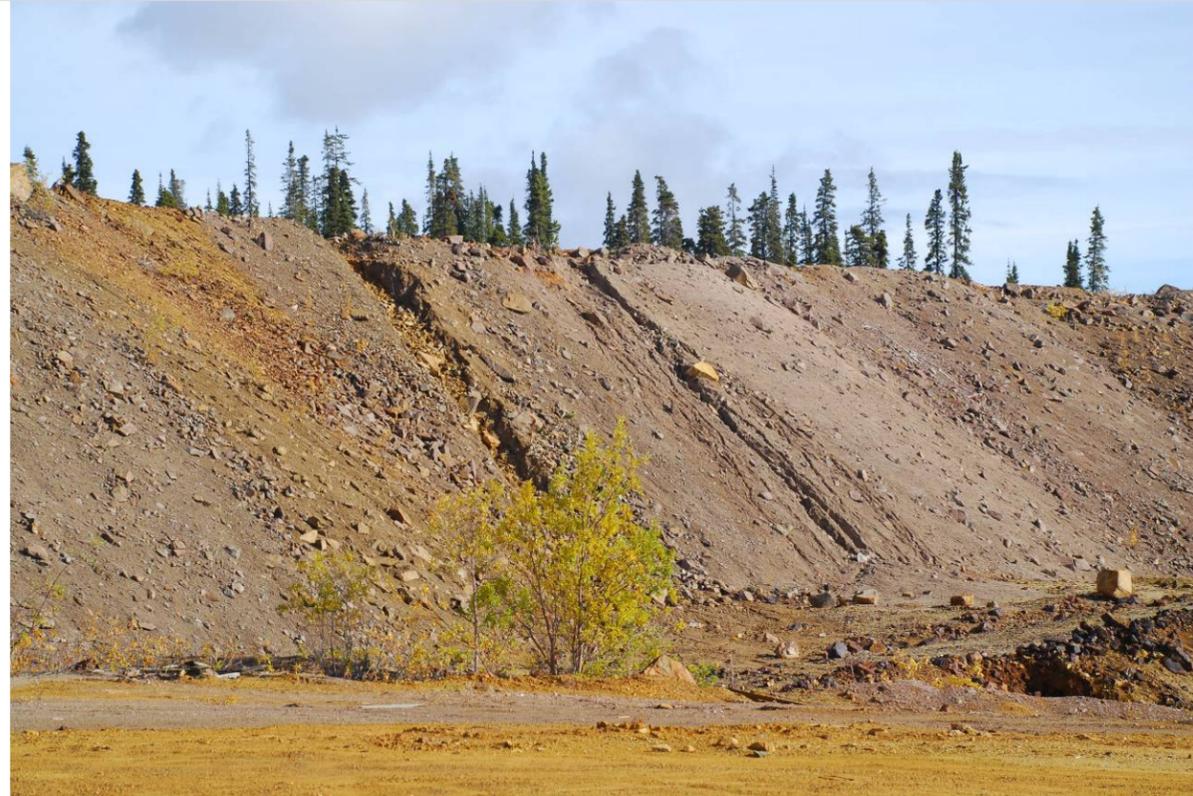
Plate C-11. Gullying on repose slopes due to water flowing over the crest

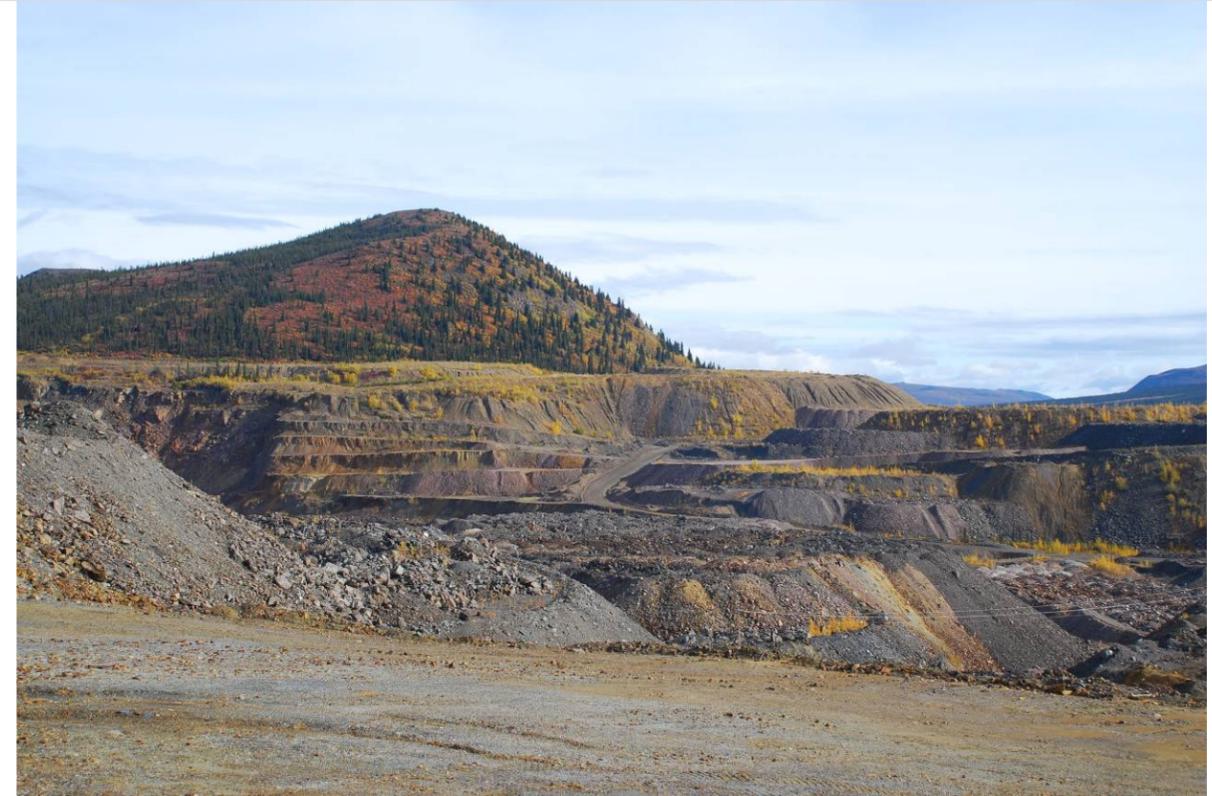
Plate C-12. The construction of the dumps lends itself to considerable diversity. Efforts should be maintained to work with the existing diversity where practical.

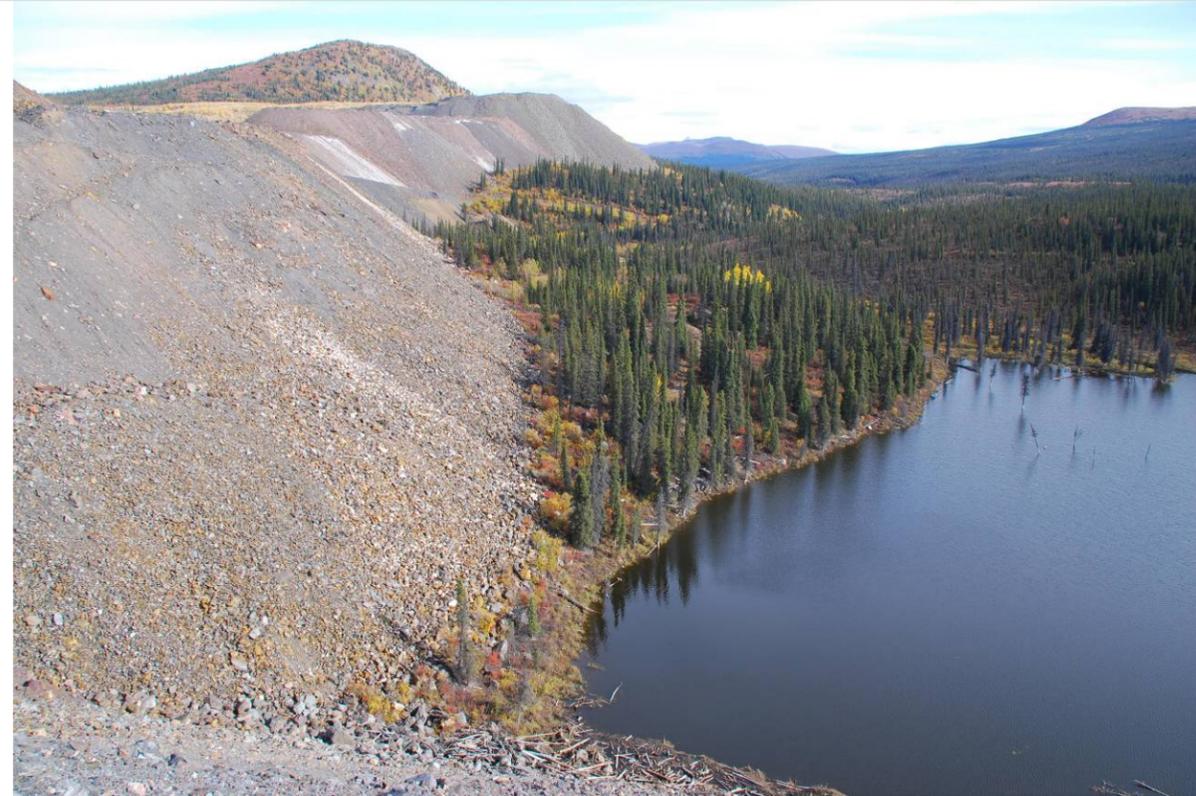
Plate C-13. Some of these slopes should likely be left at repose to avoid damaging vegetation at the toe.

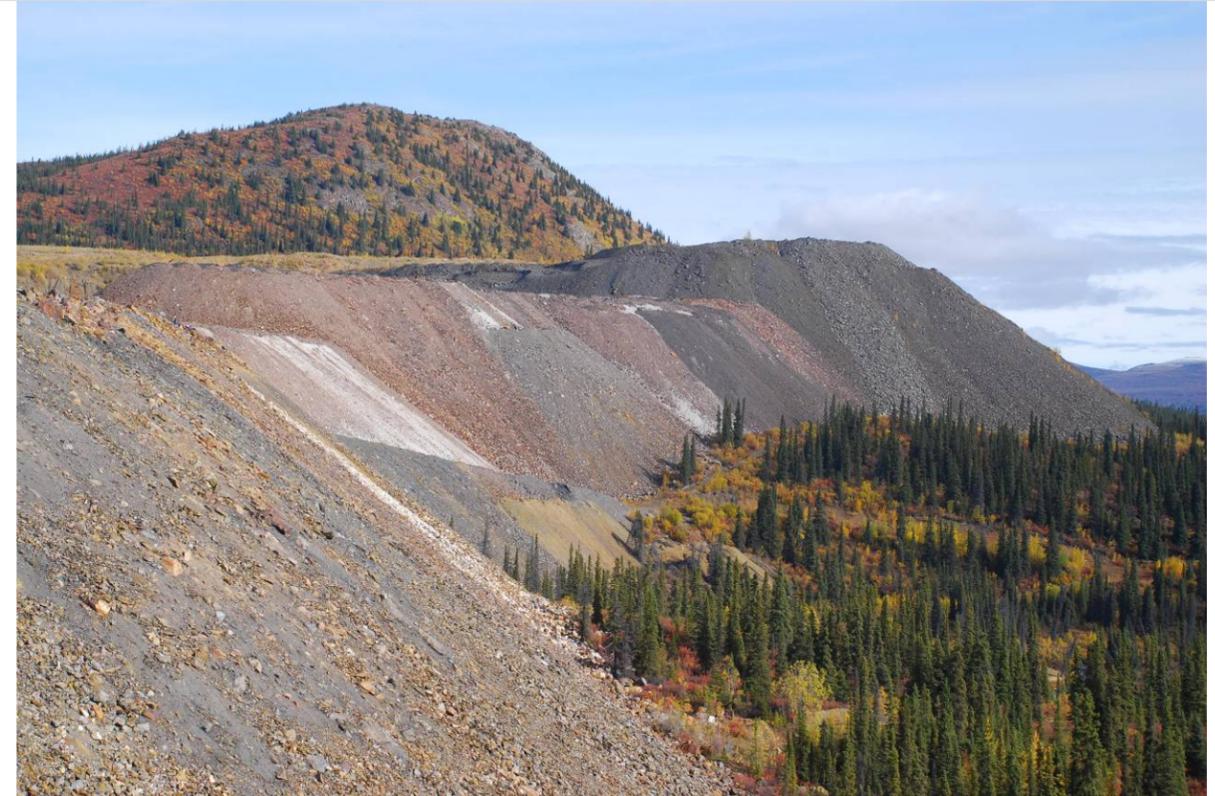
Plate C-14. There are a wide variety of rock types in the dumps. These will need to be mapped as a first step of landform grading design.

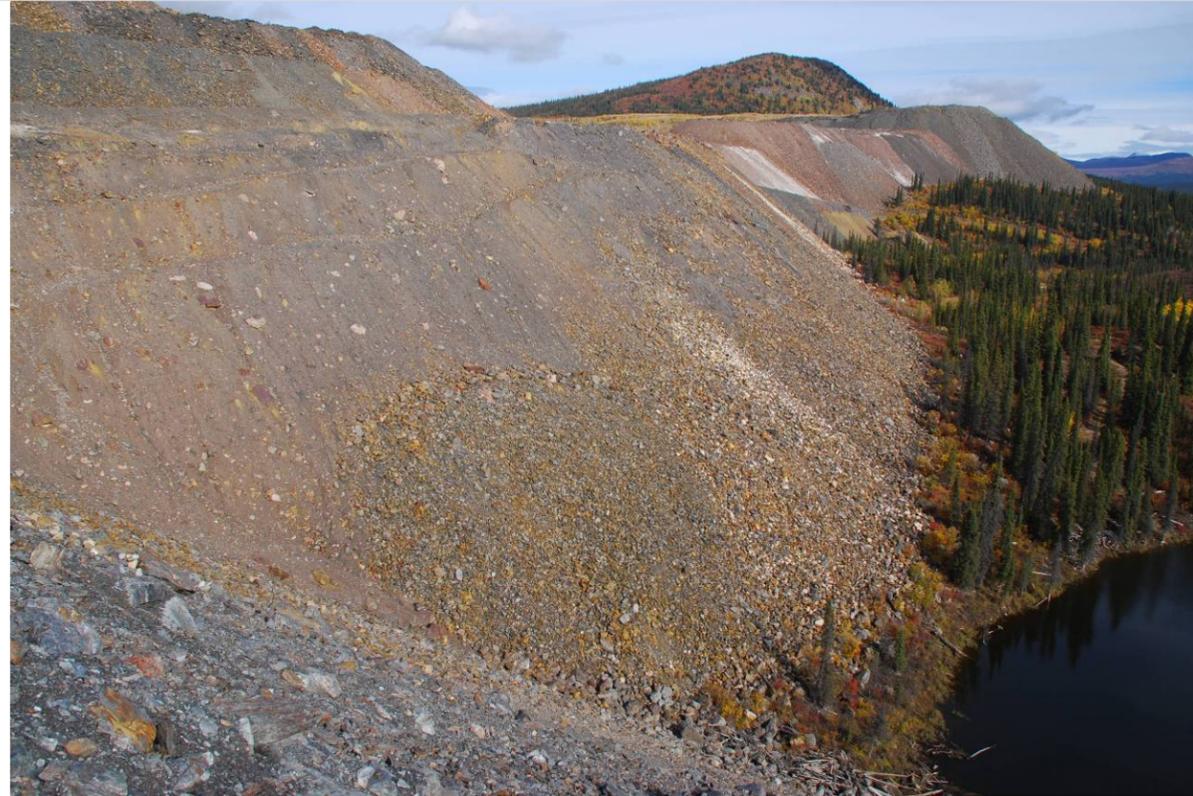
Plate C-15. Coarser rock segregates and self-armour the base of some slopes.

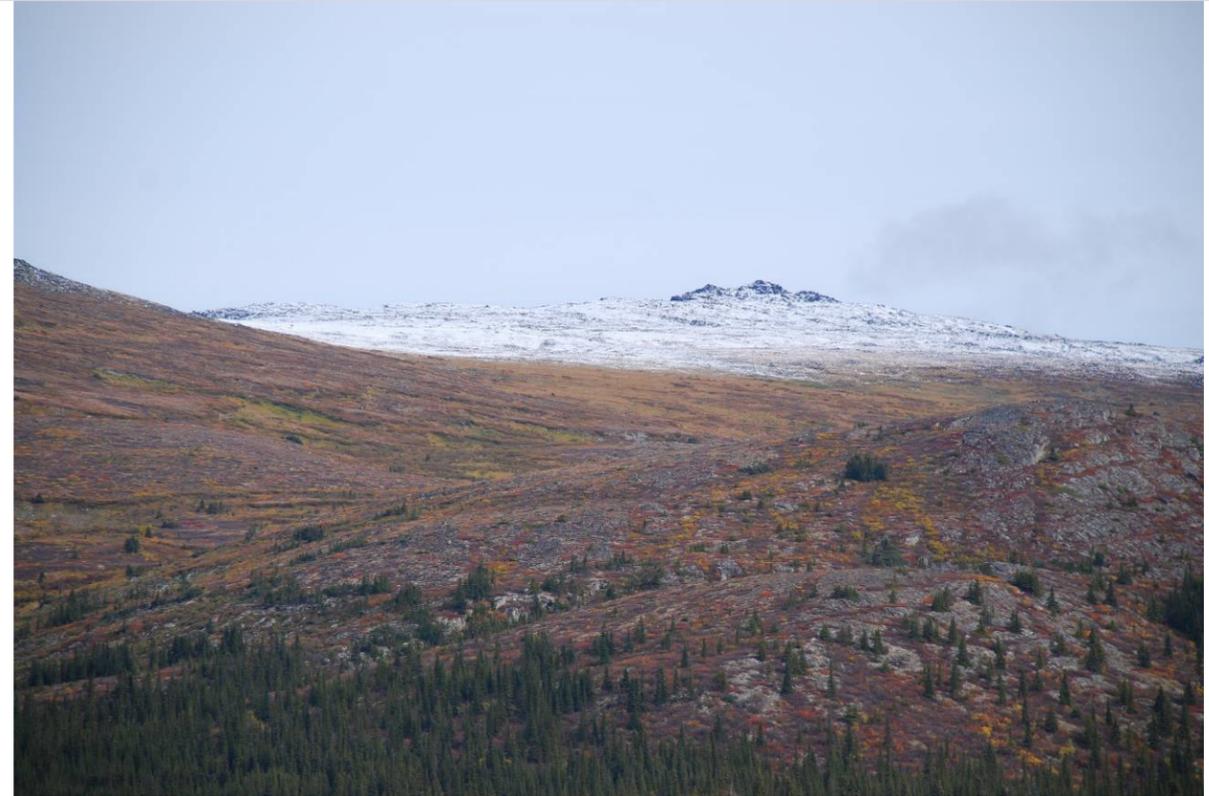
Plate C-16. Much of the natural drainage is on bedrock, soils are generally very thin and poorly developed in the region.

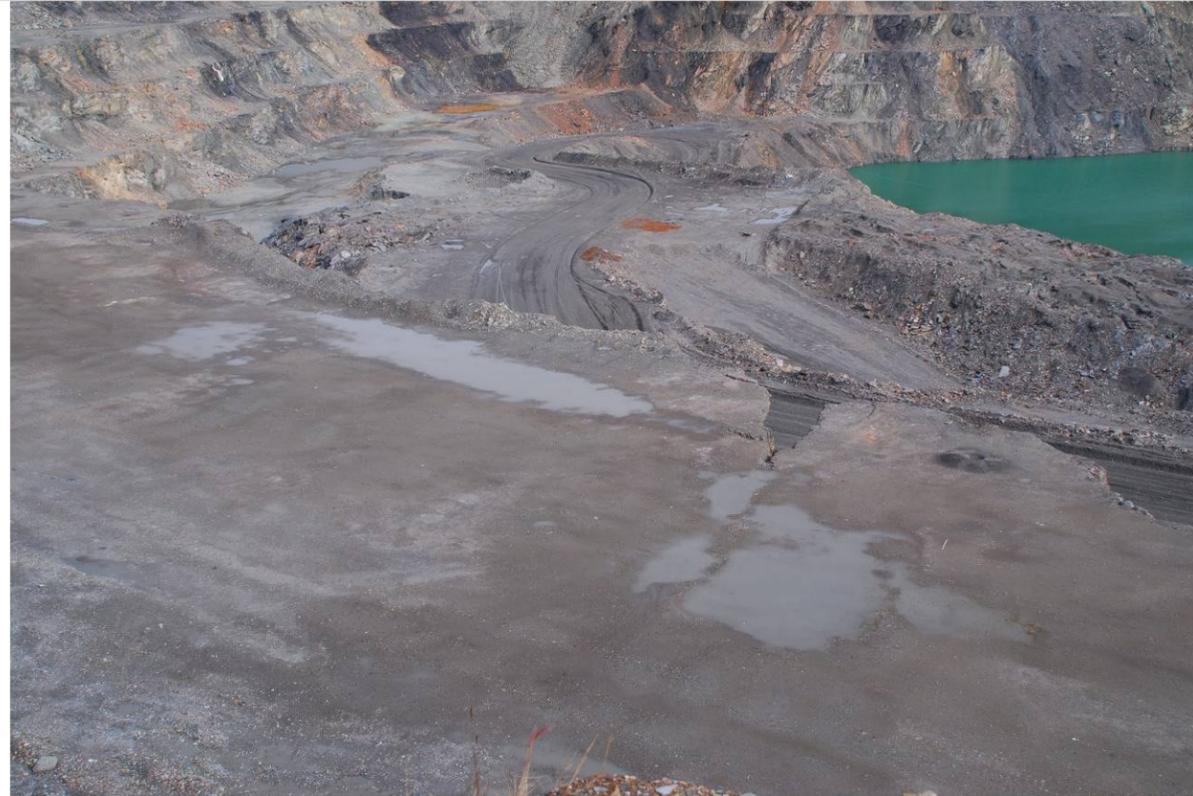
Plate C-17. Water ponding on this bench is causing a large gully.

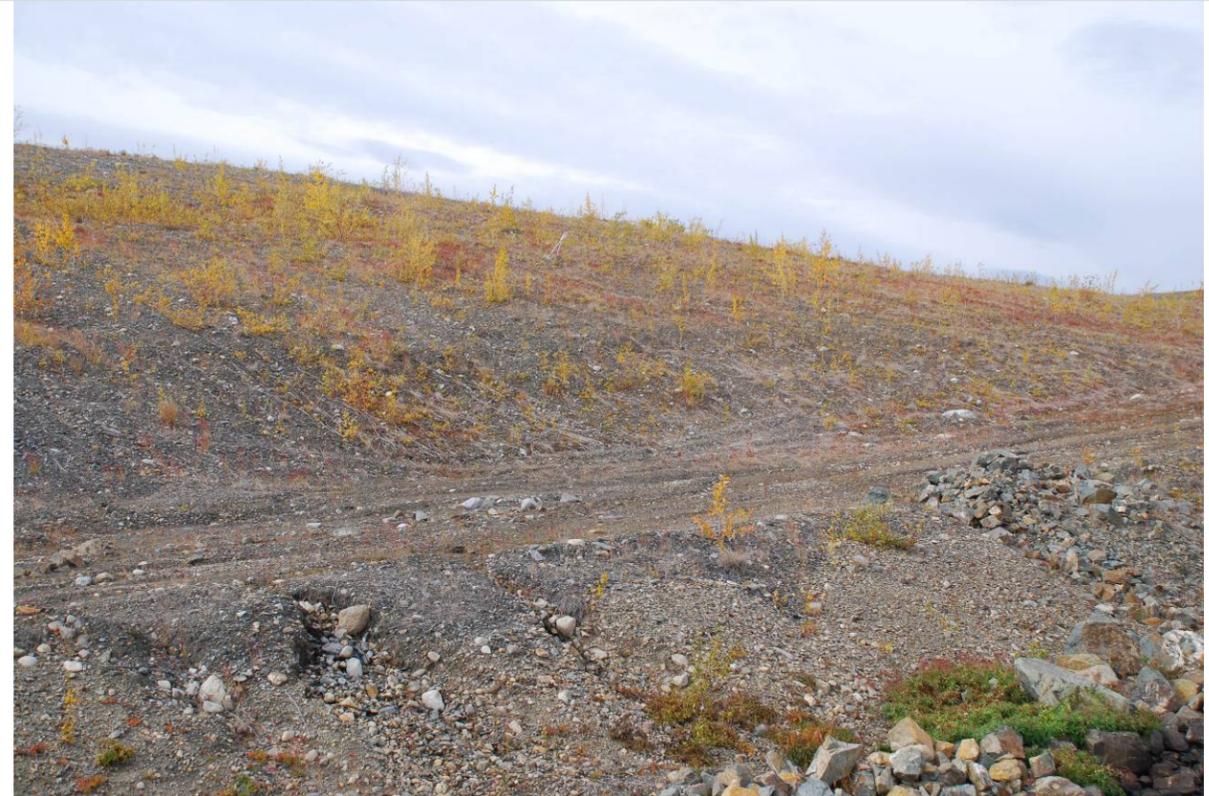
Plate C-18. Sparse vegetation on the resloped overburden dump. Vegetation is not dense enough to provide erosion protection for the slope.

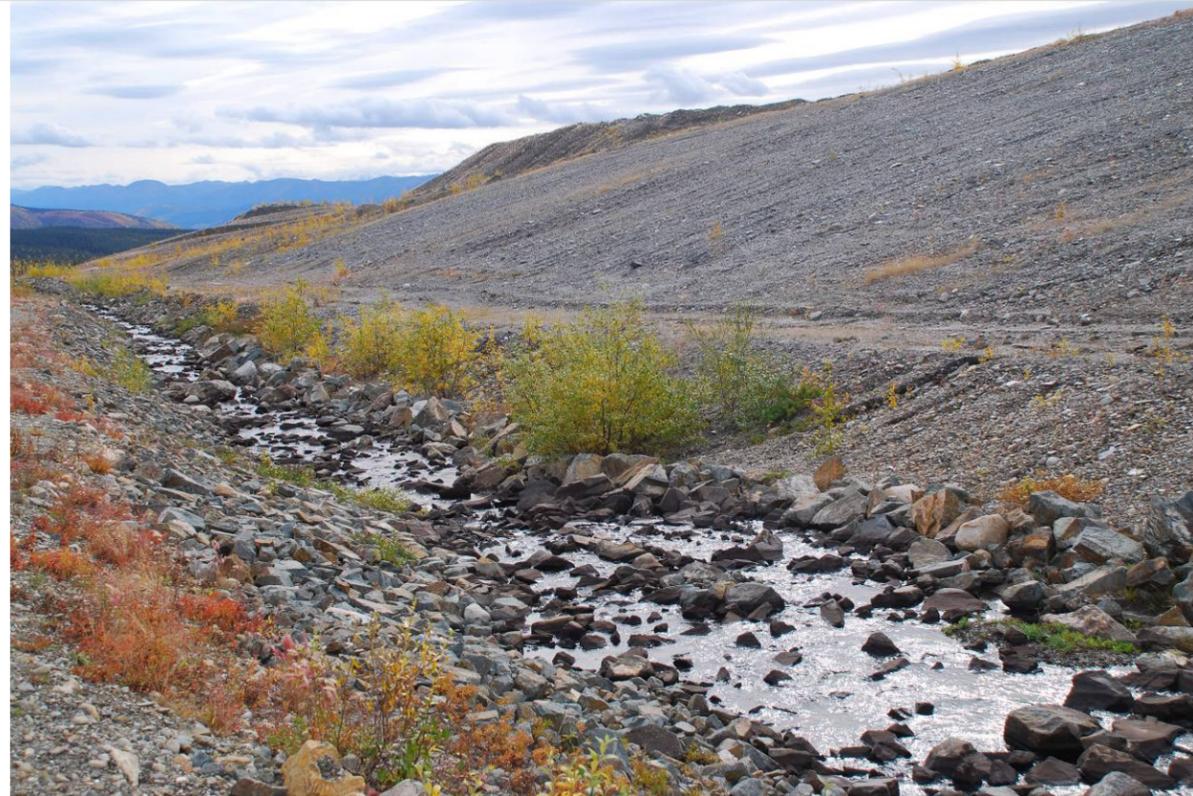
Plate C-19. Rilling on the overburden slope above the creek.

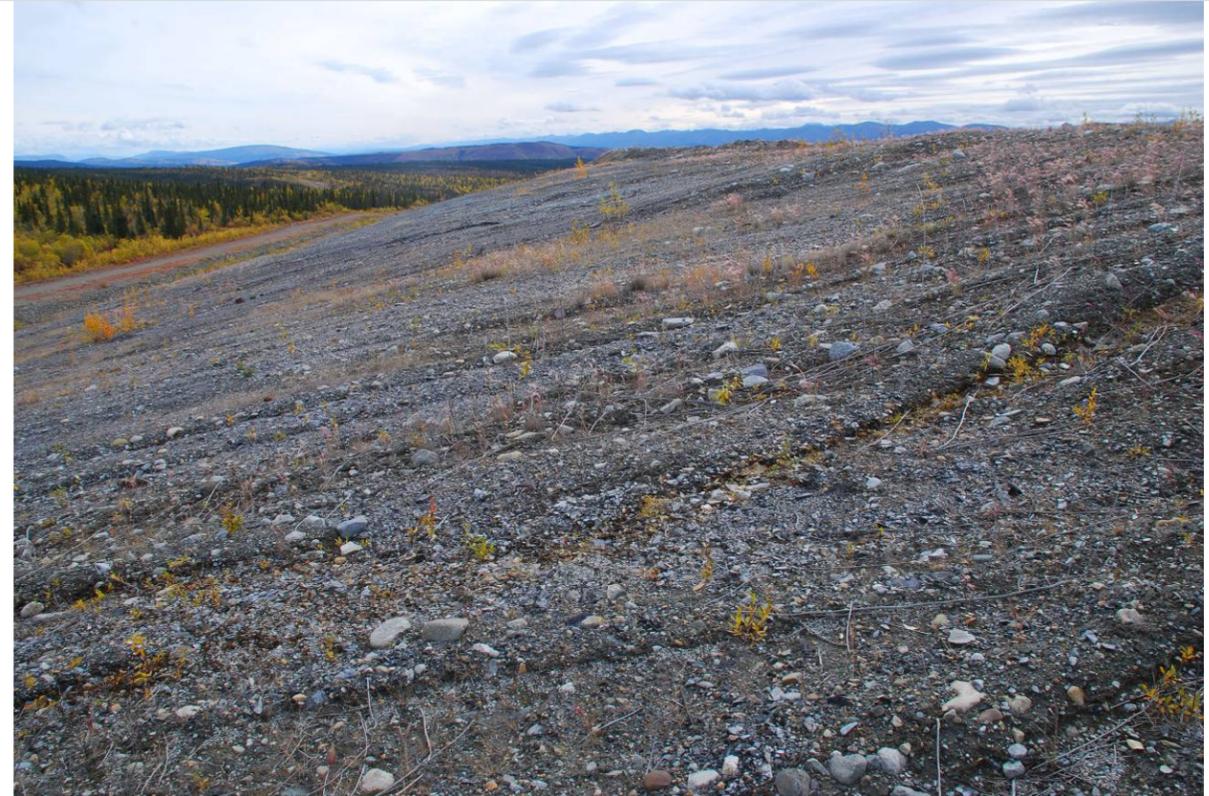
Plate C-20. Rilling on the overburden slope above the creek.

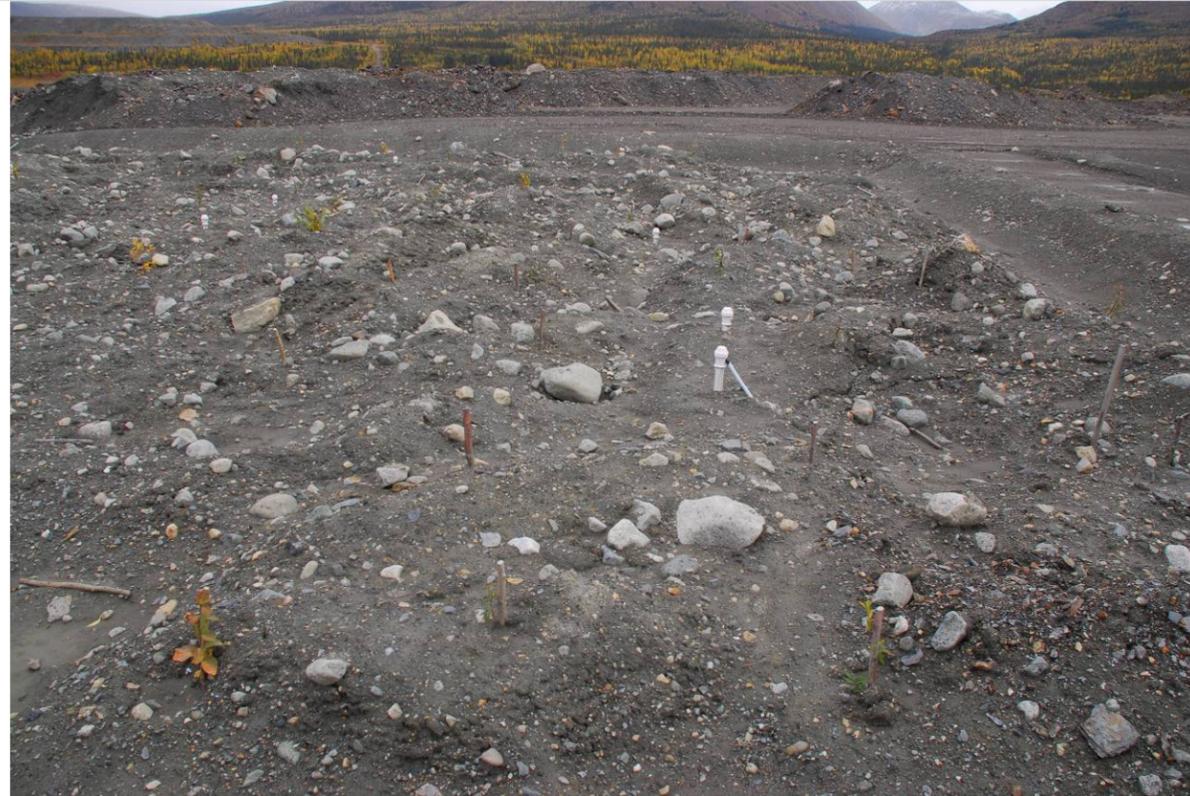
Plate C-21. Instrumented plateau with microtopography. The microtopography likely enhances percolation and should be used only on plateaus for which percolation is not a concern.
