2008 Reconnaissance-level landform grading field investigation at the Faro Minesite

SRK Project #: 1CY001.015 Task 004 // BGC Project Number: 0533-002

Final report May 26, 2009

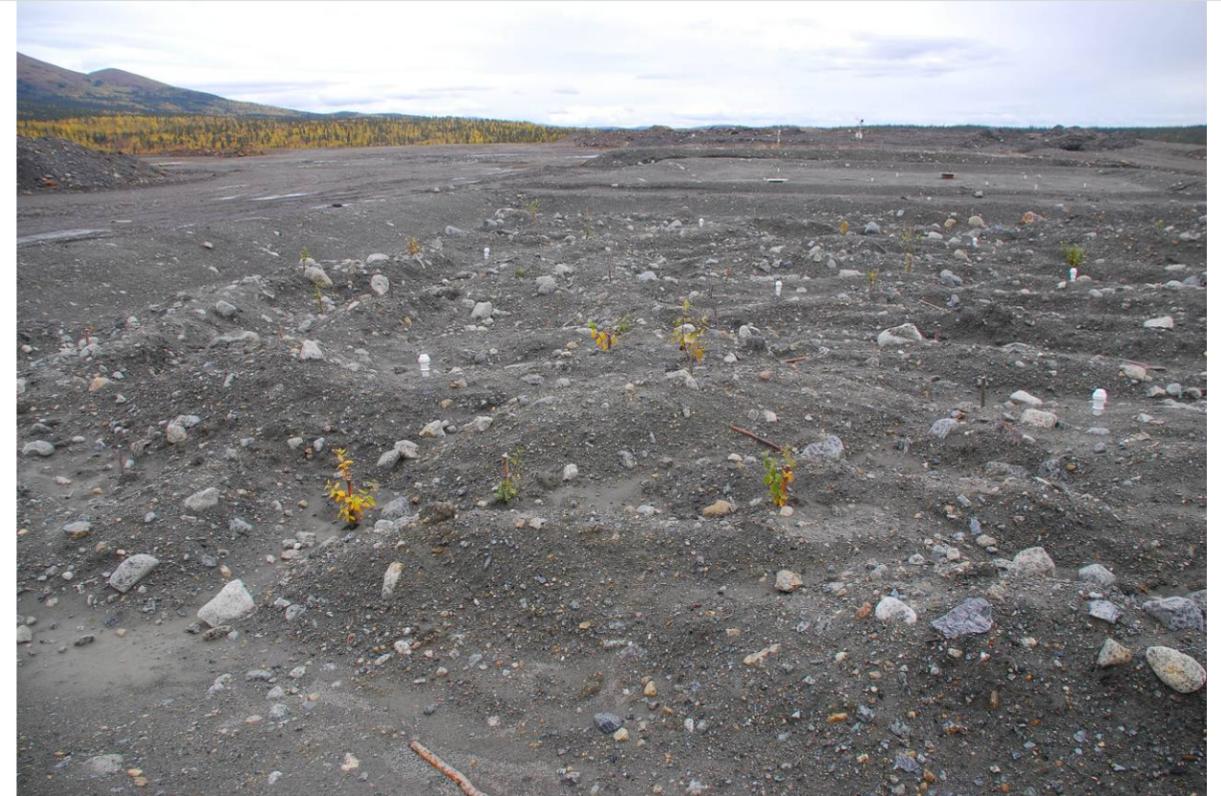
Plate C-22. Instrumented plateau with microtopography. The microtopography likely enhances percolation and should be used only on plateaus for which percolation is not a concern.

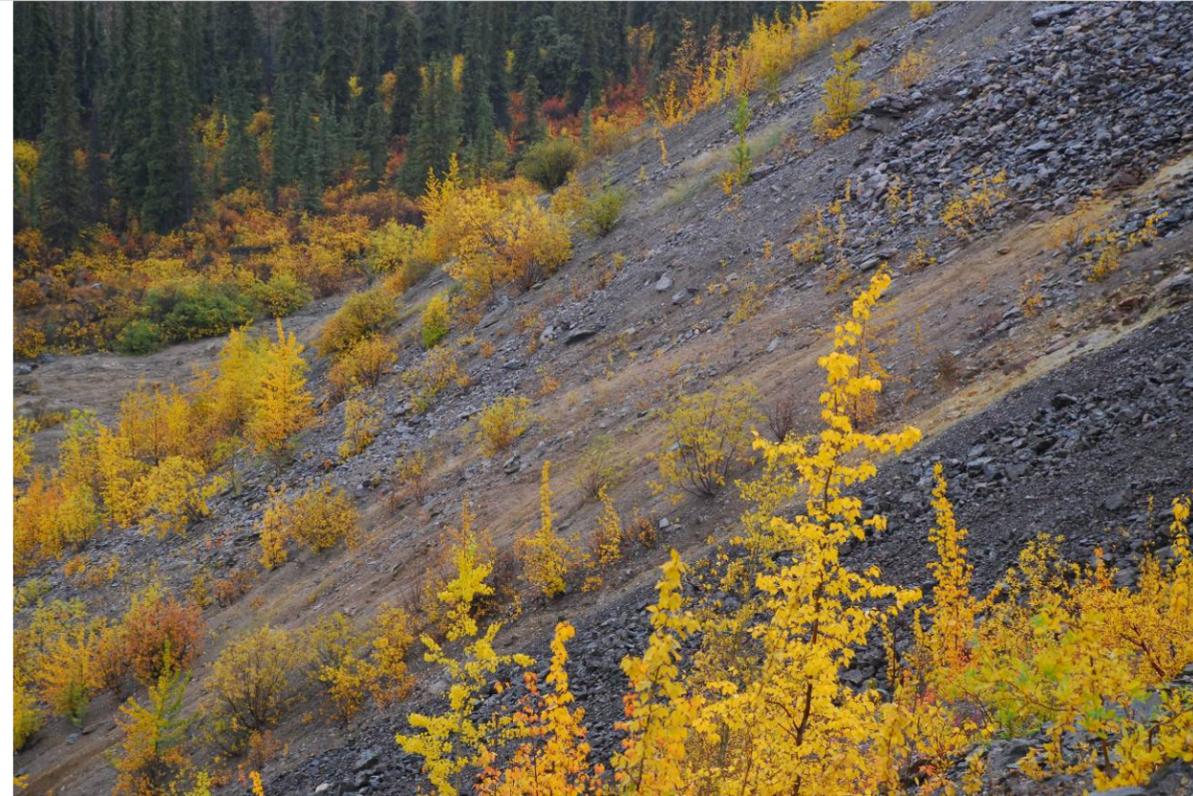
Plate C-23. Vegetation invading the finer grained materials on a repose slope.

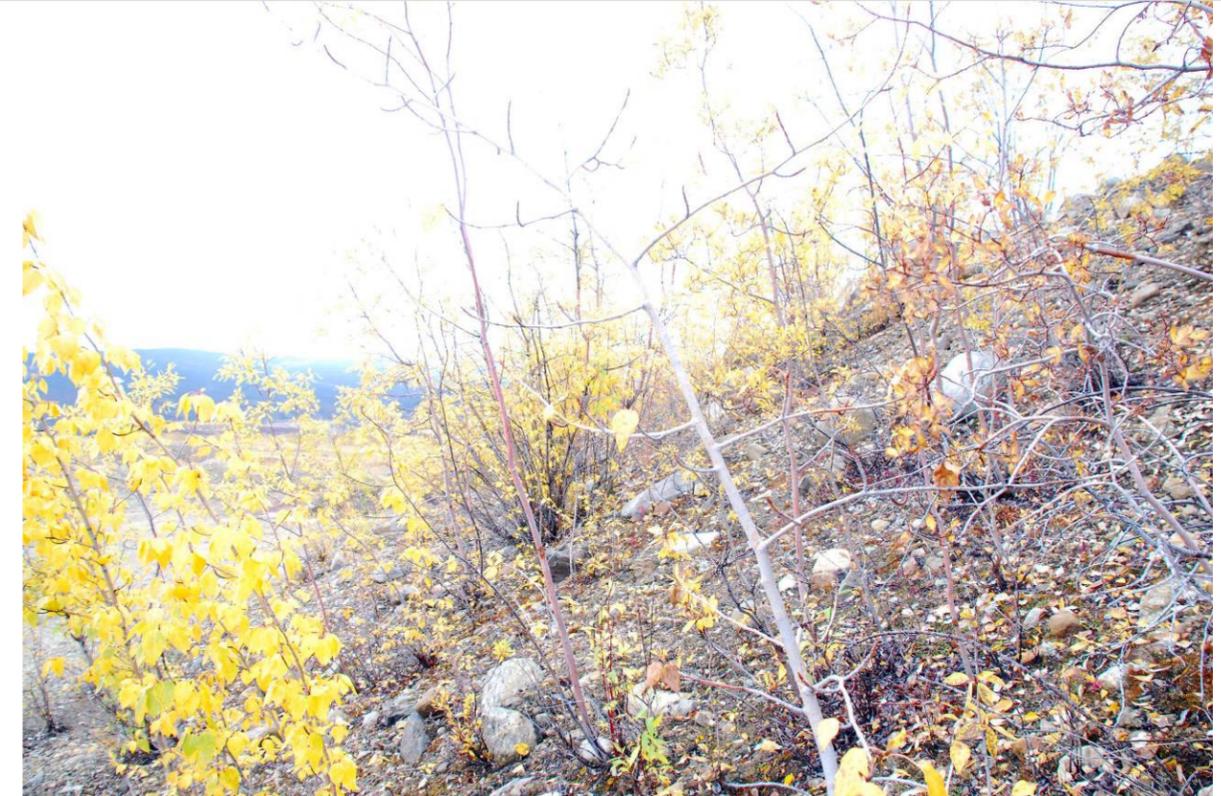
Plate C-24. An area of good vegetation growth, good invasion, and fairly good erosion protection. This area deserves a joint investigation by the engineers and soils/vegetation people to determine why it is performing so well.

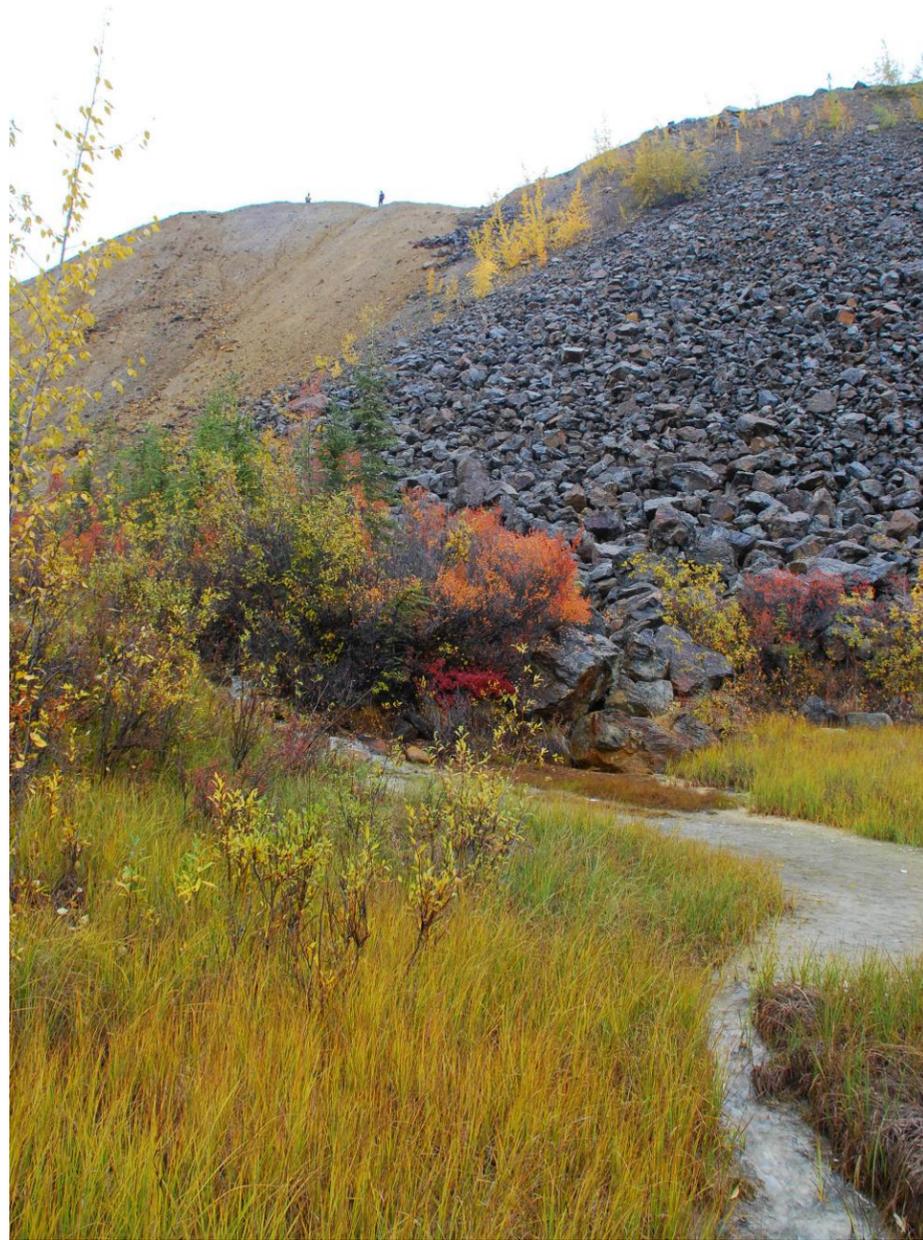
Plate C-25. An area of natural ground at the toe of a dump showing very good performance.

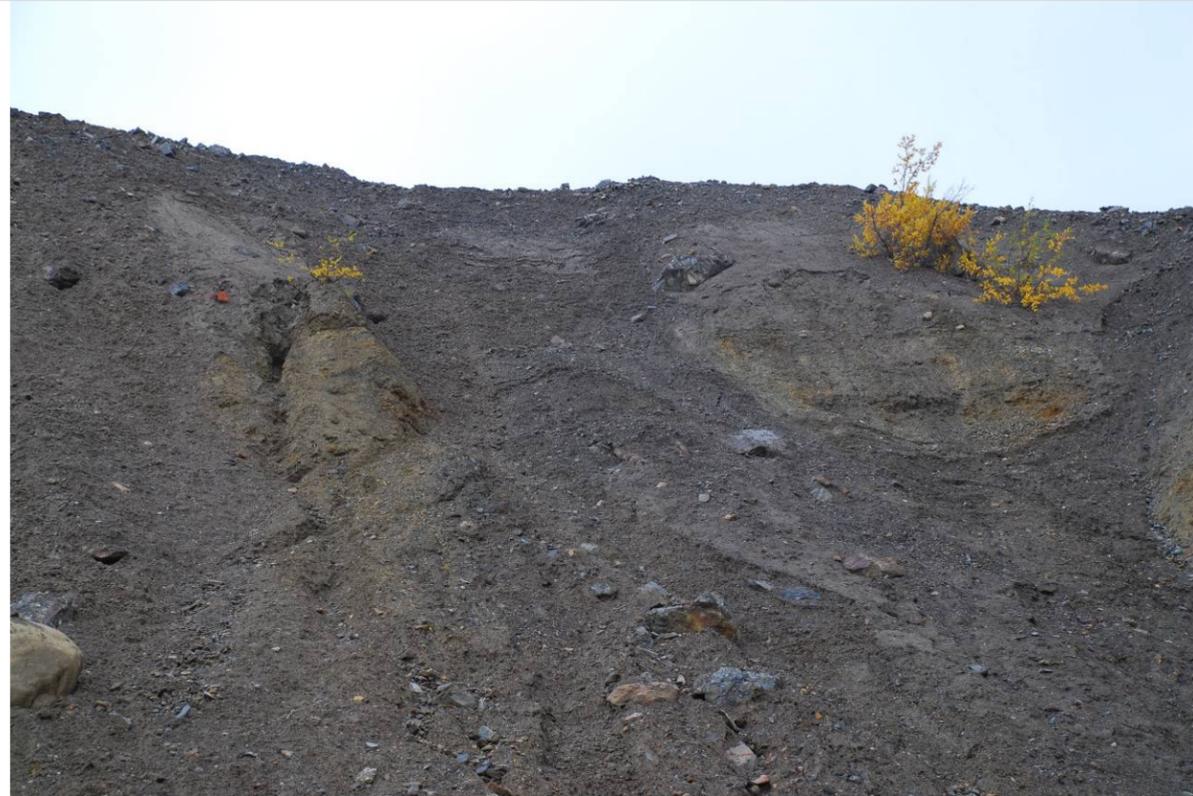
Plate C-26. Slip-off failure scars in fine grained angle of repose dump faces.

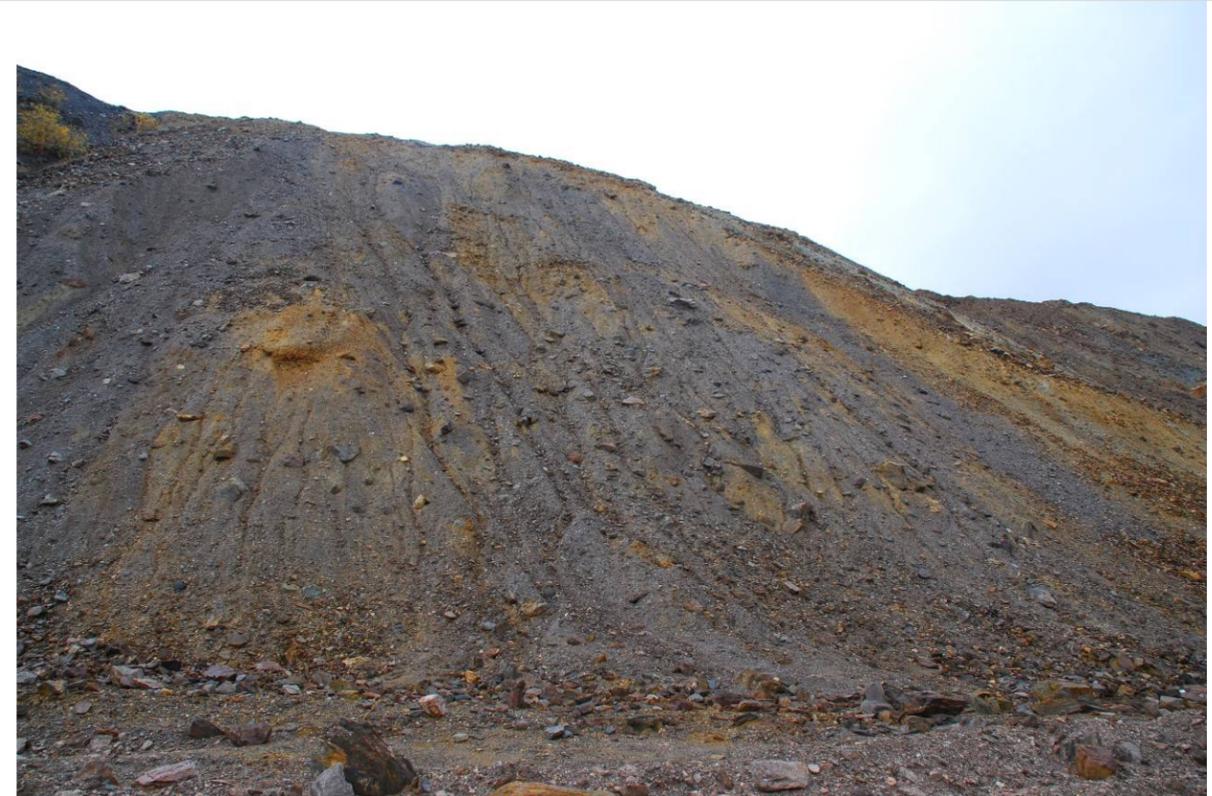
Plate C-27. Slip-off failure scars in fine grained angle of repose dump faces.

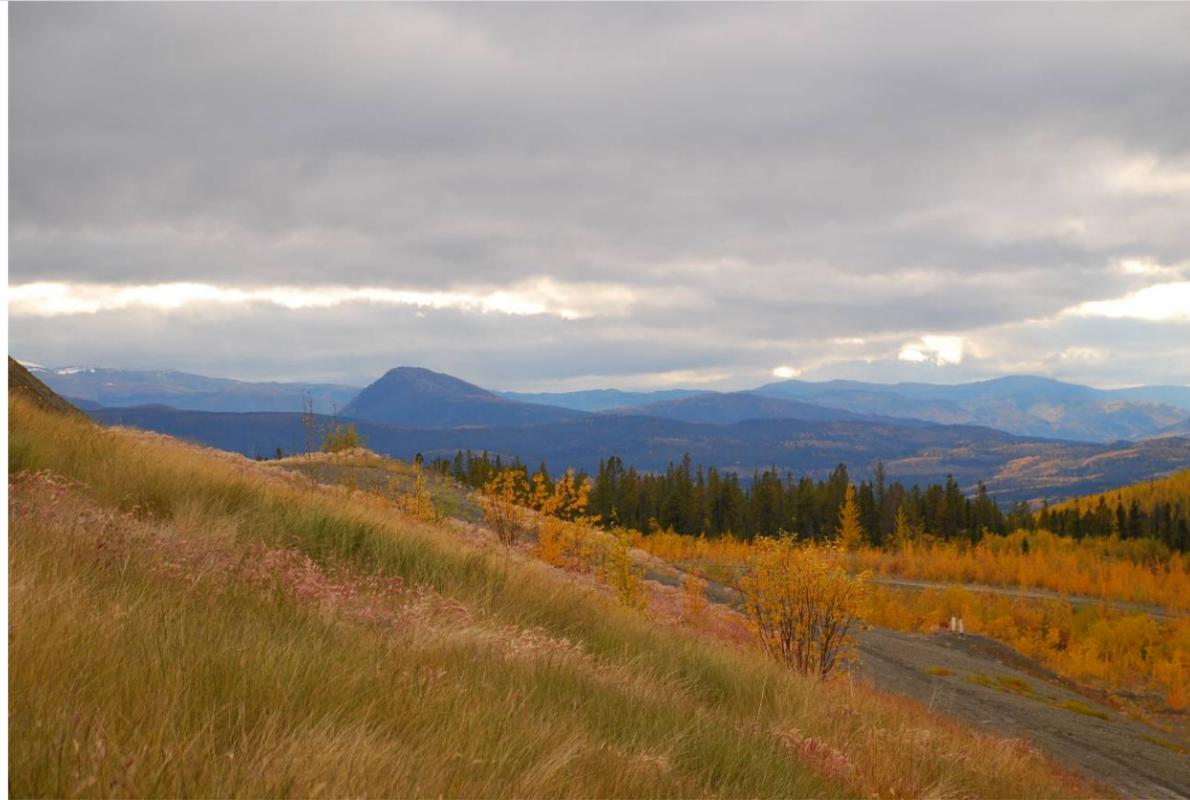
Plate C-28. Dense vegetation on a small area of one dump.

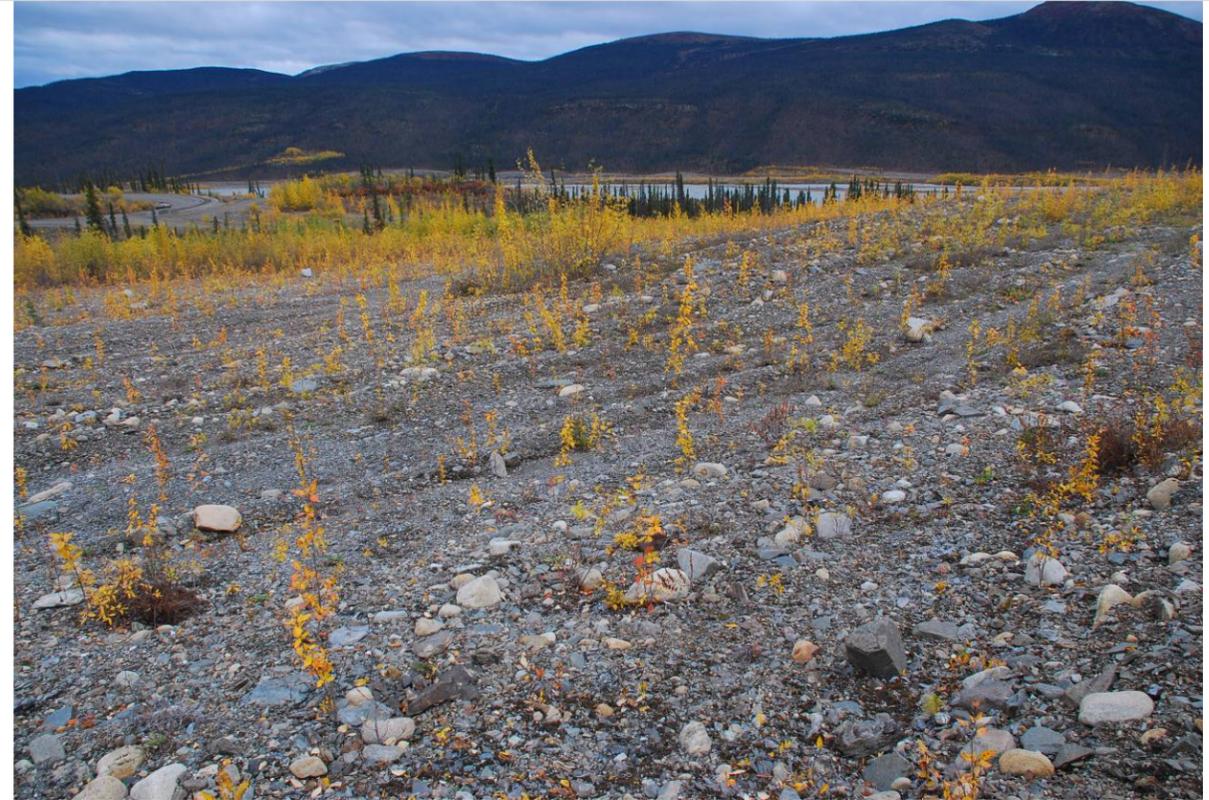
Plate C-29. Sparse vegetation on shallow glaciofluvial slope (old borrow pit).

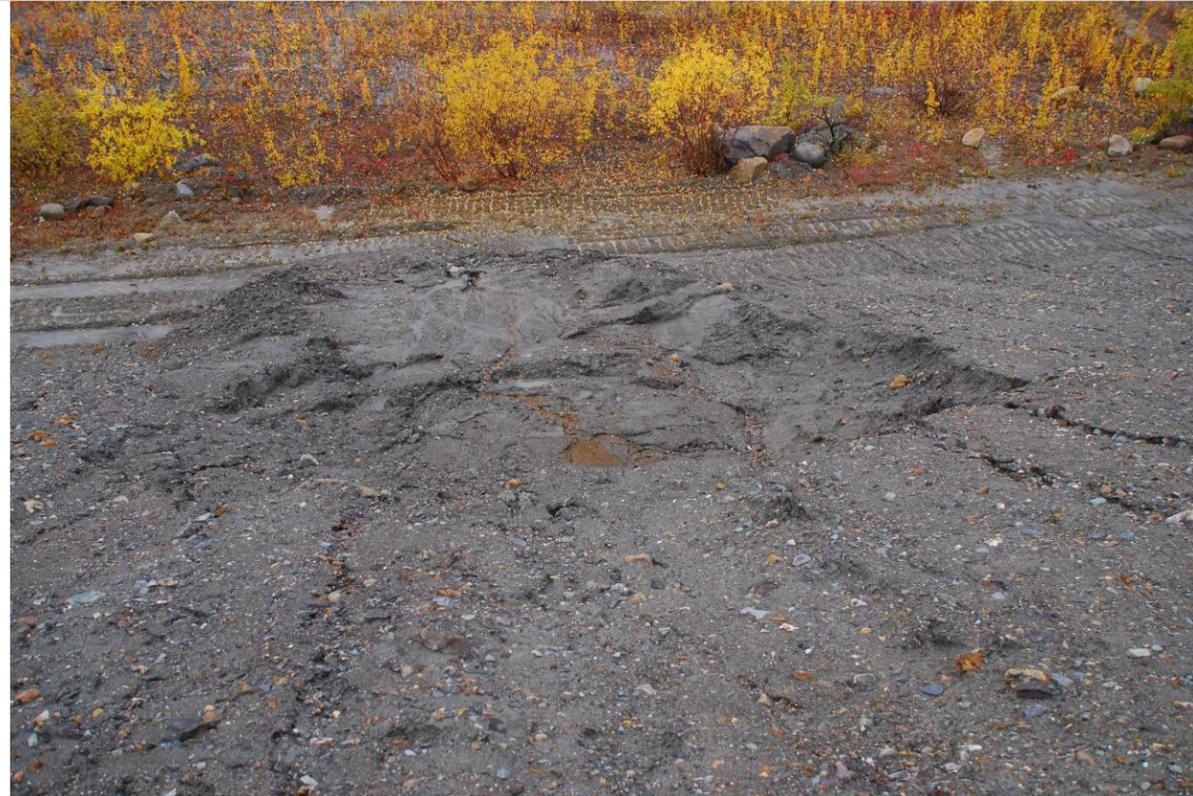
Plate C-30. Blowout style slumping at the toe of a slope caused by groundwater seepage.

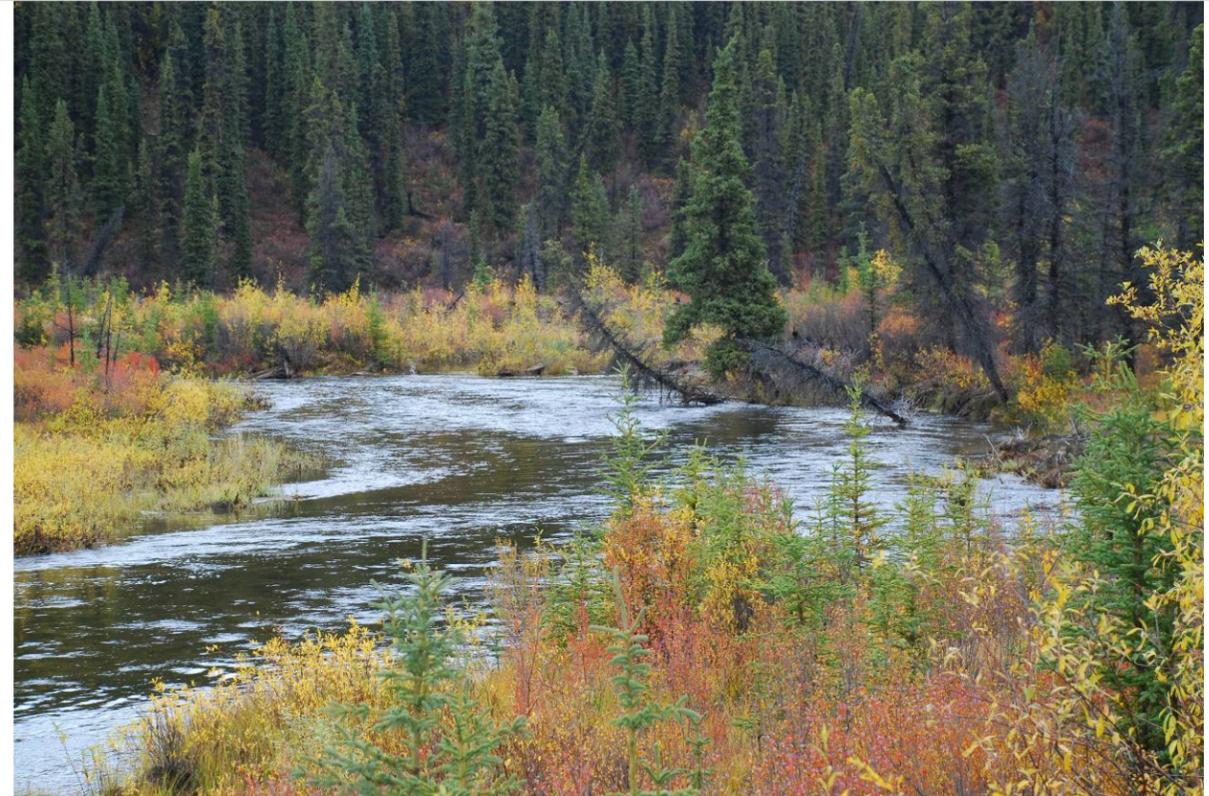
Plate C-31 Constructed creek showing good performance.
