November 24, 2009

2009 Faro Pit Slope Movement Monitoring

Submitted to:
Denison Environmental Services
Faro Care and Maintenance Project
P.O. Box 280
Faro, YT
Y0B 1K0

Report Number: 09-1426-0019/2000

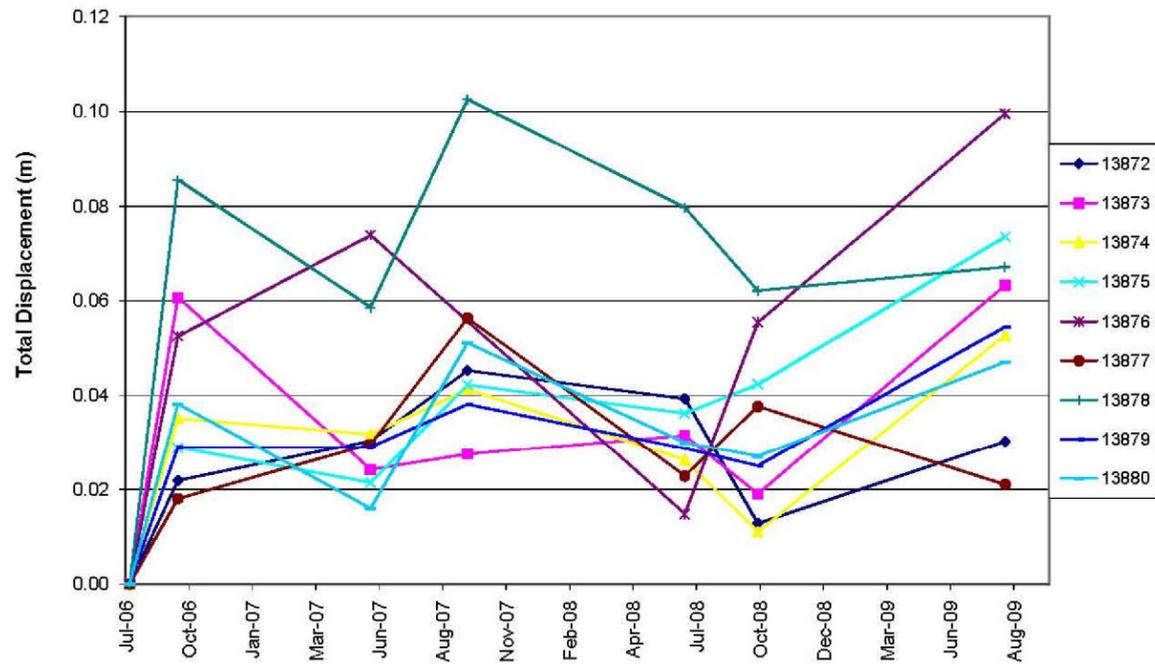
PROJECT				DENISON ENVIRONMENTAL SERVICES			
				FARO PIT, YUKON			
TITLE				REVIEW OF PIT SLOPE MONITORING SURVEY PRISMS			
PROJECT No. 09-1426-0019		PHASE No. 2000		DESIGN LP 02NOV09		SCALE AS SHOWN REV. -	
CADD OD 02NOV09				CHECK			
REVIEW

Point #	$\Delta_N(m)$	$\Delta_E(m)$	$\Delta_Z(m)$	$\Delta_{NxE}(m)$	Point #	Total Displacement (m)	Trend (deg)	Plunge (deg)
13872	0.0148	-0.0141	-0.0222	0.0204	13872	0.0302	316	-47
13873	0.0187	-0.0045	-0.0603	0.0192	13873	0.0633	346	-72
13874	0.0067	-0.0155	-0.0499	0.0169	13874	0.0527	293	-71
13875	0.0030	-0.0285	-0.0677	0.0287	13875	0.0735	264	-67
13876	-0.0016	-0.0001	-0.0995	0.0016	13876	0.0995	184	-89
13877	0.0192	-0.0036	-0.0077	0.0195	13877	0.0210	349	-22
13878	0.0292	-0.0137	0.0589	0.0323	13878	0.0672	335	61
13879	0.0181	-0.0071	-0.0509	0.0194	13879	0.0545	339	-69
13880	0.0254	-0.0026	-0.0395	0.0255	13880	0.0470	354	-57

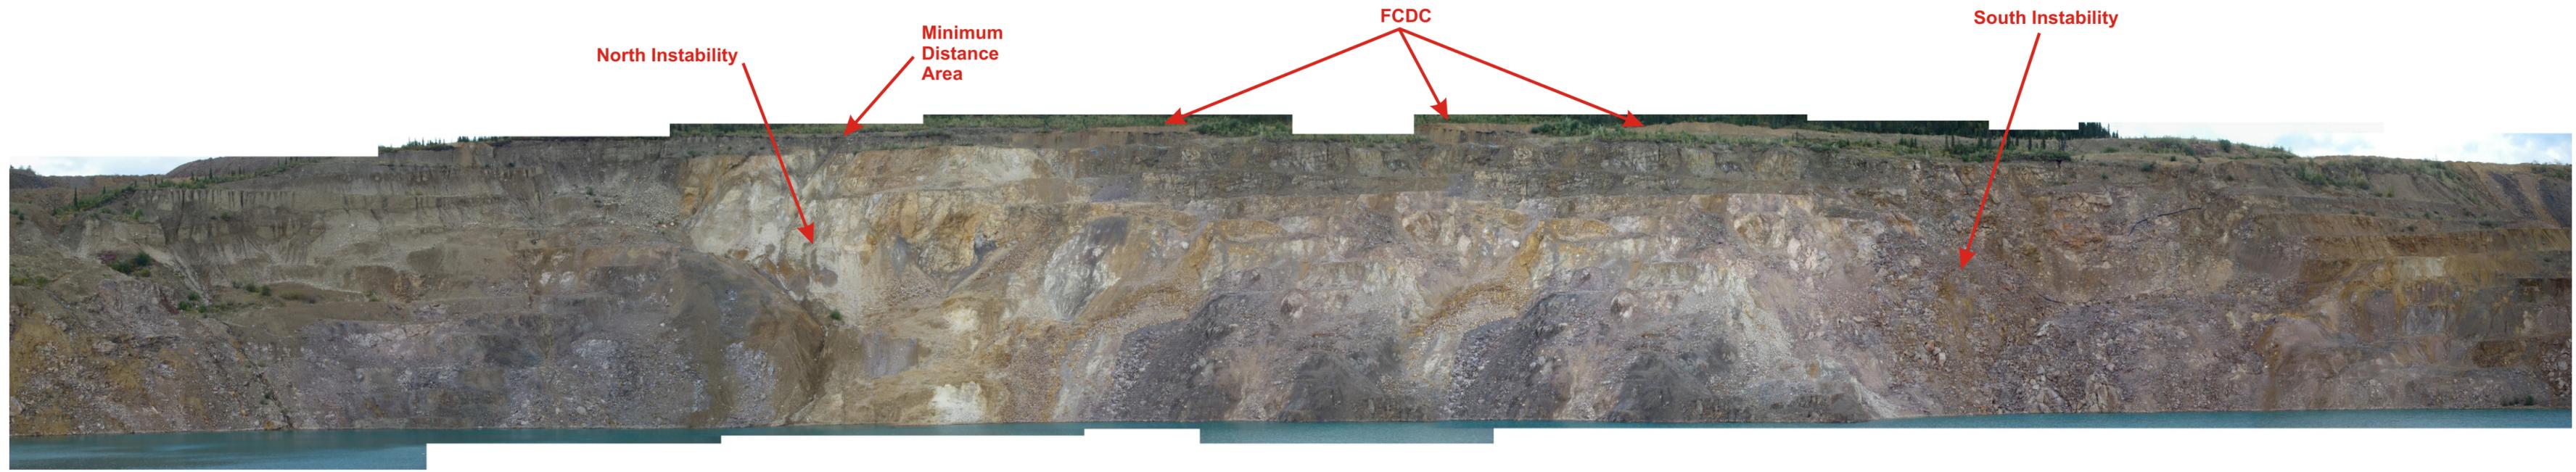
The east wall instability is still characterized by two failure zones, as the North and South instabilities which are separated by the calc-silicate band zone, as shown on Photographs 1 and 2. The observations of the pit wall inspection are discussed in the following sections.

Photograph 1 : Panoramic view of the East Wall (August, 2009).

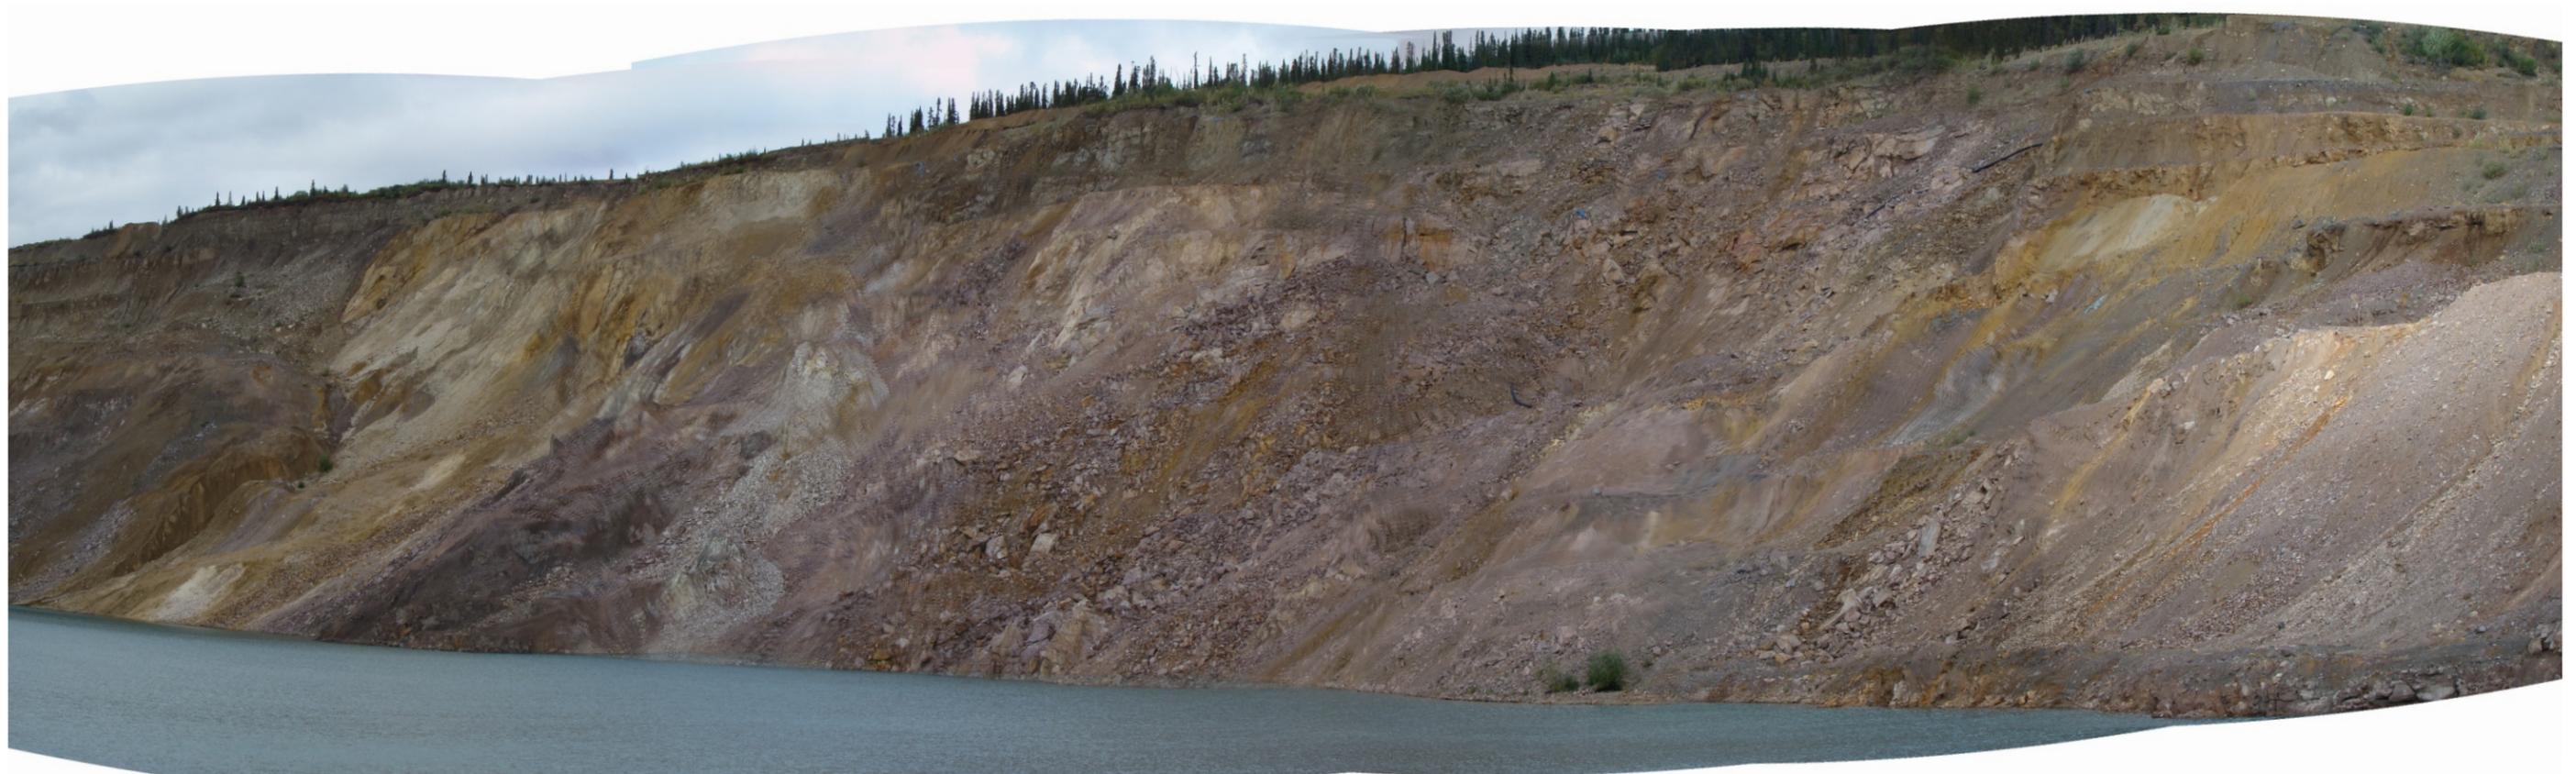
Photograph #2 : Panoramic view of the east wall (August 2009).

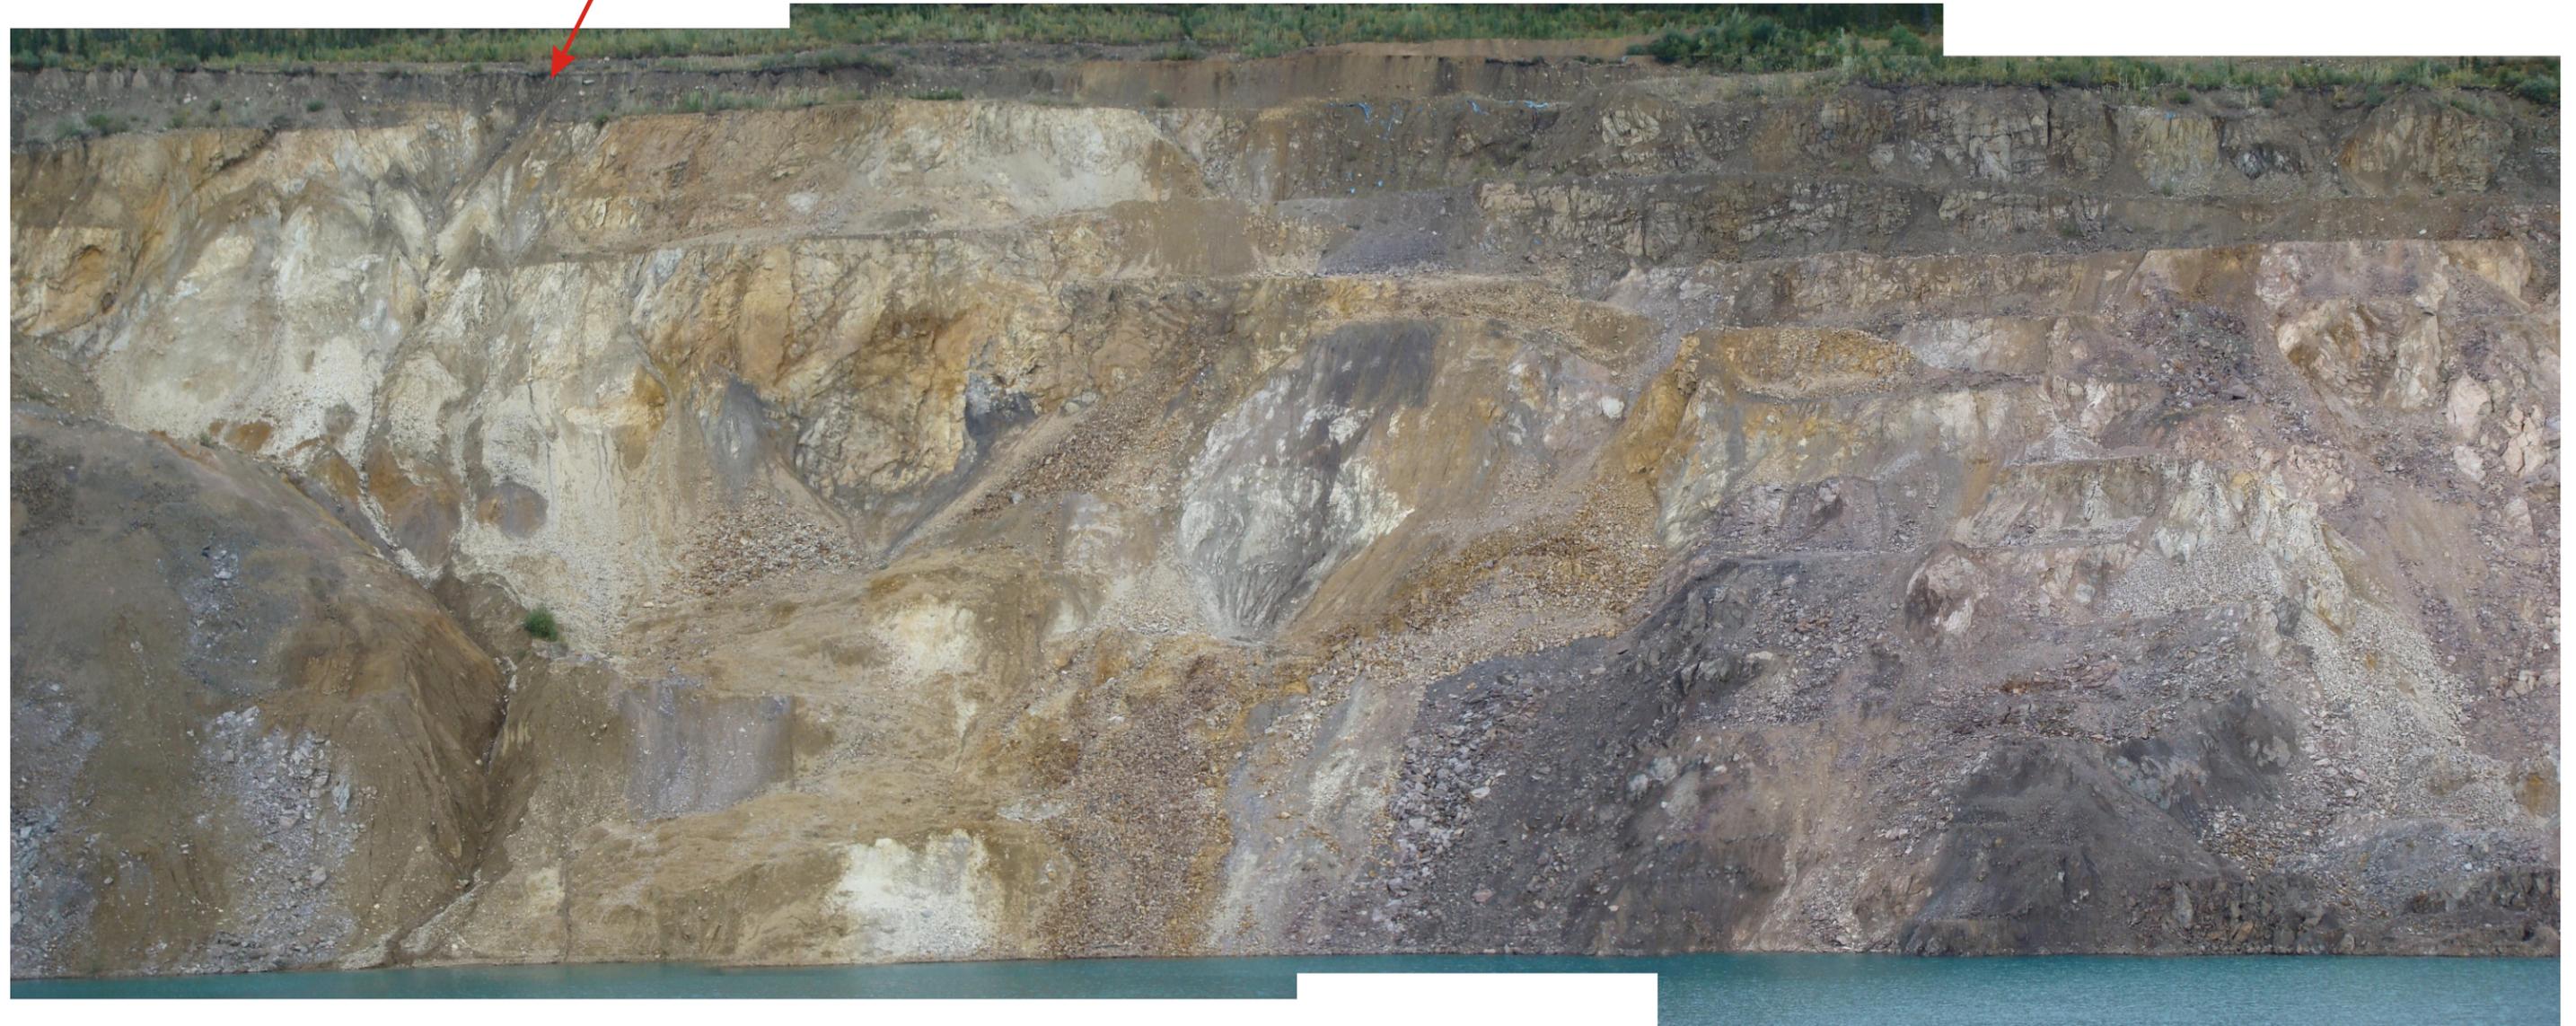
- The south boundary of the North instability zone, *i.e.*, along the north side of the calc-silicate band, appears to have not changed significantly since the previous assessment.

- The north boundary of the North instability zone appears to have not changed perceptibly since the previous assessment from a visual inspection perspective, and any down slope displacement of the failure debris appears to have been limited.

- The backscarp of the North instability zone do not exhibit signs of perceptible or significant degradation.
- The site reconnaissance inspection showed that there is no evidence of tension cracks behind the crest in the area of the North instability. Also, there is no evidence of instability behind the crest of the slope, and the rock at the backscarp appears to be stable.

Photograph #3 : North instability zone (August 2009).

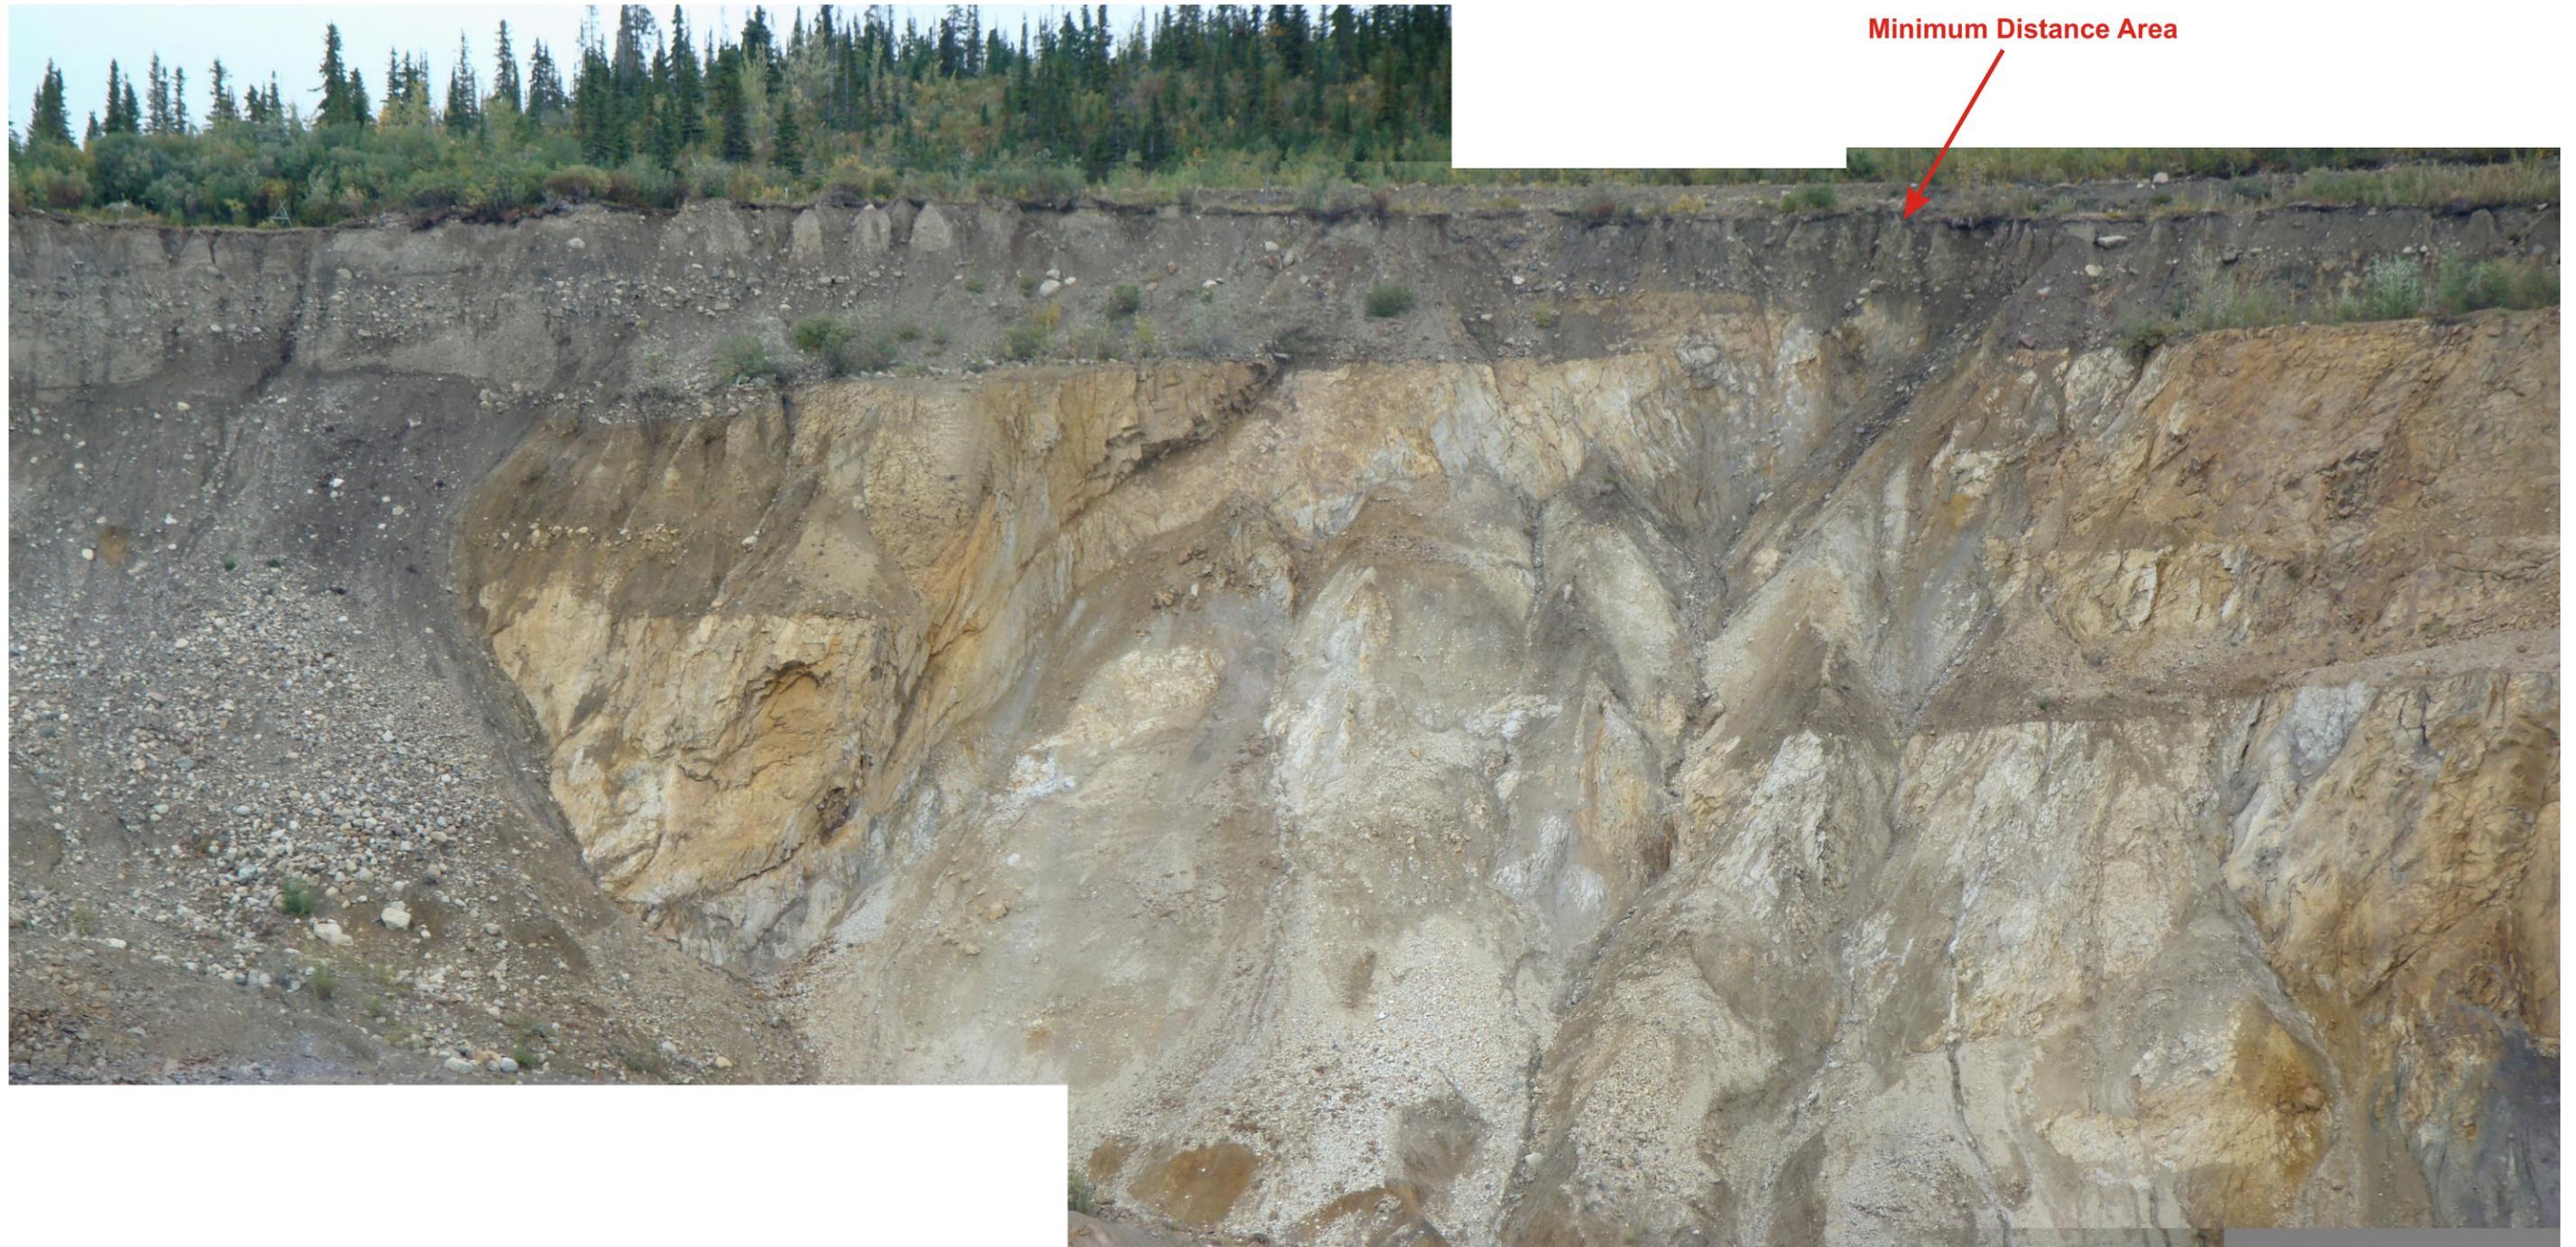
- The crest of the pit wall in overburden soils in the area of North instability does not exhibit signs of significant recession or degradation since 2008. Only limited erosion and ravelling was observed to have occurred in localized areas, and is likely due to erosion by surface water run-off over the edge of the wall during the spring season. Variable loss of overburden crest of approximately 0.25 to less than 0.5 metre appears to have occurred along the crest of the pit wall in the areas near reference bars 15355 and 15354. No tension cracks were observed behind the crest of the wall in those areas affected by some crest erosion.

Photograph #4 : North instability zone. View of the crest of the pit wall (August 2009).

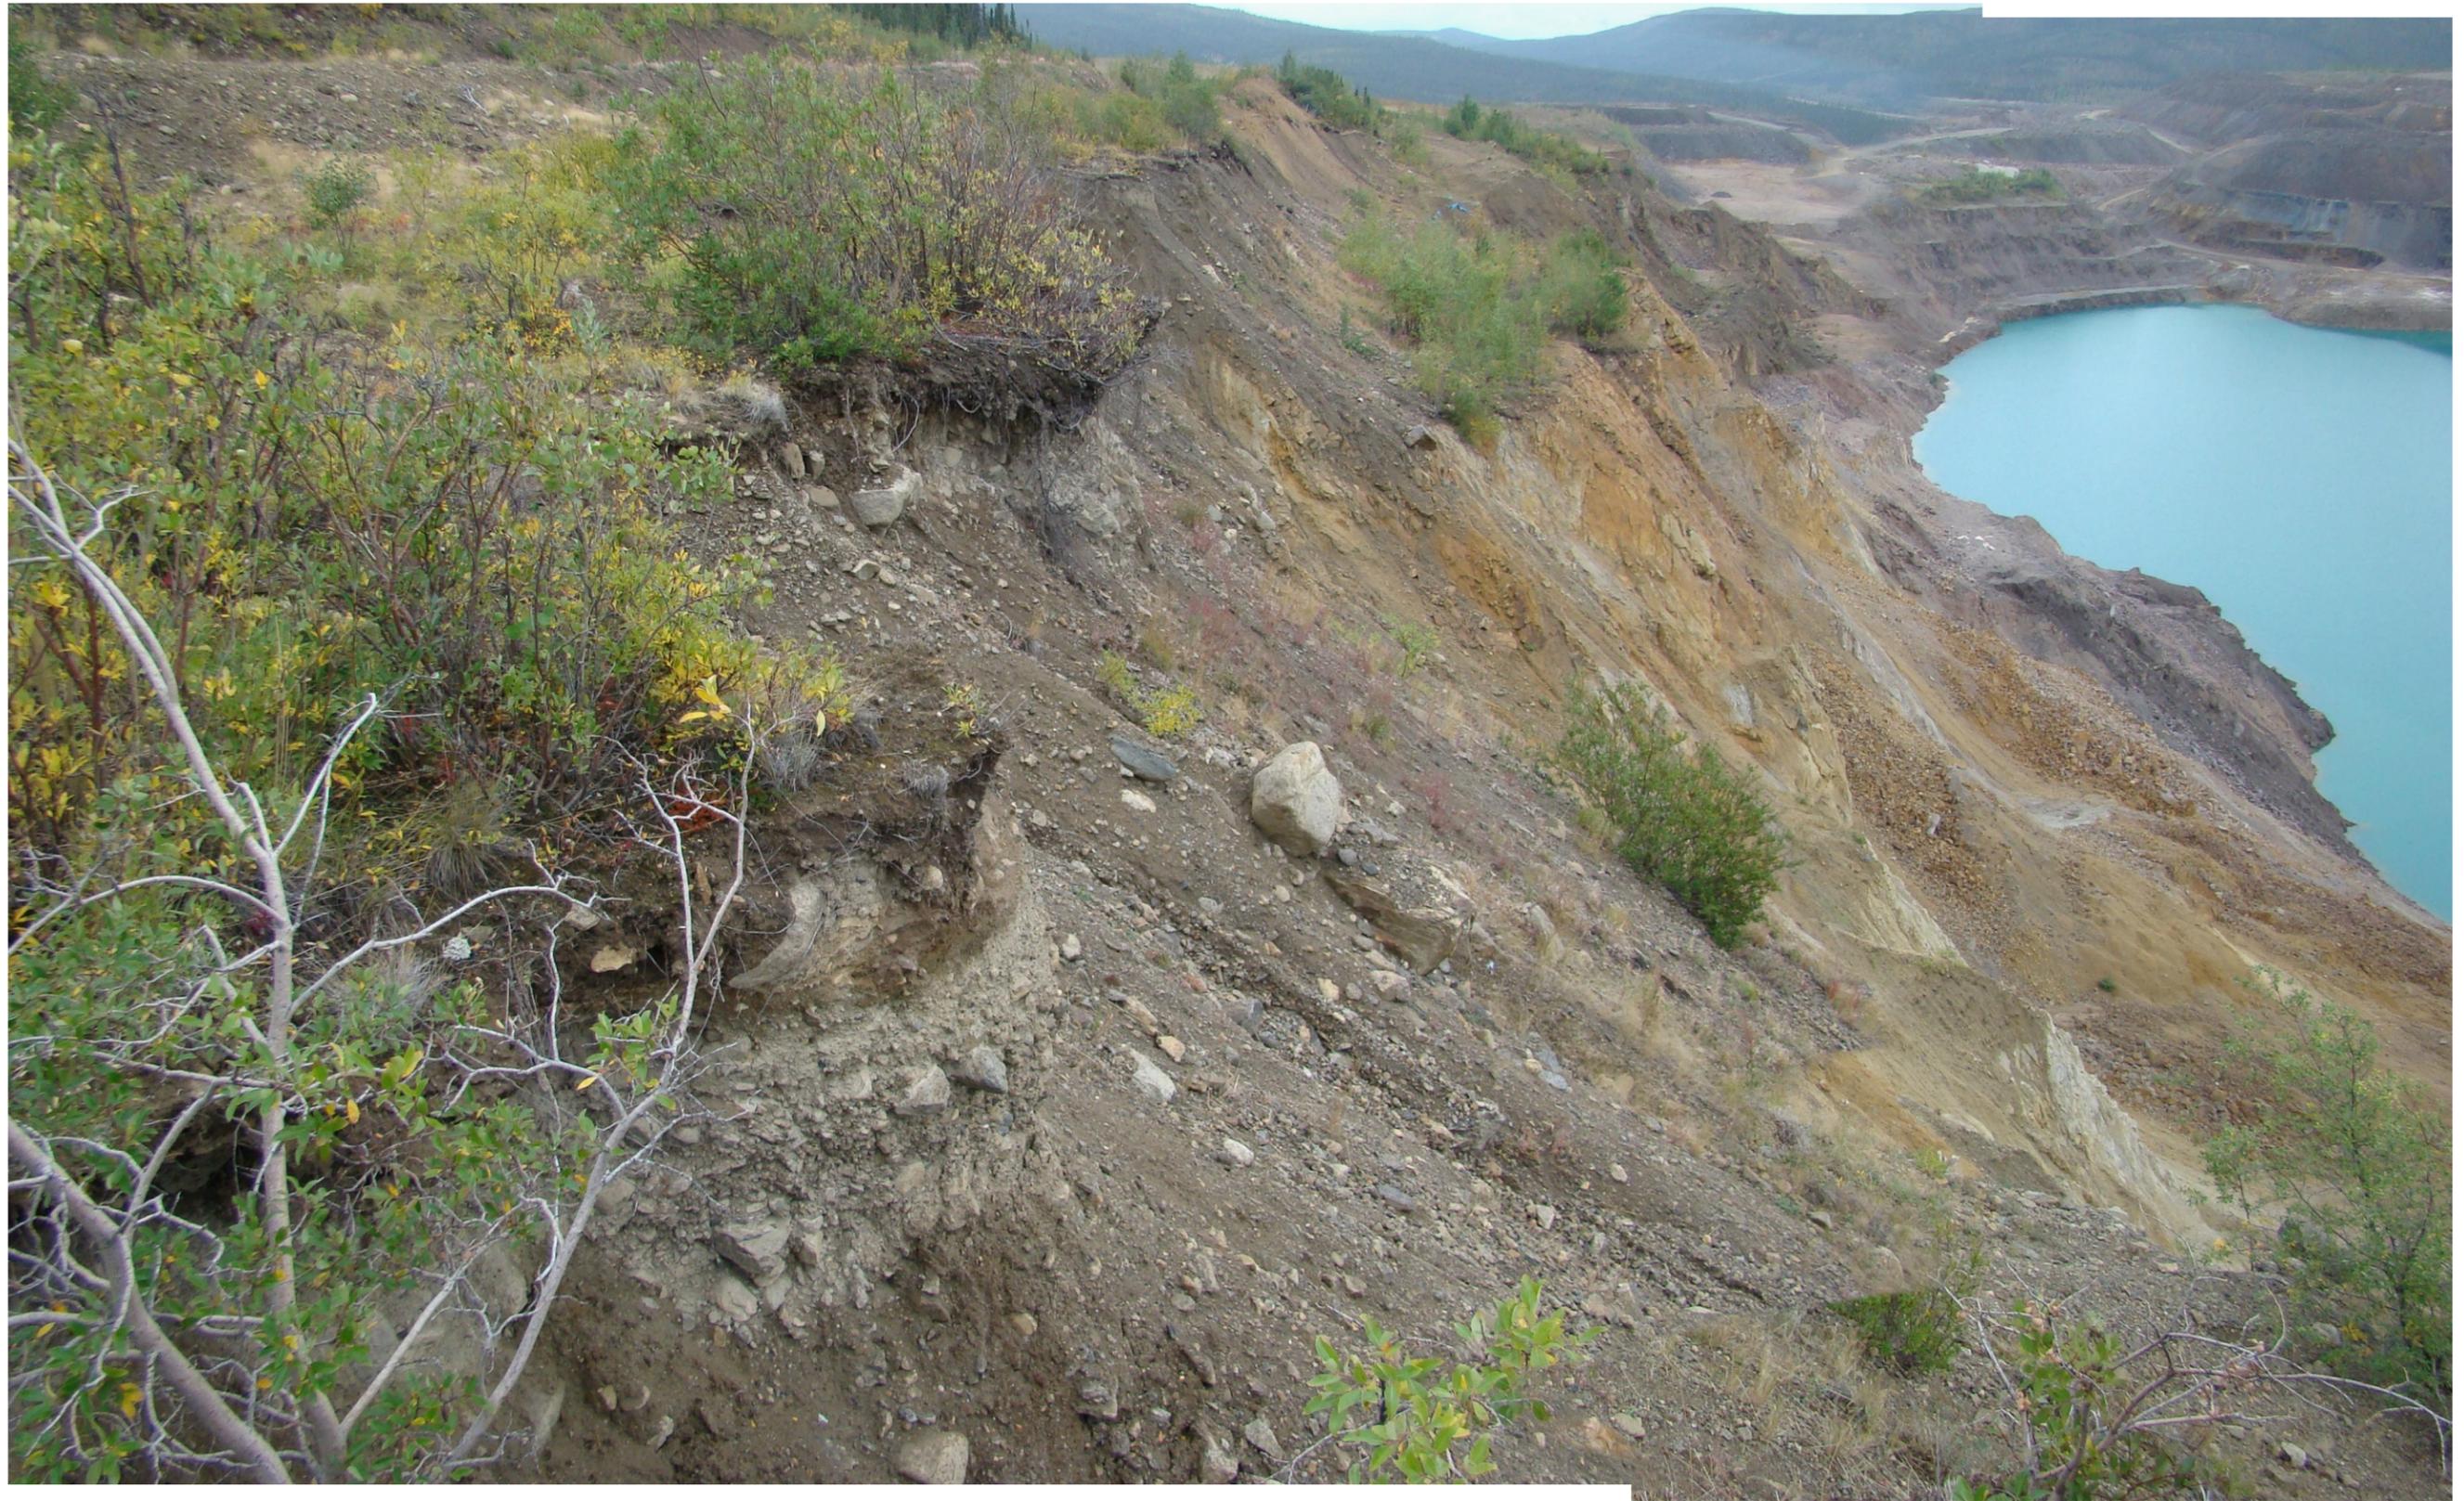
Photograph #5 : North instability zone. View of crest pit wall on overburden soils (August 2009).

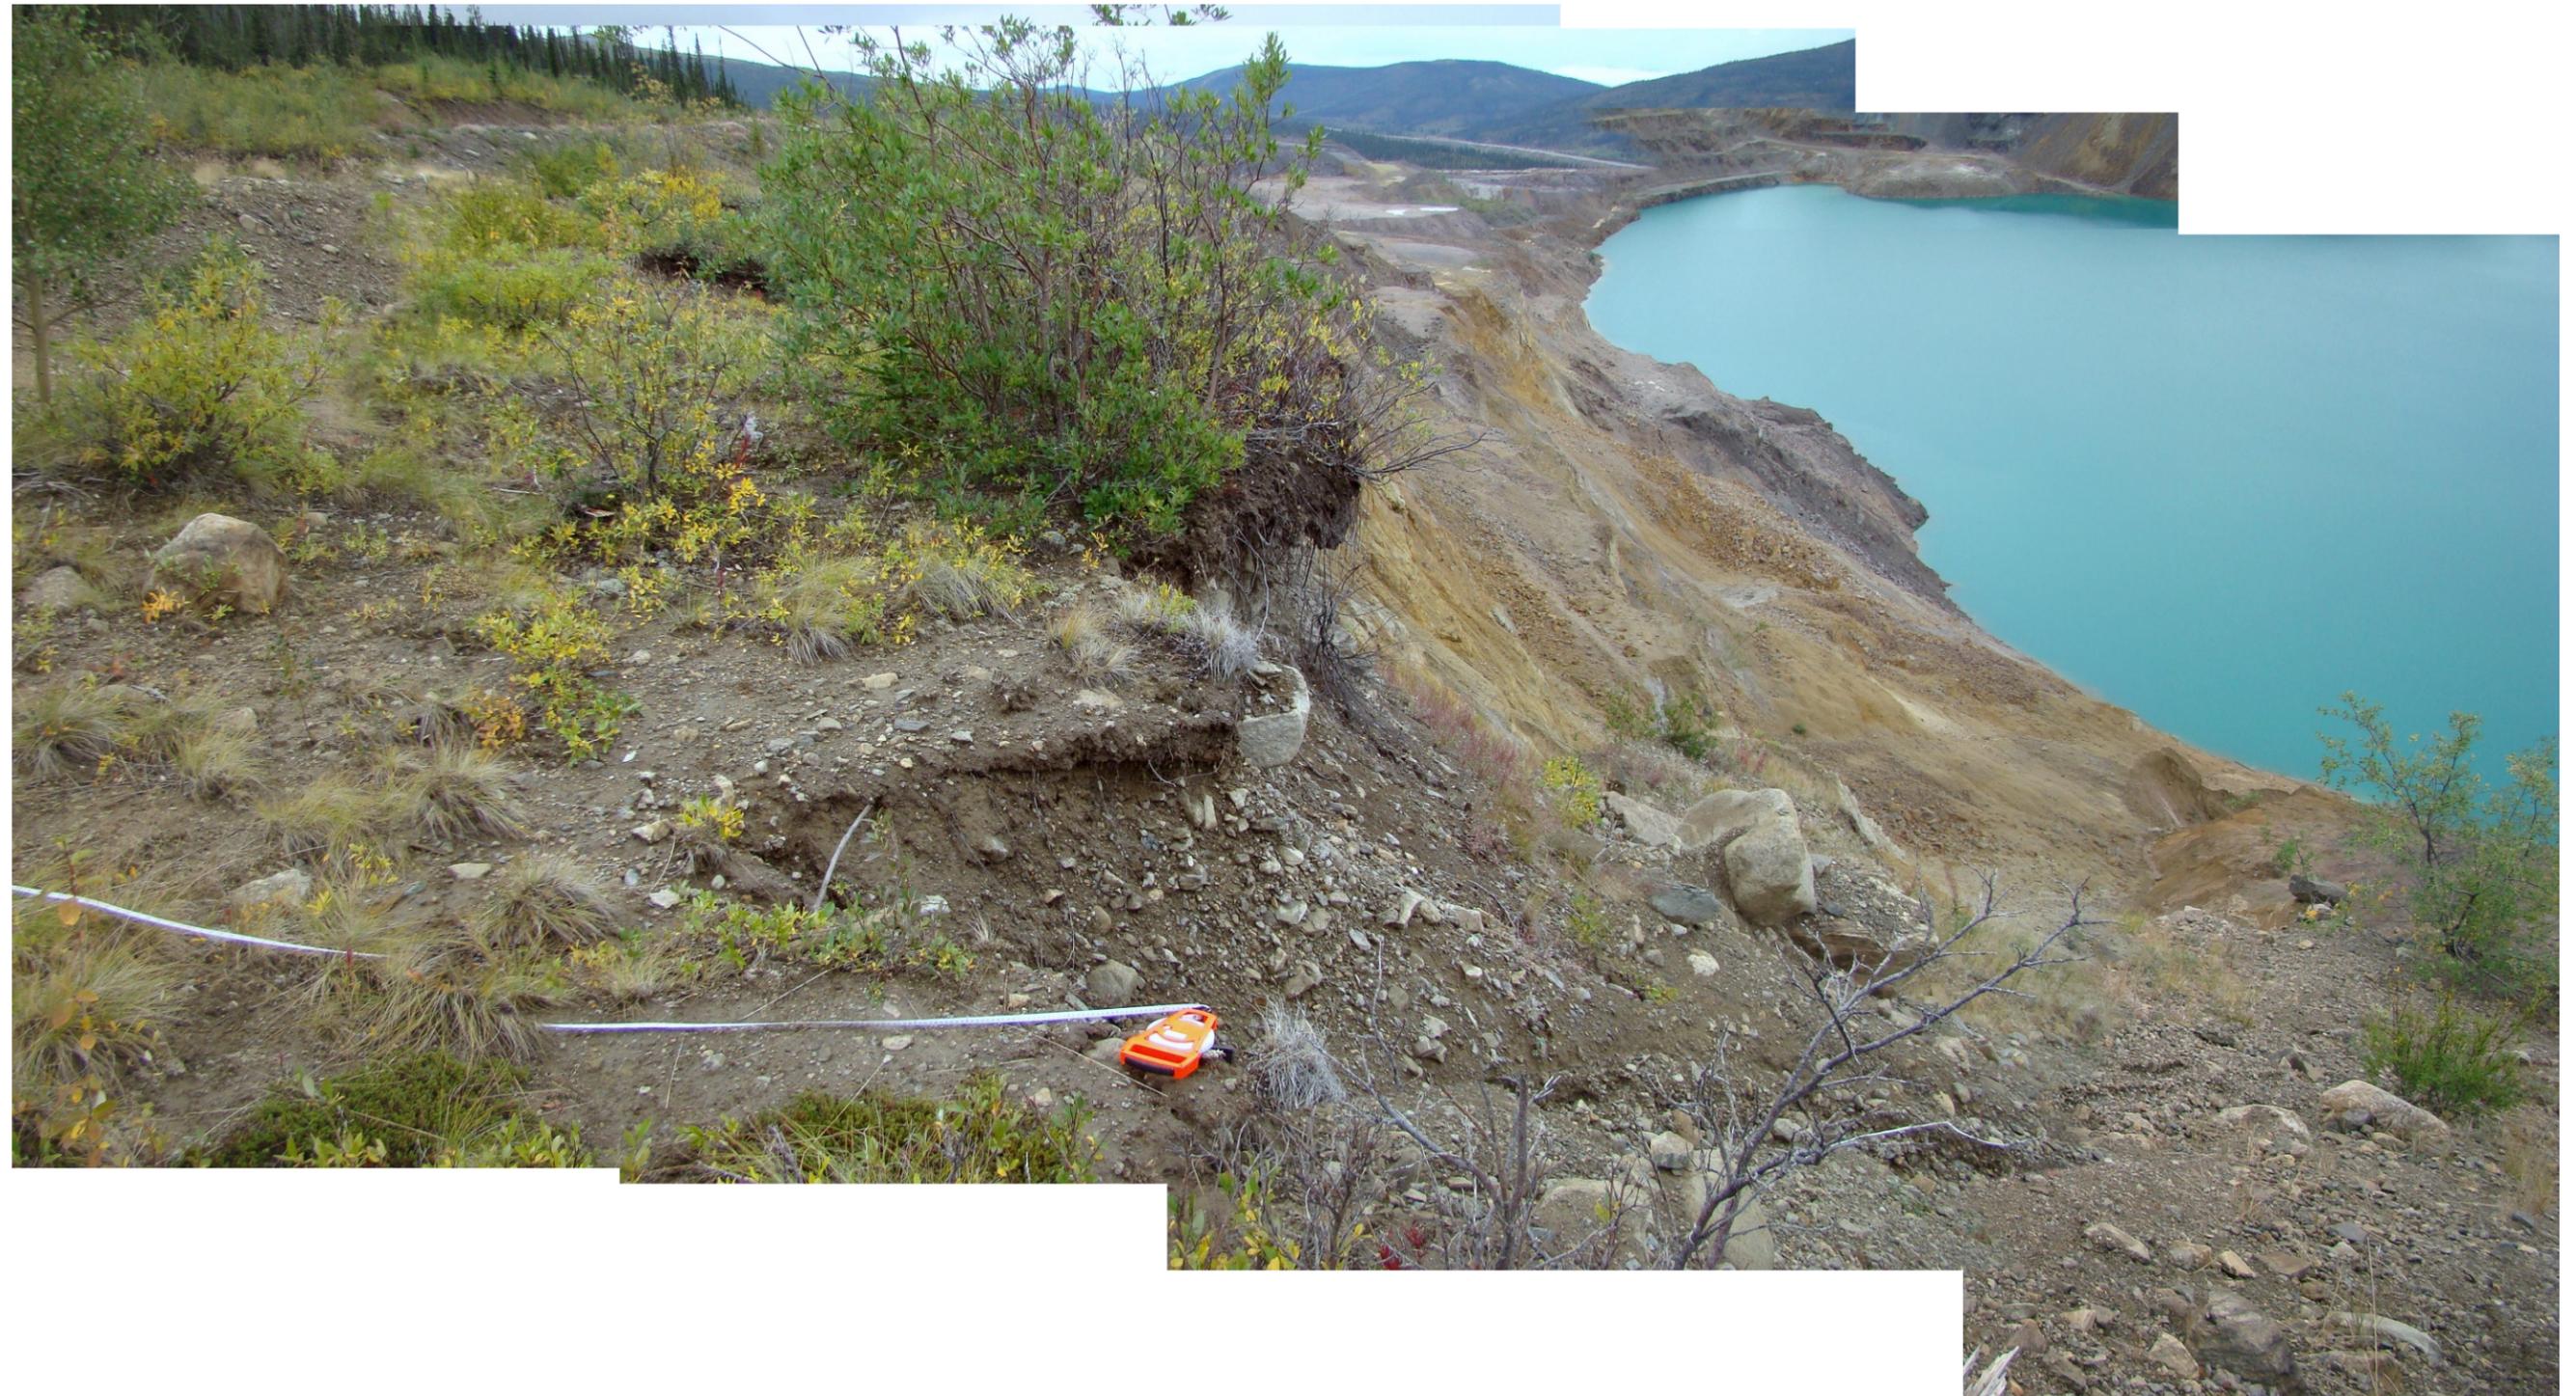
Photograph 6 : North instability zone. View of crest of the pit wall near reference bar 15354 (August 2009).

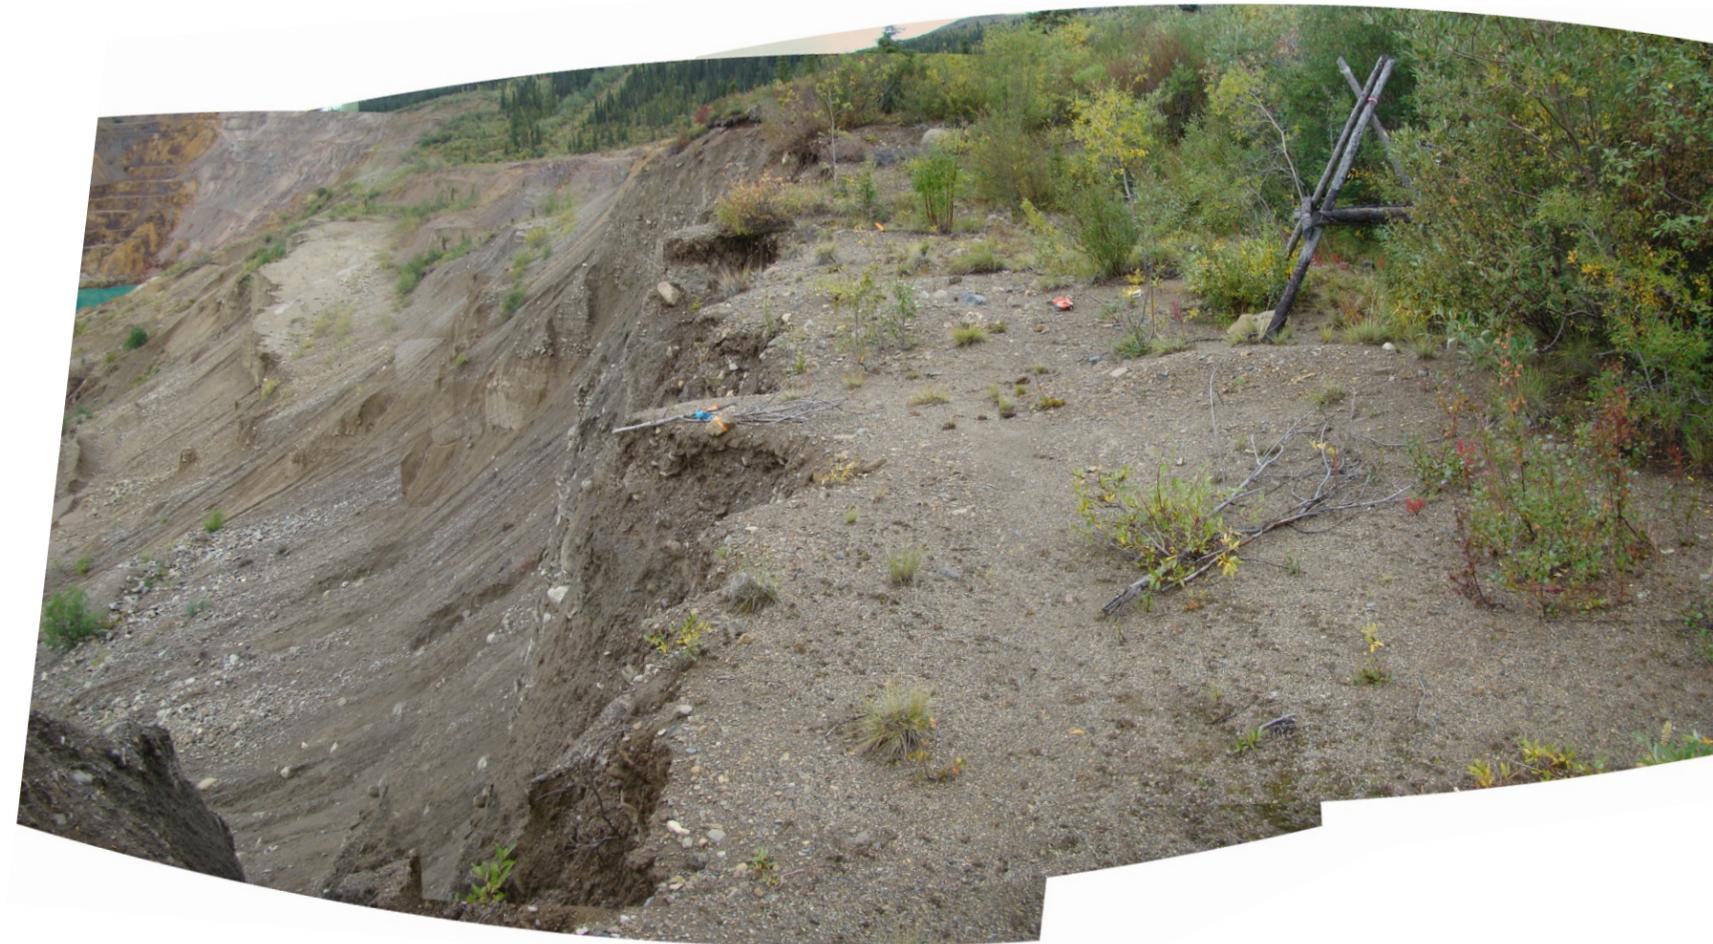
Photograph 7 : North instability zone. View of crest of the pit wall near reference bar 15355 (August 2009).

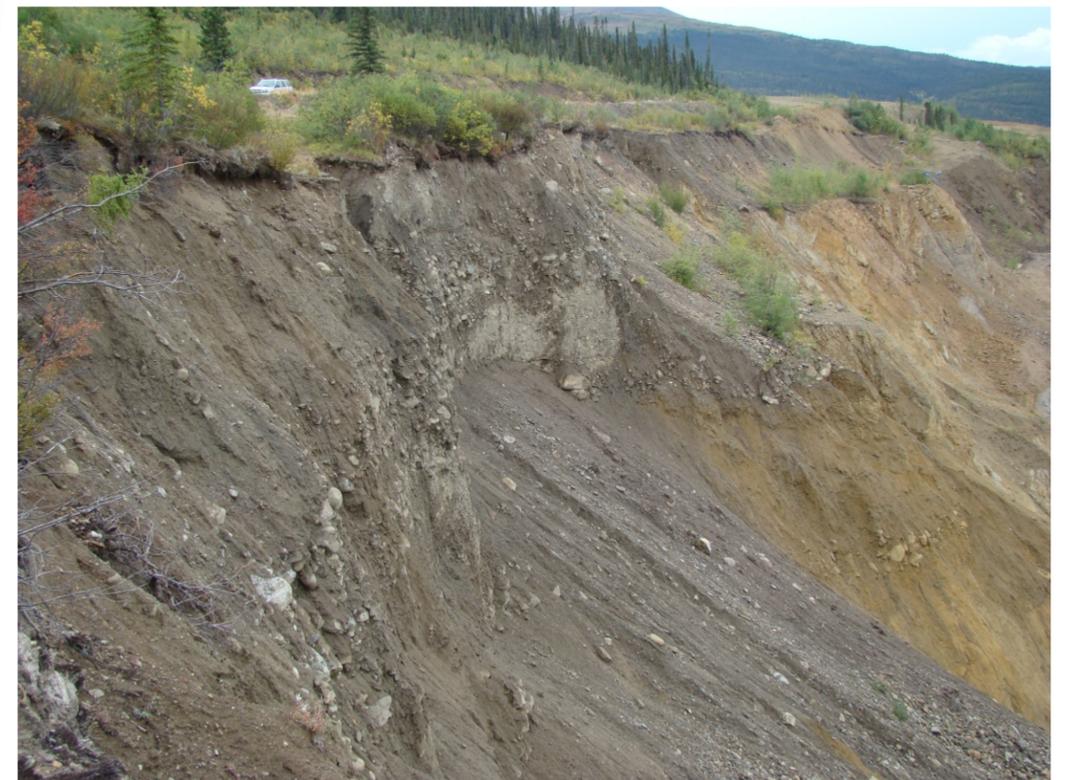
Photograph 8 : North instability zone. View of crest of the pit wall on overburden soils near reference bar 15355 (August 2009).
