November 24, 2009

2009 Faro Pit Slope Movement Monitoring

Submitted to:
Denison Environmental Services
Faro Care and Maintenance Project
P.O. Box 280
Faro, YT
Y0B 1K0

Report Number: 09-1426-0019/2000

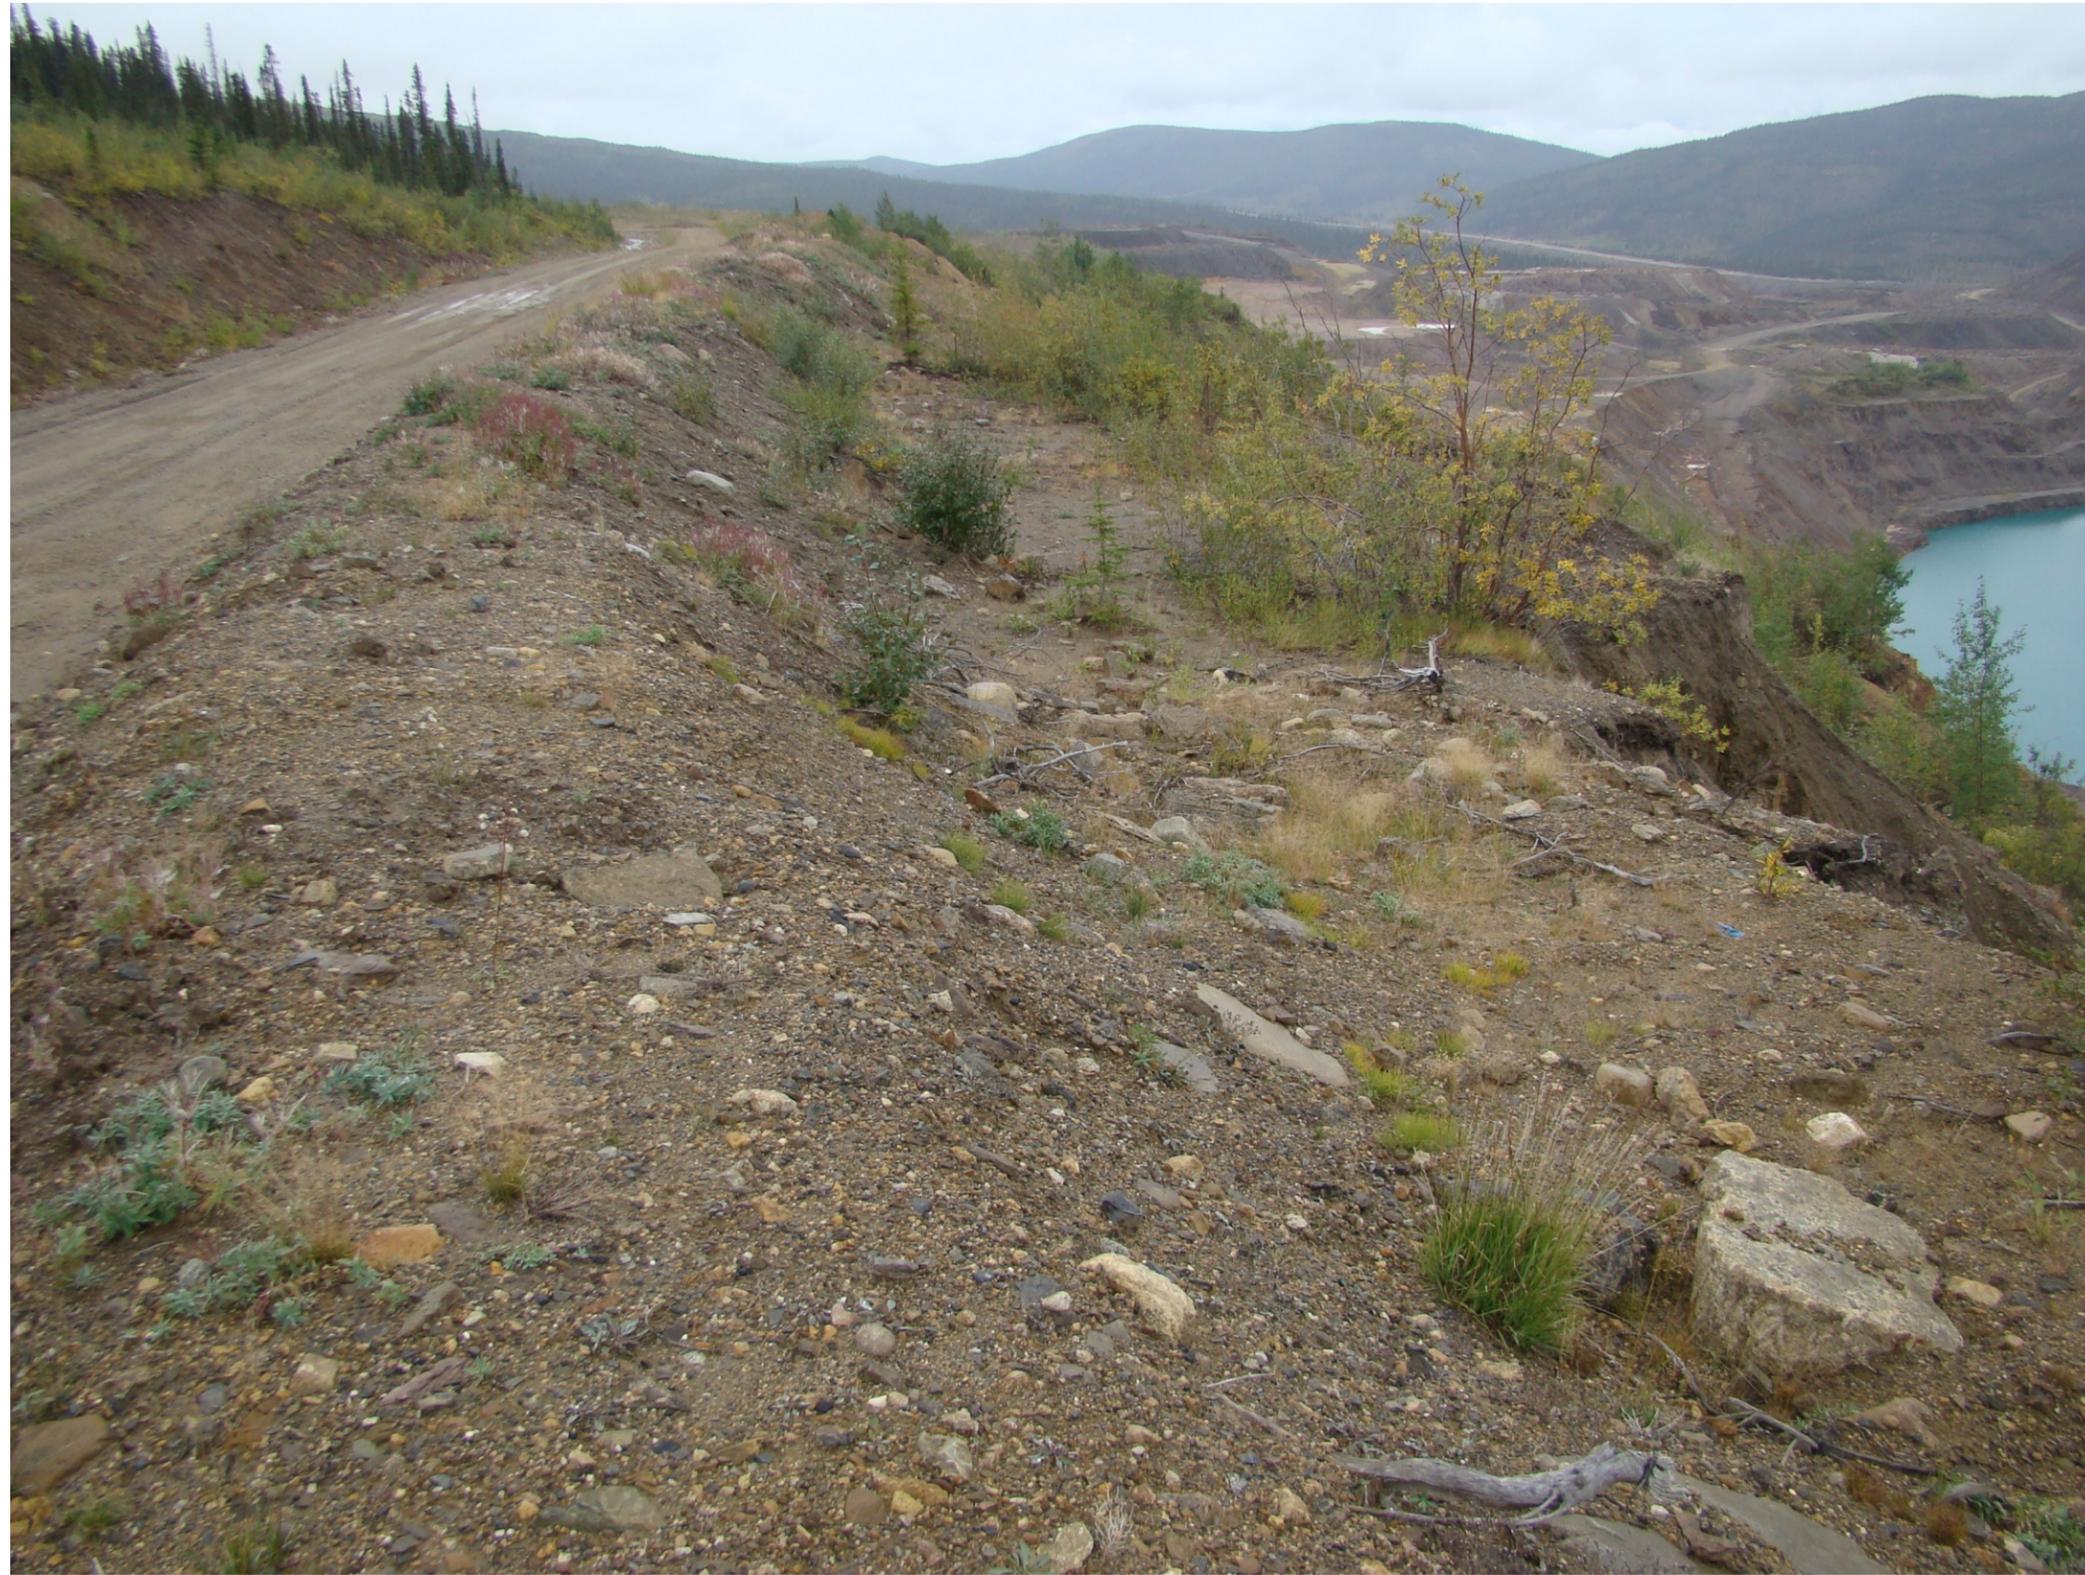
- The minimum distance between the crest of the east wall instability and the FCDC remains in the middle of the North instability zone, as shown in photographs in Appendix I. Crest recession at that location has not been sufficient to significantly reduce the minimum distance, and the actual distance remains in the same order as observed in the 2005 inspection, *i.e.*, approximately 18 metres. Only limited erosion and ravelling was observed to have occurred in this area, and is also likely due to sloughing and erosion of overburden soils by surface water run-off over the edge of the wall during the spring season. No tension cracks were observed behind the crest of the wall in this area.

Photograph 9 : North instability zone. Minimum distance area near reference bar 15353 (August 2009).

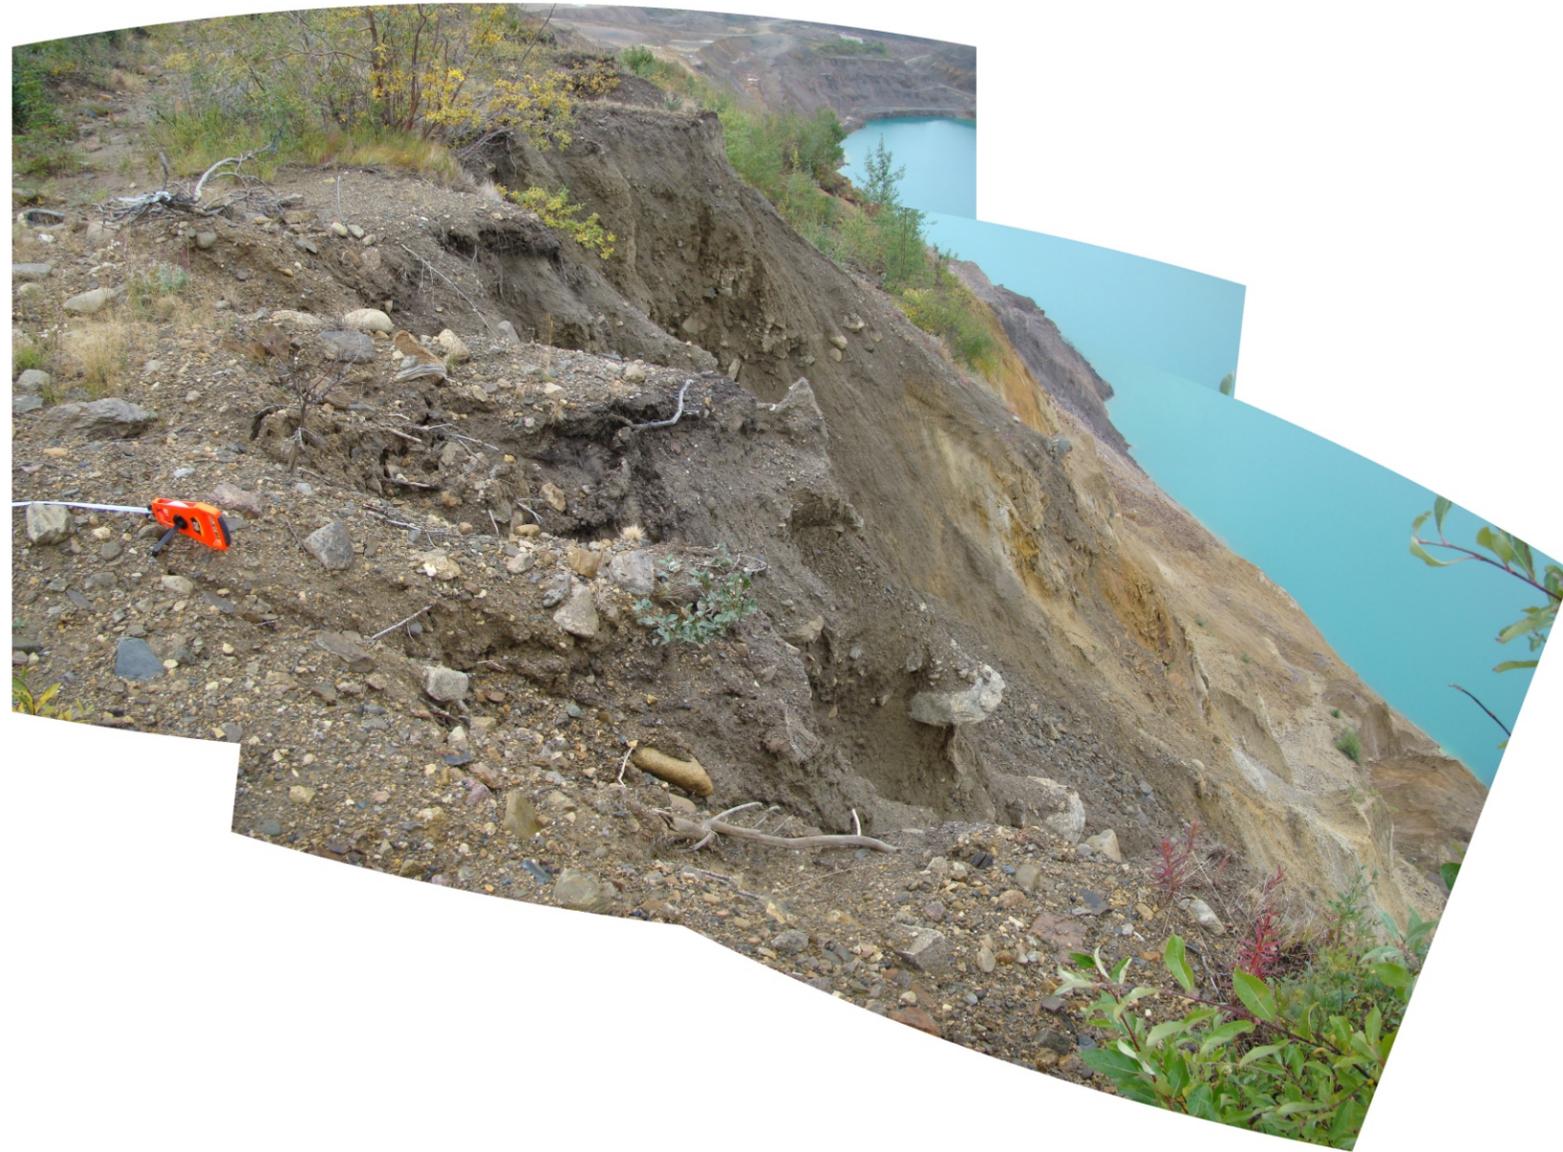
Photograph 10 : North instability zone. Minimum distance area near reference bar 15353 (August 2009).

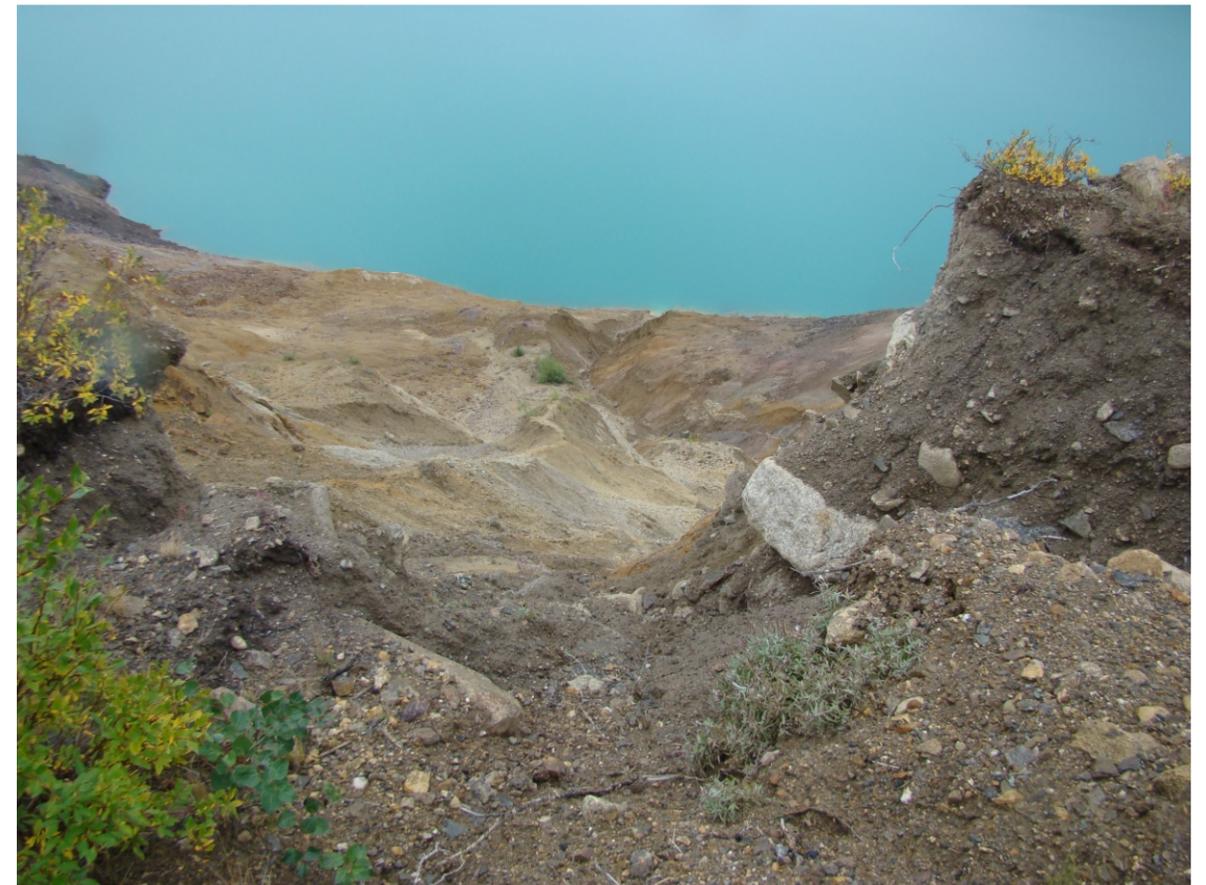
- Groundwater seepage is still observed at the minimum distance location, and is emanating from the overburden/bedrock contact. The previously existing erosion gully developed in the talus debris on the lower slope below this area has increased in size. The lateral extent of the erosion gully does not appear to have changed, but the depth of the erosion channel appears to have increased, mostly in the debris in the lower slope.

Photograph 11 : North instability zone. Erosion gully (August 2009).

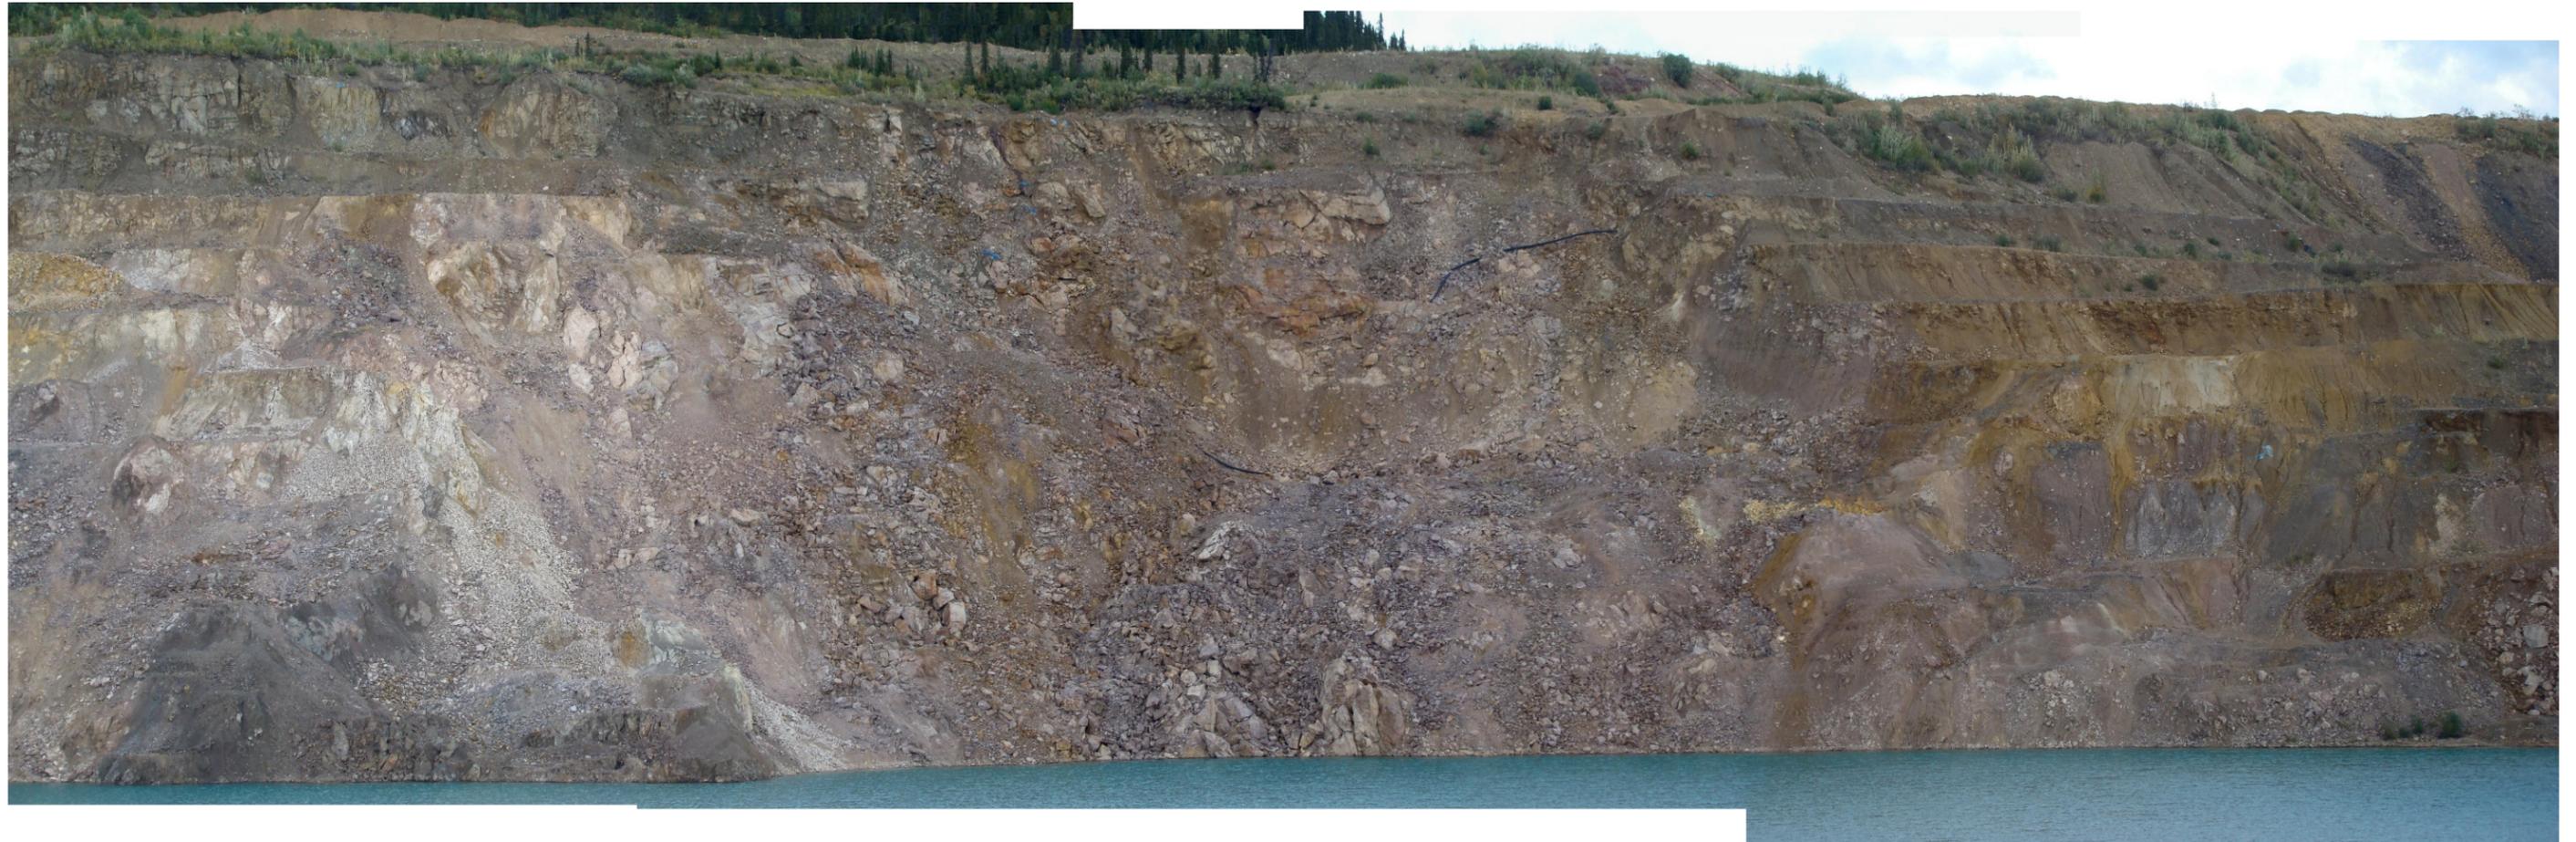
- The north boundary of the South instability zone has not significantly changed since the 2008 site visit, from a visual inspection perspective. The backscarp at the north end does not show any significant recession or degradation.

- The south boundary of the South instability zone has not changed significantly since the 2008 site visit. Only some ravelling from the backscarp and limited downward displacement of the accumulated failure debris appears to have occurred.

Photograph 12 : South instability zone. (August 2009).

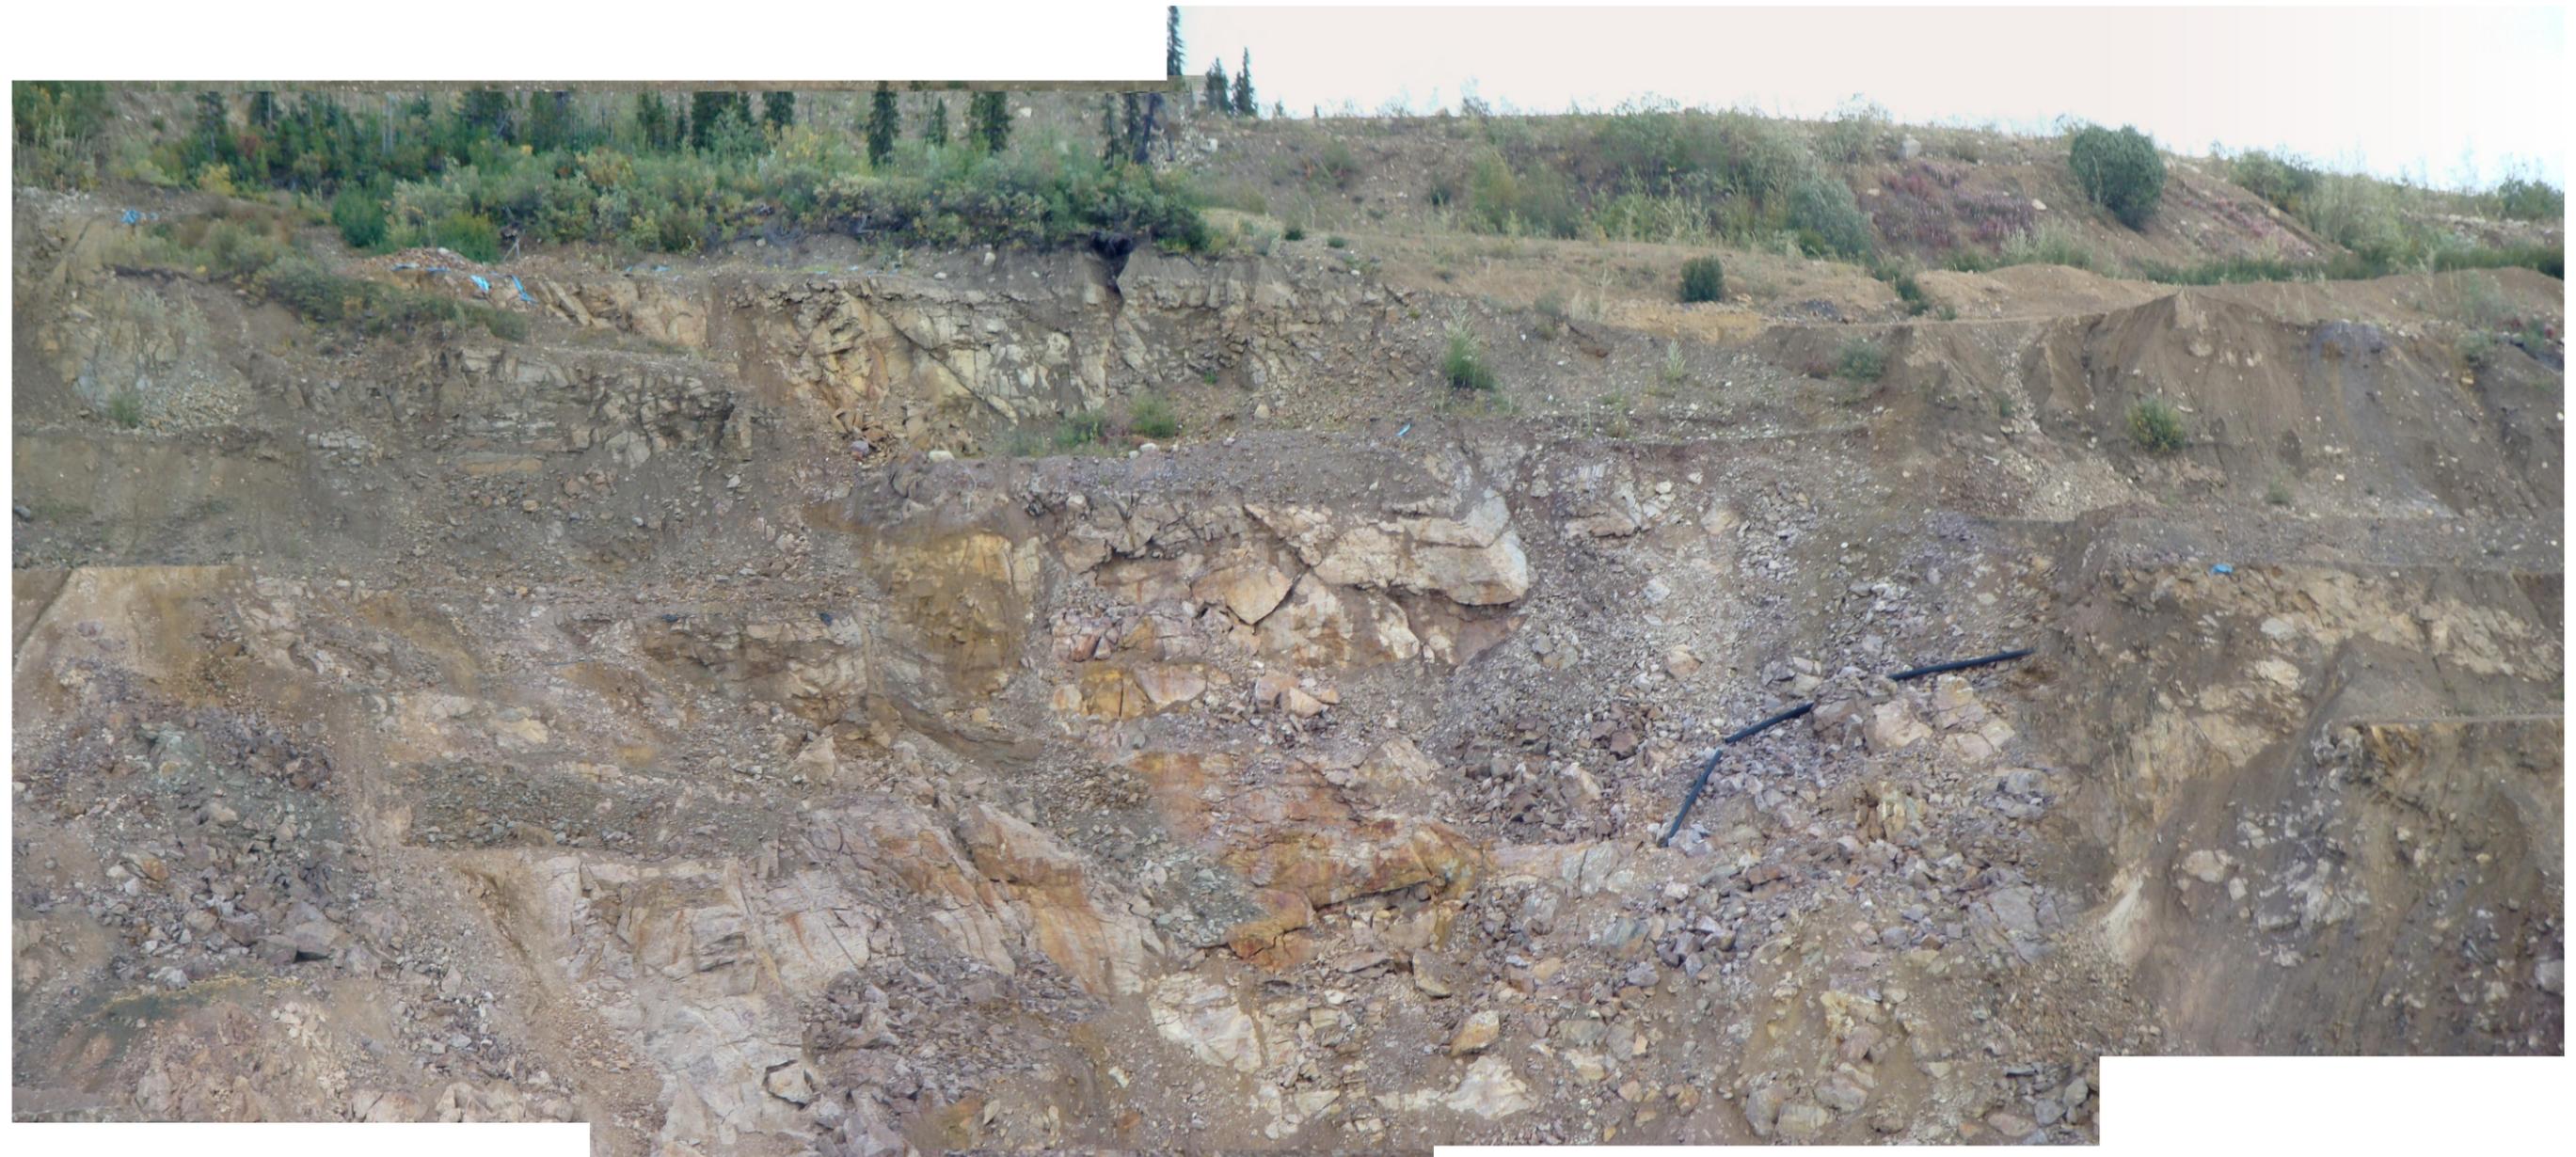
- The crest of the pit wall in the area of the South instability has not changed perceptibly since the previous assessment, from a visual inspection perspective. The crest at the backscarp does not show any significant recession or degradation. Only some limited ravelling from the backscarp appears to have occurred.

Photograph 13 : South instability zone. View of the crest of the pit wall. (August 2009).

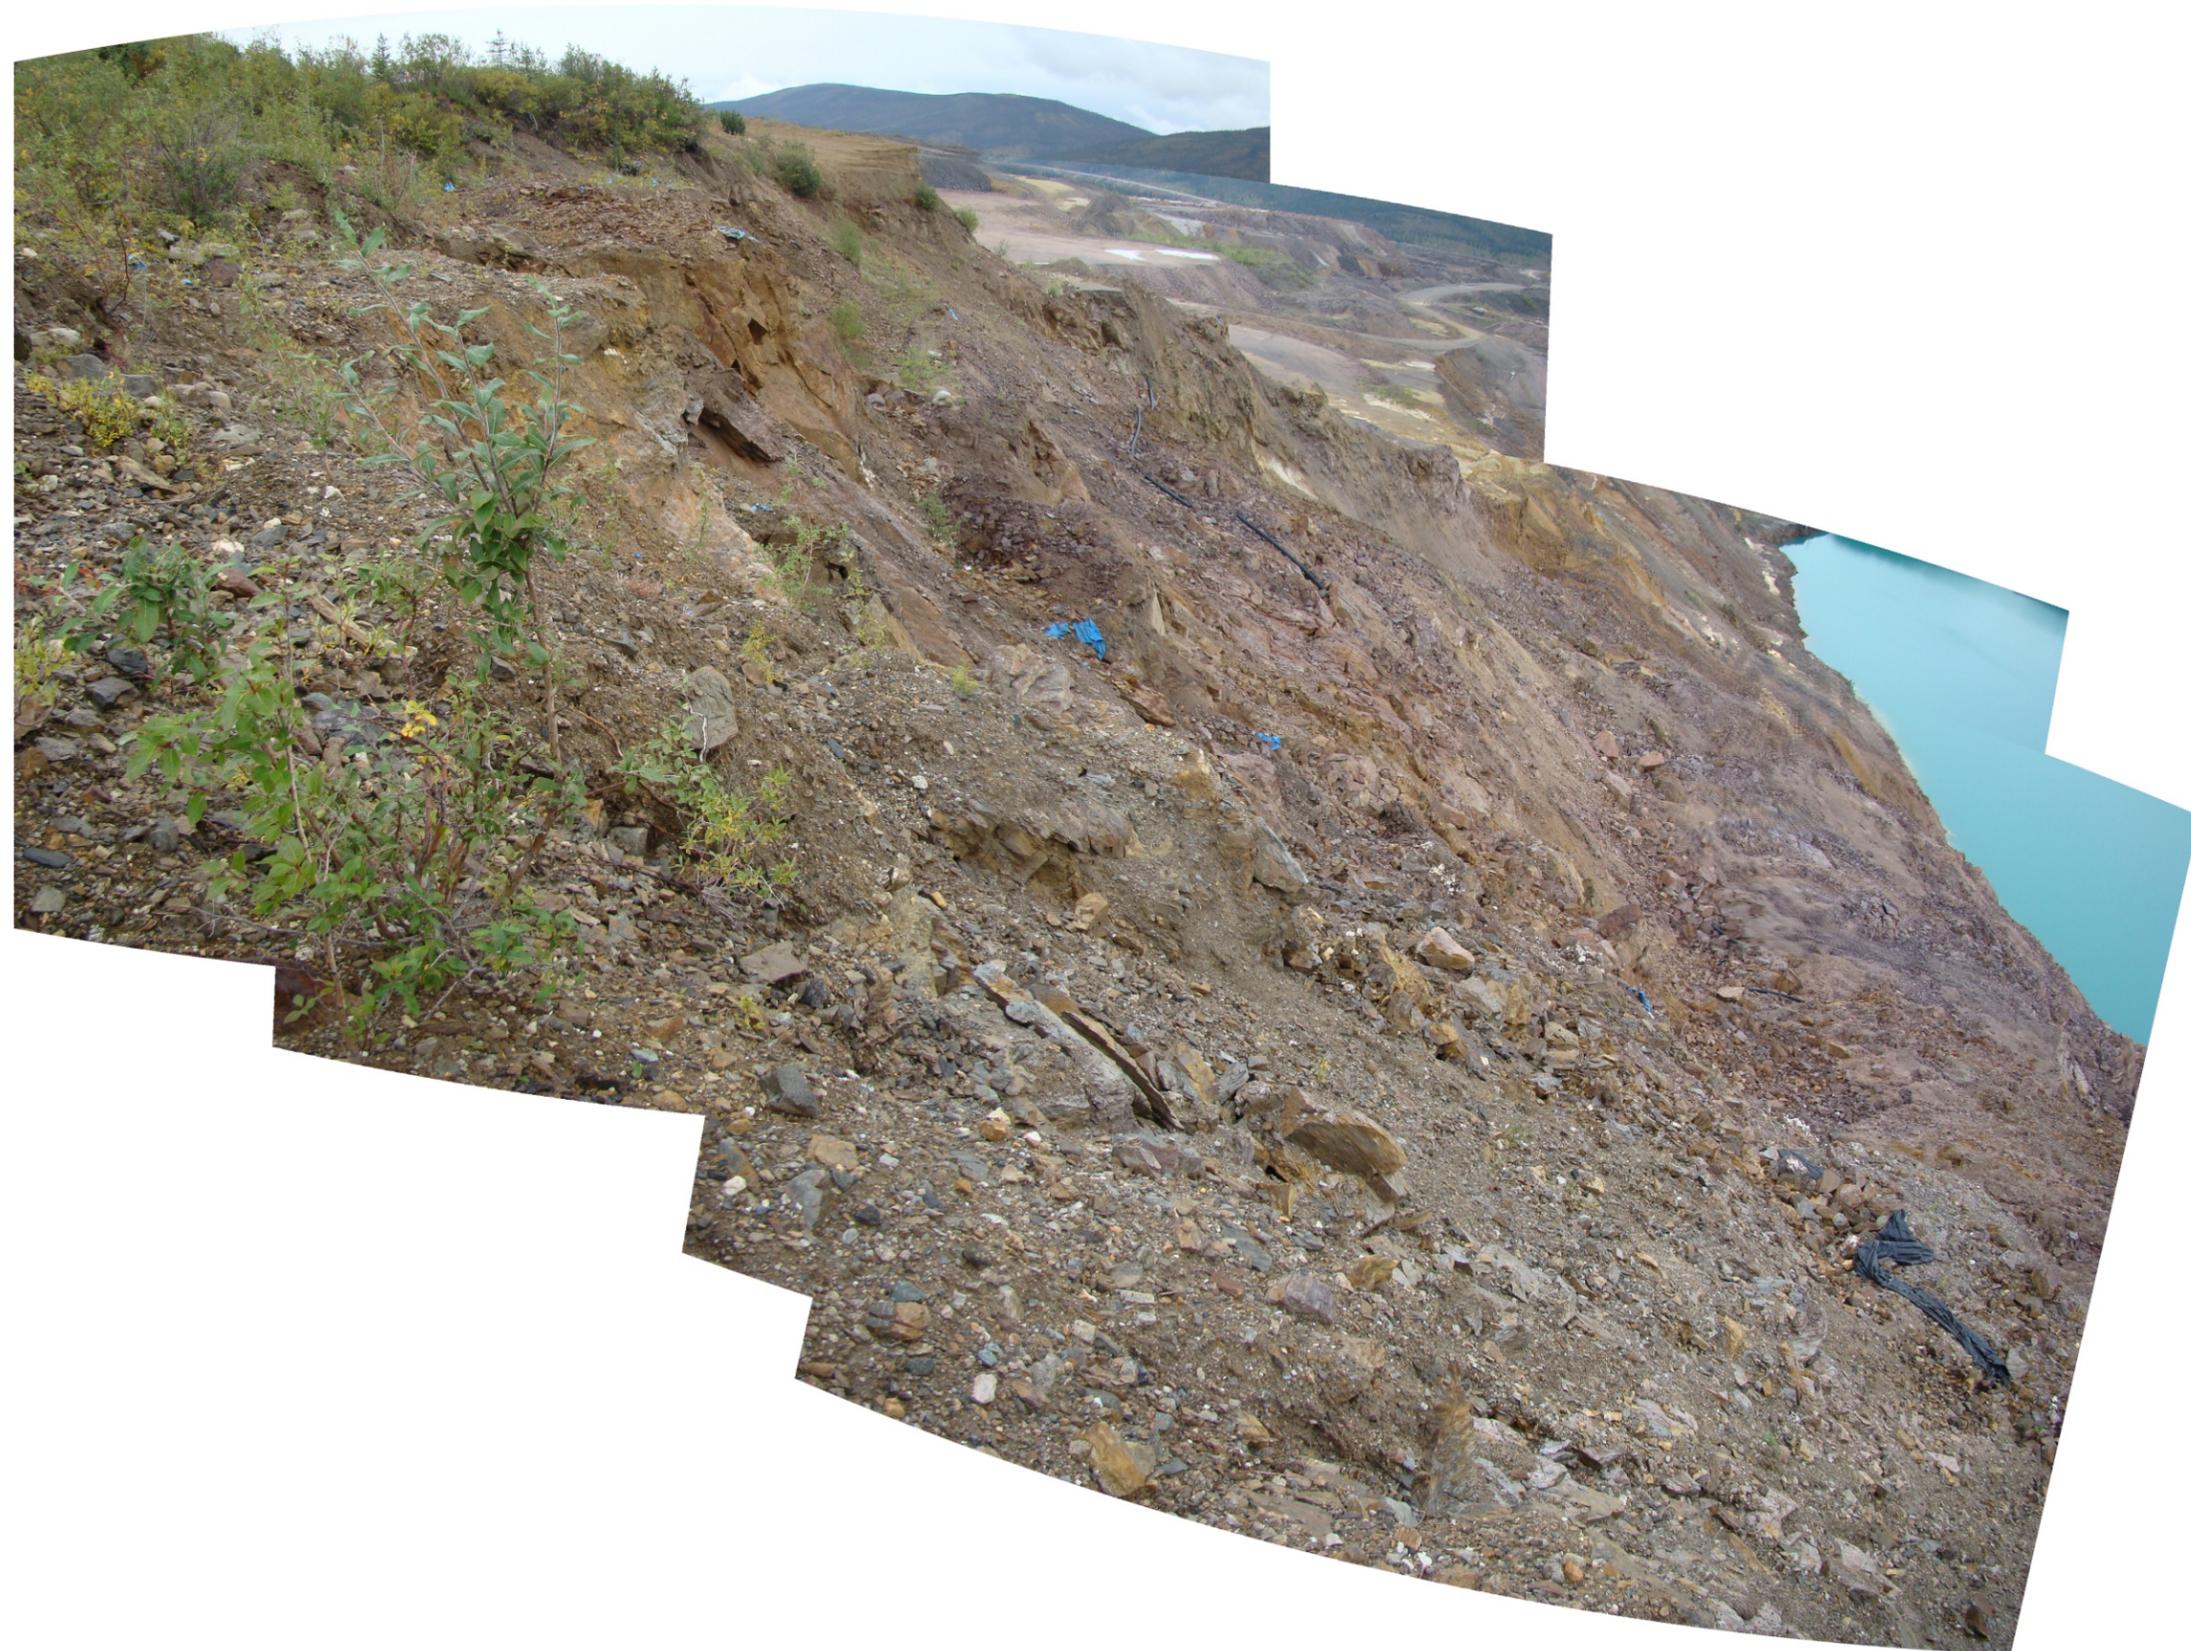
Photograph 14 : South instability zone. View of the back-scarp looking south (August 2009).
