DATE October 5, 2010

PROJECT No. 10-1427-0032

DOC No. 001

**2010 ANNUAL GEOTECHNICAL DAM INSPECTION
PRELIMINARY GEOTECHNICAL ASSESSMENT
FARO MINE COMPLEX, FARO, YUKON**

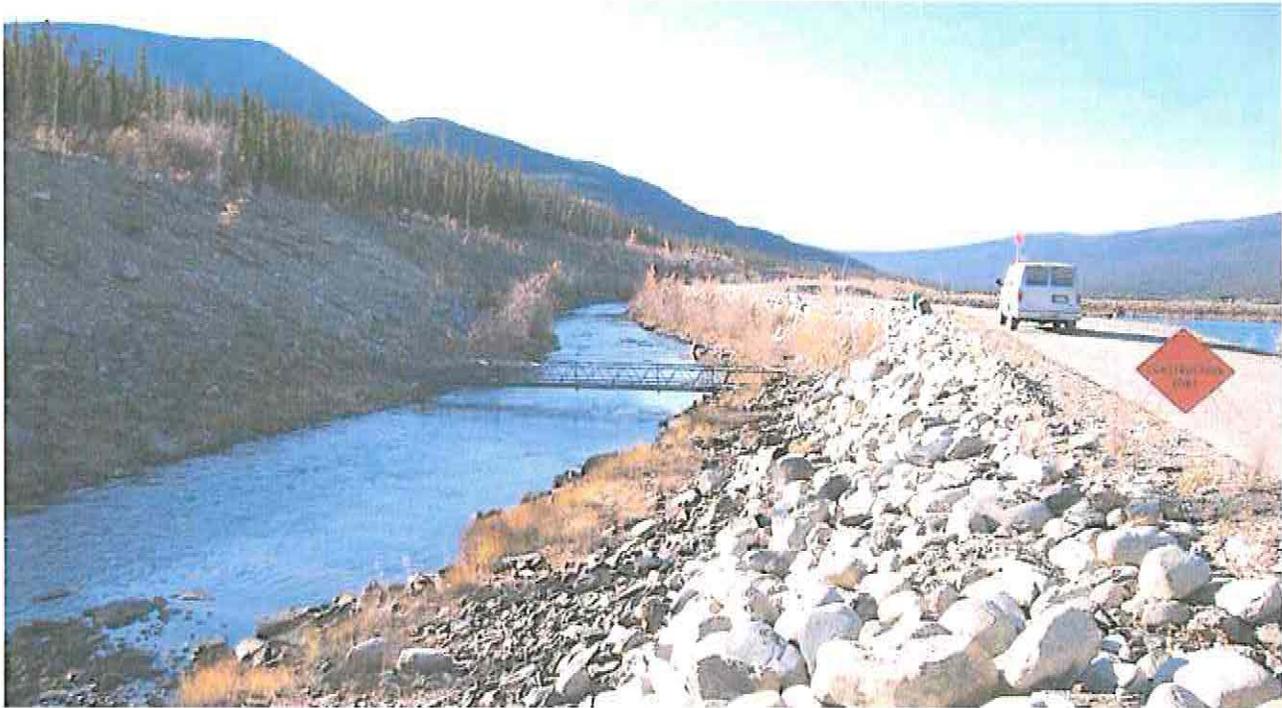
DES is proceeding to remove vegetation from the diversion channel side slopes along the length of the RCDC to improve channel flow conditions. Channel vegetation removal operations were in progress at about Stn. 2+250 and appear satisfactory.

Photograph 1: Vegetation removal progress near Stn. 2+500 of Rose Creek Diversion Channel

- The vegetation removal activities, which are currently underway within the Rose Creek Diversion Channel, appear reasonable and should be carried out to the end of the channel, as planned.

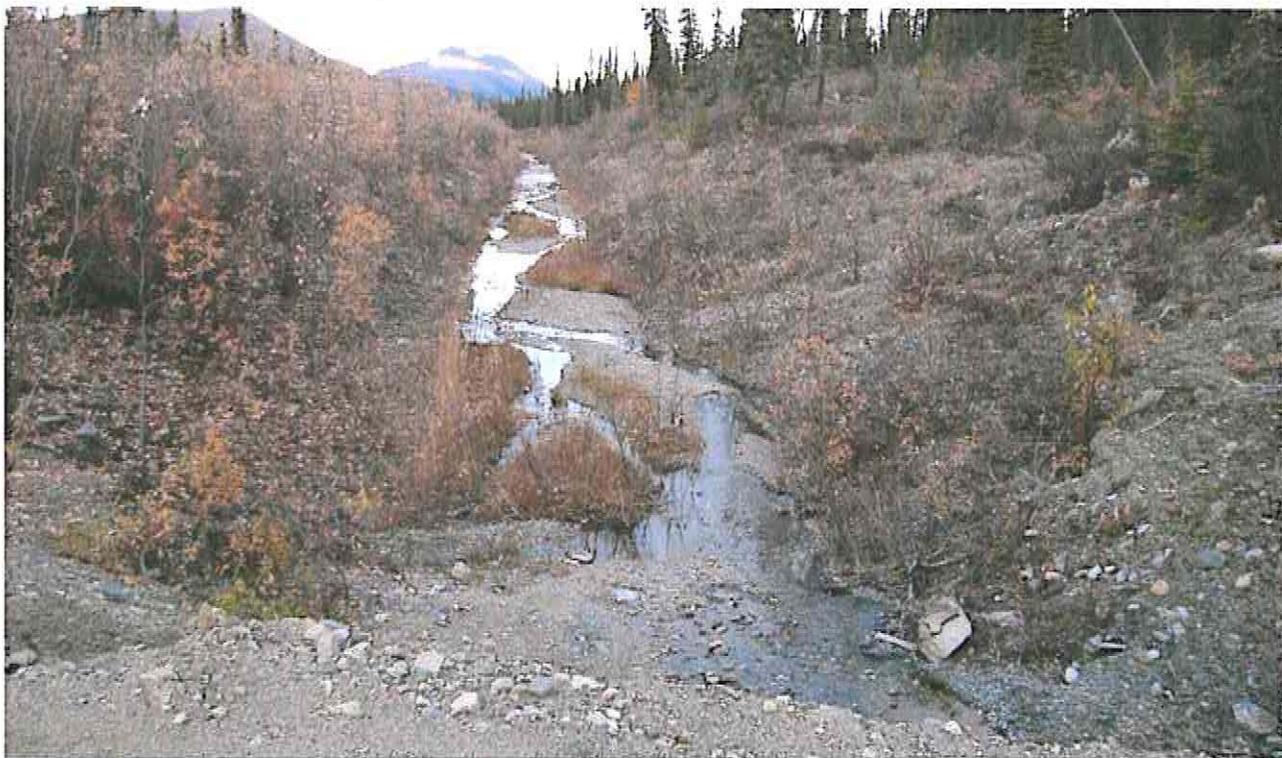
The channel gradient varies from relatively flat to moderate conditions, with ponded water developing in areas where the channel bottom undulates or is obstructed. Sedimentation is developing down gradient of the new water supply well access road crossing due to uncontrolled sediment erosion (Photo 2). Consideration should be given to address the erosion conditions that are developing along the new fresh water supply access road which crosses the NVWID, as defined in Section 4.

Photograph 2: Sedimentation downstream of well access crossing of North Valley Wall Interceptor Ditch

- The sedimentation and ponded channel conditions observed in the upper portion of the North Valley Wall Interceptor Ditch should continue to be monitored. Consideration should be given to address the erosion conditions that are developing along the new fresh water supply access road which crosses the NVWID, such as ditch lining and/or rip rap protection to limit further sedimentation degradation of the diversion channel. Furthermore, the observed ponded water conditions should be monitored as there is evidence of toe erosion occurring along the channel side slopes, which may require regrading of the drainage channel gradient in the upper channel portion.

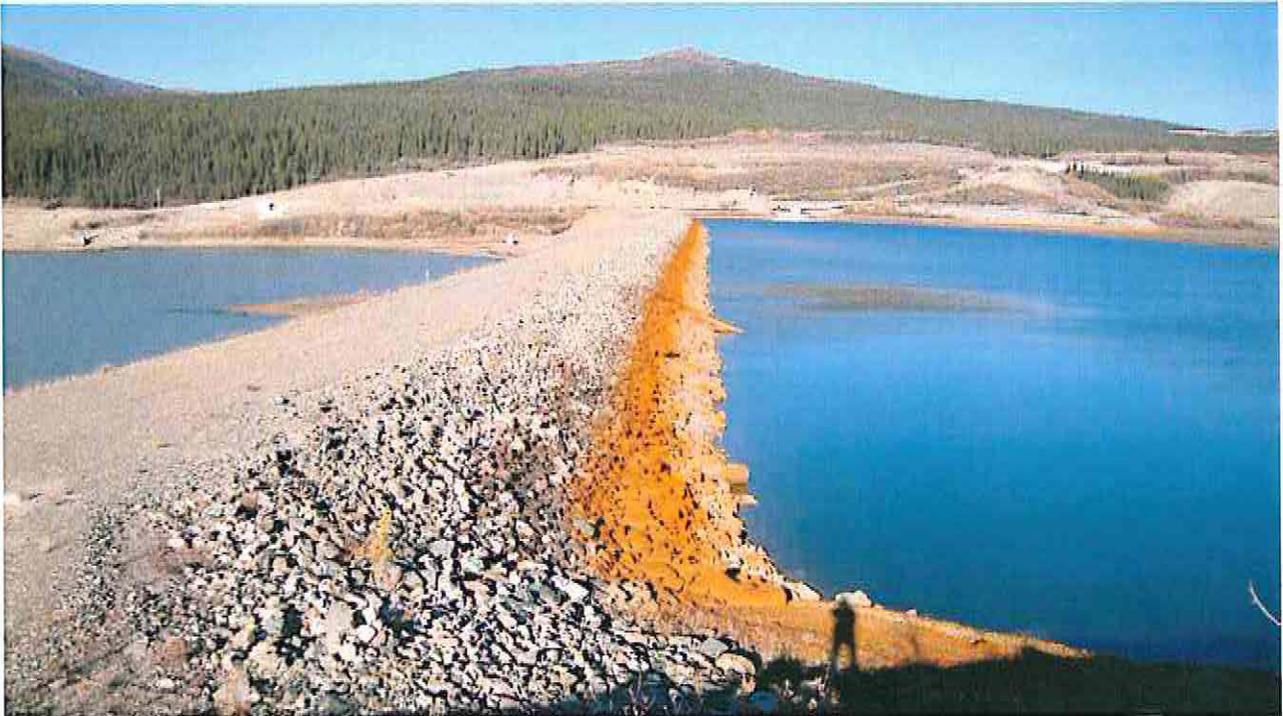
The Intermediate Dam (ID) is an internal tailings dam designed to retain tailings, supernatant water and run-off water within the tailings facility. At the time of inspection, the impoundment water level was operating below the rip rap protection provided on the upstream slope. There was at the time of the inspection no apparent evidence of upstream slope instability of the underlying sand and gravel shell material or rip rap degradation (Photo 3).

Photograph 3: Upstream drawdown operating conditions at Intermediate Dam

- The current operating impoundment water level conditions upstream of the Intermediate Dam and Cross Valley Dam should be monitored for potential soil erosion of the upstream shell material below rip rap surface and rip rap degradation if the new operating water levels are to be maintained.

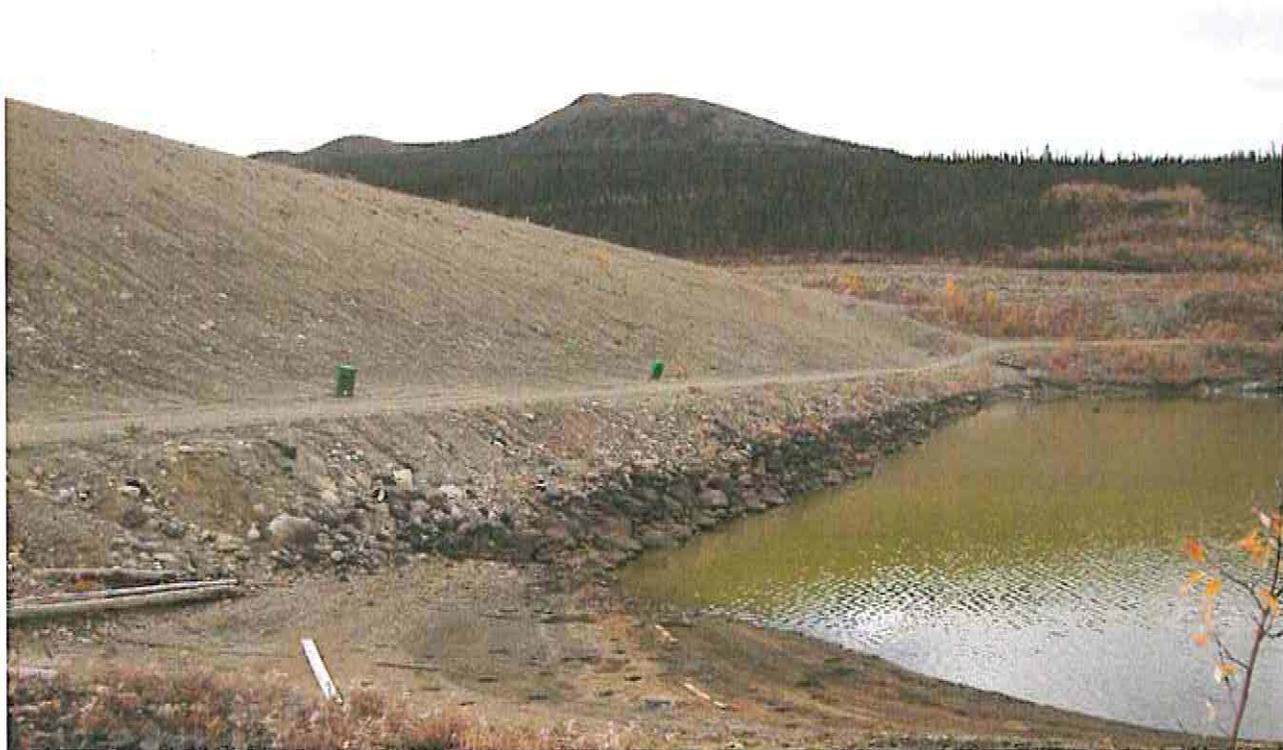
The downstream slope is experiencing extensive surficial soil erosion, with no apparent movements of underlying downstream shell material (Photo 4). The surficial soil erosion conditions comprises a series of shallow soil rills across the entire dam width from the base of slope up to at least two-thirds of the dam's downstream slope height. In addition, there are shallow soil scarps developing on the lower dam slope across the southern portion of the dam length. The shallow soil scarps extend from the base of slope up to at least half of the dam slope height across the southern two-thirds of the dam length. The shallow soil rills and shallow scarps have eroded the downstream surface to a depth of less than 0.3 m and the deeper soil scarps range between about 0.3 m and 1 m deep.

The back scarp and eroded soil conditions appear to comprise silty sand and gravel. The eroded soil has been transported down slope and deposited at the toe of slope on the downstream bench. Evidence of the underlying drainage blanket was not observed.

Photograph 4: Downstream drawdown operating conditions at Intermediate Dam

Further geotechnical evaluation of the downstream slope conditions should be considered to address the observed soil erosion slope conditions. Short and long term recommendations are summarized in Section 4.

- It is recommended that the soil erosion conditions observed on the downstream slope of the Intermediate Dam should be assessed by a geotechnical engineer. The soil erosion conditions should continue to be monitored for potential further erosion, slope creep and/or possible slope instability. While no overall slope instability mechanisms were identified during this site inspection, there is a risk that if the slope is left unattended, the observed shallow soil instabilities may become detrimental to the overall integrity of the downstream slope of the Intermediate Dam and should be addressed within the next few years.

- From our discussions with DES, it is considered too late this year to remove and/or re-grade the observed unstable soil conditions on the downstream slope of the Intermediate Dam. Therefore it is recommended that consideration should be given to addressing the observed instability conditions within the next few years, subject to the timing and scope of future regrading requirements that may be considered by the closure plan for this structure.

- As part of the geotechnical review of the Intermediate Dam conditions, it is recommended that short term and long term dam remediation measures are identified and scheduled to repair and stabilize the observed unstable dam slope conditions.

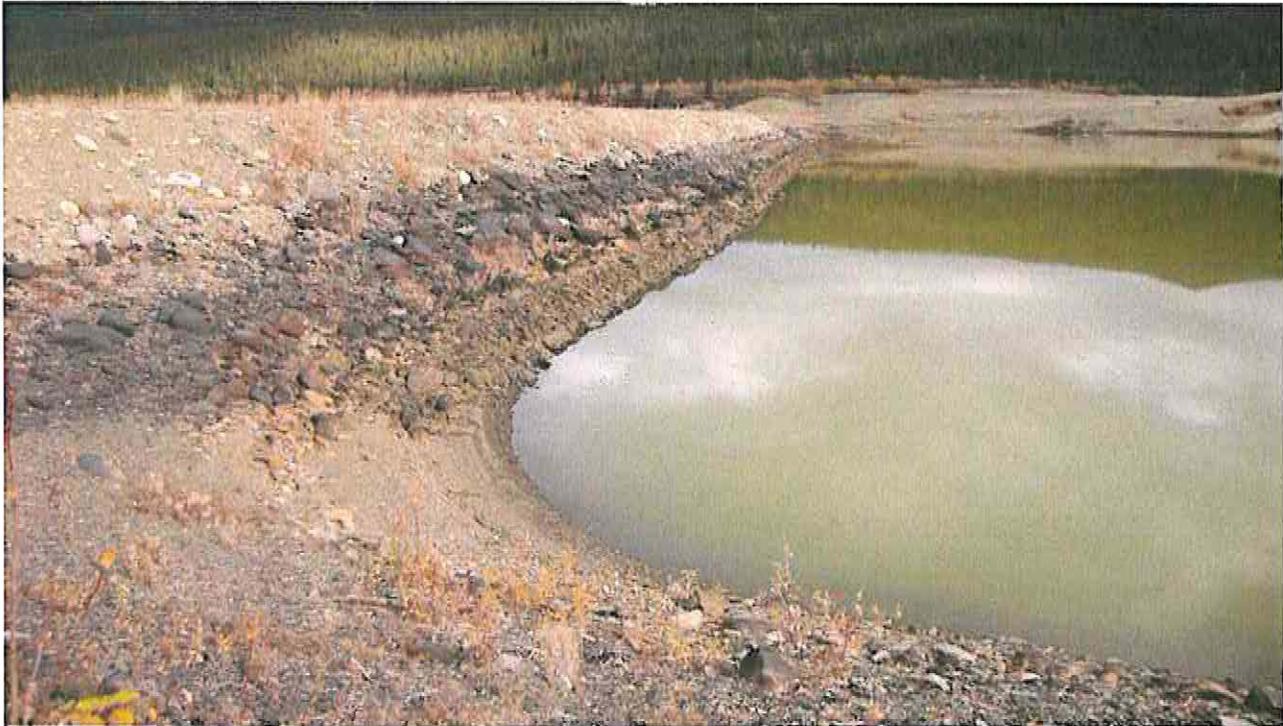
The Cross Valley Dam (CVD) is designed for a 60-day retention capacity polishing pond comprising seepage and discharge water from the tailings storage facility. Similar to the operating water level in the pond of the Intermediate Dam, the polishing pond water level was operating below the CVD rip rap surface at the time of the fall inspection. There was no apparent evidence at the time of the inspection of upstream slope instability of the underlying sand and gravel shell material or rip rap degradation (Photo 5).

Photograph 5: Upstream drawdown operating conditions at Cross Valley Dam

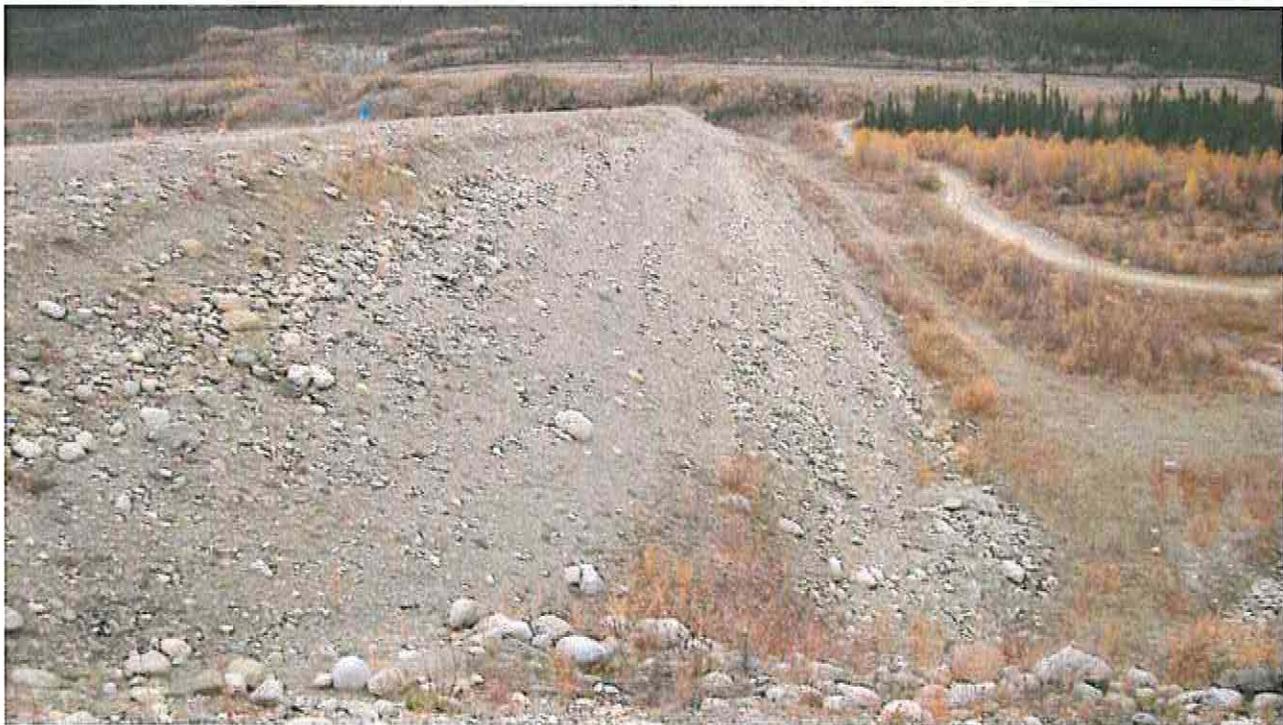
The dam crest is in satisfactory condition. However, three longitudinal tension cracks were observed along the southern portion of the dam crest, indicative of differential movement of the underlying soil conditions resulting from the zoned dam construction. The downstream slope appears stable and in satisfactory condition (Photo 6).

Photograph 6: Downstream conditions at Cross Valley Dam

- It is recommended that the longitudinal tension cracks observed on the crest of the Cross Valley Dam should continue to be monitored and re-grading of the granular surface is carried out during seasonably warm conditions to minimize surface water infiltration.

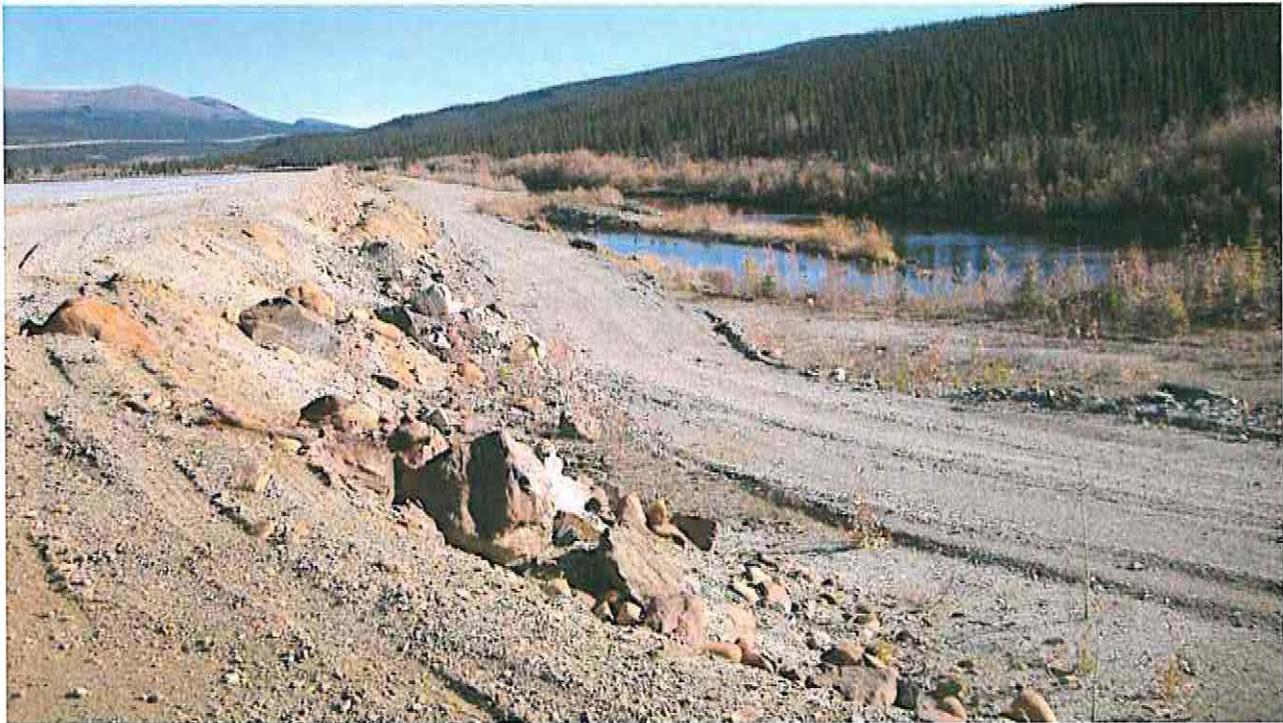
The Secondary Tailings Impoundment (STI) area was inspected. The dam crest, upstream and downstream slopes conditions appear stable at the time of inspection. The lower road conditions appear satisfactory. There was no evidence of seepage along the Secondary Dam downstream toe towards the RCDC (Photo 7).

Photograph 7: Downstream conditions at Secondary Tailings Impoundment at Diversion Dam

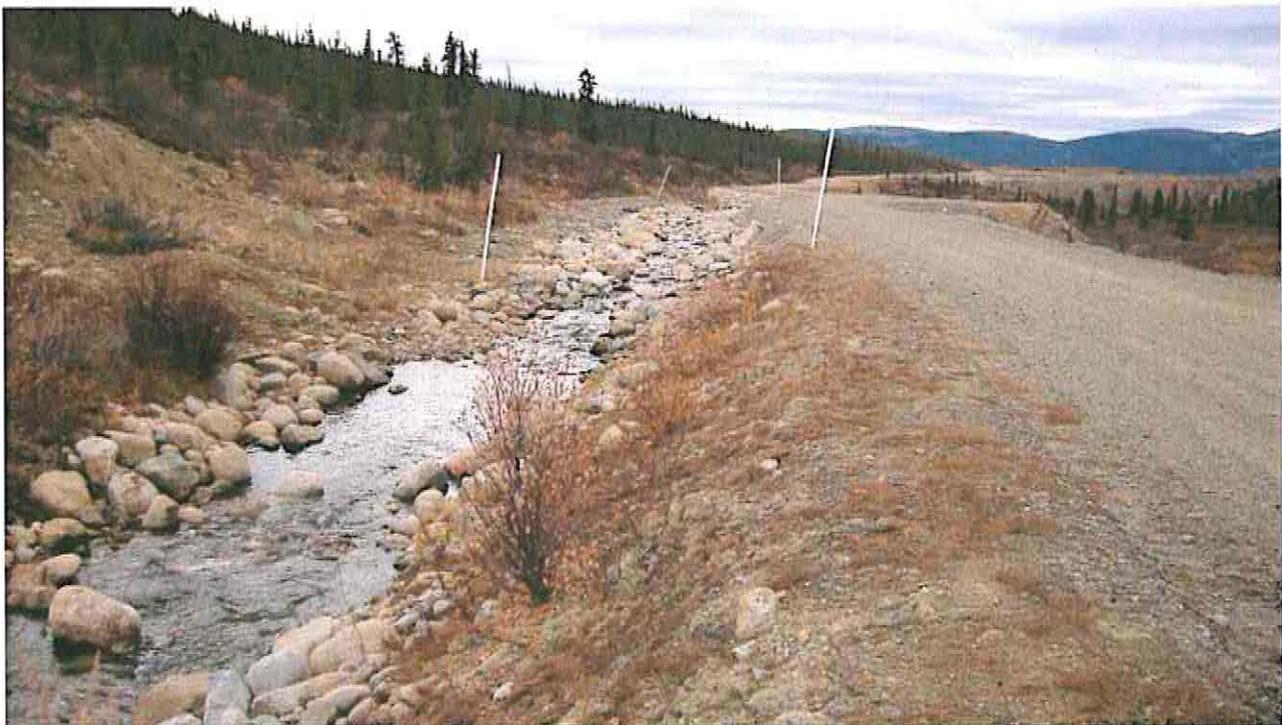
The Faro Creek Diversion Channel (FCDC) diverts creek channel flow from head waters north of the Faro Pit around the east side of the mine site. At the time of the site inspection, the seasonally, low flow conditions enable good access to view the diversion channel bottom and side slope conditions. In general, the side slopes are armoured with rip rap material comprising rounded cobble and boulder field stone. A portion of the rip rap channel near the head water diversion is underlain by a layer of synthetic liner and appears intact to limit seepage flow from the diversion channel, which is marked by white poles (Photo 8).

Photograph 8: Downstream view of lined channel conditions of Faro Creek Diversion Channel

- In general, the rock armour and lined channel conditions observed in the Rose Creek and the Faro Creek Diversion Channels appear stable and are performing satisfactorily. It is recommended that visual monitoring for any change in rip rap and/ seepage loss conditions are recorded and instrumentation monitoring activities are continued.

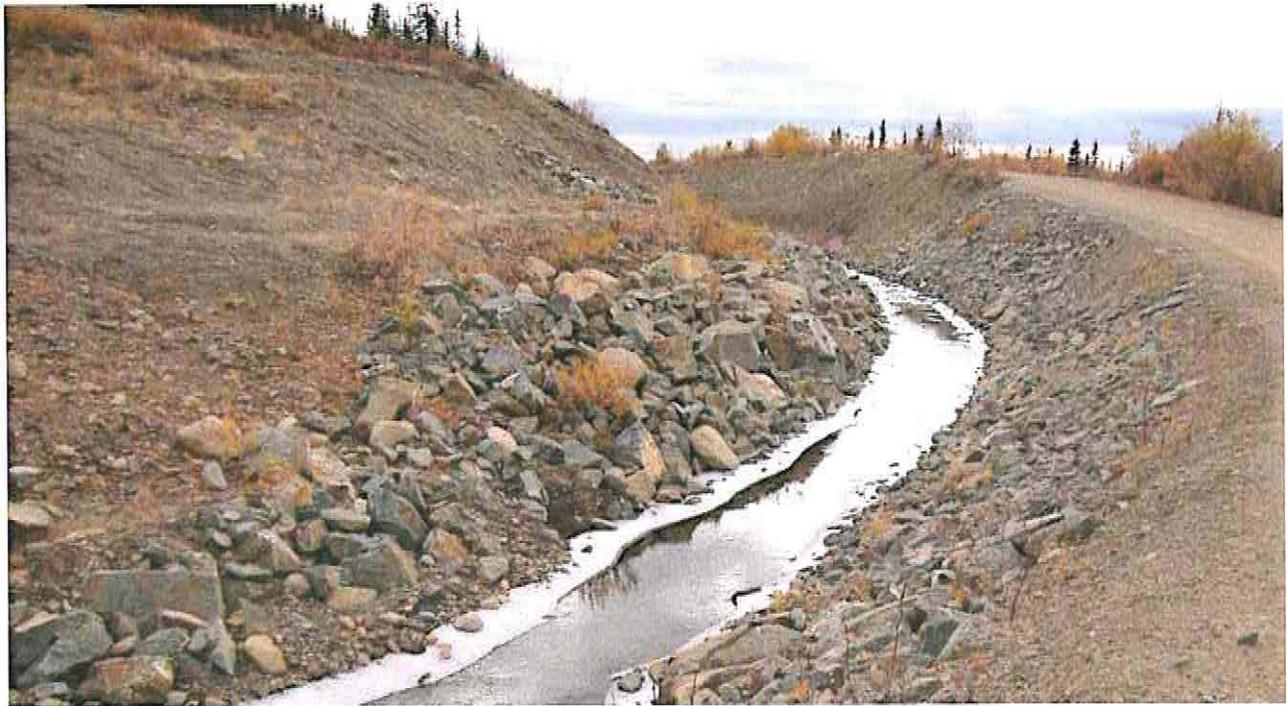
There is evidence along the length of the diversion channel that the soil back slope has experienced unstable conditions and repaired with blast rock to maintain stable channel side slope conditions (Photo 9).

Photograph 9: Downstream view of stabilized channel conditions of Faro Creek Diversion Channel

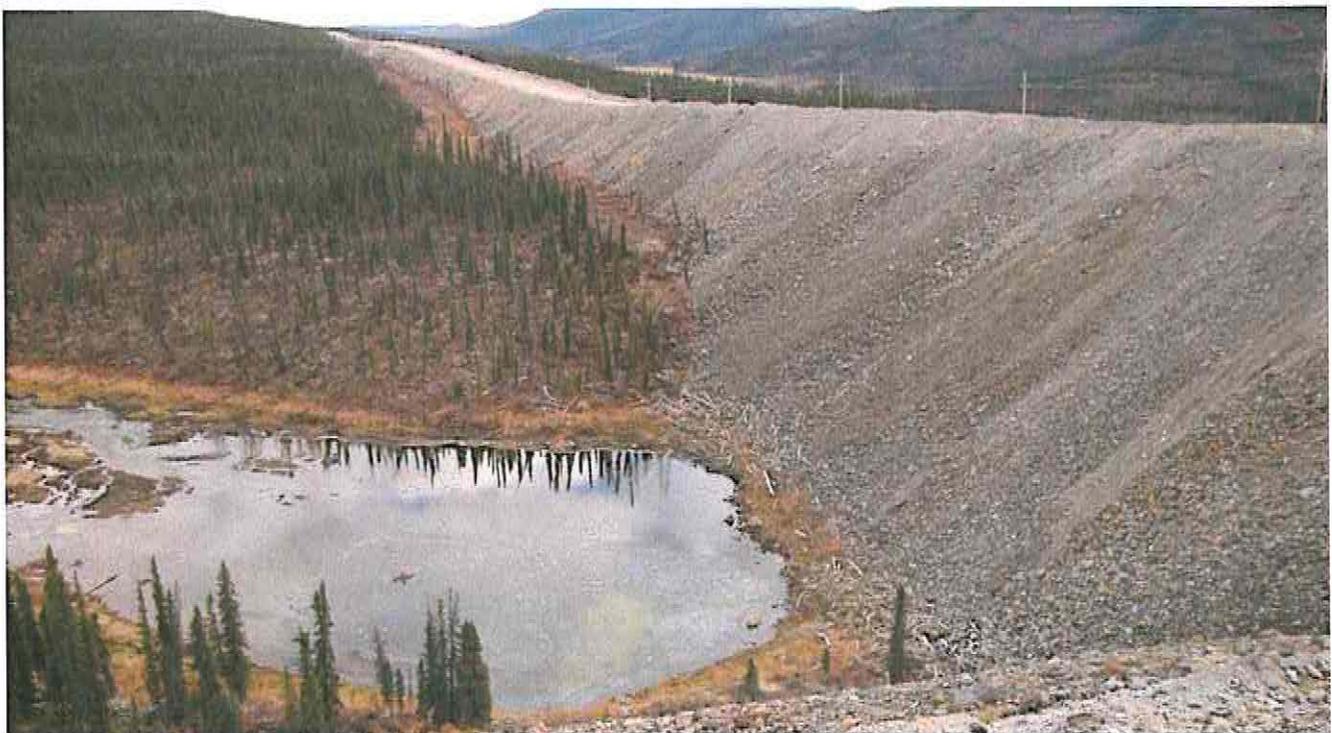
The North Fork Rock Drain (NFRD) was inspected and the head pond water level condition was found to be well below the wood debris on slope. The embankment crest and side slope conditions appeared stable at time of inspection. The downstream drainage conditions comprised three drainage channels which braided into one channel downstream at the water monitor and sample location. The head pond conditions and rock drain performance appeared satisfactory at time of inspection.

Photograph 10: Upstream view of head pond conditions at North Fork Rock Drain

- It is recommended that the upstream slope, head pond and downstream drainage conditions are monitored at the Faro Creek and K8 Creek Rock Drains locations for potential change in embankment slope erosion, blocked and/or changed drainage conditions are observed.
