**APPENDIX I  
SITE VISIT INSPECTION MEMO  
(JULY)**

**MEMORANDUM**

Mr. Gerry Ferris, P.Eng., of BGC Engineering Inc. (BGC), undertook a visual inspection of selected facilities at Faro Mine between June 30 and July 3, 2009. At the end of this inspection much of the items contained in this memo were discussed with Mr. Roy Morrell and Mr. Jon Bronson. This memo summarizes the conditions observed, along with recommendations for maintenance or monitoring:

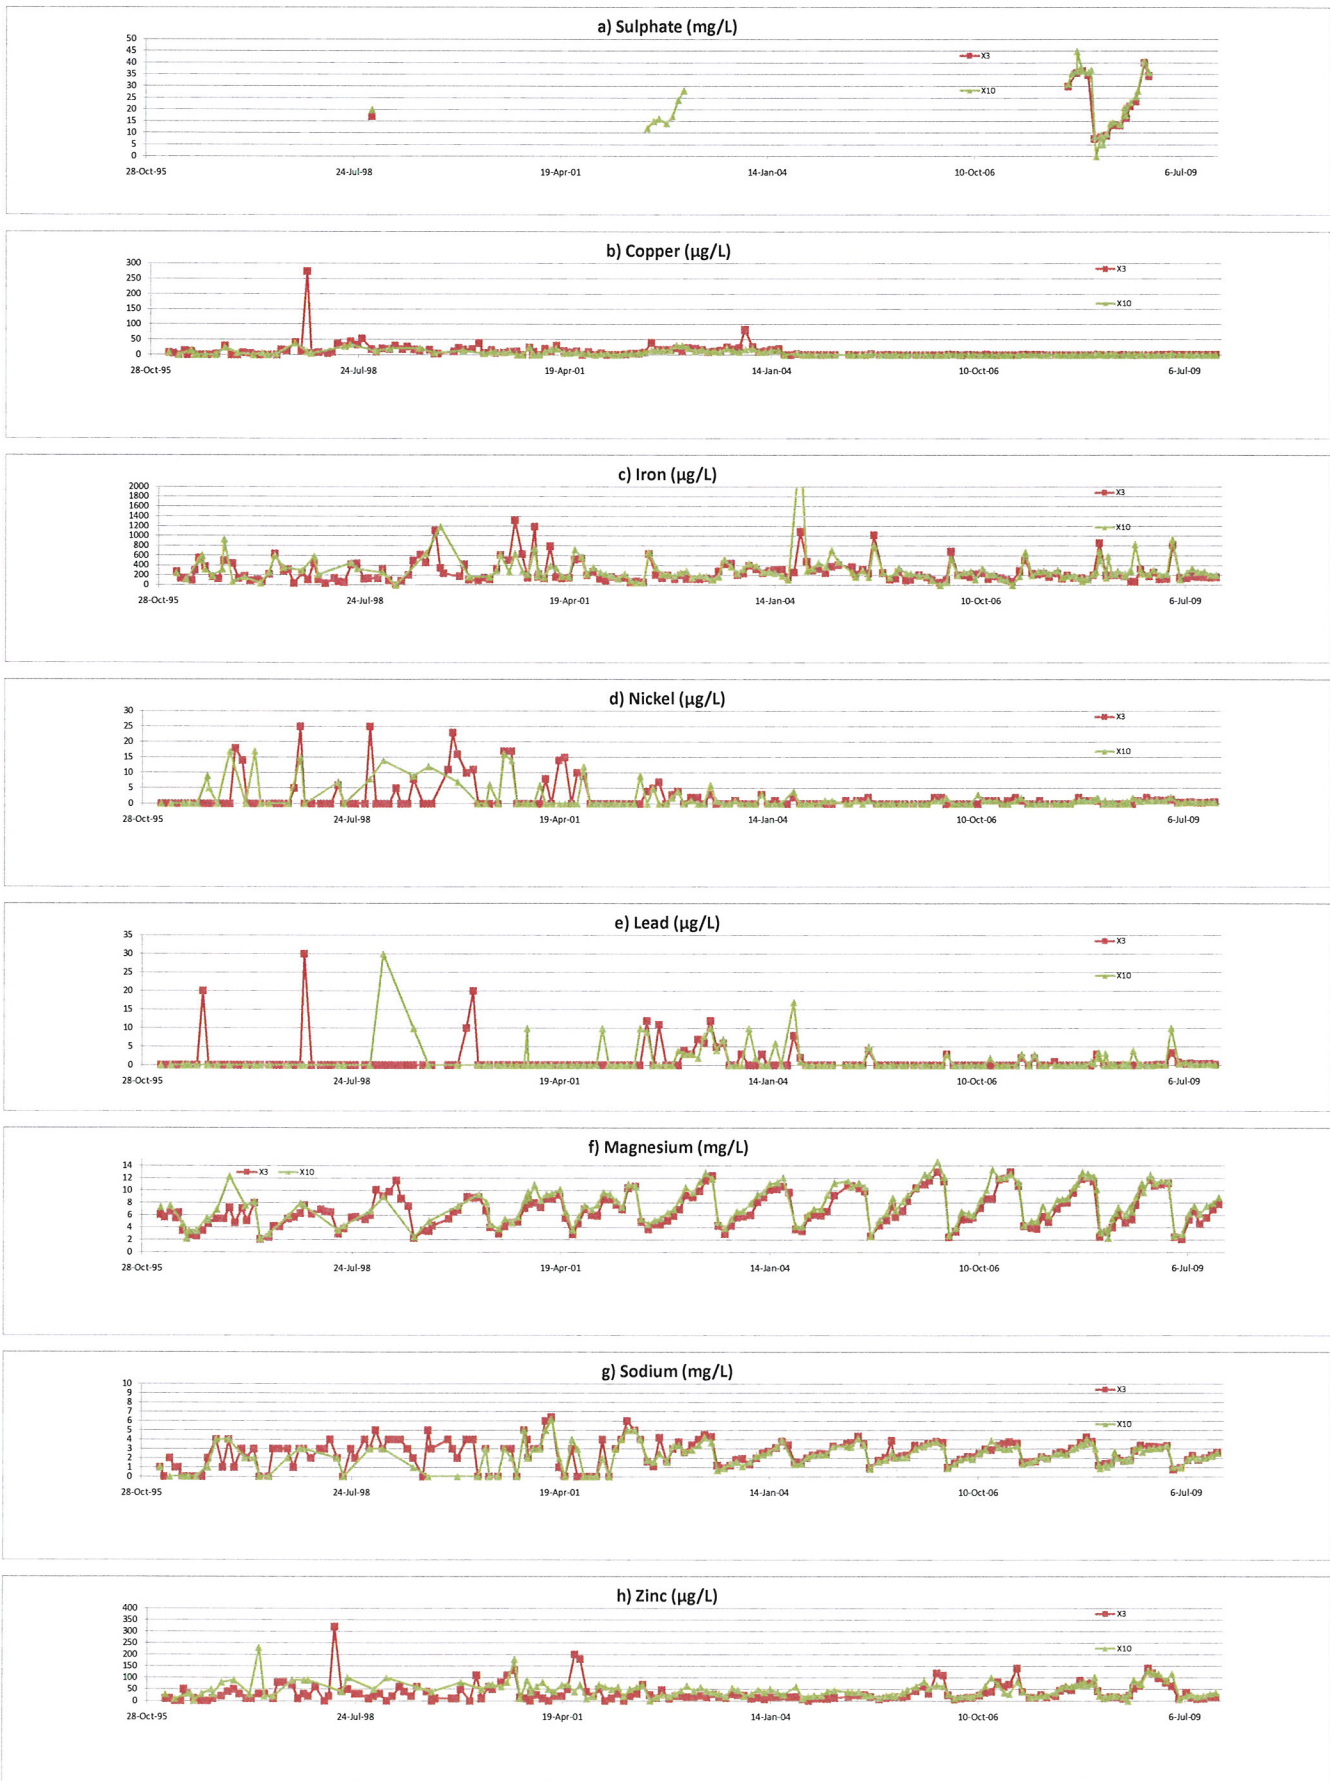
Figure 1a - h: Comparison of X3 and X10 for Select Water Quality Parameters

Staining was observed in the Rose Creek Diversion Channel (RCDC) just downstream of X3. The staining was reddish in colour, indicating the possibility of iron precipitating from groundwater seepage in the creek.

In the location that the staining was observed and at the time of year that the staining was observed, it is likely that the water table in the neighbouring tailings containment area was higher than that of the RCDC. It was therefore assumed that a likely source of the groundwater seepage was the tailings area.

Figure 1, attached, shows the results of a preliminary water quality review of select parameters in the RCDC upstream and downstream of the observed staining. The last date shown in the figures is for the last sampling event that had been undertaken at the time of the writing of this memo: December 1, 2009. The staining was observed in late December 2009, which is after this date. Results have nevertheless been reviewed for historic trends that may have been observable prior to staining having been visible.
