REPORT ON

2009 Faro Pit Slope Movement Monitoring

Submitted to:
Denison Environmental Services
Faro Care and Maintenance Project
P.O. Box 280
Faro, YT
Y0B 1K0

Report Number: 09-1426-0019/2000

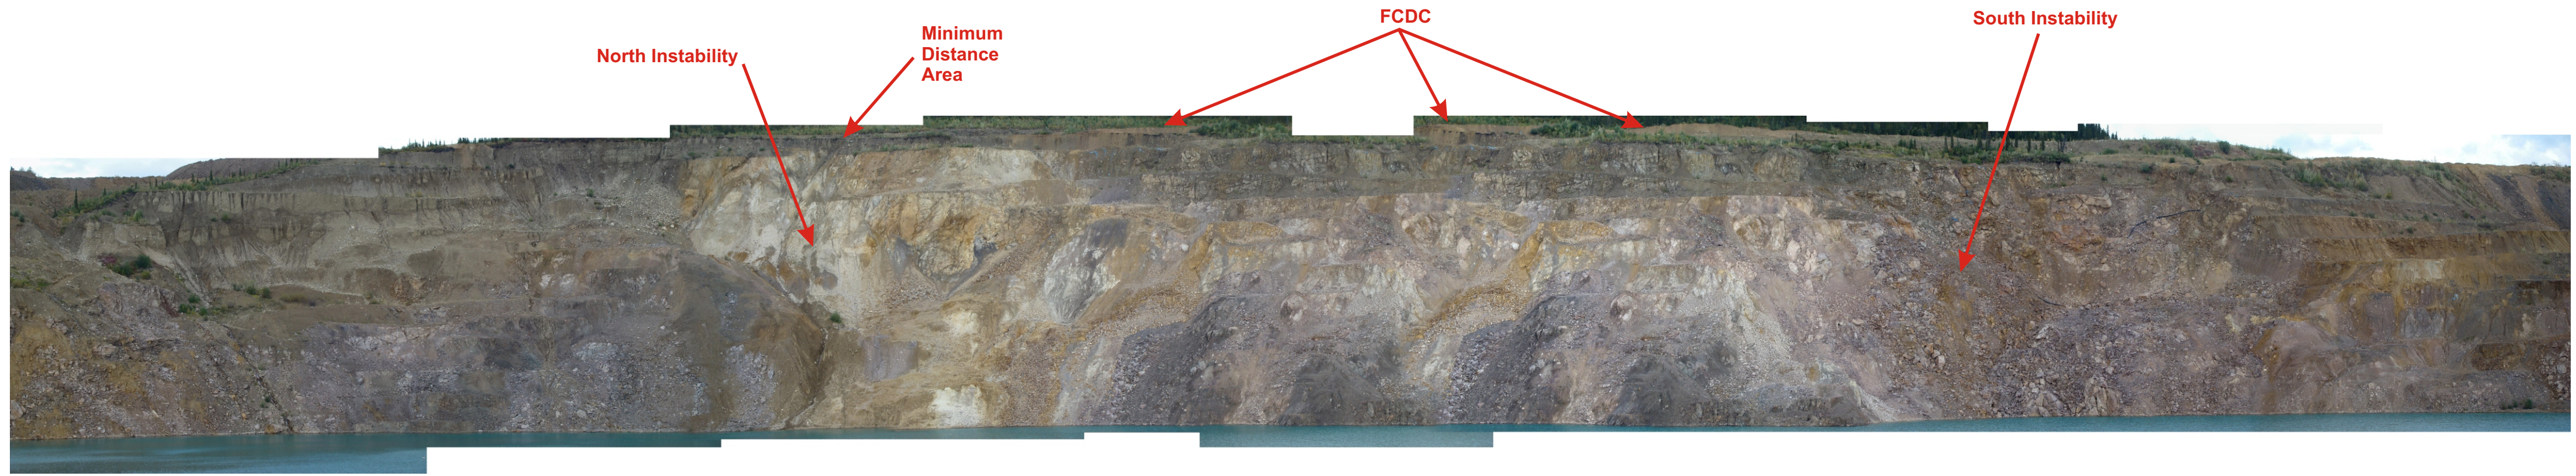
The east wall instability is still characterized by two failure zones, as the North and South instabilities which are separated by the calc-silicate band zone, as shown on Photographs 1 and 2. The observations of the pit wall inspection are discussed in the following sections.

Photograph 1 : Panoramic view of the East Wall (August, 2009).

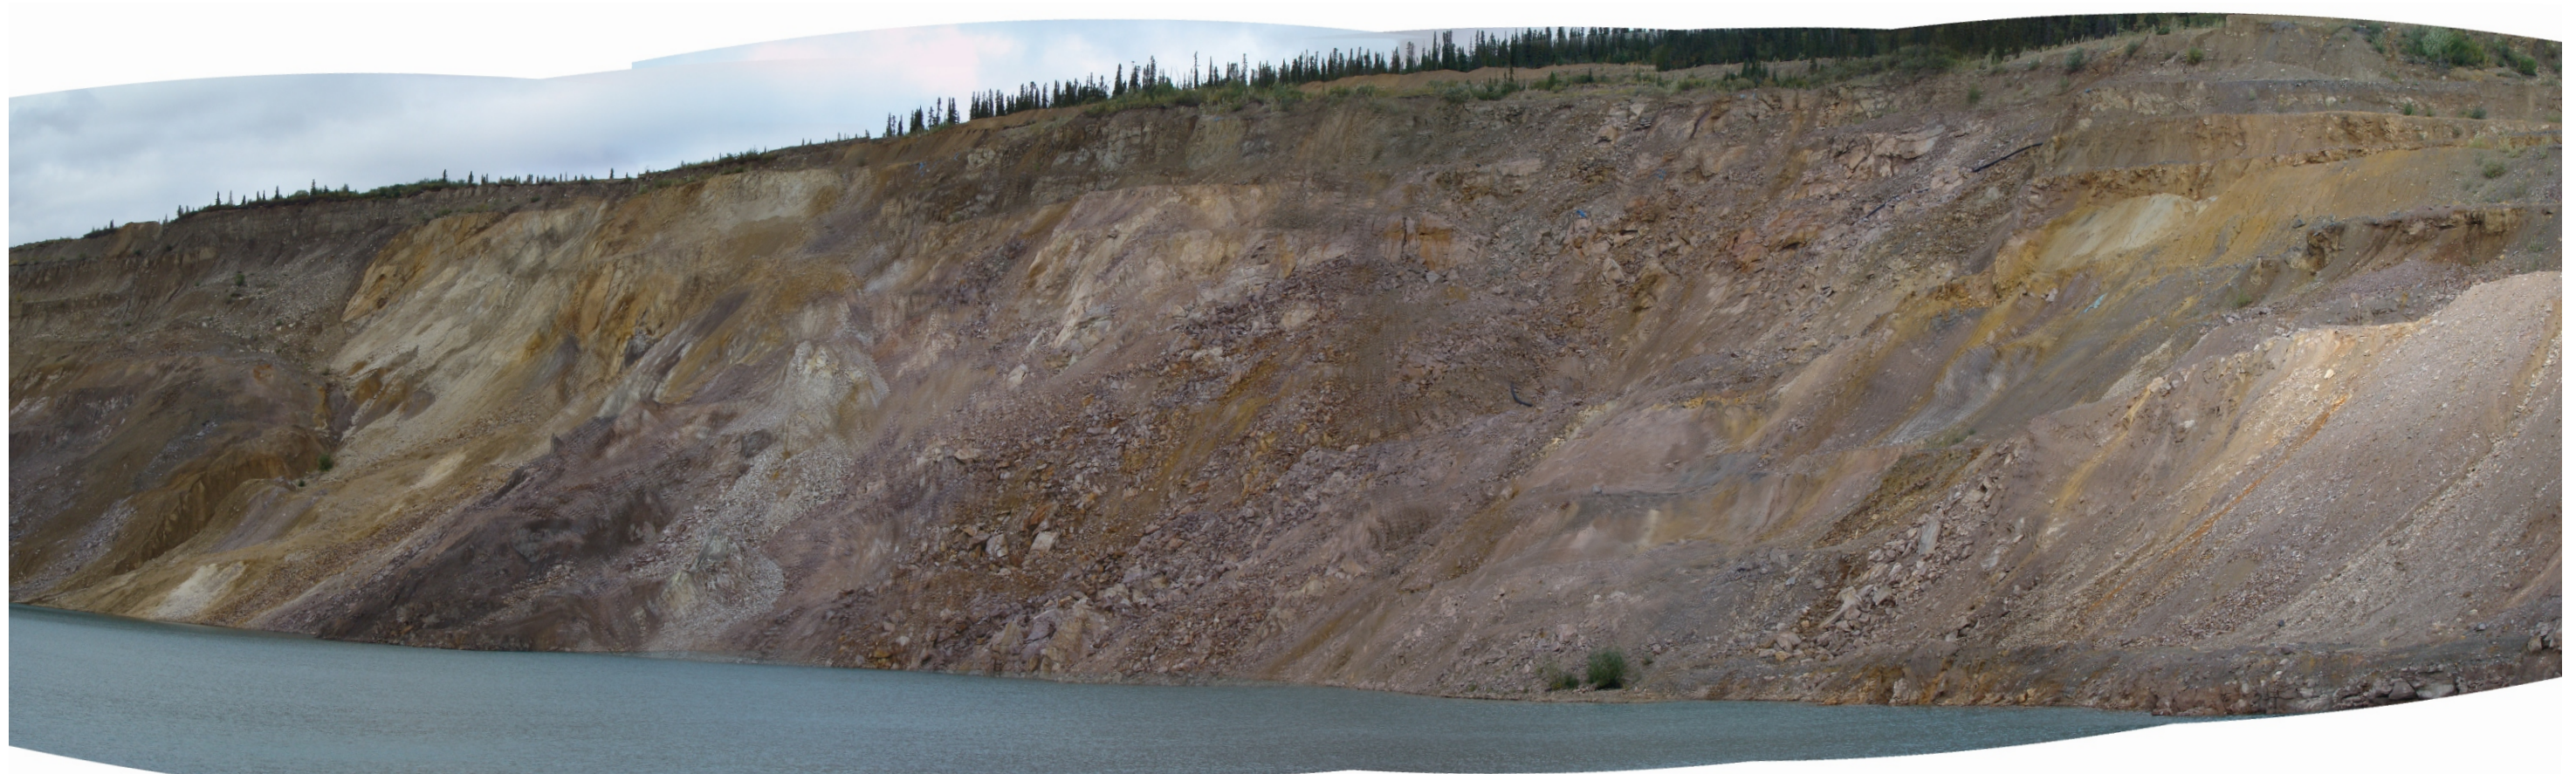
Photograph #2 : Panoramic view of the east wall (August 2009).

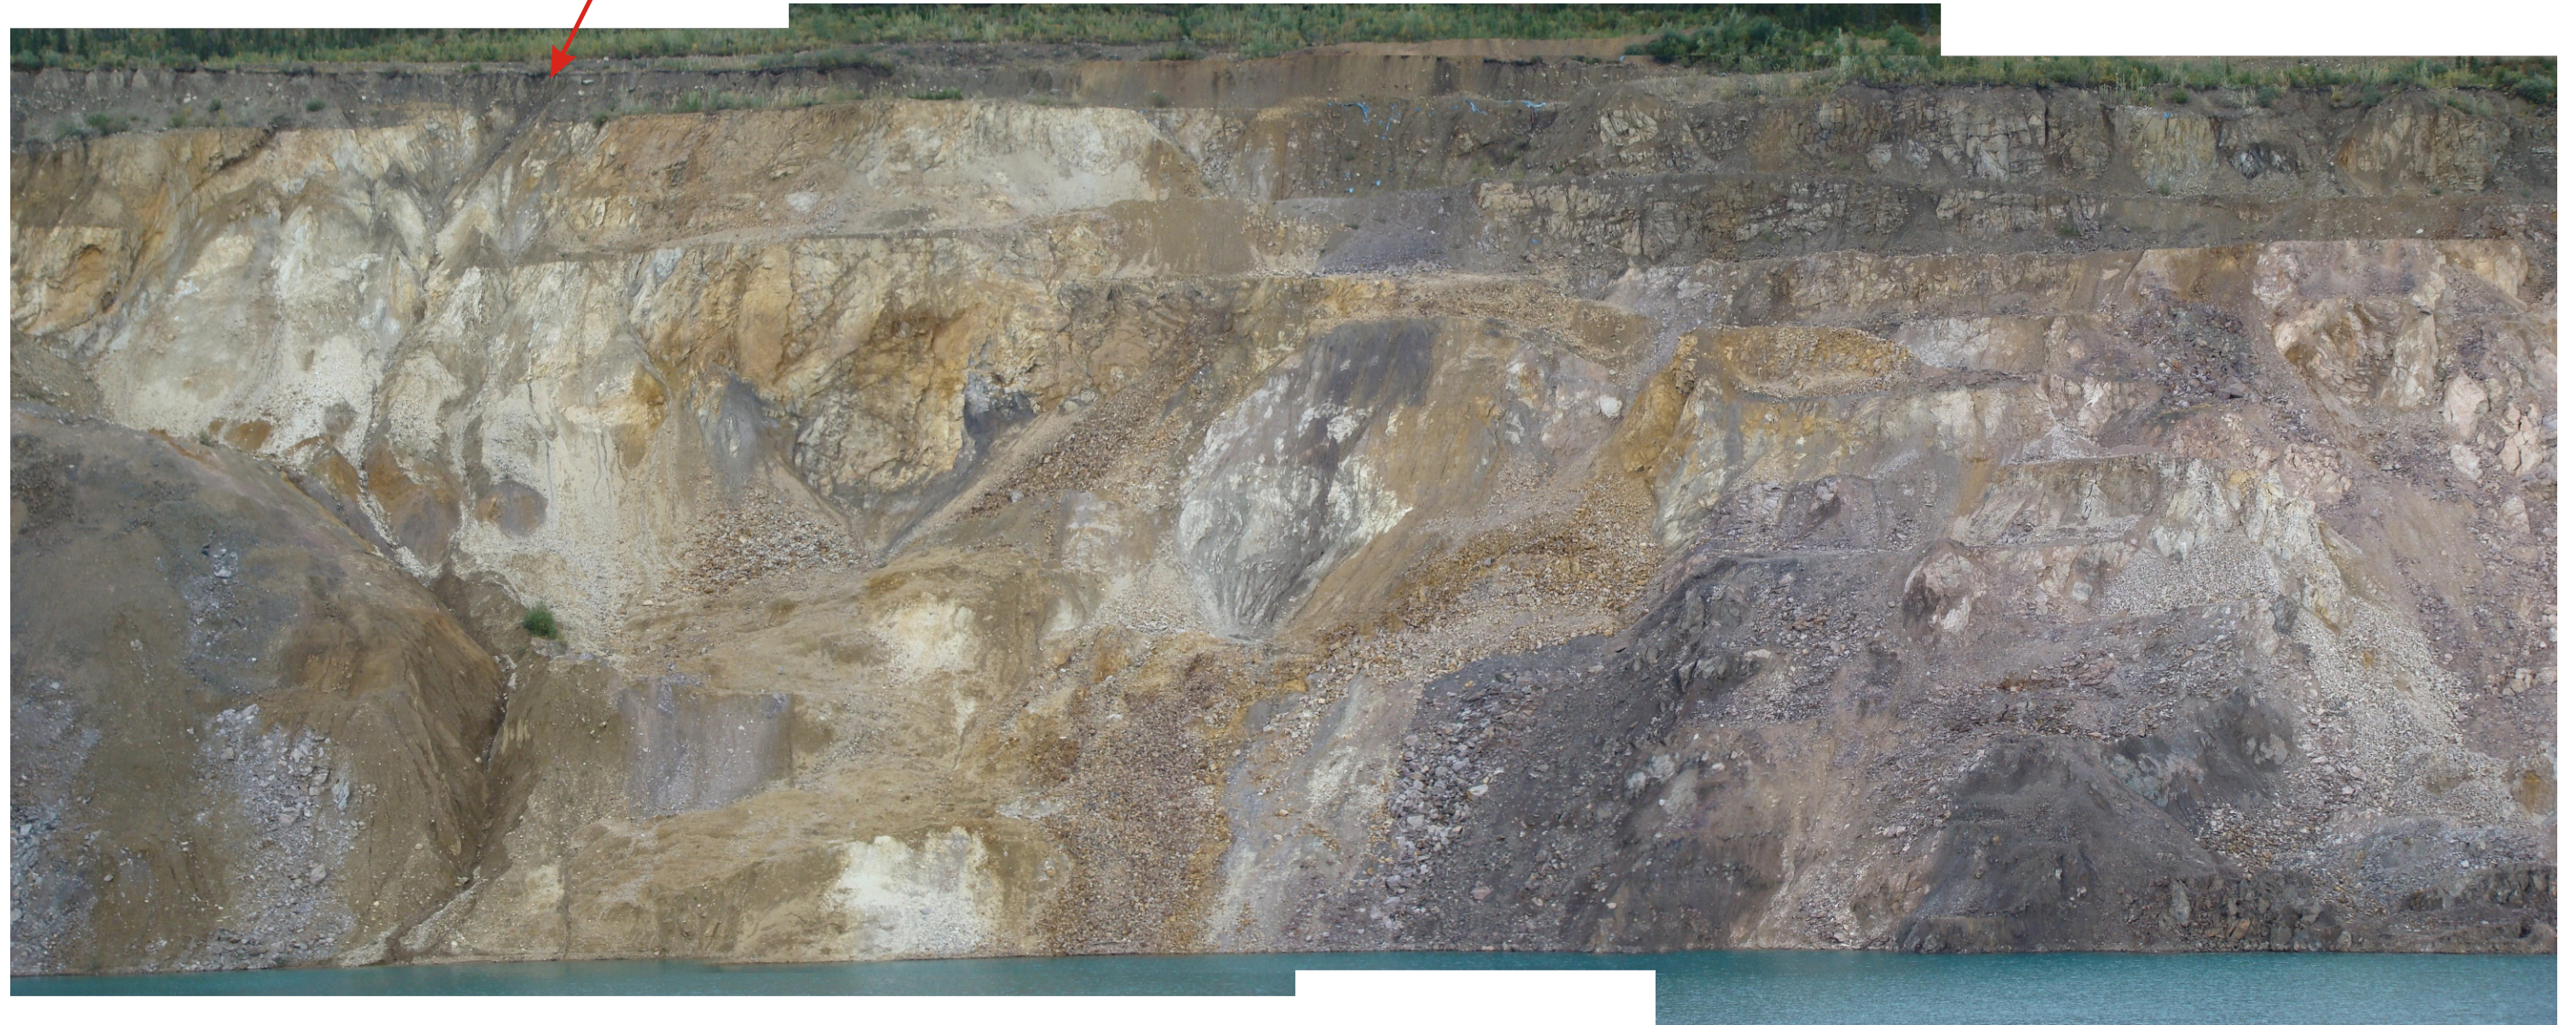
Photograph #3 : North instability zone (August 2009).

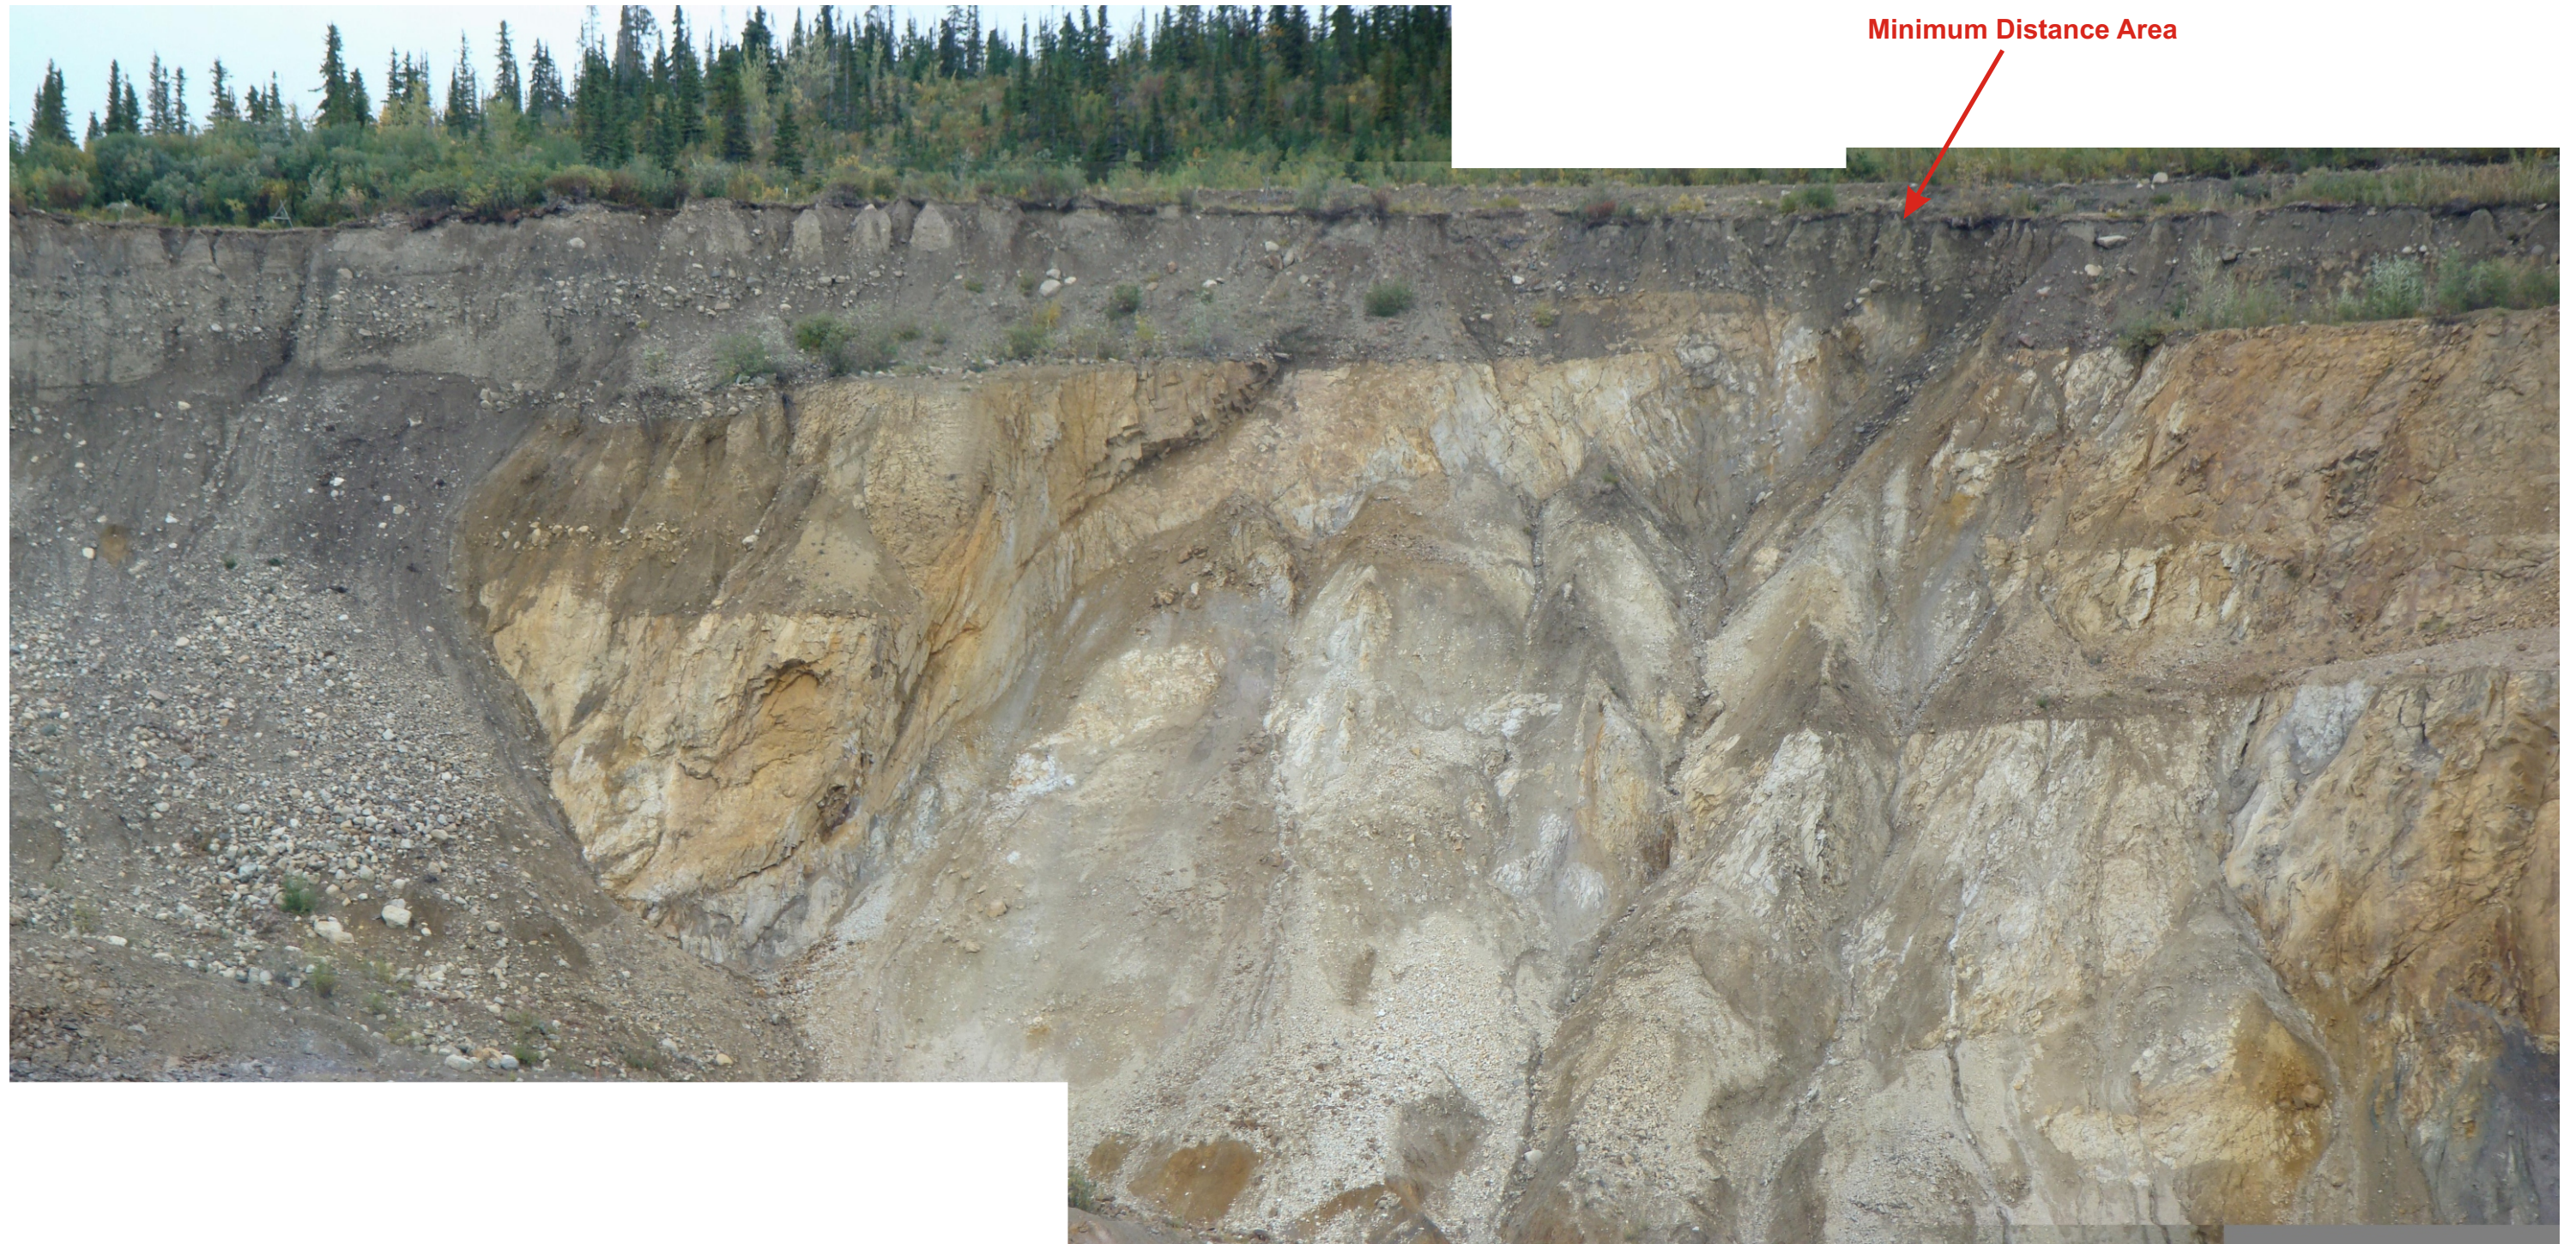
Photograph #4 : North instability zone. View of the crest of the pit wall (August 2009).

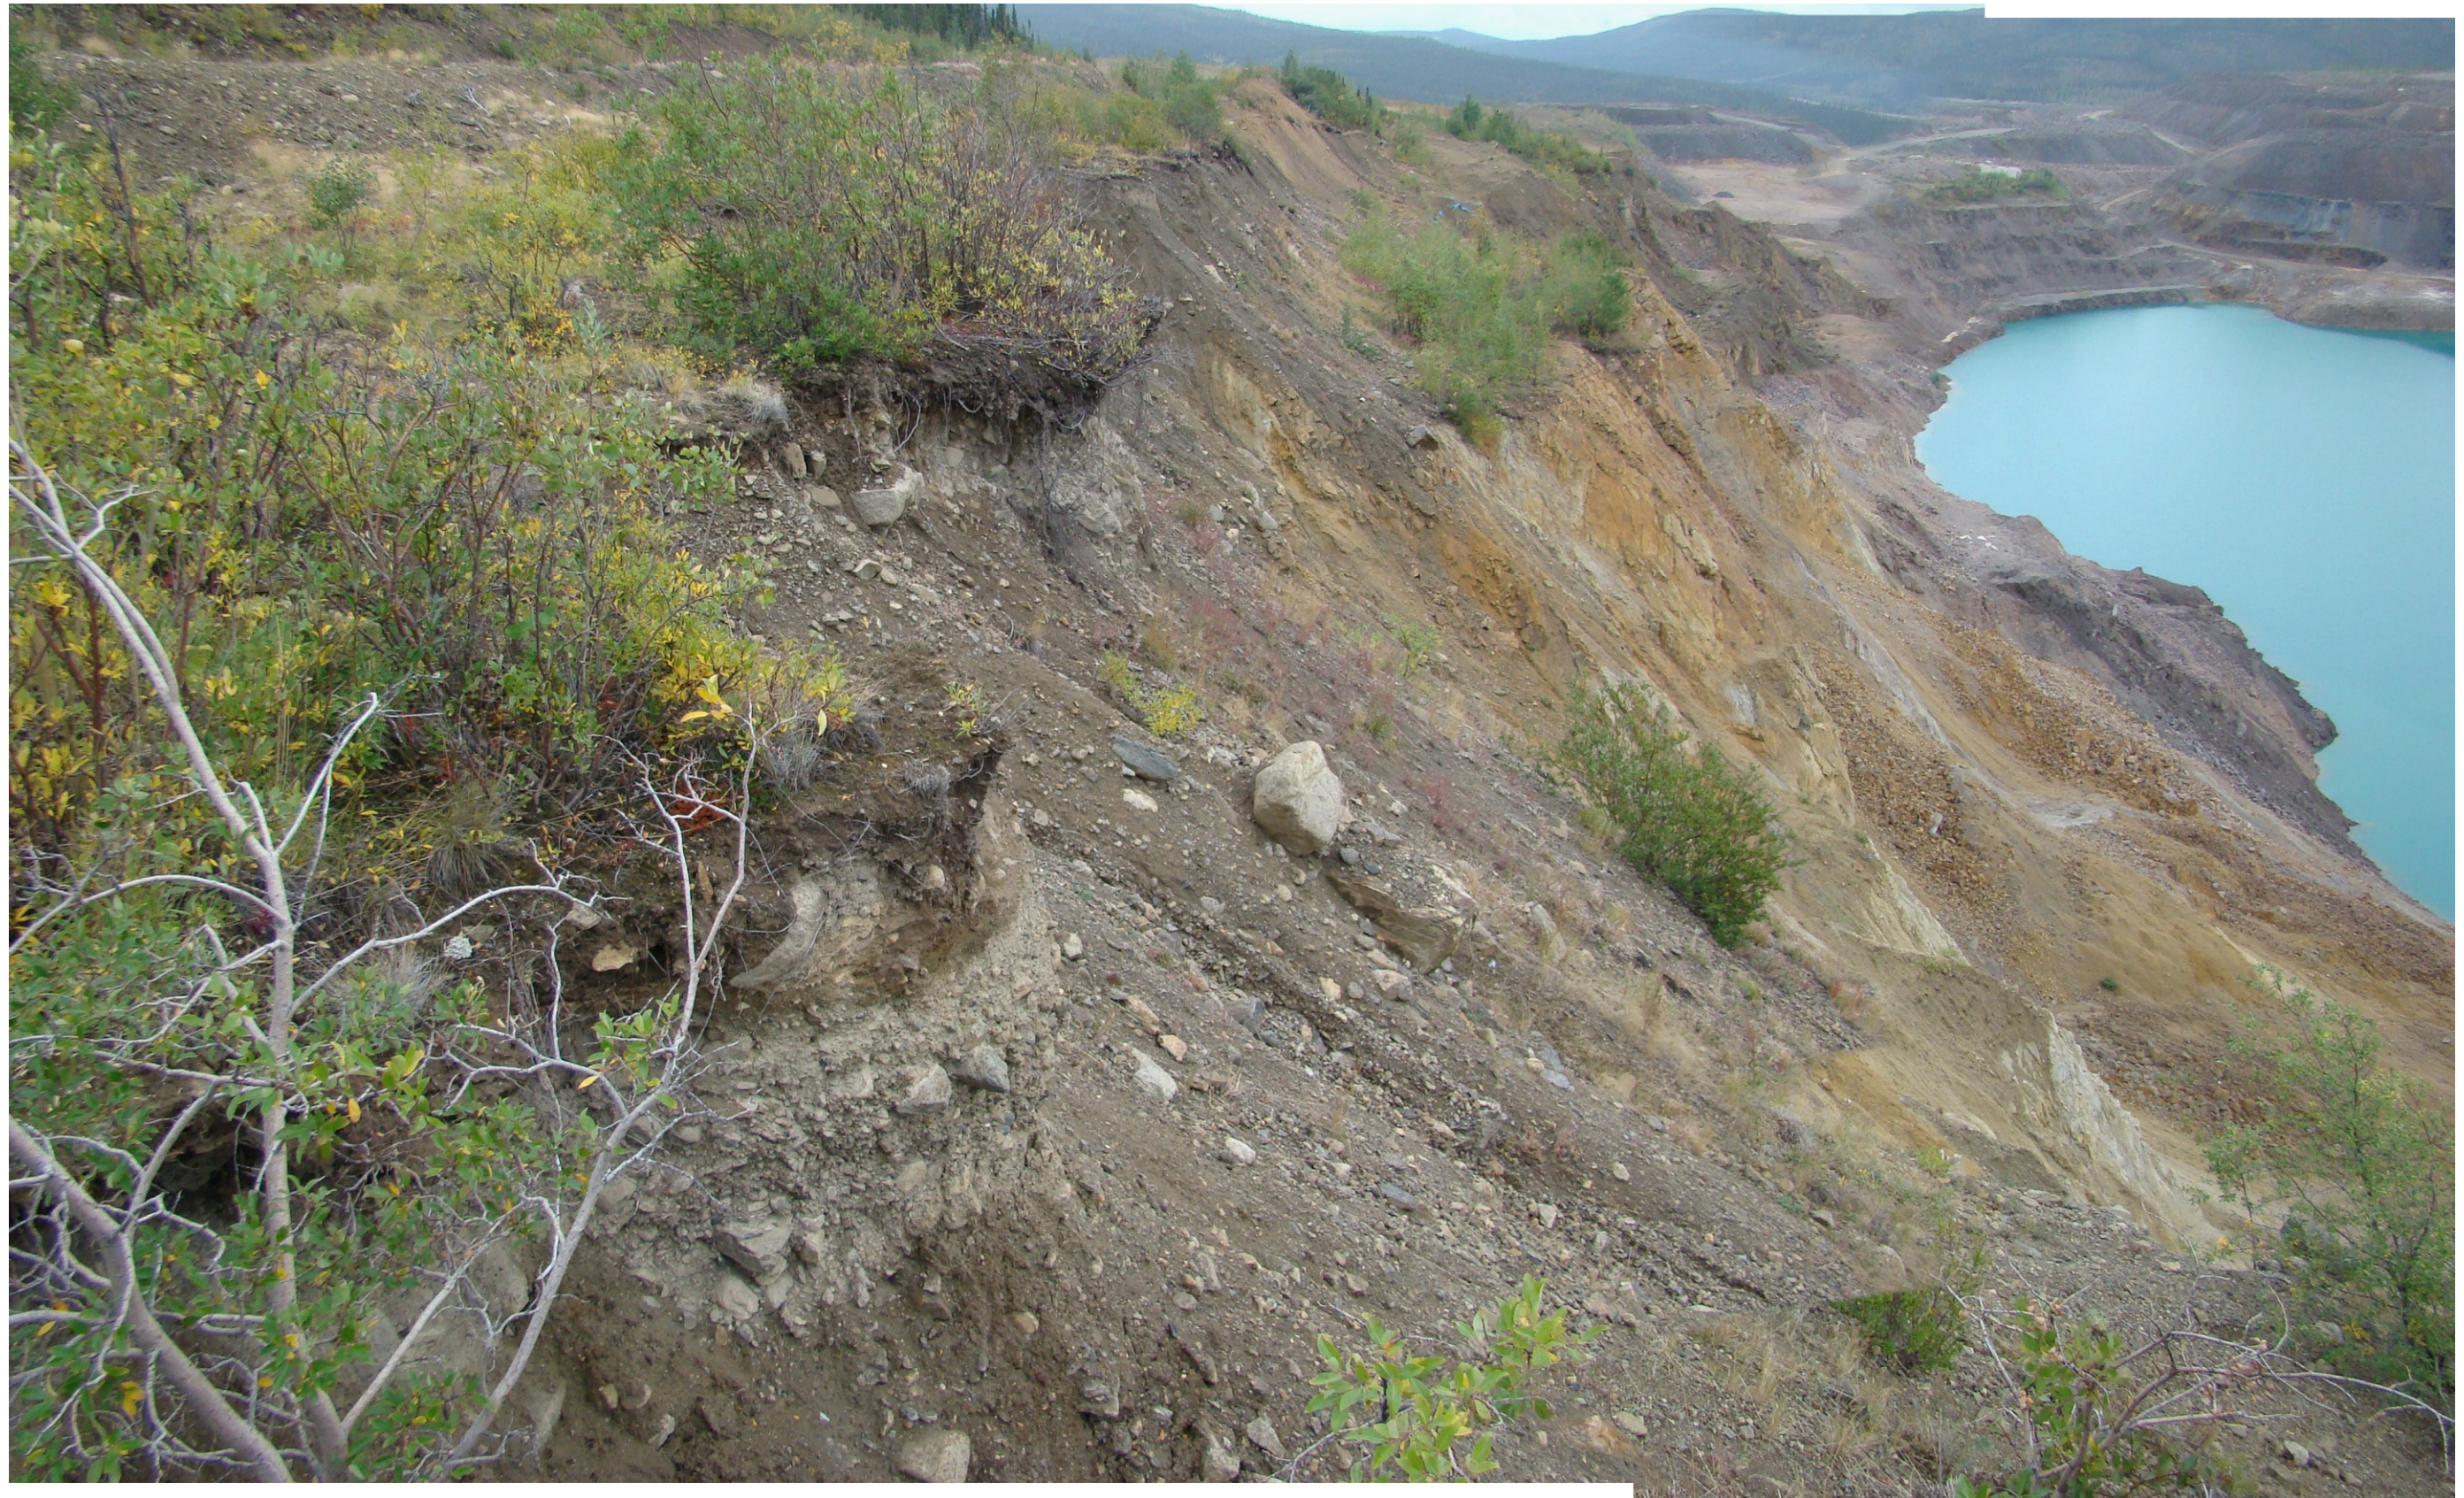
- The crest of the pit wall in overburden soils in the area of North instability does not exhibit signs of significant recession or degradation since 2008. Only limited erosion and ravelling was observed to have occurred in localized areas, and is likely due to erosion by surface water run-off over the edge of the wall during the spring season. Variable loss of overburden crest of approximately 0.25 to less than 0.5 metre appears to have occurred along the crest of the pit wall in the areas near reference bars 15355 and 15354. No tension cracks were observed behind the crest of the wall in those areas affected by some crest erosion.

Photograph #5 : North instability zone. View of crest pit wall on overburden soils (August 2009).

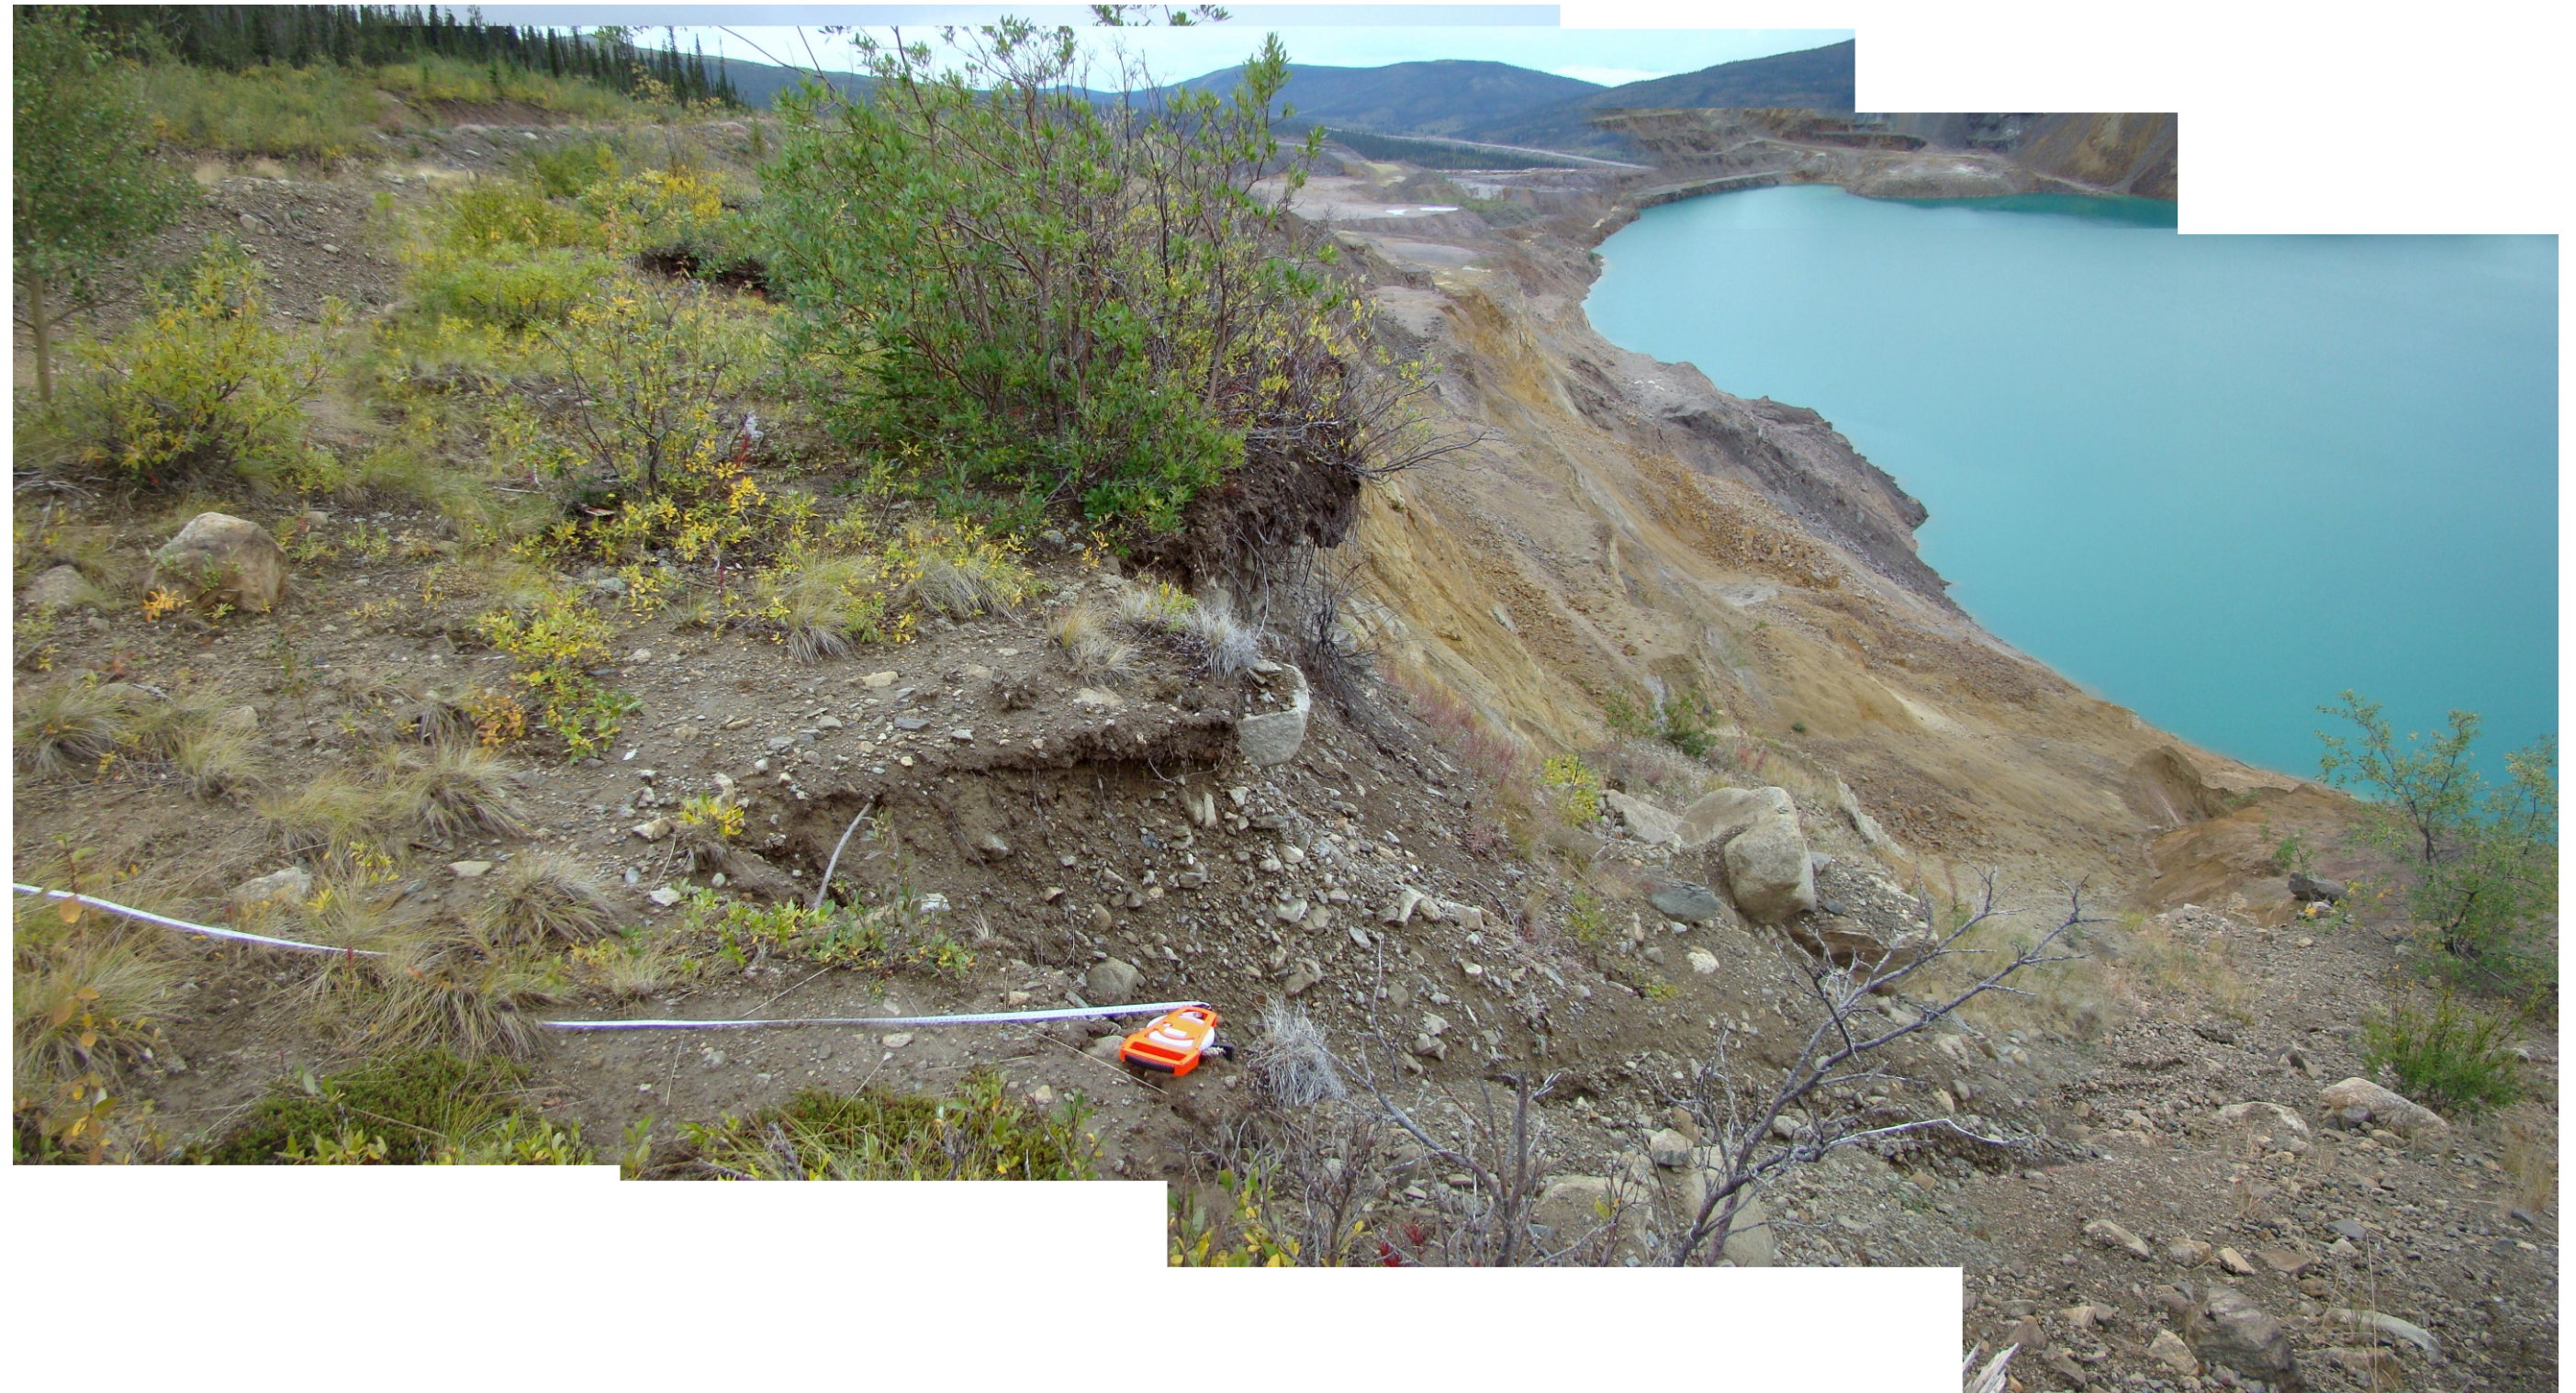
Photograph 6 : North instability zone. View of crest of the pit wall near reference bar 15354 (August 2009).

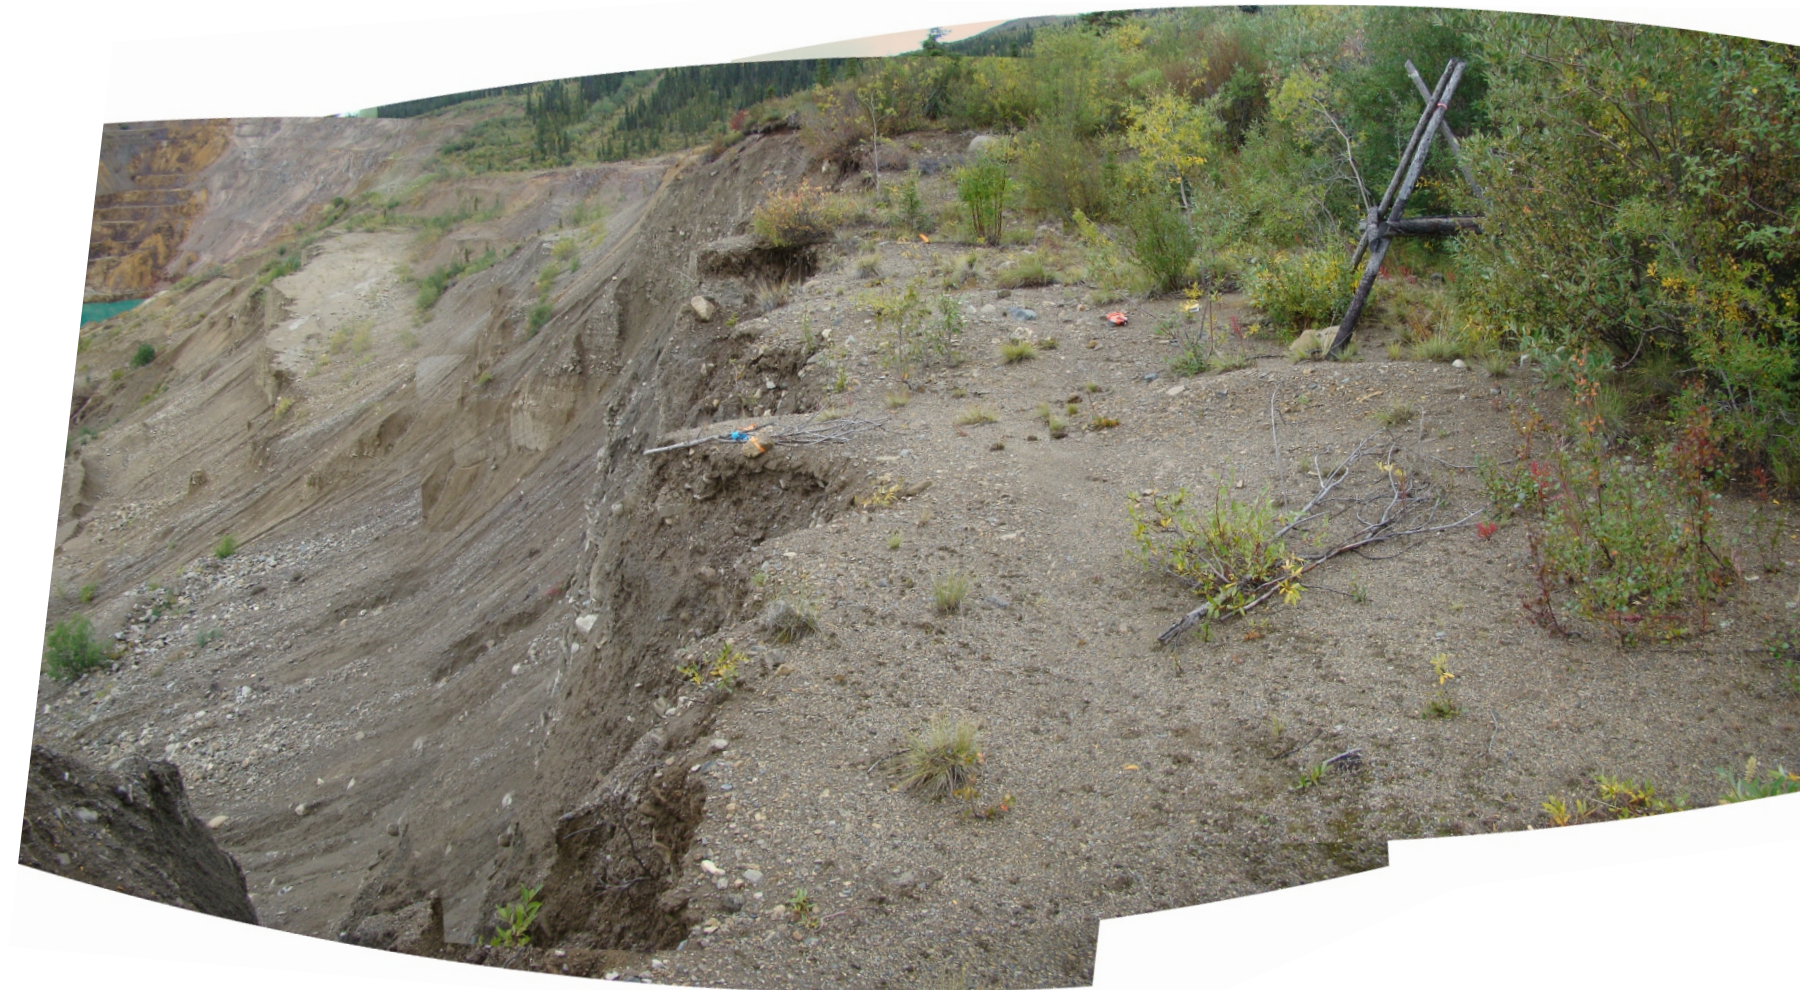
Photograph 7 : North instability zone. View of crest of the pit wall near reference bar 15355 (August 2009).

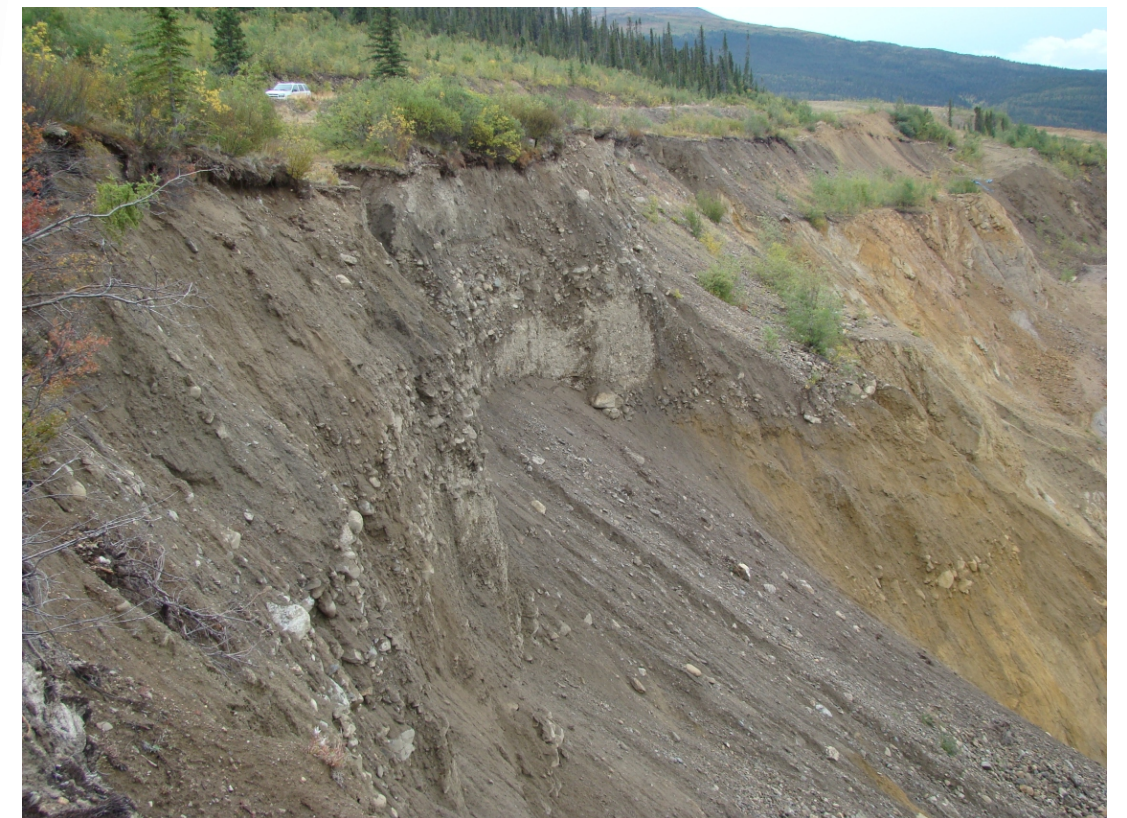
Photograph 8 : North instability zone. View of crest of the pit wall on overburden soils near reference bar 15355 (August 2009).
