REPORT ON

2009 Faro Pit Slope Movement Monitoring

Submitted to:
Denison Environmental Services
Faro Care and Maintenance Project
P.O. Box 280
Faro, YT
Y0B 1K0

Report Number: 09-1426-0019/2000

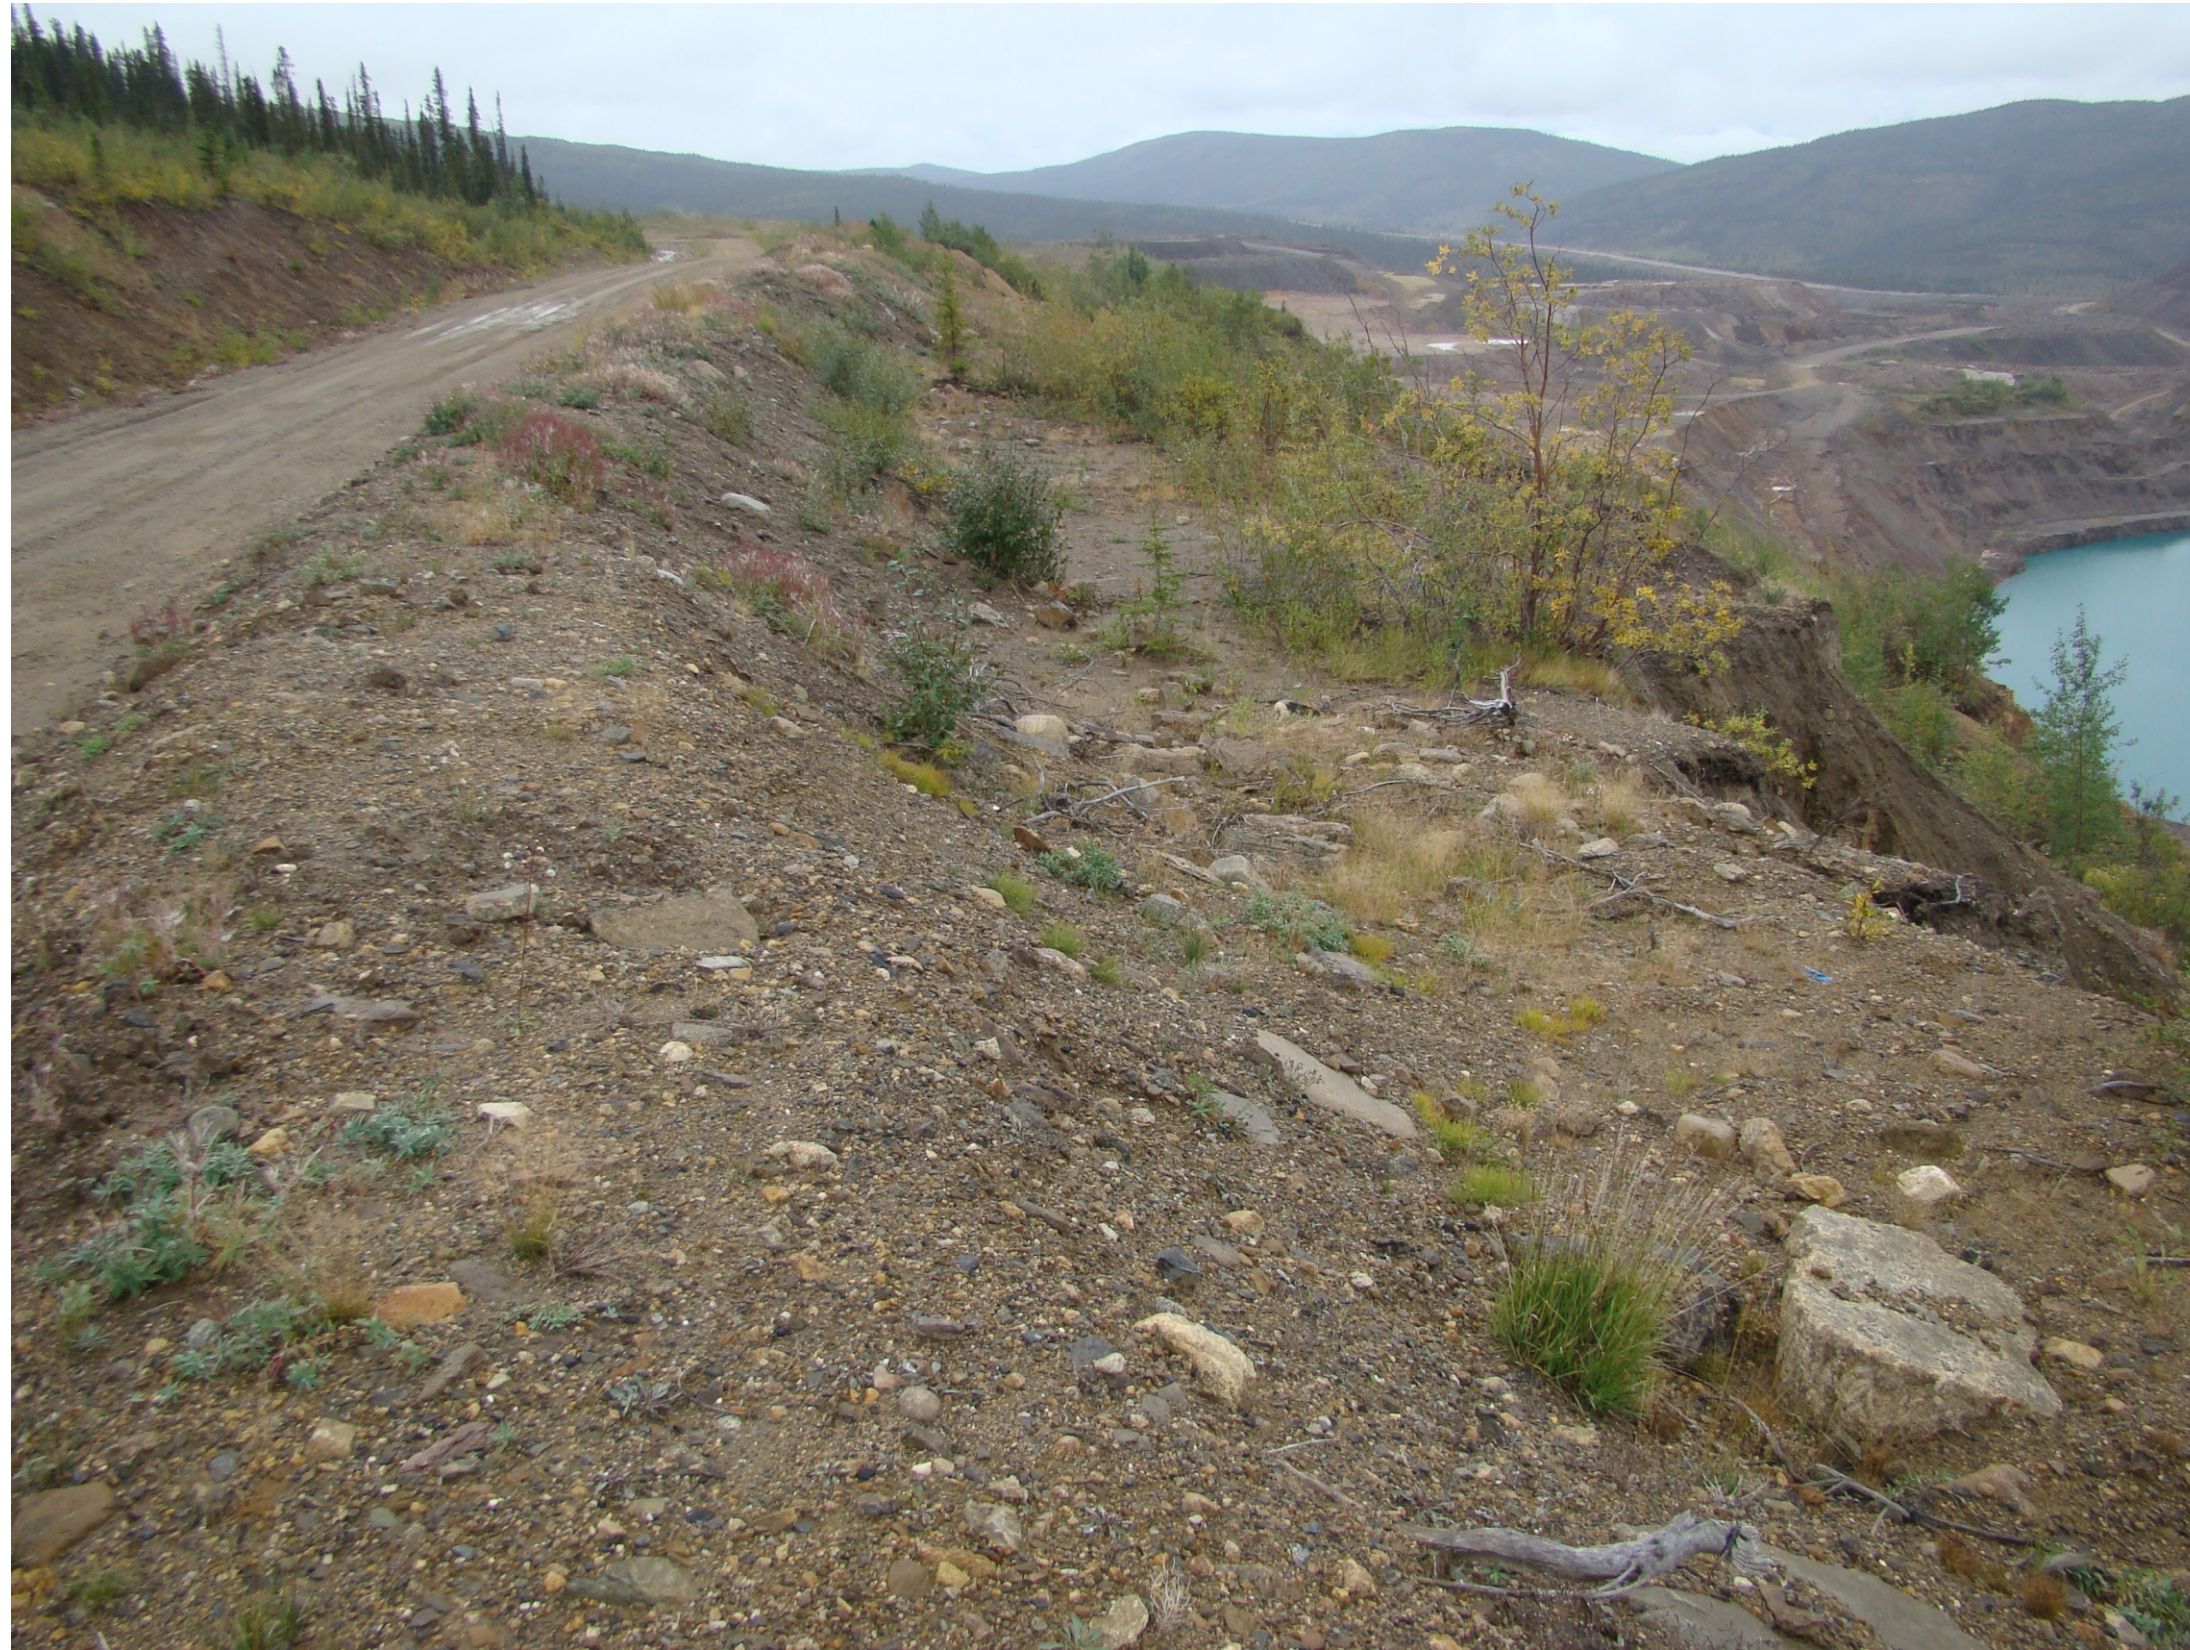
- The minimum distance between the crest of the east wall instability and the FCDC remains in the middle of the North instability zone, as shown in photographs in Appendix I. Crest recession at that location has not been sufficient to significantly reduce the minimum distance, and the actual distance remains in the same order as observed in the 2005 inspection, *i.e.*, approximately 18 metres. Only limited erosion and ravelling was observed to have occurred in this area, and is also likely due to sloughing and erosion of overburden soils by surface water run-off over the edge of the wall during the spring season. No tension cracks were observed behind the crest of the wall in this area.

Photograph 9 : North instability zone. Minimum distance area near reference bar 15353 (August 2009).

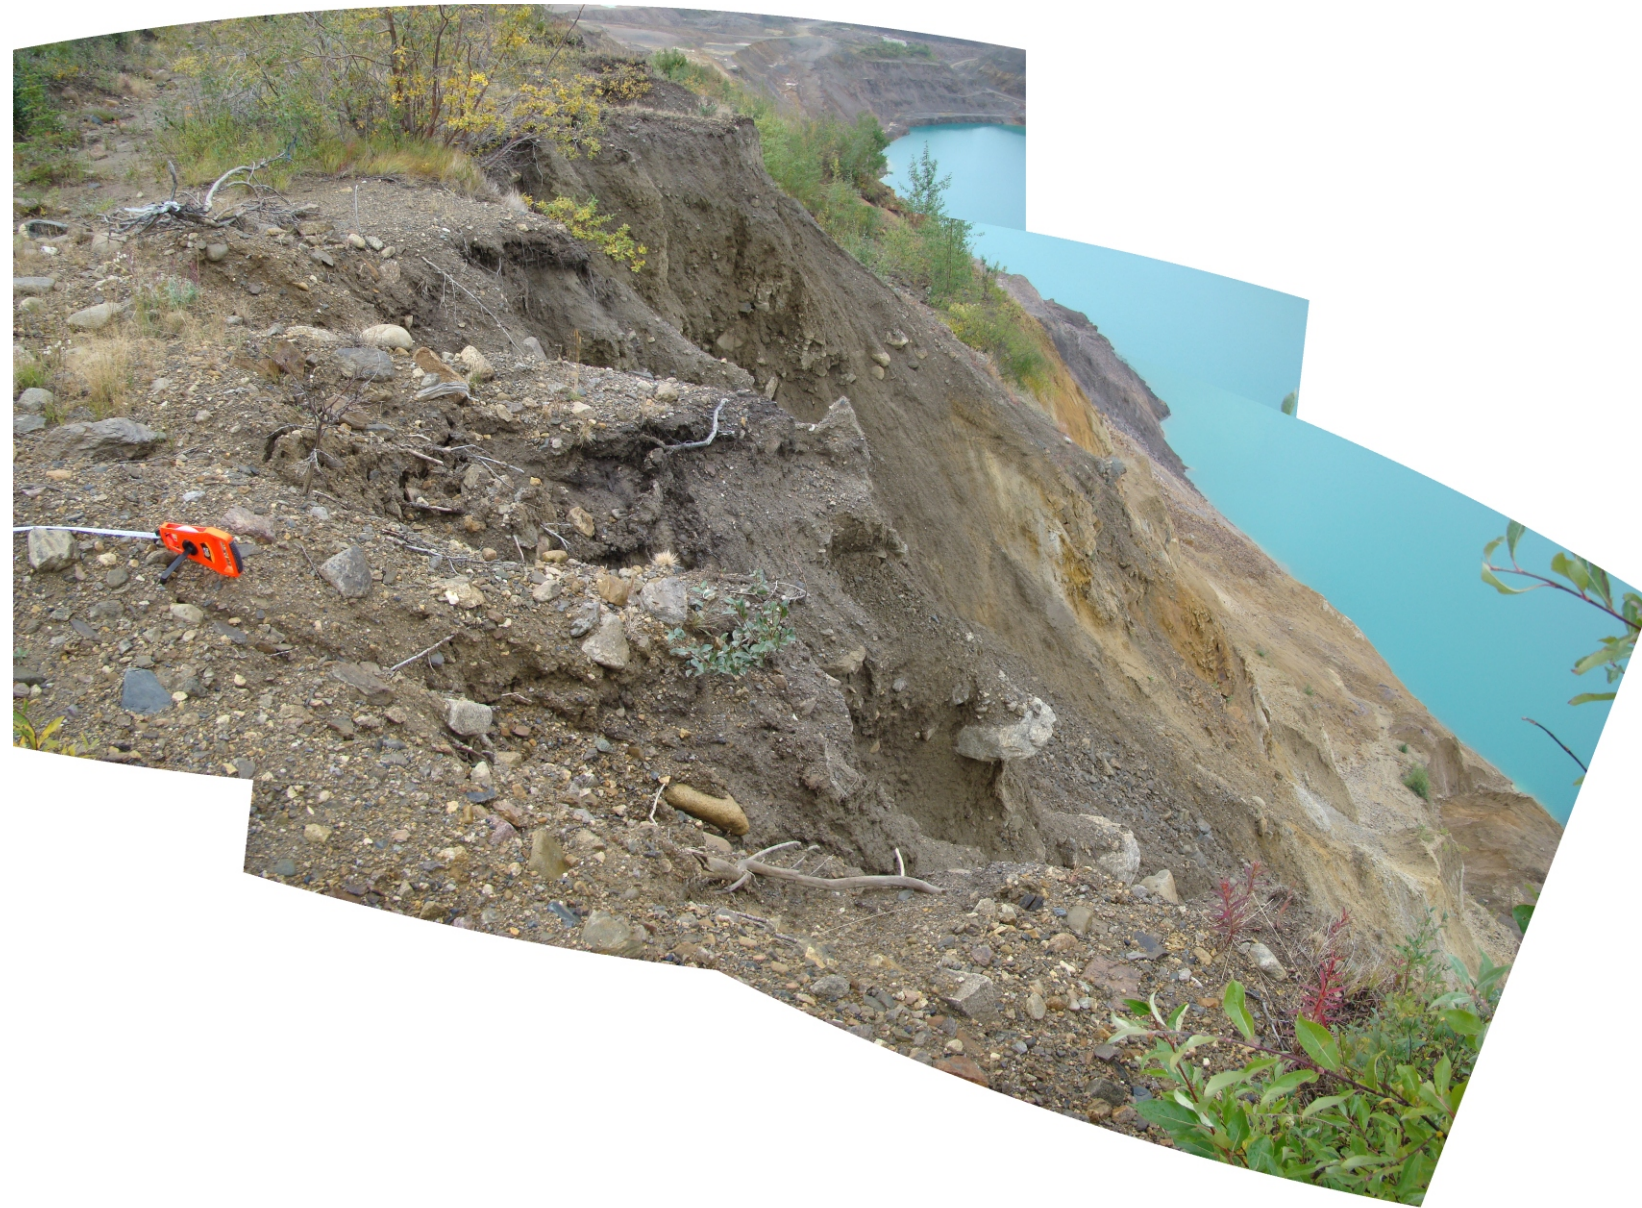
Photograph 10 : North instability zone. Minimum distance area near reference bar 15353 (August 2009).

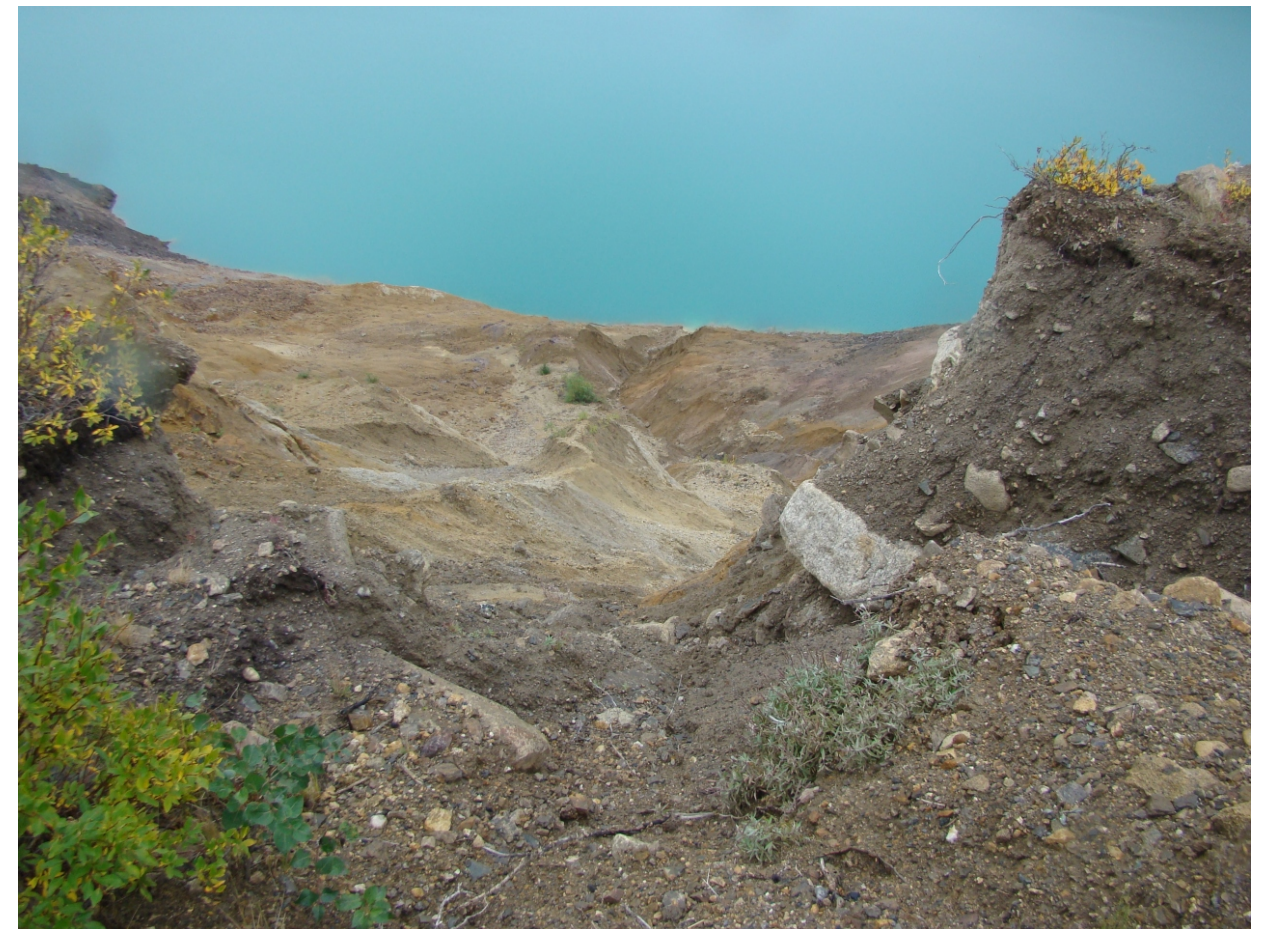
- Groundwater seepage is still observed at the minimum distance location, and is emanating from the overburden/bedrock contact. The previously existing erosion gully developed in the talus debris on the lower slope below this area has increased in size. The lateral extent of the erosion gully does not appear to have changed, but the depth of the erosion channel appears to have increased, mostly in the debris in the lower slope.

Photograph 11 : North instability zone. Erosion gully (August 2009).

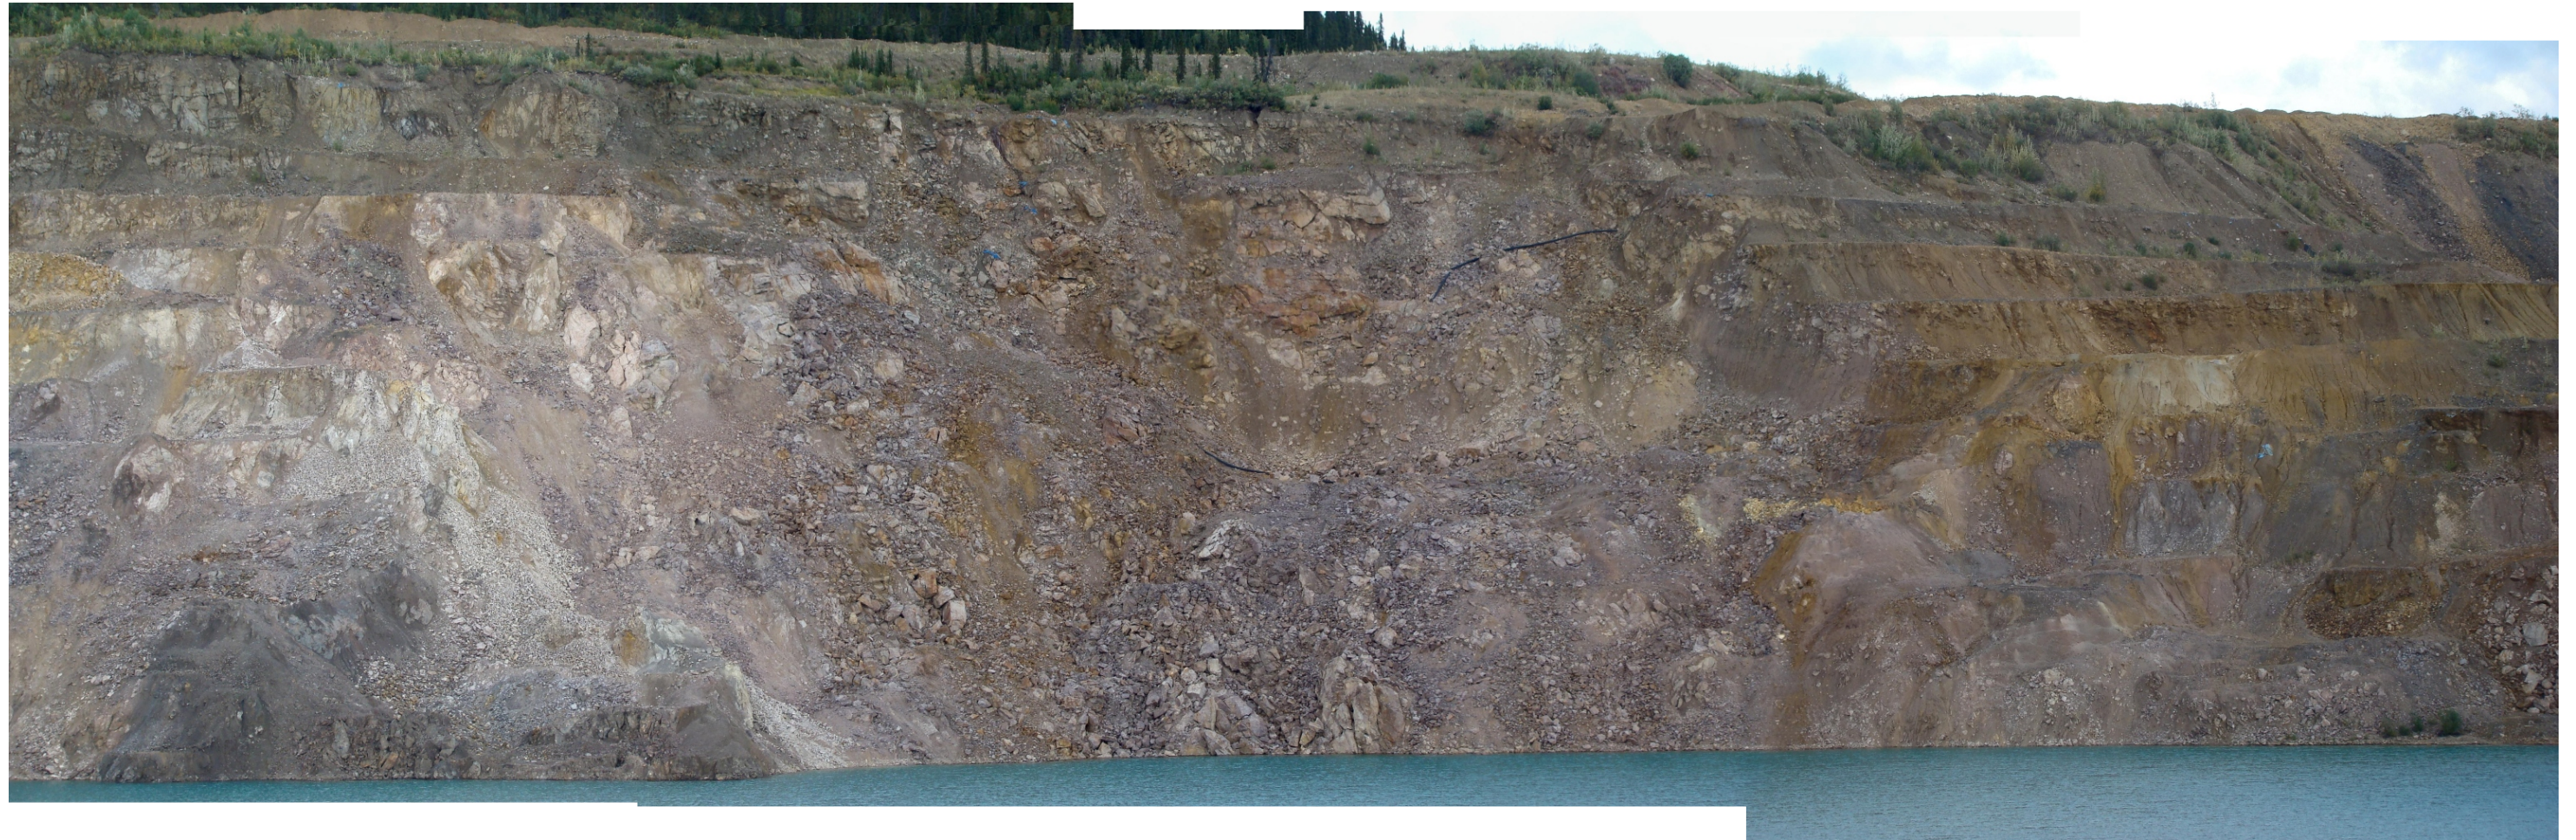
Photograph 12 : South instability zone. (August 2009).

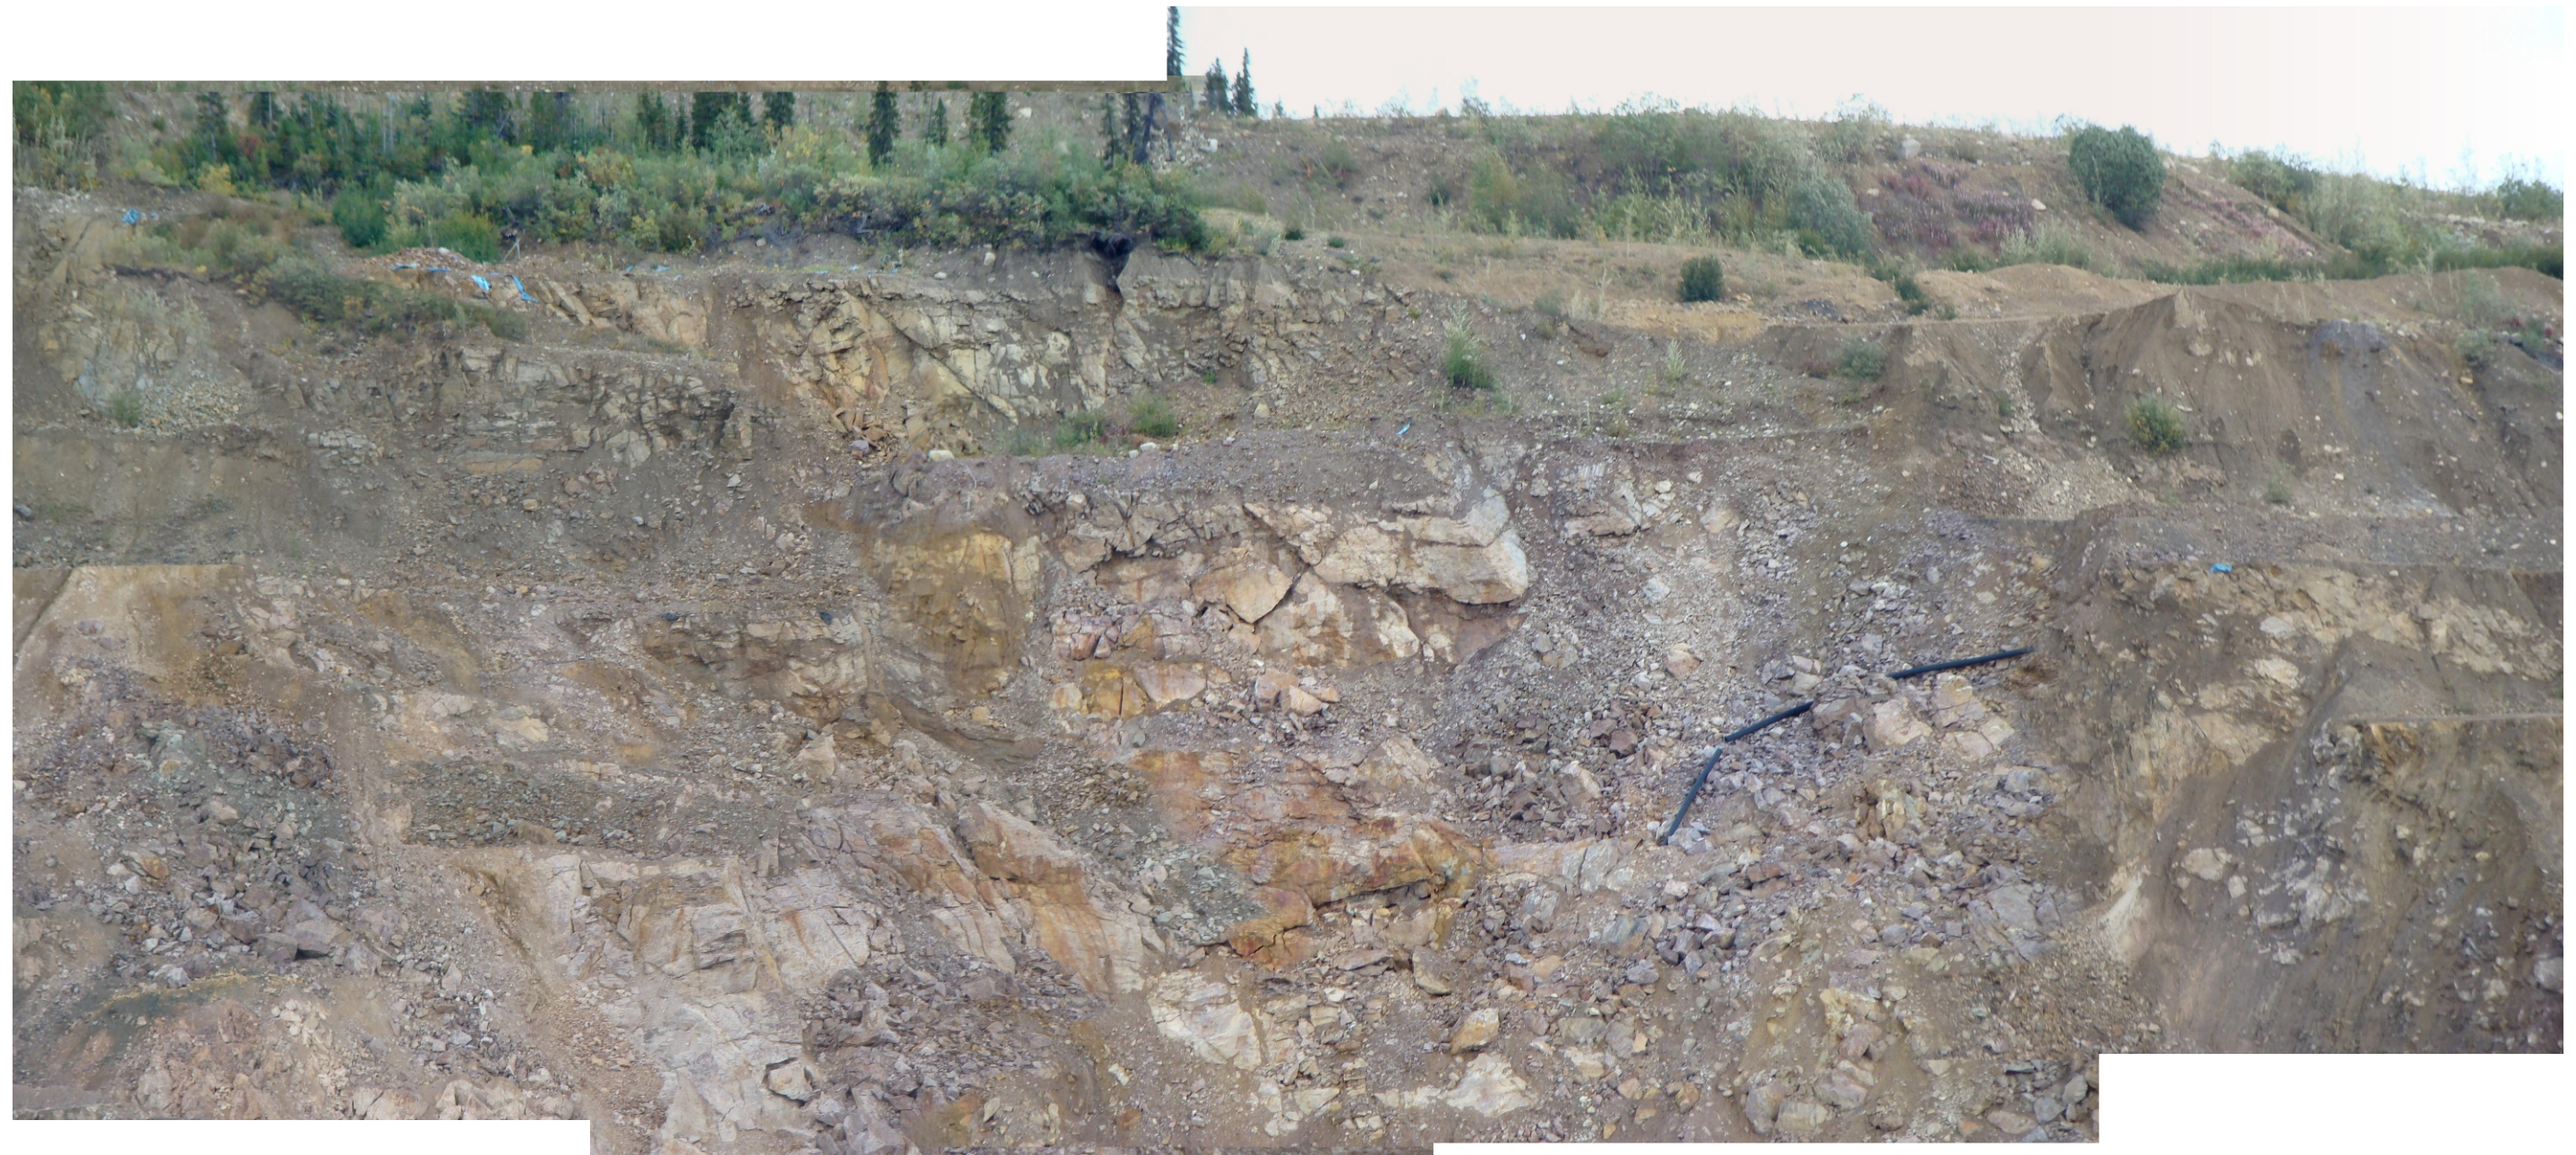
- The crest of the pit wall in the area of the South instability has not changed perceptibly since the previous assessment, from a visual inspection perspective. The crest at the backscarp does not show any significant recession or degradation. Only some limited ravelling from the backscarp appears to have occurred.

Photograph 13 : South instability zone. View of the crest of the pit wall. (August 2009).

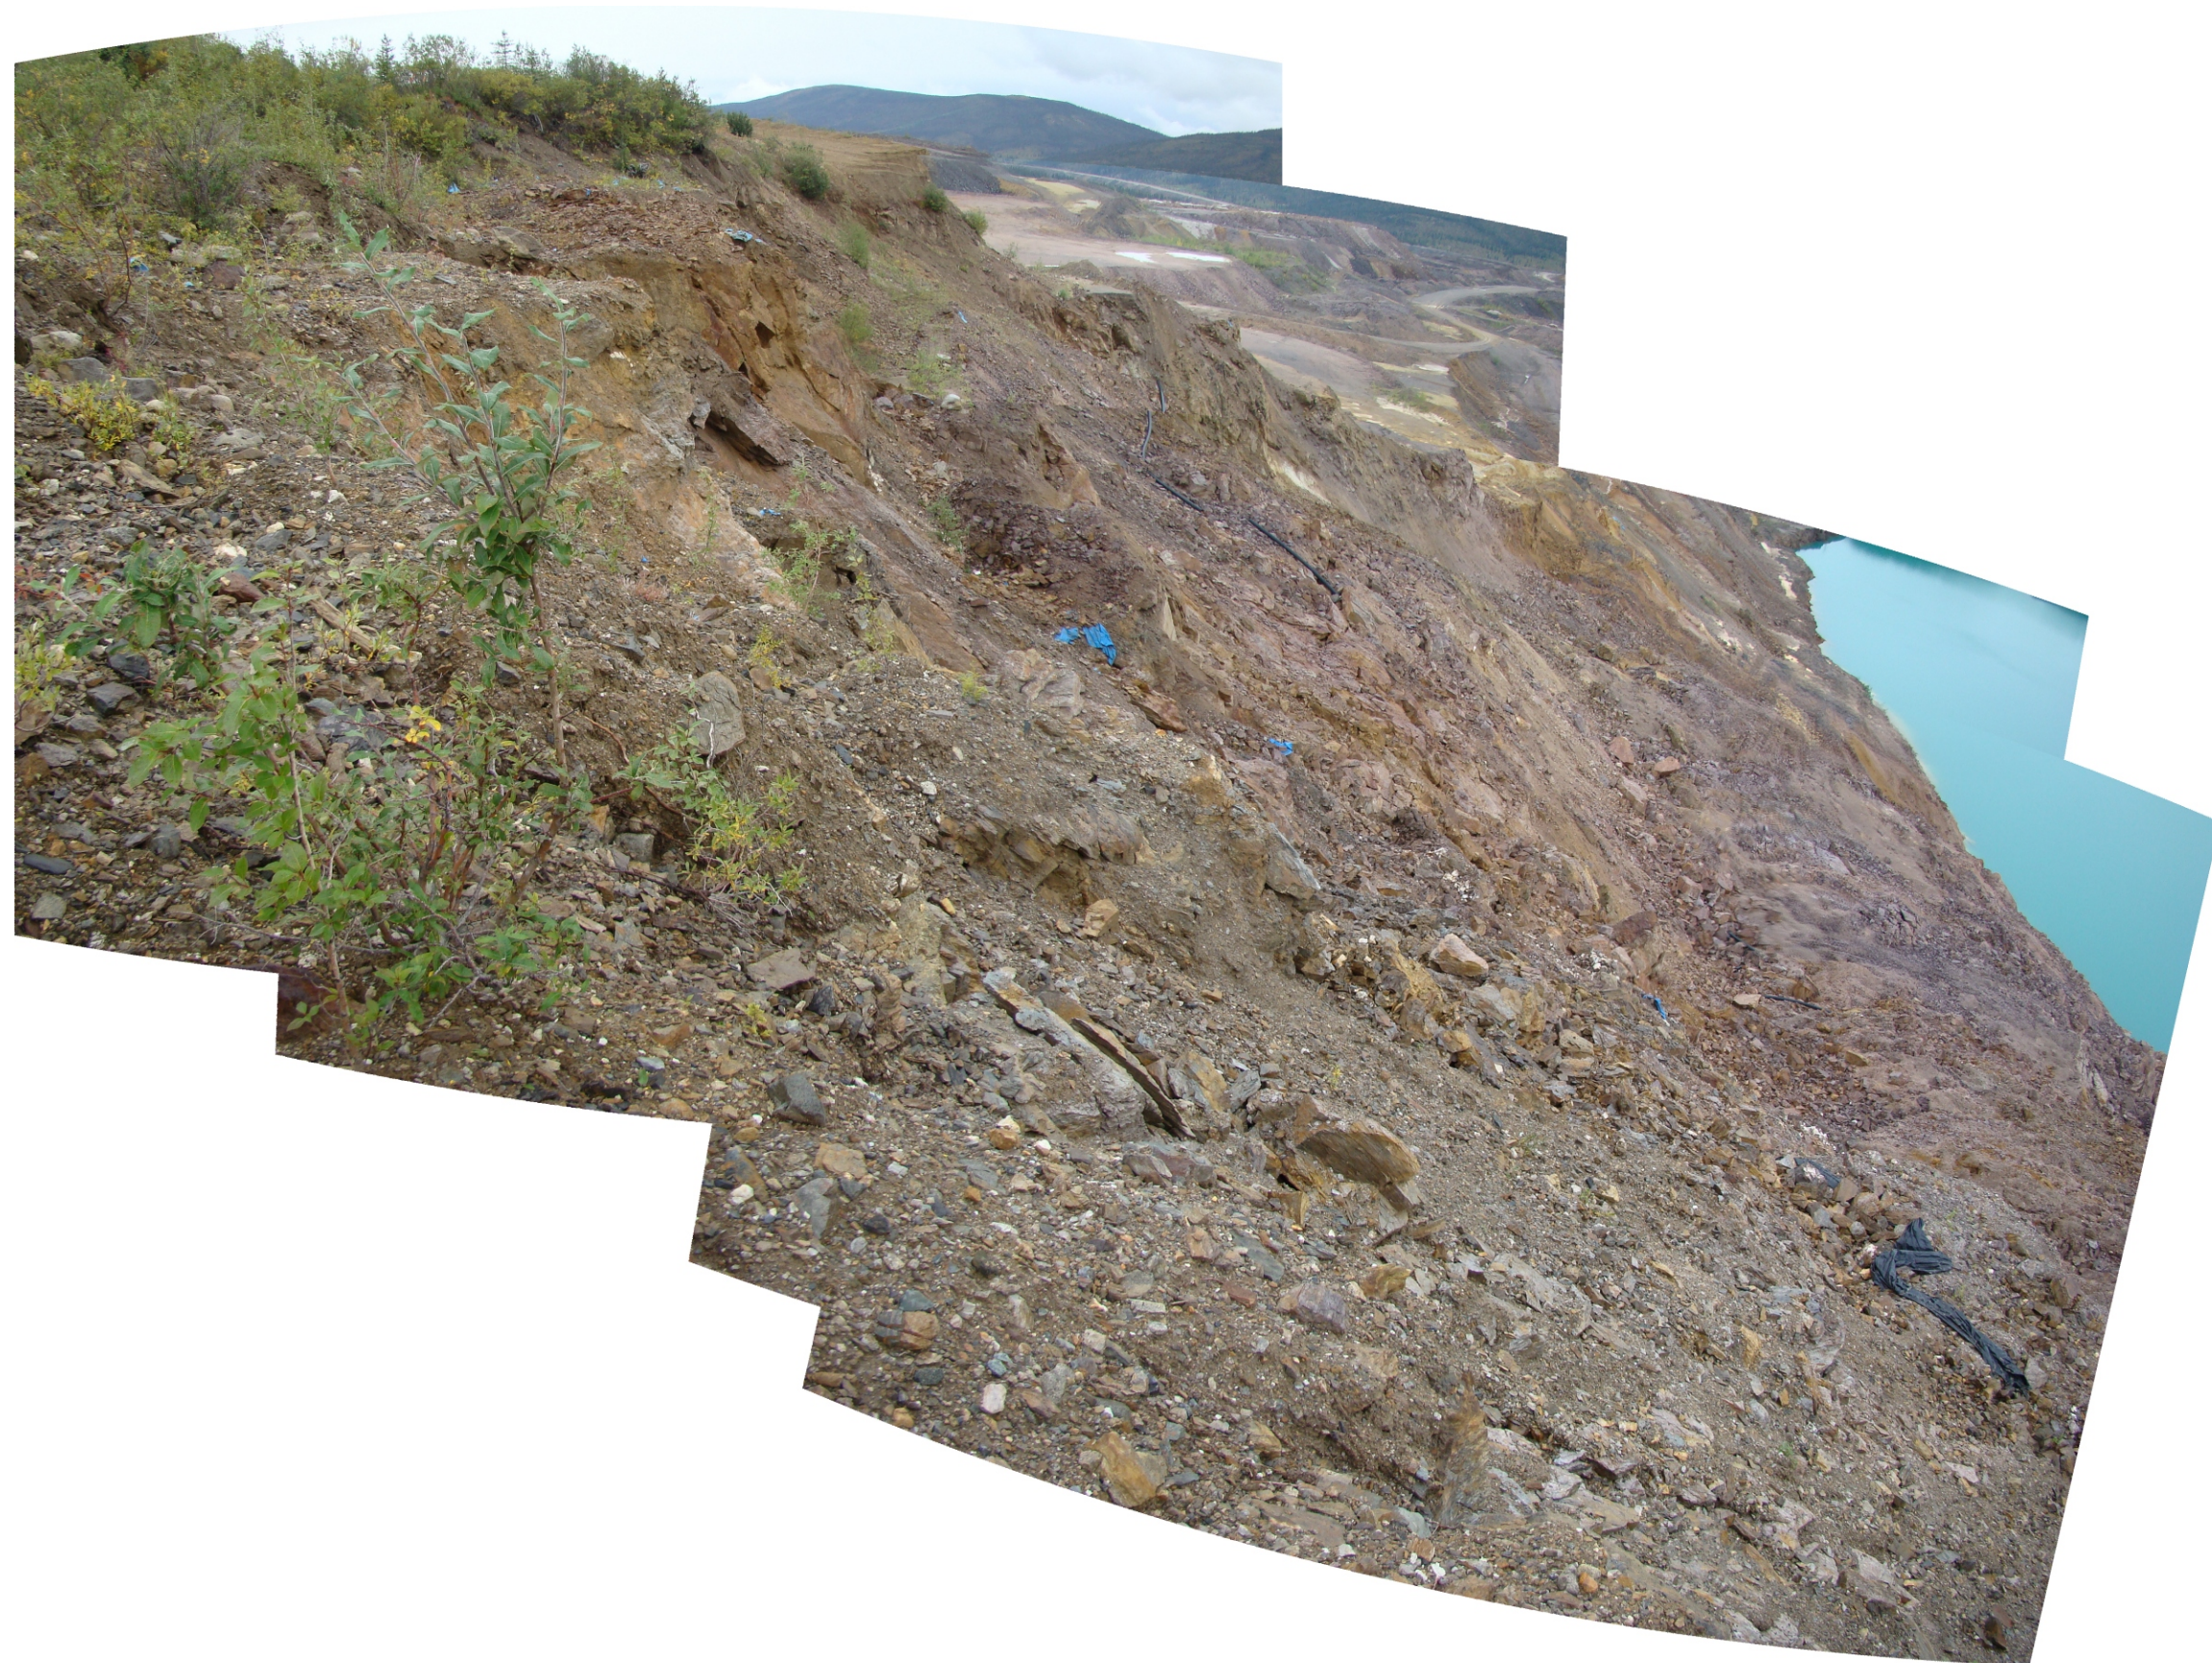
Photograph 14 : South instability zone. View of the back-scarp looking south (August 2009).
