March 13, 2012

ISSUED FOR USE  
EBA FILE: WI4101589

**Subject:** 2011 Geotechnical Inspection of Earth Structures  
Mount Nansen Mine, YT.

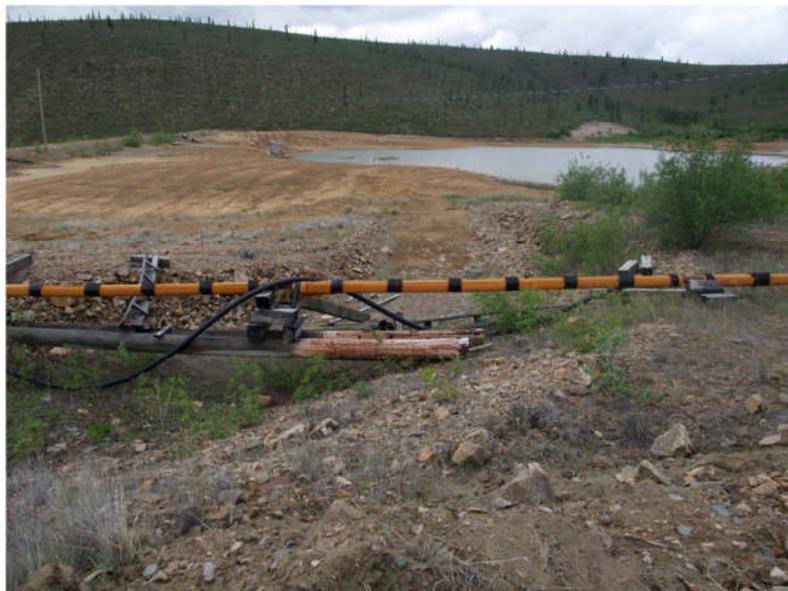
The water level in the tailings pond was very low, and had remained low for a while as there was no evidence of recent flows down the spillway. In general the spillway was well armoured, contained adequate velocity checks (large riprap in channel) and there was no evidence of permafrost thaw issues along the banks. One item noted was the old pipeline and supporting wooden structure across the inlet – if this isn’t needed any more, it should be removed to prevent blocking the inlet if it collapses (Photo 1). Photo 2 shows a general view looking down the channel.

**Photo 1:** Emergency Spillway inlet looking south towards tailings pond – remove pipeline and wooden supports that could potentially collapse and block the channel (June 22/11).

- Remove pipeline and wooden supports near spillway inlet.

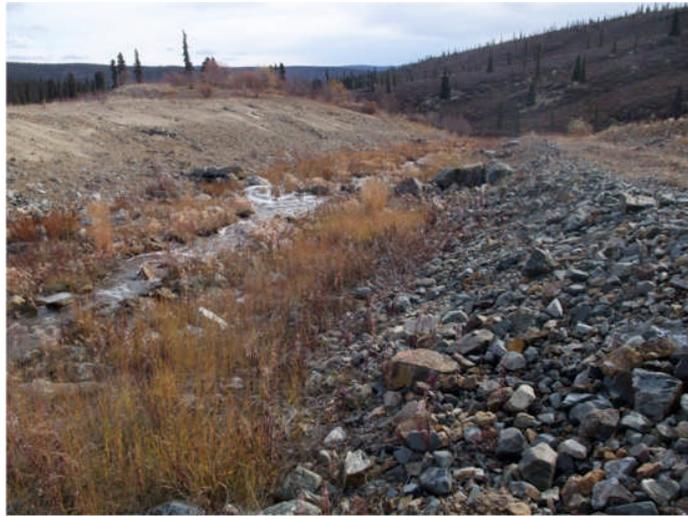
**Photo 2:** View looking SE down the emergency spillway channel – stable and adequate erosion protection (September 28/11).

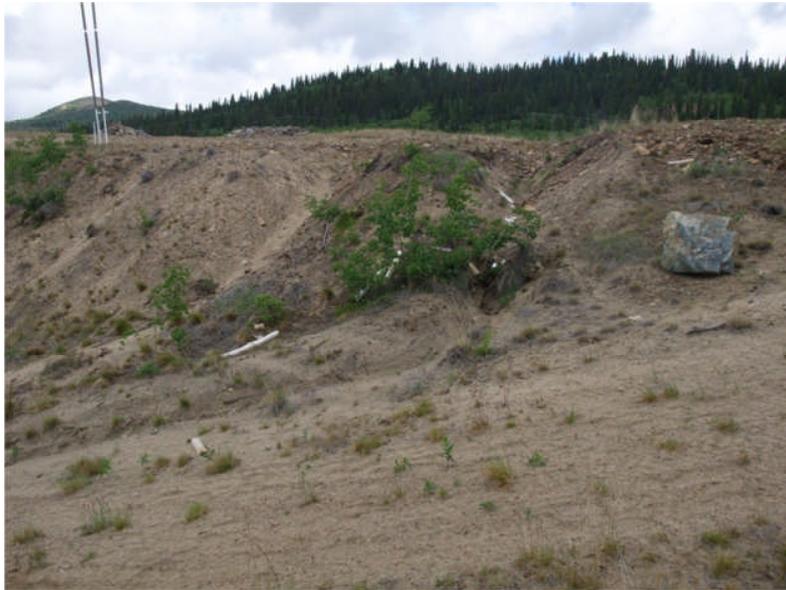
The seepage collection dam was reconstructed in 2000 and contains a frozen key trench stabilized by Thermosyphons that were installed parallel to the dam centreline. In general the dam looks good and is considered stable, although some minor seepage on the downslope face was noted in the centre of the dam in June, but not in September (lower pond level). This is not an issue at present, but should continue to be monitored. In addition, there were some erosion gullies noted on the north abutment, caused by surface runoff water, that should also be monitored and repaired with riprap if they continue to enlarge (see Photo 3).

**Photo 3:** Erosion gullies on north abutment downstream of seepage collection dam (Thermosyphon radiators visible in upper left of photo. (June 22/11).

- Monitor erosion rills on the downstream side of the north abutment and repair by filling with riprap if they continue to enlarge.
- Conduct a winter 2011/2012 thermal evaluation of the Thermosyphon radiators – an IR imaging instrument could be used to confirm that they're still functioning as designed. There is some concern that the instrumentation boreholes in the crest of the dam may have impacted the buried evaporator pipes. Note: This was completed in January 2012 and the Thermosyphons were determined to be functioning.

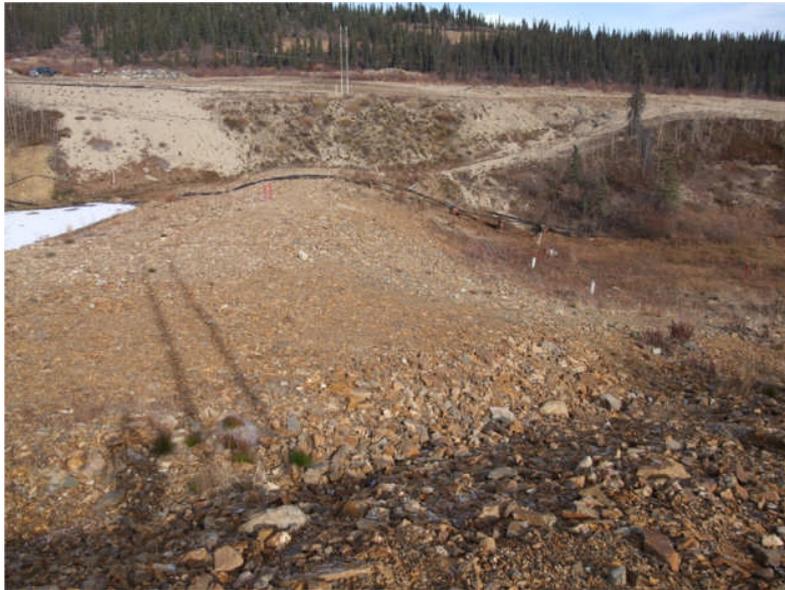
Some instrumentation installed in boreholes at the centreline of the dam was also observed, and these holes may have affected the Thermosyphon evaporators in the key trench. If this is the case, it may be the reason why some minor seepage was observed in June. It is recommended that the Thermosyphon performance be assessed this winter by using an IR imaging gun to verify that they're still operational<sup>1</sup>.

Photo 4 shows the instrumentation location in the dam, with the Thermosyphon radiators in the background.

**Photo 4:** View looking from S to N across Seepage Collection Dam -- instrumentation location (red stakes in left center of photo) in Dam that may have affected Thermosyphon evaporators connected to the radiators shown in upper center of photo (Sept 28/11).

<sup>1</sup> This work was completed by EBA in a site visit in January 2012, and the Thermosyphons were confirmed to be operational.

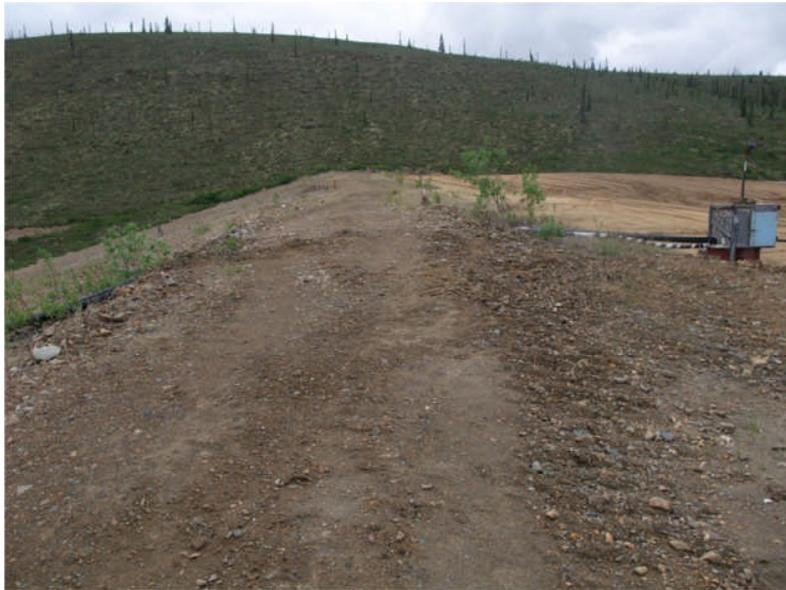
The water level in the tailings pond was very low, and the dam itself is considered to be in a stable condition (see Photo 5). No evidence of previously noted instabilities or seepage on the north abutment was observed, and there were no signs of significant erosion or permafrost thaw features that could affect stability.

**Photo 5:** General view of crest of tailings dam looking south (June 22/11).

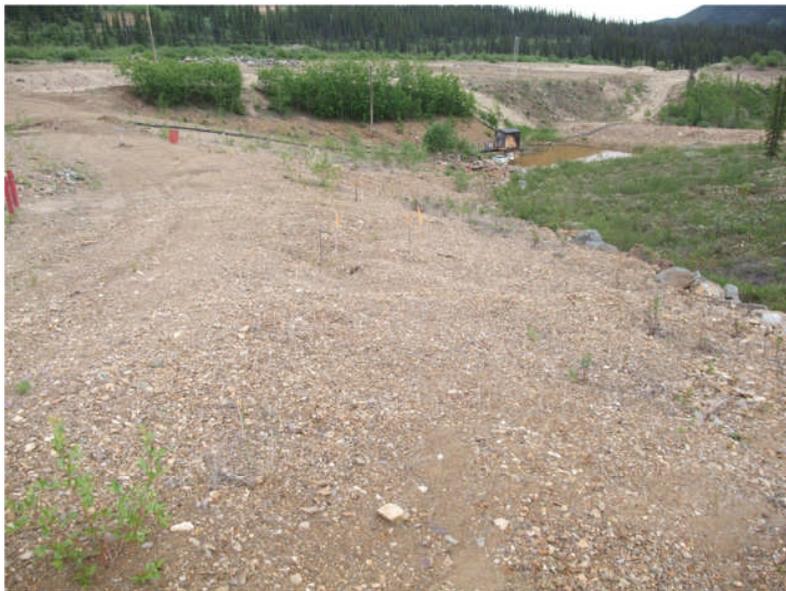
There was one area along the downstream face at the south abutment that contained minor permafrost thaw depressions (see Photo 6) but these have been here for at least ten years and are not considered to affect the slope stability.

**Photo 6:** Minor thaw-settlement depressions near survey stakes (see orange flagging in center of photo) on downslope side near south abutment of tailings dam looking NE (June 22/11).

- Continue to monitor permafrost thaw settlement on the downstream face near the south abutment.
- Consider conducting a review of the status of existing instrumentation in the dam – some of the cables are in “rough” shape and may need to be replaced (if they're still necessary).

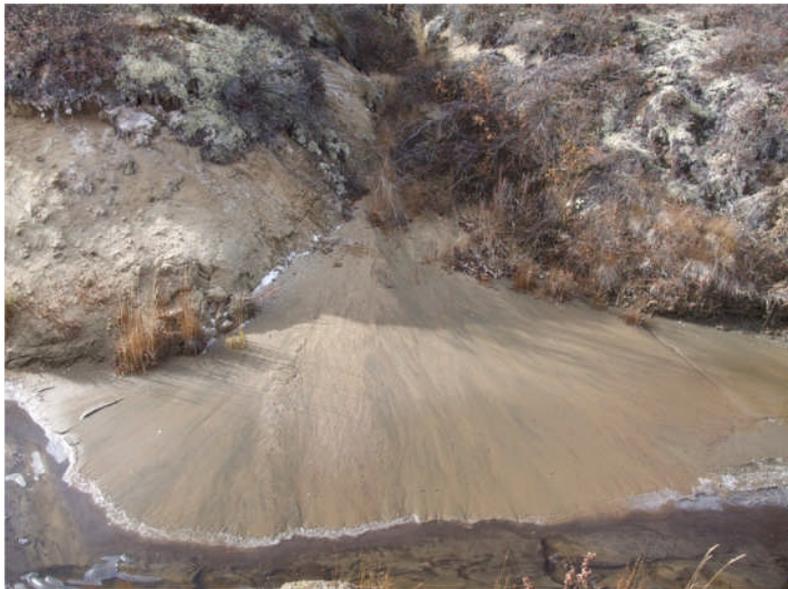
Immediately above Dome Creek, the diversion cuts through a sand terrace, the erosion of which through several small drainages is depositing fine grained sand into the diversion. To minimize the deposition of sand into the ditch (see Photos 7 and 8), and subsequent suspended solids load during high flow events, it is recommended that these areas be cleaned out as part of the annual maintenance program. In future, should a more permanent solution be required, the ditch could be armoured with geotextile and riprap. A sand sample was taken and tested in the EBA Whitehorse soils laboratory (see attached particle size curve), the results from which could be used to design a suitable geotextile for lining the ditch under a riprap cover.

**Photo 7:** Flow and sand deposition into the upper diversion ditch above Dome Creek (September 28/11). There are several of these small “fan” deposits south of the Dome Creek inlet, above and west of the tailings pond – this is one of the larger ones.

- Clean out the sand deposits in the the upper and central portion of the ditch on an annual basis. If a permanent solution is required, then armour the sides and base with non-woven geotextile and suitably sized riprap.
- Remove the abandoned pipeline and wooden supports from the diversion ditch just downstream of Dome Creek and also above the bridge to avoid potential future flow disruptions.

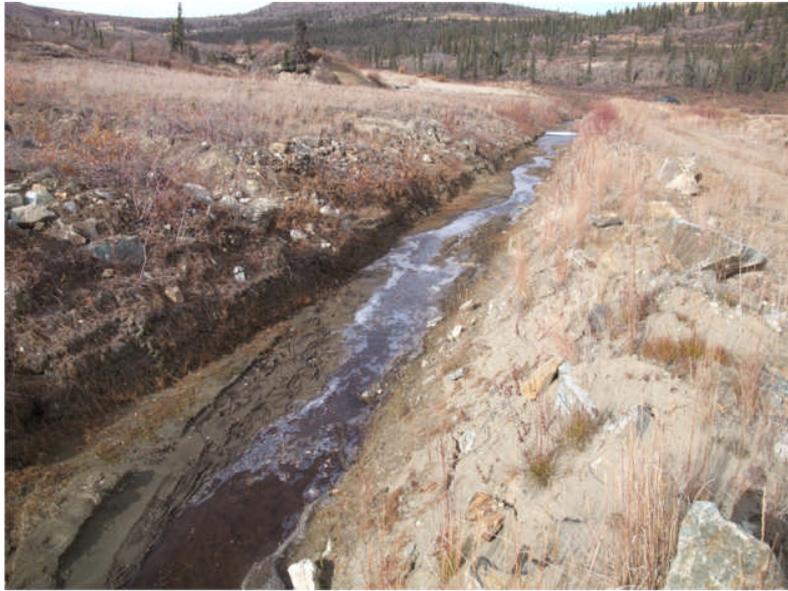
**Photo 8:** View looking NW showing upper diversion ditch filling with fine grained sand that gets washed downstream during high flow events (September 28/11).

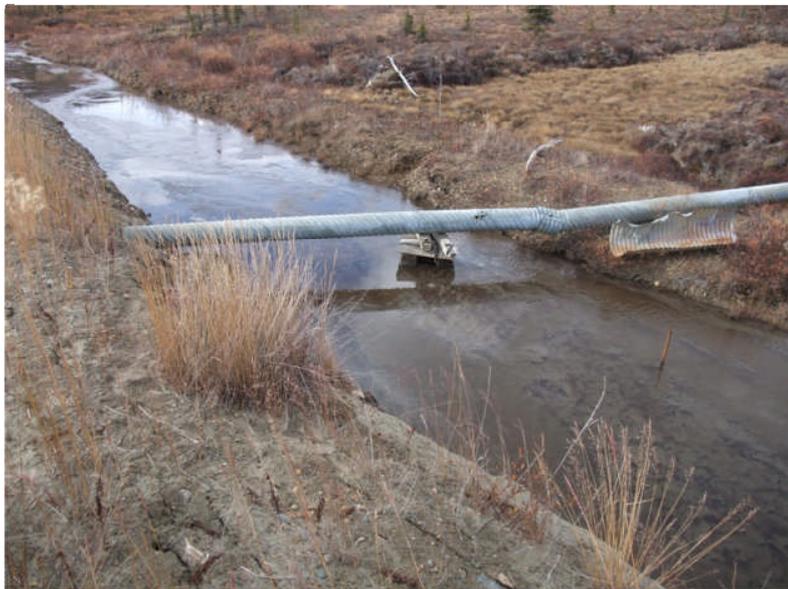
The lower section of the ditch below Dome Creek is stable; however, the abandoned pipeline and wooden supports (see Photo 9) in the creek just below Dome Creek should be removed. There is the chance that this could collapse into the channel creating disruption to the natural flow, and channel sideslope erosion.

**Photo 9:** Abandoned pipeline and wooden supports in diversion ditch immediately downstream of Dome Creek inlet– these should be removed to minimize the potential for future collapse and possible effects on future flows (September 28/11).
