January 11, 2013

ISSUED FOR USE
EBA FILE: W14101749

Subject: 2012 Geotechnical Inspection of Earth Structures
Mount Nansen Site, YT.

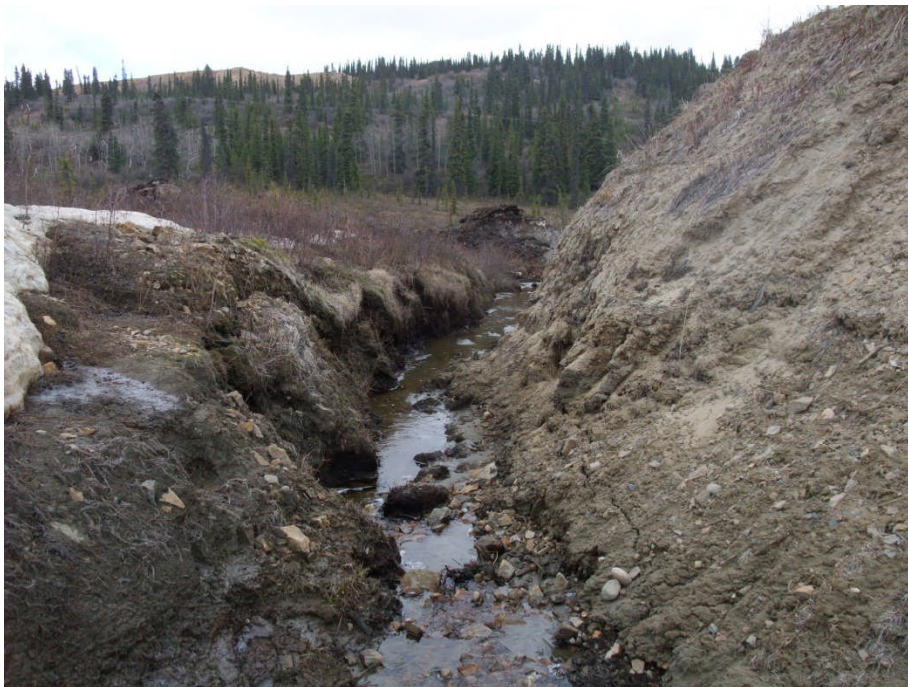
The ditches above and around the tailings pond, connecting to the emergency spillway were in similar conditions to previous years. In June, the effects of ice excavation and cleanout to keep the ditch flowing over the previous winter were evident – this included some oversteep sideslopes near Dome Creek, some areas of slower flow, and general siltation/sanding of the ditch bottom up to about the bridge. An email was sent to YG-AAM in June 2012 outlining these interim concerns, and in October, these items had been addressed by excavating the ditch bottom to make a uniform gradient, and flattening the sideslopes in the area previously identified. Photos 1 to 4, below, show before and after photos of these areas.

Photo 1: Oversteep ditch slope near Dome Creek (June 1/12)

The only concern with the reconstructed ditches will be the effects of erosion on the toes of the banks – this will have to be monitored and corrective actions taken (regular repair, possible riprap placement) if over-steepening occurs. The ditch sideslopes should be examined again after the 2013 spring runoff event.

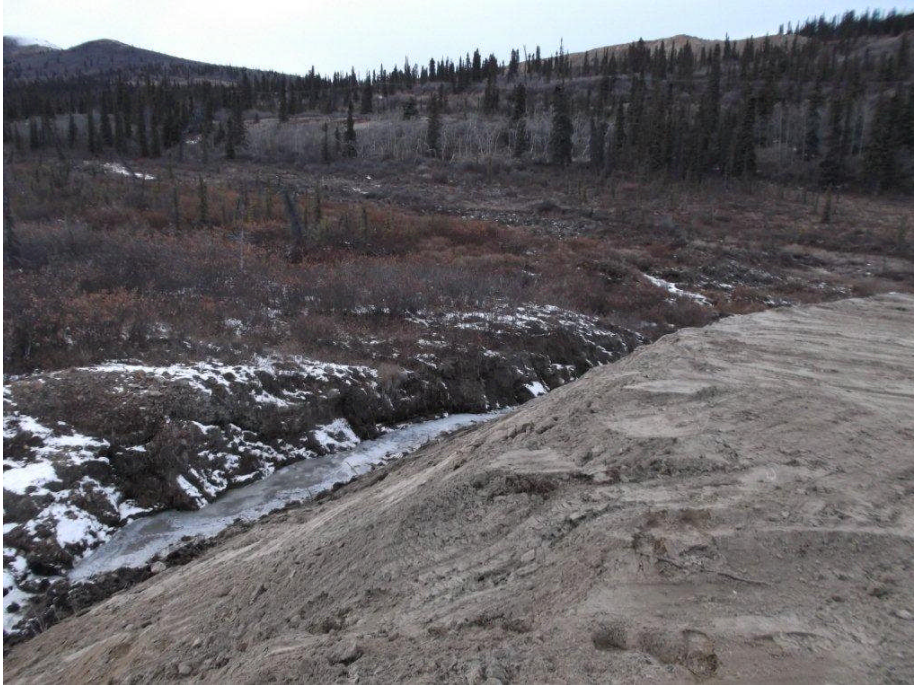
Photo 2: Flattened slope near Dome Creek (YG Photo, October 2012)

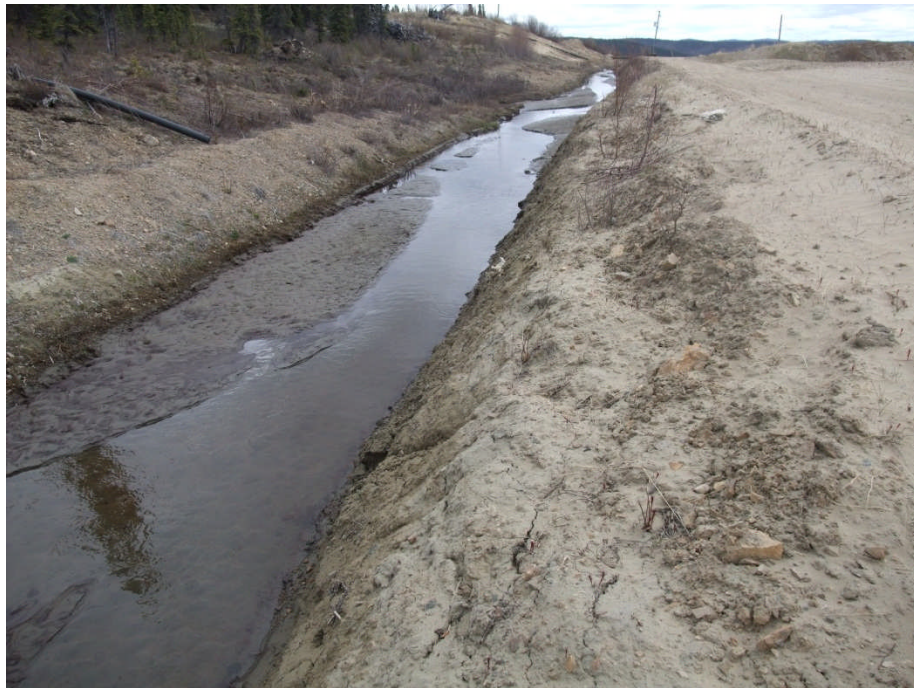
Photo 3: Low flow in diversion ditch due to silt and sand deposits (June 1/12)

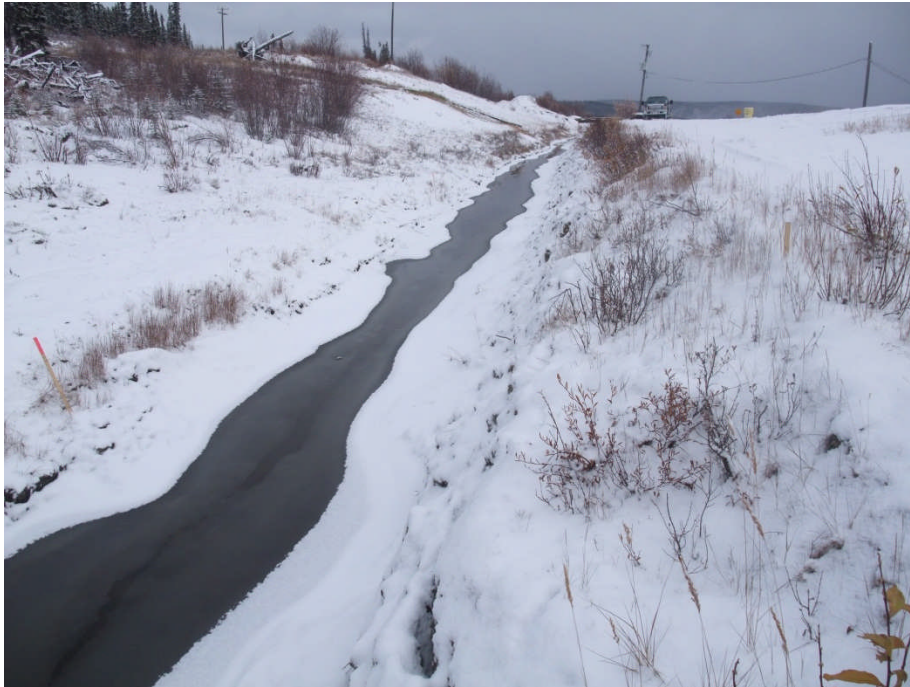
Photo 4: Cleaned out diversion ditch (October 1/12)

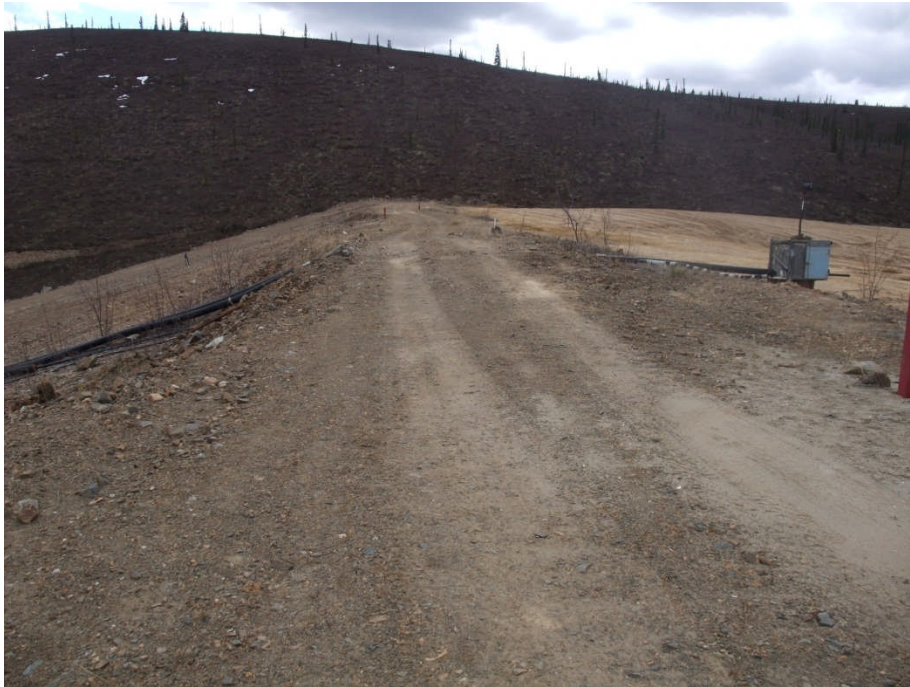
The water level in the tailings pond was well below the maximum operating level elevation in both June and October, and the dam itself is considered to be in a stable condition (see Photo 5). No evidence of previously noted instabilities or seepage on the north abutment was observed, and there were no signs of significant erosion or permafrost thaw features that could affect stability. Minor surface thaw depressions previously observed on the south crest have not changed over the past several years.

Photo 5 shows the crest of the tailings dam on June 1, 2012, with no changes to stability observed in October 2012.

Photo 5: View to the south along crest of tailings dam (June 1/12)

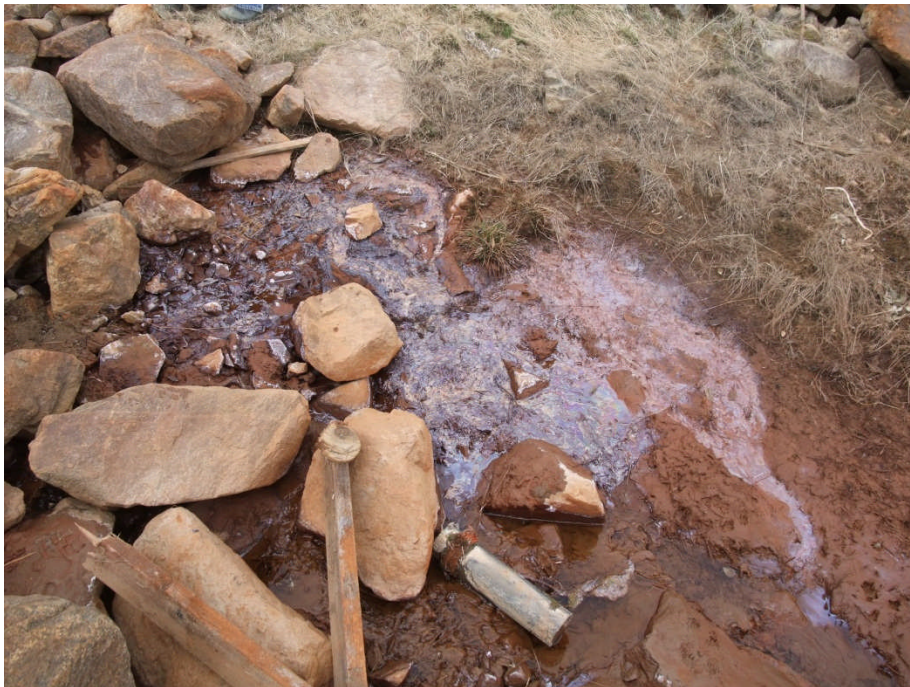
There was one area of apparently increased (not observed in 2011) seepage noted at the toe of the dam, as shown in Photo 6.

Photo 6: View of seepage from toe of tailings dam, just above the seepage collection pond (June 1/12)

This seepage was rusty in colour with a “sheen” on the surface. This intermittent seepage has been noticed before, and is the reason for the large riprap placed at the toe in this location. This area should continue to be monitored, and the water sampled and tested for comparison to both the tailings pond water and Dome Creek to try and ascertain its source.

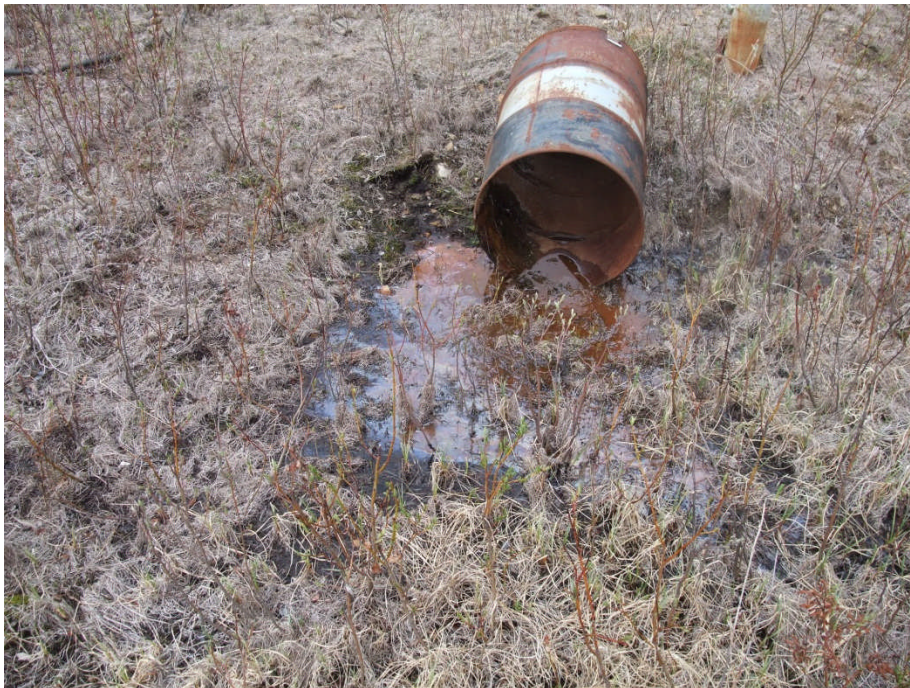
The water level in the seepage collection pond was also below the design elevation, and the dam was noted to be in a stable condition. Several seepage zones were observed on the downstream toe, similar to previous years. These are intermittent seepages that have been noted sporadically over the years, and not considered to significantly affect dam stability.

Photo 7: Seepage noted in approximately the centre of downstream face of seepage collection dam (barrel was used as a marker) June 1/12.

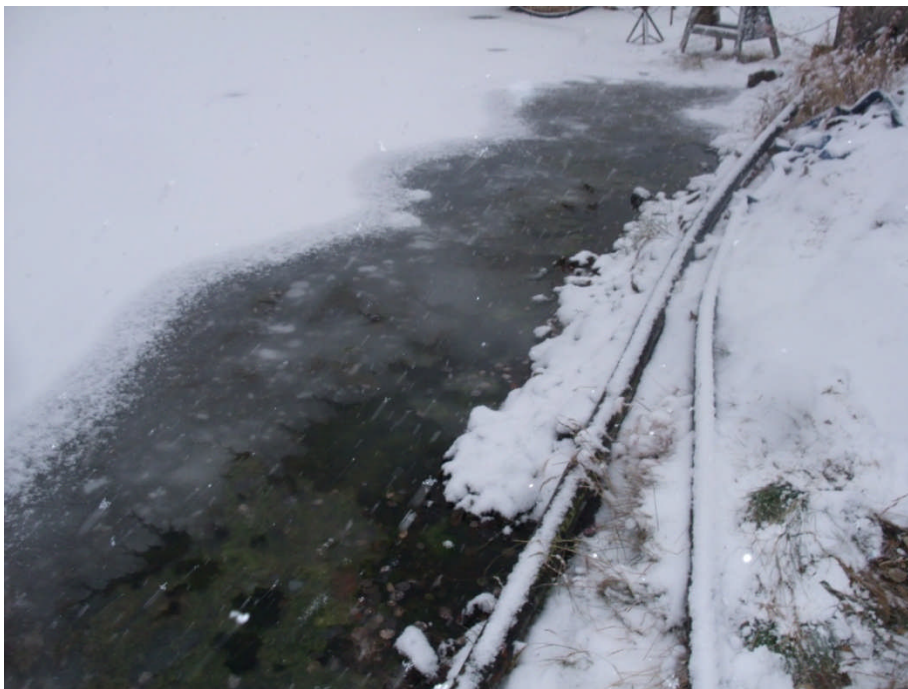
In the summer of 2012, YG-AAM personnel noted an increase in seepage from the toe of the sand terrace on the north side of the seepage collection pond. The water was clear and free of sediment. During the October 1/12 inspection, the recent and light snowfall provided an opportunity to view the seepage coming from this slope – it was not concentrated in one spot, but was originating from the entire toe (see Photo 8).

Photo 8: Seepage observed from base of sand terrace at north slope of seepage collection pond on October 1/12.

It is recommended that seepage from this side of the pond be examined at least weekly to look for signs of increased or decreased flow, and to verify that the seepage water remains clear of silt and fine grained sand. Record photos from the same location should be taken about once a month during unfrozen conditions.

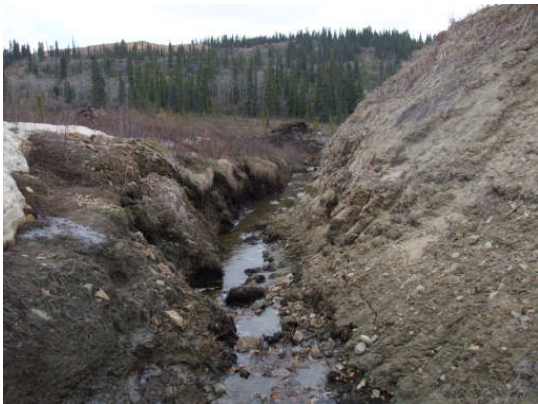
Photo 1192

1. Dome Creek diversion ditch – the excavation work this past winter has over-steepened the bank close to where Dome Creek enters (see attached photo 1192). This should be flattened to about 1.5:1 (H:V) and provided with some armouring at the toe so the bank doesn't get undercut any more over the summer.

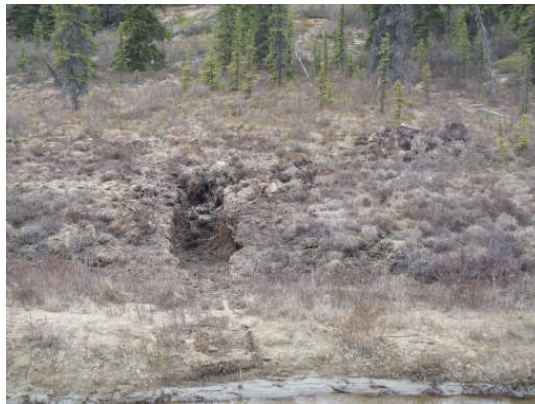
Photo 1199

2. Permafrost disturbance – several channels were inadvertently cut into the permafrost/natural soils this past winter to drain water (see photo 1199)– these should be "hand" backfilled with the excavated materials (replace organics on top) to minimize future disturbance to the terrain. Also consider doing something similar closer to Dome Creek where the hoe was working.....
