August 6, 2013

ISSUED FOR USE  
EBA FILE: W14103179-01

**Subject:** June 2013 Geotechnical Inspection of Earth Structures  
Mount Nansen Site, YT.

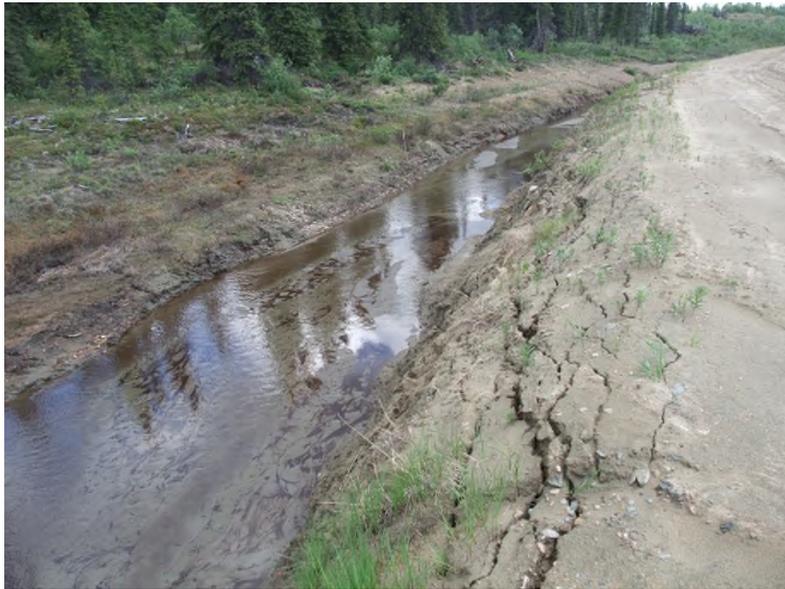
The ditches above and around the tailings pond, connecting to the emergency spillway were in similar conditions to previous years. The effects of ice excavation and cleanout to keep the ditch flowing over the previous winter were evident – this included some oversteep sideslopes near Dome Creek, some areas of slower flow, and general siltation/sanding of the ditch bottom up to about the bridge. See Photos below.

Photo 1: Oversteep ditch slope on Dome Creek Diversion (June 21/13)

The primary concern with these ditches is the effects of erosion on the toes of the banks – this will have to be monitored and corrective actions taken (regular repair – flattening to 1.5:1, possible riprap placement) if over-steepening occurs.

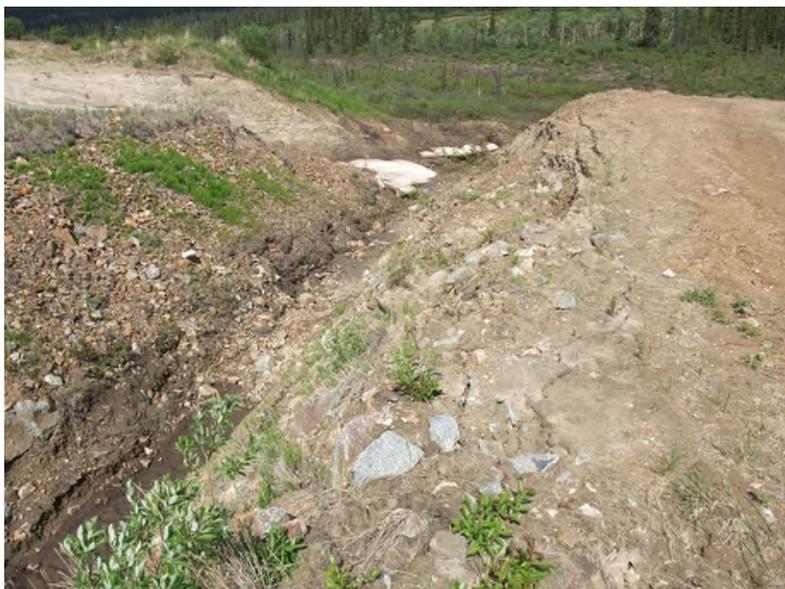
Photo 2: Oversteep ditch slope upstream of Dome Creek intersection (June 21/13)

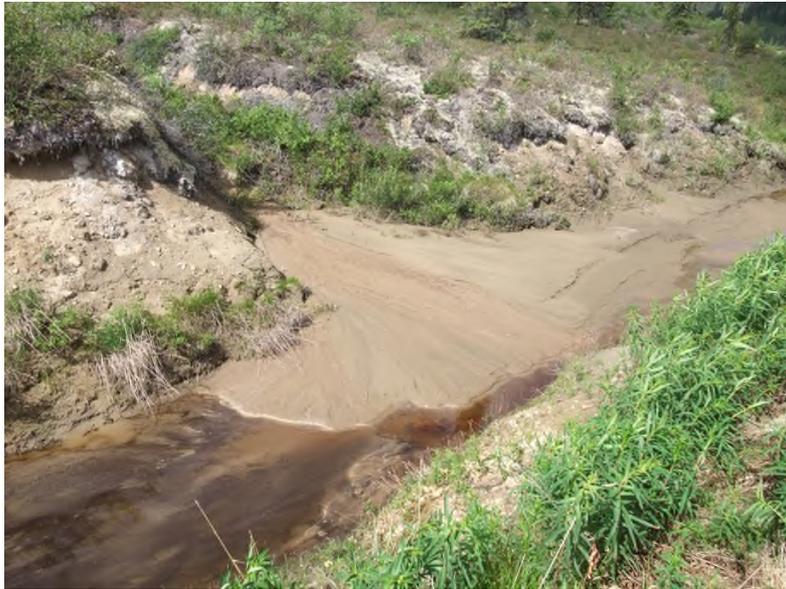
Erosion gullies from water entering the interceptor ditch were in the same condition as previous years, and should continue to be monitored. These small erosion gullies are probably significant contributors to sand and silt deposits in the diversion ditch. See Photo 3.

Photo 3: Sand deposits in channel bottom upstream of Dome Creek intersection (June 21/13)

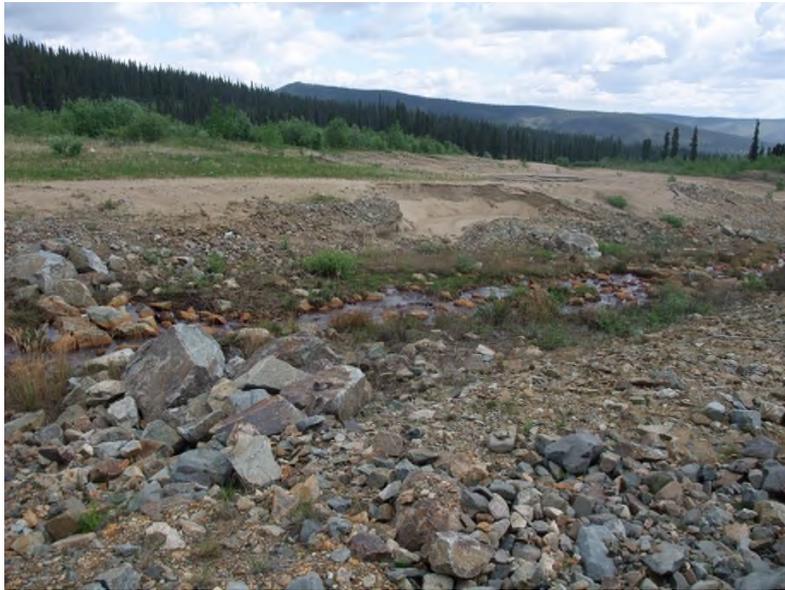
One item requiring immediate attention is a small erosion scar on the north side of the emergency spillway. It appears as though ice-damming this past winter caused the channel to deflect into the north bank, overtopping the riprap and geotextile, and eroding the sand. This area must be repaired before next winter, using the following suggested procedure:

Photo 4 shows the erosion scour on June 21/13.

Photo 4: View of Erosion Scour on north side of spillway that must be repaired (June 21/13)

1. Expose the ends of the geotextile adjacent to the erosion scar, and fold them back
2. Remove all riprap down to the water line
3. Smooth out the edges of the scour area by excavating the sand
4. Reconstruct the channel bank by using compacted sand and/or gravel, in maximum 300 mm lifts
5. Add new geotextile, overlapping at least 1.0 m on all three sides
6. Replace the riprap to match adjacent area (EBA took samples of the riprap on site, and it is presently being tested for suitability, prior to placement).

During re-construction, photos should be taken at all stages of the work, for future reference purposes.

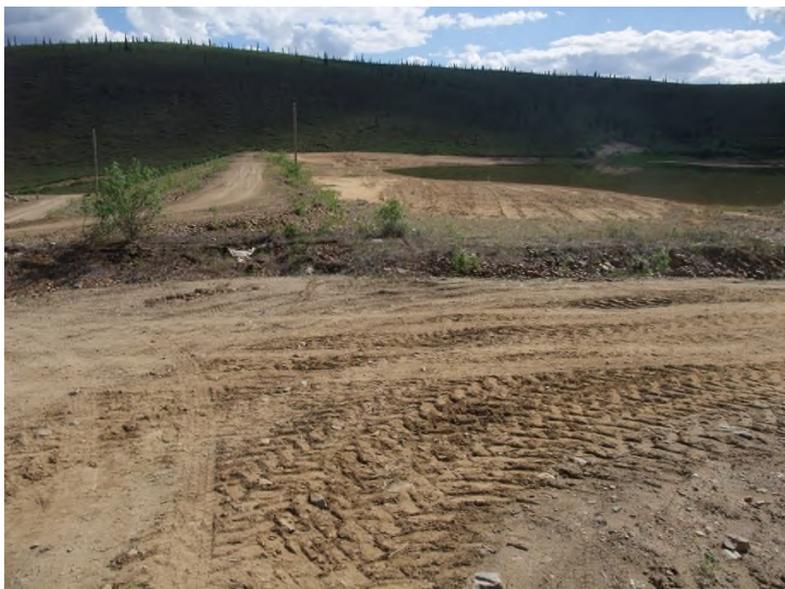
The water level in the tailings pond was below the maximum operating level elevation, but higher than it has been in previous years. However, the dam itself is considered to be in a stable condition (see Photo 5). No evidence of previously noted instabilities or seepage on the north abutment was observed, and there were no signs of significant erosion or permafrost thaw features that could affect stability. Minor surface thaw depressions previously observed on the south crest have not changed over the past several years.

Photo 5: View to the south along crest of tailings dam (June 21/13)

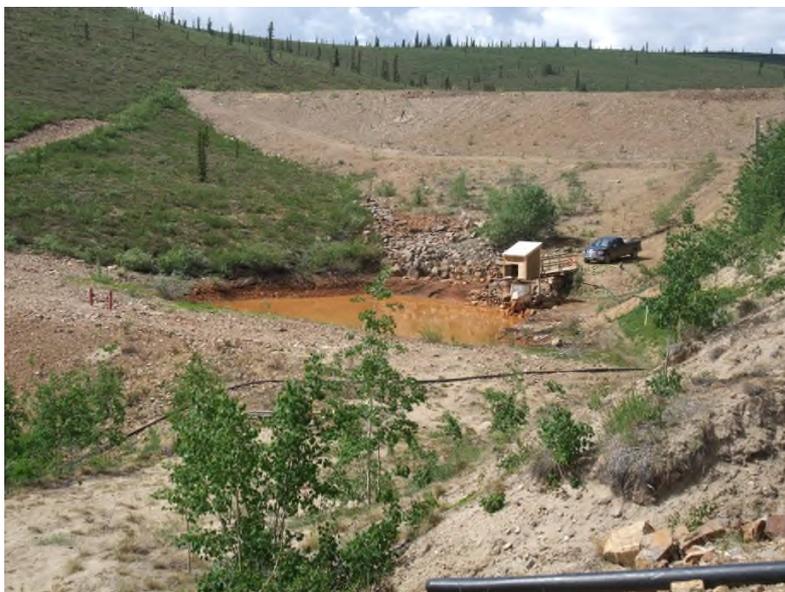
As previously arranged by YG-AAM, the water in the seepage collection pond had been "drawn down" as low as practically possible in the days before the inspection – see Photo 6.

Photo 6: View of Seepage Collection Pond – water level pumped down (June 21/13).

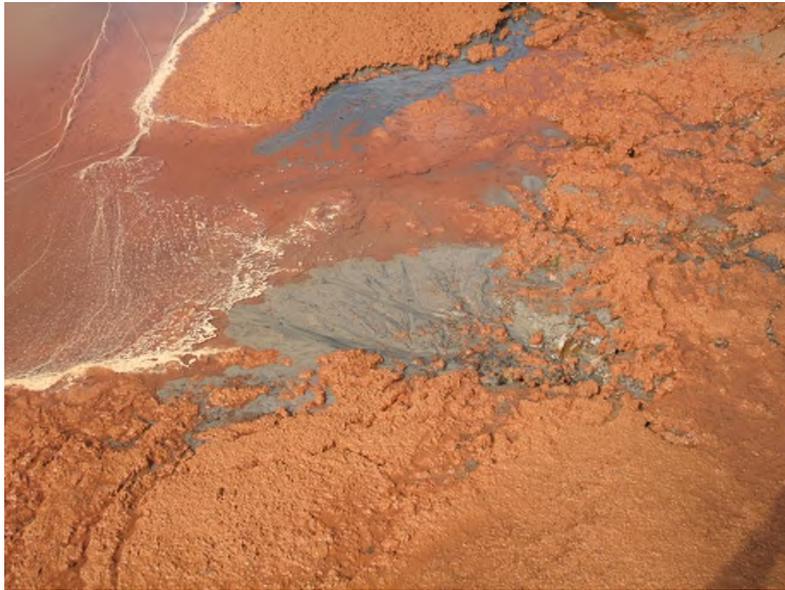
Photo 7 shows one of these seepage zones from the base of the sand terrace on the north side of the pond. The water was observed to be clear, and the small alluvial fan visible in the photo is the result of erosion of the natural sand surface by moving water, not by subsurface piping.

Photo 7: Seepage observed from base of sand terrace at north side of seepage collection pond (June 21/13).
