December 20, 2013

ISSUED FOR USE
EBA FILE: WI4103179-01

Subject: 2013 Annual Geotechnical Inspection of Earth Structures
Mount Nansen Site, YT.

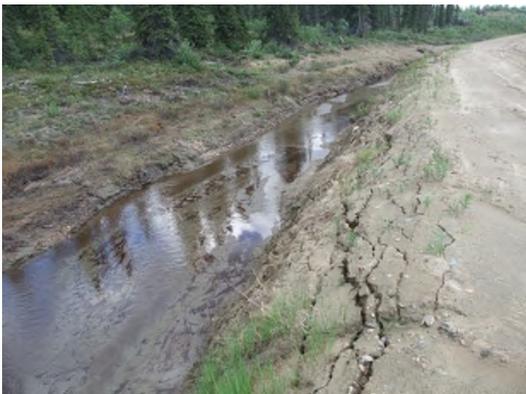
Photo 1: Oversteep ditch slope on Dome Creek Diversion (June 21/13)

The primary concern with these ditches is the effects of erosion on the toes of the banks that contribute to widening, grade flattening due to channel infill, and oversteep slopes during periods of high water flow. It was recommended that these slopes be flattened prior to the onset of winter.

As described in the report attached in Appendix B, these sideslopes were flattened by Boreal Engineering, under direction of YG-AAM on October 12, 2013.

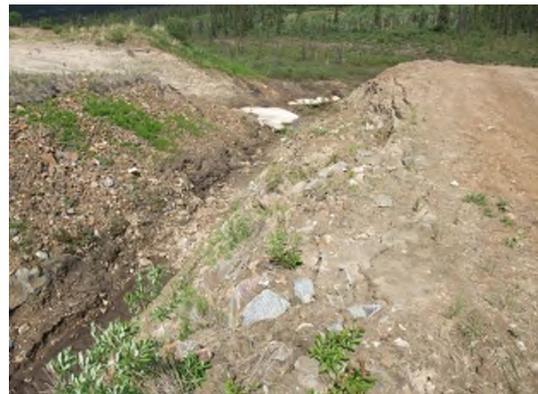
Photo 2: Oversteep ditch slope upstream of Dome Creek intersection (June 21/13)

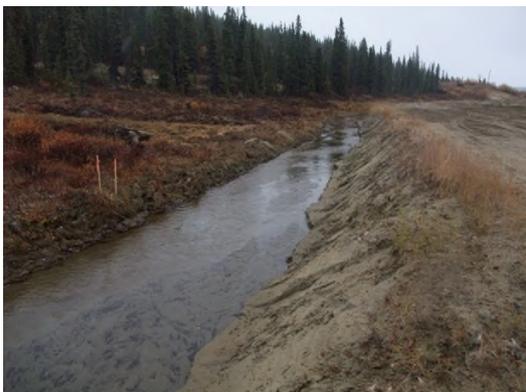
Photo 3: Naturally eroded ditch slope on Dome Creek Diversion (October 1/13)

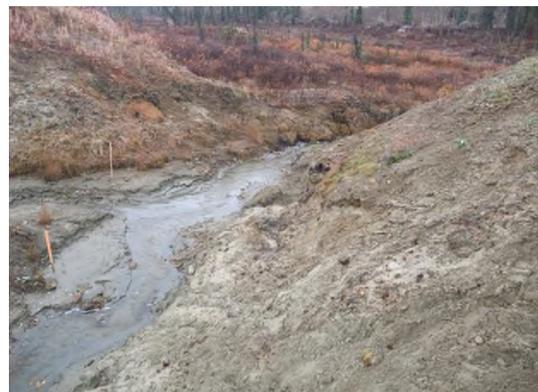
Photo 4: Naturally eroded ditch slope upstream of Dome Creek intersection (October 1/13)

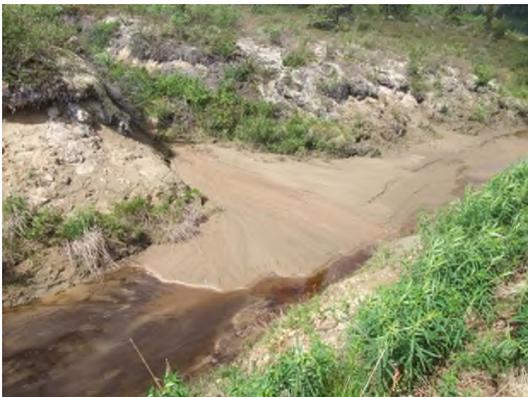
Erosion gullies from water entering the interceptor ditch were in the same condition as previous years, and should continue to be monitored. These small erosion gullies are significant contributors to sand and silt deposits in the diversion ditch. See Photos 5 and 6.

Photo 5: Sand deposits in channel bottom upstream of Dome Creek intersection (June 21/13)

It was recommended that some riprap be placed at this location to slow down the inflow of sand to the interceptor ditch. This work was completed by Denison Environmental Services on October 6, 2013 under the direction of YG-AAM. A summary of this work is also presented in the report in Appendix B.

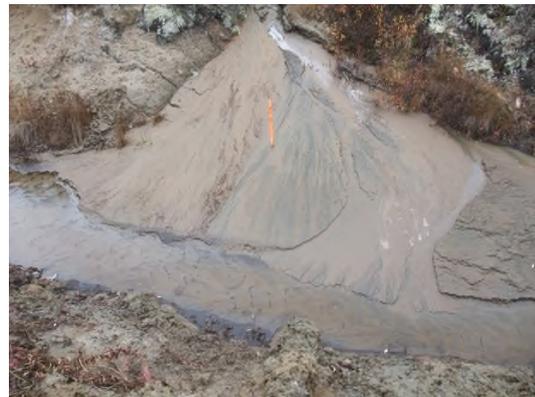
Photo 6: Sand deposits in channel bottom upstream of Dome Creek intersection (October 1/13)

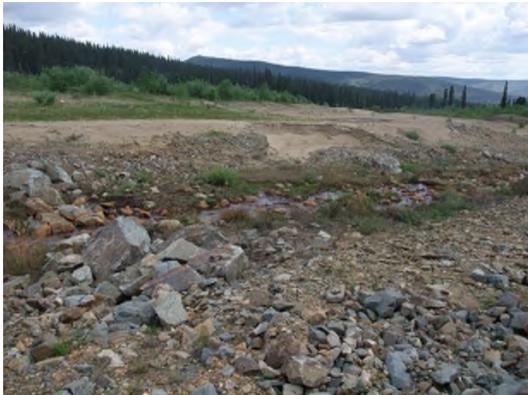
An item identified in the June 21 inspection that required immediate attention was a small erosion scar on the north side of the emergency spillway. It appears as though ice-damming during the winter of 2012/13 caused the channel to deflect into the north bank, overtopping the riprap and geotextile, and eroding the sand. Recommendations for repair were presented in the June 21/13 inspection report.

Photo 7: View of erosion scour on north side of spillway that must be repaired (June 21/13)

This work was essentially completed by the October 1 inspection, with the exception of additional riprap to be placed at the toe of the repair, closer to the water level in the diversion. This final repair work was completed by Denison Environmental Services on October 1, 2013 under the direction of YG-AAM. The report describing the repair is attached in Appendix C.

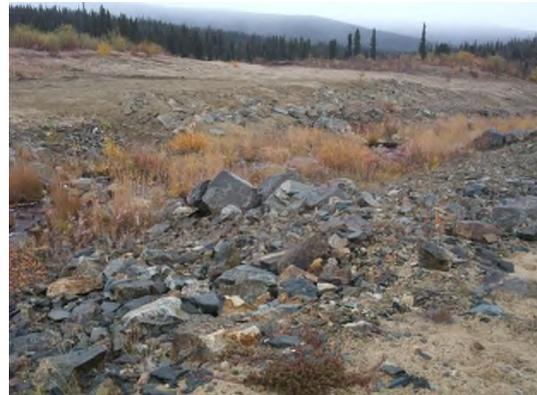
Photo 8: Completed repairs to erosion scour on north side of spillway (October 1/13)

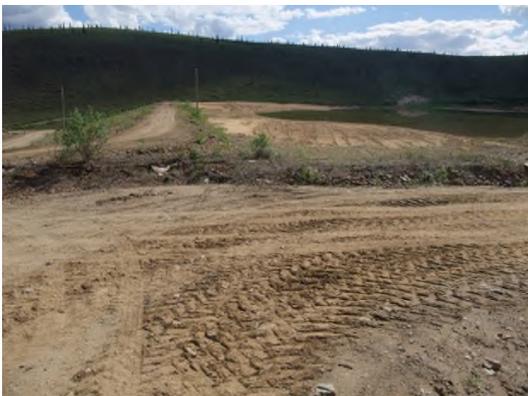
Photo 9: View to the south along crest of tailings dam (June 21/13)

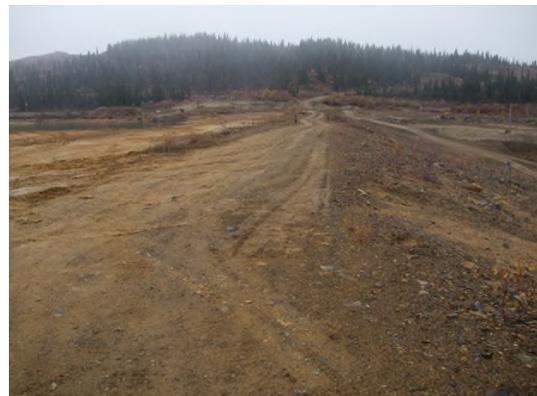
Photo 10: View to the north along crest of tailings dam (October 1/13)

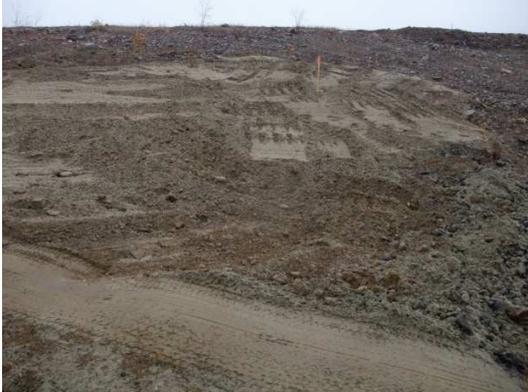
One item of concern noted in the October inspection was the condition of the backfilled testpits excavated by others on the dam surface. The backfilled areas contained no erosion protection and should be repaired.

Photo 11: View of backfilled testpit near crest of tailings dam (October 1/13)

This repair work was completed by Boreal Engineering, under the direction of YG-AAM on October 11, 2013, and is summarized in the report contained in Appendix D.

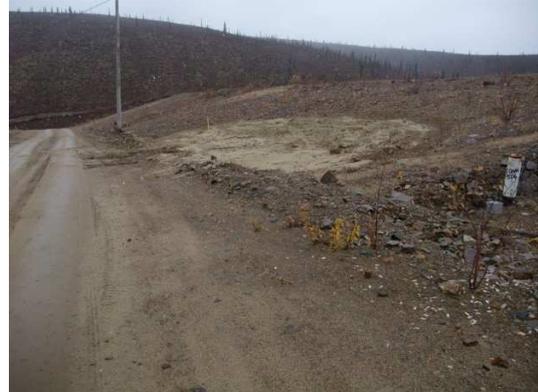
Photo 12: View of backfilled testpit near crest of tailings dam (October 1/13)

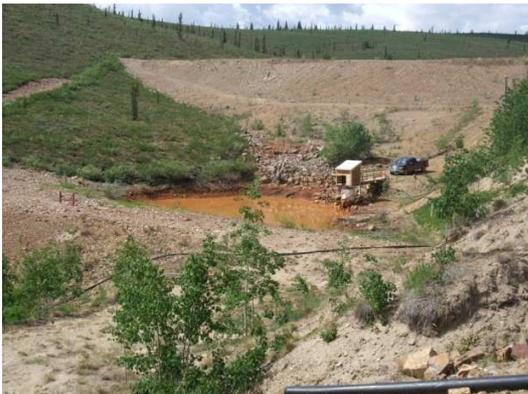
As previously arranged by YG-AAM, the water in the seepage collection pond had been “drawn down” as low as practically possible in the days before the inspection on June 21/13. This facilitated a better observation of several seepage zones that had been observed over the years – primarily from the toe of the tailings dam, and also from the north abutment. Based on these new observations, the seepages are still not considered to significantly affect dam stability.

Photo 11: View of Seepage Collection Pond – water level pumped down (June 21/13)

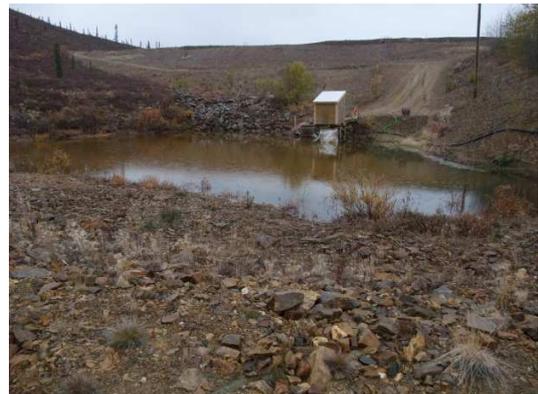
Photo 12: View of Seepage Collection Pond – normal operating water level (October 1/13)

The water level on October 1/13 was back to normal operating levels, with a reading of 0.5 m on the staff gauge that corresponds to an elevation of 1077.5 m. The Fall 2012 reading at this location indicated an elevation of 1077.3 m. For reference, the maximum operating level of this pond is 1078.1 m.

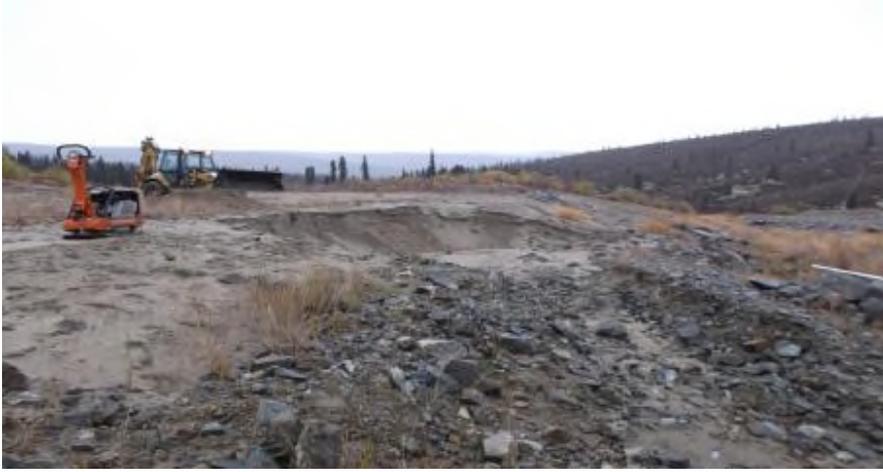
Figure 1: 2013-09-26 Erosion area before backfilling.

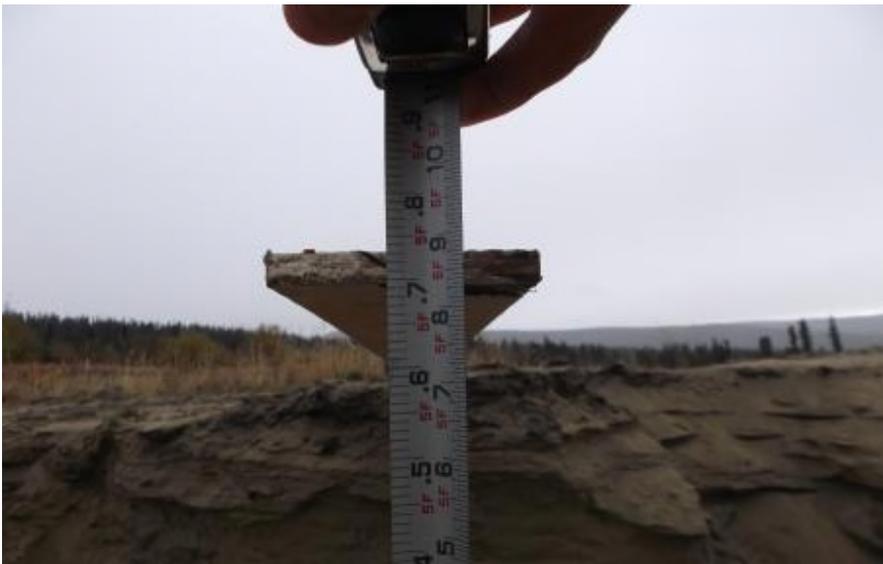
Before the backfilling of the erosion scar began, Jeff Moore measured the depth of the erosion scar. Measuring from the highest point on the bank to the bottom of the erosion scar, the height was approximately 69 inches, or 175.30 centimetres. According to the EBA recommendations, the sand that would be used for backfilling the erosion scar should be placed in 300mm lifts and then compacted between each lift. Using the 300 millimetre increments compared to the depth of the erosion scar, it should be filled with 6 lifts of sand. During the backfilling process, it took 9 lifts of sand to backfill the erosion scar and slope the area similar to the rest of the spillway.

Figure 2: 2013 09 26 Depth of erosion scar before backfilling.
