January 23, 2015

ISSUED FOR USE
FILE: W14103403-01
Via Email: josee.perron@gov.yk.ca

Subject: 2014 Annual Geotechnical Inspection Report on Earth Structures
Mount Nansen Site, YT

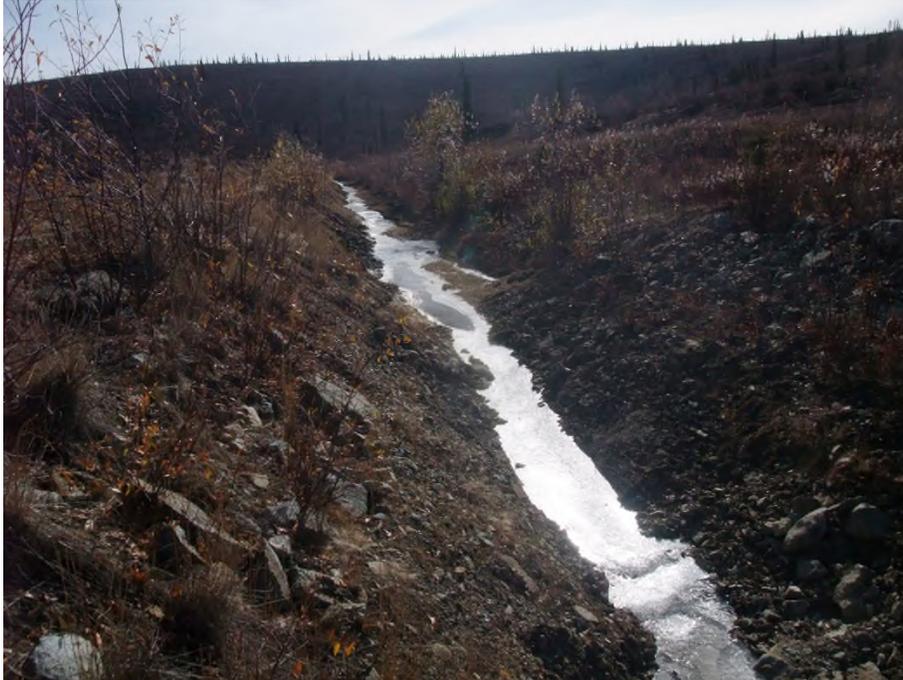
The ditches above and around the tailings pond, connecting to the combined spillway, were in similar conditions to previous years, although in September 2014 it was observed that there had been recent dredging to remove accumulated silt/sand in the base to improve winter flows, and the sideslopes had been flattened/re-contoured to a more stable condition. See photos below.

Photo 1: Interceptor ditch above Dome Creek – stable sideslopes (September 26/14)

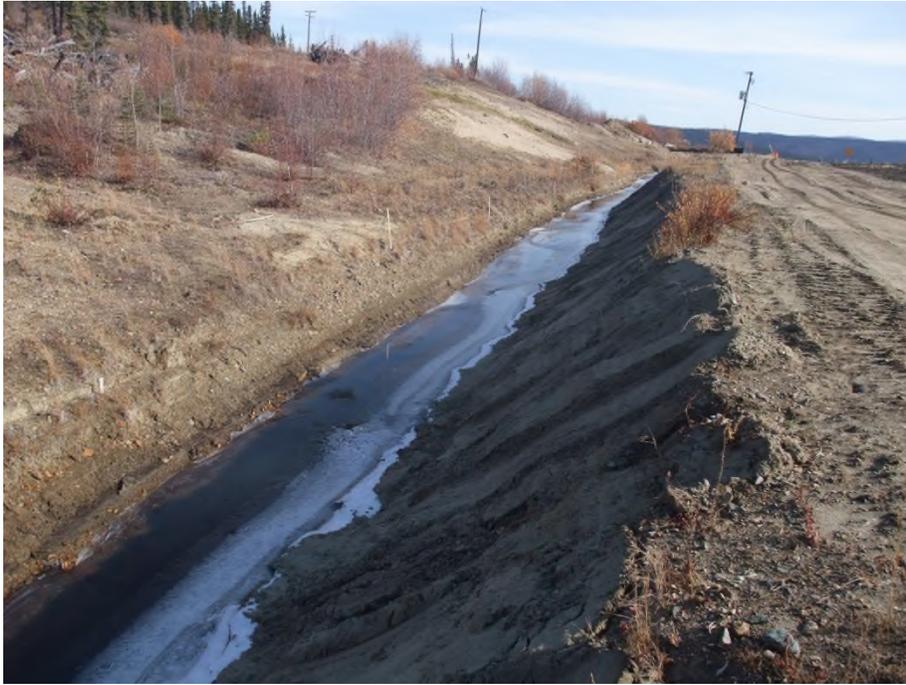
Erosion gullies from water entering the interceptor ditch were in the same condition as previous years, and should continue to be monitored. These small erosion gullies are significant contributors to sand and silt deposits in the diversion ditch. Previously recommended and subsequently implemented channel blocks using riprap were not entirely successful at containing the eroded sand. If monitoring and maintenance is not being provided, then a more permanent solution (geotextile placement) may have to be considered.

Photo 2: Re-contoured diversion ditch with stable sideslopes. (September 26/14)

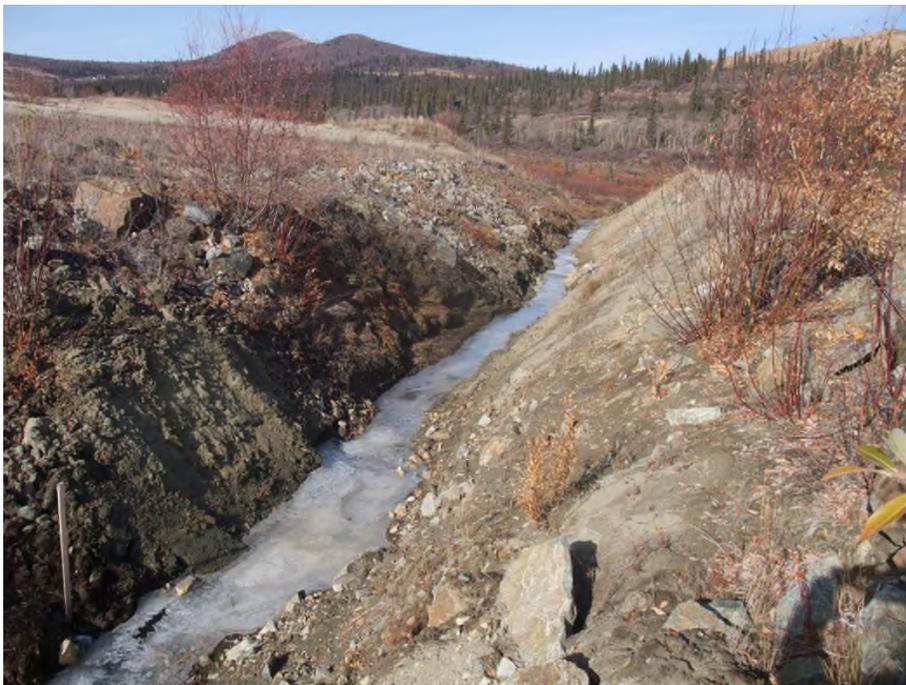
One area that has historically had oversteep slopes was the intersection of the interceptor ditch with Dome Creek. In September 2014, the sideslopes in this area were observed to have been flattened satisfactorily (see Photo 3, below).

Photo 3: Re-contoured and stable sideslopes at intersection with Dome Creek (September 26/14)

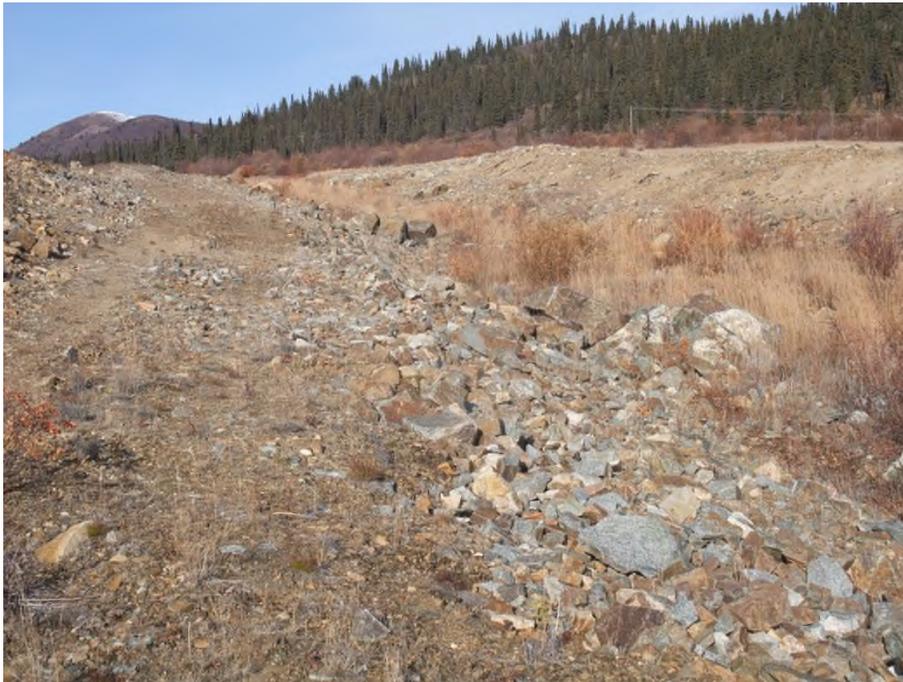
The combined emergency spillway/Dome Creek diversion channel was in a similar condition to previous years. The small erosion scar that was repaired in 2013 has blended in well with the rest of the channel.

Photo 4: View of stable emergency spillway with minor vegetation growth. The 2013 repair is located in upper centre of photo (September 26/14)

Woody vegetation (willows, etc.) that continue to grow in the combined emergency spillway channel may eventually have to be cut down if there is a potential for impeding the flow during flood events. Continued monitoring is recommended.

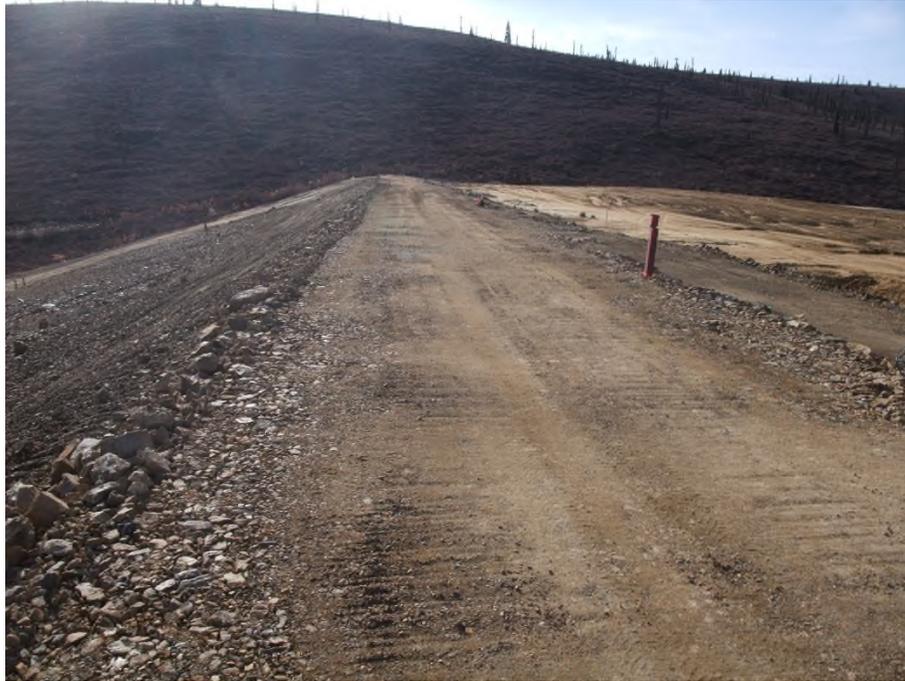
The tailings dam is considered stable in its present condition. Work completed in 2014 included levelling the crest of the dam to a uniform elevation of 1099.6 m, and installing four surface settlement monitoring points. Photo 5 shows the condition of the dam crest at the time of the inspection.

Photo 5: View of recently re-levelled crest of tailings dam looking south (September 26/14)

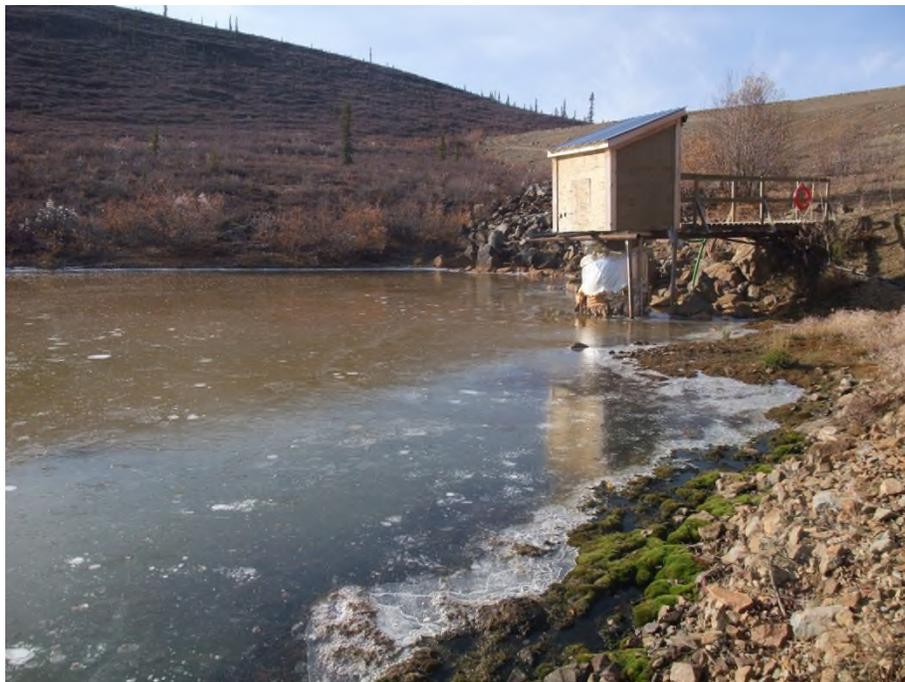
Some minor seepage was observed from the base of the riprap at the toe of the tailings dam, and from the north terrace at the seepage pond. Both of these seepage zones were observed as containing clear water, and are consistent in flow rates with that observed in previous years. Seeps at the downstream toe of the berm, as noted in previous years, were not observed during the September inspection.

Photo 6: View of seepage collection pond, with areas of minor seepage noted just above the green moss at lower right of photo. This seepage from the north abutment is consistent with that noted in previous years (September 26/14)

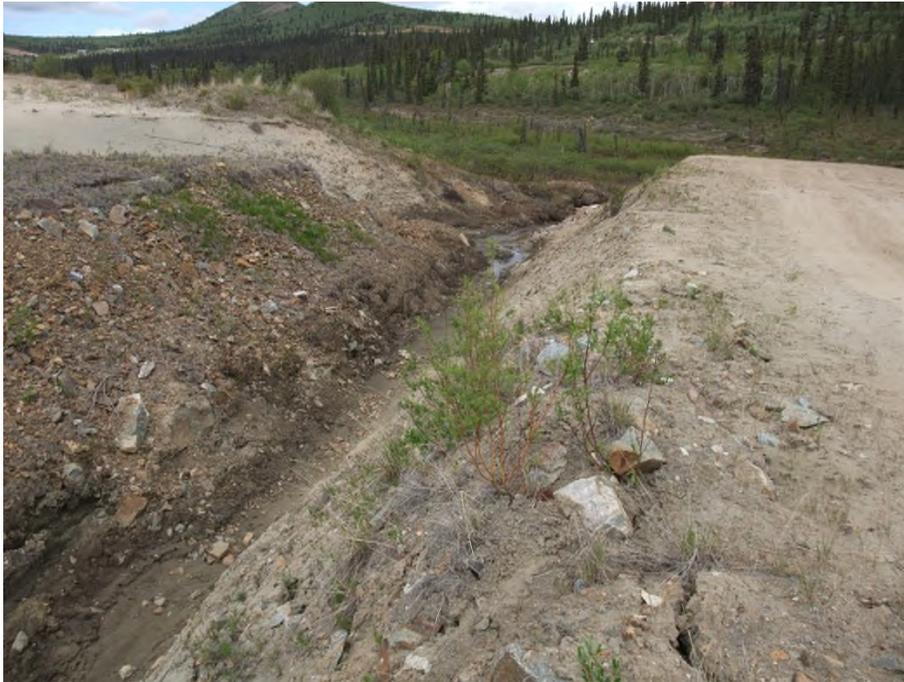
Photo 1:

Oversteep ditch slope just south of Dome Creek intersection (June 11/14)

During the June 2014 inspection, some oversteepening and potential instability was observed that should be repaired this year (see Photo 1). The east interceptor ditch slope upstream (south) of the intersection with Dome Creek, for about 30 m or so (estimate, field decision required), should be flattened to about 1.5:1 (cut about one metre out of the crest width) and the toe of the slope armoured to minimize the effects of oversteepening created by erosion at the toe. While on site, a survey stake with “0+377” was observed on the west slope of the interceptor ditch – the slope flattening and armouring should proceed from this stake, proceeding north to the intersection with Dome Creek. Care should be taken to maintain the width of the access road to be at least 6.0 m in this area. The excavated material from the upstream side could be re-used as fill on the downstream side to maintain the road width. Regarding armouring, the intent would be to salvage the existing armouring from this area and re-use it, and import acceptable riprap as required from other identified areas on the site.

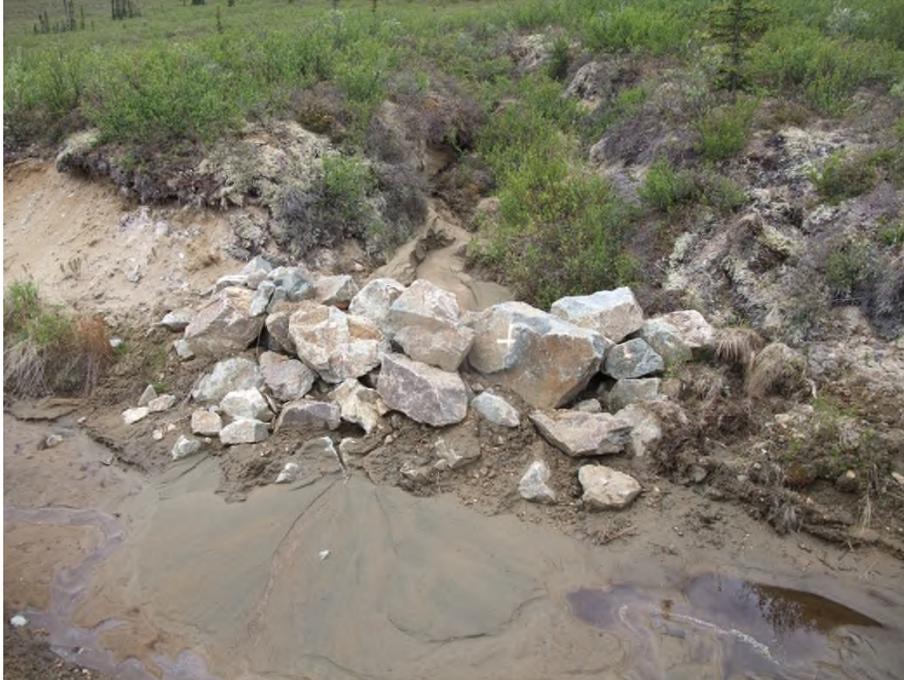
Photo 2:

Erosion gullies from water entering the interceptor ditch were in the same condition as previous years and should continue to be monitored. These small erosion gullies are probably significant contributors to sand and silt deposits in the diversion ditch. The placement of riprap recommended in 2013 has been completed (see Photo 2). This hasn't done much to minimize sand migration into the ditch, but does provide some stability to the sideslopes. If desired, a short section of geotextile "silt fence" or other alternate material could be placed on the upstream side of this riprap (and anchored with hand placed riprap) to trap and prevent sand from entering the interceptor ditch.

Armouring to minimize sand deposits in channel bottom upstream of Dome Creek intersection (June 11/14)

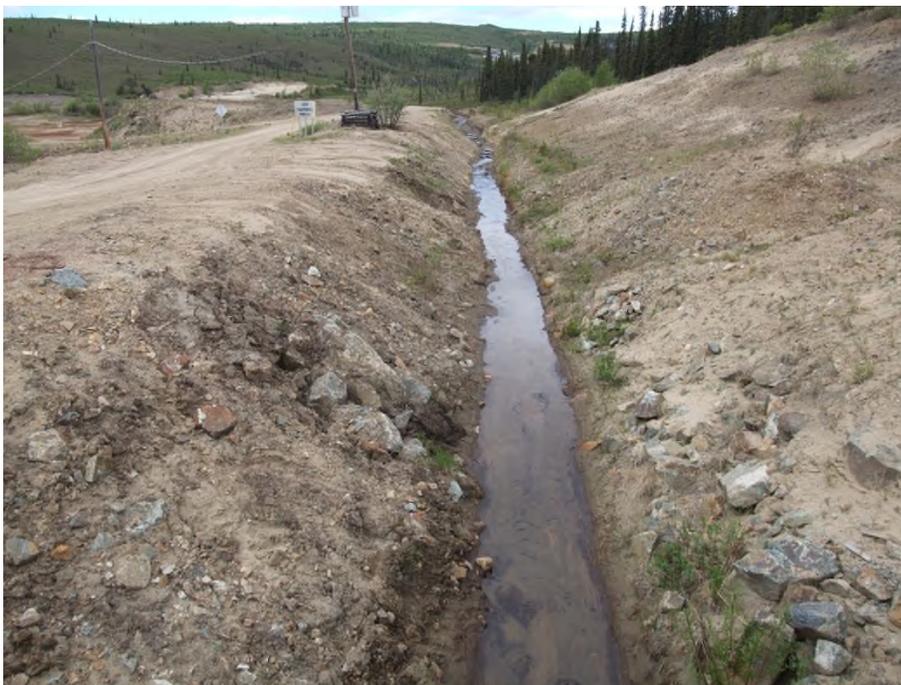
Photo 3:

The diversion ditch and spillway were in an acceptable and stable condition – no work is required at this time other than the regular maintenance. Photo 3 shows the typical condition of the diversion ditch and Photo 4 shows the emergency spillway below the tailings dam.

Typical condition of the Dome Creek diversion ditch (June 11/14)

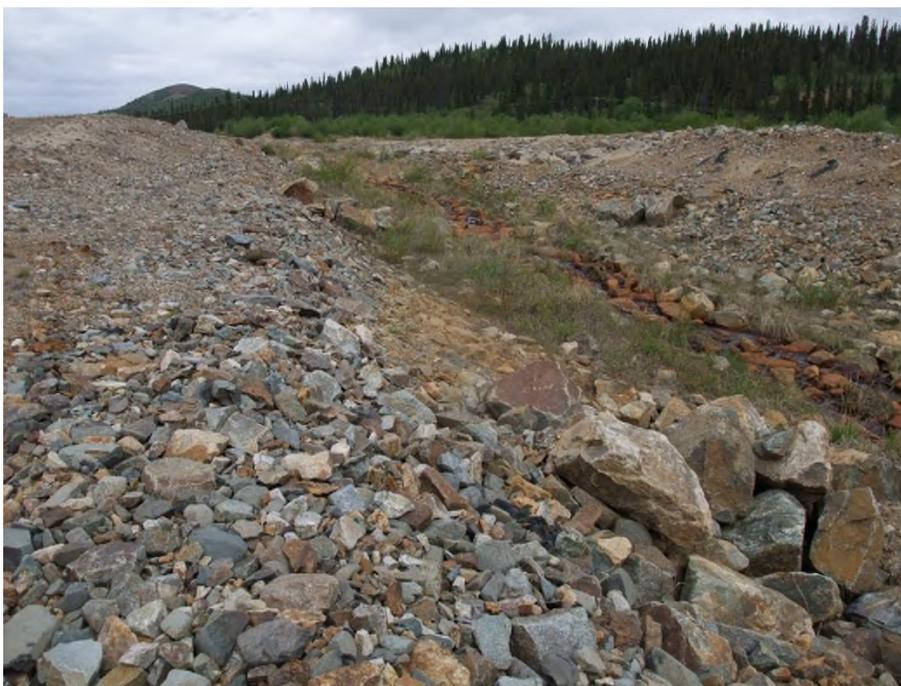
Photo 4:

The erosion scour noted in June 2013 had been repaired, as previously reported in the 2013 Annual Report.

Typical condition of the emergency spillway channel – last year's repair is in centre upper right of photo (June 11/14)

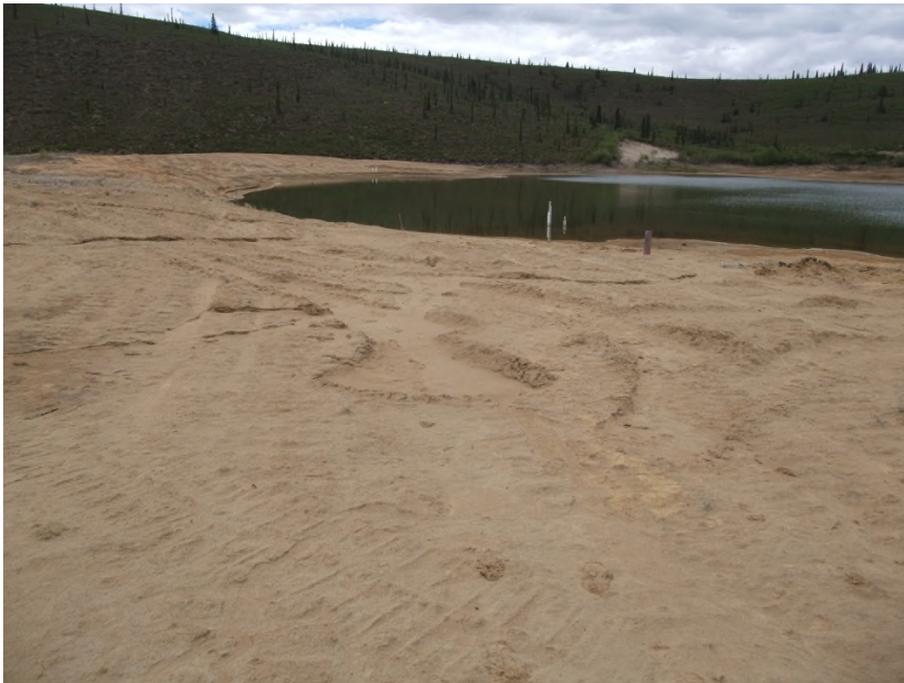
Photo 5:

View to the south along upstream face of tailings dam (June 11/14)

One item to be addressed is the woody vegetation that is growing near the crest on the upstream and downstream sides. All large and small woody vegetation should be removed (pulled out with roots) everywhere on the upstream face and within the top 10 m, as measured on the slope, on the downstream side. Do not disturb natural vegetation on the natural abutments.

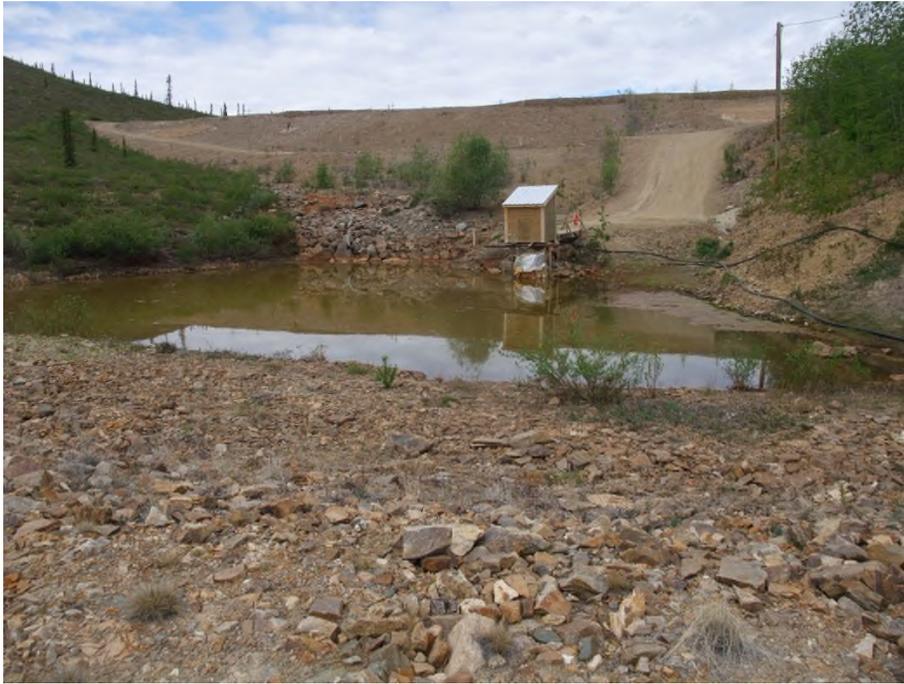
Photo 6:
View of Seepage Collection Pond (June 11/14).

The three minor seeps that have been noted in previous years on the downstream face of the dam were still present, but were observed as primarily wet spots on the ground surface, rather than actual seeps with flowing water. The other seeps flowing into the dam from the north abutment were also still observed, with clear water flowing – this is no cause for concern.

An item that needs to be addressed is the increased number of ground squirrel holes and burrows along the dam crest. There appears to be more of them this year than in previous years, and it is recommended that the ground squirrels be removed/relocated from the crest and their burrows backfilled. The concern is potential damage to the buried liner, as well as the creation of seepage paths if the water level in the pond was to increase.

All woody vegetation, including roots, should be removed from the crest of the dam and the upstream face, and within the top 5 m of the downstream face as measured on the face.

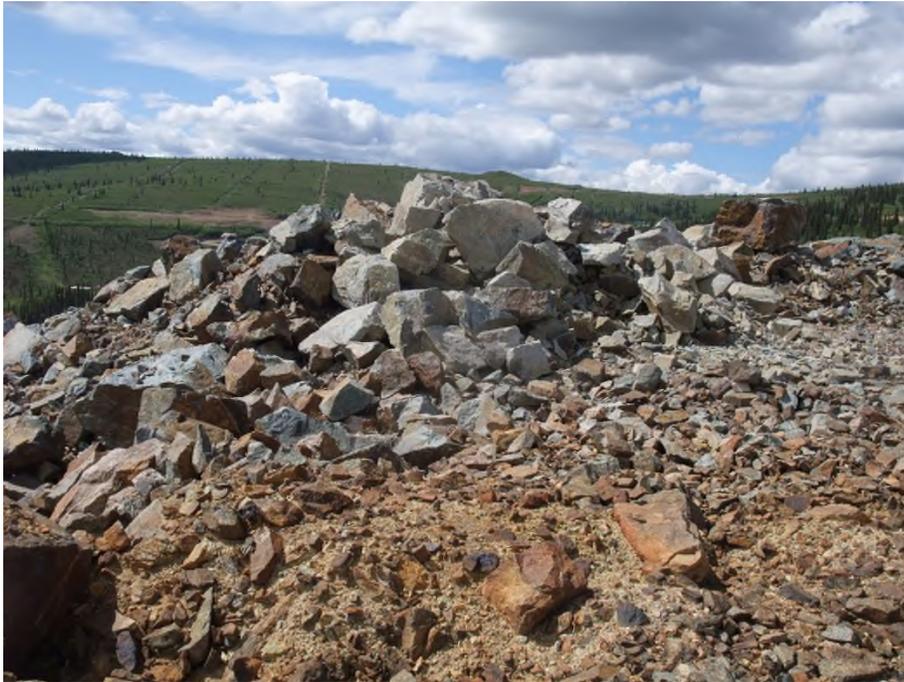
Photo 7:

It was noted by YG-AAM that more riprap is required for the ongoing care and maintenance of the site. Several stockpiles of potential riprap were located and examined while on site, and the acceptable rock pieces (greyish granite or granodiorite), based on the results of the 2013 ARD testing were noted for the YG-AAM personnel. These rock pieces will be acceptable for use as riprap provided they don't contain any oxidized materials, or sulphide inclusions.

View of acceptable riprap by open pit, including an enlargement (below) showing the best materials (June 11/14).

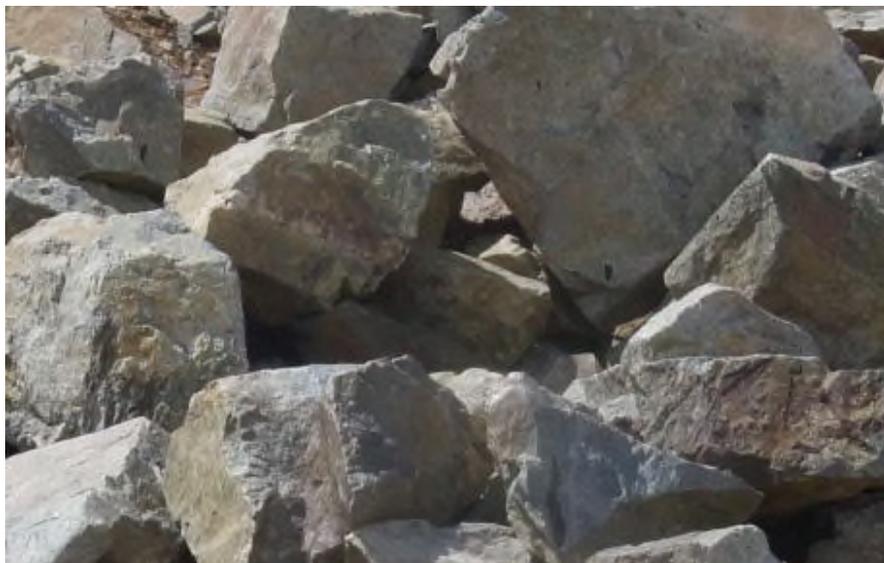
Photo 8:

Enlargement of a section of Photo 7 showing the best riprap materials to use (June 11/14).
