July 30, 2015

ISSUED FOR USE  
OUR FILE: W14103577-01

**Subject:** June 2015 Geotechnical Inspection of Earth Structures  
Mount Nansen Site, YT.

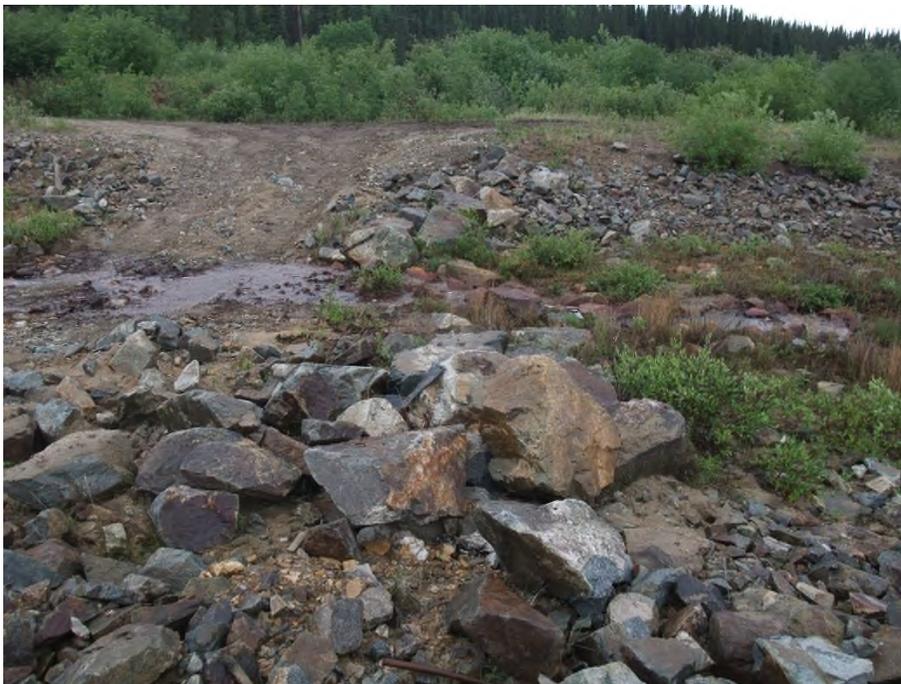
**Photo 4:**

One “velocity check” requires the addition of several boulders to maintain its effectiveness during periods of high flow. Photo 4 shows this area. It is understood that this work was completed shortly after the site visit, and will be reported by the author during the fall 2015 inspection.

Velocity check just below bridge requires the addition of several large boulders (in channel at centre of photo) to maintain its effectiveness during periods of high flow – looking north (June 11/15).

Item Description	Recommended Maintenance	Status
<b><u>June 2015 Recommendations</u></b>		
North Interceptor, Diversion Ditch and Emergency Spillway	Repair first “velocity check” below the bridge by adding several large riprap boulders to the centre of the channel.	To be completed in 2015
Tailings Dam	No work required.	n/a
Seepage Collection Dam	Monitor seepage zones from below riprap at toe of tailings dam, from base of north terrace, and at the three previously identified locations on the downstream face of the dam. If seepage volumes significantly increase from that observed, or if water becomes silty, notify a geotechnical engineer immediately.	On-going
	Continue to record pumping rates from seepage collection pond, and notify a geotechnical engineer if the rates significantly increase to maintain a constant water pond elevation.	On-going

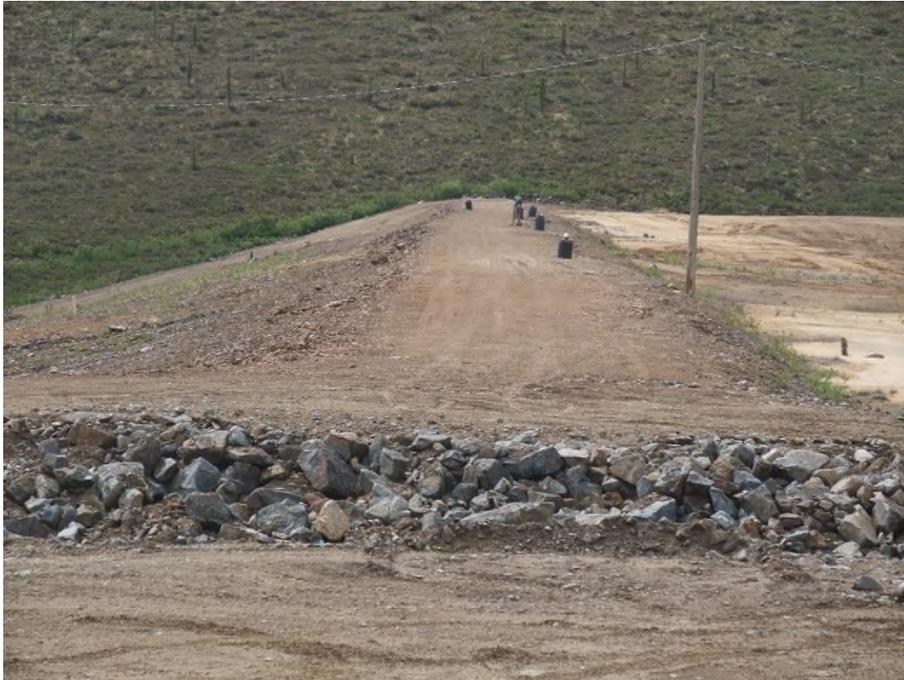
**Photo 5:**

The water level in the tailings pond was well below the maximum operating level elevation, and lower than has been noted in previous years. The dam itself is considered to be in a stable condition with a large upstream tailings beach. No evidence of previously noted instabilities or seepage on the north abutment was observed, and there were no signs of significant erosion or permafrost thaw features that could affect stability. The surface of the dam was flattened in 2014, and this has assisted in visual monitoring. Vegetation has been adequately removed from all locations noted in previous inspections.

View to the south along centerline of tailings dam (June 11/15)

The water in the pond was recorded at 1.07 m on the installed staff gauge(s) which corresponds to an elevation of 1095.20 m (per June 2015 elevation survey completed by YG-AAM). This places the water at about 2.60 m below the design “pond operating level” of 1097.80 m. With respect to geotechnical stability, low water levels are always good to see.
