November 18, 2015

ISSUED FOR USE  
FILE: W14103577-01  
Via Email: josee.perron@gov.yk.ca

**Subject:** 2015 Annual Geotechnical Inspection Report on Earth Structures  
Mount Nansen Site, YT

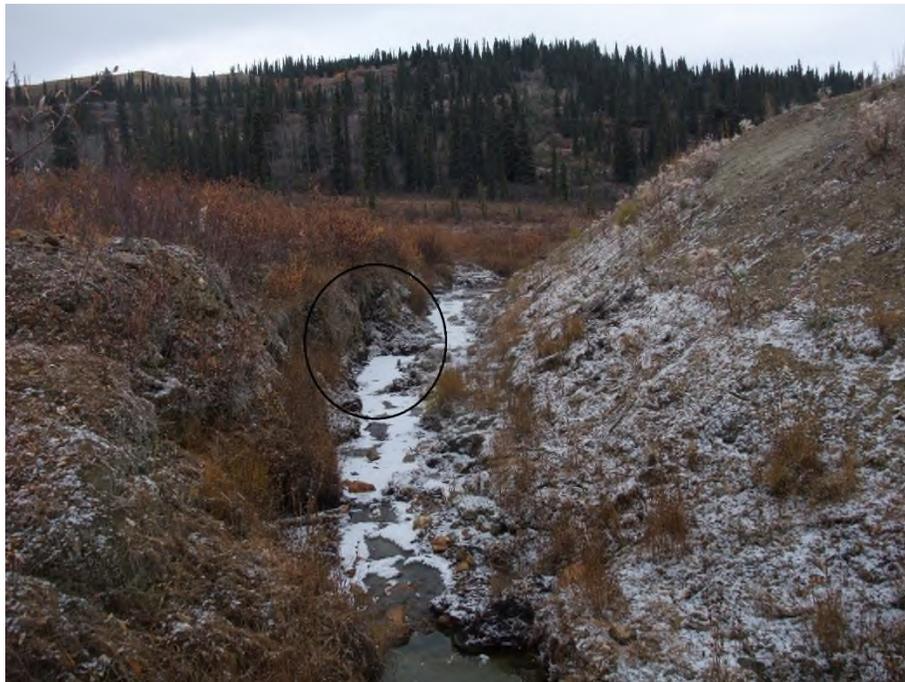
The ditches above and around the tailings pond, connecting to the combined spillway, were in similar conditions to previous year. In September 2015 it was observed that the previously completed dredging undertaken to remove accumulated silt/sand in the base to improve winter flows had lowered the grade of the ditch enough so that toe erosion on the left (west) side of the interceptor ditch above Dome Creek was observed (see Photo 1). Elsewhere, the slopes were acceptably flattened and in a stable condition. It is recommended that future winter ice removal be completed so that the base of the ditch is not lowered any further. This section of ditch should be re-examined in the spring to see if conditions have stabilized. – If not, the placement of riprap may be required to stabilize the toe of the slope on the west side.

**Photo 1:** Interceptor ditch above Dome Creek (looking downstream)– stable sideslopes on right side of ditch, but locally undercut (see circled area) on left side (September 24/15)

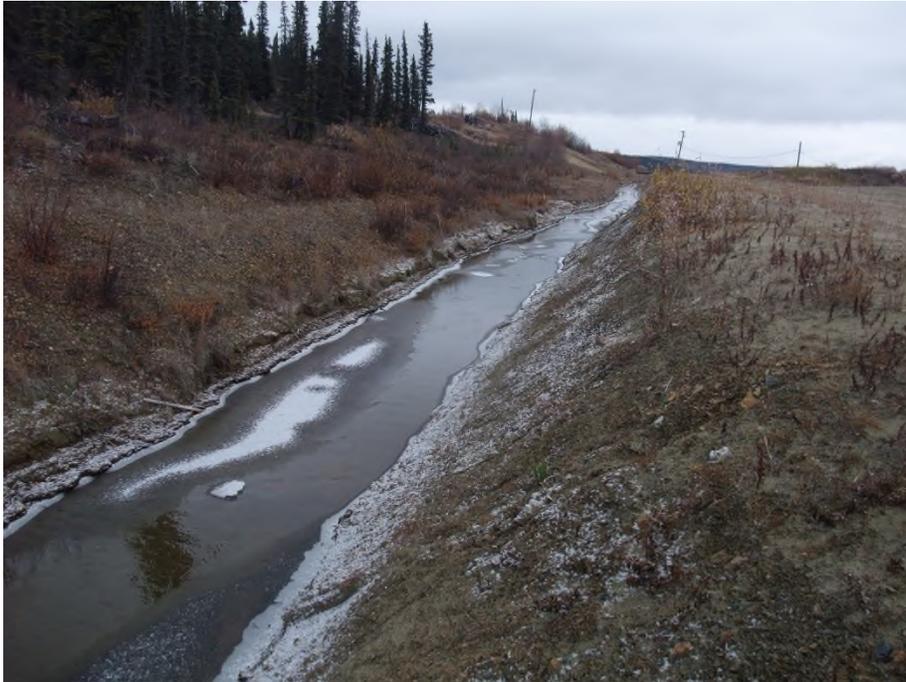
Photo 2, below, shows the stable condition of the diversion ditch downstream of the Dome Creek intersection.

**Photo 2:** Re-contoured Diversion Ditch with stable sideslopes, looking downstream (September 24/15)

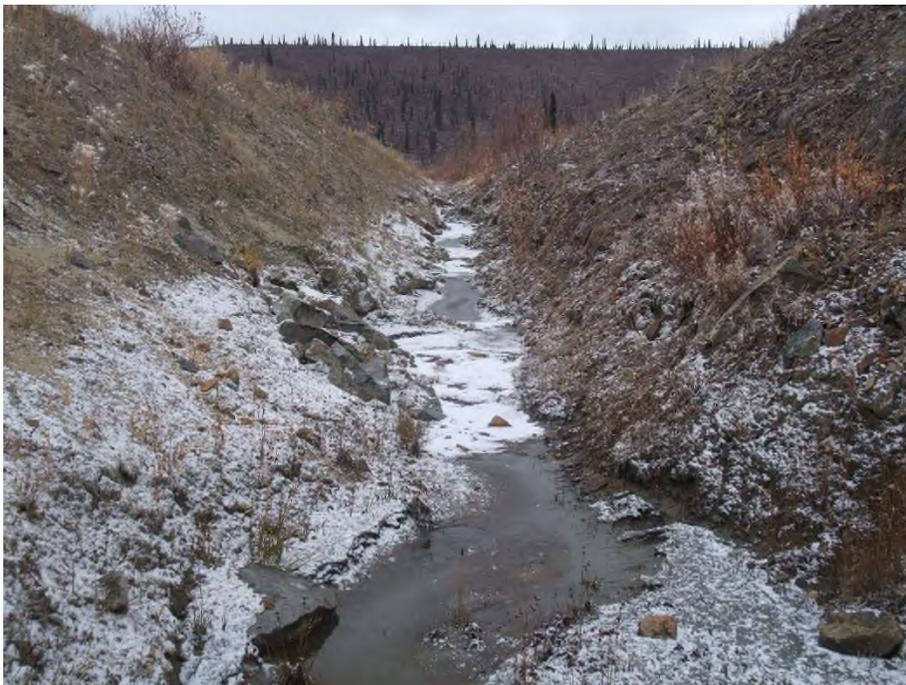
One area that has historically had oversteep slopes was immediately above and below the intersection of the interceptor ditch with Dome Creek and the Diversion Ditch. In September 2015, the sideslopes in this area were observed to have been flattened satisfactorily (see Photo 3, below).

**Photo 3:** Looking upstream at the re-contoured and stable sideslopes of Interceptor Ditch near intersection with Dome Creek and Diversion Ditch (September 24/15)

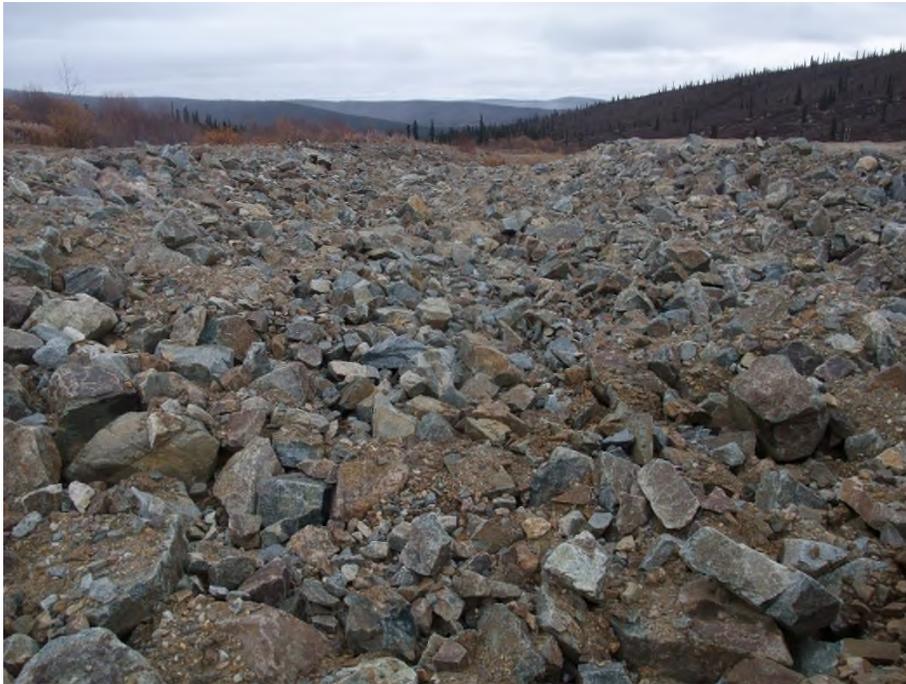
The combined emergency spillway/Dome Creek diversion channel was in a similar condition to previous years. Work that was completed in 2014 on the outlet from the tailings pond has created a stable configuration that is adequate to carry the design flows.

**Photo 4:** View of stable emergency spillway upstream of combined channel (September 24/15)

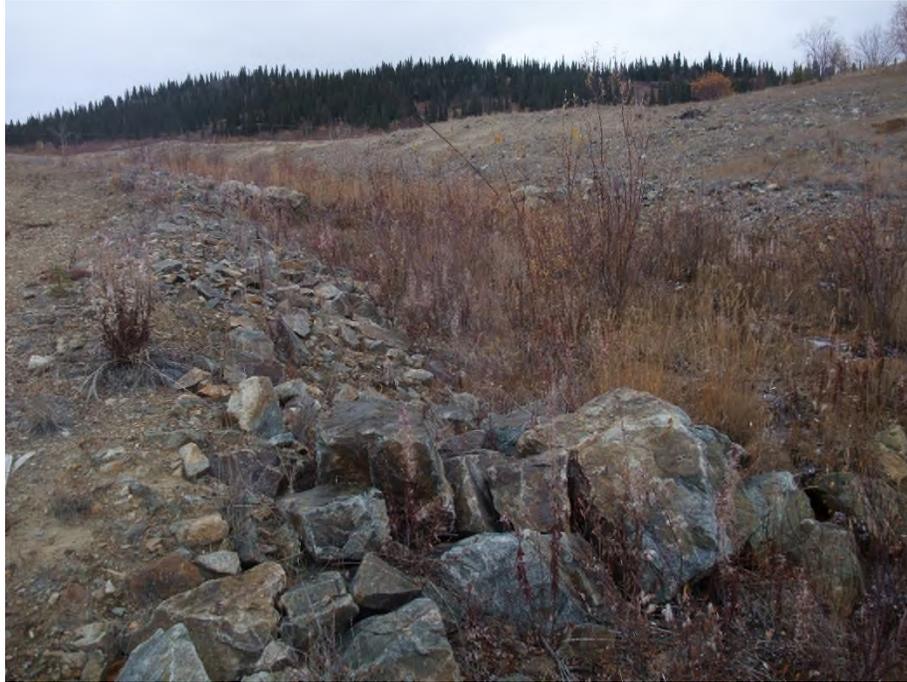
**Photo 5:** Willow and vegetation growth in the lower portion of combined emergency spillway and diversion channel (September 24/15)

Some minor woody vegetation (willows, etc.) was growing in the combined emergency spillway channel further downstream. This should continue to be monitored and the vegetation will eventually have to be cut down if there is a potential for impeding water flow during flood events.

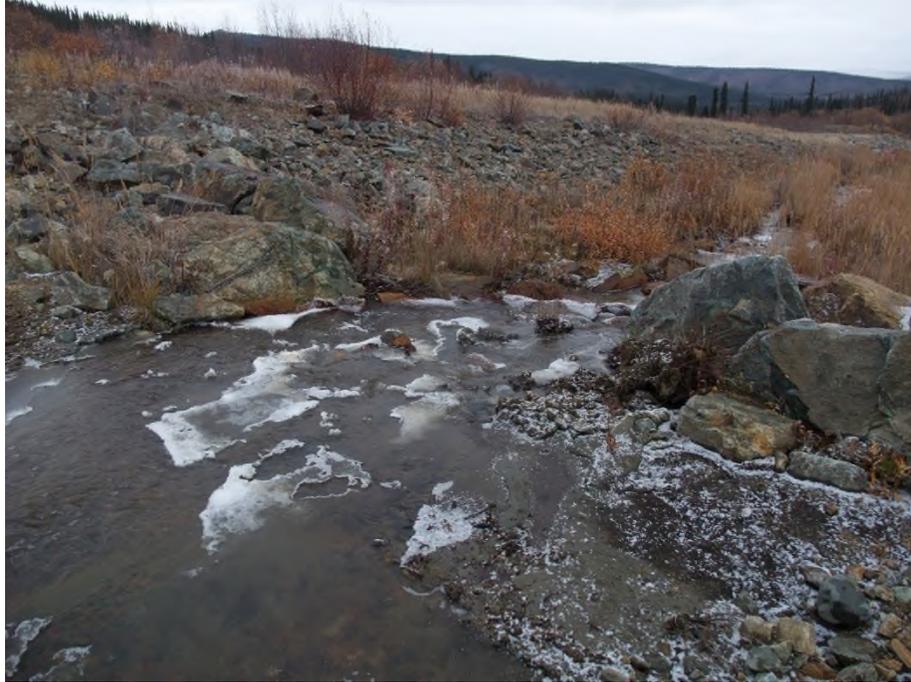
The upper velocity check dam was observed to contain a section of missing riprap. It was recommended that this area be reconstructed to the design intent by placing/moving several boulders into the centre of the channel.

**Photo 6:** First velocity check dam in combined spillway diversion channel – add large boulders to fill the gap for effective water velocity control (September 24/15)

Immediately after the fall inspection, it is understood that this work was completed by site operations – this will be examined during the next inspection -- photographs supplied by YG-AAM indicate that the work was completed satisfactorily.

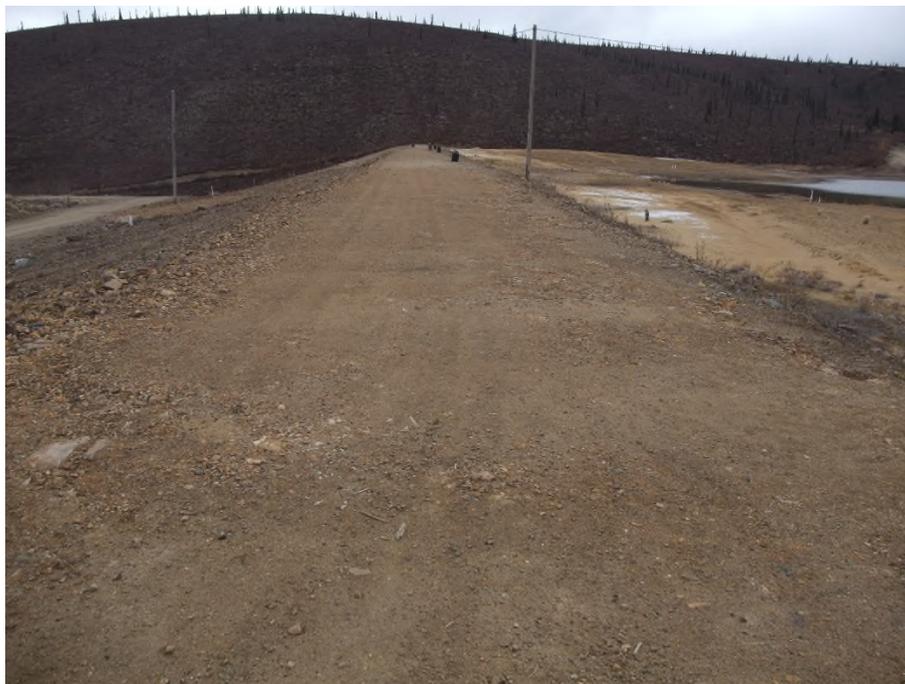
The tailings dam is considered stable in its present condition and no concerns are noted.

**Photo 7:** View of the level crest of tailings dam looking south (September 26/14)

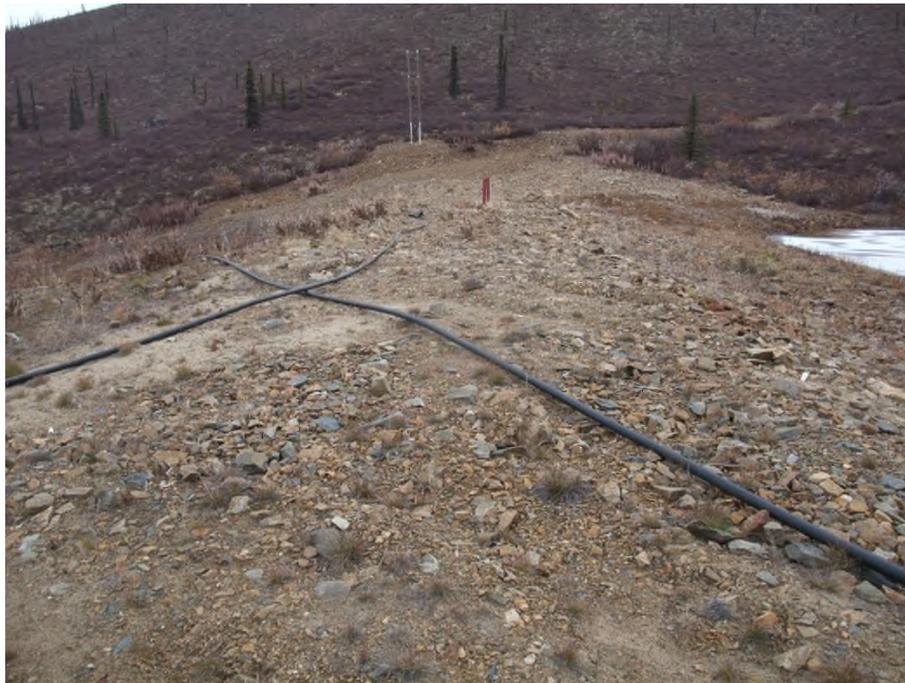
The removal of woody vegetation, and the clearing of ground squirrel burrows that had been previously recommended has been satisfactorily completed.

**Photo 8:** View (looking south) of seepage collection dam crest showing stable condition (September 24/15)

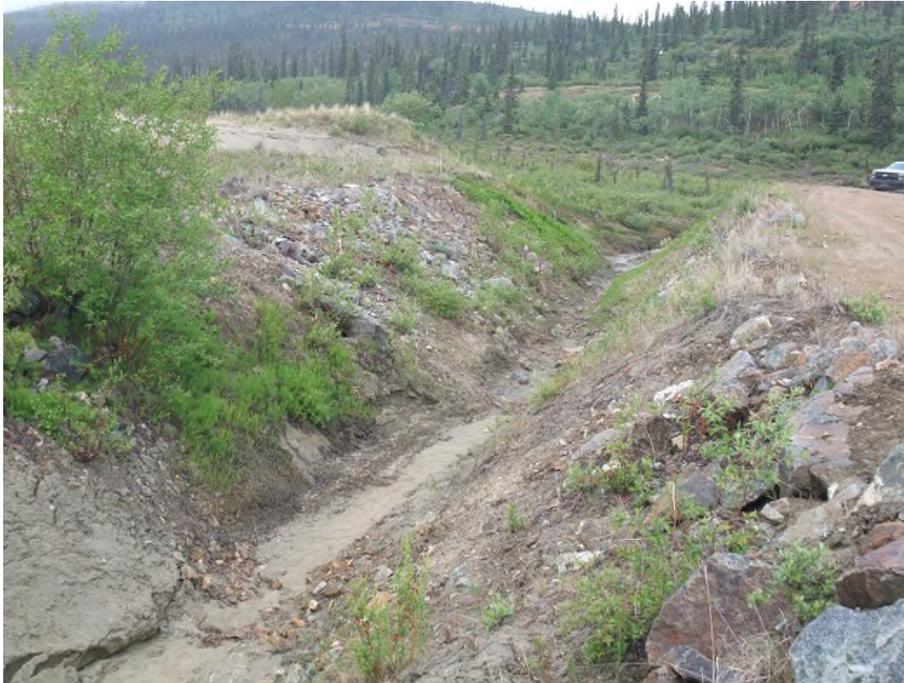
**Photo 1:**

Stable ditch slopes just south of Dome Creek intersection, looking downstream (June 11/15)

For all maintenance activities, care should be taken to maintain the width of the access road to be at least 6 m in this area. The excavated material from the upstream side could be re-used as fill on the downstream side to maintain the road width.

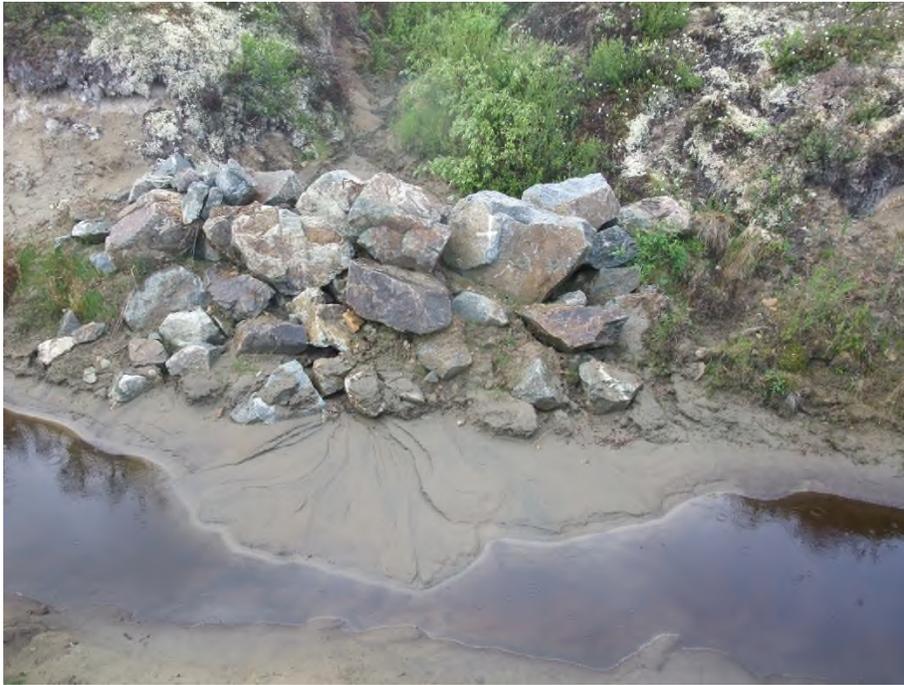
**Photo 2:**

Erosion gullies from water entering the interceptor ditch were in the same condition as previous years and should continue to be monitored. These small erosion gullies are significant contributors to sand and silt deposits in the diversion ditch. Riprap has been placed at all these gullies, as previously recommended (see Photo 2). This hasn't been entirely effective in minimizing sand migration into the ditch, but does provide some stability to the sideslopes at these locations. A complete sand/silt barrier at these locations would require additional annual maintenance to clean out materials on the other side of the ditch, which is not considered necessary at this time.

Armouring to minimize sand deposition from contributory gullies into channel bottom upstream of Dome Creek intersection looking west (June 11/15)

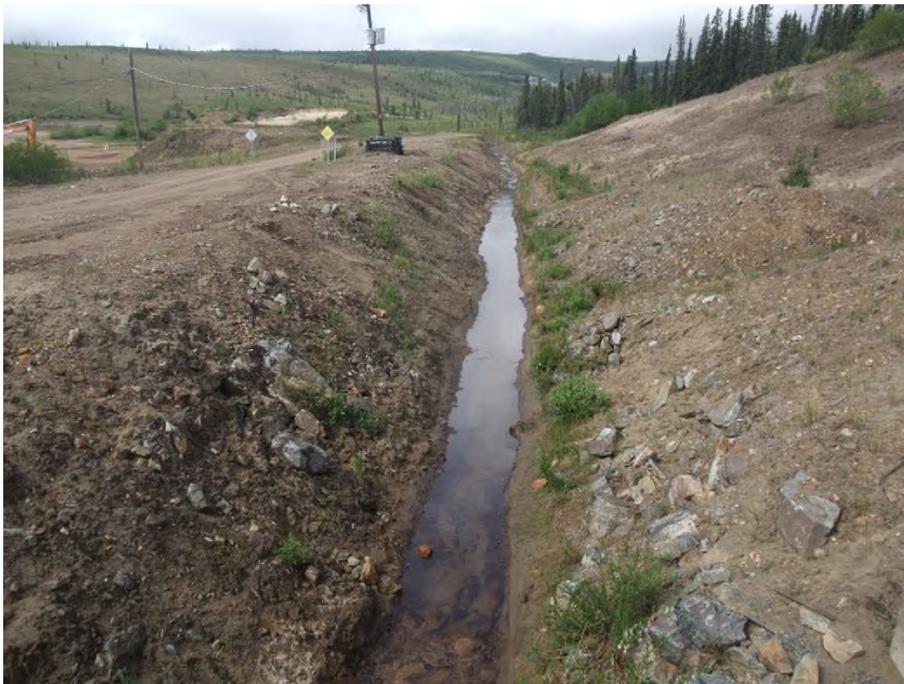
The diversion ditch was in an acceptable and stable condition – no work is required at this time other than regular maintenance to remove silt/sand in the spring and fall of each year, as required to maintain flow and sideslope stability. Photo 3 shows the typical condition of the diversion ditch.

**Photo 3:** Typical condition of the Dome Creek diversion ditch looking upstream (June 11/15)

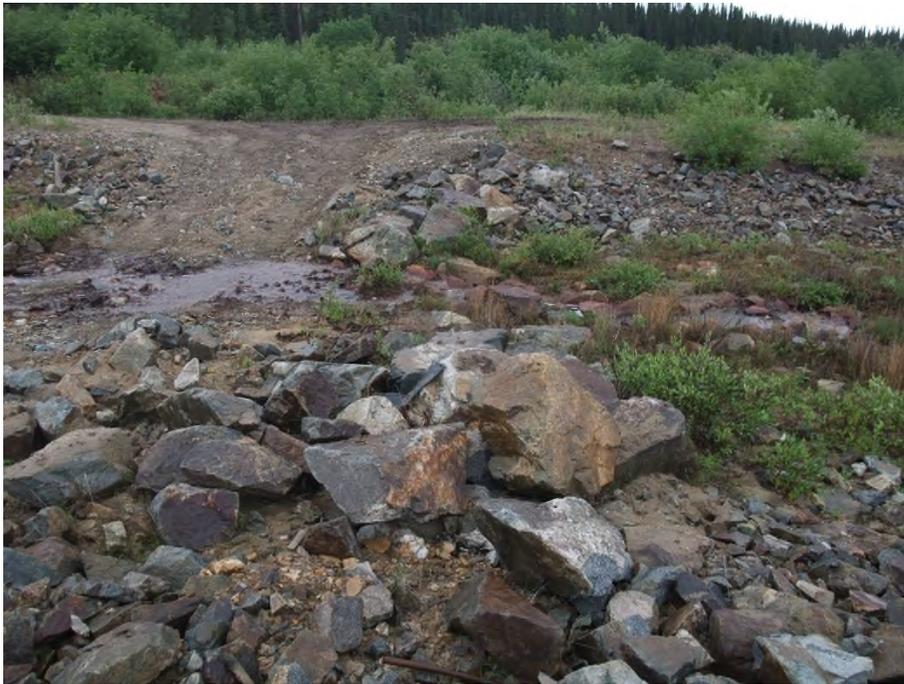
**Photo 4:**

One “velocity check” requires the addition of several boulders to maintain its effectiveness during periods of high flow. Photo 4 shows this area. It is understood that this work was completed shortly after the site visit, and will be reported by the author during the fall 2015 inspection.

Velocity check just below bridge requires the addition of several large boulders (in channel at centre of photo) to maintain its effectiveness during periods of high flow – looking north (June 11/15).

| Item Description | Recommended Maintenance | Status |
|---|--|---|
| North Interceptor, Diversion Ditch and Emergency Spillway | Repair first “velocity check” below the bridge by adding several large riprap boulders to the centre of the channel. | To be completed in 2015 |

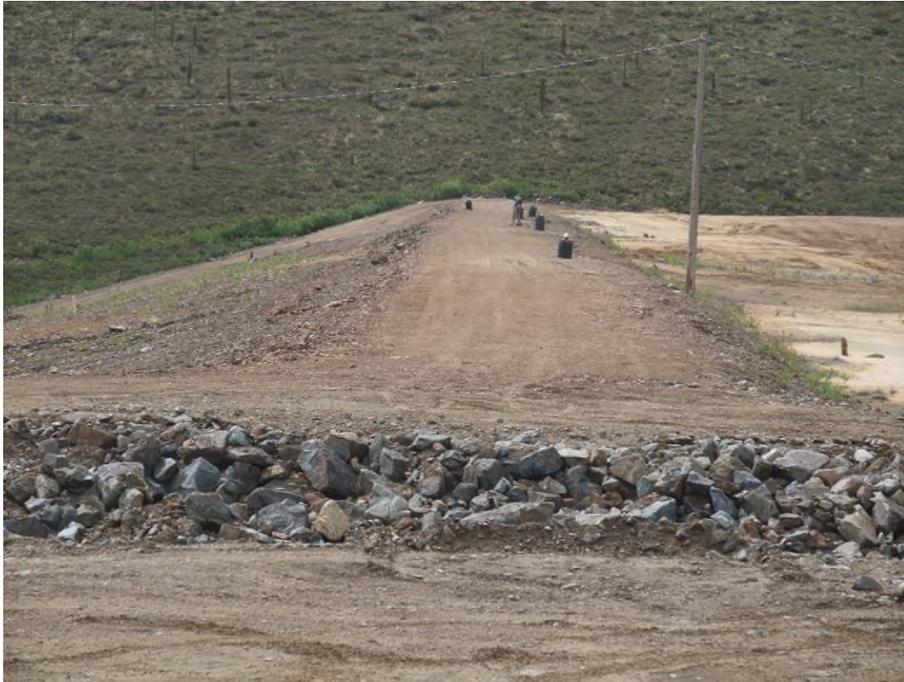
**Photo 5:**

The water level in the tailings pond was well below the maximum operating level elevation, and lower than has been noted in previous years. The dam itself is considered to be in a stable condition with a large upstream tailings beach. No evidence of previously noted instabilities or seepage on the north abutment was observed, and there were no signs of significant erosion or permafrost thaw features that could affect stability. The surface of the dam was flattened in 2014, and this has assisted in visual monitoring. Vegetation has been adequately removed from all locations noted in previous inspections.

View to the south along centerline of tailings dam (June 11/15)

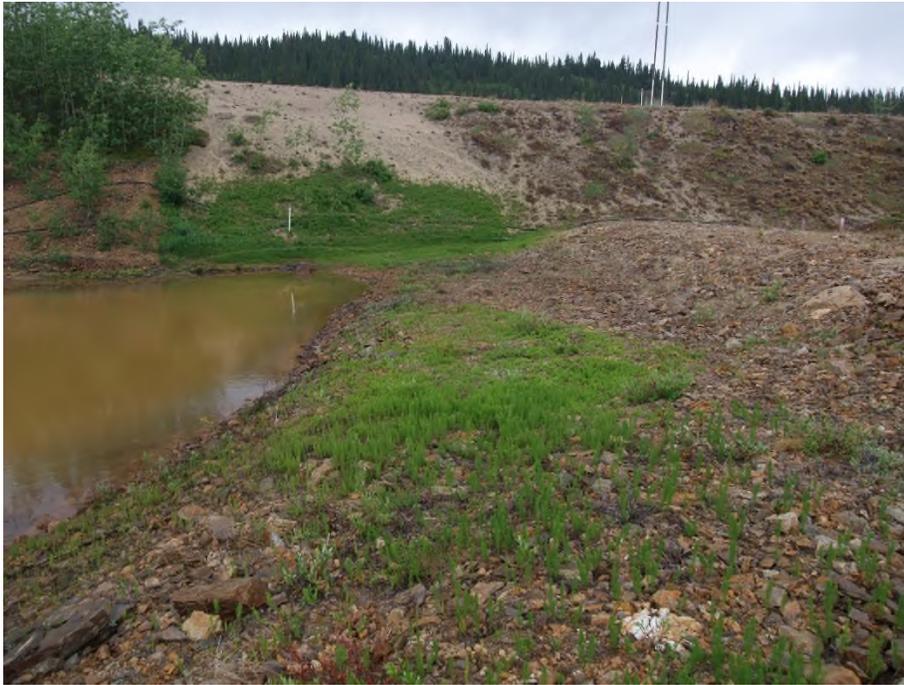
**Photo 6:**

The water in the seepage collection pond was recorded at a level of 0.19 m on the staff gauge, and the pumping rate was 161 L/min at the time of the inspection. This pond elevation is close to the usual operating level of the pond over the past year, and according to the onsite maintenance personnel, it is necessary to pump at varying rates over the year to keep it at about this level. The corresponding elevation for the staff gauge reading is about 1077.09 m (per June 2015 elevation survey completed by YG-AAM) or about 1.01 m below the design operating level of 1078.10 m. Photo 6 shows the berm and edge of the pond at the time of the inspection.

View of Seepage Collection Pond berm, looking north (June 11/15).
