July 22, 2016

ISSUED FOR USE
OUR FILE: ENG.WARC03063-01

Subject: May 2016 Geotechnical Inspection of Earth Structures
Mount Nansen Site, YT.

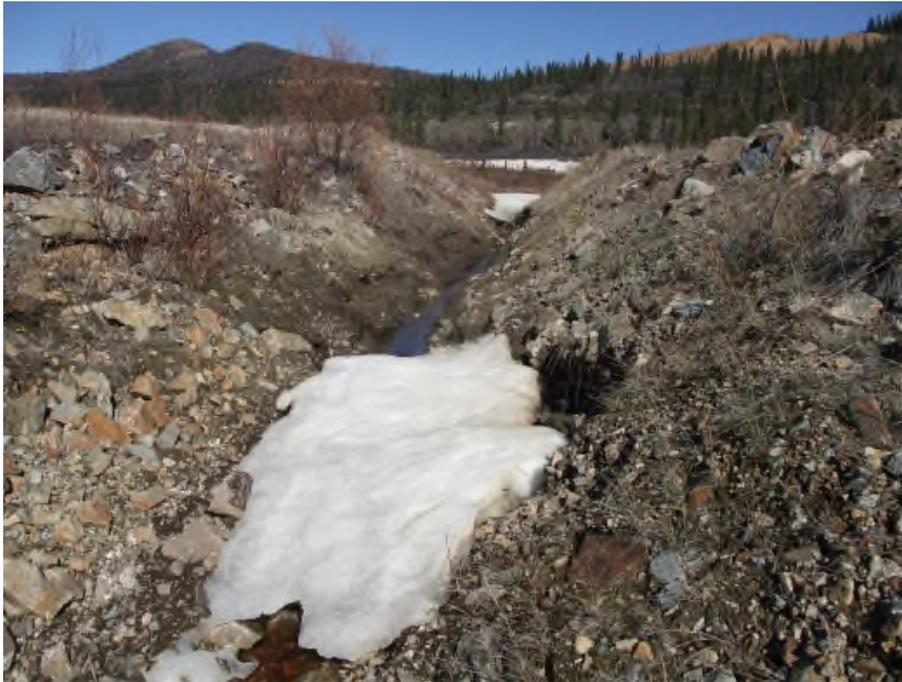
Photo 1:

The ditches above and around the tailings pond, connecting to the emergency spillway are intended to keep runoff water out of the tailings area, and were generally in a similar condition to that observed in previous years. Site personnel indicated that there was minimal ice excavation and cleanout required to keep the ditch flowing over the previous winter. Some evidence of toe erosion by water flow was observed, but not significant --see Photos below.

Interceptor ditch slopes just south of Dome Creek intersection, looking downstream. Undercut slope toes are evident between the two snow patches in about centre of photo (May 13/16)

The primary concern with these ditches is over-steepening of the slopes caused by erosion at the toes of the banks – this will have to be monitored and corrective actions taken when tension cracks are observed at the access road elevation at the crest of the slope. This might normally occur during spring runoff or after large rainfall events. The corrective actions should include flattening the slopes to 1.5:1 and possible riprap placement at the toe of the slope to minimize this over-steepening.

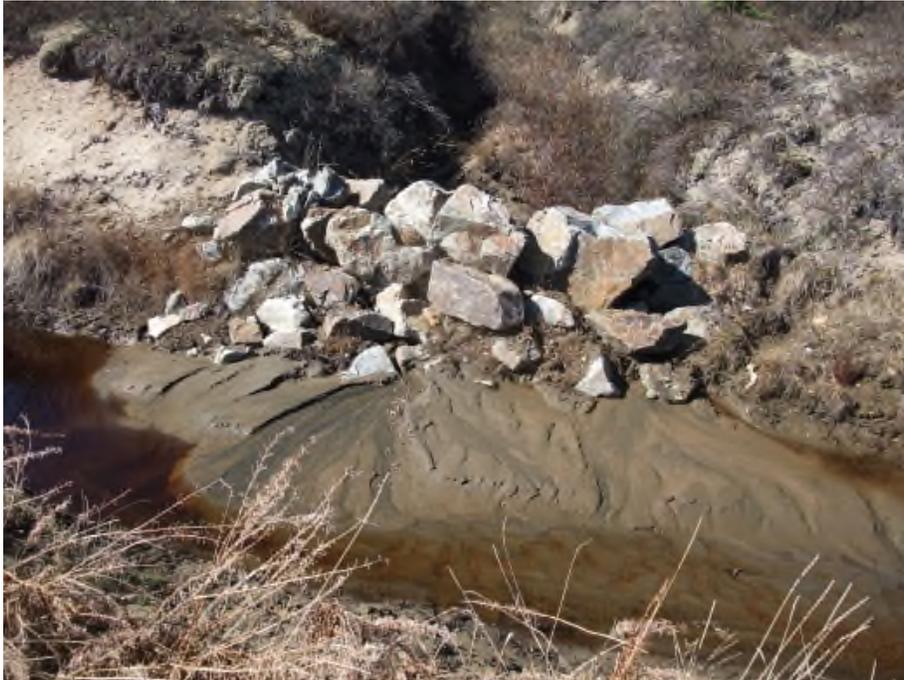
Photo 2:

Erosion gullies from water entering the interceptor ditch were in the same condition as previous years and should continue to be monitored. These small erosion gullies are significant contributors to sand and silt deposits in the diversion ditch. Riprap has been placed at all these gullies, as previously recommended (see Photo 2). This hasn't been entirely effective in minimizing sand migration into the ditch, but does provide some stability to the

Armouring to minimize sand deposition from contributory gullies into channel bottom upstream of Dome Creek intersection looking west (May 13/16)

It is understood that these sand/silt deposits have been cleaned out with a backhoe over the past year, to maintain flow in the ditches. This practice should be continued.

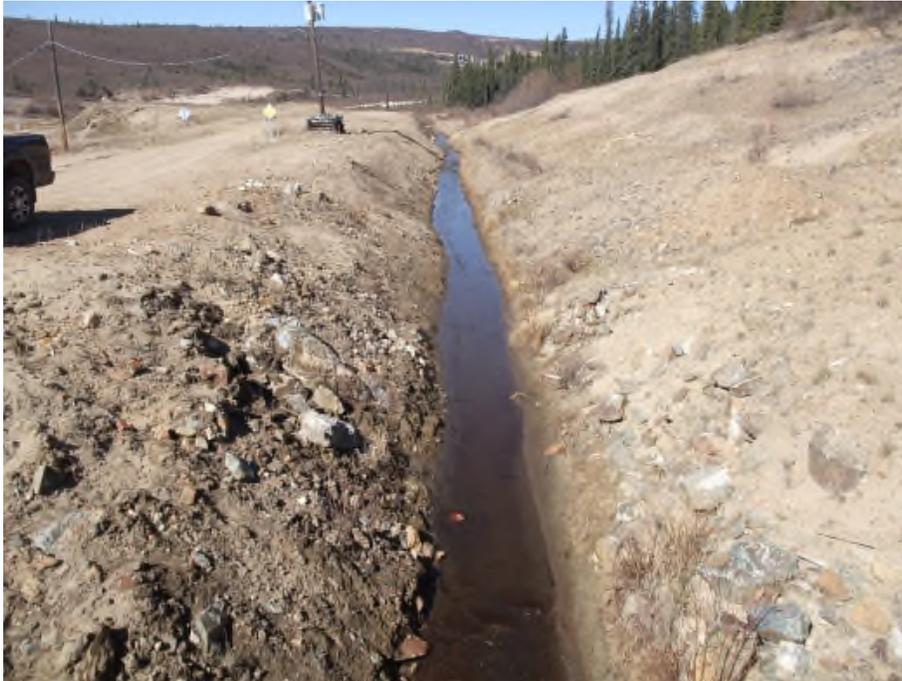
The diversion ditch was in an acceptable and stable condition – no work is required at this time other than regular maintenance to remove silt/sand in the spring and fall of each year, as required to maintain flow and side slope stability. Photo 3 shows the typical condition of the diversion ditch.

Photo 3:
Typical condition of the Dome Creek diversion ditch looking upstream (May 13/16)

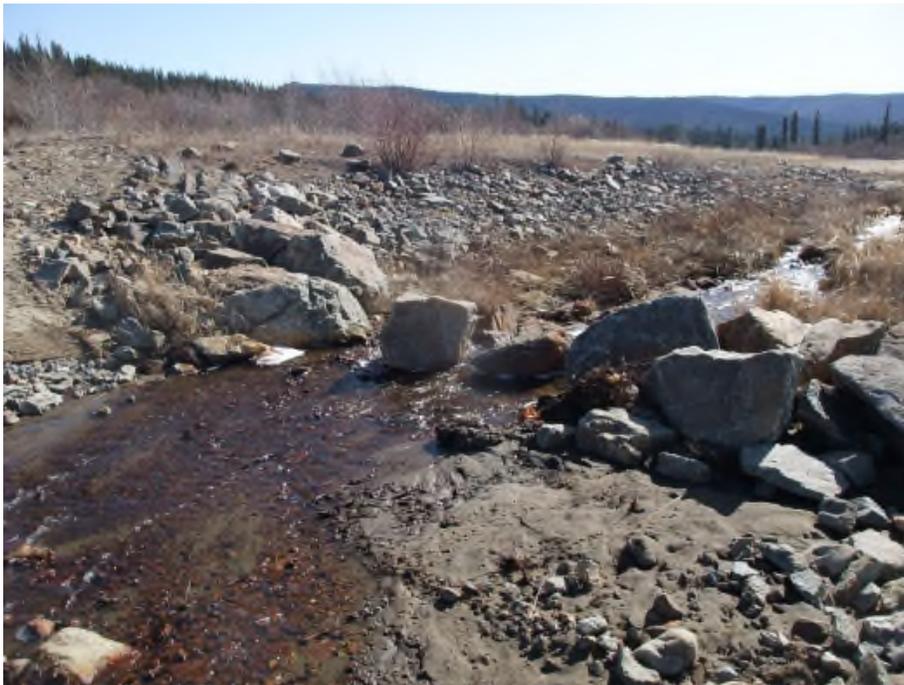
Photo 4:

The top “velocity check” immediately downstream of the vehicle crossing was previously noted as needing additional boulders in the centre of the stream, which were placed in 2015. Photo 4 shows this area. The Denison Environmental personnel asked if these could be removed in the late fall to facilitate ice removal in the winter – this is acceptable to Tetra Tech EBA provided they are replaced prior to spring freshet, and this was acknowledged by the Denison personnel.

Velocity check just below bridge showing the addition of several large boulders (in channel at centre of photo) to maintain its effectiveness during periods of high flow – looking east (May 13/16).

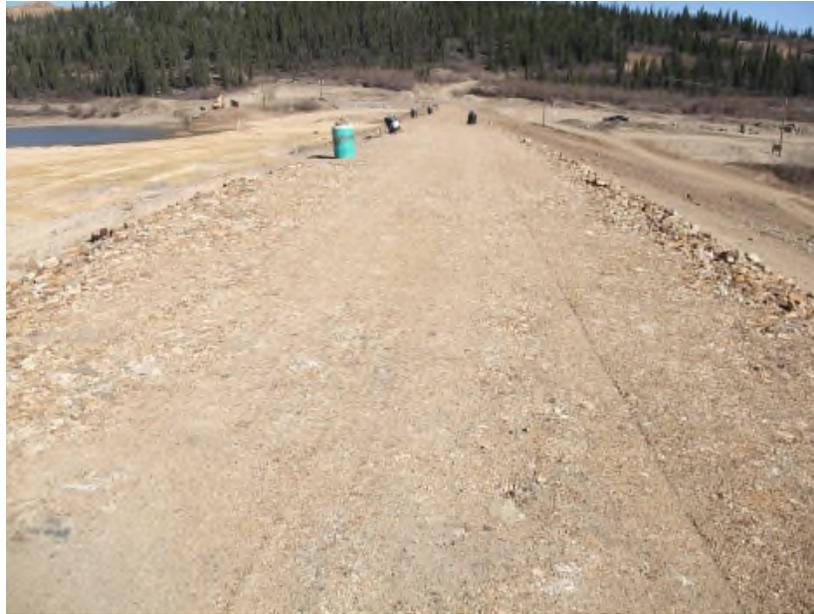
The water level in the tailings pond was well below the maximum operating level elevation, was similar to last year, and lower than has been traditionally been observed in the preceding years. The dam itself is considered to be in a stable condition with a large upstream tailings beach. No evidence of previously noted instabilities or seepage on the north abutment was observed, and there were no signs of significant erosion or permafrost thaw features that could affect stability. The surface of the dam was flattened in 2014, and this has assisted in visual monitoring. Vegetation has been adequately removed from all locations noted in previous inspections.

Photo 5:
View to the north along centerline of tailings dam (May 13/16)

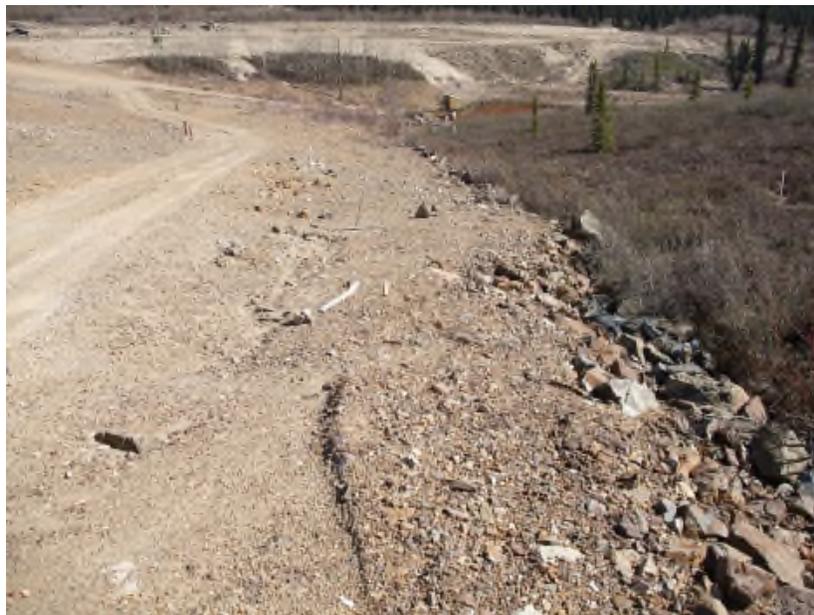
Photo 6:
Area of historical permafrost thaw settlement on downstream face, southeast edge (May 13/16)

The southeast edge of the downstream face where it abuts natural terrain has experienced permafrost thaw settlement since construction. These settlement areas were surveyed and monitored for several years in the early 2000's, but have not experience any noticeable settlement in recent years.

It is recommended that some fill be hauled, placed and compacted in these depressions – see Photo 6. Some of the depressions are marked by survey stakes and metal pins, but all are obvious and extend from near the crest down to the toe. The purpose in having this area levelled is to facilitate future observations of permafrost thaw settlement, if any.

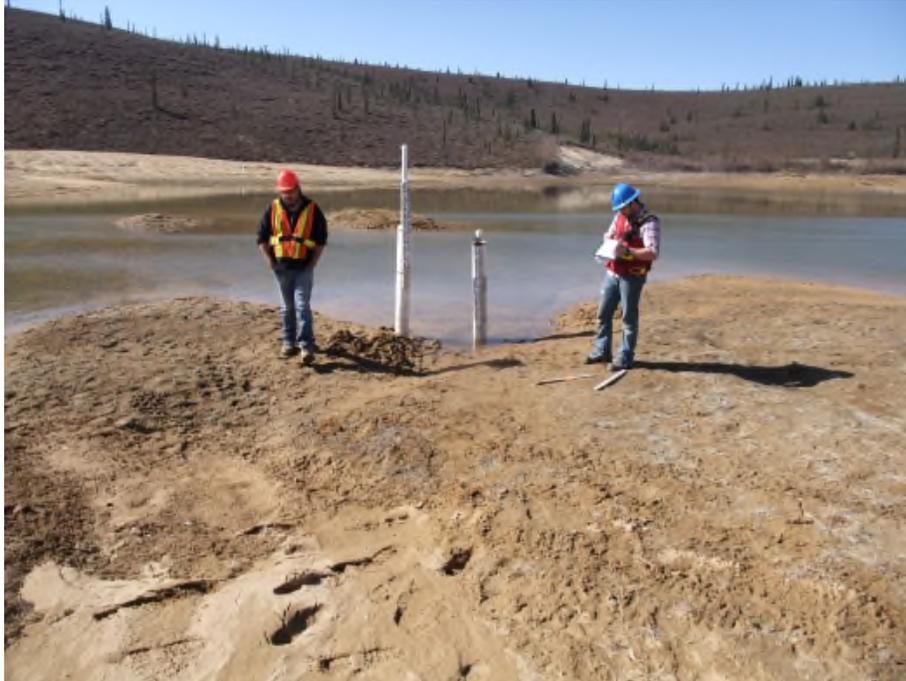
Photo 7:

Low tailings pond water level – water just barely registers on the lower staff gauge (May 13/16)

The water in the pond was recorded at 0.82 m on the first installed staff gauge which corresponds to an elevation of 1095.42 m (per May 2016 elevation survey completed by YG-AAM). This places the water at about 2.38 m below the design “pond operating level” of 1097.80 m. With respect to geotechnical stability, low water levels are always preferred.

It is recommended that the elevations of the staff gauge, pond water level and top of tailings dam be surveyed twice per year (spring and fall) to confirm that seasonal frost heave is not affecting readings on the staff gauge. It is assumed that the elevations of the geodetic benchmark (BM) and top of tailings dam are stable.

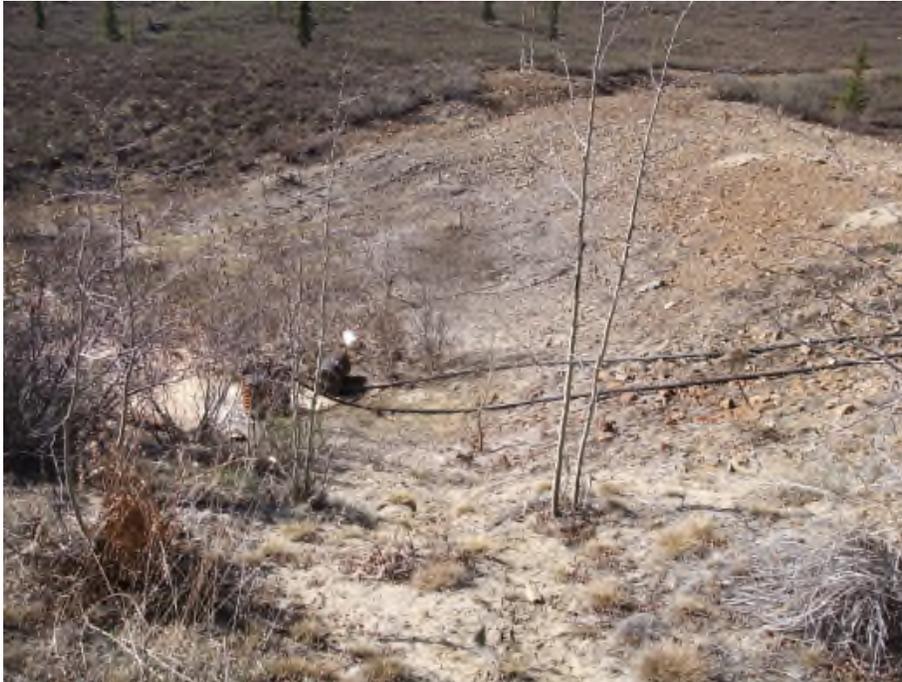
Photo 8:

The water in the seepage collection pond was recorded at a level of 0.19 m on the staff gauge, and the pumping rate to keep it at this level, according to Denison personnel, was similar to previous years. This pond elevation is close to the usual operating level of the pond over the past year, and according to the onsite maintenance personnel, it is necessary to pump at varying rates over the year to keep it at about this level. The corresponding elevation for the staff gauge reading is about 1077.09 m (per June 2015 elevation survey completed by YG-AAM) or about 1.01 m below the design operating level of 1078.10 m. Photo 8 shows the downstream face of the berm at the time of the inspection.

View of downstream face of Seepage Collection Pond berm, looking south (May 13/16).
