November 28, 2016

ISSUED FOR USE  
FILE: ENG.WARC03063-01  
Via Email: jeff.moore@gov.yk.ca

**Subject:** 2016 Annual Geotechnical Inspection Report on Earth Structures  
Mount Nansen Site, YT

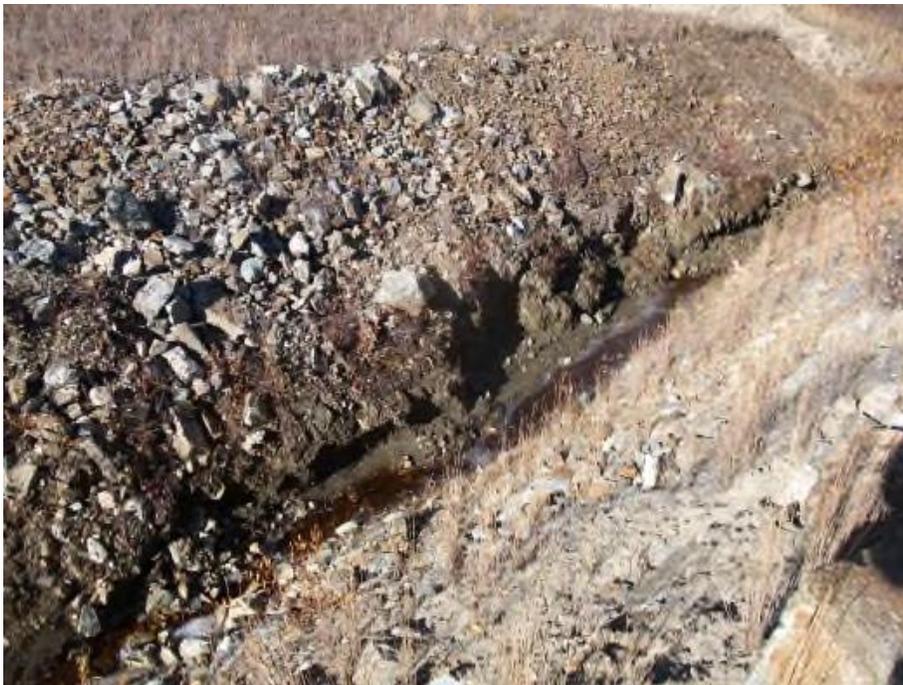
The ditches above and around the tailings pond, connecting to the combined spillway, were in similar conditions to prior years. In previous inspections it was observed that the dredging undertaken to remove accumulated silt/sand from the base of the ditch to improve winter flows had lowered the grade of the ditch enough so that toe erosion on the west side (left side looking downstream) of the interceptor ditch above Dome Creek was observed (see Photo 1). Elsewhere, the slopes were acceptably flattened and in a stable condition. It is recommended that future winter ice removal be completed with minimal disturbance to the base of the ditch so that ditch grades are not lowered any further. This entire section of ditch should be re-examined in the spring to see if conditions have stabilized. – If not, the placement of riprap may be required to stabilize the toe of the slope on the west side.

**Photo 1:** Interceptor ditch above Dome Creek (looking downstream)– undercut sideslopes on left side of ditch (September 23/16)

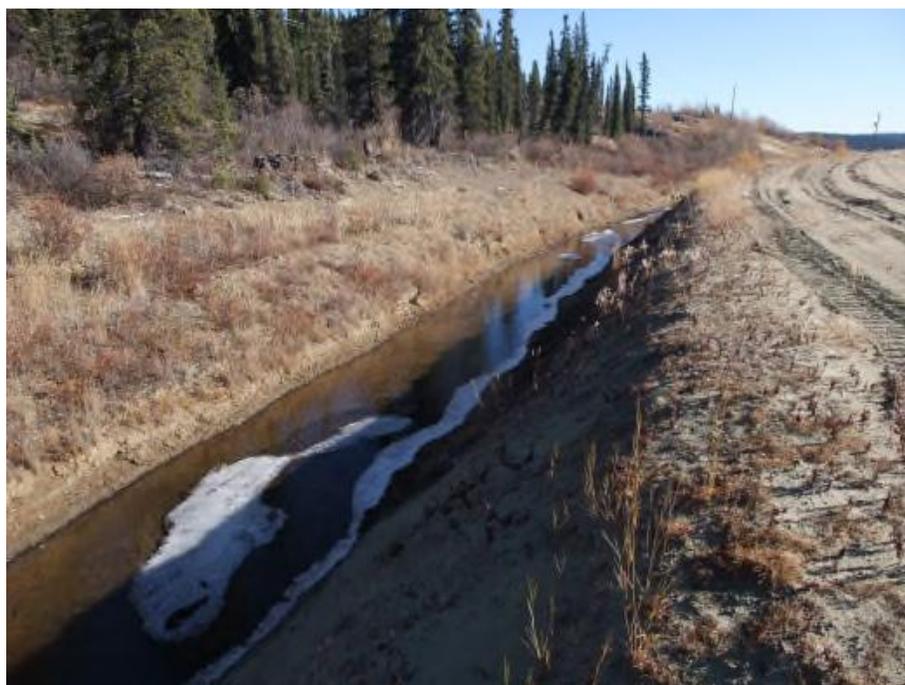
The remainder of the diversion ditch from the Dome Creek interceptor was in good shape, and no work is recommended at this time other than continued monitoring for slope instability caused by toe erosion.

Photo 2, below, shows the stable condition of the diversion ditch downstream of the Dome Creek intersection.

**Photo 2:** Diversion Ditch with stable sideslopes, looking downstream (September 23/16)

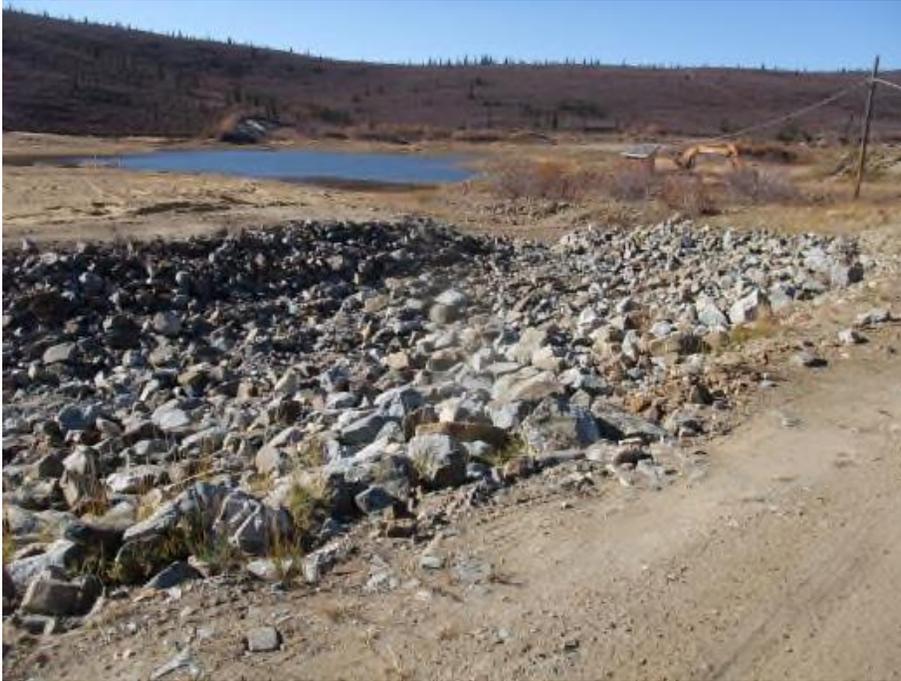
The combined emergency spillway/Dome Creek diversion channel was in a similar condition to previous years. Work that was completed in 2014 on the outlet from the tailings pond has created a stable configuration that is adequate to carry the design flows. No recommendations for additional work are required at this time.

**Photo 3:** View of stable emergency spillway upstream of combined channel (September 23/16)

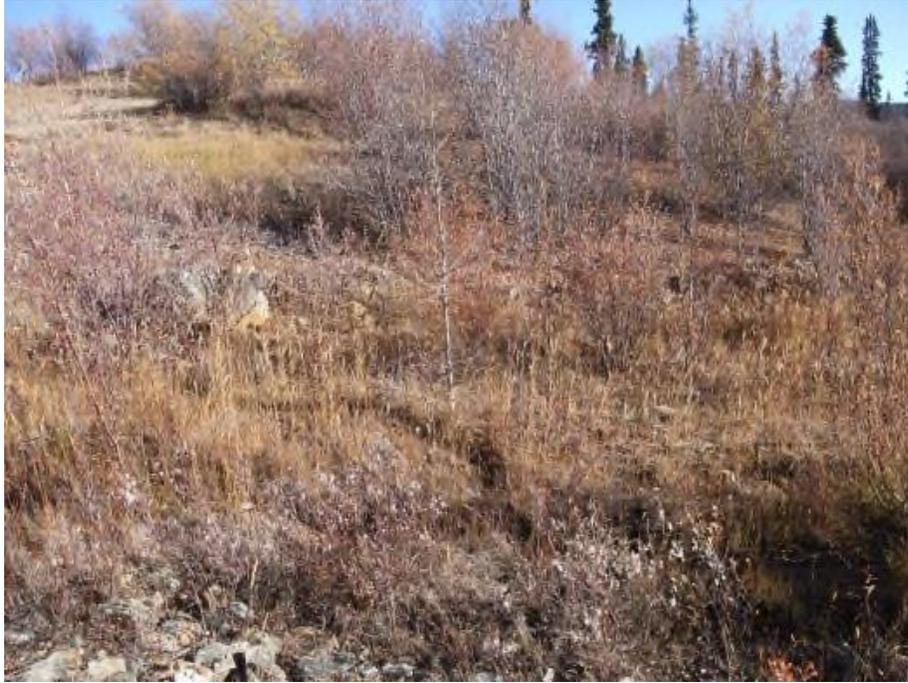
It is understood that some woody vegetation was removed following the 2015 inspection – there is still some woody vegetation (willows, etc.) just above the confluence with the original Dome Creek channel that should be removed. The primary purpose is to not impede water flow during future flood events.

**Photo 4:** Minor willow and vegetation growth in the lower portion of combined emergency spillway and diversion channel – foreground of photo (September 23/16)

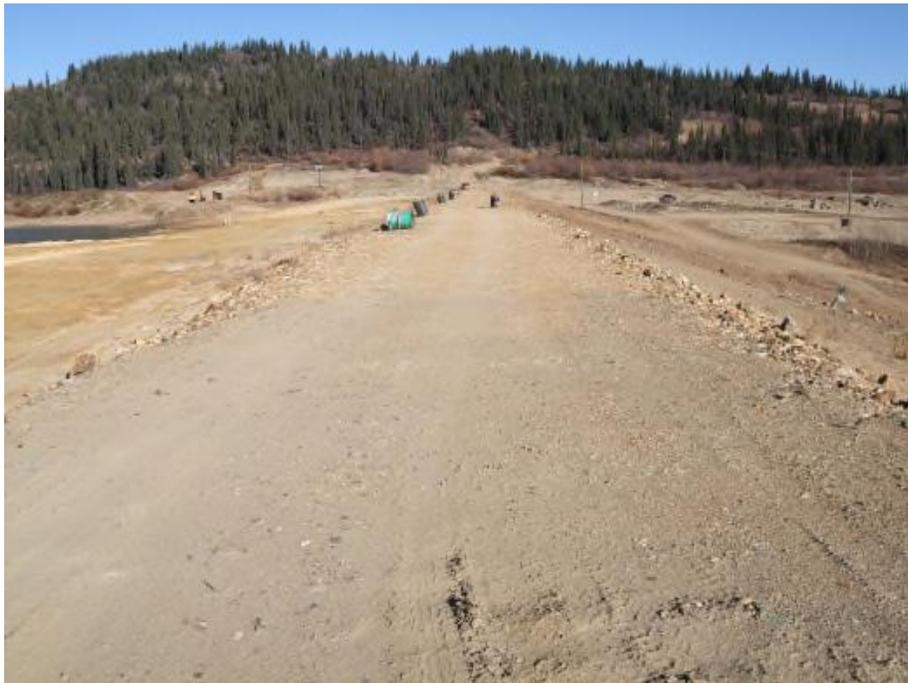
The tailings dam is considered stable in its present condition and no concerns are noted.

**Photo 5:** View of the tailings dam crest looking north (September 23/16)

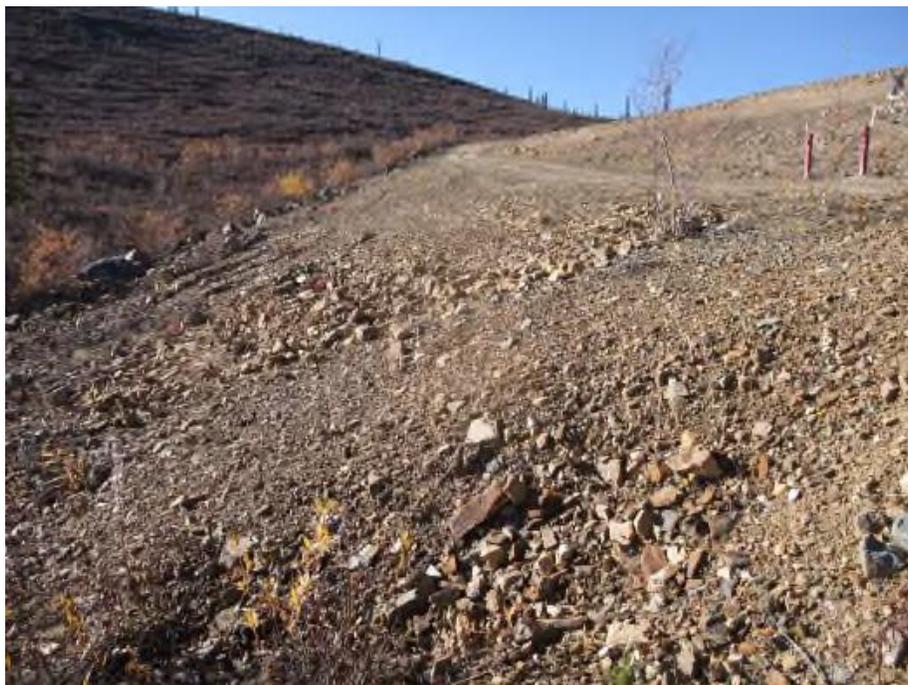
A maintenance item from the May 2016 inspection was to fill in the permafrost thaw depressions near the downstream toe at the south end. This work was completed satisfactorily as shown in Photo 6 below.

**Photo 6:** View of south downstream toe of tailings dam looking south, showing acceptable backfill and levelling of previously noted permafrost thaw depressions (September 23/16)

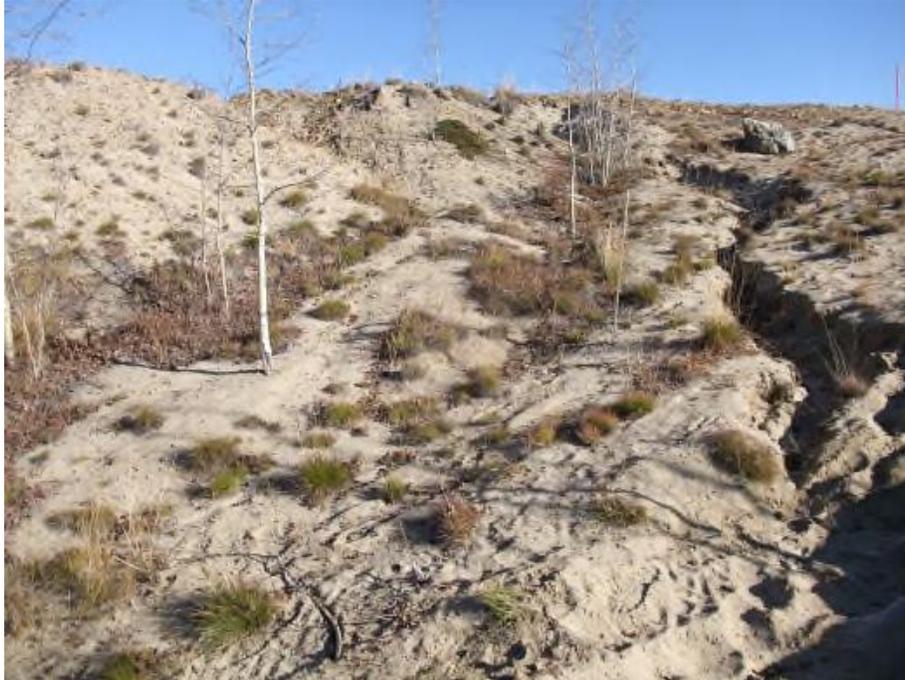
An item noted in previous inspections, but not considered significant, is the development of erosion gullies and rills in the north abutment just downstream of the seepage collection dam.

**Photo 8:** View (looking north) at erosion gullies above downstream toe of seepage collection dam (September 23/16)

This is not an immediate stability requirement, but more of an on-going maintenance issue.

As shown in Photo 8 below, it is recommended that these erosion gullies be filled and blocked off at the crest with rip-rap so that the gullies don't get any larger

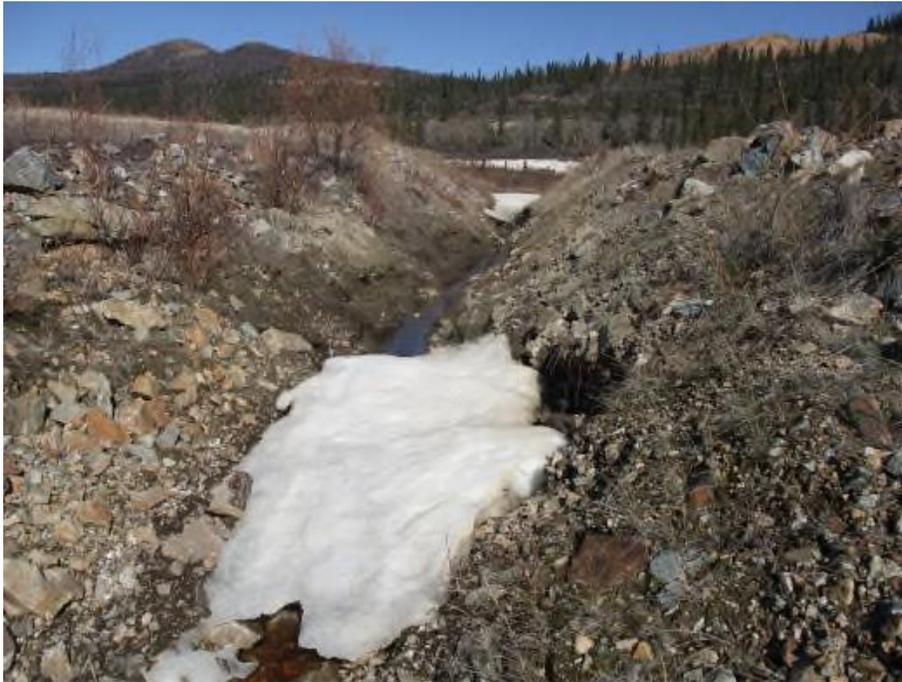
**Photo 1:**

The primary concern with these ditches is over-steepening of the slopes caused by erosion at the toes of the banks – this will have to be monitored and corrective actions taken when tension cracks are observed at the access road elevation at the crest of the slope. This might normally occur during spring runoff or after large rainfall events. The corrective actions should include flattening the slopes to 1.5:1 and possible riprap placement at the toe of the slope to minimize this over-steepening.

Interceptor ditch slopes just south of Dome Creek intersection, looking downstream. Undercut slope toes are evident between the two snow patches in about centre of photo (May 13/16)

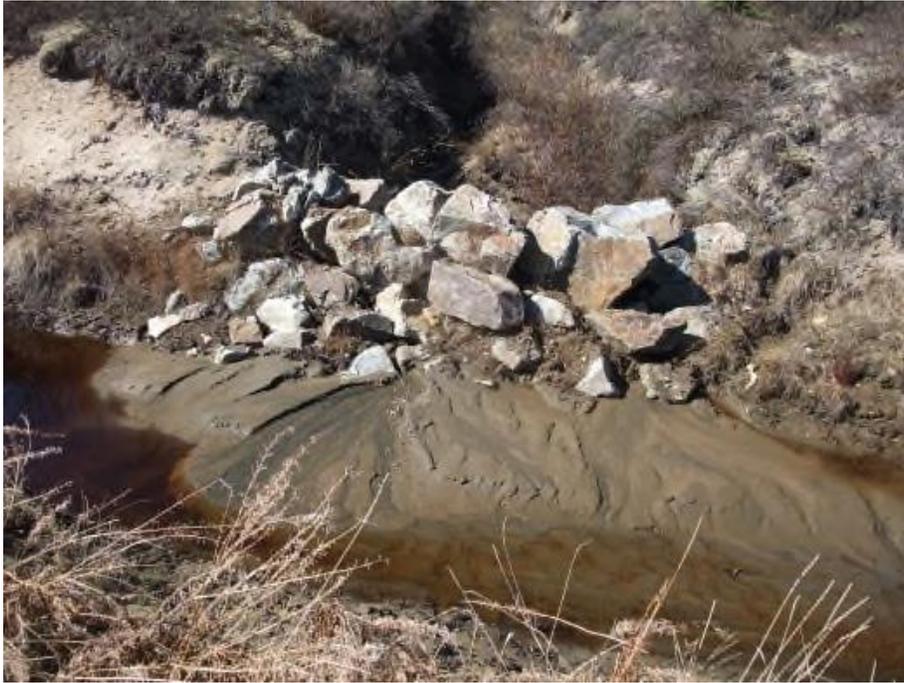
**Photo 2:**

Erosion gullies from water entering the interceptor ditch were in the same condition as previous years and should continue to be monitored. These small erosion gullies are significant contributors to sand and silt deposits in the diversion ditch. Riprap has been placed at all these gullies, as previously recommended (see Photo 2). This hasn't been entirely effective in minimizing sand migration into the ditch, but does provide some stability to the

Armouring to minimize sand deposition from contributory gullies into channel bottom upstream of Dome Creek intersection looking west (May 13/16)

It is understood that these sand/silt deposits have been cleaned out with a backhoe over the past year, to maintain flow in the ditches. This practice should be continued.

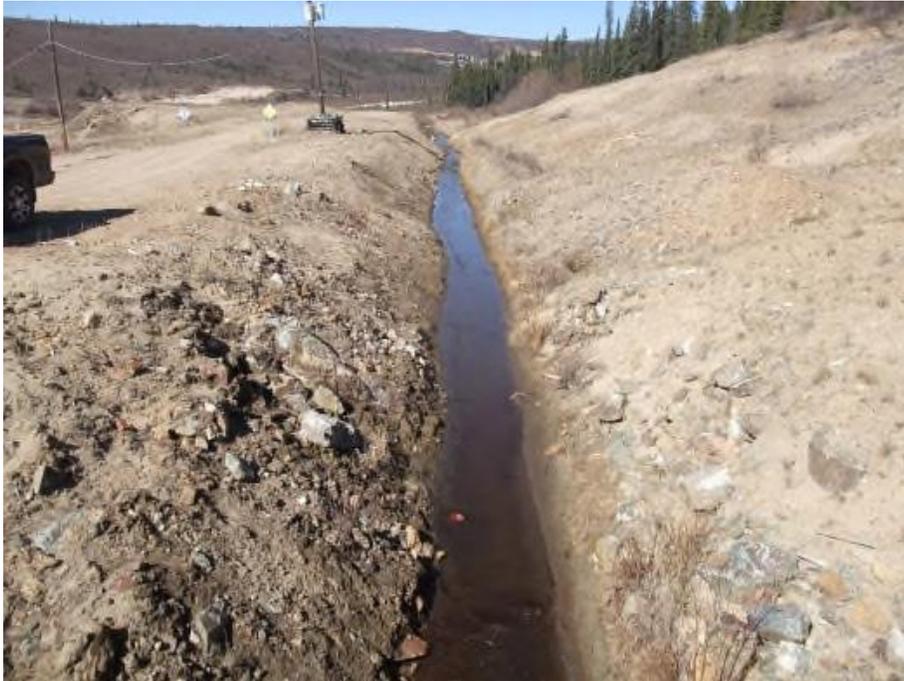
The diversion ditch was in an acceptable and stable condition – no work is required at this time other than regular maintenance to remove silt/sand in the spring and fall of each year, as required to maintain flow and side slope stability. Photo 3 shows the typical condition of the diversion ditch.

**Photo 3:**  
Typical condition of the Dome Creek diversion ditch looking upstream (May 13/16)

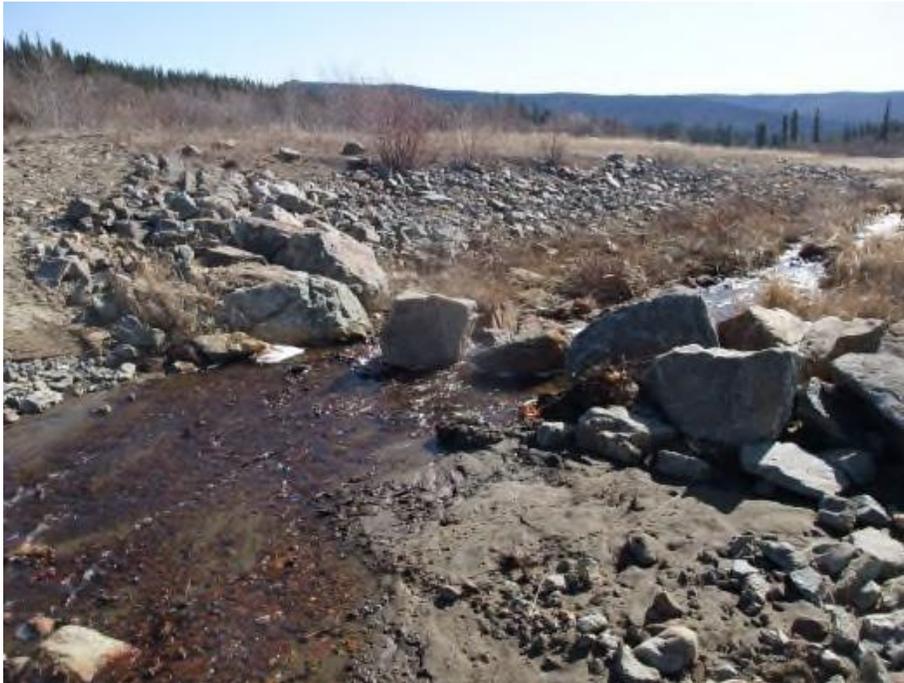
**Photo 4:**

The top “velocity check” immediately downstream of the vehicle crossing was previously noted as needing additional boulders in the centre of the stream, which were placed in 2015. Photo 4 shows this area. The Denison Environmental personnel asked if these could be removed in the late fall to facilitate ice removal in the winter – this is acceptable to Tetra Tech EBA provided they are replaced prior to spring freshet, and this was acknowledged by the Denison personnel.

Velocity check just below bridge showing the addition of several large boulders (in channel at centre of photo) to maintain its effectiveness during periods of high flow – looking east (May 13/16).

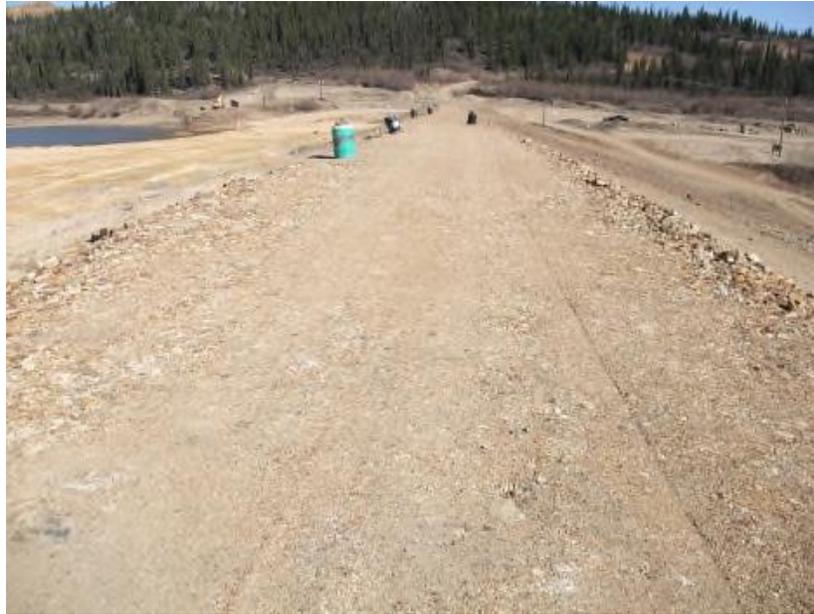
**Photo 5:**  
View to the north along centerline of tailings dam (May 13/16)

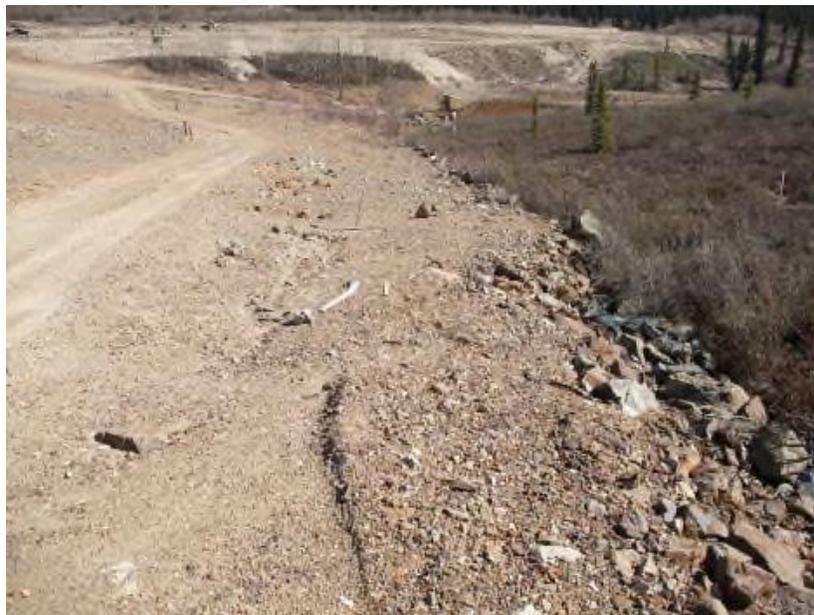
**Photo 6:**  
Area of historical permafrost thaw settlement on downstream face, southeast edge (May 13/16)

The southeast edge of the downstream face where it abuts natural terrain has experienced permafrost thaw settlement since construction. These settlement areas were surveyed and monitored for several years in the early 2000's, but have not experience any noticeable settlement in recent years.

It is recommended that some fill be hauled, placed and compacted in these depressions – see Photo 6. Some of the depressions are marked by survey stakes and metal pins, but all are obvious and extend from near the crest down to the toe. The purpose in having this area levelled is to facilitate future observations of permafrost thaw settlement, if any.

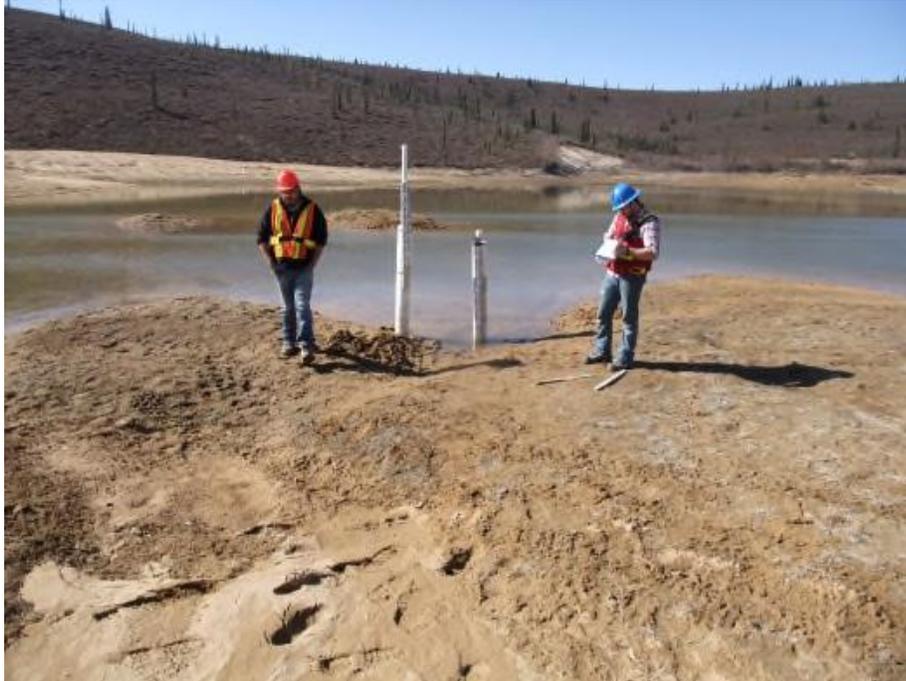
**Photo 7:**

Low tailings pond water level – water just barely registers on the lower staff gauge (May 13/16)

It is recommended that the elevations of the staff gauge, pond water level and top of tailings dam be surveyed twice per year (spring and fall) to confirm that seasonal frost heave is not affecting readings on the staff gauge. It is assumed that the elevations of the geodetic benchmark (BM) and top of tailings dam are stable.

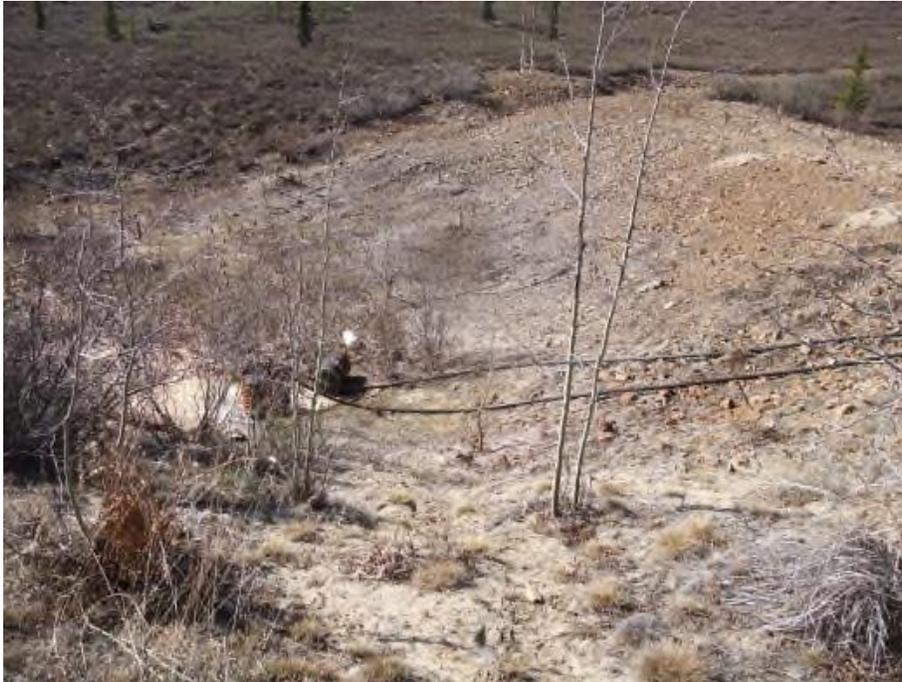
**Photo 8:**

The water in the seepage collection pond was recorded at a level of 0.19 m on the staff gauge, and the pumping rate to keep it at this level, according to Denison personnel, was similar to previous years. This pond elevation is close to the usual operating level of the pond over the past year, and according to the onsite maintenance personnel, it is necessary to pump at varying rates over the year to keep it at about this level. The corresponding elevation for the staff gauge reading is about 1077.09 m (per June 2015 elevation survey completed by YG-AAM) or about 1.01 m below the design operating level of 1078.10 m. Photo 8 shows the downstream face of the berm at the time of the inspection.

View of downstream face of Seepage Collection Pond berm, looking south (May 13/16).
