June 15, 2012

Yukon Government
Faro Mine Remediation Project
Suite 2C-4114-4th Ave
PO Box 2703 (K-149)
Whitehorse, Yukon Territory
Y1A 2C6

Faro Mine Complex
2011 Annual Geotechnical Review

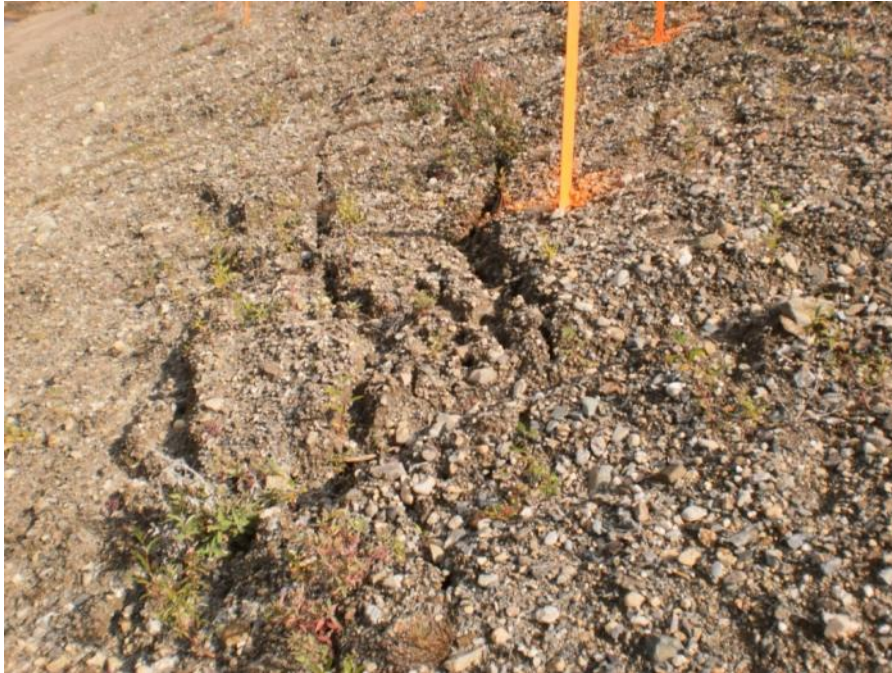
- Downstream slope is experiencing extensive rill erosion (see Photos 34 and 38), with longitudinal cracks and minor slope slumps developing (see Photo 35), and eroded materials are depositing on the downstream berm, which had been graded for berm maintenance, thus was not very apparent.

Photo 35 Close-up of horizontal cracks due to slope slump of surficial layer (August 23, 2011)

- Continue to monitor minor damfill adjustment of the upstream slope near the south abutment.
- Repair shoulder erosions of the downstream berm.
- Monitor ongoing development of rill erosions on the downstream slope and related longitudinal cracks and slope slumps.

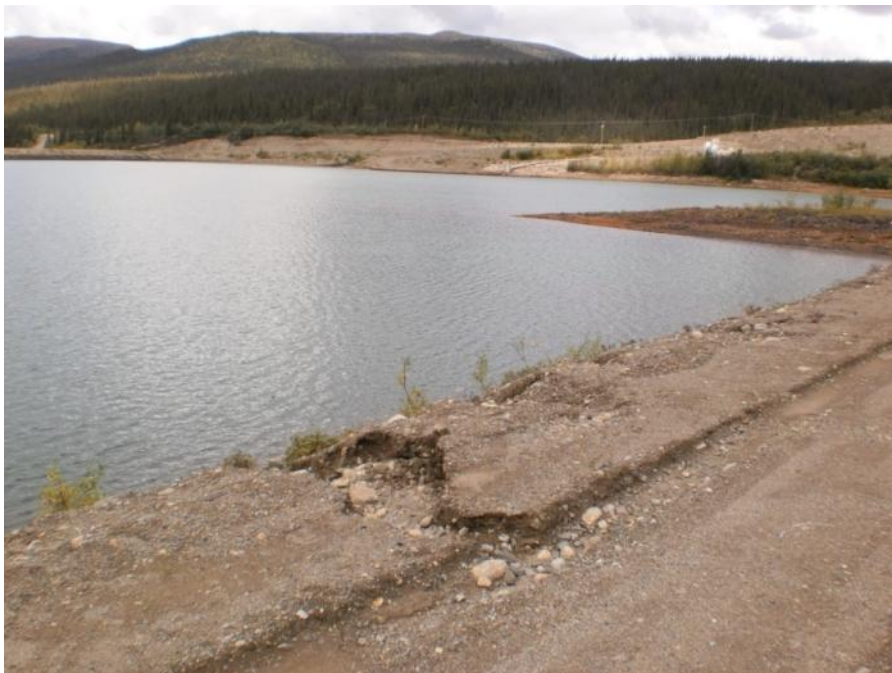
- DES placed wooden stakes on the downstream slope in the southwest portion to assist ongoing monitoring (see Photos 34 and 35).
- Significant shoulder erosion of the downstream berm was also observed at numerous locations, which require repair (see Photo 36).

Photo 36 Gully erosion of downstream berm slope (August 23, 2011)

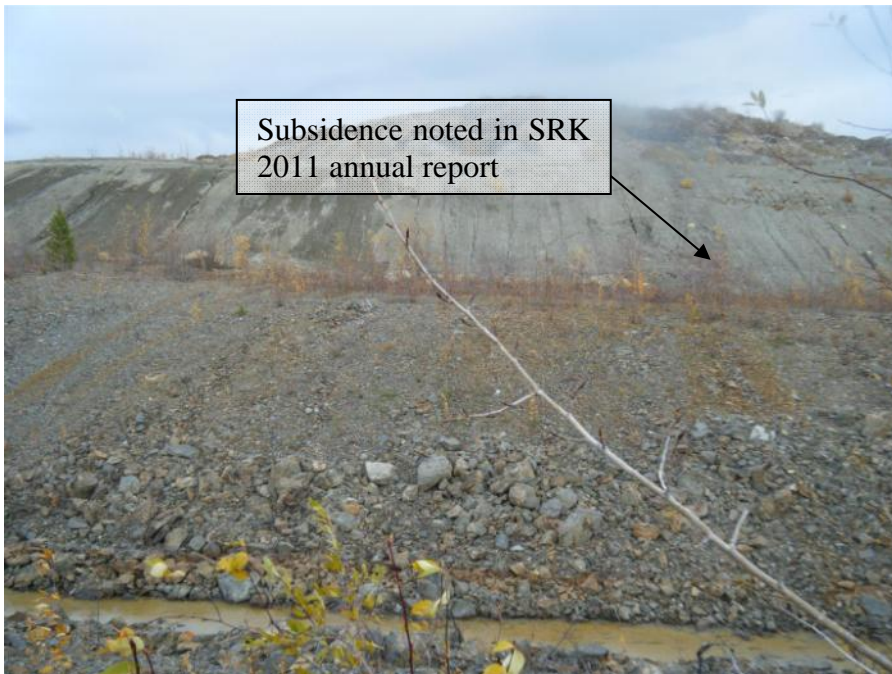
Photo 52 Vangorda Waste Dump previously noted subsidence (September 20, 2011)

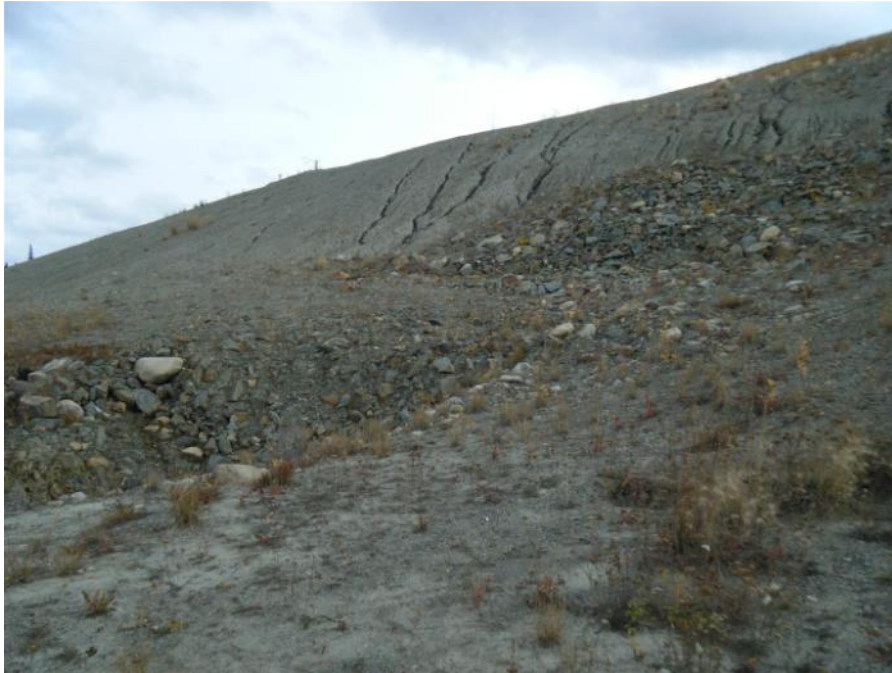
Photo 53 Vangorda Waste Dump at Drain No. 6 - showing previous subsidence of dump face (September 20, 2011)

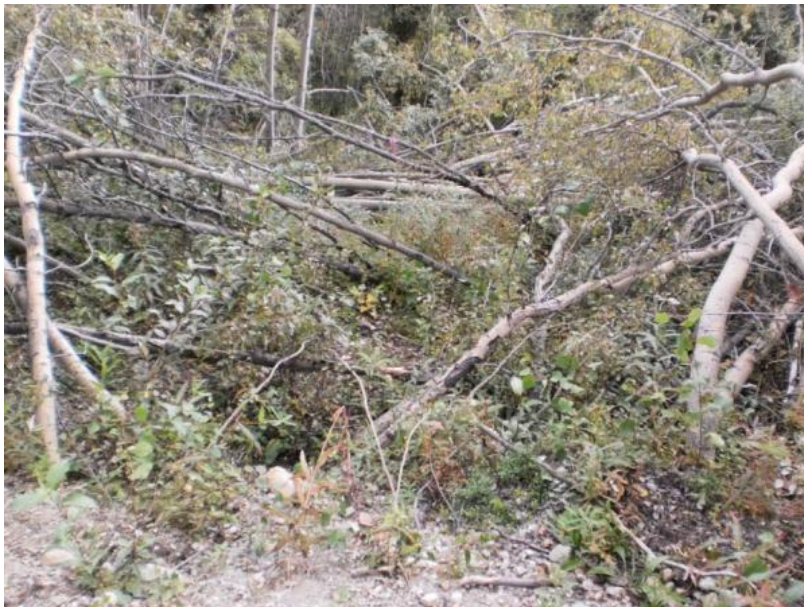
Photo 115 Disturbed bank slope and fallen trees caused by excess seepage issuing from esker downstream of Moose Pond during 2011 spring runoff event (August 23, 2011)

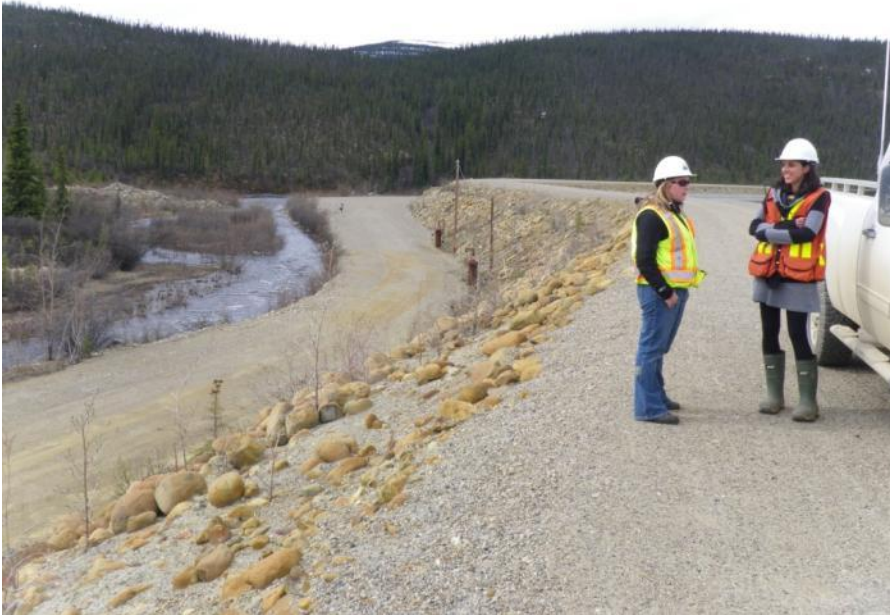
Photo 25 Secondary Tailings Dam crest and downstream slope - longitudinal cracks reappeared along road surface of downstream berm (May 29, 2012)

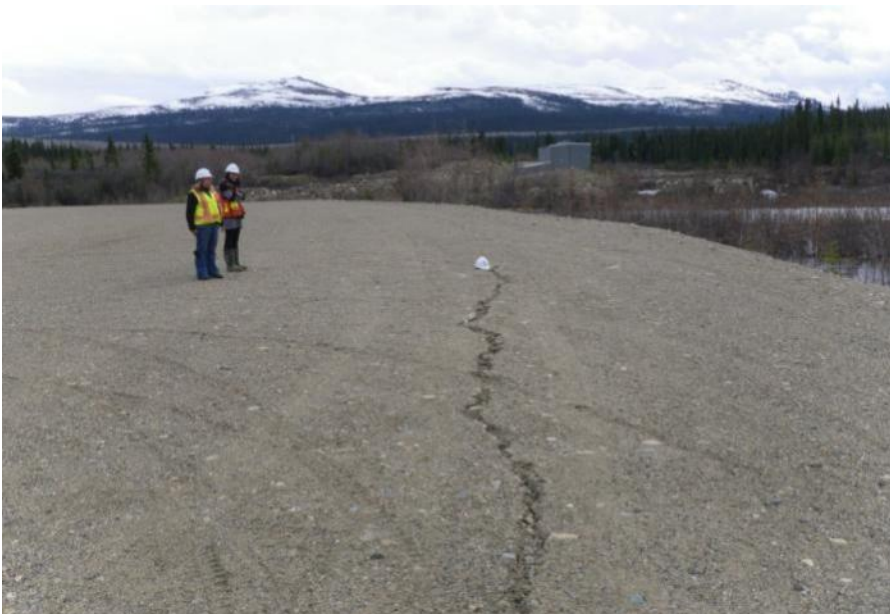
Photo 26 Longitudinal crack along downstream berm road surface towards Canal Dyke (May 29, 2012)

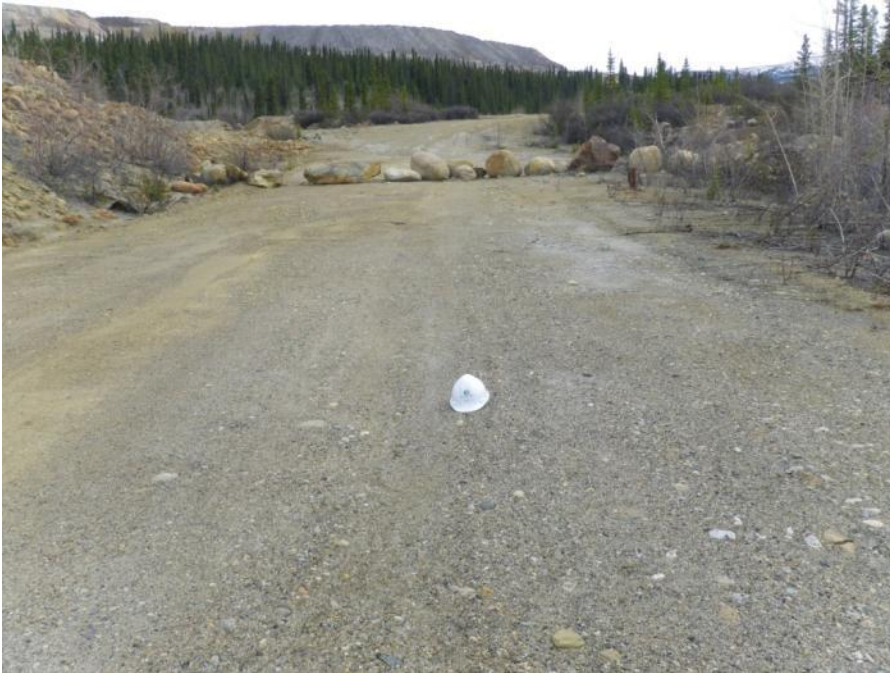
Photo 27 Longitudinal crack along downstream berm road surface towards Mine Access Road (May 29, 2012)

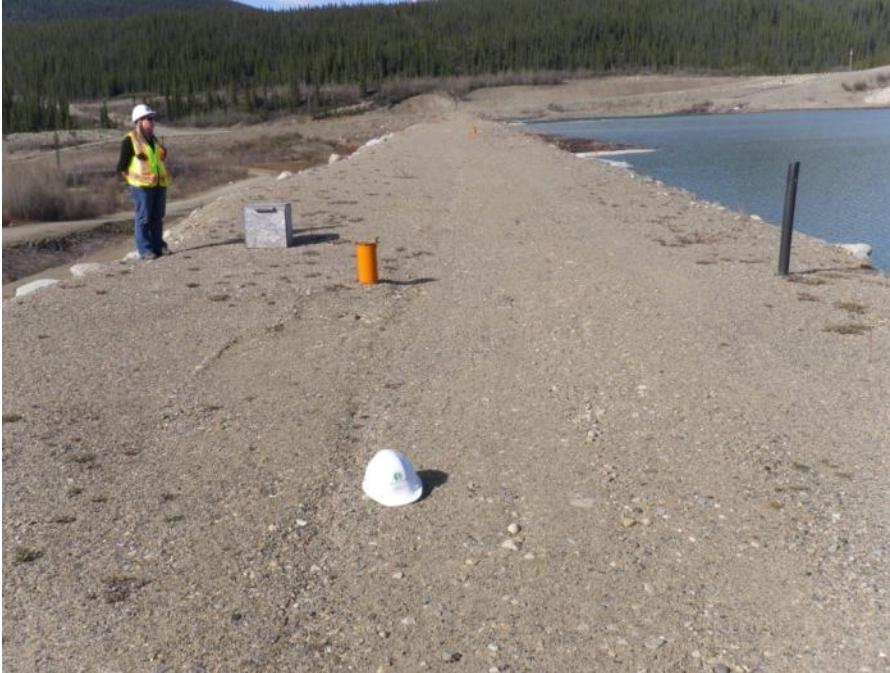
Photo 39 Longitudinal crack in the middle of crest along southwest segment (May 29, 2012)

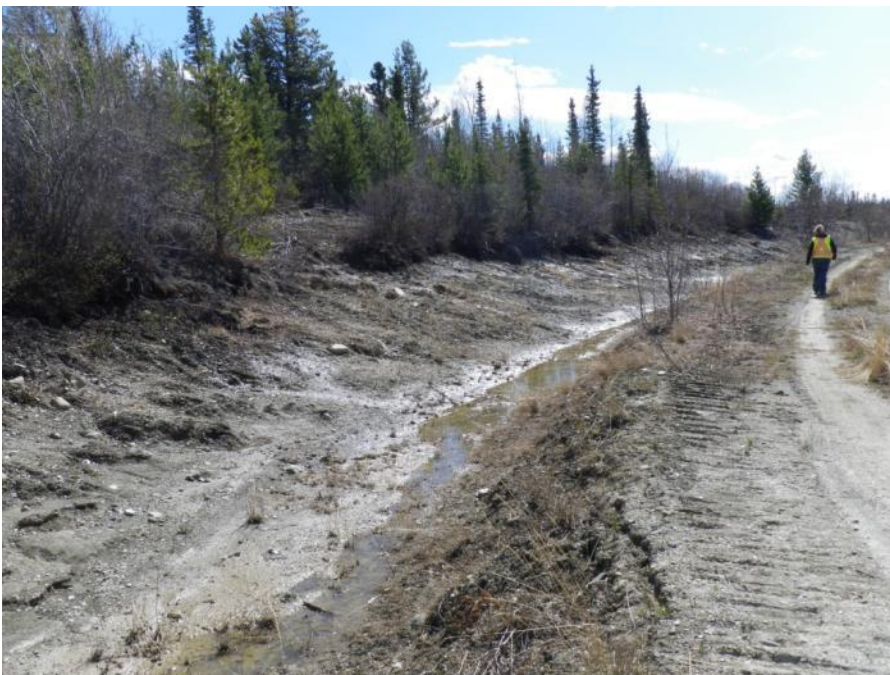
Photo 64 Ditch bank slopes – note bank slope erosion condition (May 30, 2012)
