2006 ANNUAL REPORT

FRESH WATER SUPPLY DAM BREACH PROJECT FARO MINE, YUKON

PROJECT NO.: 0257-040-01
DATE: JANUARY 26, 2007

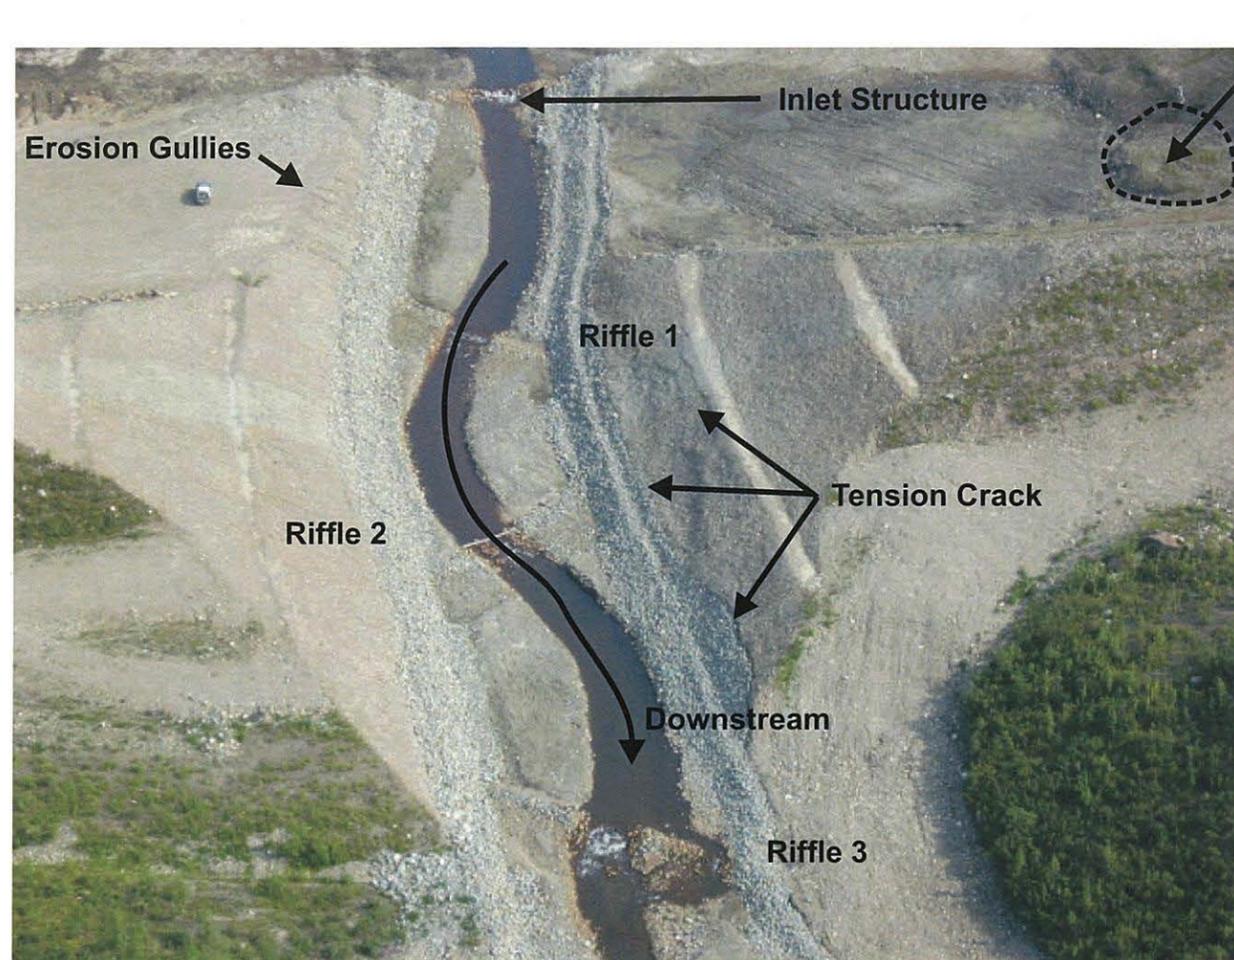
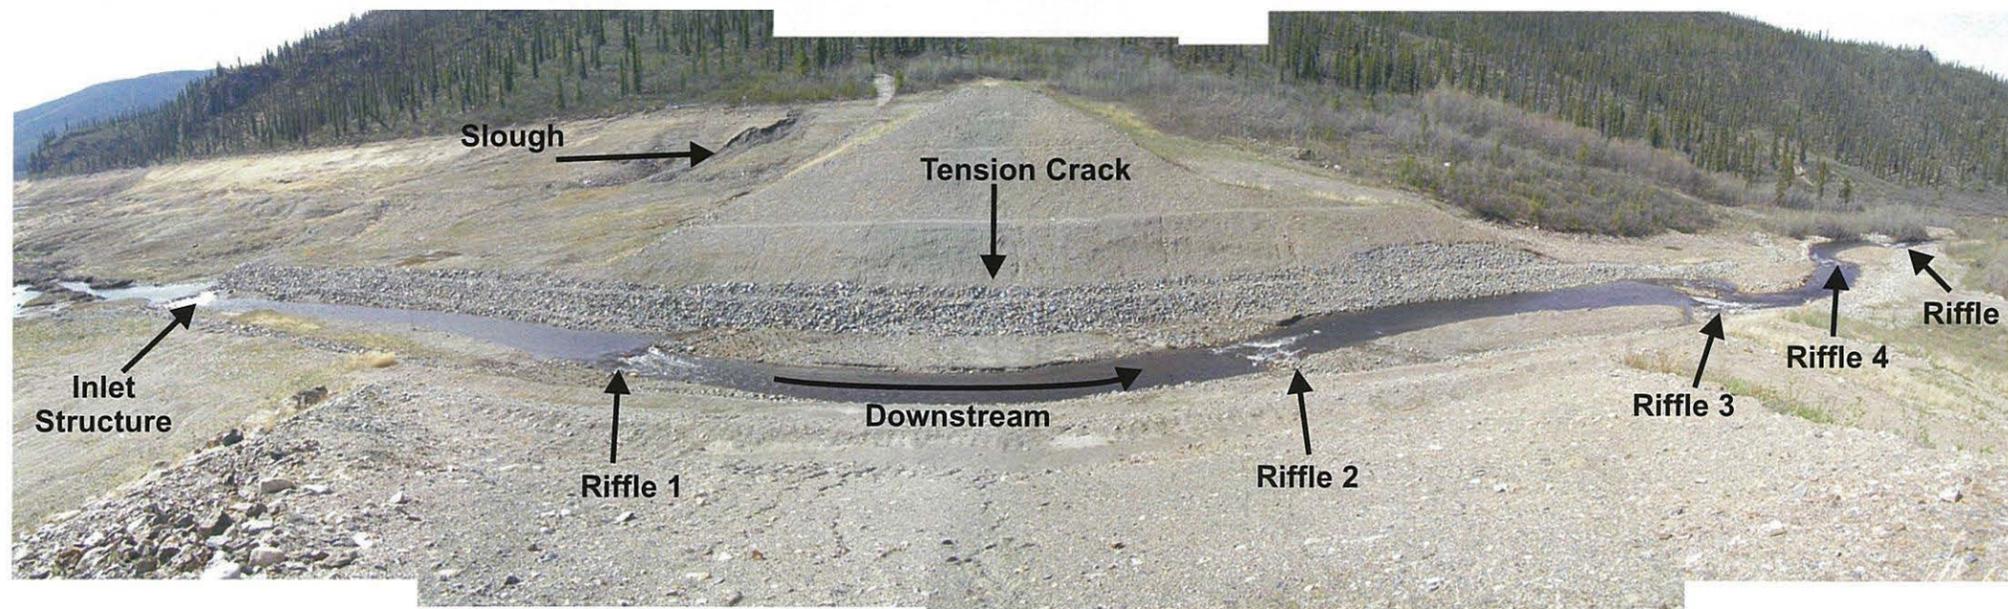
PROJECT	2006 ANNUAL REPORT, FWSB	
TITLE	2004 TO 2006 COMPARISON OF FWS DAM BREACH	
PROJECT No.	Figure No.	REV.
0257-040-01	7	0

Two different views of the FWSB project area are shown in Figure 7. Included on the 2004 aerial view are the locations of the inlet structure, tension crack and erosion gullies. The locations of these features in 2006, except the erosion gullies, are also shown in the top photo of Figure 7 as viewed from the dam crest.

Some cracks and slumping were evident above the upper limit of the erosion protection. This slumping appeared to be related to the steep nature of the excavations made to install the erosion protection. One larger-scale tension crack was encountered on the south bank of the excavation section between Riffle 1 and Riffle 2, as shown on Figure 7.

August 2004: An aerial view of the breach section. This overview of the project shows the location of the breach and channel. Also shown is the slough on the former reservoir wall, the erosion gullies, the tension crack located between Riffle 1 and 2. The water flowing around the left side of Riffle 3 shown in this photo was repaired in September 2004.

June: The breach channel through the dam. As shown at the far left, some stream braiding has occurred upstream of the inlet structure. This photo also shows the slough, the location of tension cracks in the core of the dam and the five riffles.

- Perform twice monthly visual inspections of the performance of the sideslopes and constructed creek elements. The three areas of concentration should be the slough near the south abutment of the dam, the erosion gullies near the inlet on the north side of the breach, the tension crack between Riffle 2 and 3 on the south side of the breach channel and the tension cracks forming upslope from the top of the erosion protection.

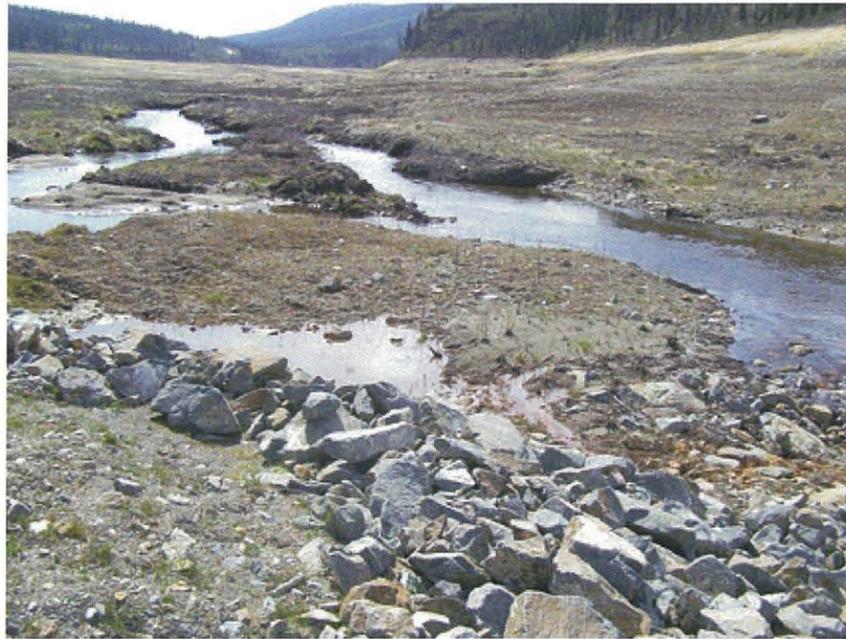
In general, the channel section through the breach has worked as designed. The majority of the creek flow is concentrated in the channel section, even during a higher flow period (June), as shown in Figure 8. During lower flow conditions (August and September), all of the flow is contained within the channel (Figure 9). During the high flow period, erosion of some of the soil at the downstream limit of construction occurred which has created another riffle zone. The erosion has created some sloughing of the banks (Figure 9).

June: Flow in the channel and flood plain during higher flow period immediately upstream of breach. The channel has formed into a braided stream upstream of the inlet structure.

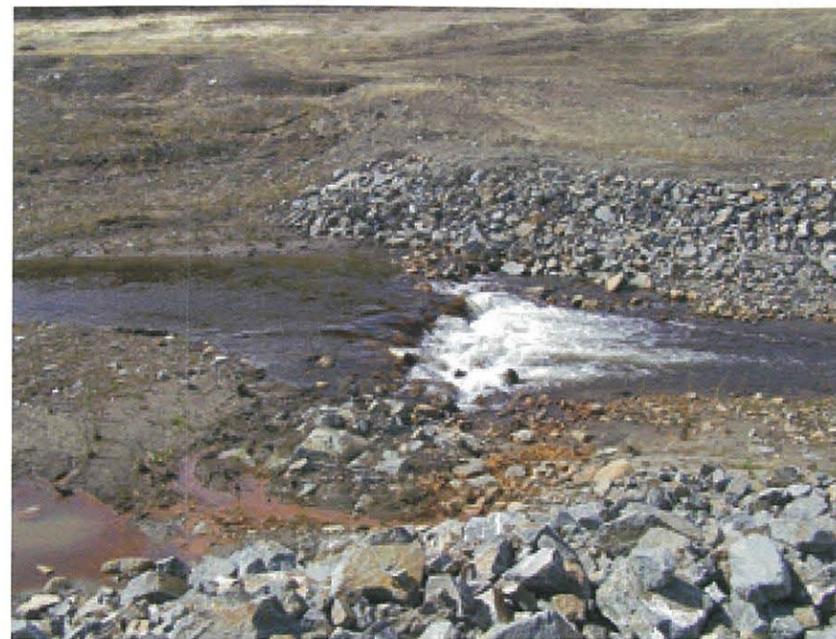
June: Looking along crest of inlet structure.

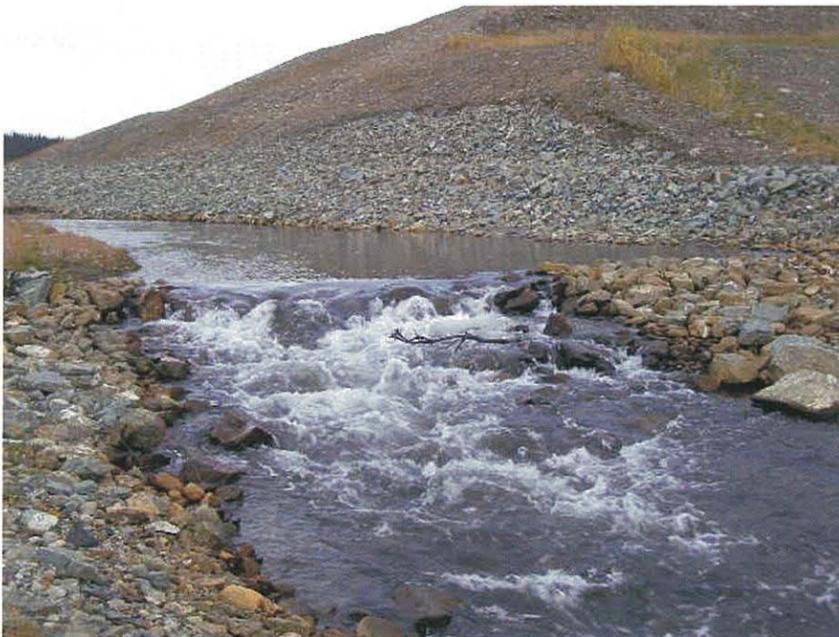
September: A view of the normal Fall water flow within the channel at Riffle 3.

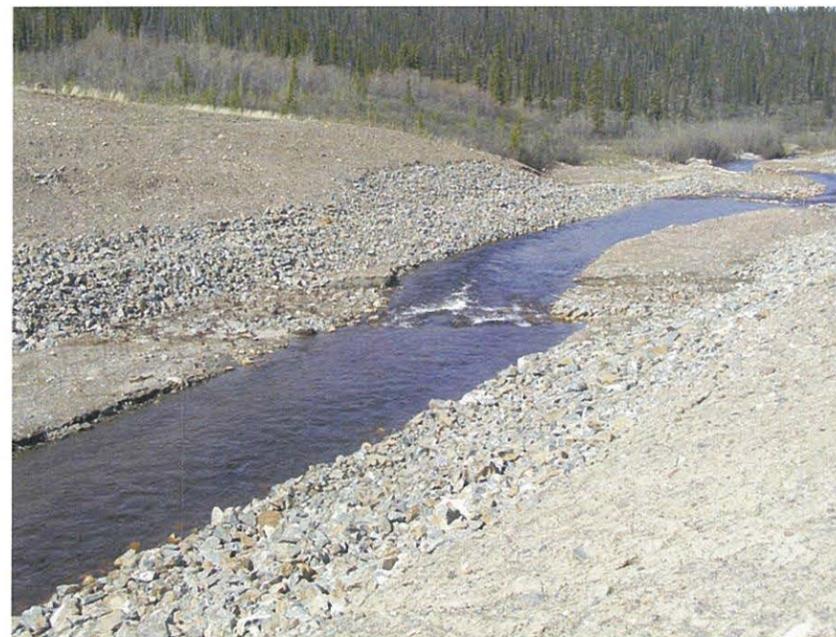
June: Looking downstream at Riffle 2.

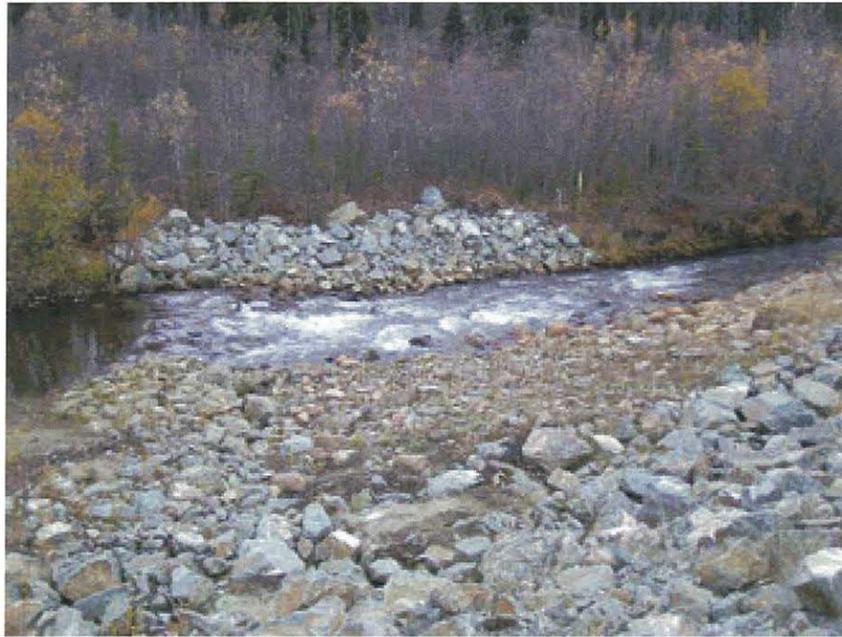
September: Shows the condition of Riffle 5. The riprap on the far side appears to be in good condition.

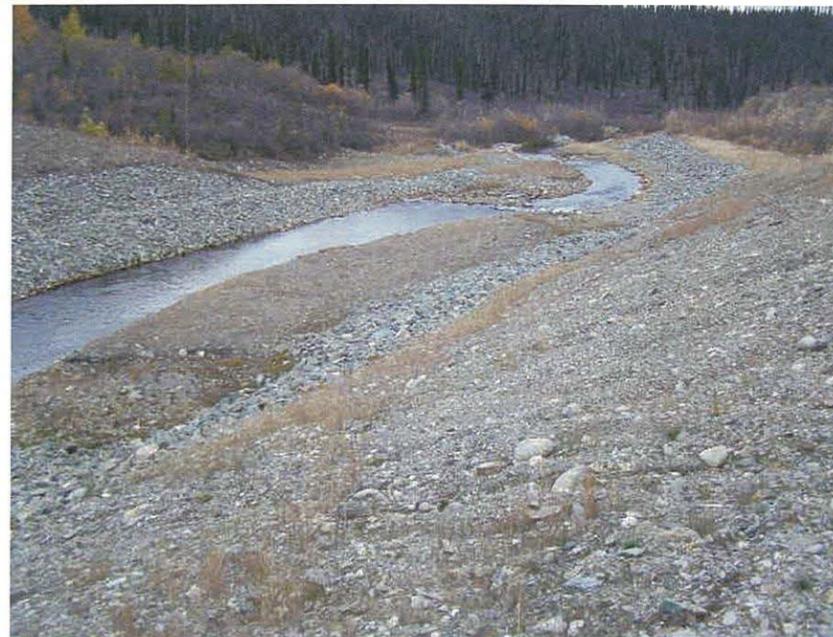
September: Flow contained in channel during low flow period near Riffle 3.

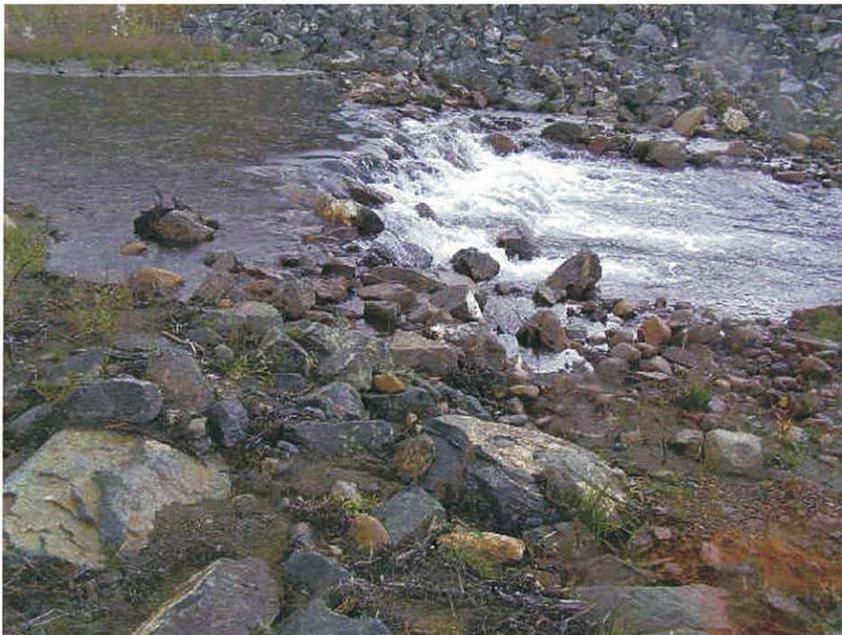
August: Looking along the crest of Riffle 3.

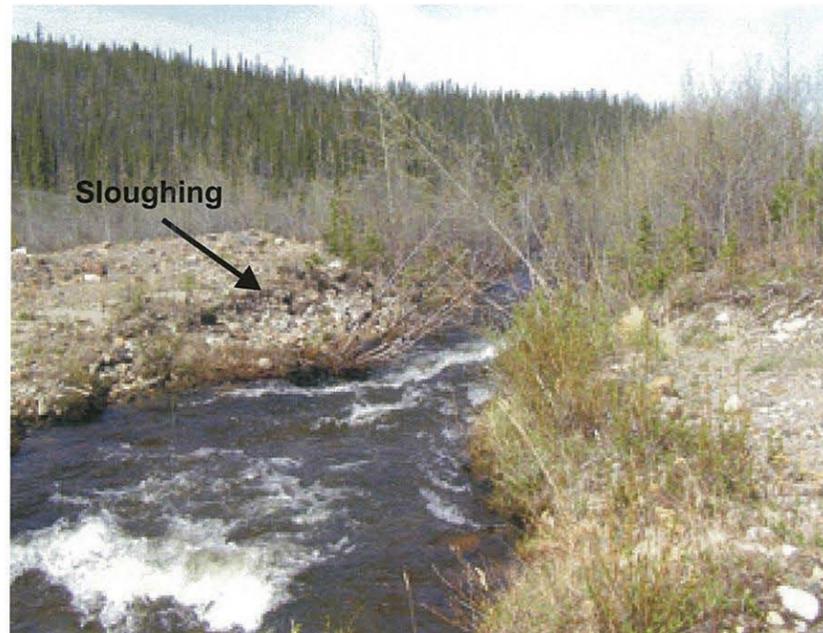
June: Erosion of left bank immediately downstream of the limit of the 2003 construction.

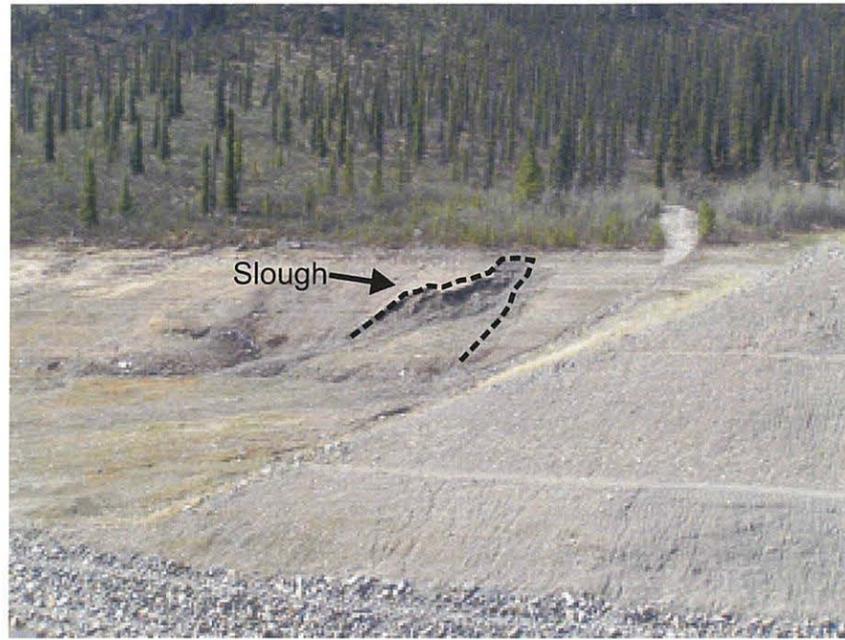
June: Shows a view of the slough located over towards the south abutment.

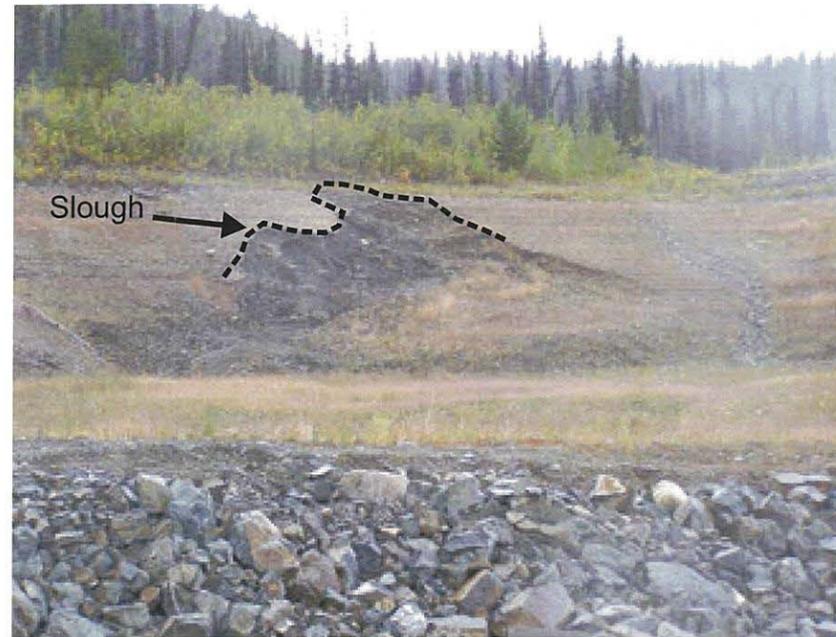
August: Shows a view of the slough at south abutment, which appears to be partly stabilizing itself and naturally re-vegetating.

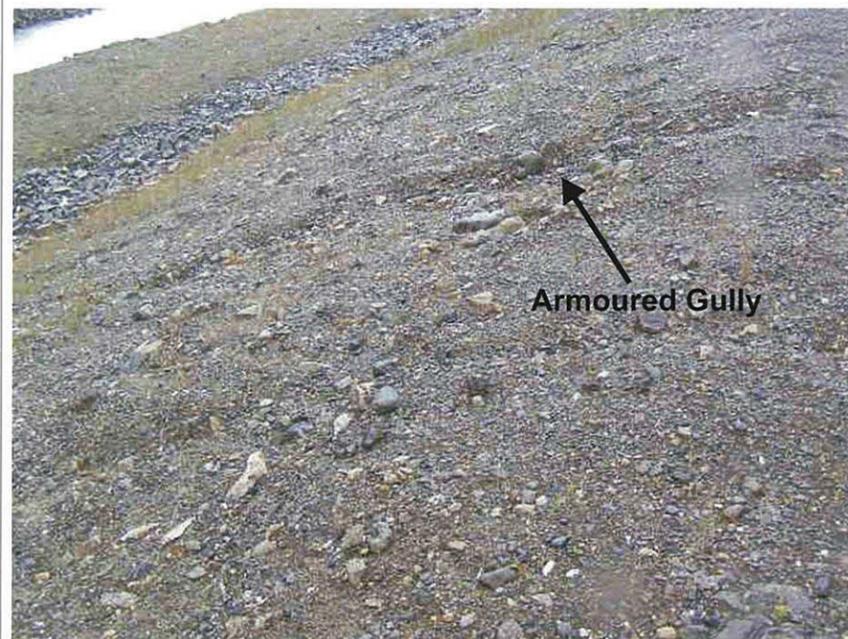
August: View of erosional gullies which have formed on the right side of the breach. Note that these gullies appear to be self-armouring.

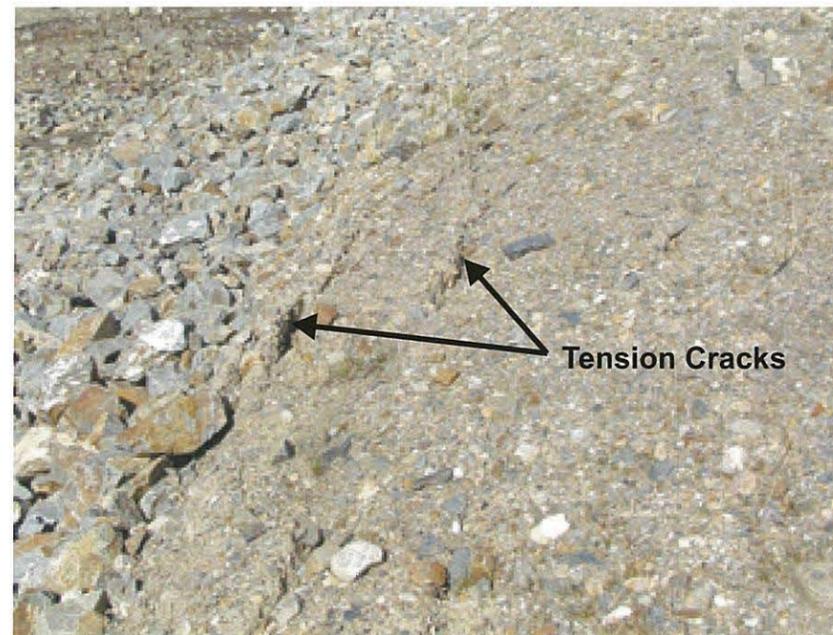
June: Shows longitudinal tension cracks located behind the riprap near channel.

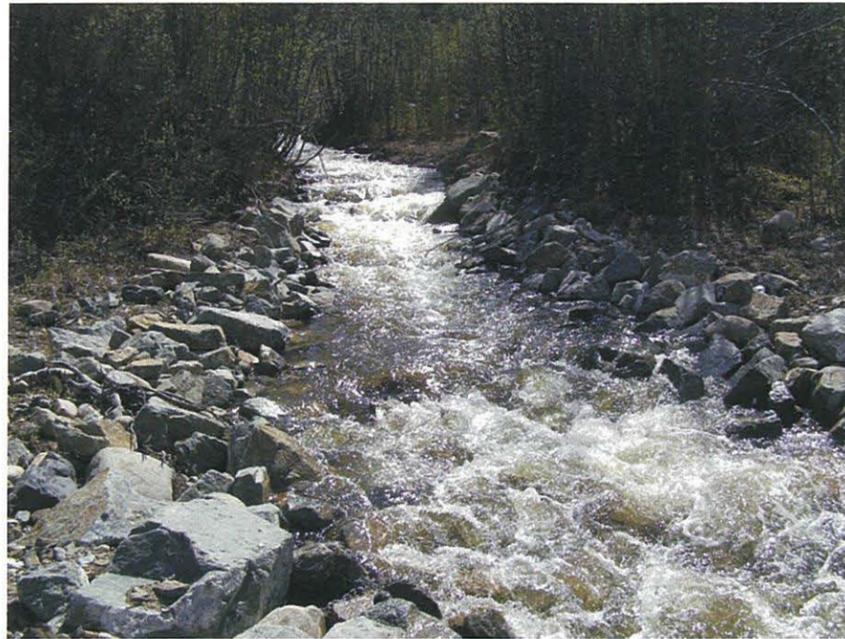
June: Shows a view of the creek, looking in the upstream direction.

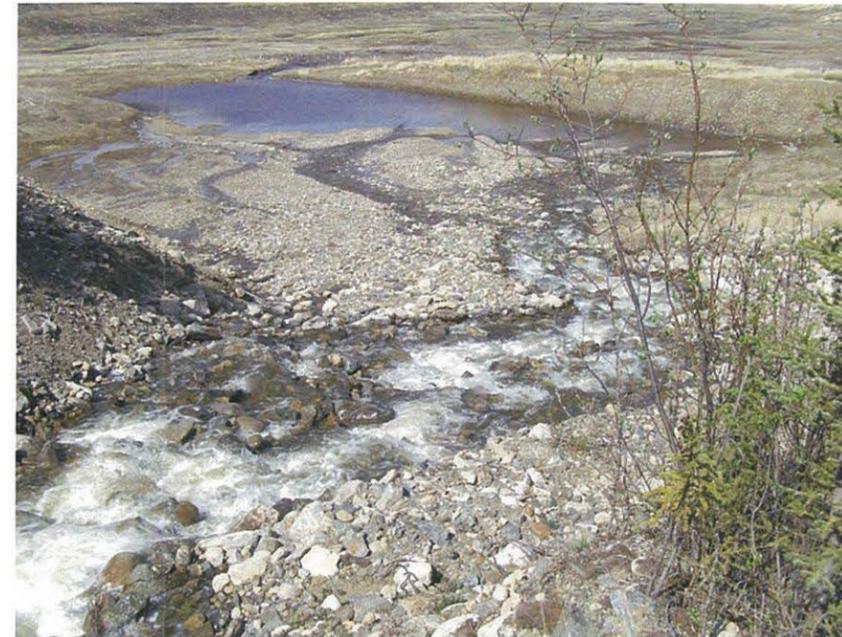
September: View looking in the downstream direction.

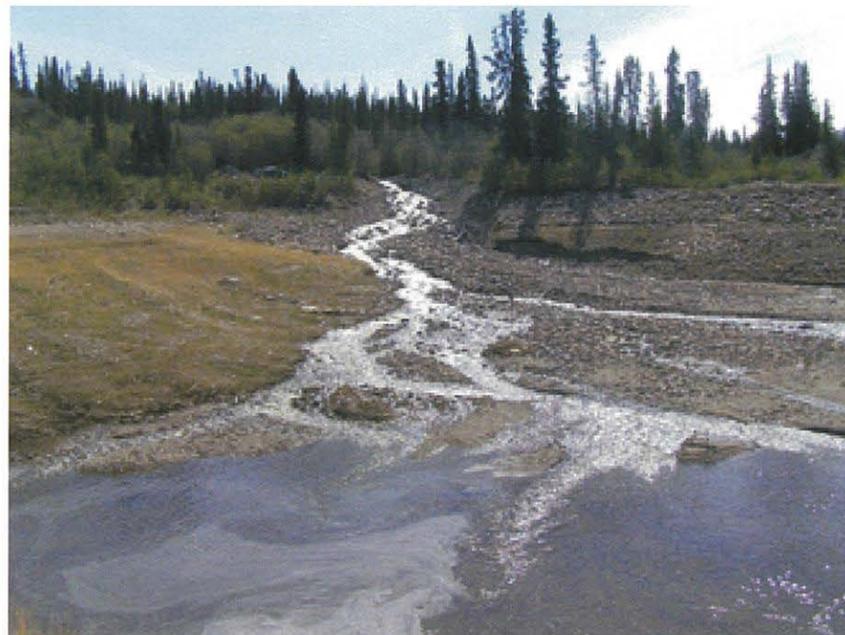
June: View of K8 Creek entering the reservoir area.

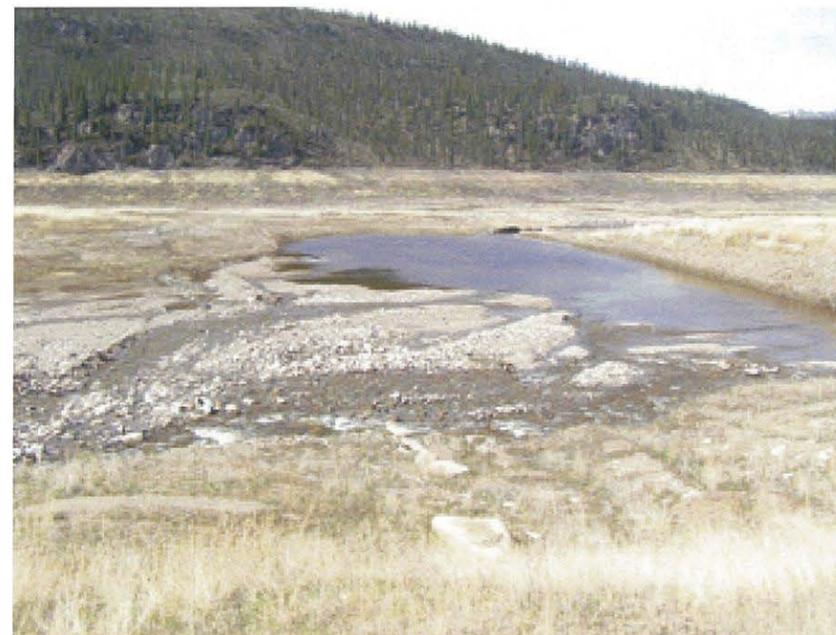
In 2004, riprap was placed within the K8 Creek tributary in a location where significant erosion was occurring (BGC 2004). In 2005, some minor repairs were carried out following some minor movement of the riprap (BGC 2006). The minor repairs (placement of additional riprap) were completed by site personnel. The riprap appears to have arrested the erosion (Figure 11) and a distinct channel is beginning to form downstream from the borrow pit, although this process is not yet complete (Figure 11).

June: View of the K8 Creek entering the reservoir area from the borrow pit
Note that the water flow has now formed into a distinct channel at the outlet of the borrow pit.

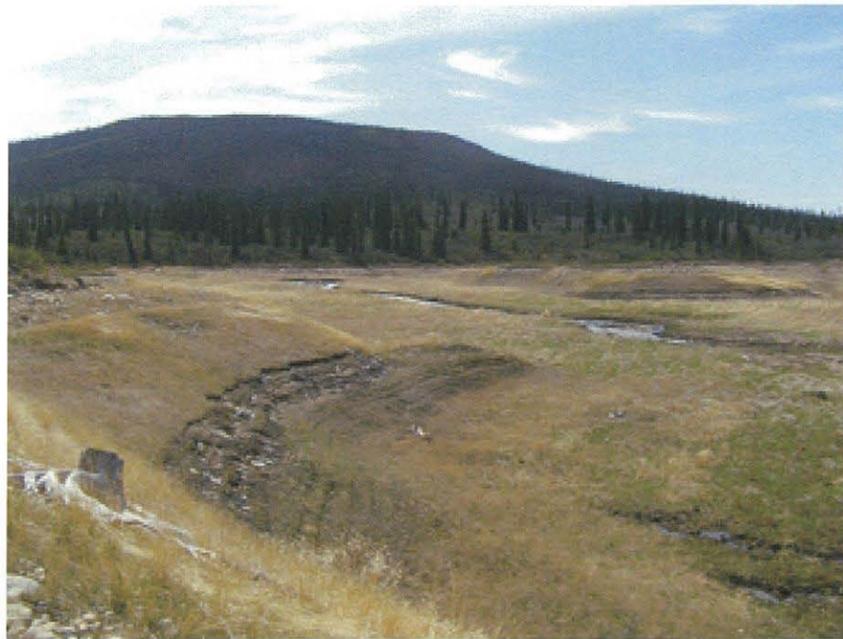
June: Shows the condition of the vegetation at the upstream end of the reservoir. The early phases of re-vegetation in the upper part of the former reservoir appears to be performing better than the later (lower) re-vegetation efforts.

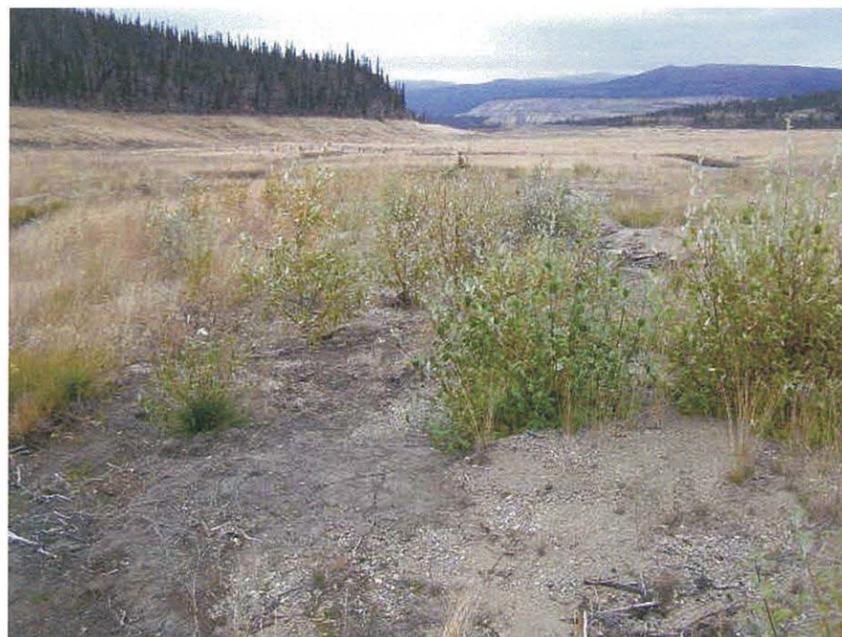
September: Shows an overall view of the vegetation in the former reservoir bottom. Note the recent sand and fines deposited by creek.

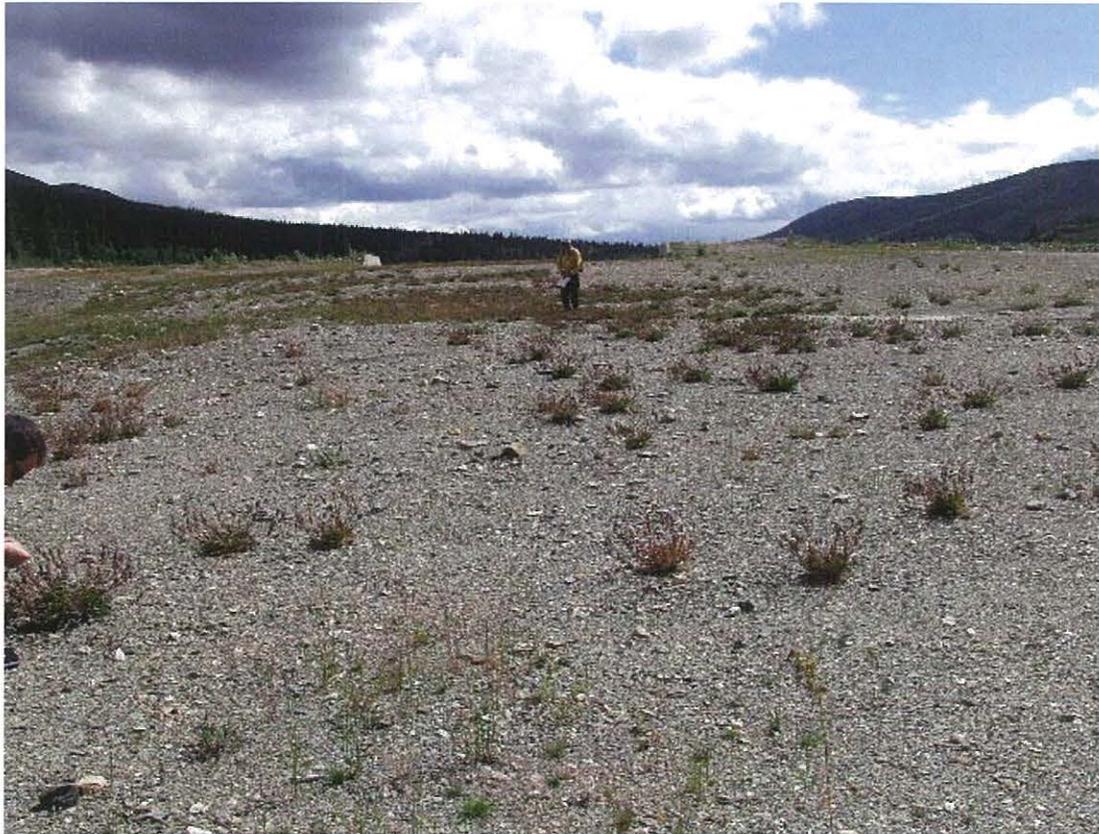
Sparse growth in some areas of Phase V, July 2006

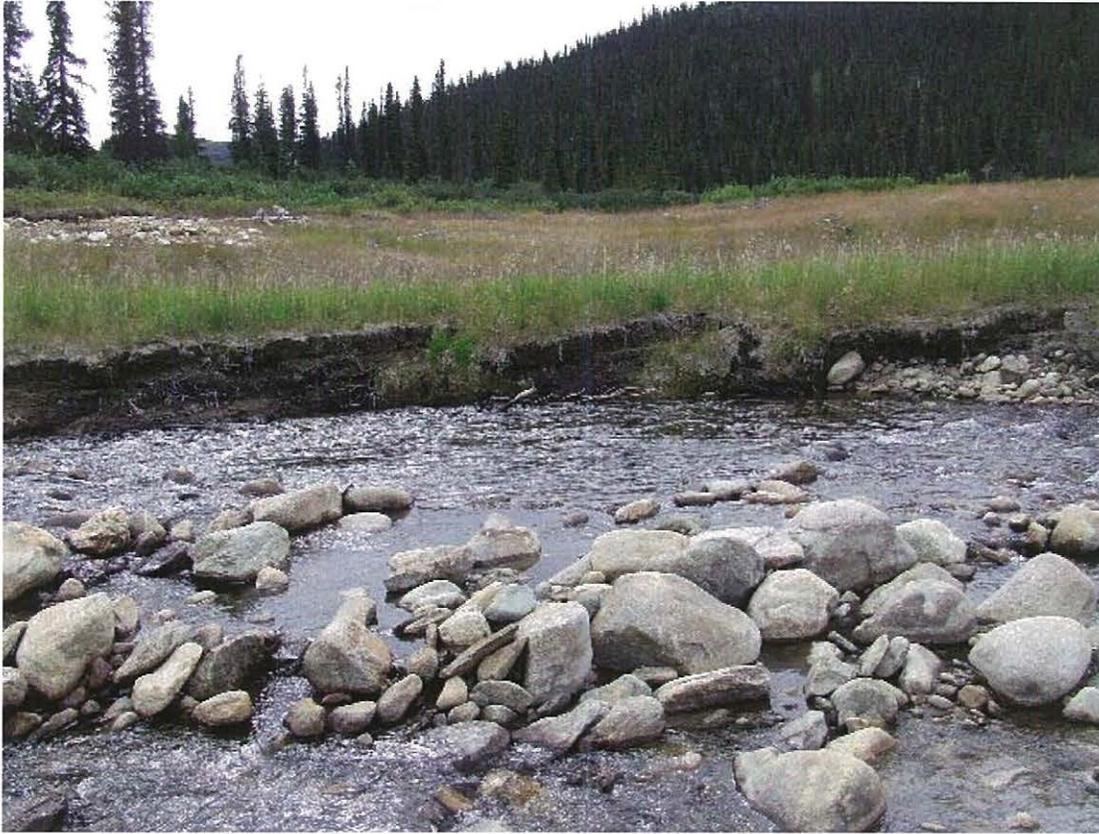
Some erosion of the banks near the inlet, July 2006.

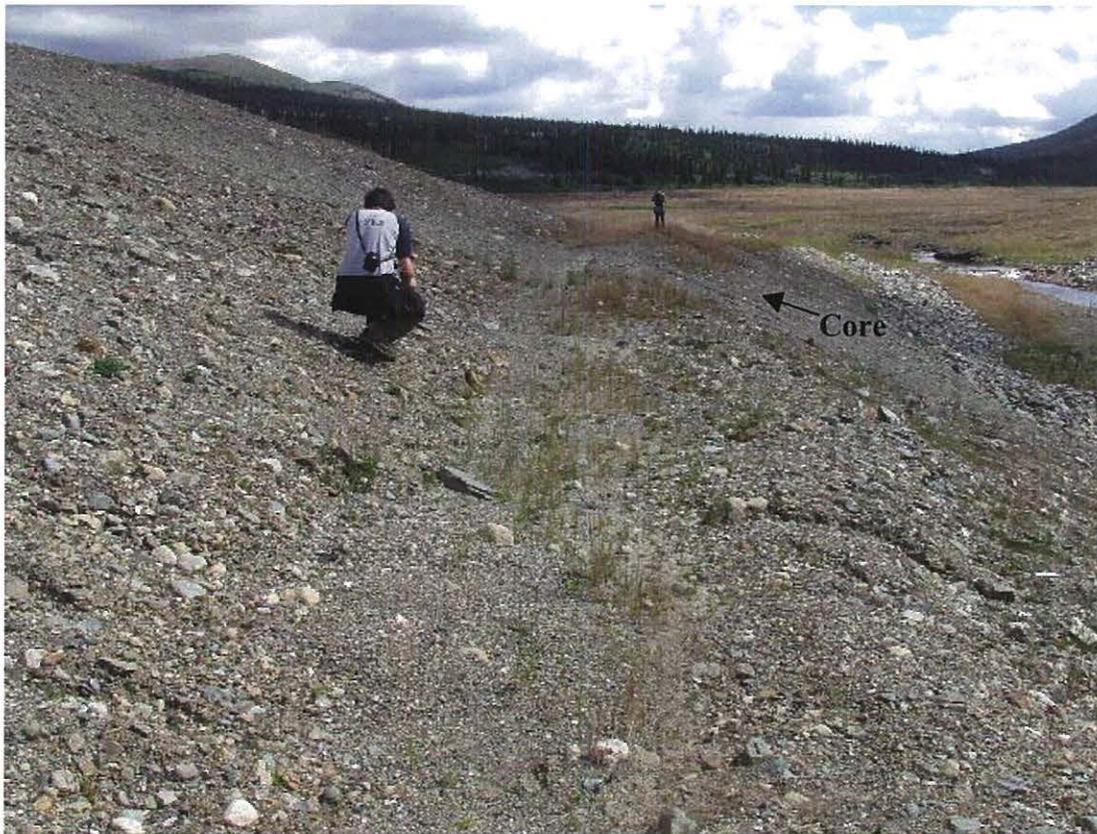
Sparse growth on the breached walls of the dam. Note that very little growth has taken place on the core of the dam.

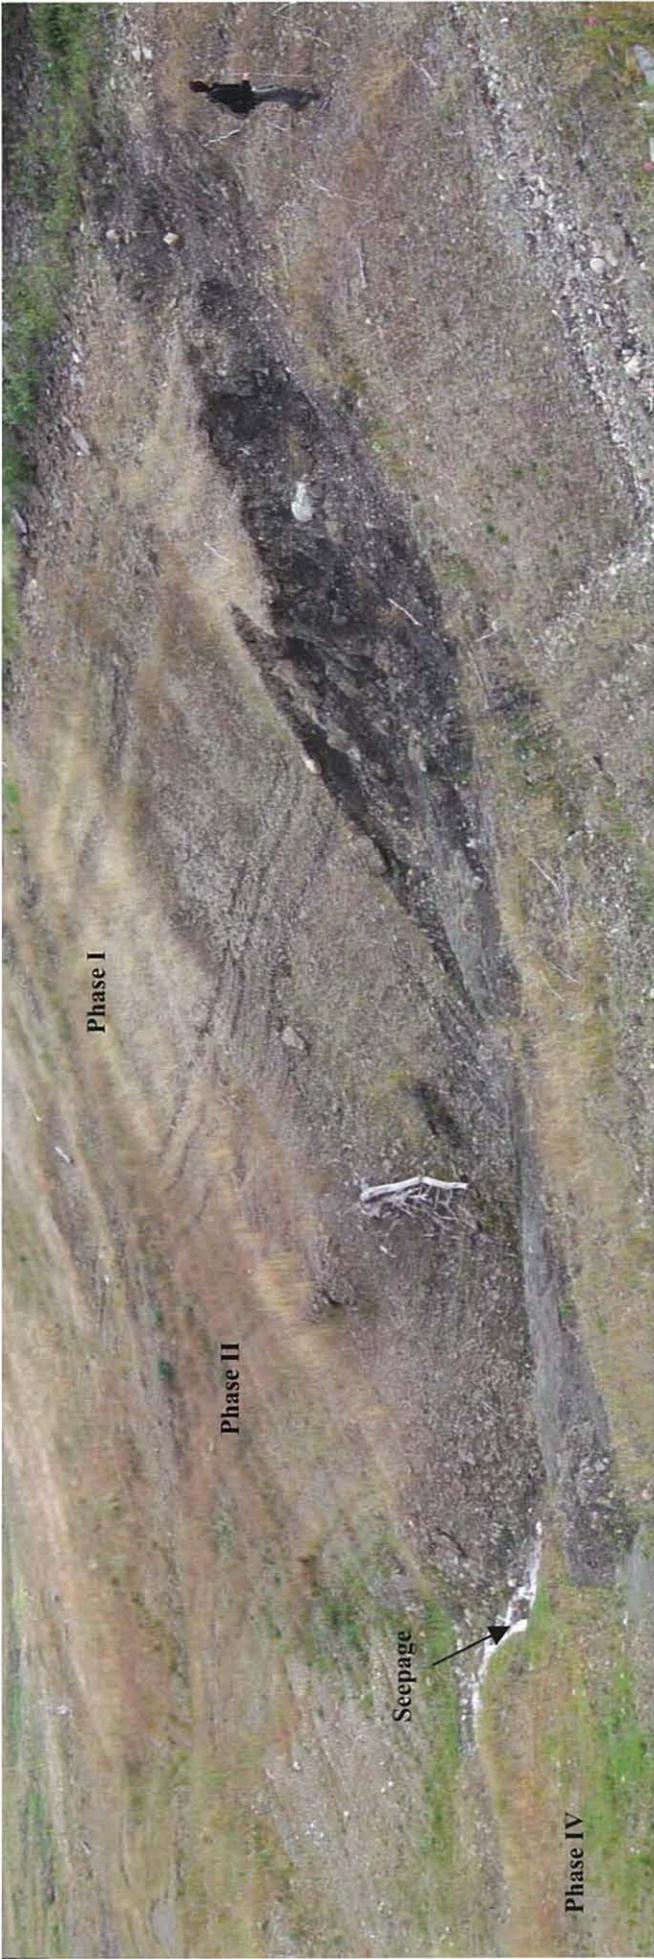
Panoramic view of the eroded gully, July 2006.

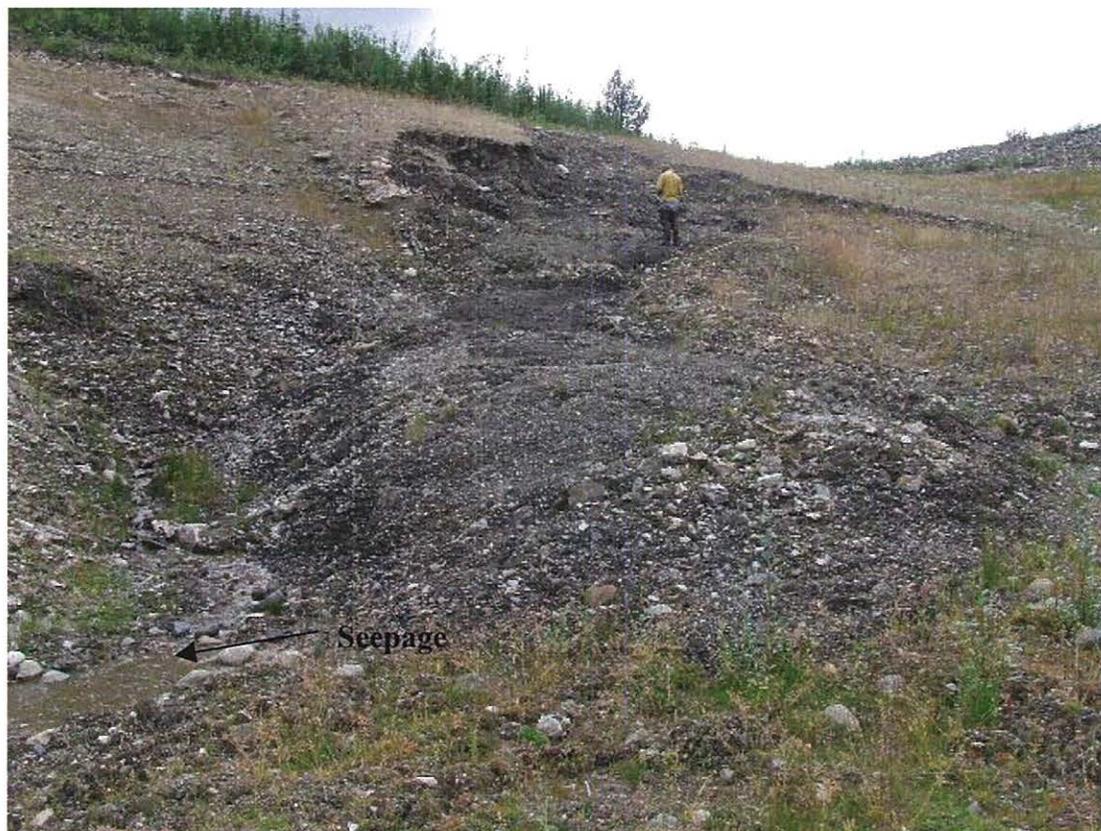
The eroded gully appears to be stabilizing and new grass growth is occurring on the earth that slumped last season.

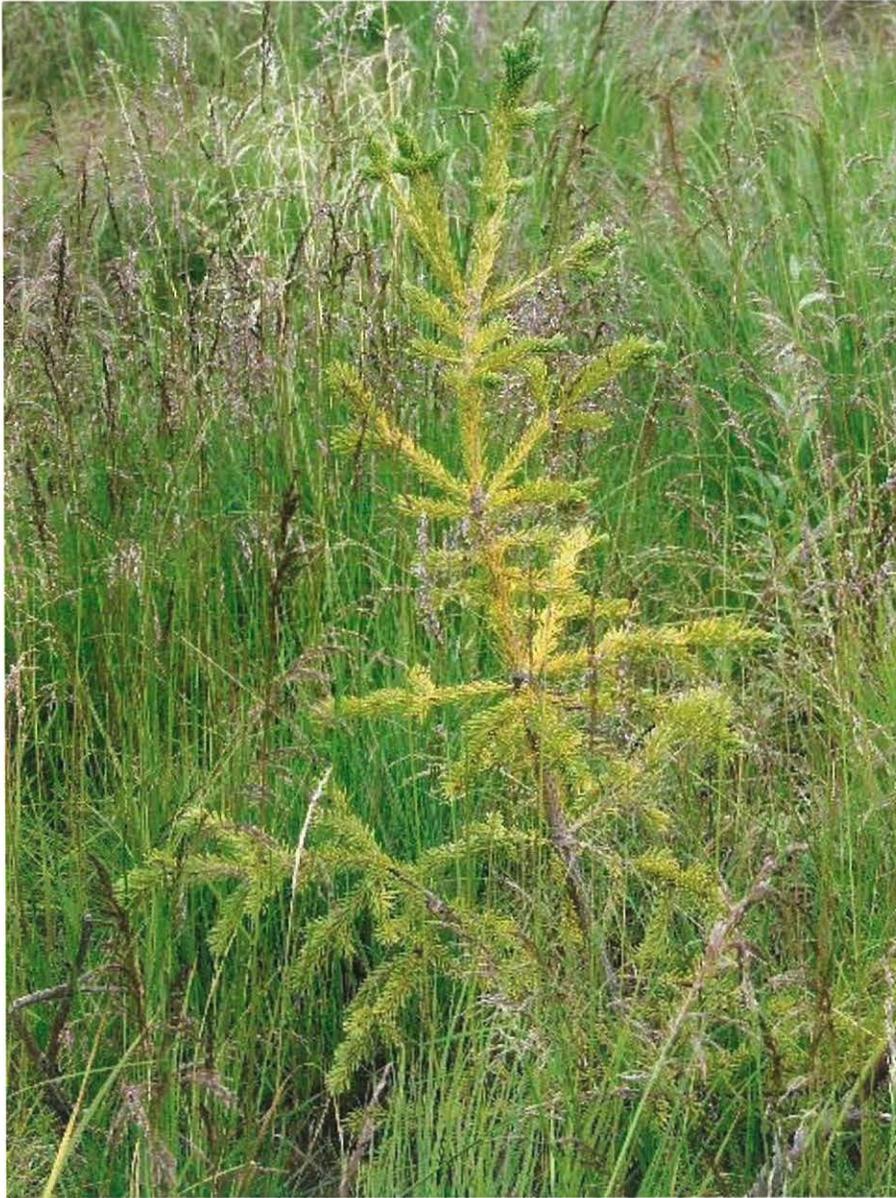
A transplanted spruce is surviving but not thriving, although some branches support new growth, July 2006.

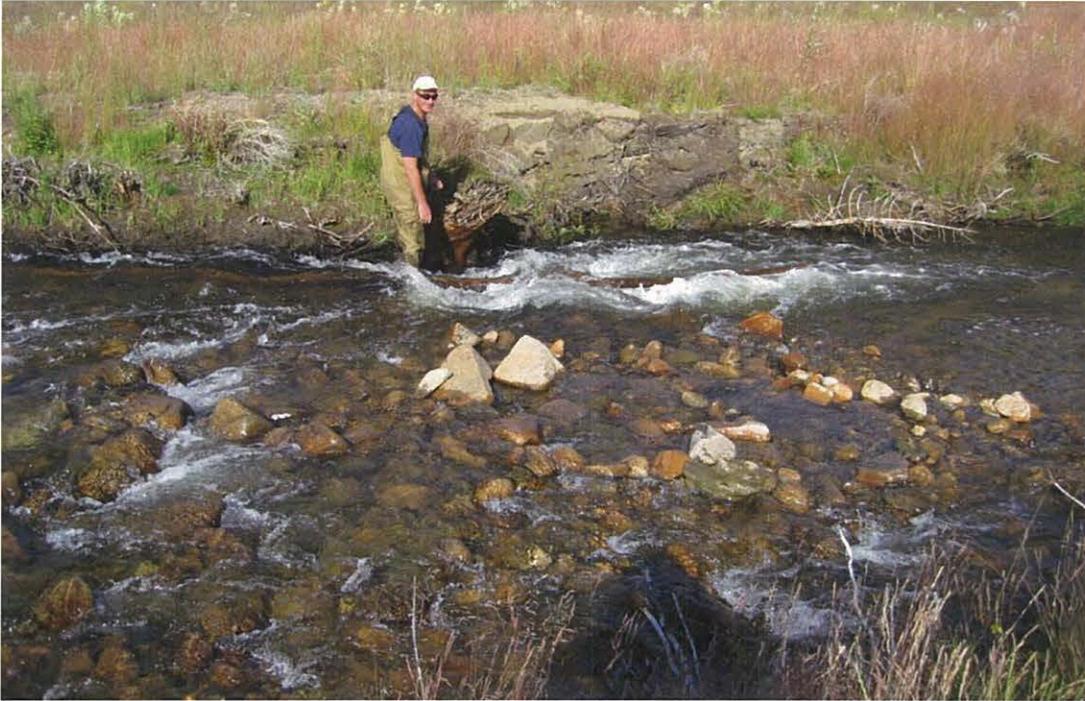
Photo #5: Ongoing erosion on reach 1, 2006.

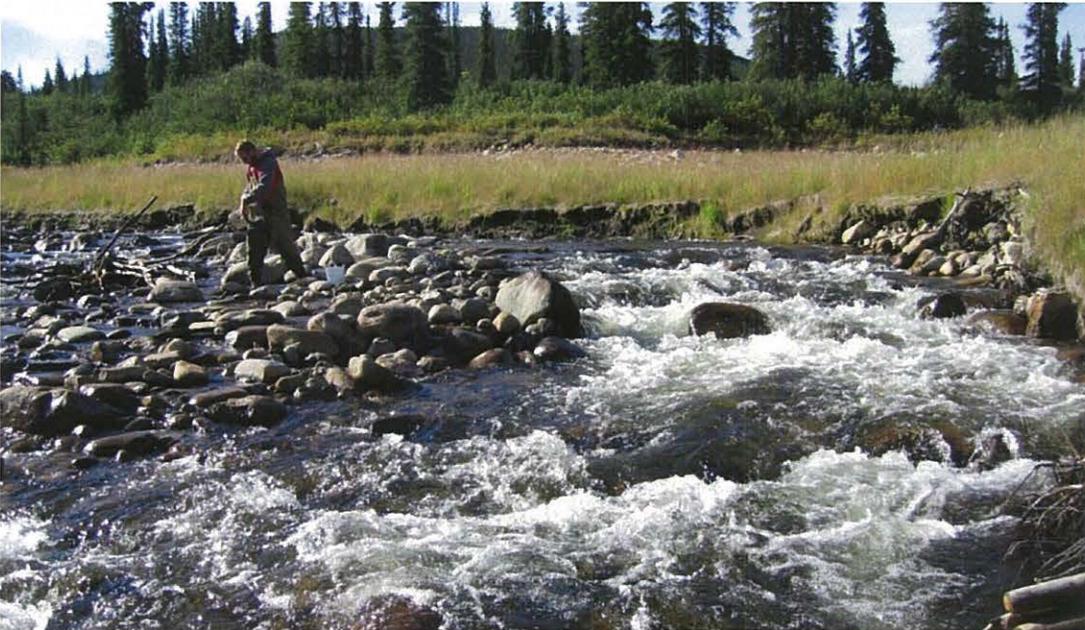
Photo #6: Continuing erosion in Reach 1 during 2006 at location of major erosion from 2004.

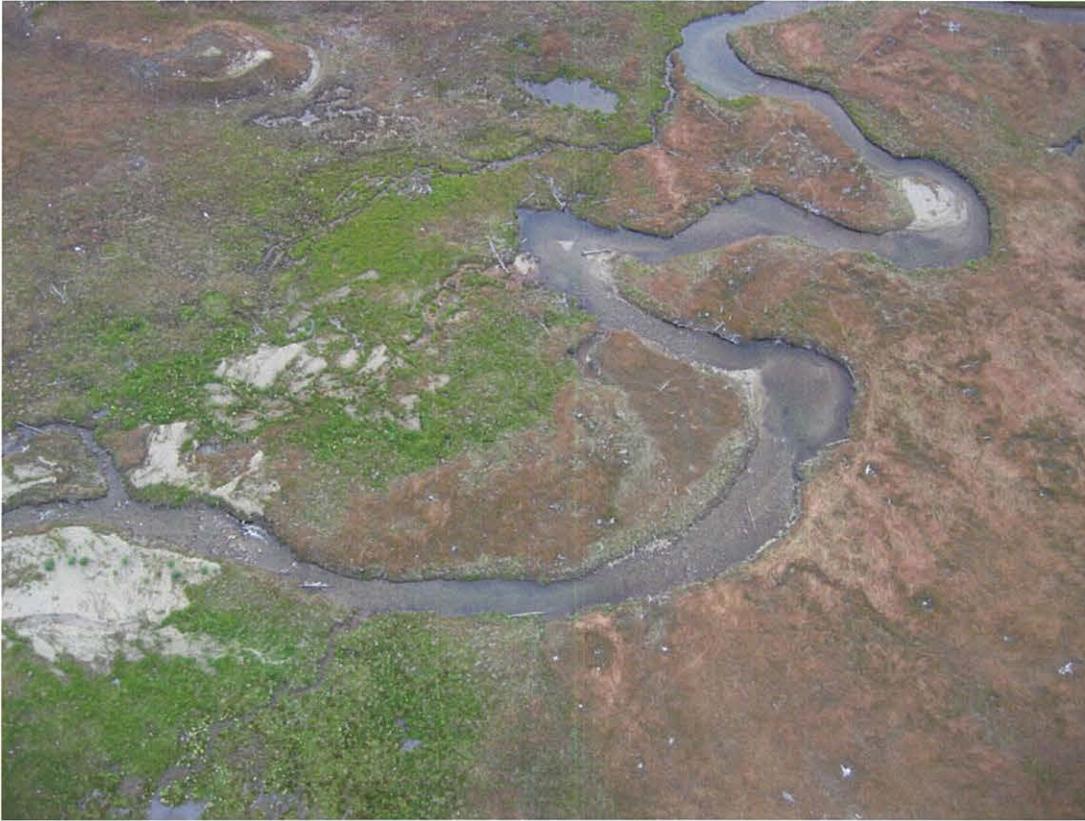
Photo #7: Upstream end of reach 2, August, 2006 with showing erosion bank on lower right and gravel deposition from freshet flows on left

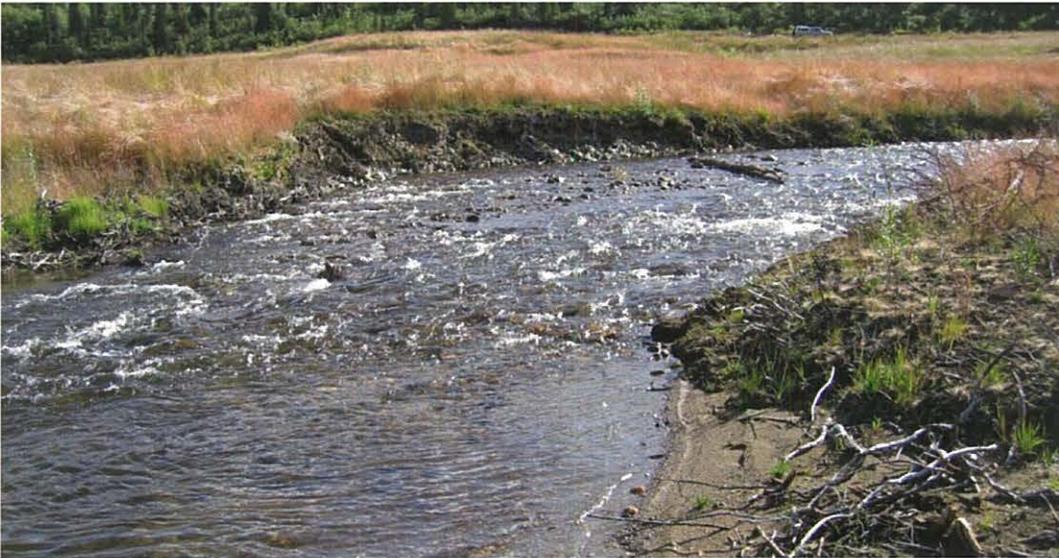
Photo #8: Active erosion bank in upper reach 2, 2006

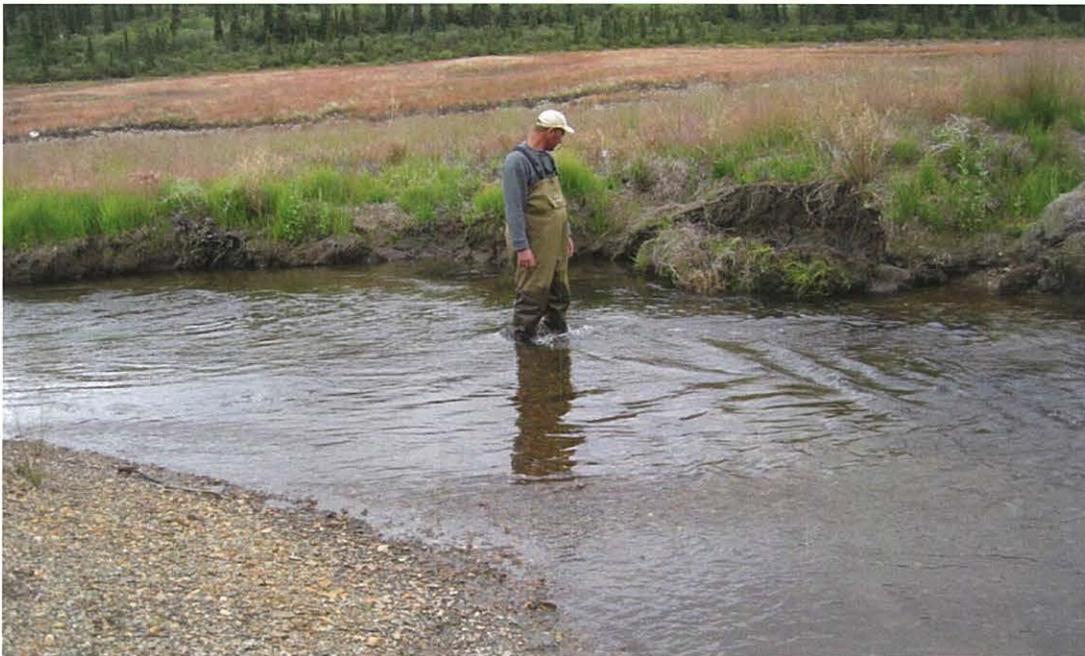
Photo #9: Eroding “rolled” banks in reach 3, 2006.
