2006 ANNUAL REPORT

FRESH WATER SUPPLY DAM BREACH PROJECT FARO MINE, YUKON

PROJECT NO.: 0257-040-01
DATE: JANUARY 26, 2007

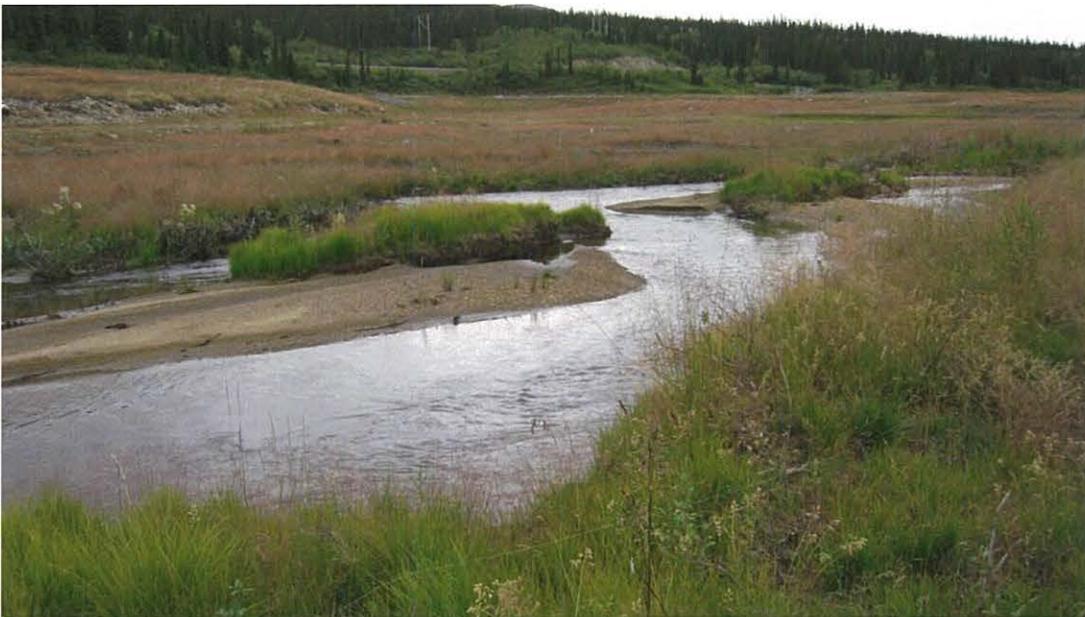
Photo # 10: Gravel bar development and non-confining banks in reach 3, 2006.

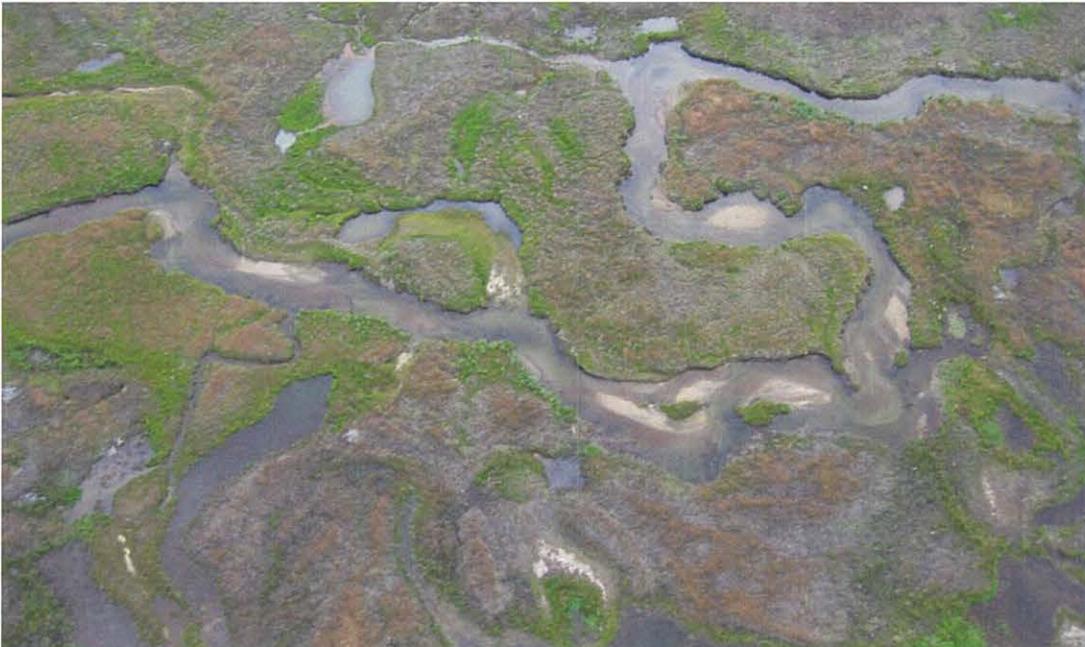
Photo #12: Sand and gravel bar development with non-confining banks in reach 3, 2006.

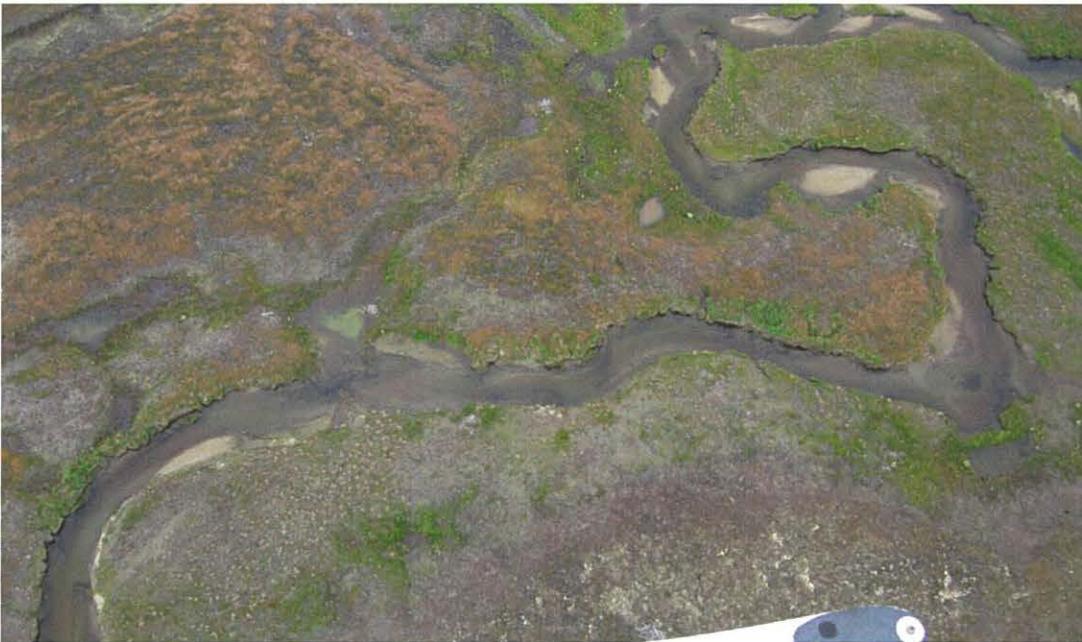
Photo #14: The same bend as in photo #13 in 2006, note increase in non-confining banks.

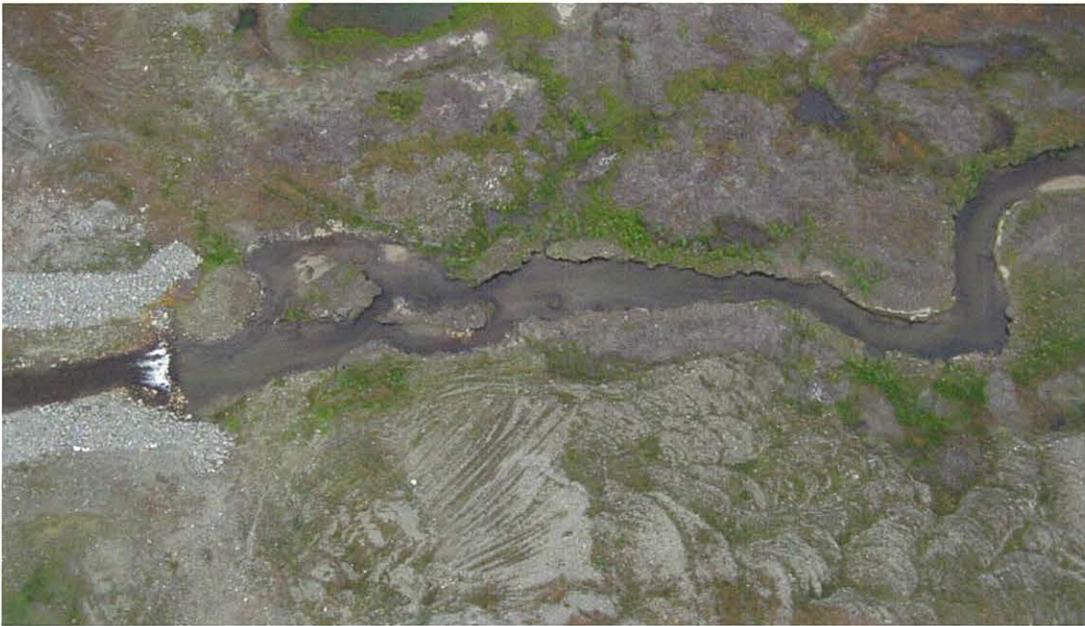
Photo # 17: The downstream end of reach 3 at the old coffer dam in August of 2006. Channel widening and in-stream deposition are clearly visible in comparison to photos # 15 and 16.

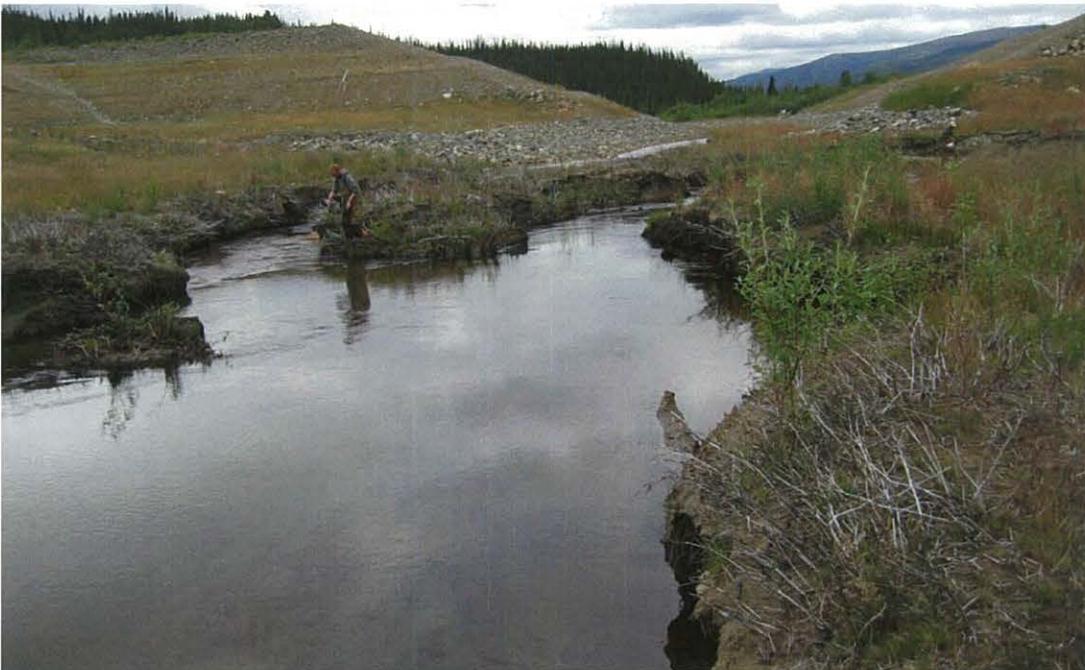
Photo #18: Active erosion upstream of the old coffer dam, 2006.
