**ANVIL RANGE PROPERTY
2007 DAM SAFETY REVIEW
Cross Valley Dam, Intermediate Dam,
and Little Creek Dam**

Prepared for
Deloitte & Touche Inc.

April 9, 2008

**Anvil Range Mining Complex
2007 Dam Safety Review for
Cross Valley, Intermediate and Little Creek Dams**

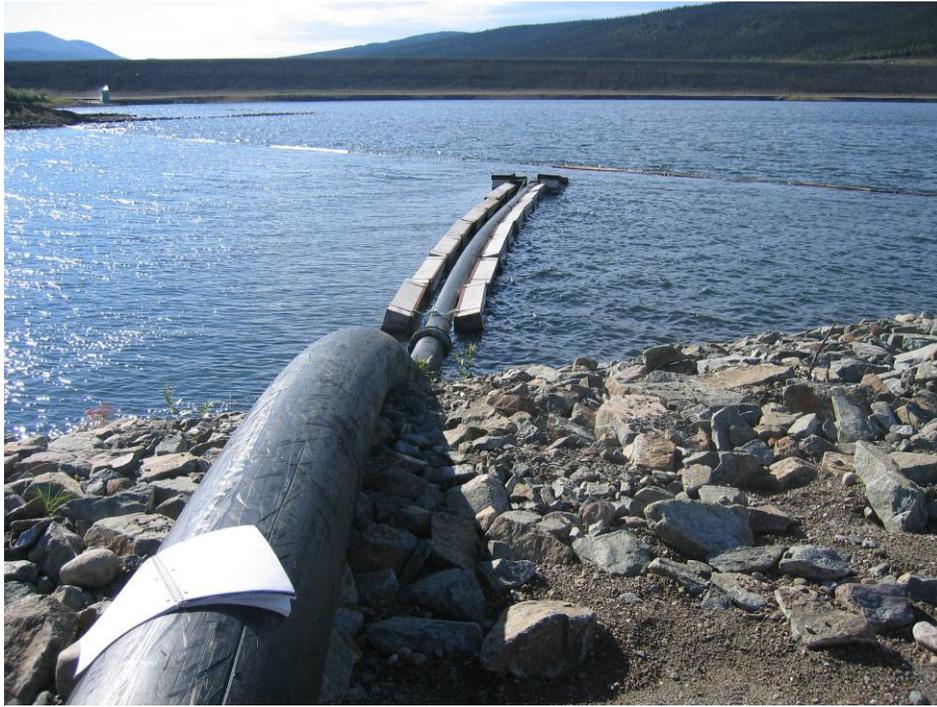
Photo II - 1 - Cross Valley Dam Floating Syphon Inlet.

The right abutment syphon is used to control the level of the polishing pond. The syphon has a floating intake as shown in Photo II-1 which conveys pond water to an HDPE pipe, Photo II-2, thence to Rose Creek, well downstream of the toe of the dam. The inlet and pipe are performing acceptably. If the syphon is overwhelmed, there is a rock lined spillway in alluvium on the right abutment as shown on Photo II-3. The rockfill lining is in good shape but there are no records to show that the spillway has ever seen flow. BGC notes in their 2006 report that the rockfill lining needs to be repaired in spots.

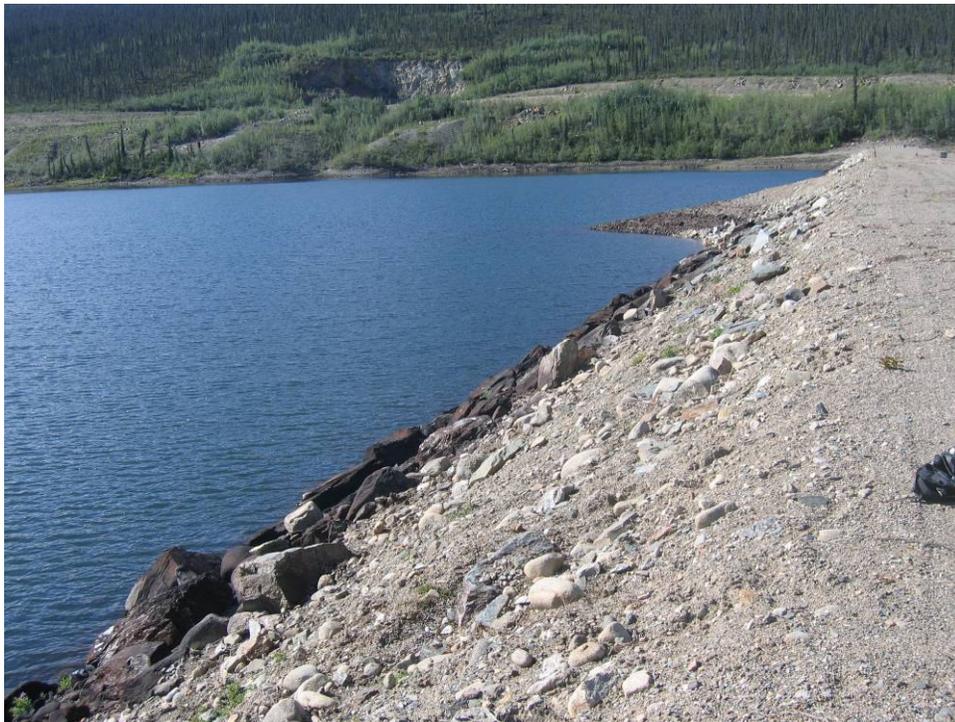
Photo II-6 shows the upstream slope of the dam from the right abutment looking south. Generally there is a lack of riprap above the previous high water mark on the upstream slope which is again illustrated in Photo II-7. There are a few spots where the riprap is beached or washed out but these minor repairs are part of normal maintenance. BGC (2007) shows that, at times, the polishing pond level drops below the base of the upstream riprap. This should be avoided as upstream wave action could erode the face of the dam.

Photo II - 6 – Cross Valley Dam – Upstream slope without riprap above high water mark – looking south from right abutment.

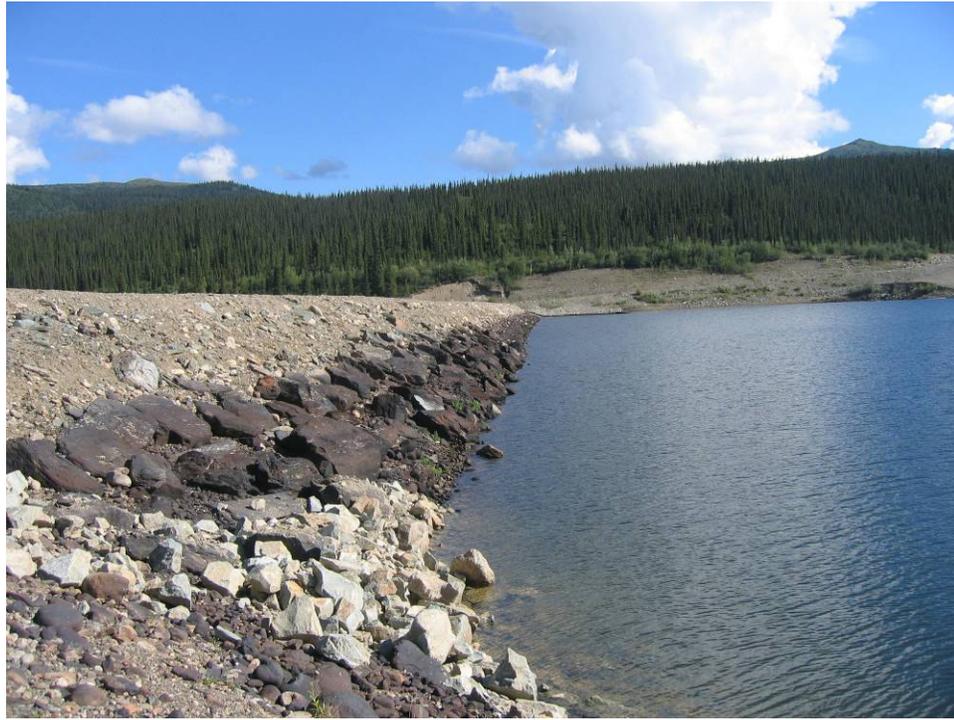
Photo II - 7 – Cross Valley Dam – Upstream slope from left abutment looking north.

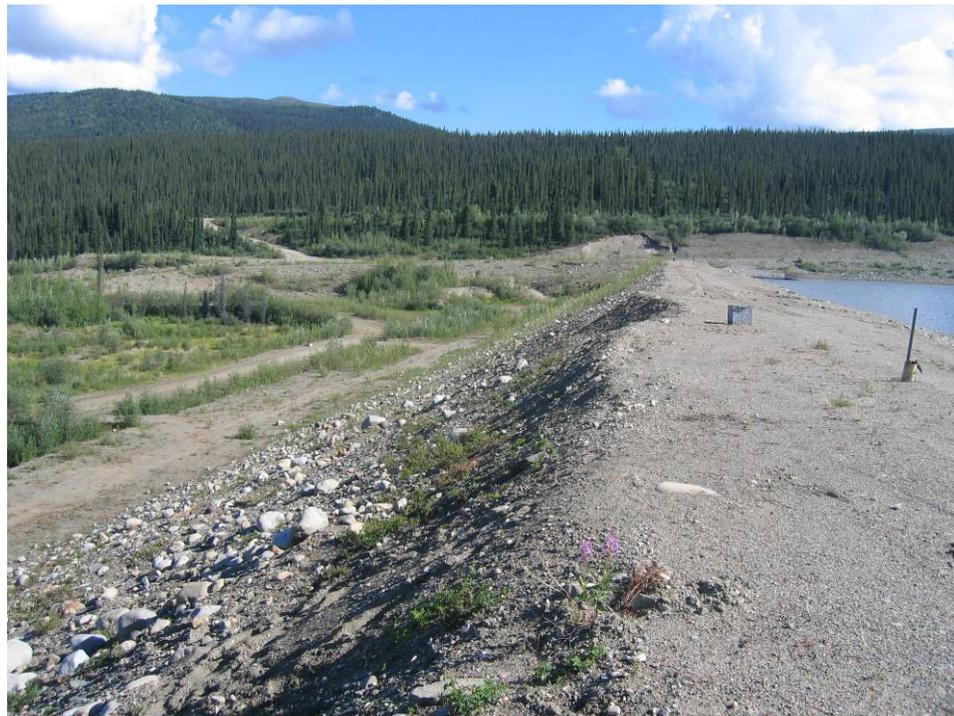
Photos II-8 and II-9 show the downstream slope from the crest near the left abutment. There is a lack of vegetation on the downstream slope. The slope itself is in good shape with few erosion gulleys. Photos II-8 and II-9 also show the crest of the dam which is good shape without any signs of cracking or other distress.

Photo II - 8 – Cross Valley Dam – Downstream slope looking north.

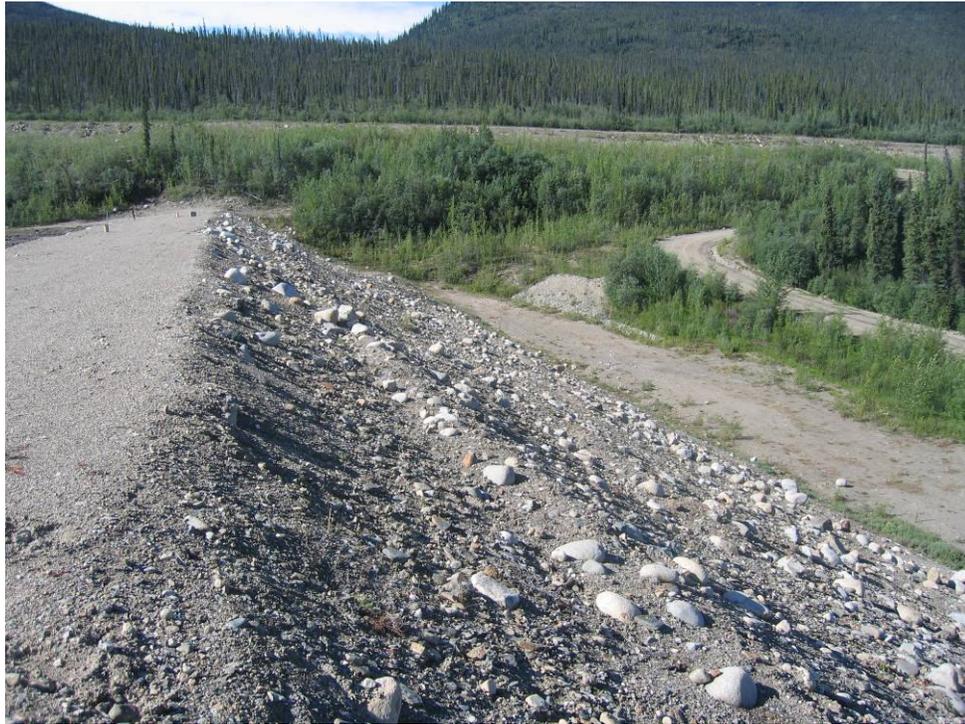
Photo II - 9 – Cross Valley Dam – Downstream slope looking south to left abutment.

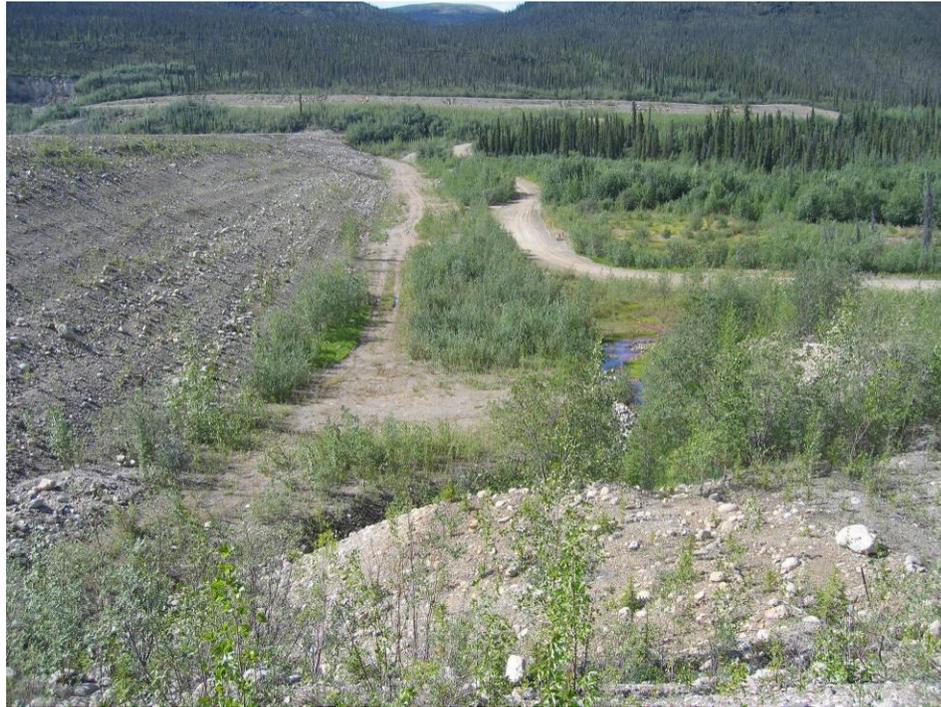
Photo II - 13 – Cross Valley Dam – Downstream slope from right abutment looking north. Note low trees on toe as shown on Photo II-5 from crest.

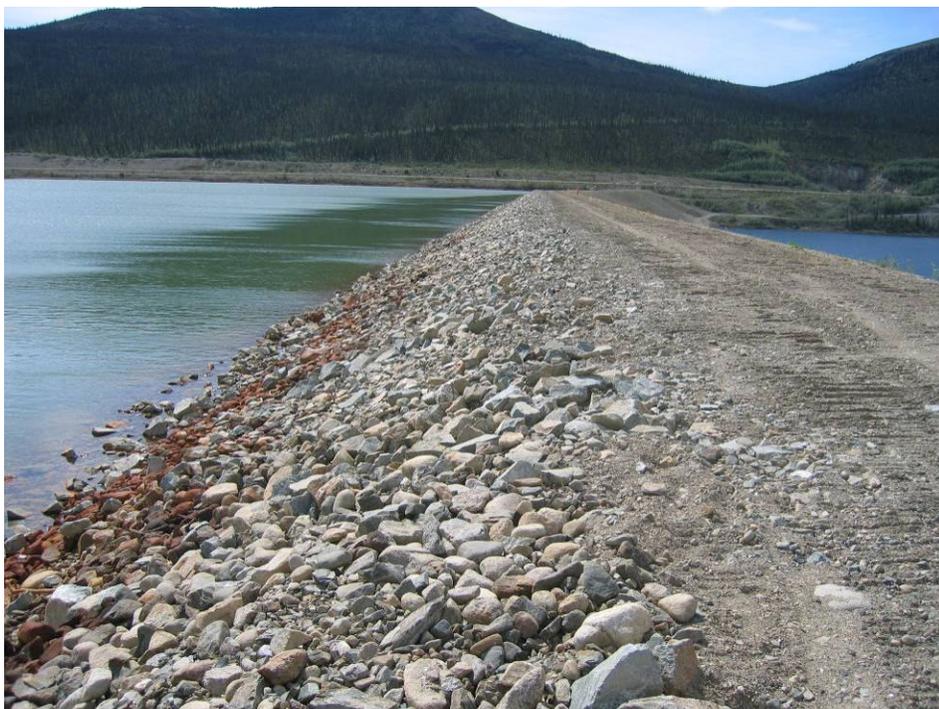
Photo II-18 shows the crest and the upstream slope riprap from the right abutment. Photo II-19 shows riprap beaching¹ on the upstream slope. Photo II-21 shows the upstream slope with riprap from the left abutment looking north. In general, the riprap is in good condition but will require a periodic maintenance as was done in 2007

Photo II - 18 – Intermediate Dam – Upstream riprap looking south from right abutment.

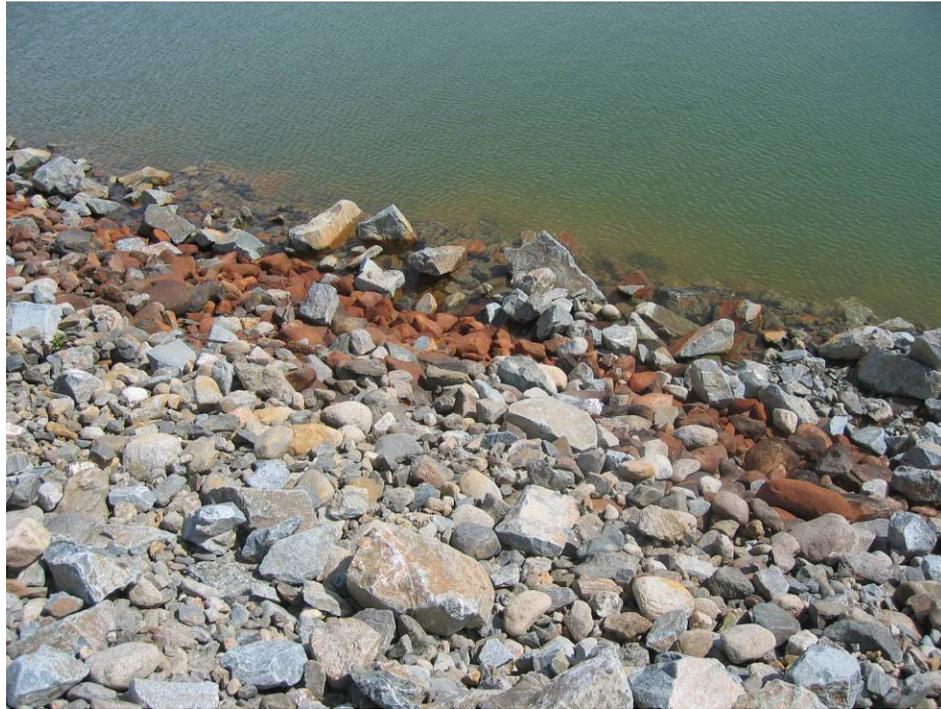
Photo II - 19 – Intermediate Dam – Riprap beaching.

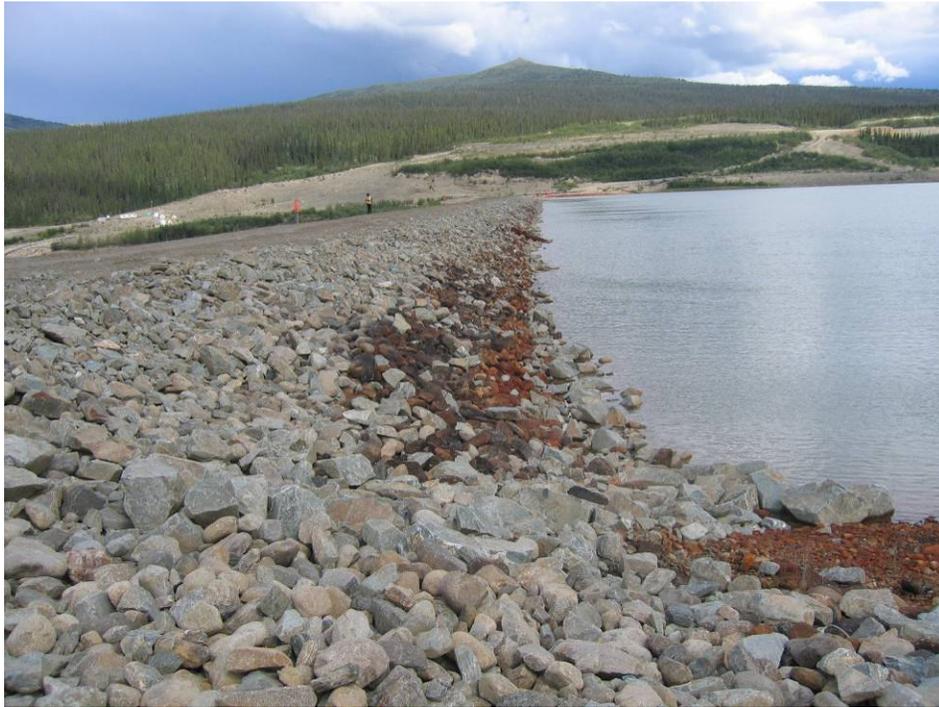
Photo II – 21 – Intermediate Dam – Upstream slope from left abutment looking north.

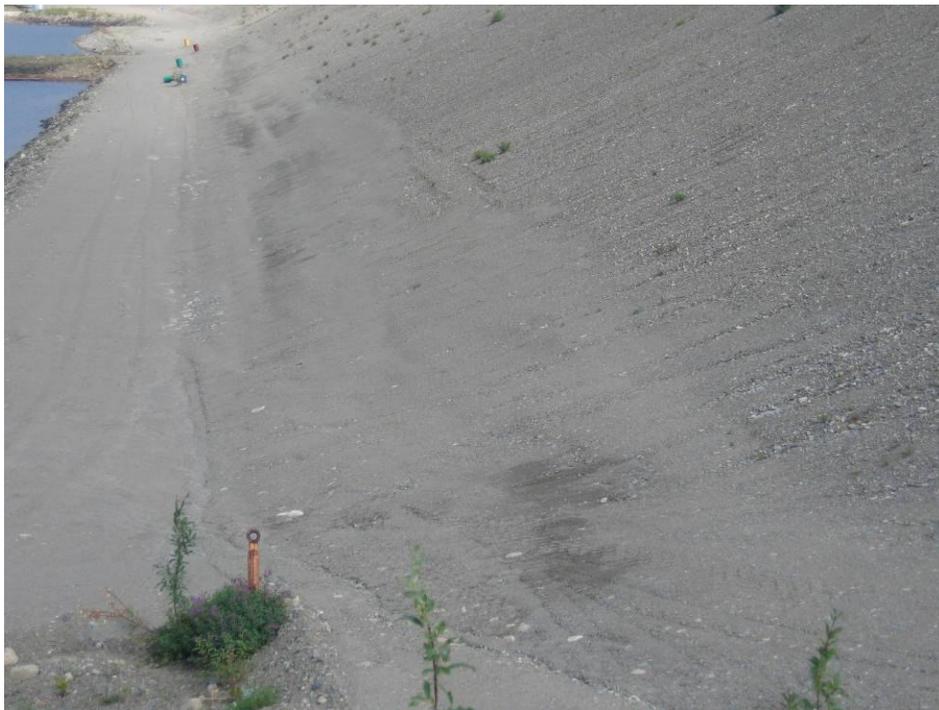
emanating from the drain above the 1031 m berm should be temporary and due to infiltration of precipitation only.

Photo II – 22 – Intermediate Dam – Downstream slope looking north along 1031m berm. Note drain exposure and minor erosion rills above drain.

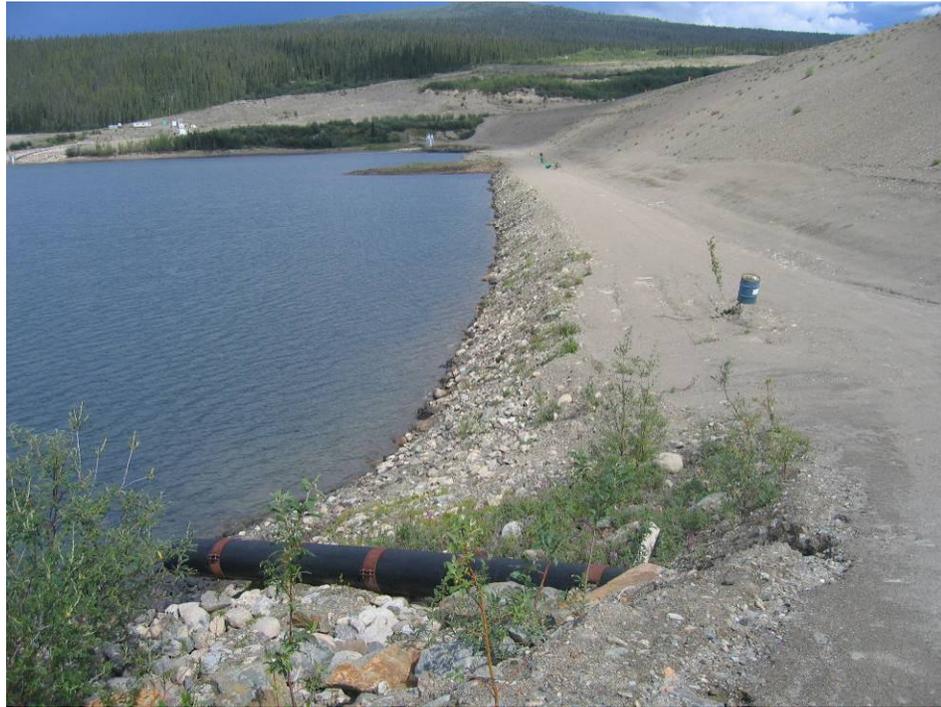
Photos II -23 and 24 show the 1031m berm from the left and right abutments respectively. Note that there is no riprap on the berm slope at the polishing pond but there is also no evidence of erosion. The 1031 m berm is in good shape with no evidence of cracks or slumps. Photos II-17 and II-18 show the crest of the dam which is also in good shape with no evidence of cracking or slumping.

Photo II – 23 – Intermediate Dam – 1031m berm looking north. No erosion of berm at waterline, no riprap.

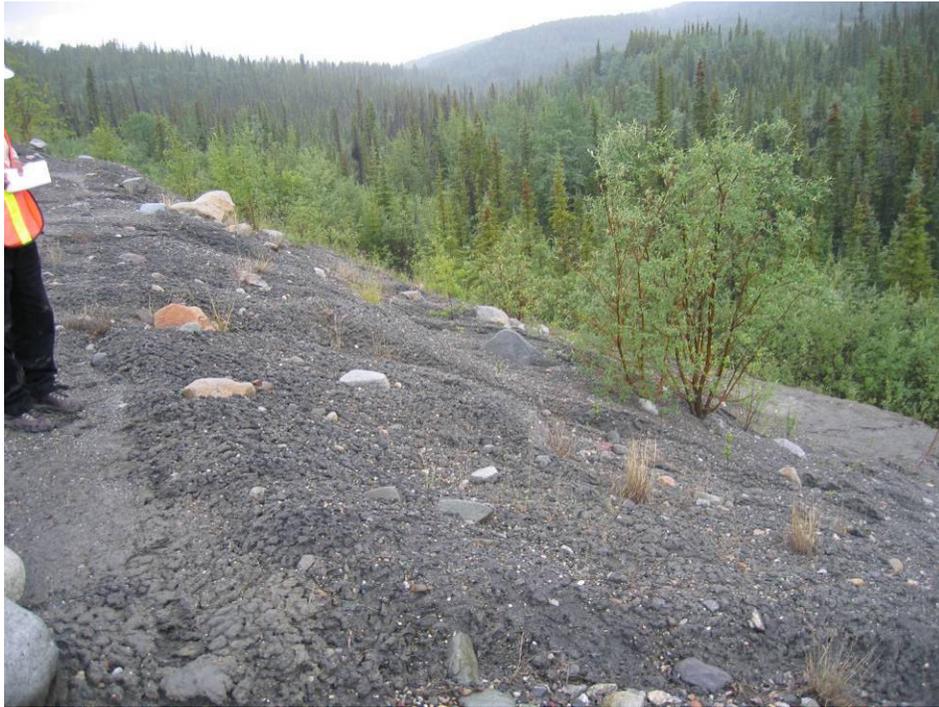
Photos 11-27, 28, and 29 show erosion and slumping on the downstream slope of the dam which requires repair. Because the downstream slope is glacial till, and not free draining sand and gravel like the Cross Valley Dam and the Intermediate Dam, it is subject to freeze/thaw softening. Rainfall then erodes gulleys into the loose surficial slope material. There is also shallow sloughing down the slope.

Photo II – 27 – Little Creek Dam – Downstream slope, note slumping.

This freeze/thaw loosening is common in similar dams in northern Canada and can be reduced by placing material on the downstream slope whose thickness exceeds the average frost penetration depth. This improvement needs to be designed to find the optimum material and construction procedure. Sand and gravel, filter compatible with the

glacial till, of thickness 2.5 m would be a suitable frost protection fill. This fill should be placed on the downstream slope from the bottom after stripping the slope of vegetation and loose material.

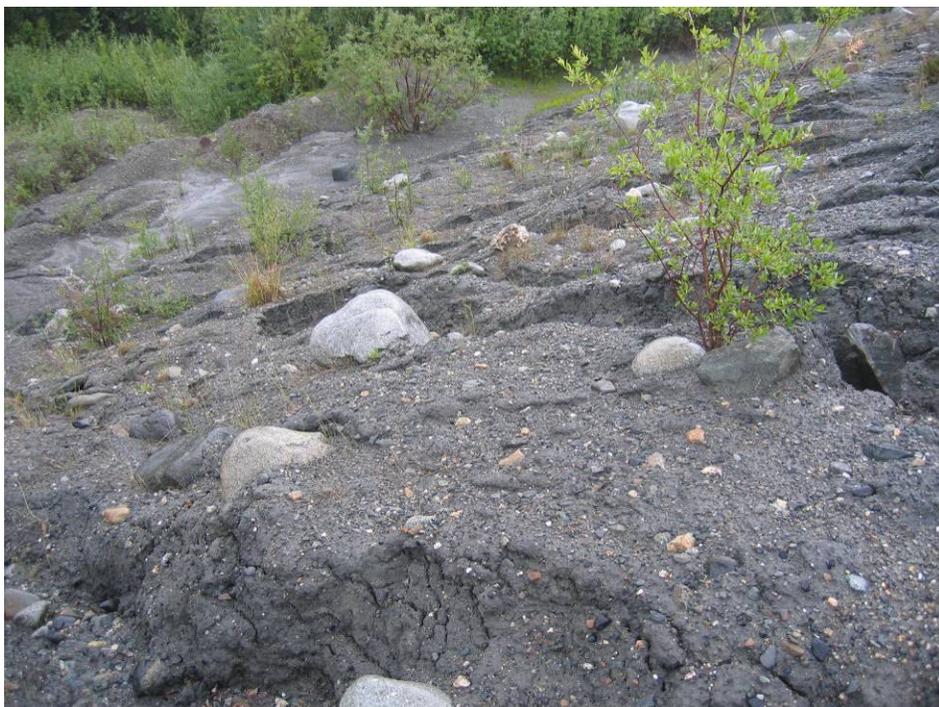
Photo II – 28 – Little Creek Dam – Slumping and erosion of slope at downstream toe.

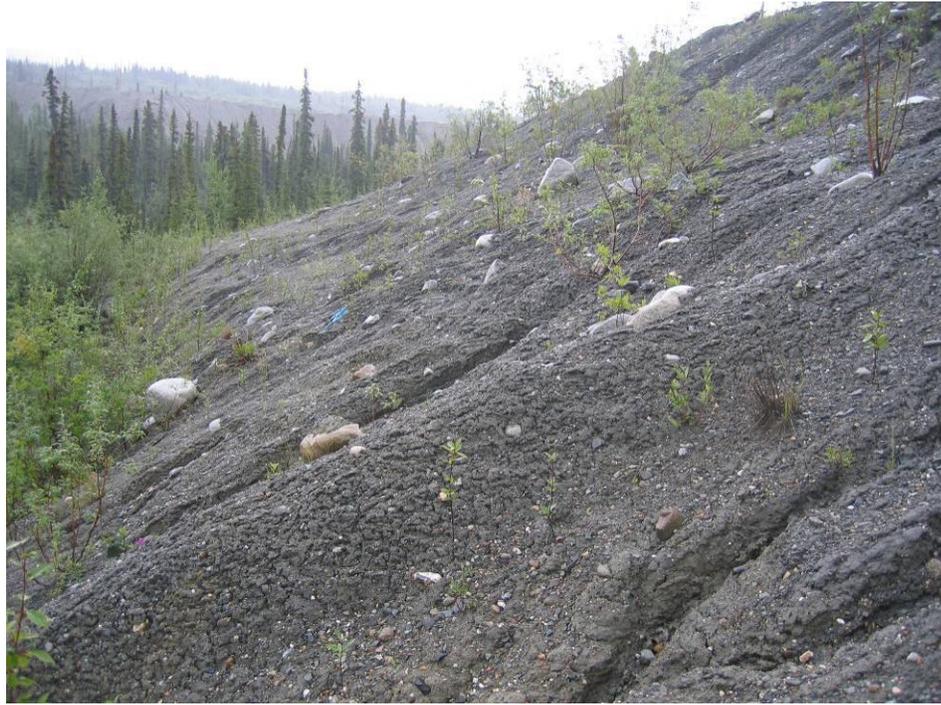
Photo II – 29 – Little Creek Dam – Slumping and erosion of downstream slope.
