Arctic Gold and Silver Tailings Site TA005

Monitoring Report 2010

Prepared by:
**Indian and Northern Affairs
Waste Management Program
Yukon Region**

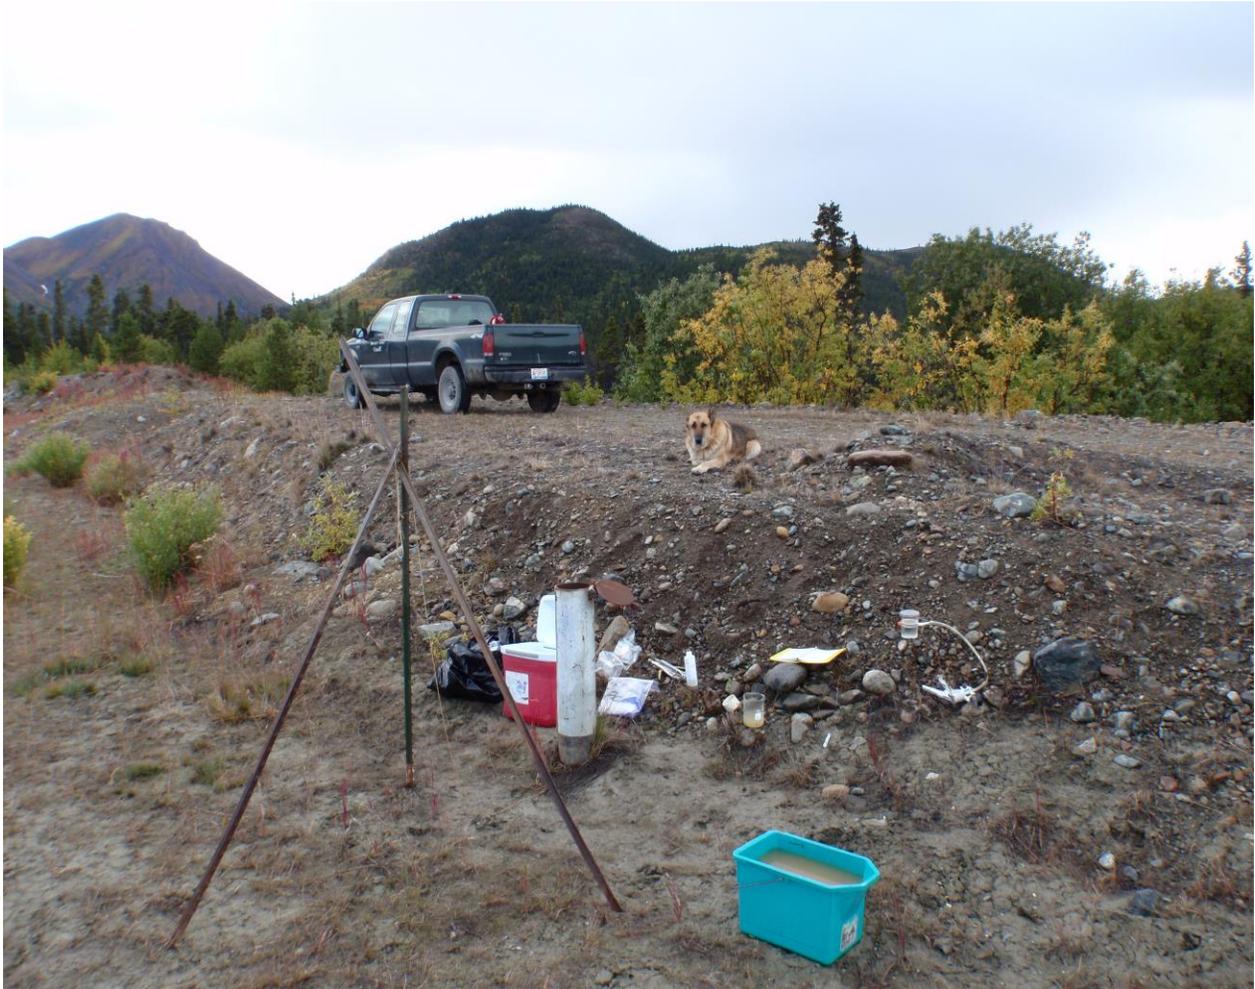
Photo 1: Sampling of monitoring well MW-2

The analysis of the groundwater samples for dissolved metals showed elevated levels of several metals in monitoring well MW-2 which is located near the lowest area in the tailings impoundment, next to the drainage channel. The results are generally higher again than the concentrations found in this well last year, after a trend of slightly lower levels in previous years (see **Table 2**). The water quality for this well (low pH and high conductivity – see **Table 1**) suggests that metals would be present in a dissolved state. Since the tailings are covered with a low permeable layer of clay capping material, acid generation should be strongly reduced or not happening at all. Seasonal outflow of water containing high levels of metals from the containment cell into the surface water of the Unnamed Pond via the spillway or by seepage is evident in surface staining of the lower portion of the spillway.

Table 2: Comparison of Metal Levels (dissolved) in Groundwater at MW-2

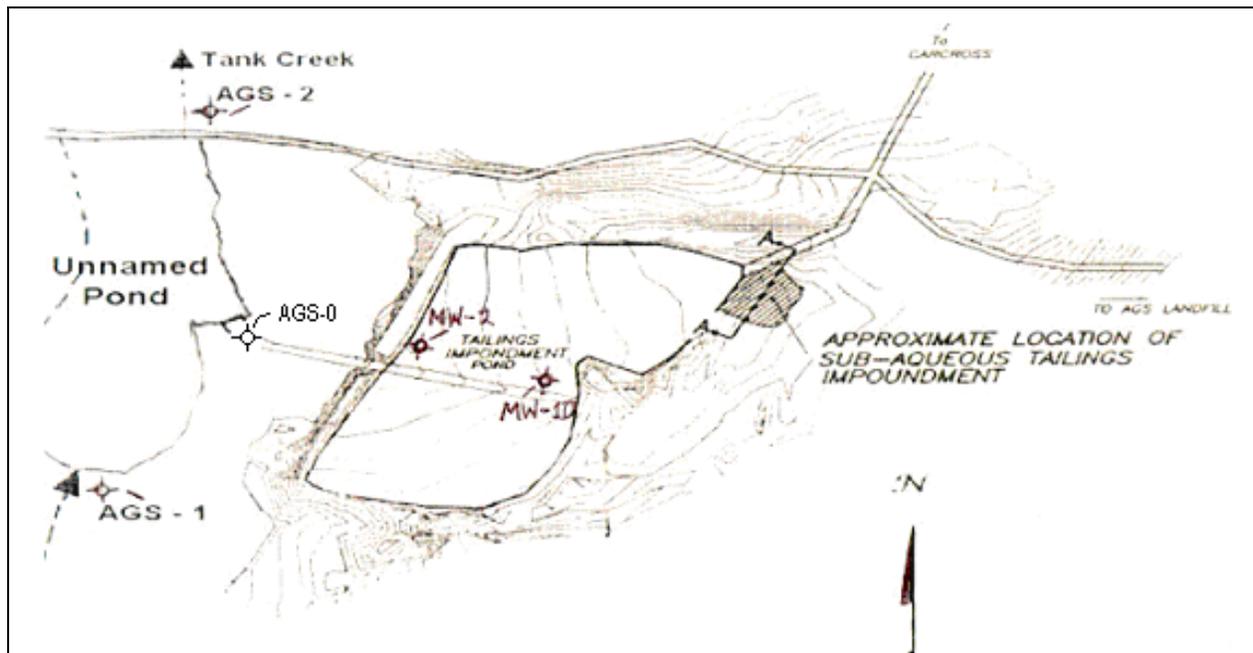
Figure 2: Water Sampling Locations

Groundwater samples were taken from two selected monitoring wells (MW-2 and MW-1D) within the tailings impoundment area (see **Figure 2**). The well volume was established and each well was purged (3 x well volume) prior to sampling. Water quality data as recorded on site is shown in **Table 1**. The samples were filtered (0.45 μm) and sent to an accredited laboratory for dissolved metals analysis.

Surface water samples were taken from Tank Creek at the inflow (AGS-1) and outflow (AGS-2) of the unnamed lake as well as at the point of seepage from the tailings pile (AGS-0). Water quality data as recorded on site is shown in **Table 1** and sampling locations on **Figure 2**. The samples were filtered (0.45 µm) and sent to an accredited laboratory for dissolved metals analysis.

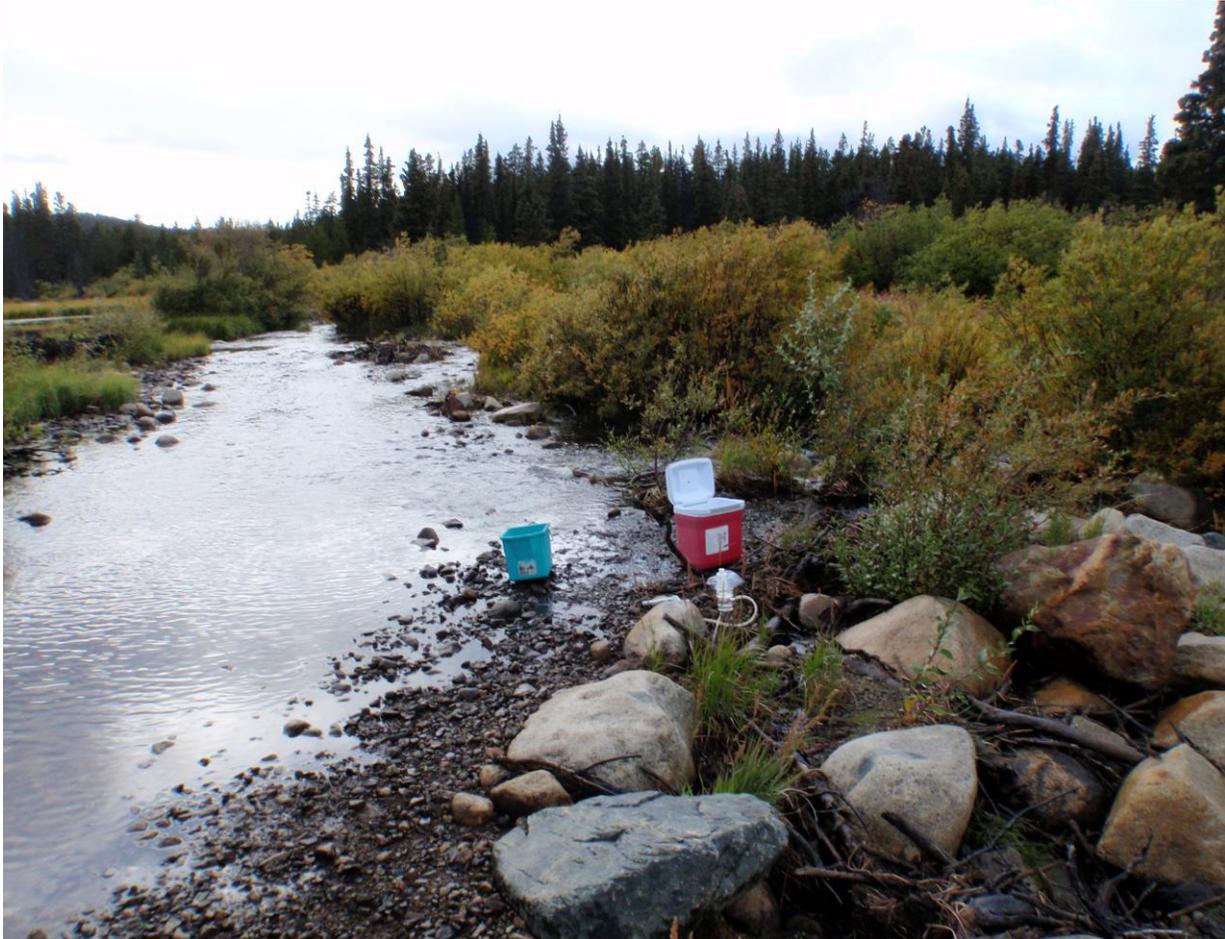
Photo 3: Surface water sampling at the outflow of the unnamed pond.

The analysis of the surface water samples for dissolved metals indicated a slight but insignificant increase in metal content in the outflow sample compared to the inflow (see **Appendix** for analytical report). The concentrations are below the Yukon Contaminated Sites Regulations and CCME guidelines for the protection of aquatic life (YCSR 2002, CCME 2002).

The annual monitoring will be continued.
