Arctic Gold and Silver Tailings Site TA005

Monitoring Report 2010

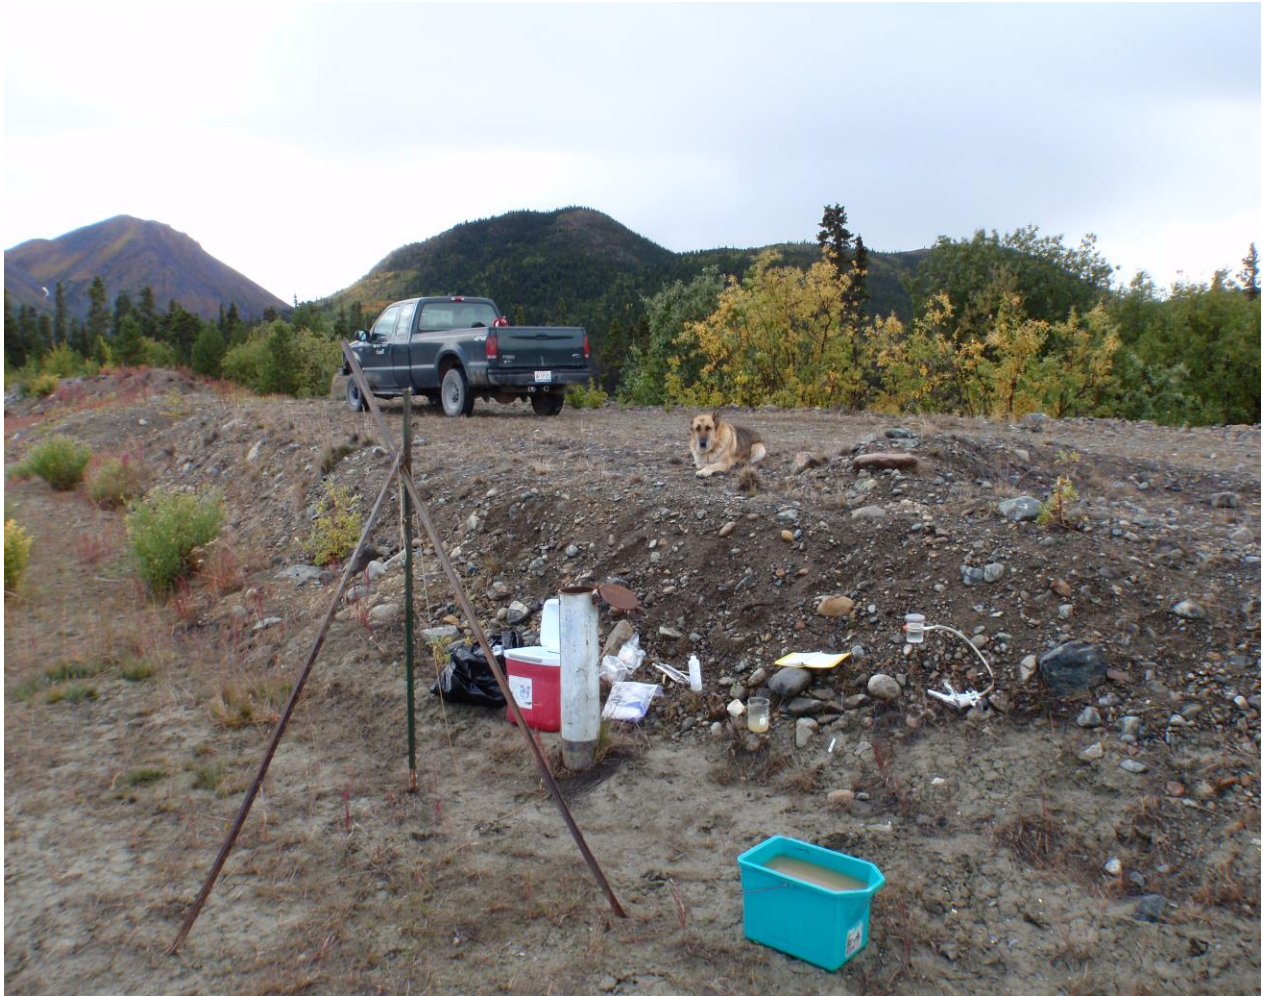
Photo 1: Sampling of monitoring well MW-2

The analysis of the groundwater samples for dissolved metals showed elevated levels of several metals in monitoring well MW-2 which is located near the lowest area in the tailings impoundment, next to the drainage channel. The results are generally higher again than the concentrations found in this well last year, after a trend of slightly lower levels in previous years (see **Table 2**). The water quality for this well (low pH and high conductivity – see **Table 1**) suggests that metals would be present in a dissolved state. Since the tailings are covered with a low permeable layer of clay capping material, acid generation should be strongly reduced or not happening at all. Seasonal outflow of water containing high levels of metals from the containment cell into the surface water of the Unnamed Pond via the spillway or by seepage is evident in surface staining of the lower portion of the spillway.

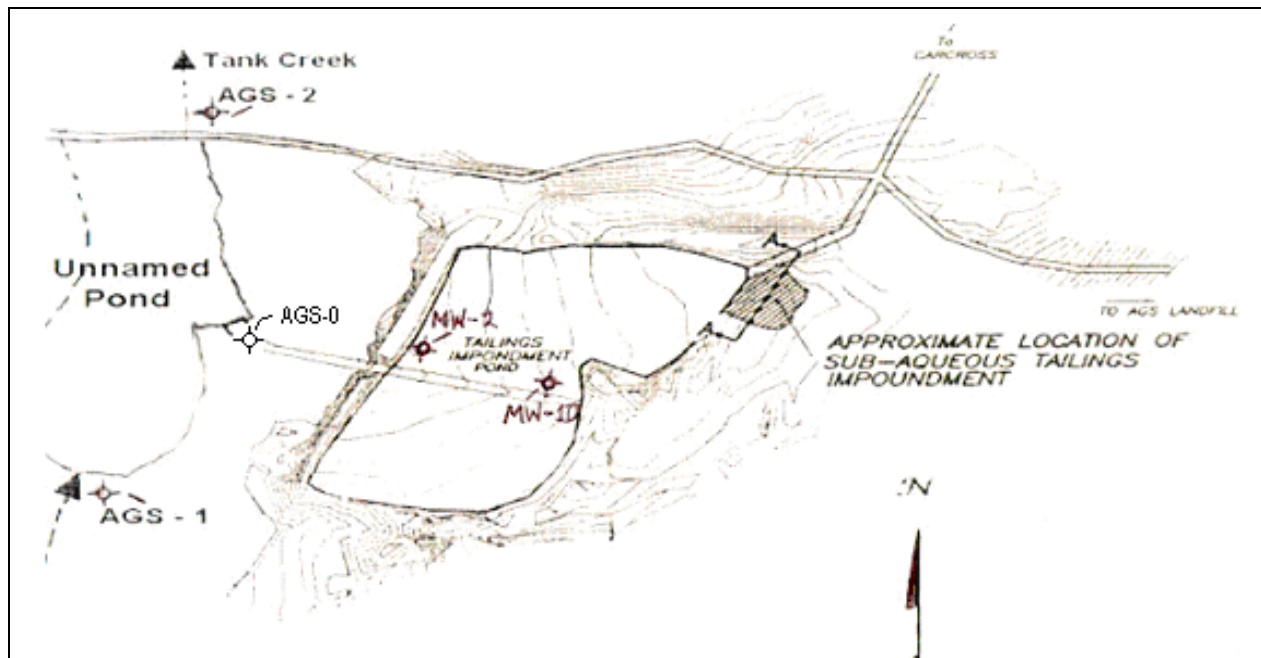
Figure 2: Water Sampling Locations

Groundwater samples were taken from two selected monitoring wells (MW-2 and MW-1D) within the tailings impoundment area (see **Figure 2**). The well volume was established and each well was purged (3 x well volume) prior to sampling. Water quality data as recorded on site is shown in **Table 1**. The samples were filtered (0.45 μm) and sent to an accredited laboratory for dissolved metals analysis.

Surface water samples were taken from Tank Creek at the inflow (AGS-1) and outflow (AGS-2) of the unnamed lake as well as at the point of seepage from the tailings pile (AGS-0). Water quality data as recorded on site is shown in **Table 1** and sampling locations on **Figure 2**. The samples were filtered (0.45 µm) and sent to an accredited laboratory for dissolved metals analysis.

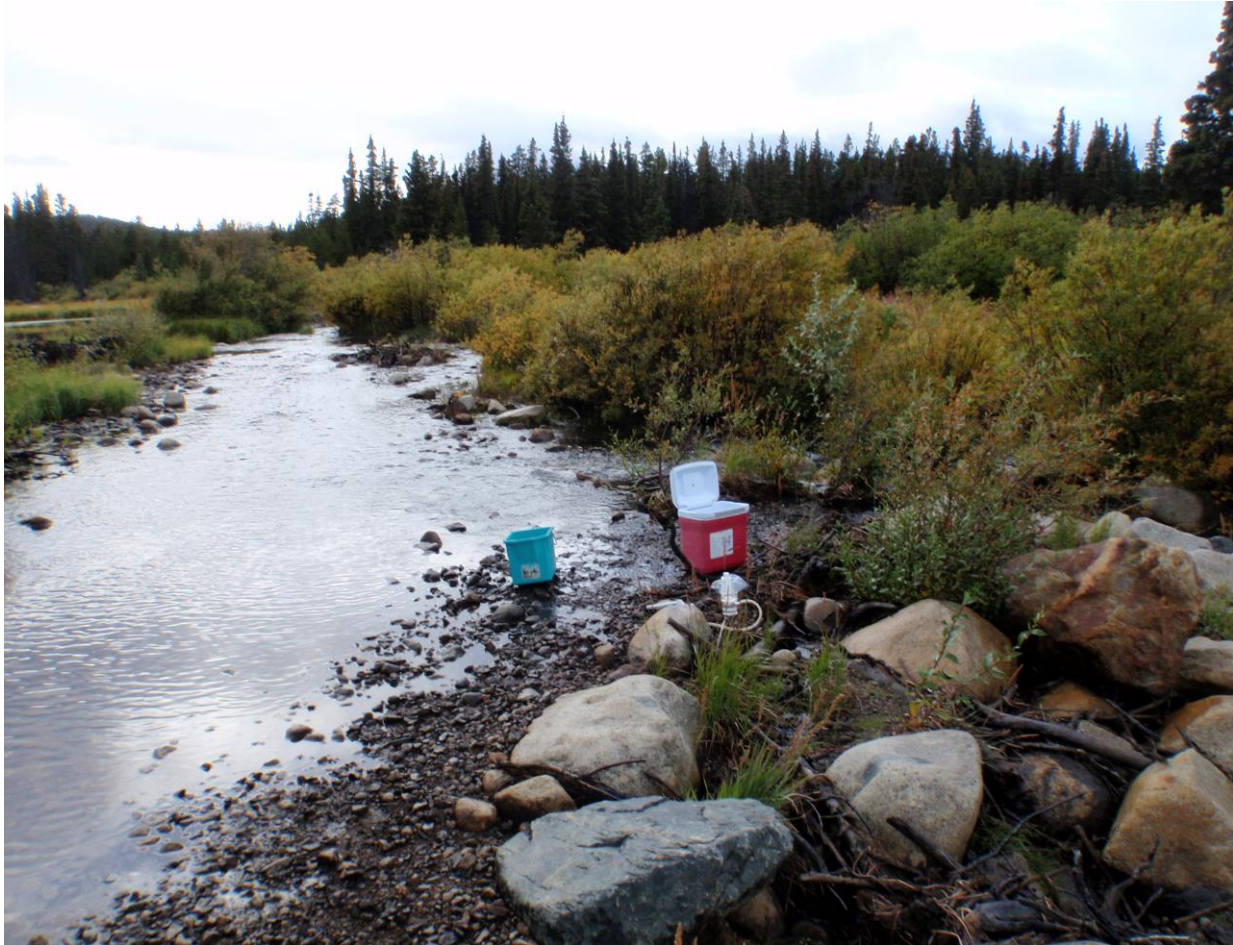
Photo 3: Surface water sampling at the outflow of the unnamed pond.

The analysis of the surface water samples for dissolved metals indicated a slight but insignificant increase in metal content in the outflow sample compared to the inflow (see **Appendix** for analytical report). The concentrations are below the Yukon Contaminated Sites Regulations and CCME guidelines for the protection of aquatic life (YCSR 2002, CCME 2002).

The annual monitoring will be continued.
