Re: EBA Engineering Report “Assessment of Rail Car and Small Mixing Tank - Mount Nansen Site - Yukon” (November 2012)

ASSESSMENT OF RAIL CAR AND SMALL MIXING TANK MOUNT NANSEN SITE YUKON

NOVEMBER 2012
ISSUED FOR USE
EBA FILE: W23101576

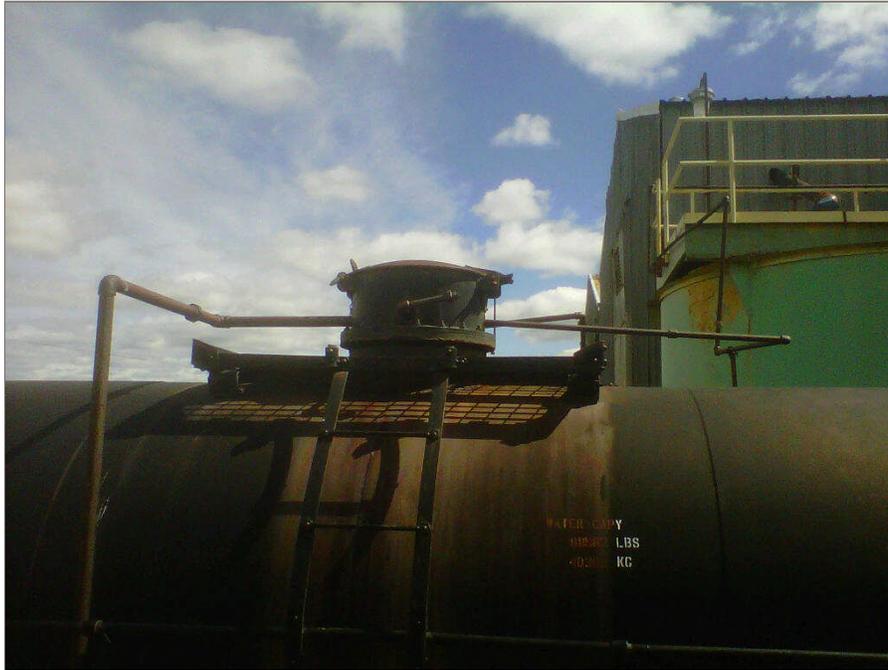
Black paint on the exterior of the rail car was determined to be lead based (> 90 ppm) as per Inductively Coupled Plasma analysis. Toxicity Characteristic Leachate Properties analysis determined that the paint and substrate do not require regulated disposal as per the Hazardous Products Act (< 5 ppm).

Based on the findings of our assessment, the black paint on the exterior of the rail car was determined to be lead based (> 90 ppm)(EBA sample # EBA-LBP-001) as per ICP analysis. TCLP analysis determined that the paint and substrate do not require regulated disposal as per the Hazardous Products Act (< 5 ppm). The paint was deemed to be in fair condition at the time of assessment as depicted by photograph No. 1.

Photo 1: H₂SO₄ Rail car with small green mixing tank in back ground. EBA LBP sample number EBA-LBP-001 is the black paint associated with the exterior of the rail car.

- The paint and substrate from the exterior of the rail car can be disposed of as general construction waste. During decommissioning activities, ensure the lead based paint (LBP) and substrate are removed and disposed of in accordance with the requirements of the Yukon Workers Compensation Health and Safety Board, the Transportation of Dangerous Goods Act and the Yukon Ministry of Environment. Prior to removal of the LBP, adequate safe work procedures must be developed by the contractor to ensure workers are protected from exposure to finely divided airborne lead particles during the demolition work. During demolition of the rail car, if LBP are to be demolished in place, the contractor must implement an exposure control plan.

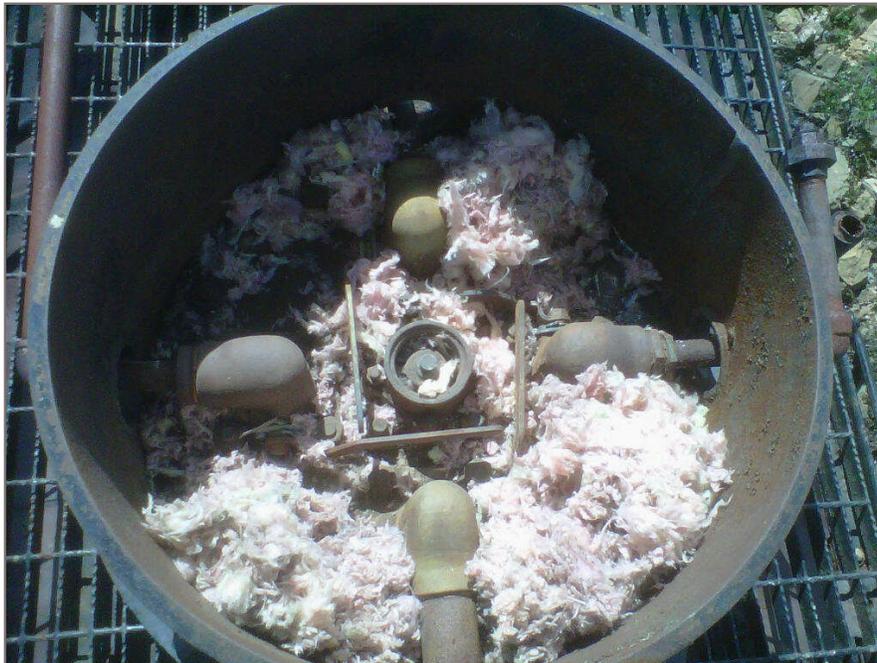
At the top plate there were four valves, one associated with each distribution pipe and EBA attempted to move a valve to the open position to access a bolt. When the valve was actuated, the associated pipe became pressurized. EBA is unsure if the pressurization of the pipe was vapour or liquid contents from the rail car. As EBA is not certified nor trained to access pressurized vessels, the valve was returned to initial position and the assessment ceased immediately due to health and safety concerns. This information was relayed to Jeff Moore with AAM whom was onsite at the time of assessment.

Photo 2: Piping and associated valves entering the top hatch of the rail car.

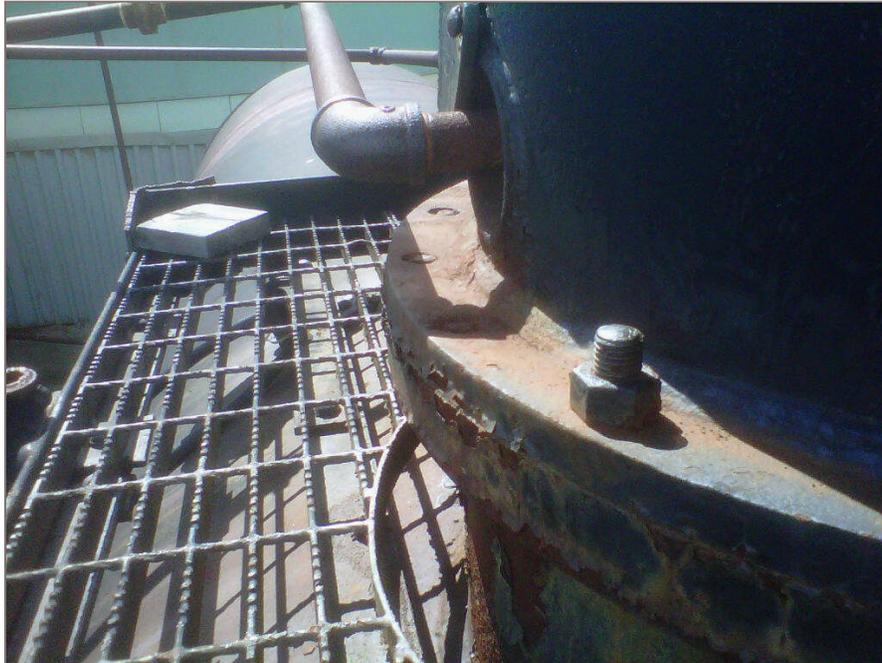
At the time of assessment, EBA attempted to determine if the remaining bolts holding the hatch could be removed with the use of a wrench. EBA determined that the bolts holding the hatch and plate would require a cutting device as they were rusted and seized. EBA attempted and could not remove any of the bolts with the equipment available at the site.

Photo 3: Exterior bolts holding the top hatch and plate in place. Evidence of bolts historically removed in the background.

- The top plate and hatch at the top of the rail car may require either a plasma torch or grinding wheel to cut each stud at the plate below the bolt. When the plate and hatch are released from the rail car, a small hoist attachment may be required to safely move the plate and hatch. EBA estimates the weight of the units combined to be approximately 100 kg. This cannot be safely maneuvered by a person due to the location and the round aspect at the top of the rail car.
- If interior contents are present, EBA recommends qualified personnel be employed to sample contents for classification and comparison against YCSR and MMER to determine disposal procedures. All work should be completed in accordance with, but not limited to, the Yukon Workers Compensation Health and Safety Board, the Transportation of Dangerous Goods Act and the Yukon Ministry of Environment.

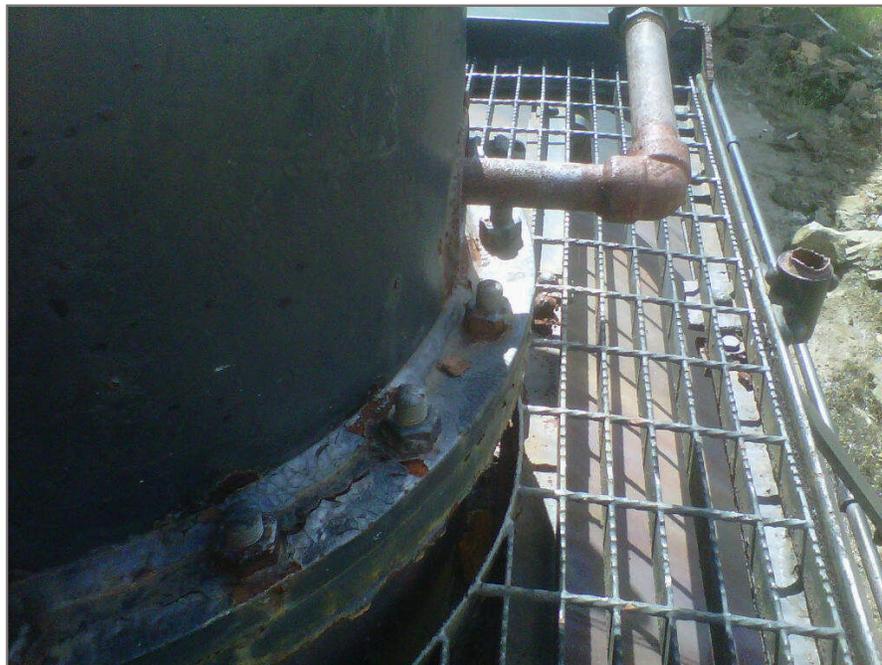
Photo 4: Exterior bolts holding the top hatch and plate in place.
