**ASSESSMENTS OF THE REVEGETATION OPTIONS  
CONDUCTED AT THE  
WASTE ROCK DUMP AT CLINTON CREEK  
- YEAR THREE -**

**ASSESSMENT AND ABANDONED MINES**

**Laberge**  
ENVIRONMENTAL SERVICES

March 2012

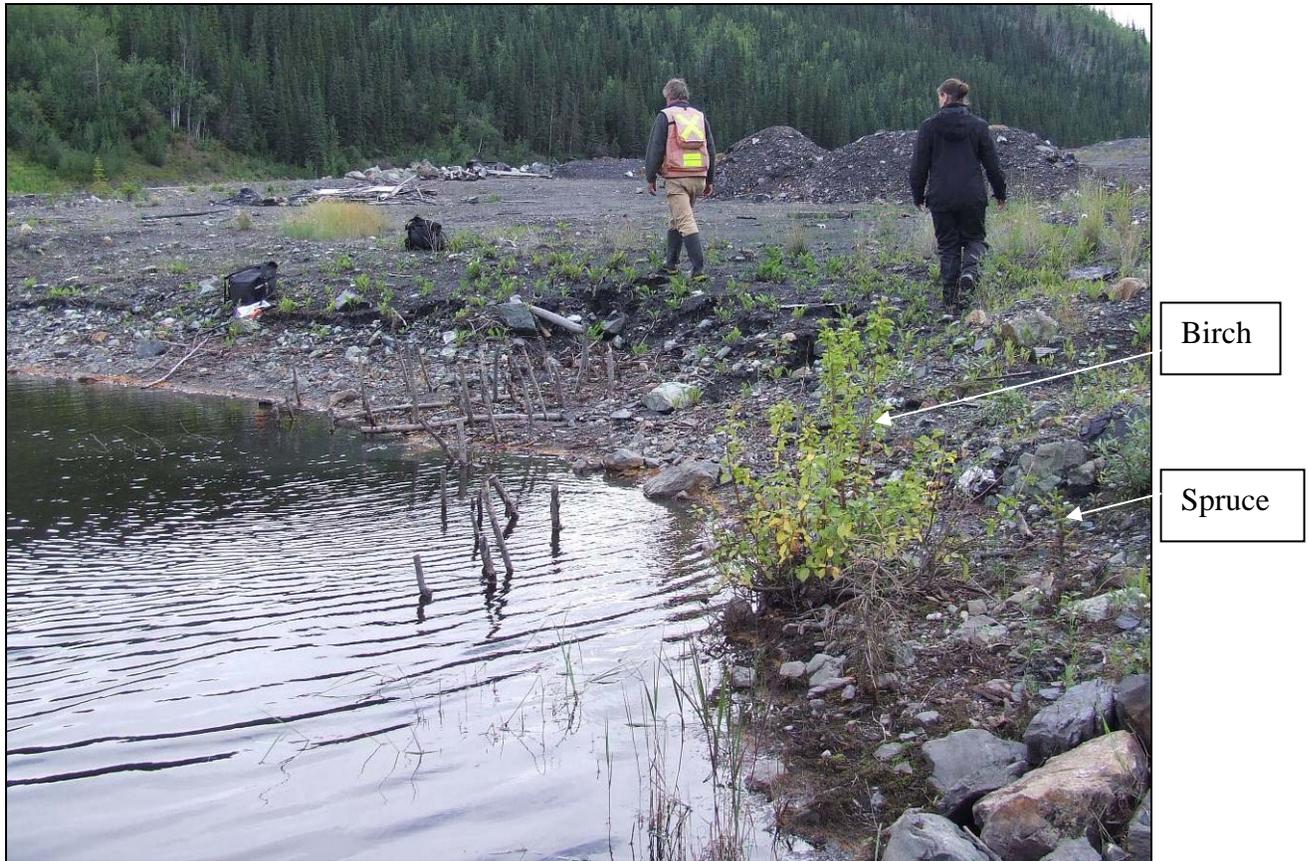
During the 2011 survey, all stakes were dead. Natural colonization of the riparian area by dandelions was occurring. A volunteer birch shrub and a spruce sapling were also observed (Photo #1, Appendix C).

Photo #1; There is no survival of the live staking at Hudgeon Lake, however volunteer dandelion, birch and spruce are colonizing the riparian area.

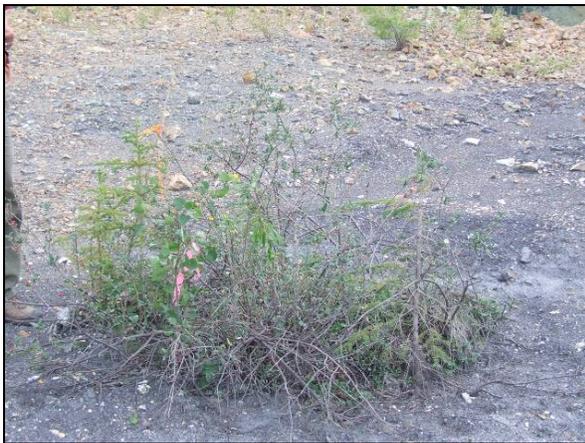
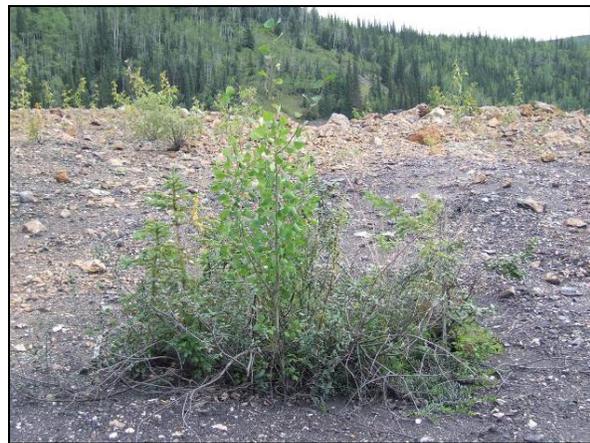
Photo # 2; Plot I-2 on July 21, 2009.

Photo #3; Plot I-2 on July 26, 2011. Note the increased growth of the aspen and undergrowth.

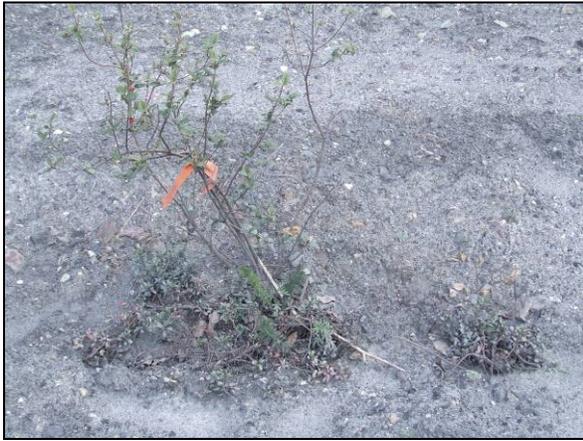
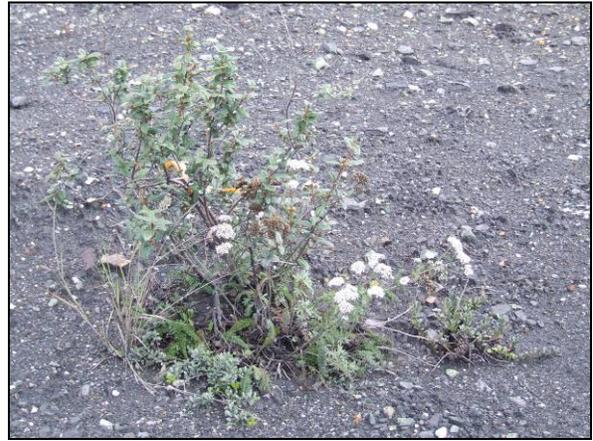
<b>Plot #</b>	<b>Treatment</b>	<b>Comments and Species (common names) Observed</b>
IC-1B	Island within community	Overall appears very healthy, increased growth from 2009, soapberry in berry, willow with catkin, yarrow, Jacob's ladder, kinnikinnick.
IC-1C	Island within community	Vegetation appears healthier than in 2009, 4 spruce, a small poplar, willow, shrubby cinquefoil in flower, kinnikinnick, fleabane, dandelion.
IC-1D	Island within community	Increased growth from 2009, several aspen – all healthy, 3 healthy spruce, poplar leaning a bit more than in 2009 but still healthy, shrubby cinquefoil in flower, soapberry, fireweed, many flowering crepis, dandelion, kinnikinnick.
I-1	Individual island	Overall appears fairly healthy. 3 spruce trees - one with cone, poplar and willow growing but not robust, shrubby cinquefoil, fireweed, foxtail, wheatgrass, alkali grass, aster and dandelion.
I-2	Individual island	Overall appears very healthy, increased growth from 2009. 6 spruce – 1 dead, 1 broken, kinnikinnick with berries, 2 willow, 2 aspen, soapberry with berries, shrubby cinquefoil – had flowered, rose, yarrow, fireweed, Jacob's ladder, grasses.

Photo #4; Plot IC-1B on July 21, 2009.

Photo #5; Plot IC-1B on July 26, 2011. Note the robust growth of the soapberry bush plus the introduction of yarrow plants.

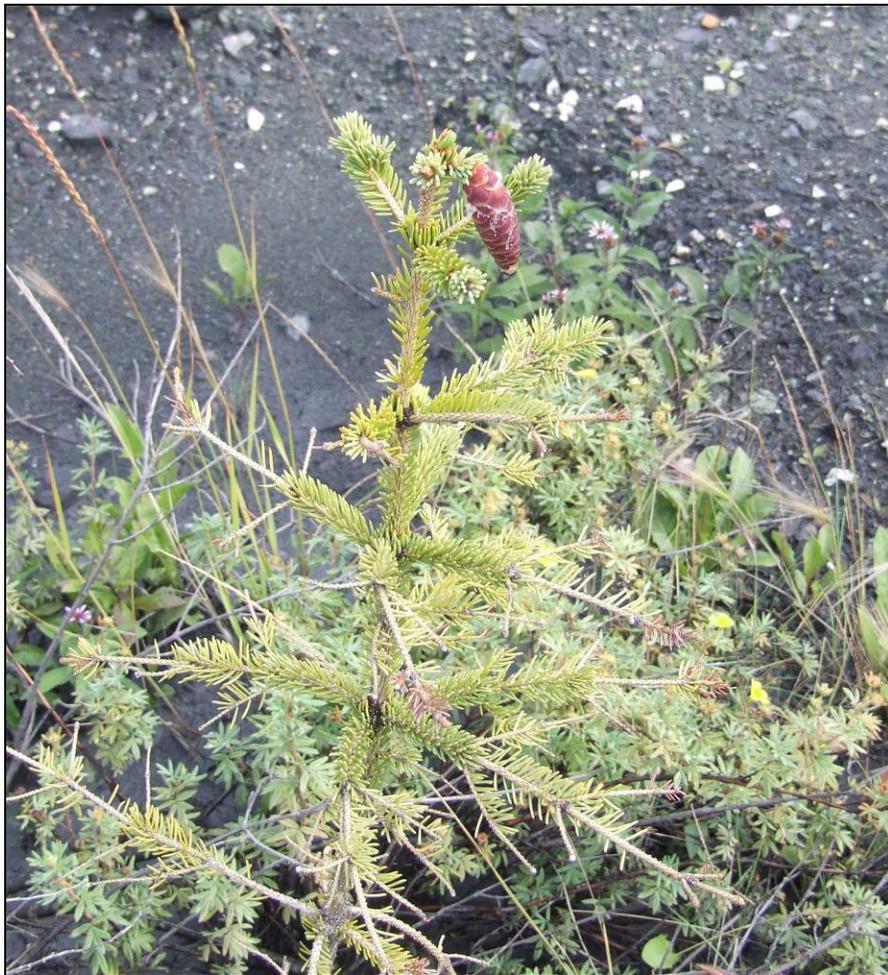
Photo #6; The spruce tree in plot I-1 had produced a cone, July 26, 2011.

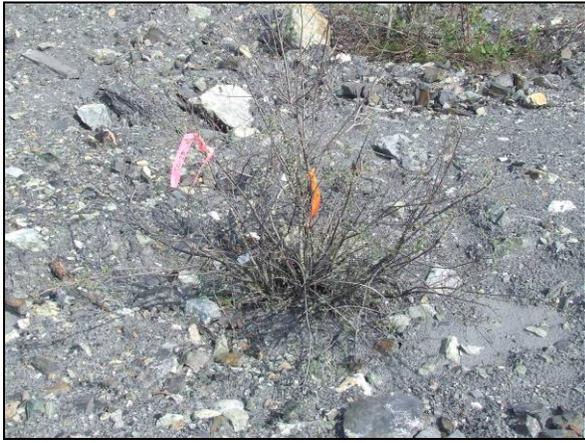
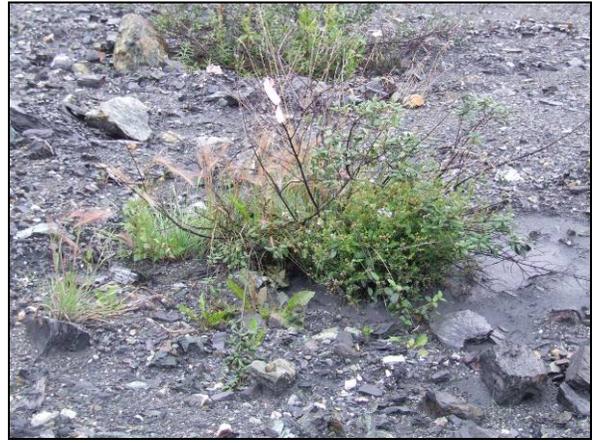
The layout of the various treatment methods at Plot 2 is displayed in Figure 3. For the most part, the islands on this plot were doing extremely well. The islands within the community particularly displayed increased and robust growth since July 2009. A notable example of this was Plot # IC-2B which appeared to have very low survival of any plants in 2009 yet showed robust healthy growth of several species in July 2011 (Photos #7 and 8).

Photo #7; Minimal growth at IC-2B, July '09

Photo #8; Increased growth of vegetation at IC-2B. Note spreading of dandelion and foxtail beyond island perimeter, July 26, 2011.

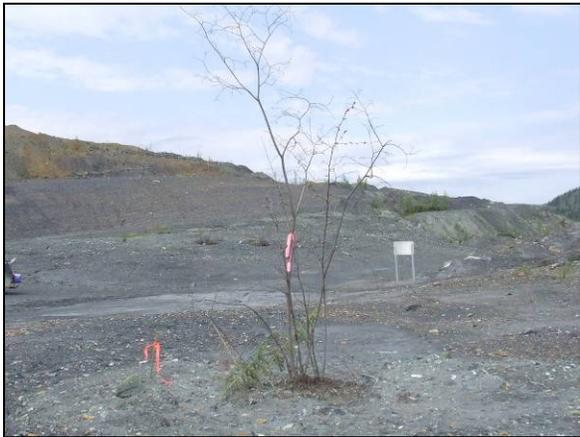
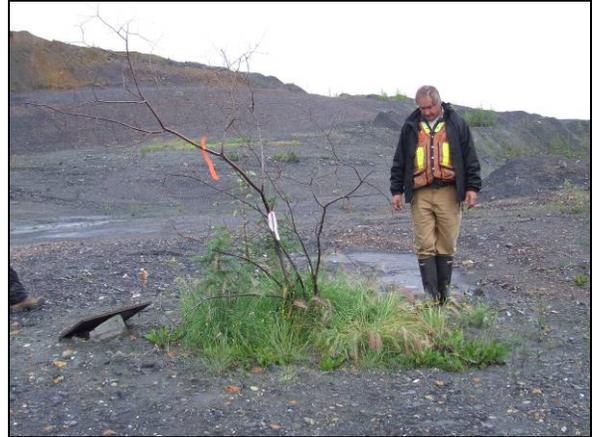
<b>Plot #</b>	<b>Treatment</b>	<b>Comments and Species (common names) Observed</b>
I-3	Individual vegetation island	Much greater growth than in 2009. Several small willows, one dead willow, poplar, 2 healthy white spruce, 1 dead spruce, dandelion, hawks beard – appears to be spreading, Jacob’s ladder, fleabane, dandelion, alkali grass in seed, foxtail.
I-4	Individual island	The health and growth of this island has improved considerably since 2009. 1 aspen, 1 willow, 1 spruce (healthy), 3 dead spruce, plentiful fireweed and hawks beard in flower, mustard, dandelion, alkali grass in seed and spreading.
I-5	Individual island	Very little change since 2009. 2 spruce, willow, poplar, soapberry, wheatgrass, foxtail, alkali grass.
I-6	Individual island	An increase in growth since 2009. 1 healthy large birch, 1 dead birch, willow with blotch miner, 1 spruce and seedling, 1 aspen with leaf miner, shrubby cinquefoil, twin flower, fireweed, bromegrass.

Photo #9; Minimal growth at I-3, July 21, 2009.

Photo #10; Considerable increase in ground cover at I-3 on July 26, 2011.

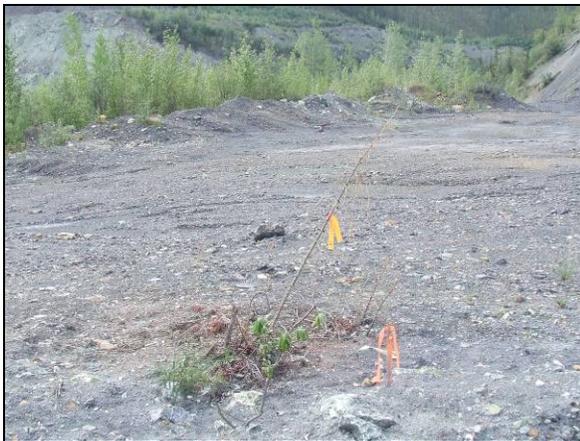
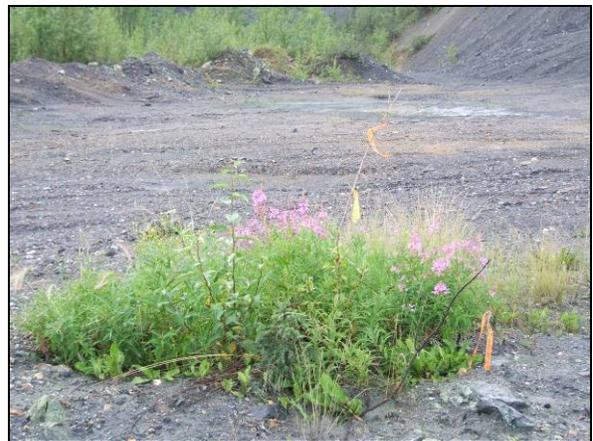
Photo #11; Minimal growth at I-4, July 21, 2009.

Photo #12; Considerable increase in growth and biodiversity at I-4 on July 26, 2011.

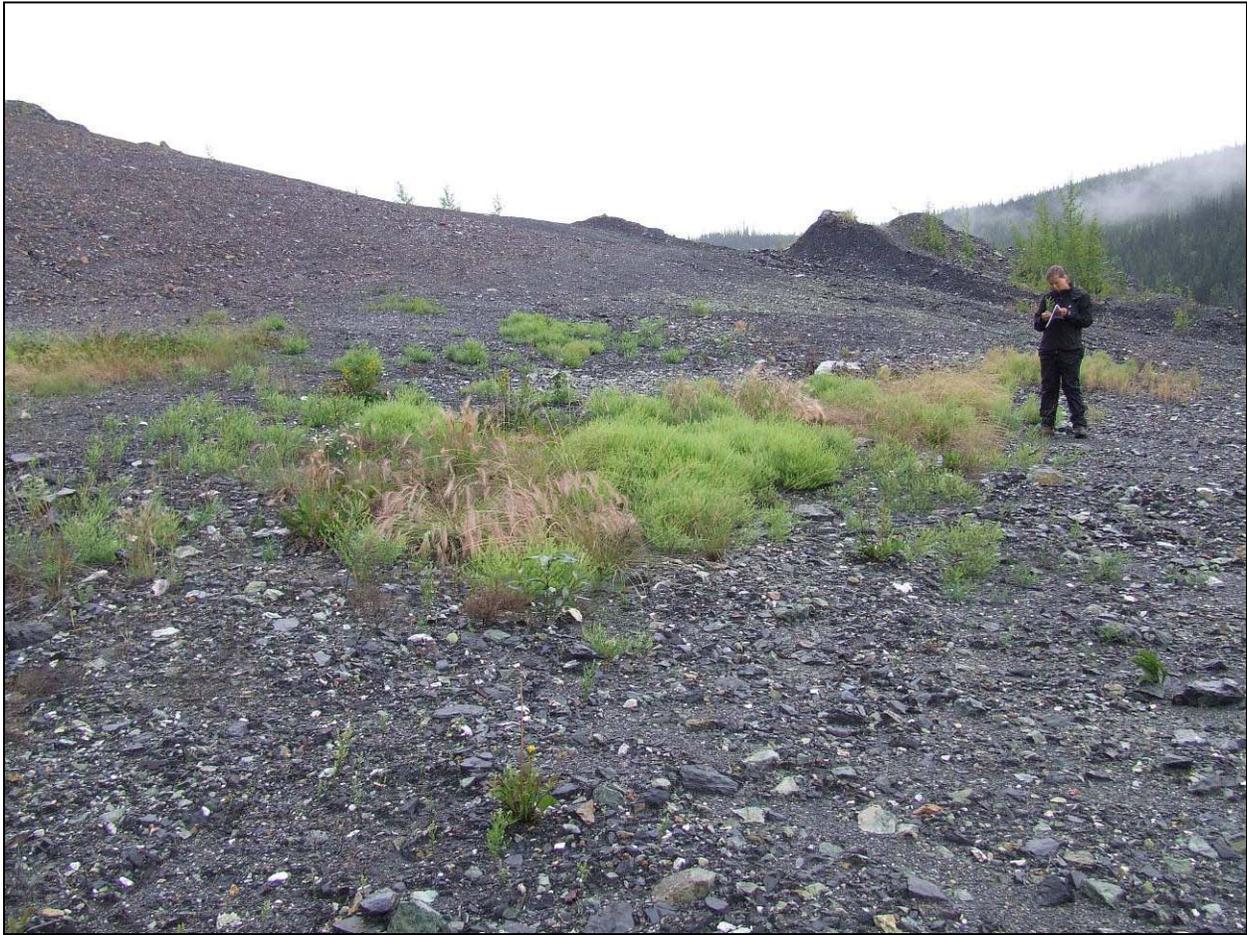
There are areas throughout the waste rock dump where natural colonization has been occurring with no anthropogenic assistance. One such area is the recent development of a large patch of mustard (*Descurainia* sp.) with occurrences of foxtail and dandelion (Photo #13) located approximately 100 m upslope from the island community at Plot #2, IC-2.

Photo #13; A large and expanding patch largely composed of Tansy mustard (*Descurainia sp.*) naturally colonizing the area upslope of the island community IC-2 at Plot #2.

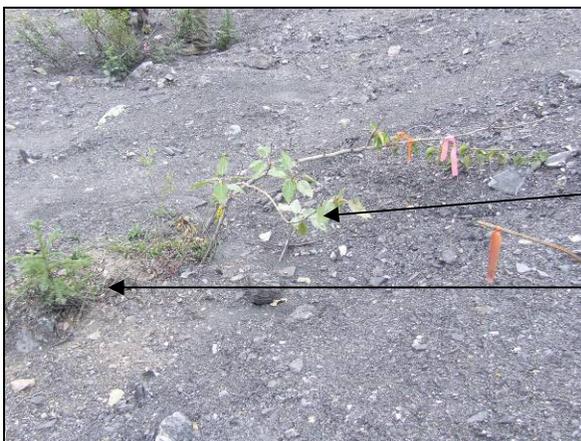
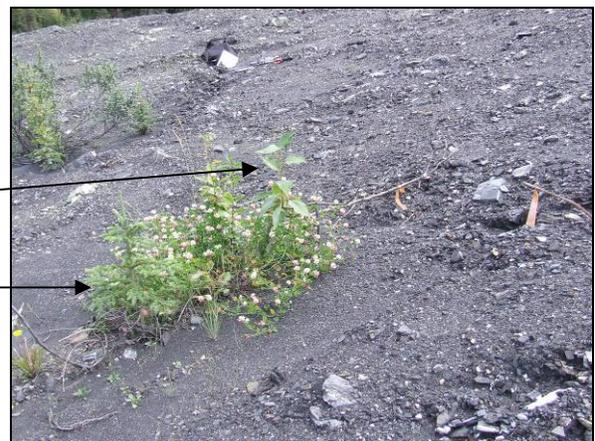
There are two island communities at Plot 3 representing a total of 9 islands (Figure 4). Detailed descriptions of the observations on each island are summarized in Table 5. When Plot #3 was assessed in July 2009, it was observed that at some point prior to the site visit, an all terrain vehicle had driven over the island IC-3A. This had damaged some of the vegetation, however this plot had recovered significantly when assessed on July 26, 2011 (see Photos #14 and 15).

<b>Plot #</b>	<b>Treatment</b>	<b>Comments and Species (common names) Observed</b>
IC-3A	Island within community	This island has recovered well from the damage it suffered when driven over by an ATV sometime in 2008 or 2009. Poplar – prone one is dead, 1 healthy spruce, kinnikinnick, clover, foxtail, dandelion, vegetation is spreading.
IC-3B	Island within community	Increased growth since 2009. 4 spruce, willow, aspen, poplar, soapberry in berry, kinnikinnick, fireweed, aster, dandelion, Jacob's ladder.
IC-3C	Island within community	Increased growth since 2009. 2 spruce, willow, poplar with galls, soapberry in berry, shrubby cinquefoil, aster, yarrow, dandelion, plantain, wheatgrass, fescue, foxtail.
IC-3D	Island within community	Increased growth since 2009 and spreading. Aspen, spruce, willow, shrubby cinquefoil, soapberry, milk vetch in seed, death camas, fireweed, dandelion, and aster, yarrow and golden rod in flower, fescue.

Photo #14; Plot IC-3A on July 21, 2009.

Photo #15; Increased growth on Plot IC-3A on July 26, 2011, with some spreading of dandelion and grass. Note the increased growth of the spruce tree and the straightening of the poplar.

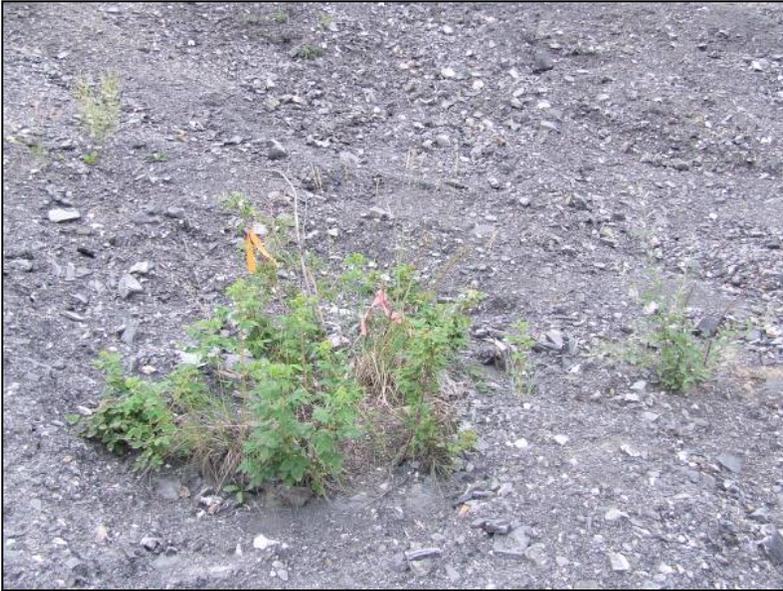
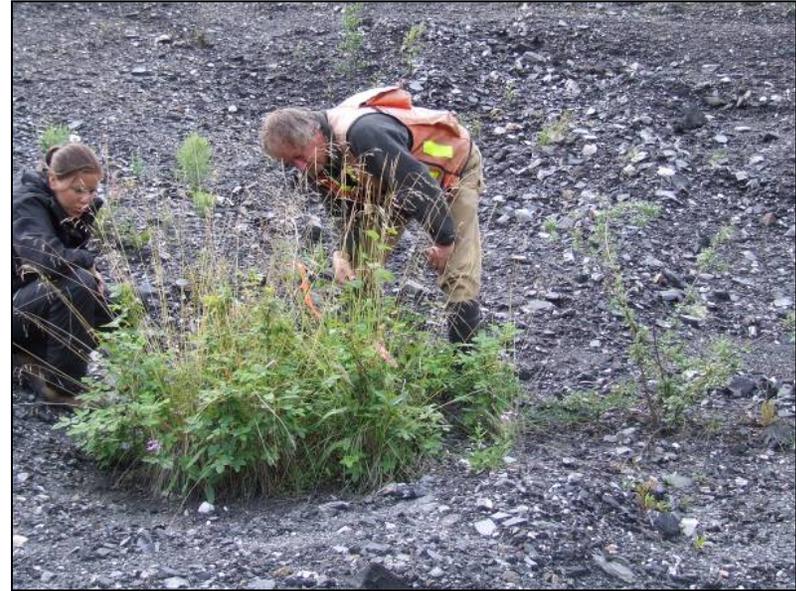
All islands exhibited a healthy state and most of them supported increased vigorous growth. An example of this occurred at Plot IC-4B (Photos #16 and 17). As with Plots 1 and 2, many of the plants were in seed or blooming. There was also evidence of several species of plants spreading from the original site of the translocated island. In 2008 prior to the installation of the islands, the ground for the sites was prepared through mechanical scarification and excavation resulting in terrain devoid of any plant life. Photographs 18 and 19 show the island community of IC-4 immediately after the islands were installed in September 2008, and in July 2011 respectively. Although the photos are small in the printed report, it can be observed that natural colonization beyond the islands has been occurring.

IC-4A	Island within community	Healthy and similar to 2009. 3 spruce, poplar, willow, soapberry in berry, dandelion in flower, goldenrod, foxtail.
IC-4B	Island within community	Considerable increase in growth since 2009. Aspen, willow with blotch miner, rose bushes with hips, aster in flower, gentian, languid lady, Jacob's ladder, bluejoint grass, fescue.

Photo #16; Plot IC-4B on July 21, 2009.

Photo #17; Substantial increase in growth on Plot IC-4B on July 26, 2011 with some spreading of dandelion in the foreground.

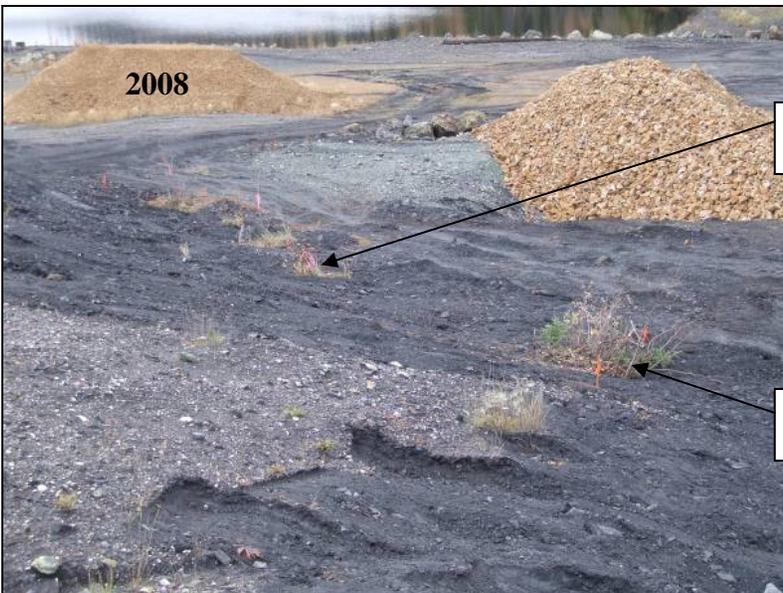
Photo #18; When the islands were transplanted in Sept 2008, the area was previously worked up resulting in an absence of growth.

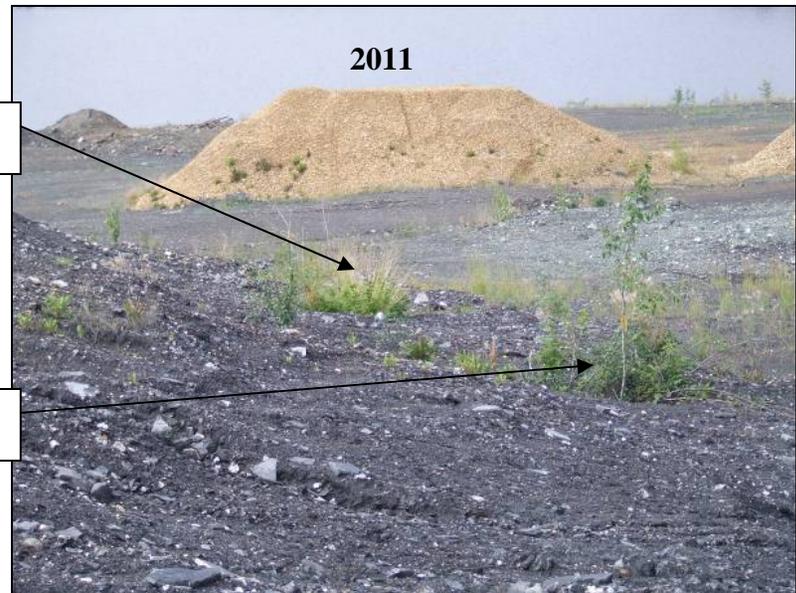
Photo #19; All the plants visible outside of the islands in community IC-4 have colonized naturally since September 2008. Photo taken July 2

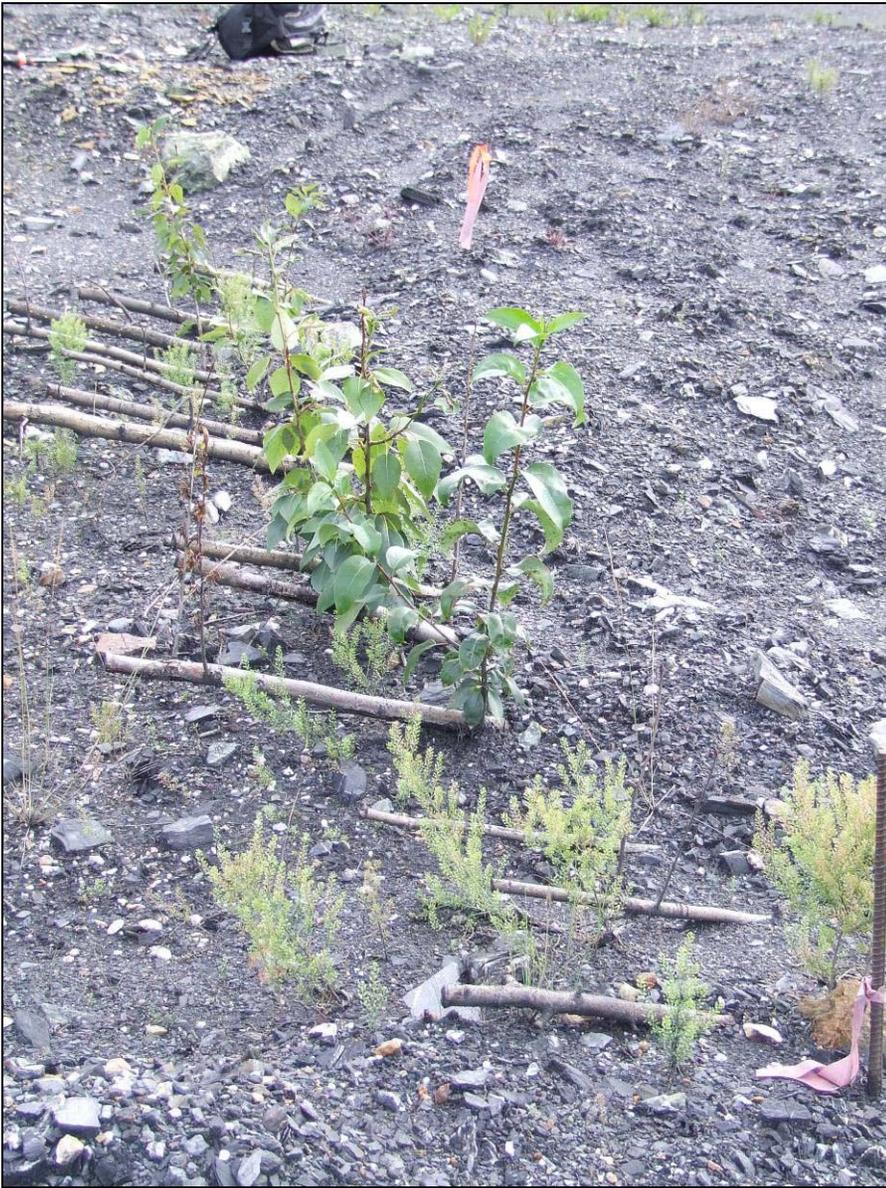
The live trench staking fared better but mortality had increased since 2009. Four of the original 15 poplar stakes were alive (Photo #20) and three of the 15 willow stakes survived. Tansy mustard has notably invaded the plot of the dead willow stakes (Photo #21).

Photo #20; Some survival of the poplar trenched stakes, Plot PS-3.  
Invasion of tansy mustard in some of the plot, July 26, 2011.

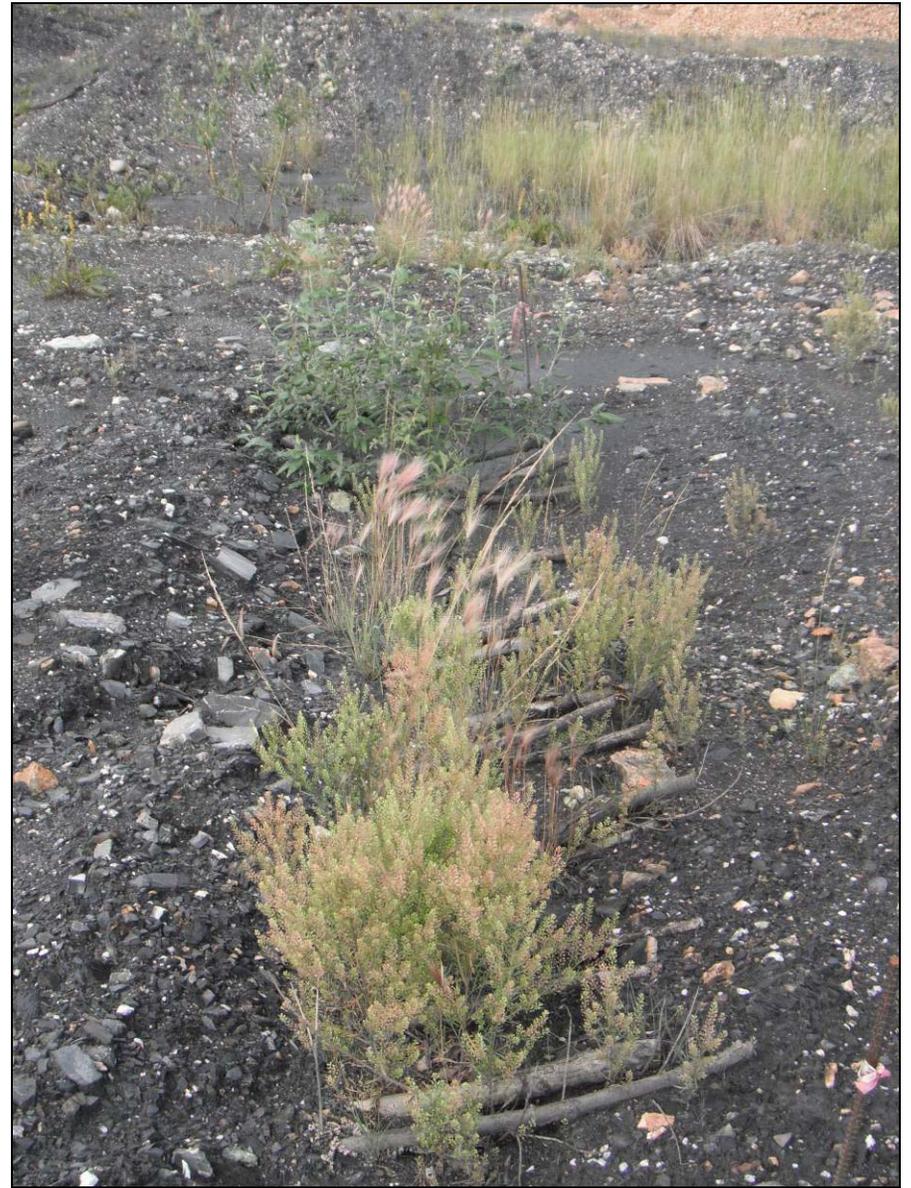
Photo #21; Some survival of the willow trenched stakes, Plot WS-3, on  
July 26, 2011. Prolific growth of tansy mustard and some foxtail within  
the plot.
